| Site Number | Location | Name | Hwy | km |
|---|---|---|---|---|
| PH045 | Hwy 35:08 C1 26.2 | Meikle Pile Wall | 35:08 | Km 26.2 |

**ALBERTA TRANSPORTATION AND ECONOMIC CORRIDORS GRMP (CON0022164)
PEACE REGION (PEACE RIVER DISTRICT)
INSTRUMENTATION MONITORING RESULTS**

SPRING 2024

SITE PH045: HWY 35:08, MEIKLE RIVER (km 26.2 PILE WALL)

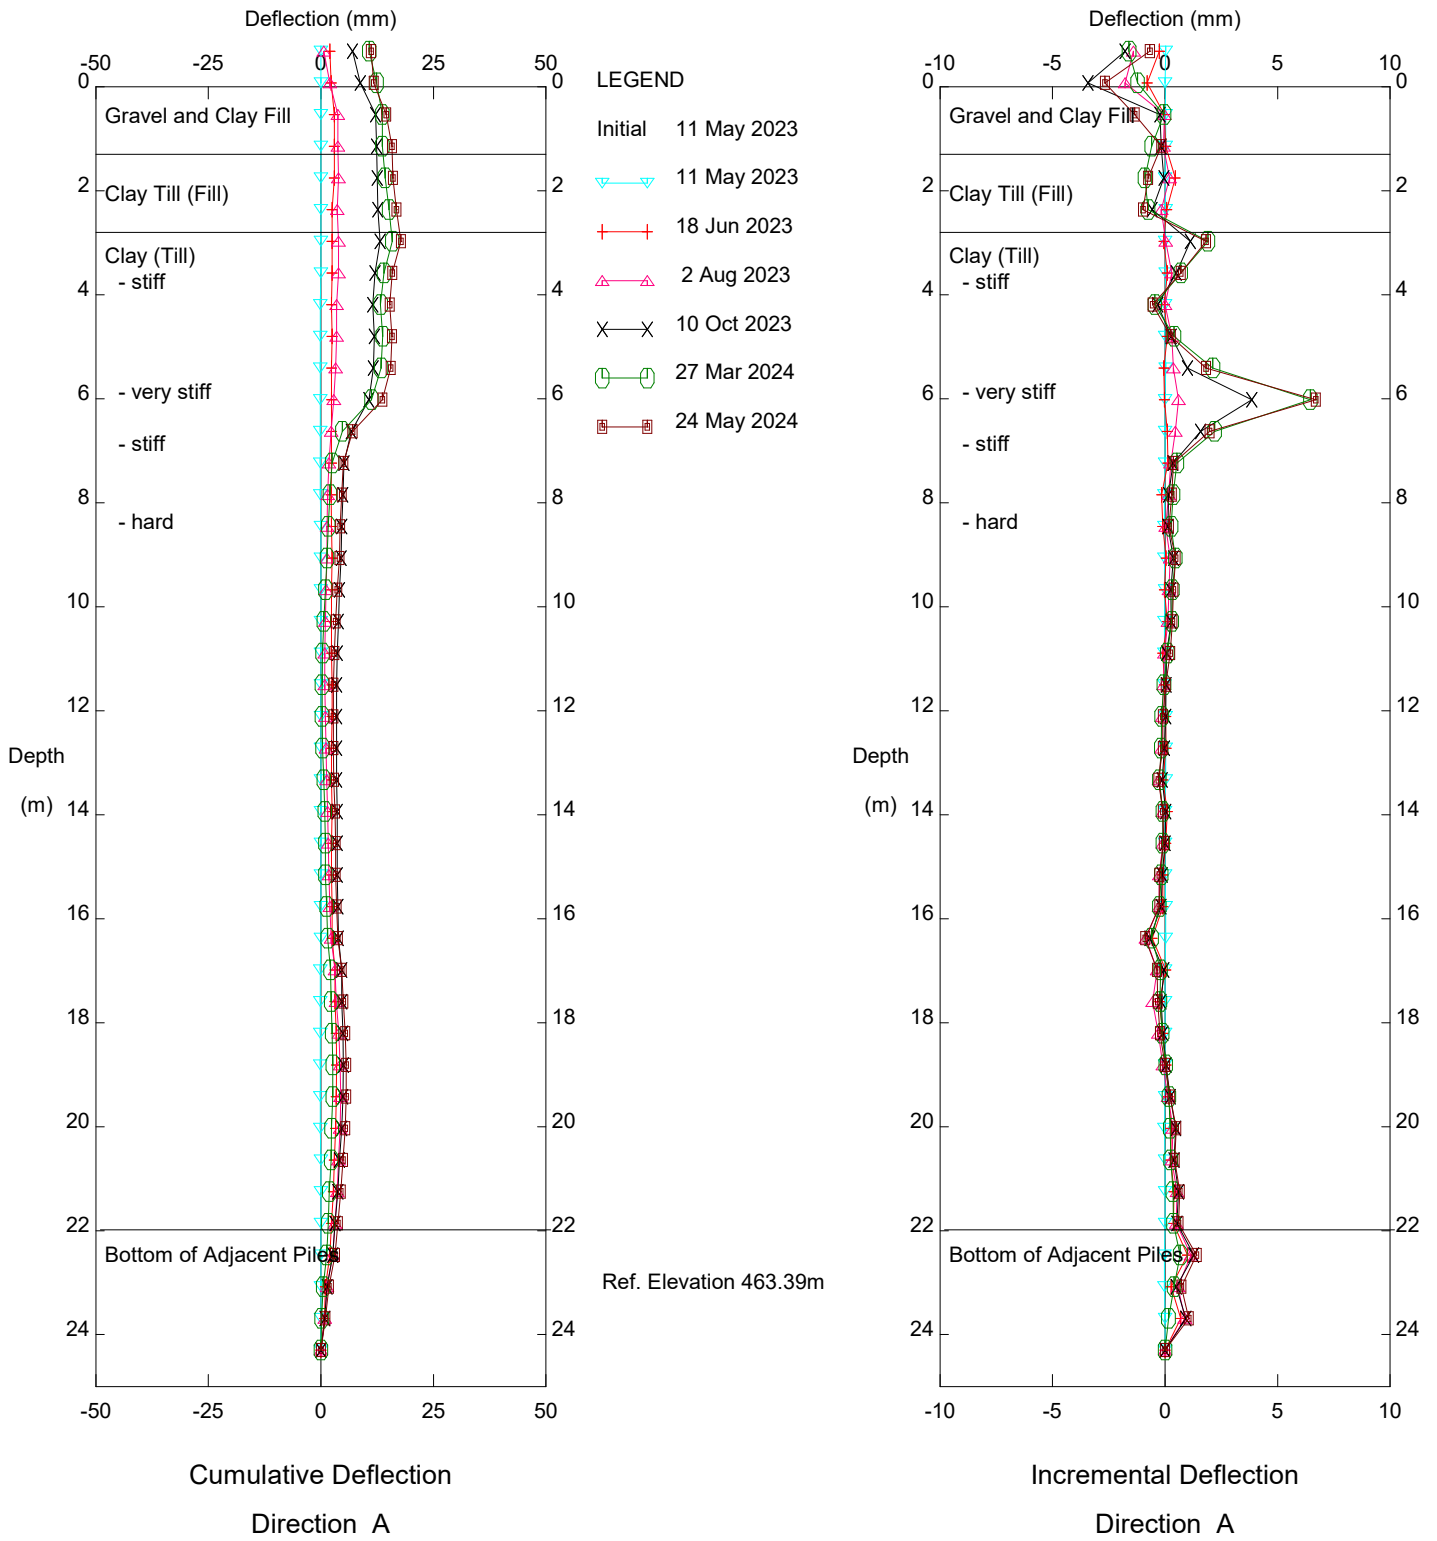
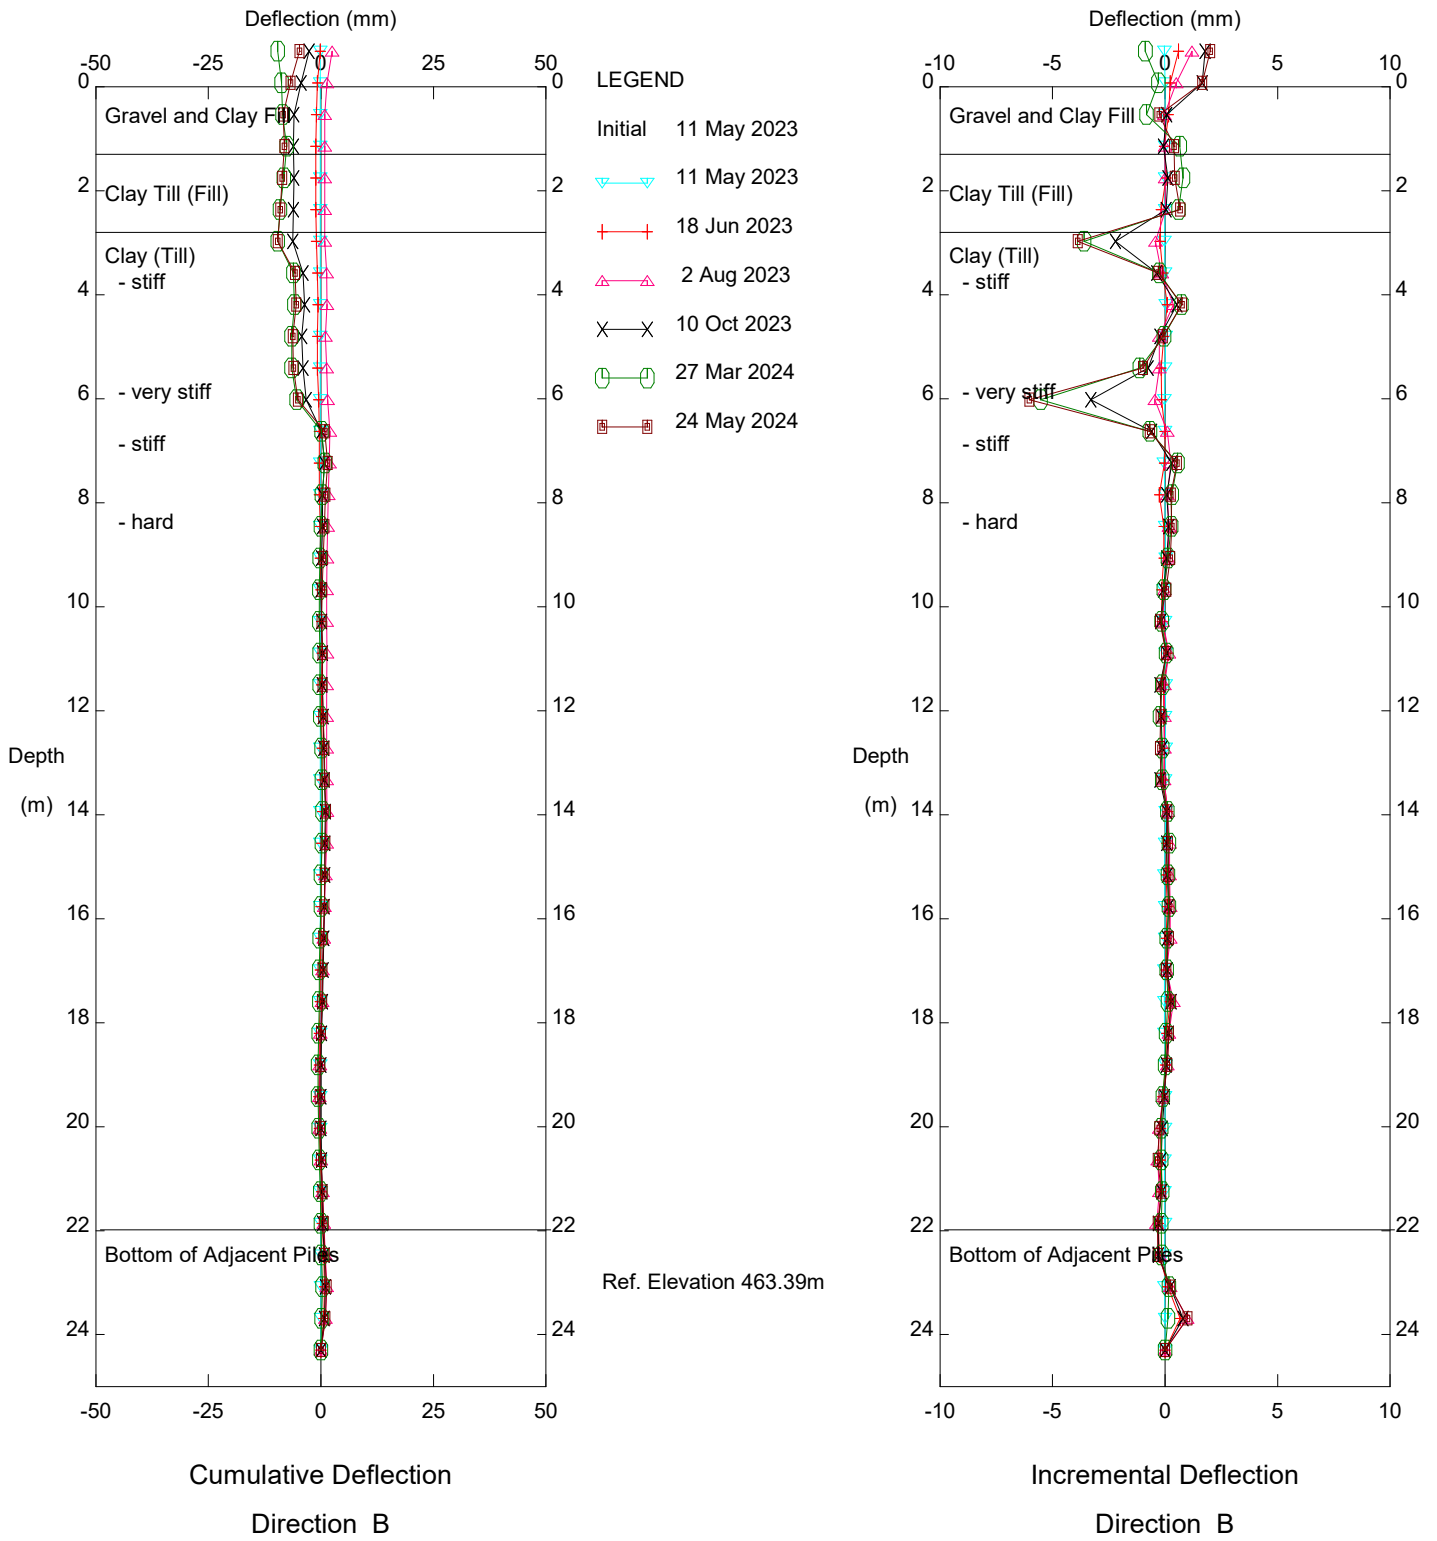
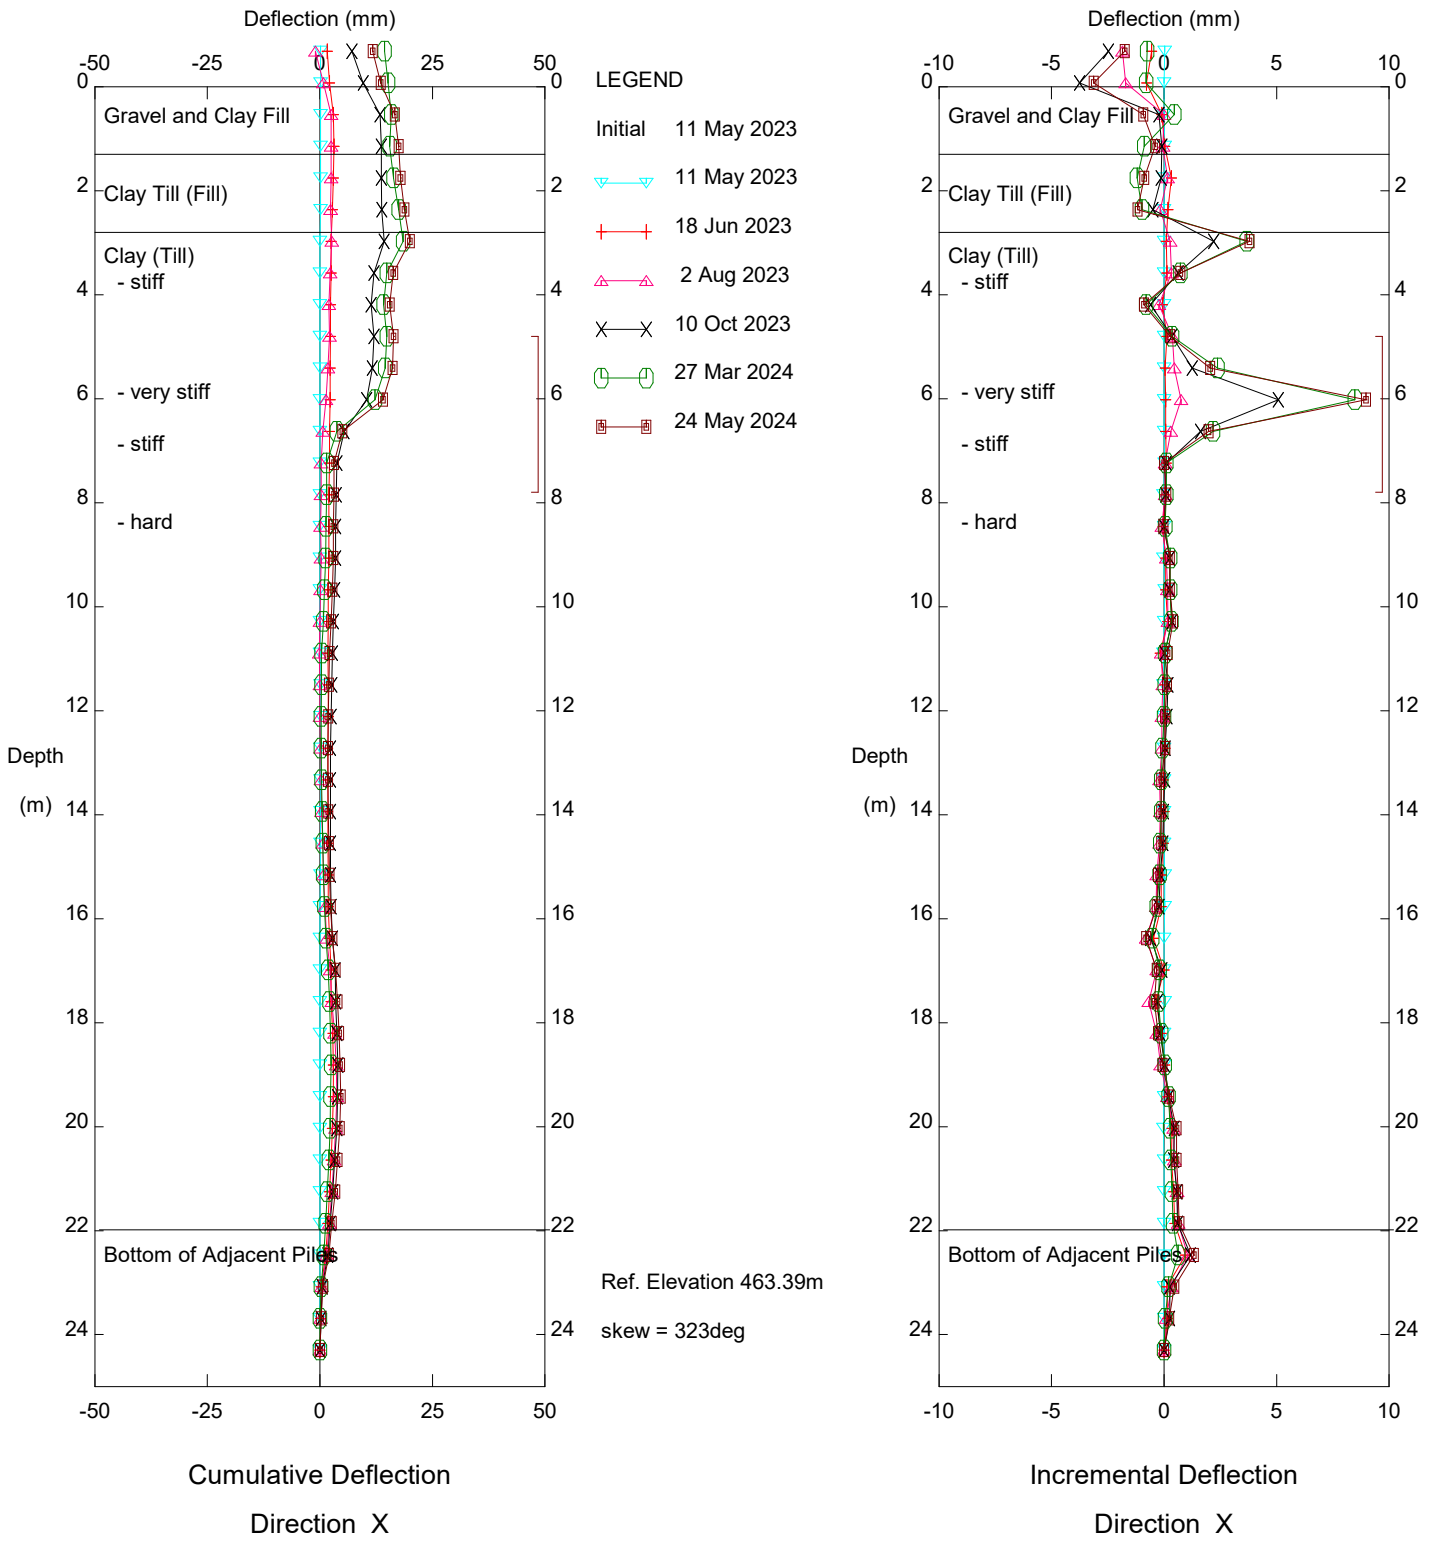
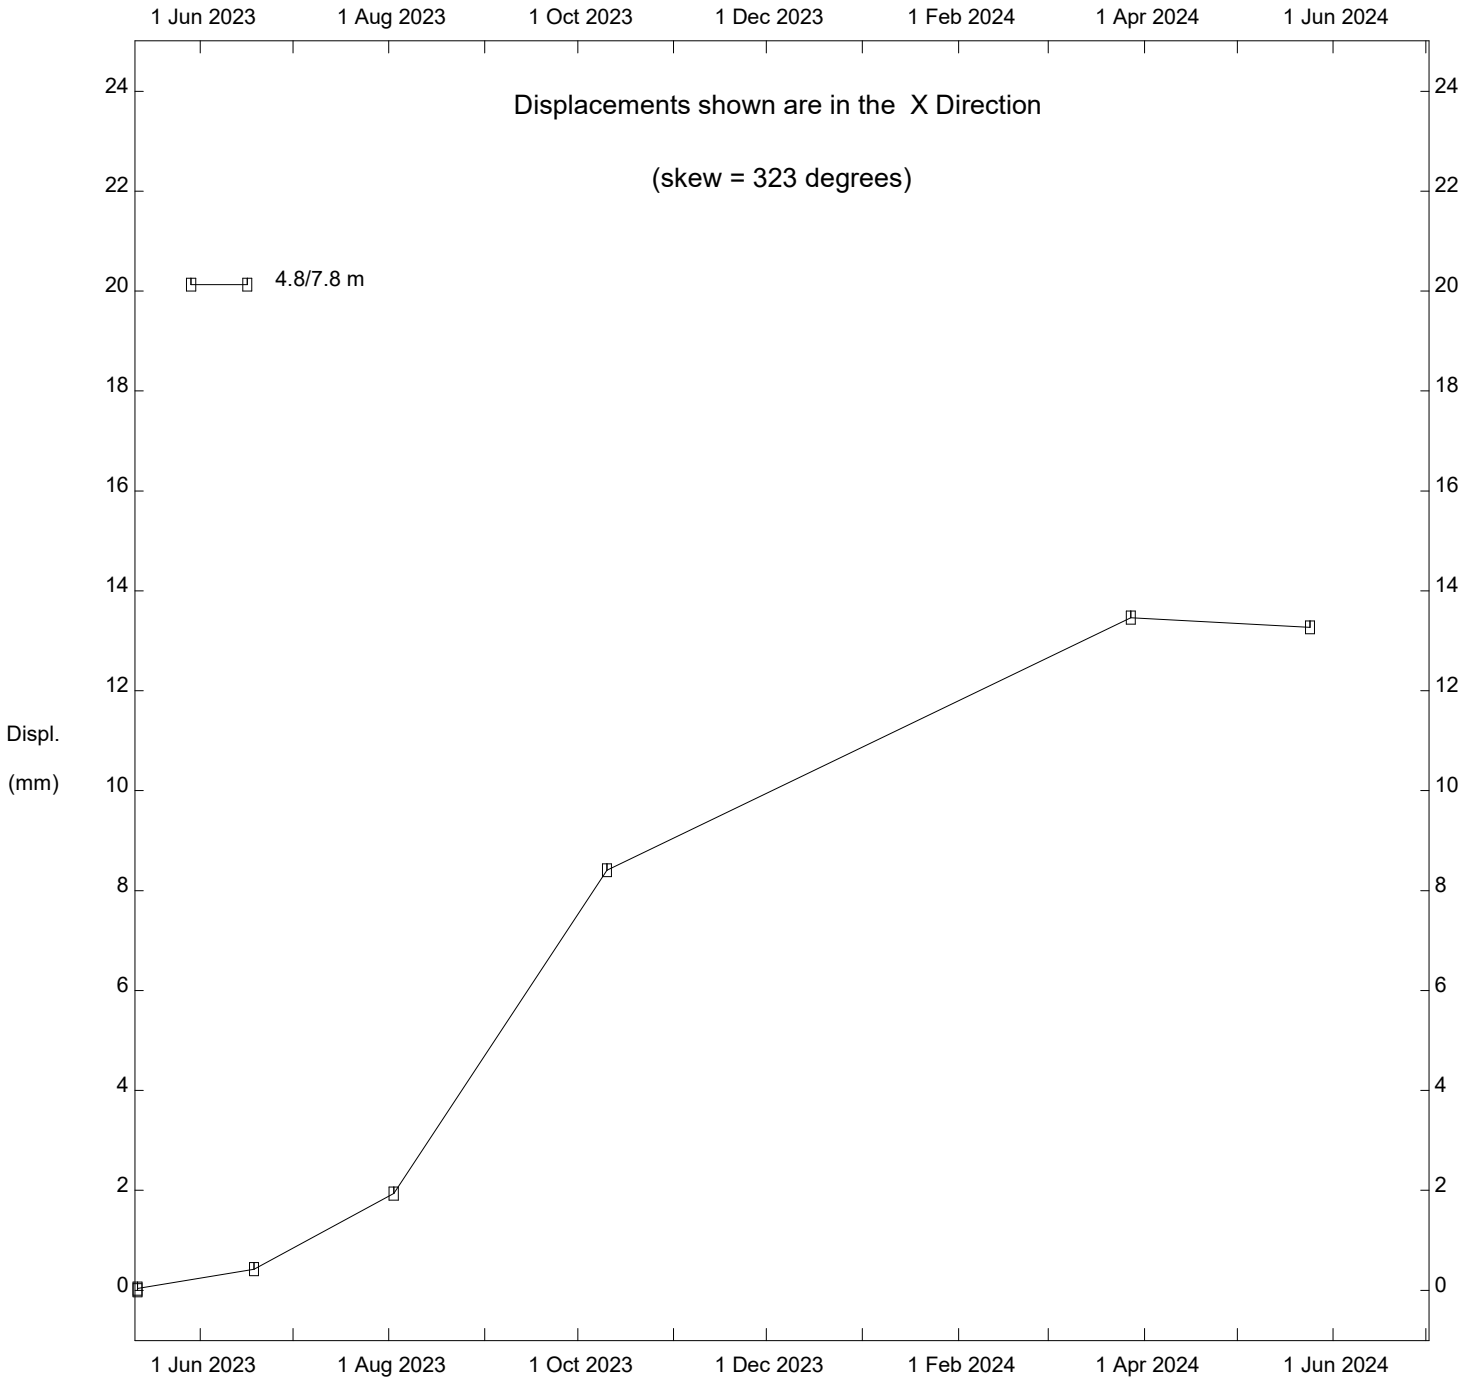
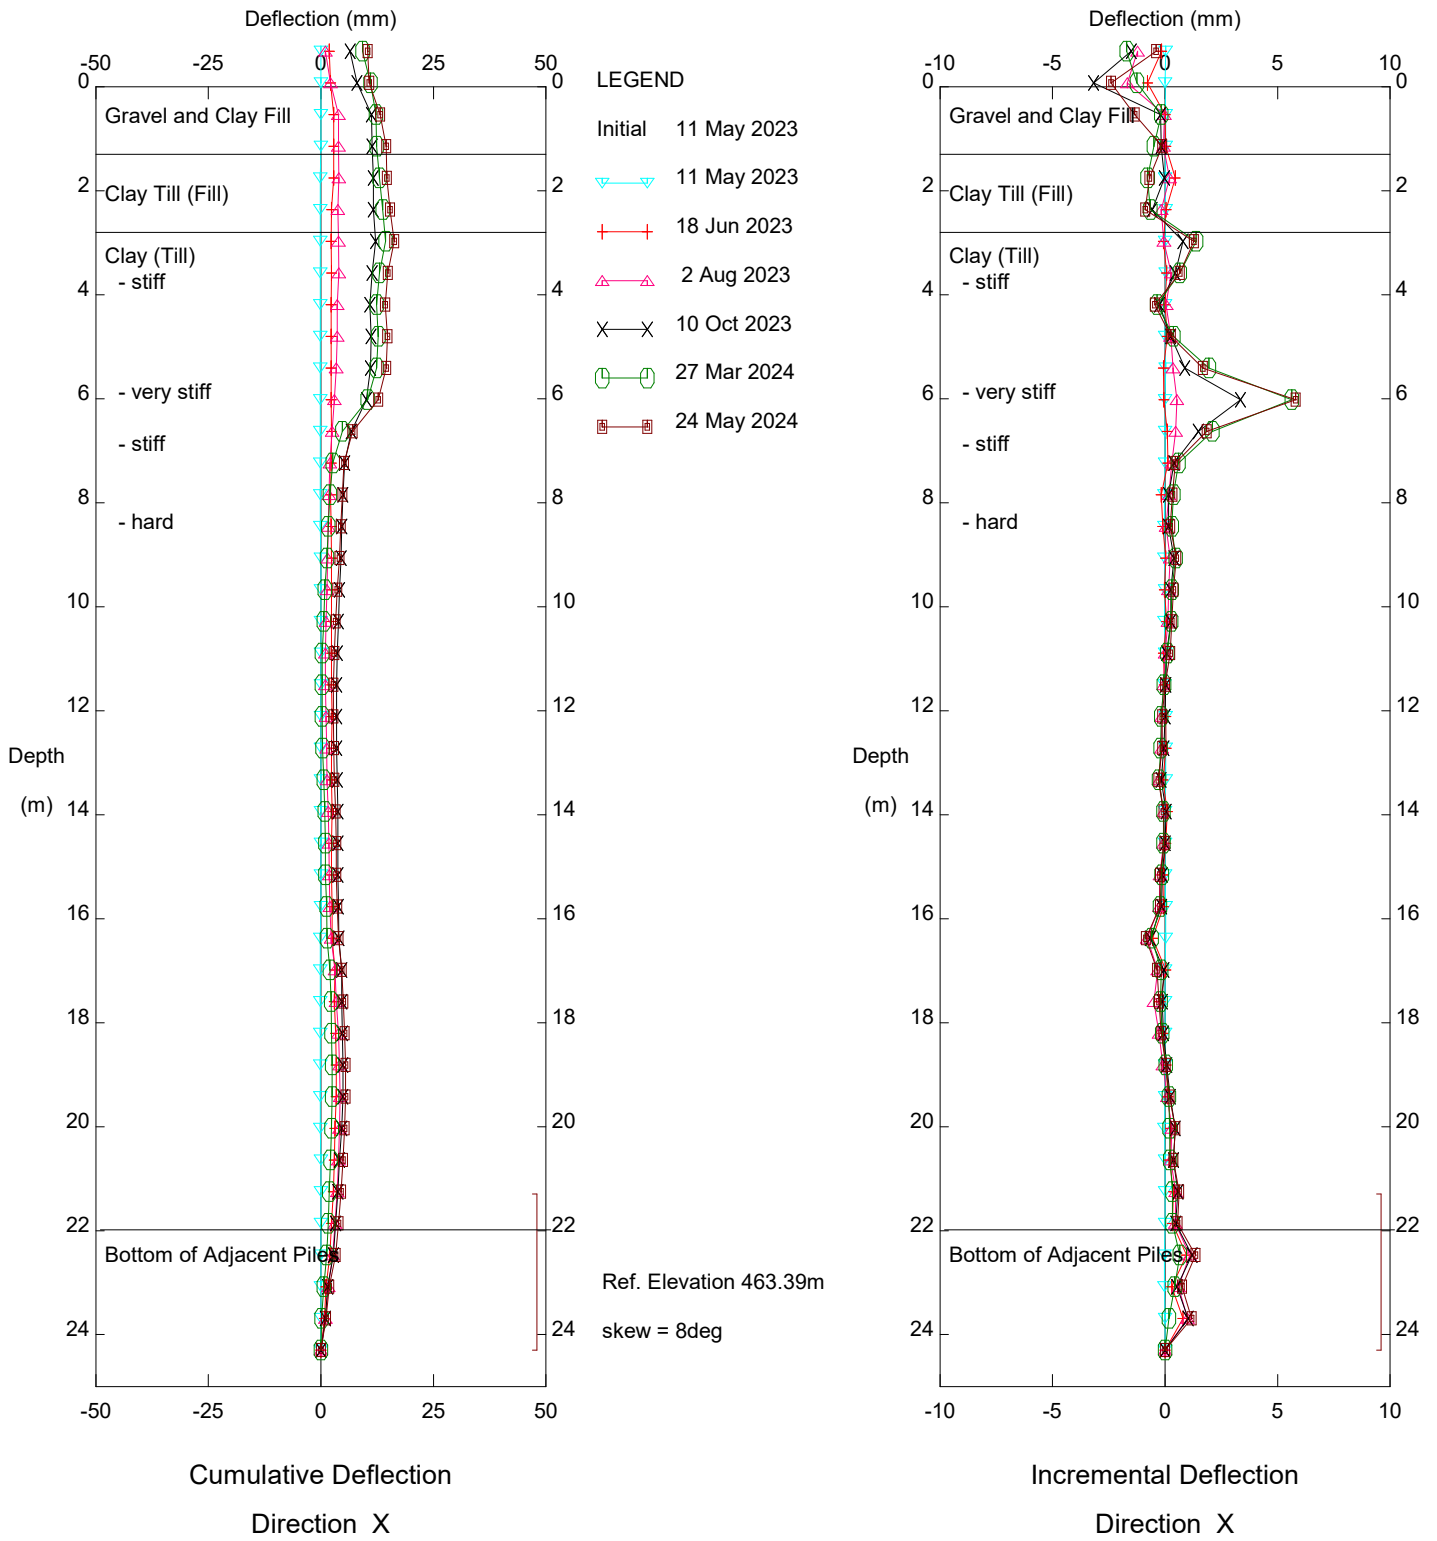
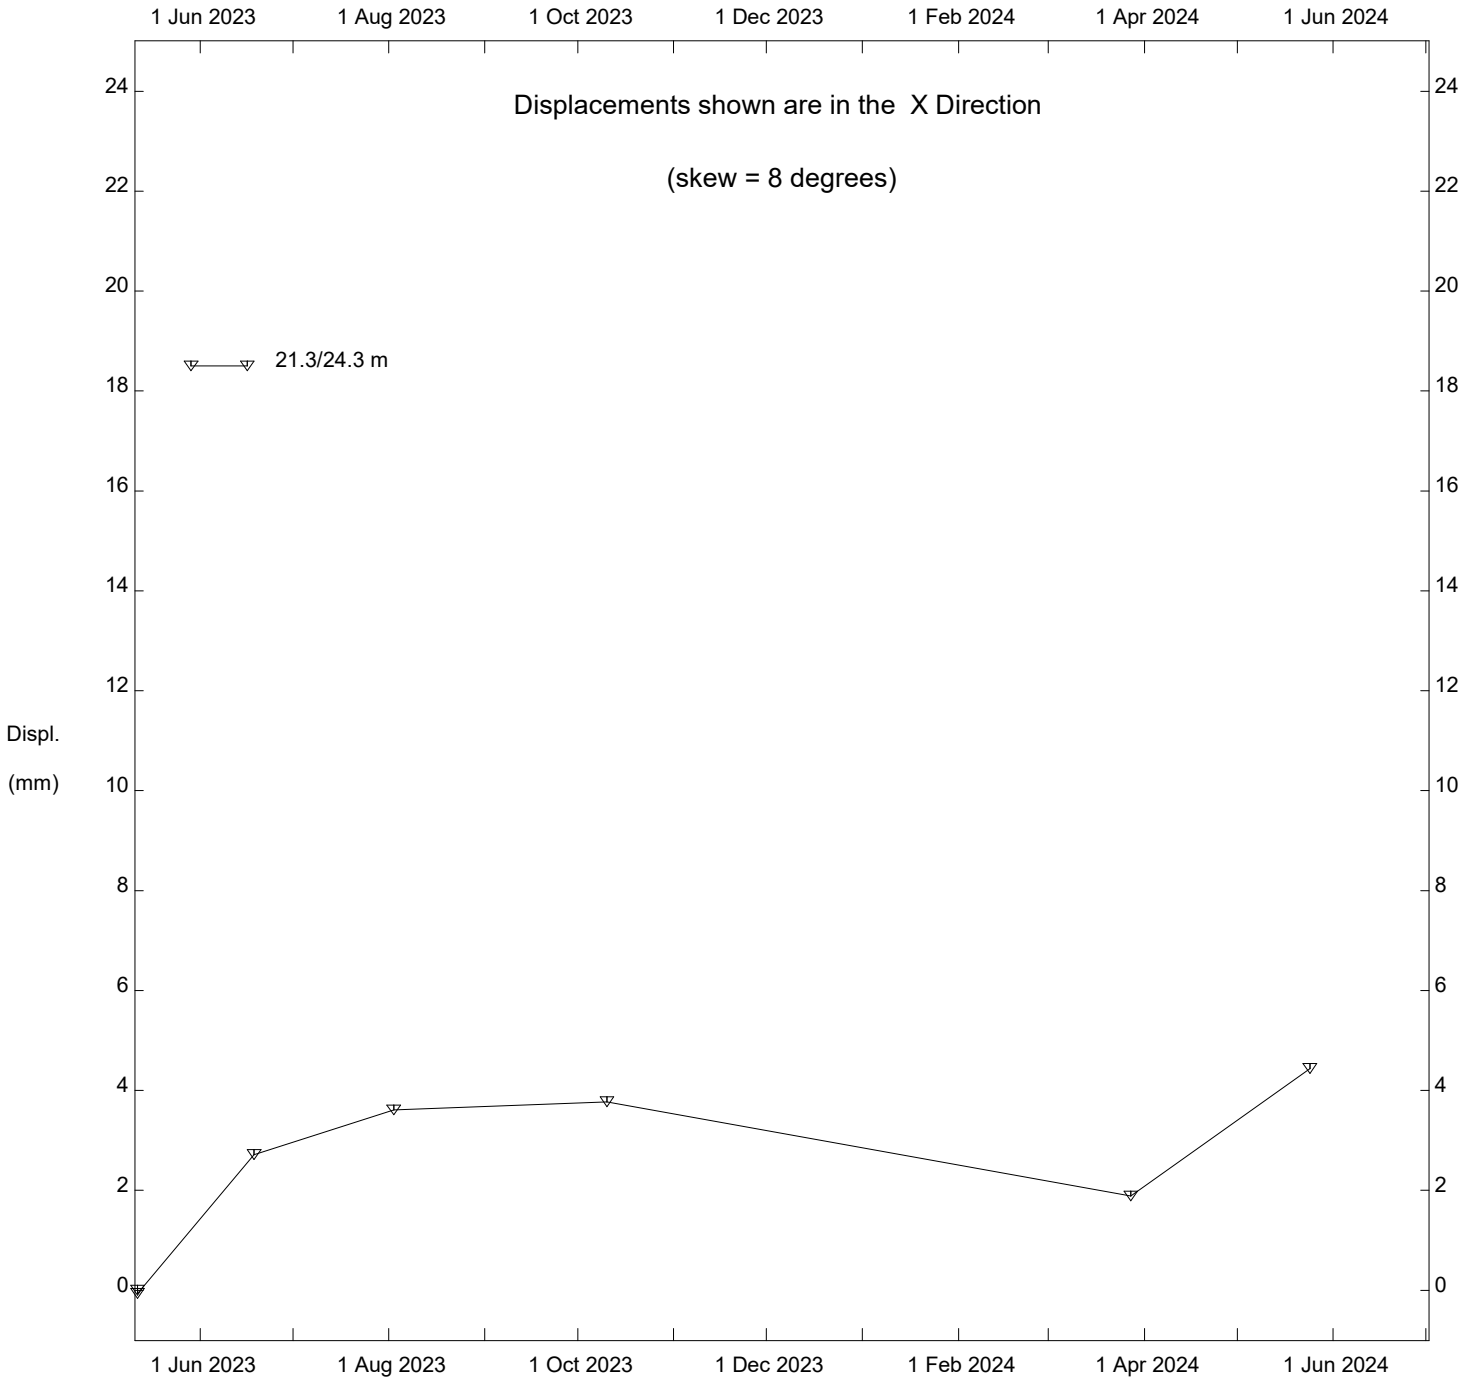
PH045 Hwy 35:08 Meikle River Pile Wall, Inclinator SI23-100

| INSTRUMENT # | DATE INITIALIZED | TOTAL CUMULATIVE RESULTANT MOVEMENT AT NOTED DEPTH SINCE INITIAL READING (mm) | MAXIMUM RATE OF MOVEMENT (mm/yr) | CURRENT STATUS | DATE OF PREVIOUS READING | INCREMENTAL MOVEMENT SINCE PREVIOUS READING (mm) | CURRENT RATE OF MOVEMENT (mm/yr) | CHANGE IN RATE OF MOVEMENT SINCE PREVIOUS READING (mm/yr) |
|---|---|---|---|---|---|--|---|---|
| SI23-100 | May 11, 2023 | 13.3 mm over 4.8 m to 7.8 m depth in the 160° direction | 34.1 mm/yr in October 2023 | Operational | October 10, 2023 | 4.9 | 7.8 | -26.5 |
| | | 4.4 mm over 21.9 m to 24.3 m depth in the 207° direction | 23.3 mm/yr in June 2023 | | | 0.7 | 1.1 | 0.1 |

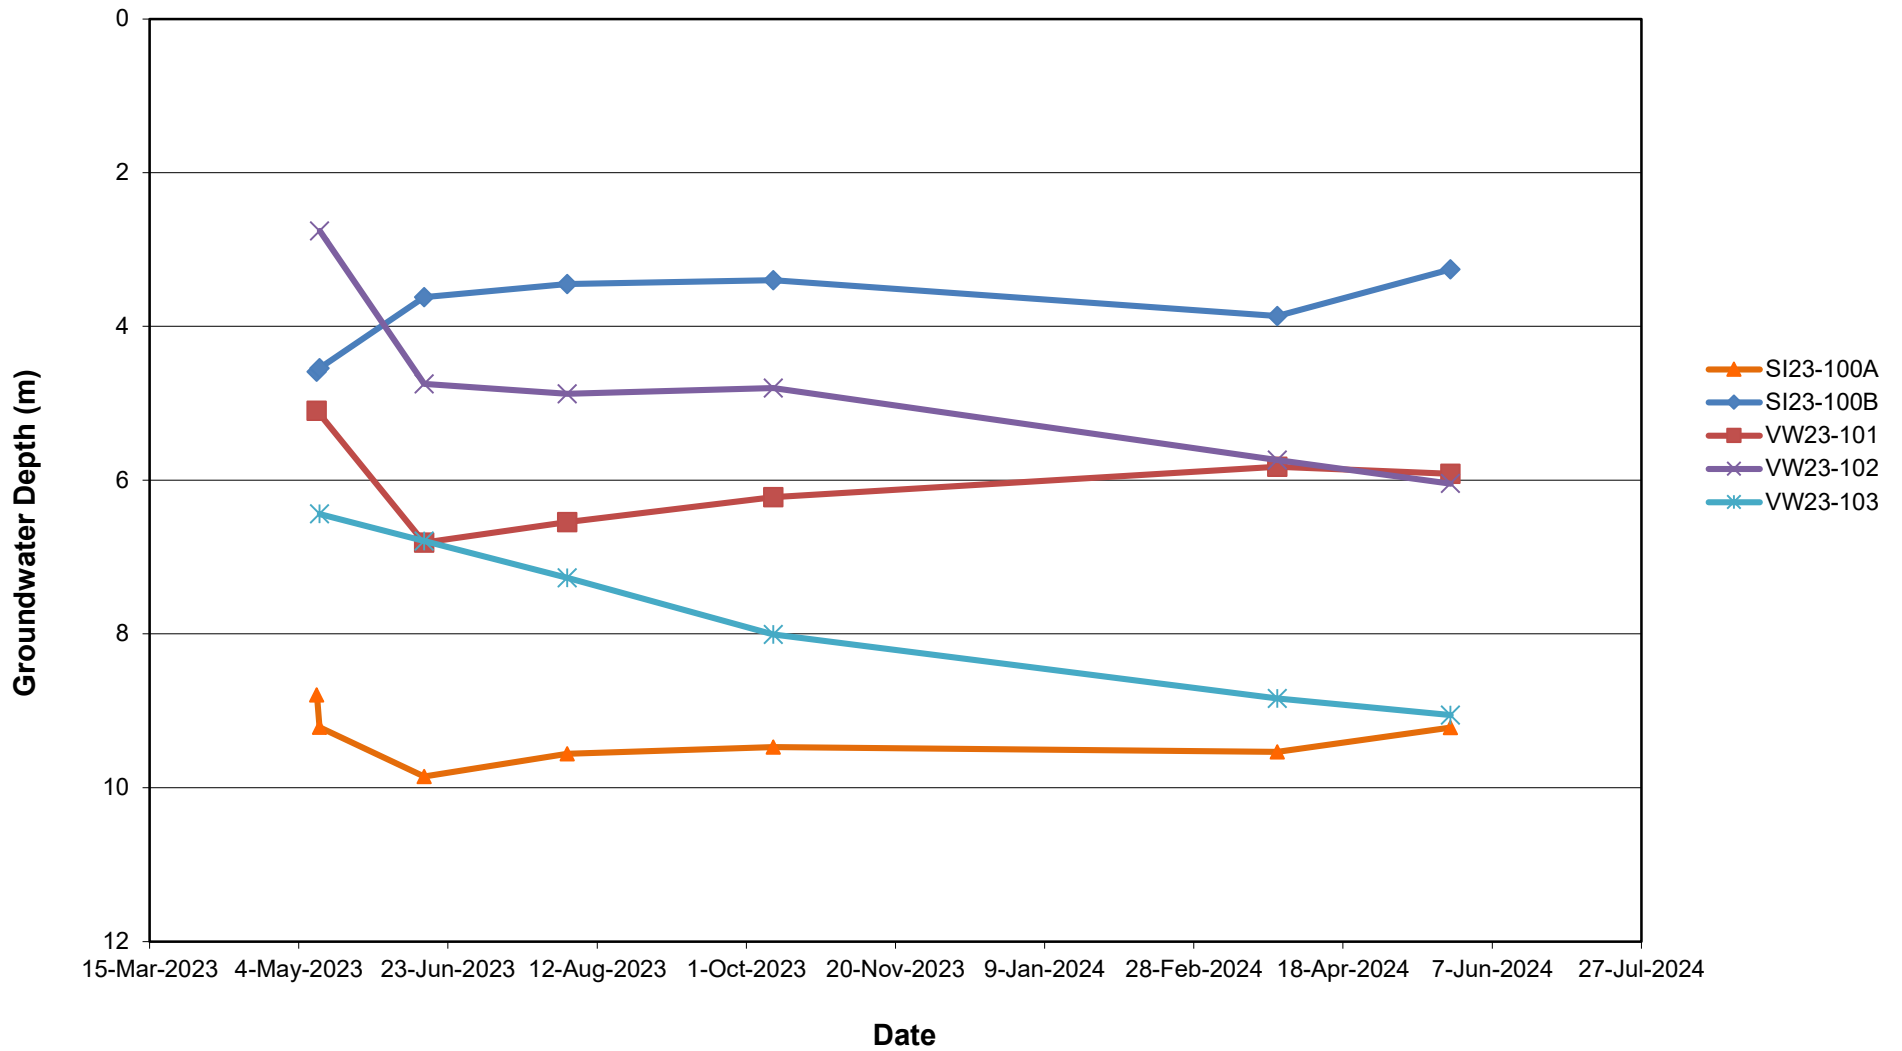
FIGURE PH045-1
HWY 35:08 MEIKLE RIVER PILE WALL VIBRATING WIRE PIEZOMETER DATA

| INSTRUMENT | DATE INITIALIZED | GROUND ELEVATION (m) | TIP DEPTH (m) | CURRENT STATUS | MAXIMUM GROUNDWATER DEPTH (m) | CURRENT GROUNDWATER DEPTH (m) | PREVIOUS (Oct 10, 2023) GROUNDWATER DEPTH (m) | CHANGE IN WATER LEVEL SINCE PREVIOUS READING (m) |
|---|---|---|---|---|---|---|---|--|
| VW23-100A | May 10, 2023 | 463.39 | 23.37 | Operational | 8.80 on May 10, 2023 | 9.22 | 9.47 | 0.25 |
| VW23-100B | May 10, 2023 | 463.39 | 11.37 | Operational | 3.26 on May 24, 2024 | 3.26 | 3.40 | 0.14 |
| VW23-101 | May 10, 2023 | 463.06 | 15.00 | Operational | 5.10 on May 10, 2023 | 5.92 | 6.22 | 0.30 |
| VW23-102 | May 11, 2023 | 465.26 | 19.10 | Operational | 2.76 on May 11, 2023 | 6.05 | 4.80 | -1.25 |
| VW23-103 | May 11, 2023 | 468.23 | 15.40 | Operational | 6.44 on May 11, 2023 | 9.06 | 8.01 | -1.05 |
