**ALBERTA TRANSPORTATION
GEOHAZARD ASSESSMENT PROGRAM
PEACE REGION (PEACE RIVER DISTRICT)
2023 INSPECTION**

Site Number	Location	Name	Hwy	km
SH008-1	2 km E of Watino Bridge	Watino East Hill	49:08	18.80-19.05
Legal Description		UTM Co-ordinates		
NE26-77-24-W5M		11U E 462,307	N	6,173,153

**SH008-1: HWY 49:08 WATINO EAST HILL SMOKY RIVER
2023 SITE INSPECTION PLAN**

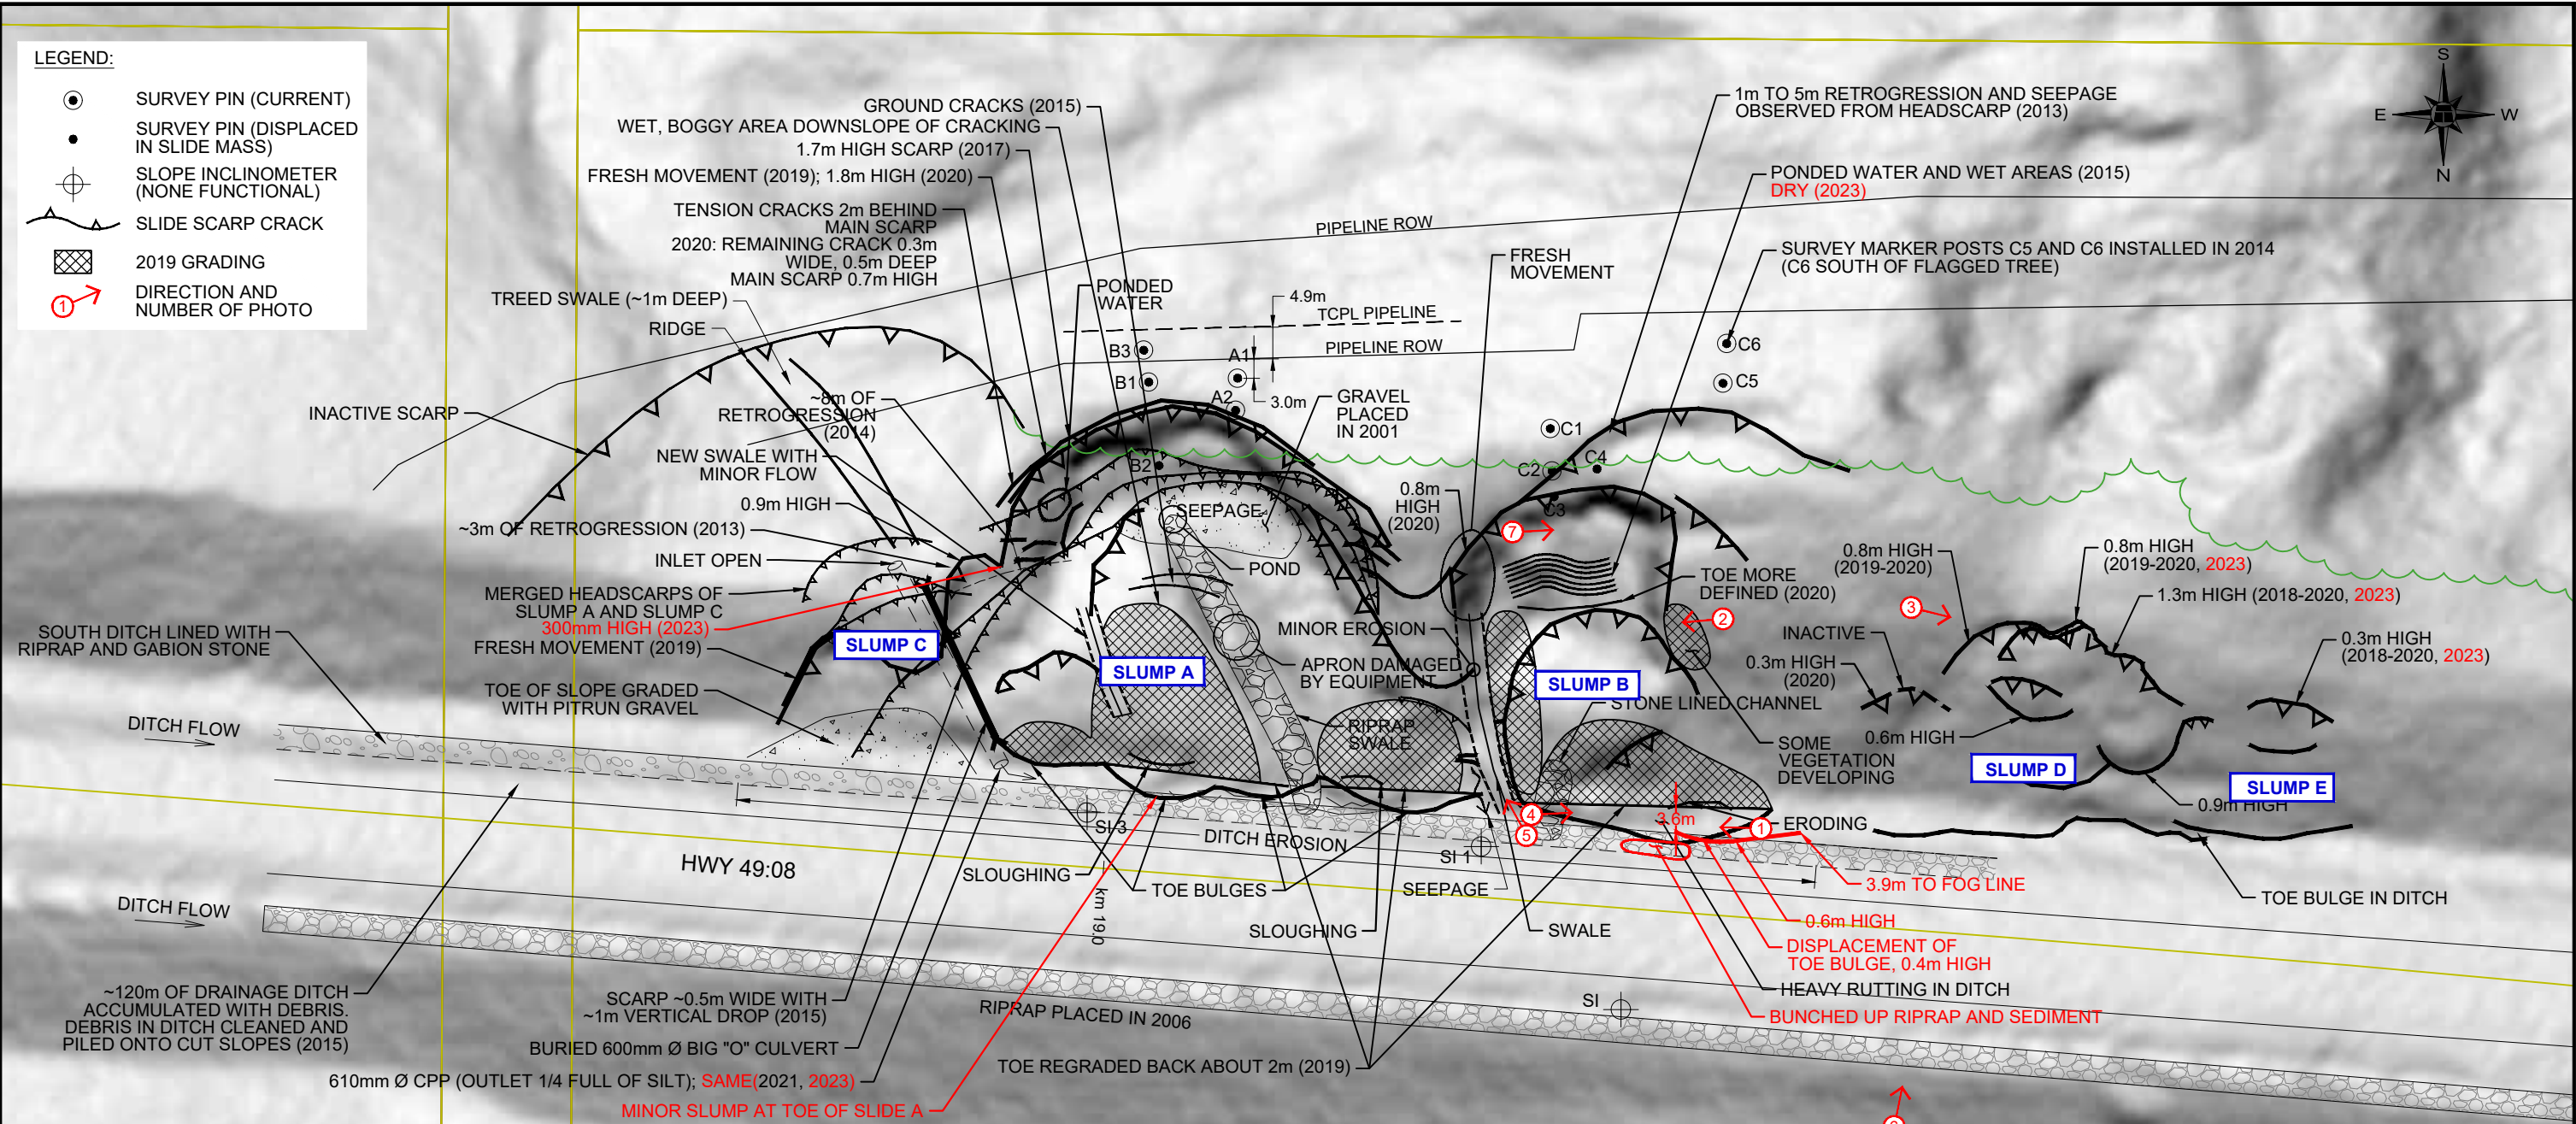
Observations:	Description	Worsened?
<input type="checkbox"/> Pavement Distress		<input type="checkbox"/>
<input checked="" type="checkbox"/> Slope Movement	Five separate slump blocks in the south backslope. Continued creep movement causing toe rolls to obstruct the ditch.	<input checked="" type="checkbox"/>
<input checked="" type="checkbox"/> Erosion	Slumped material removed from the ditch, leaving bare soil exposed.	<input checked="" type="checkbox"/>
<input checked="" type="checkbox"/> Seepage	Seepage noted in the backslope and accumulating in grabens.	<input type="checkbox"/>
<input checked="" type="checkbox"/> Bridge/Culvert Distress	Outlet of drainage pipe partially obstructed.	<input type="checkbox"/>
<input checked="" type="checkbox"/> Other	Two pipelines are located immediately south of the backslope.	<input type="checkbox"/>
Instrumentation:	None.	
Assessment:

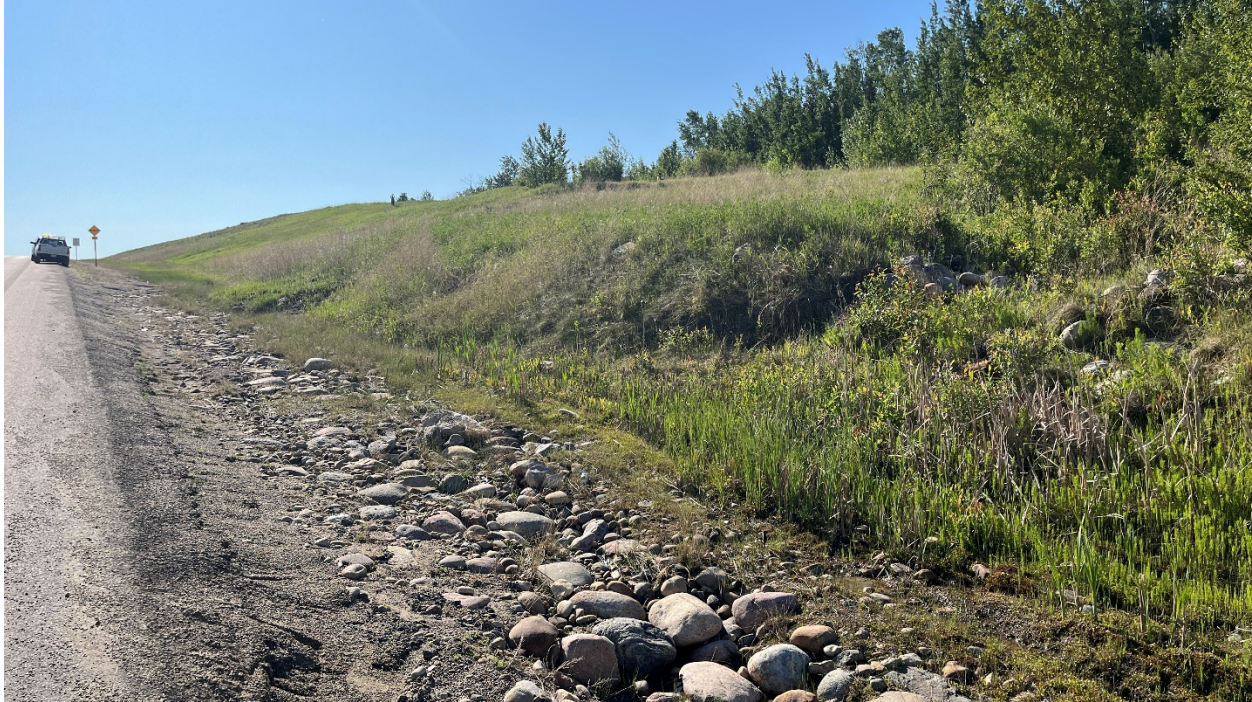
In the spring of 2019, the maintenance contractor excavated the toe rolls to improve ditch drainage. The material was wasted higher up on the slopes. The contractor also added two swales on the slope to assist with drainage from the sag ponds further up the slope. The grading work obscured some of the slide features and may also contributed to local instability at the toe due to the overall steepening of the lower portion of the backslope. However, the work re-established flow in the south ditch. In 2020, there was deterioration of the toe of this regrading with some sloughing and erosion observed. Not many changes were observed at the site in 2021; it was noted that the upper portions of the fill revegetated. The conditions of the site in 2023 were mostly similar to 2021. The toe of Slump B has pushed out further into the ditch and some minor slumping of the Slump A toe roll was noted. Some of the previously wet sag ponds were dry in 2023.

Photo 1 – Looking east at toes of Slumps B and A which were excavated in 2019 to improve ditch flow with the material placed back on top of the slumps.

- Remove material from the ditch when required to maintain flow, but do not place the excavated material back onto the slide mass as it will load the slump. Augment the ditch bottom riprap to minimize downcutting and erosion of the recently graded faces of the slide toe rolls.
- Establish a line of communication with the pipeline owners to determine risk tolerance and minimum setback distance.

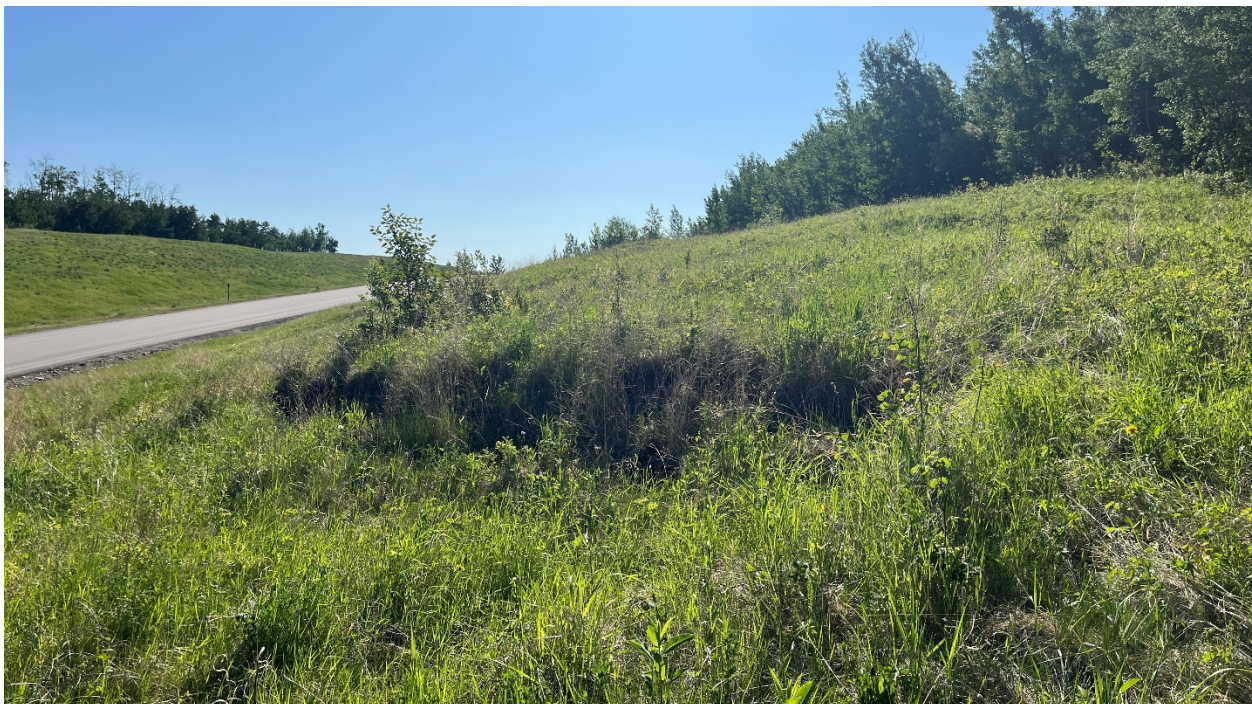
Photo 2 – Looking east at the top of Slump B. Vegetation has grown within the regraded area in 2019.

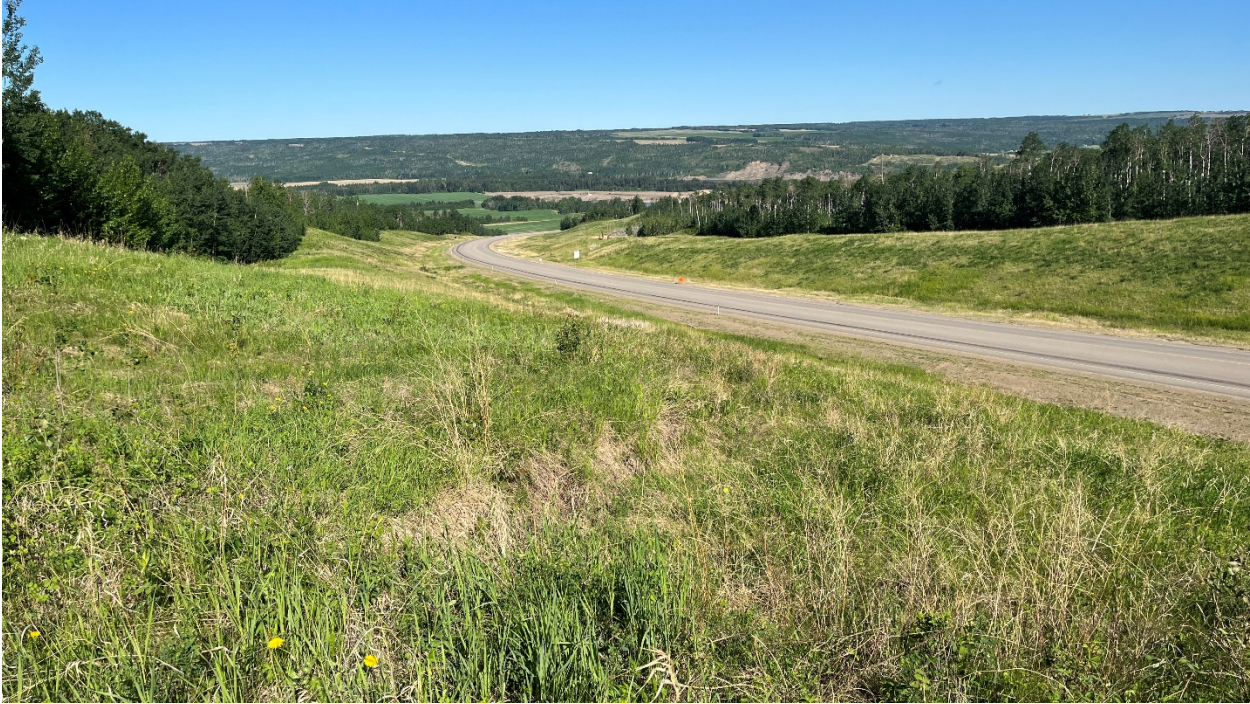
Photo 3 – Looking northwest at the crest of Slump D

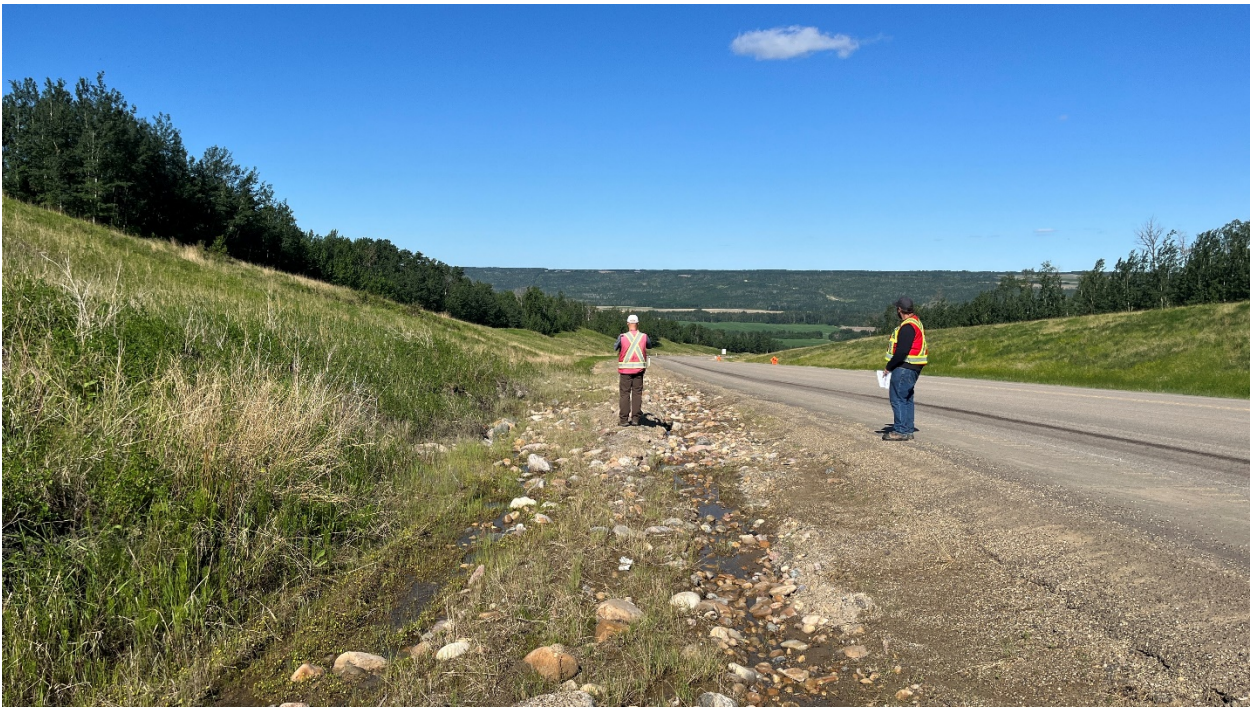
Photo 4 – Looking west at the toe of Slump B.

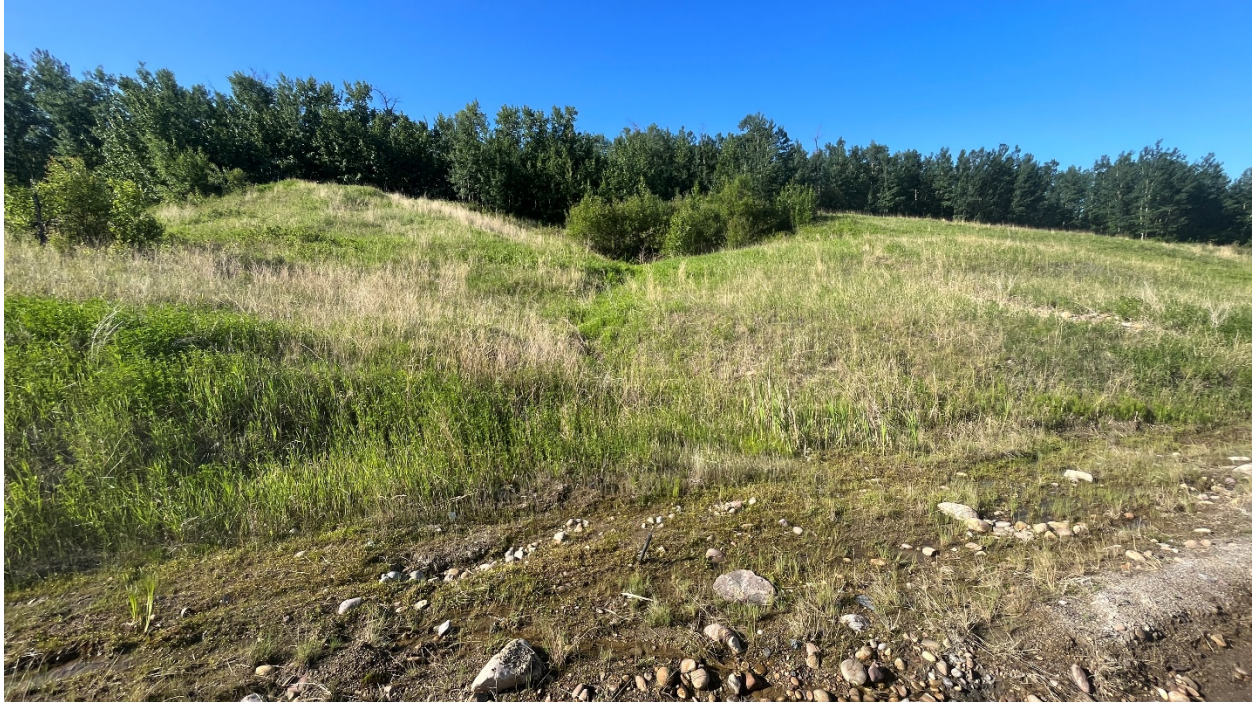
Photo 5: Lower portion of the slope at toe of Slump B becoming vegetated since the 2019 grading work.

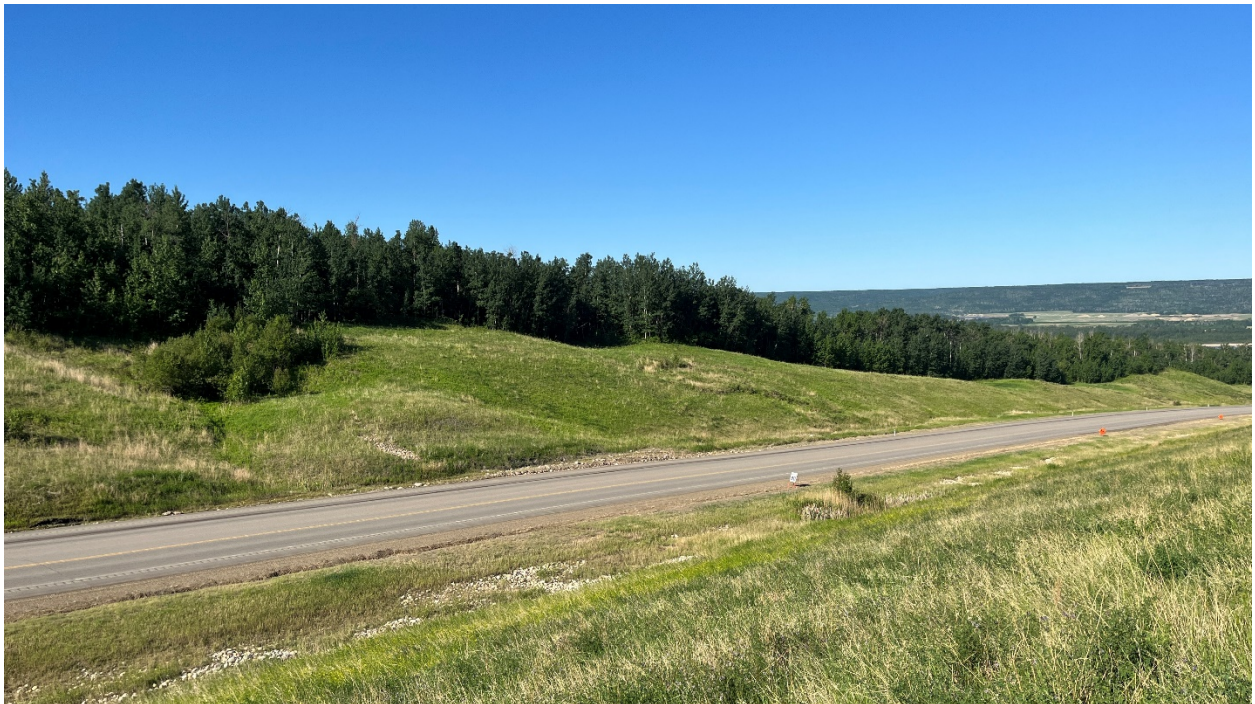
Photo 6: Looking southwest at Slump D.

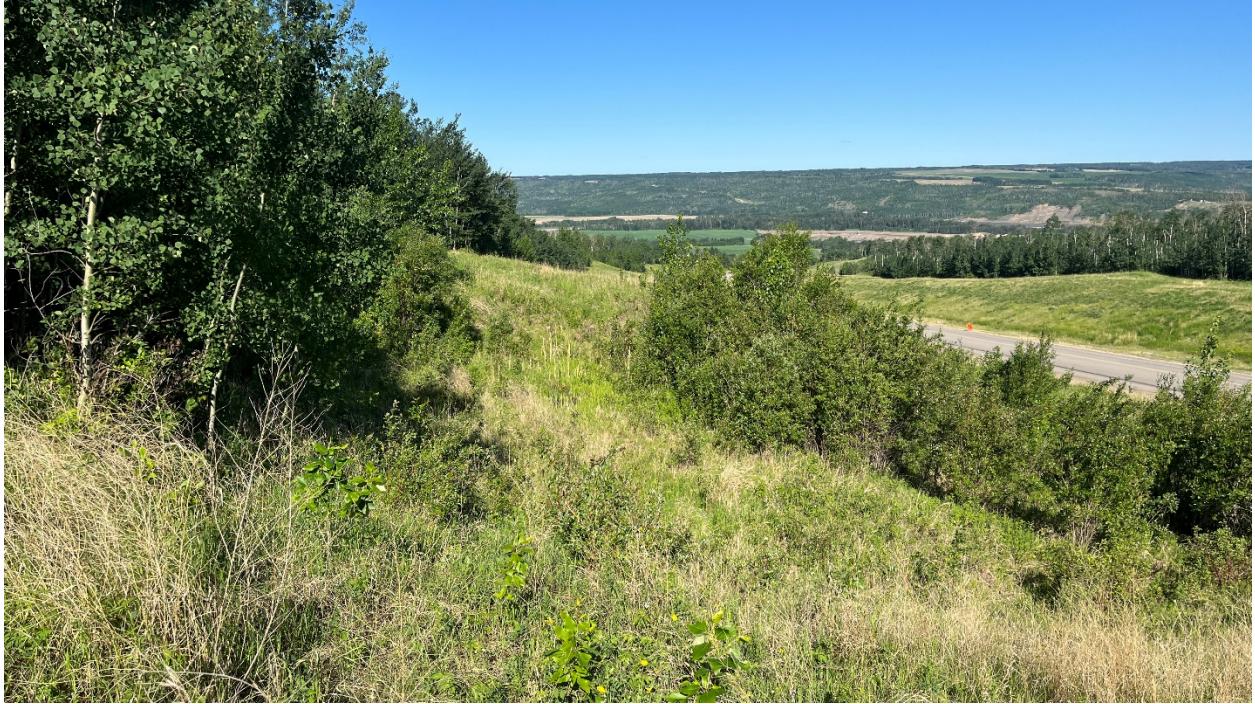
Photo 7: Looking west at the top of Slump B.
