**ALBERTA TRANSPORTATION AND
ECONOMIC CORRIDORS
GEOHAZARD ASSESSMENT PROGRAM
PEACE REGION (PEACE RIVER DISTRICT)
2024 INSPECTION**

Site Number	Location	Name	Hwy	km
SH016-1	Little Smoky River	West Bridge Abutment	49:12	1.90
Legal Description		UTM Co-ordinates		
NE33-74-21-W5M		11 E 489,573	N 6,145,499

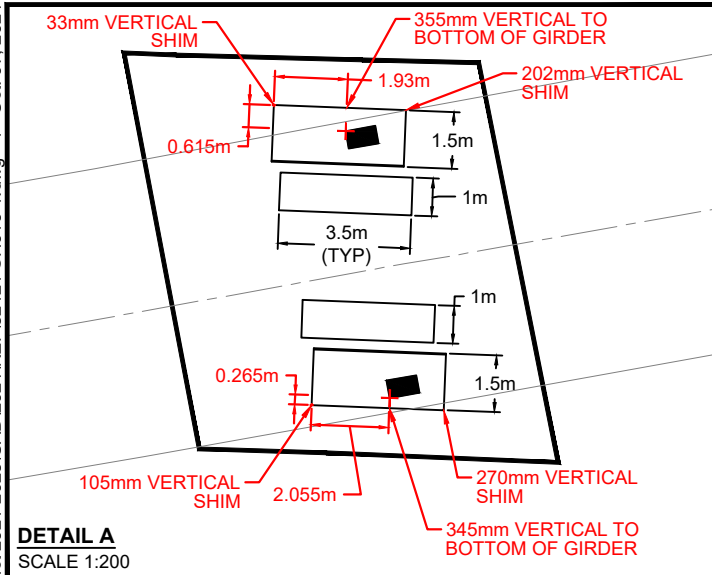
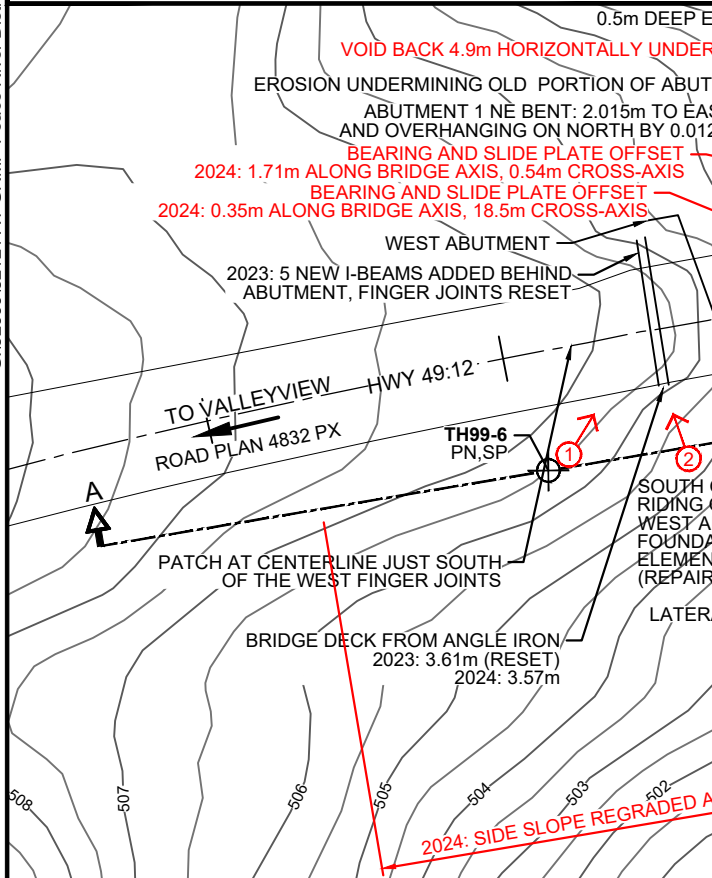
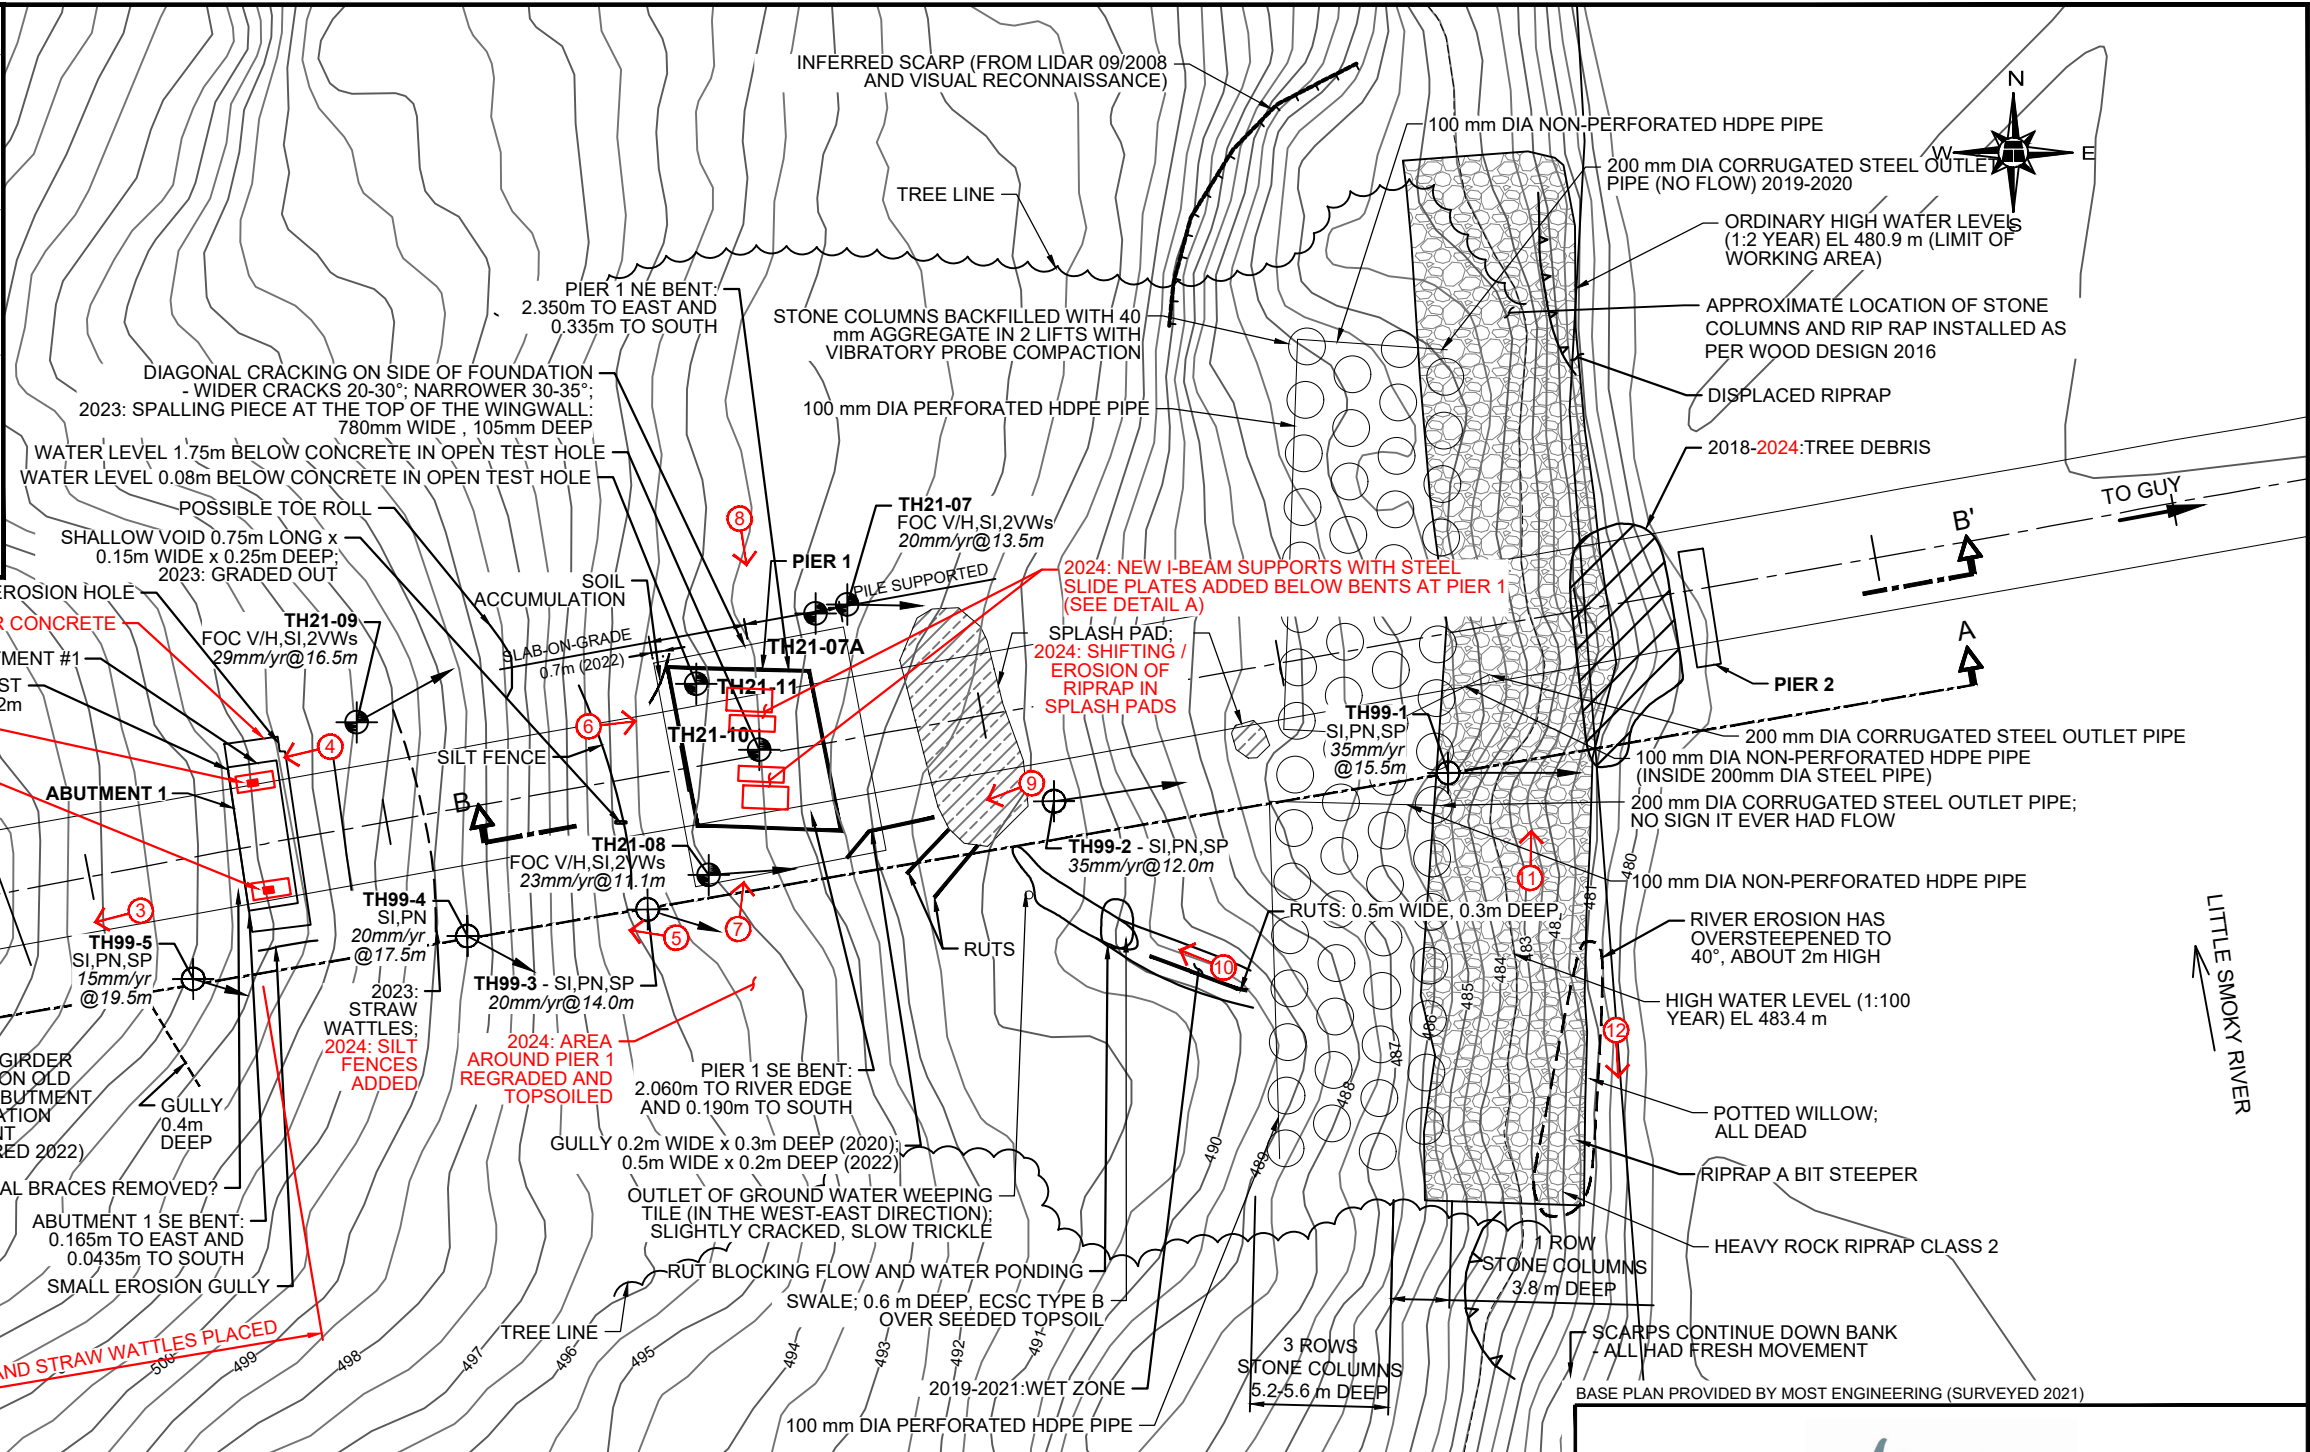
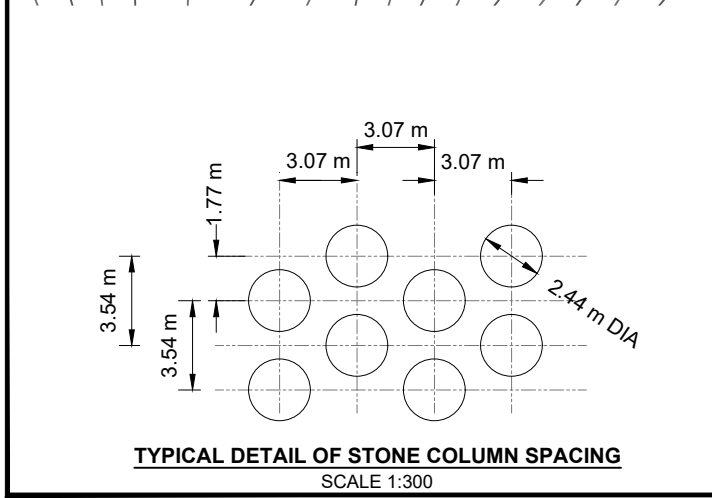
G:\32000\32121 AT GRIMP Peace River District\2021-2025\CAD\2024\KEF\32121 SH016-1.dwg - 1 - Oct. 07, 2024

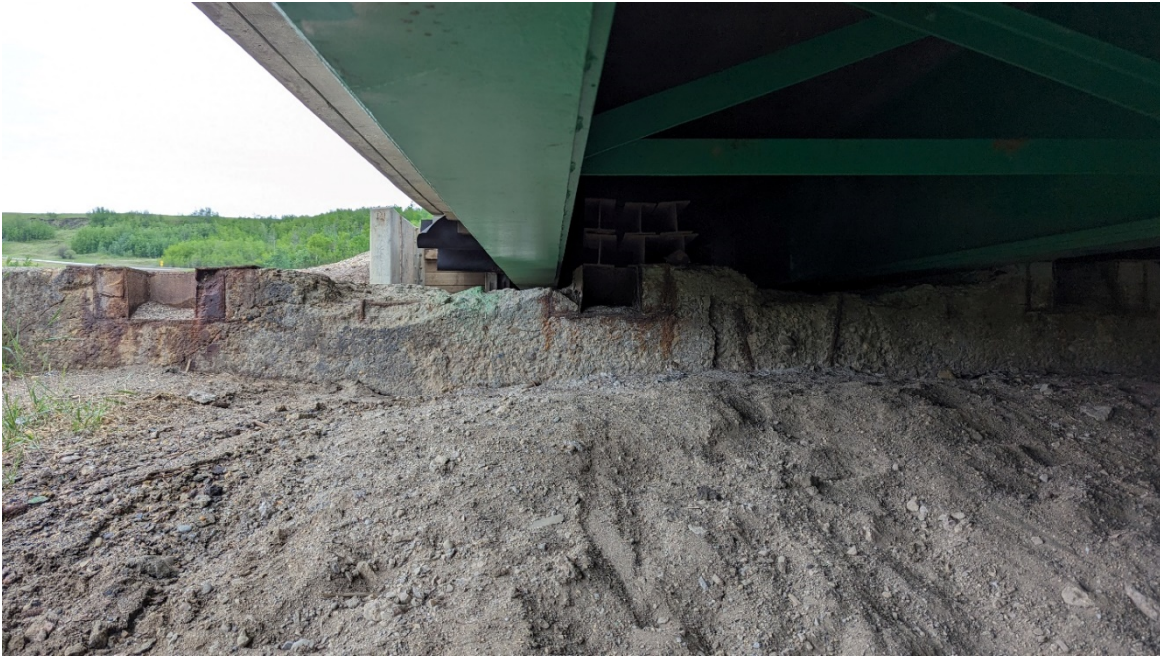
Photo 3 – Looking towards the West Abutment where portions of the old foundation concrete was removed to allow movement of the girders between the West Abutment and Abutment 1.

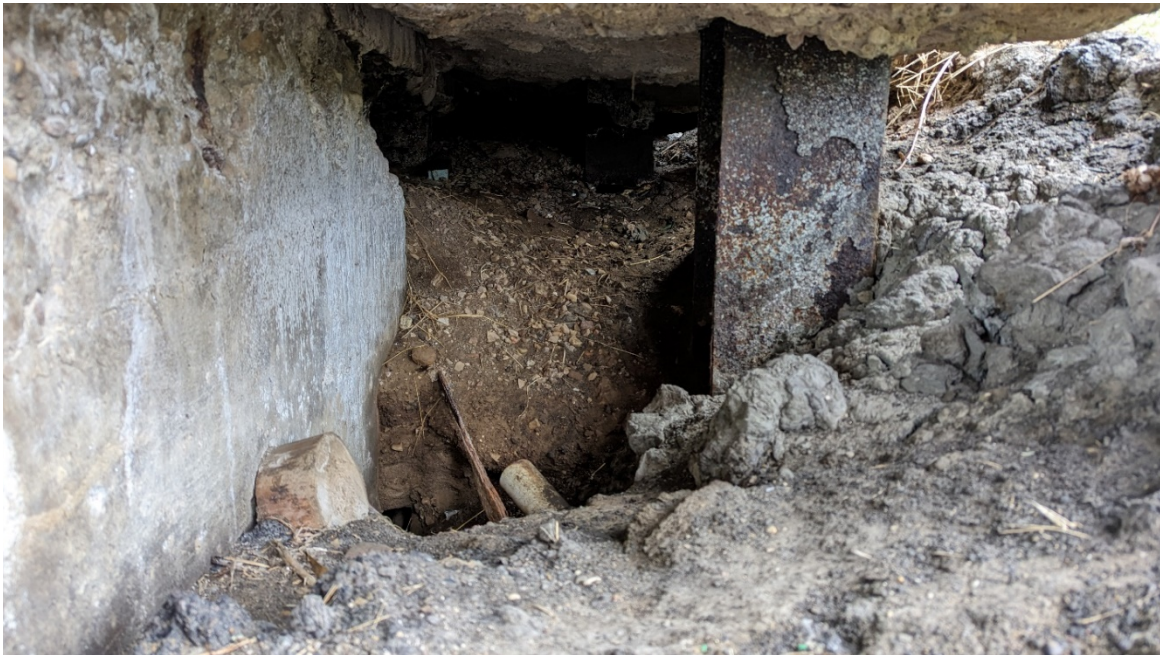
Photo 4: Void forming underneath the northeast corner of the old Abutment 1.

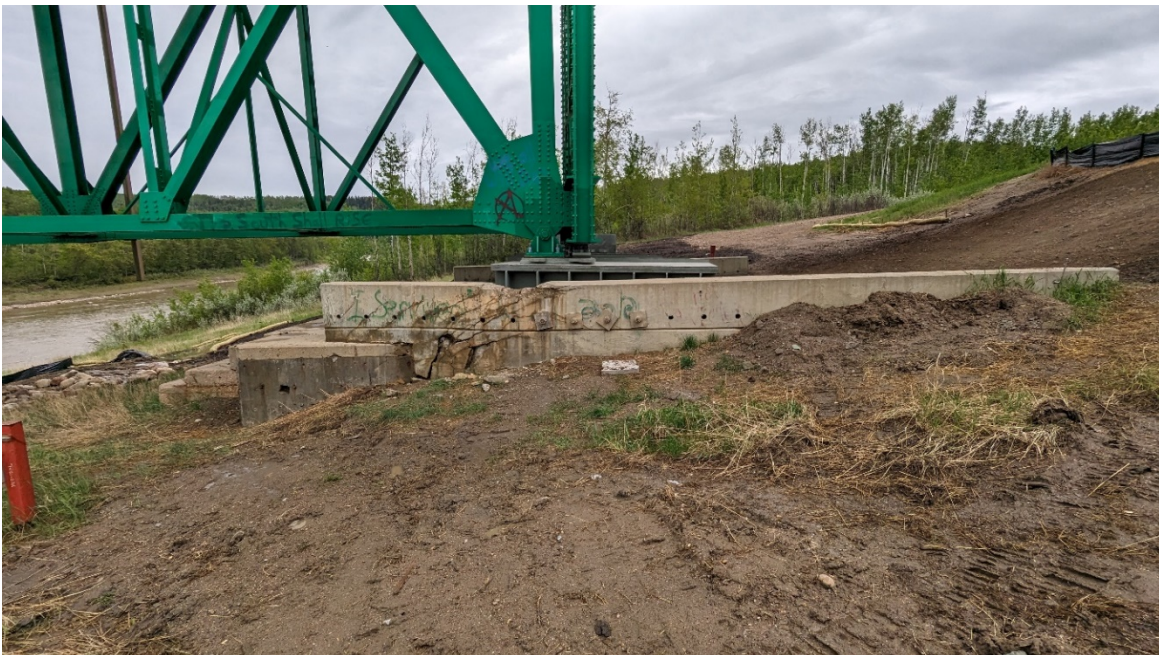
Photo 8 – Looking south at Pier 1 wingwall at arc-shaped compression crack pattern in foundation. Left-hand portion of foundation is pile supported; right-hand is on-grade.

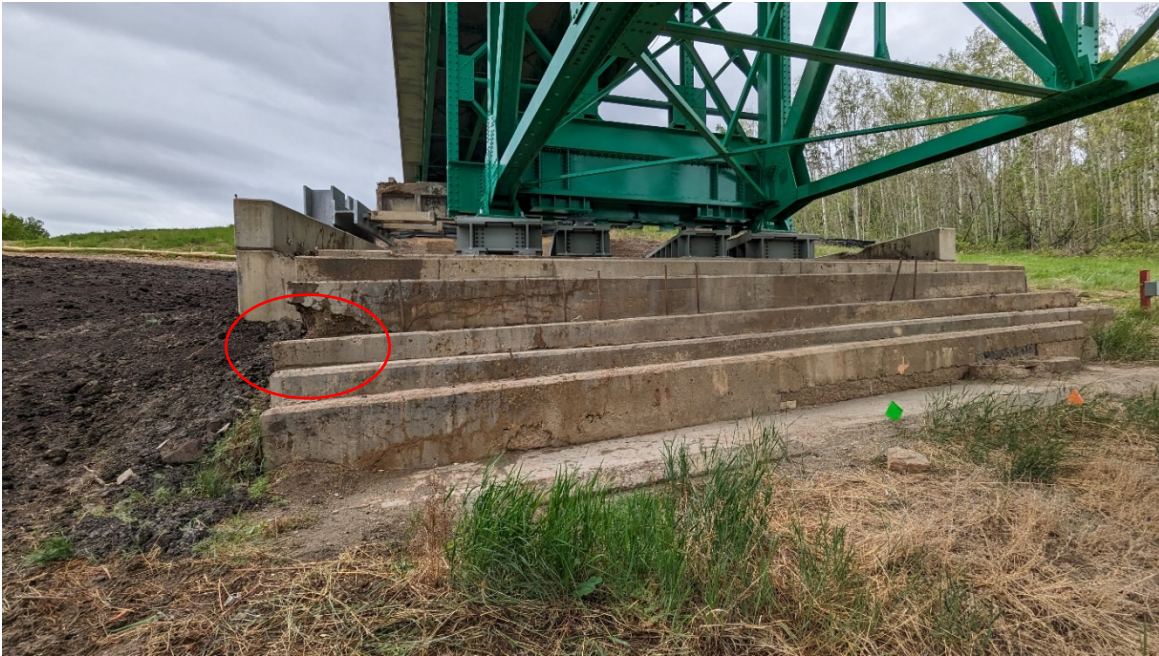
Photo 9 – Looking west at Pier 1 foundation which is tilted downward to the south. The angle from horizontal was 4° at the top and 7° at the bottom stage. Concrete is starting to crack and spall in circled area.

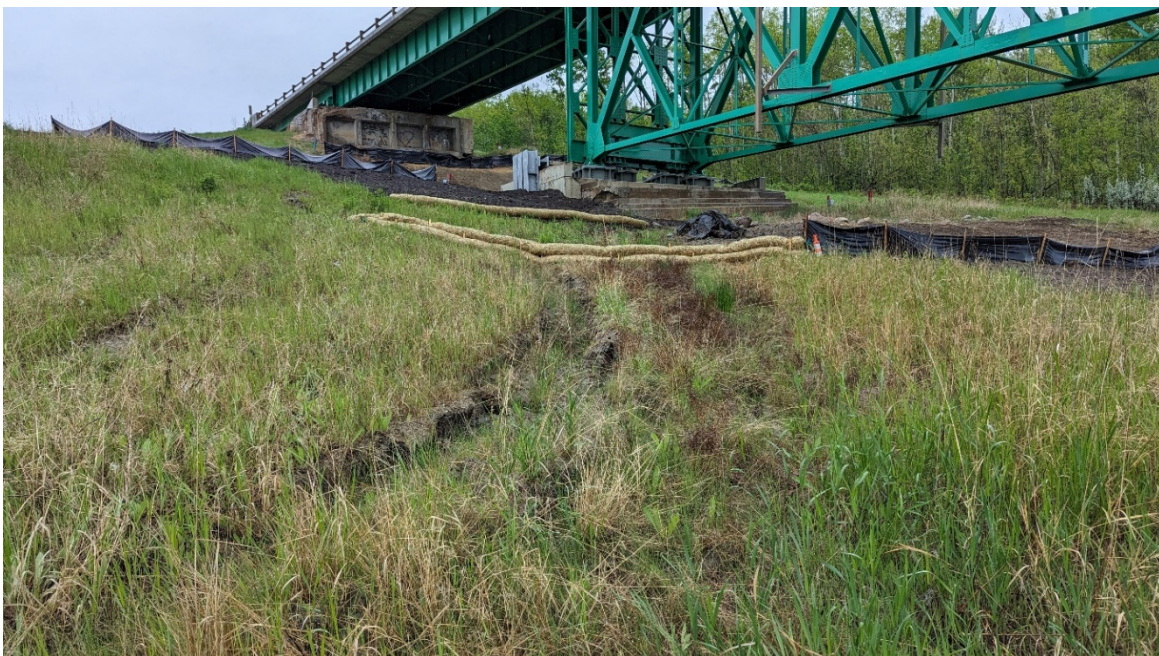
Photo 10 – Looking west toward Pier 1 at rutting and recently-installed erosion control measures.
