**ALBERTA TRANSPORTATION AND  
ECONOMIC CORRIDORS  
GEOHAZARD ASSESSMENT PROGRAM  
PEACE REGION (PEACE RIVER DISTRICT)  
2024 INSPECTION**

Site Number	Location	Name	Hwy	km
SH003-1	North of Little Smoky River	Little Smoky River (North of Bridge)	49:12	0.4-0.8
Legal Description		UTM Co-ordinates		
NW34-74-21-W5M		11 E 490,730	N 6,145,966

**SH003-1: HWY 49:12  
2024 SITE INSPECTION PLAN**

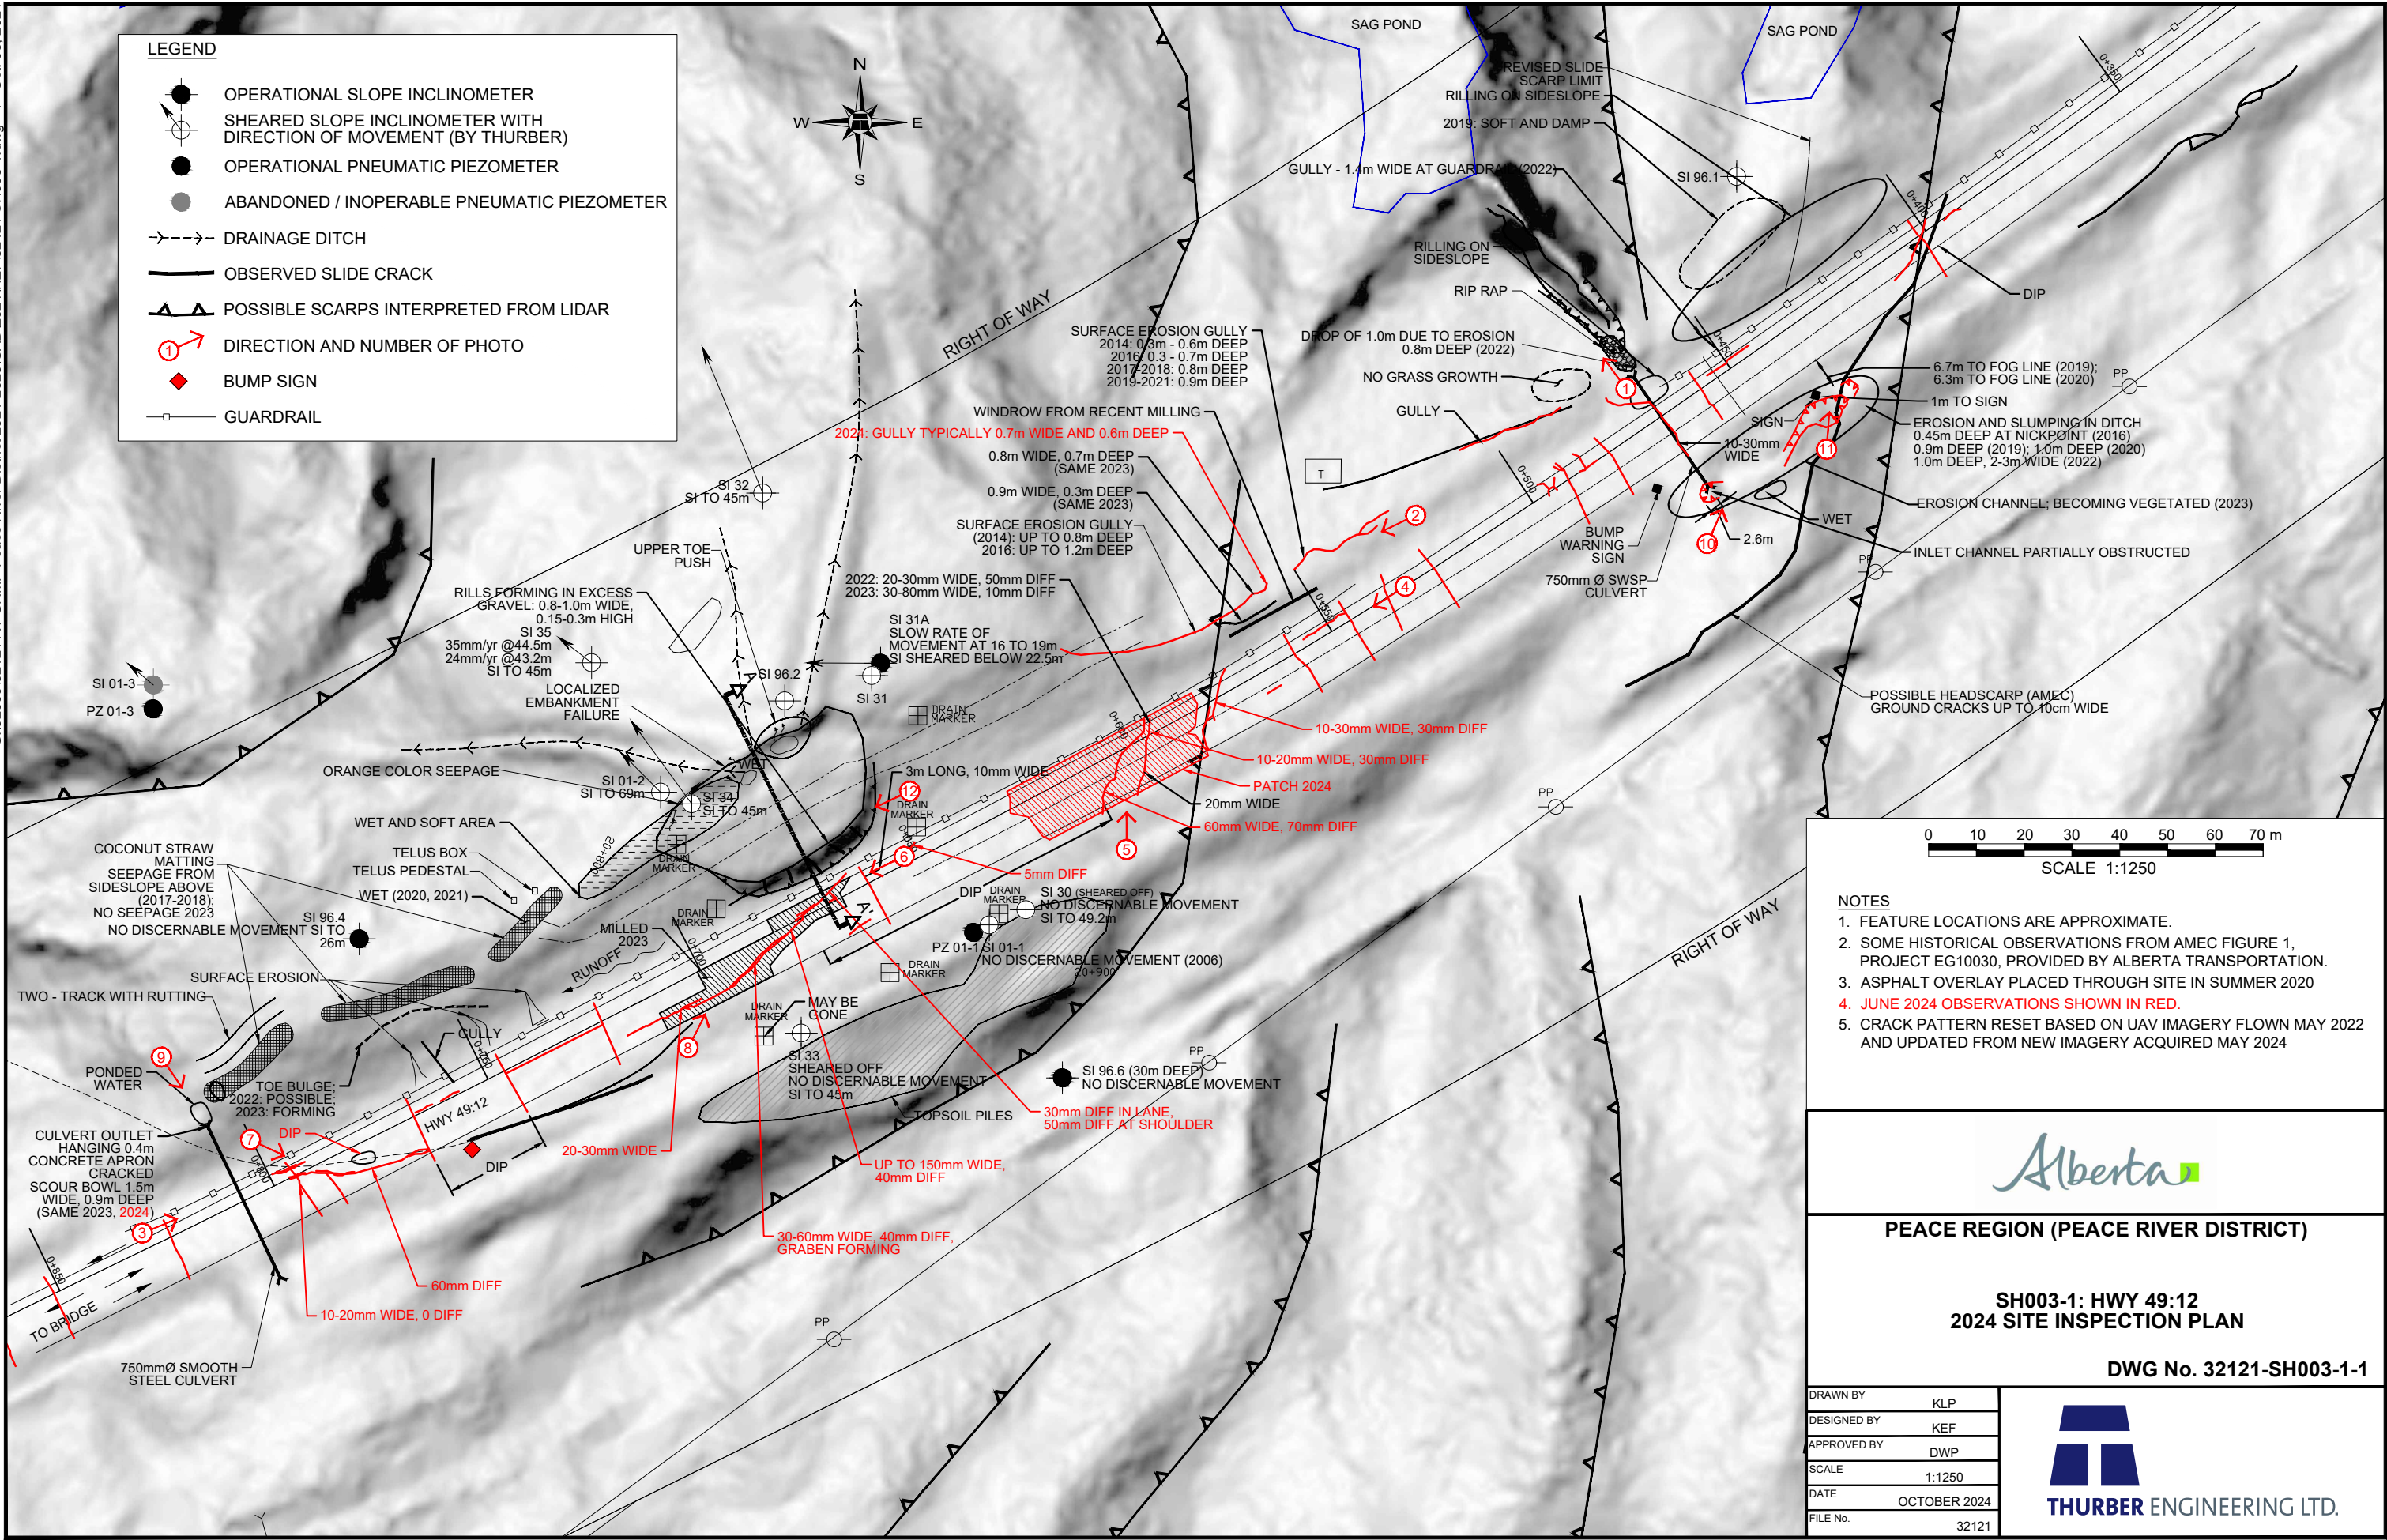
**DWG No. 32121-SH003-1-1**

<b>Primary Site Issue:</b>	The highway traverses the 120 m deep Little Smoky River valley over a WNW-oriented 55 m deep-seated, retrogressive landslide. There are persistent widespread creep movement over most of the valley slope. The movements are partly related to erosion of the bottom of valley by the Little Smoky River. This site is related to Geohazard sites SH004 and SH016.	
<b>Dimensions:</b>	At least 400 m length of highway affected by several intersecting scarps resulting in uneven riding surface. There is also a localized embankment failure on the north slope and erosion issues at specific locations. Approx. 1.5 km of the highway crosses this unstable east valley slope.	
<b>Date of Remediation:</b>	1972: Minor road realignment to accommodate new climbing lane. 1990's: Draining and regrading of a sag pond adjacent to the highway. 2003: Slope flattening of the local instability failure.

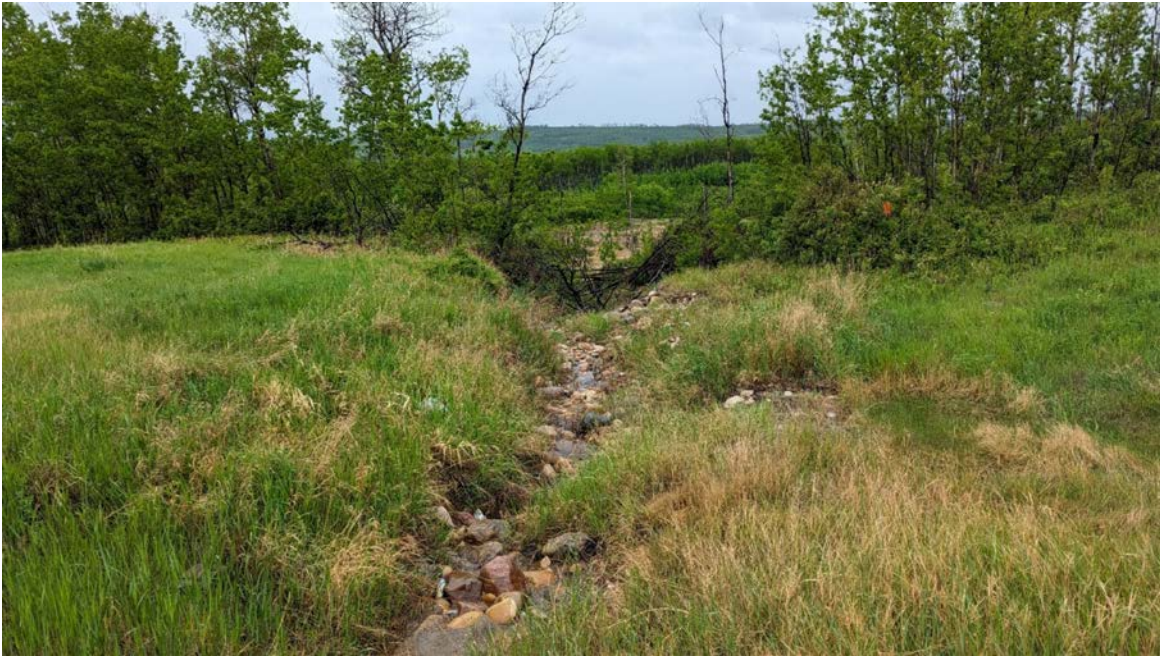
**Photo 1 – Erosion gully at outlet of culvert at about Sta. 0+450.**

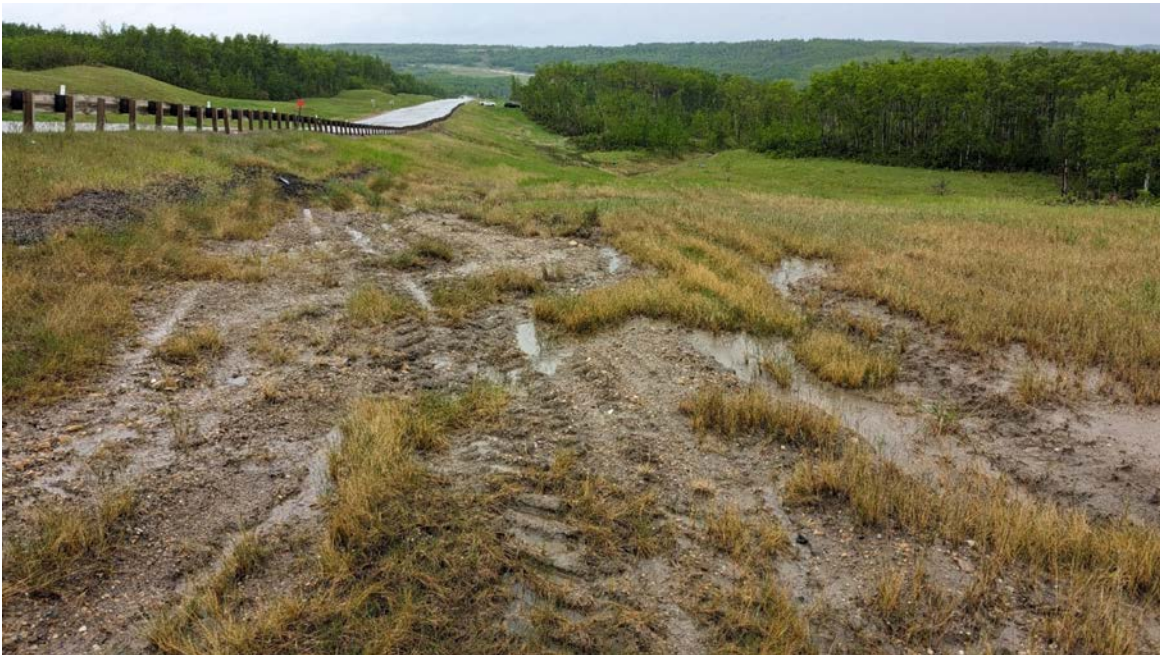
**Photo 2 – Looking southwest along erosion gully near Sta. 0+550.**

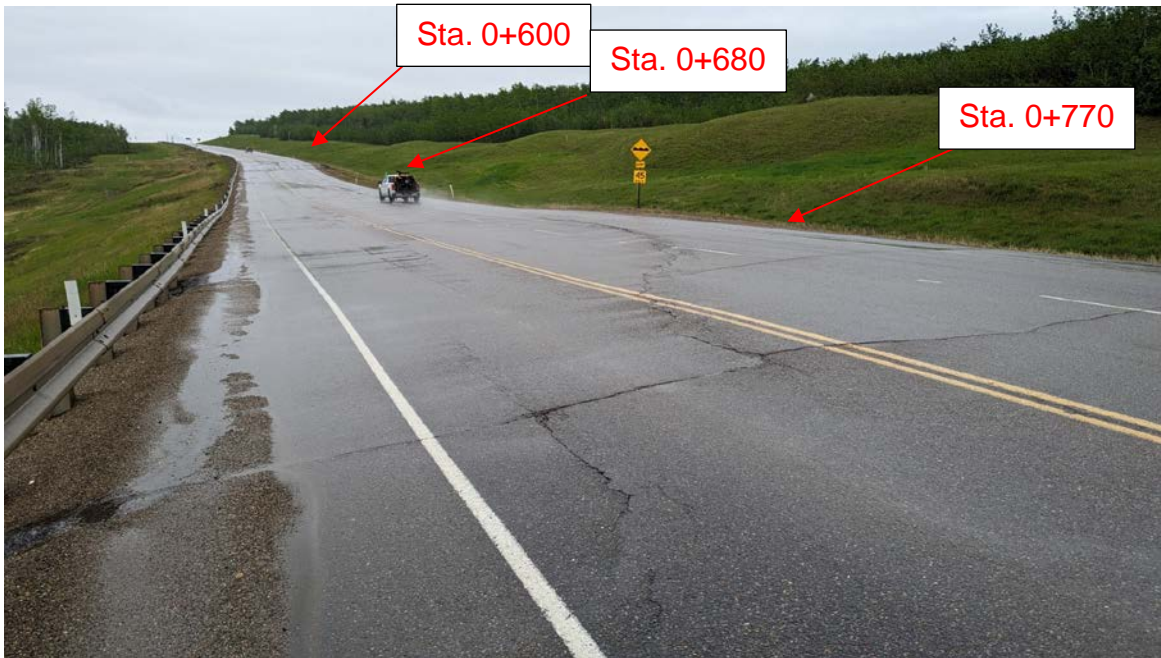
Photo 3 – Looking east where the main scarps cross the highway at three locations.

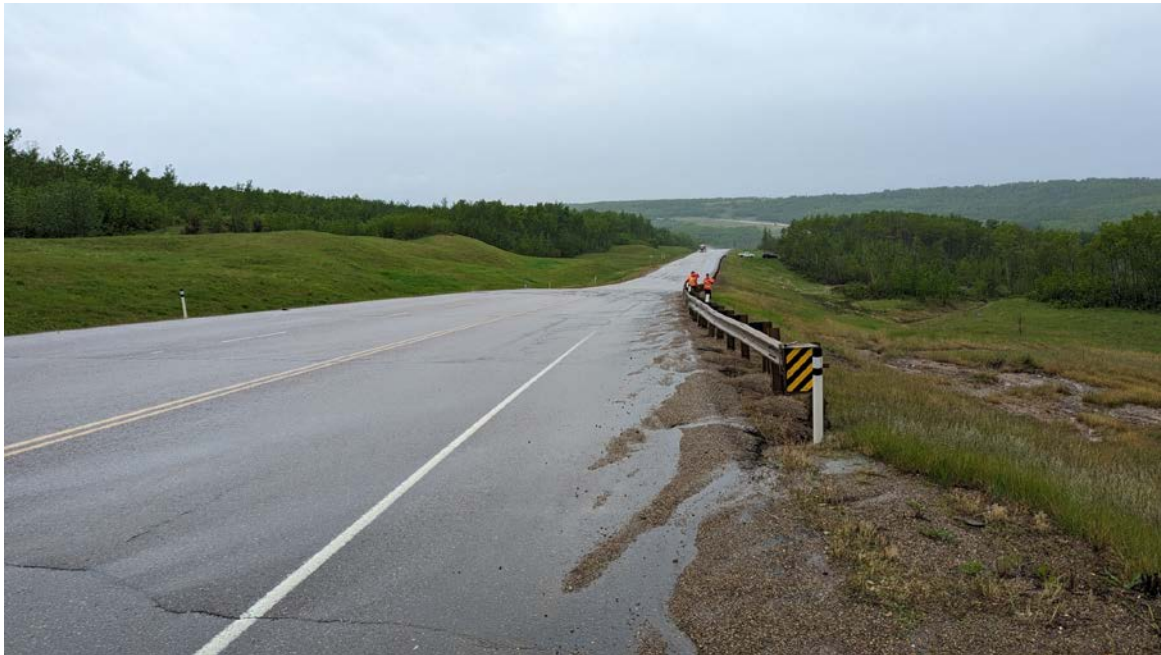
Photo 4 – Looking southwest over the main sag (graben) area extending from Sta. 0+600 to Sta. 0+800.

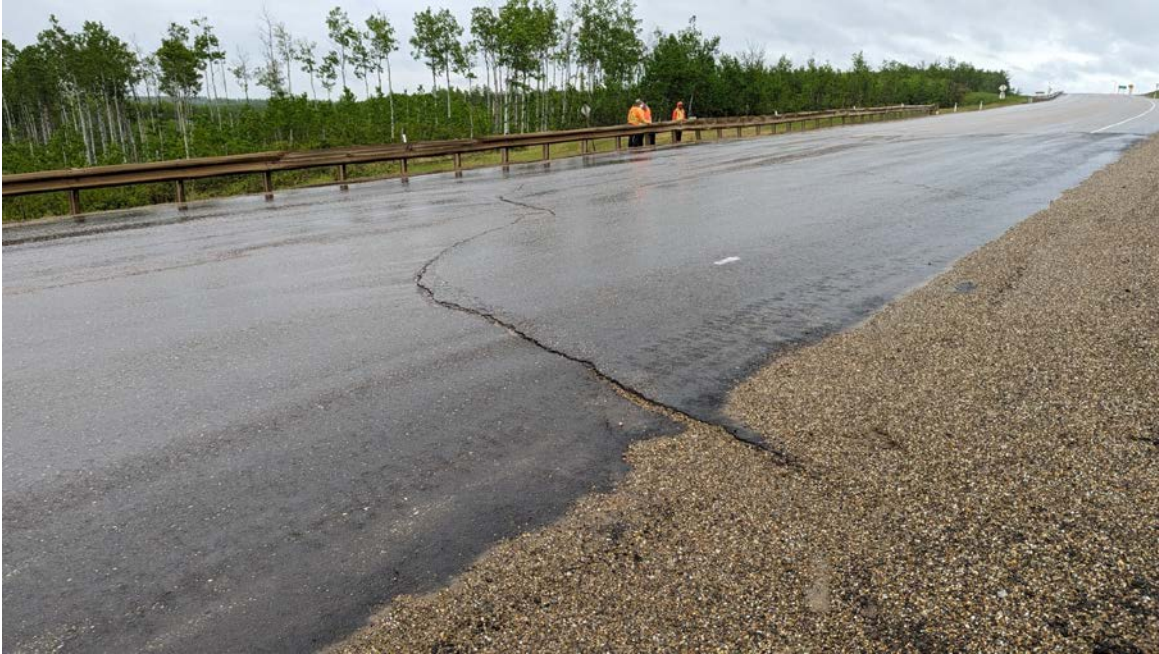
**Photo 5 – Looking north at area of frequent patching in the main graben block movement at Sta. 0+600.**

<b>Recommendations:</b>	
<b>Short-term:</b>	
<ul style="list-style-type: none"> <li>▪ Road maintenance consisting of milling and patching should continue as necessary (once or twice annually) to maintain the roadway surface in a safe condition. Crack sealing of the ACP should be done to limit infiltration of rain fall and snow melt into the extensive crack network.</li> <li>▪ The gully in the north ditch from about Sta. 0+500 to 0+550 could be repaired with minor excavation and placement of pitrun gravel. Consideration could be given to placing topsoil and seed that is secured with an erosion control blanket.</li> <li>▪ The erosion gully at the Sta. 0+460 culvert inlet is deteriorating and may affect the highway within a few years. Consideration should be given to regrading this section of the ditch and lining with erosion control measures (Class 1M riprap or comparable protection).</li> <li>▪ The erosion bowl that has recently formed at the culvert outlet at about Sta. 0+810 could be repaired before it increases significantly in size. This could consist of backfilling the bowl with pitrun gravel and adding riprap as per TEC culvert outlet protection specifications.</li> </ul>

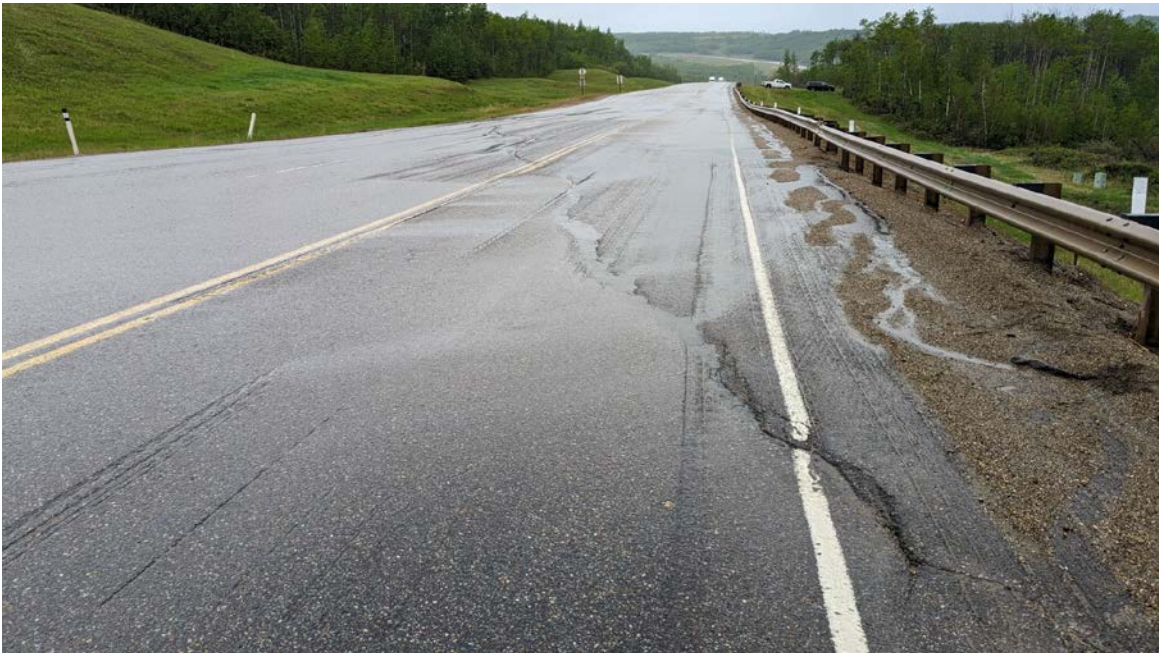
**Photo 6 – Looking west at main scarp cracks at Sta. 0+680.**

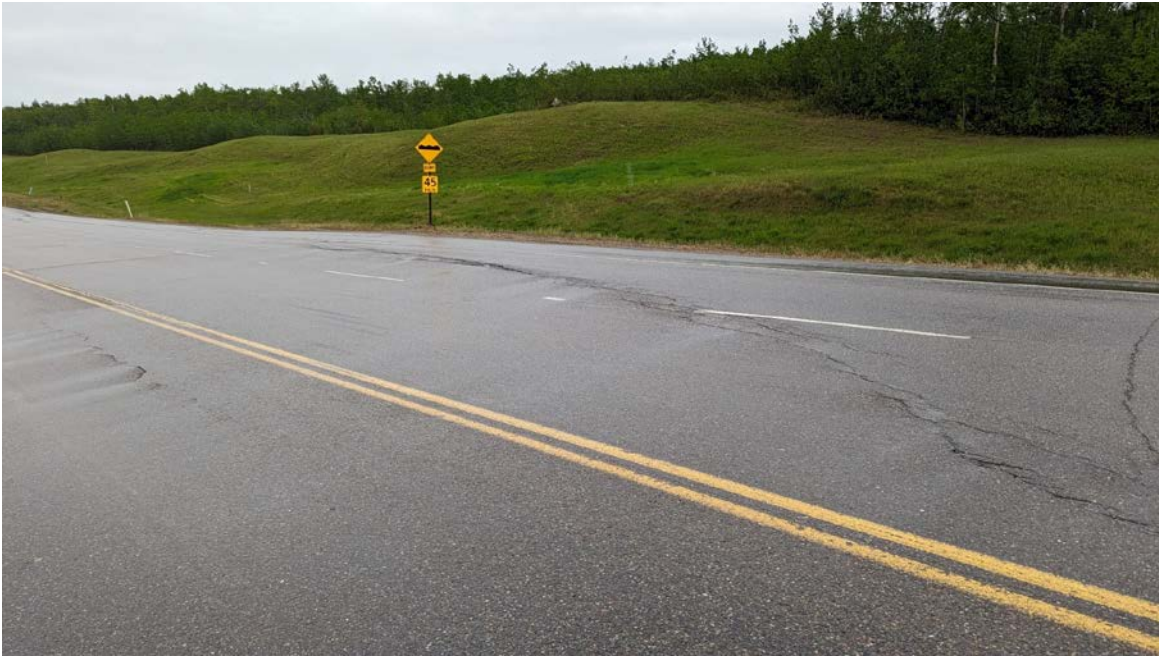
Photo 7 – Looking southeast at the cracks on the west side of main scarp block at Sta. 0+770.

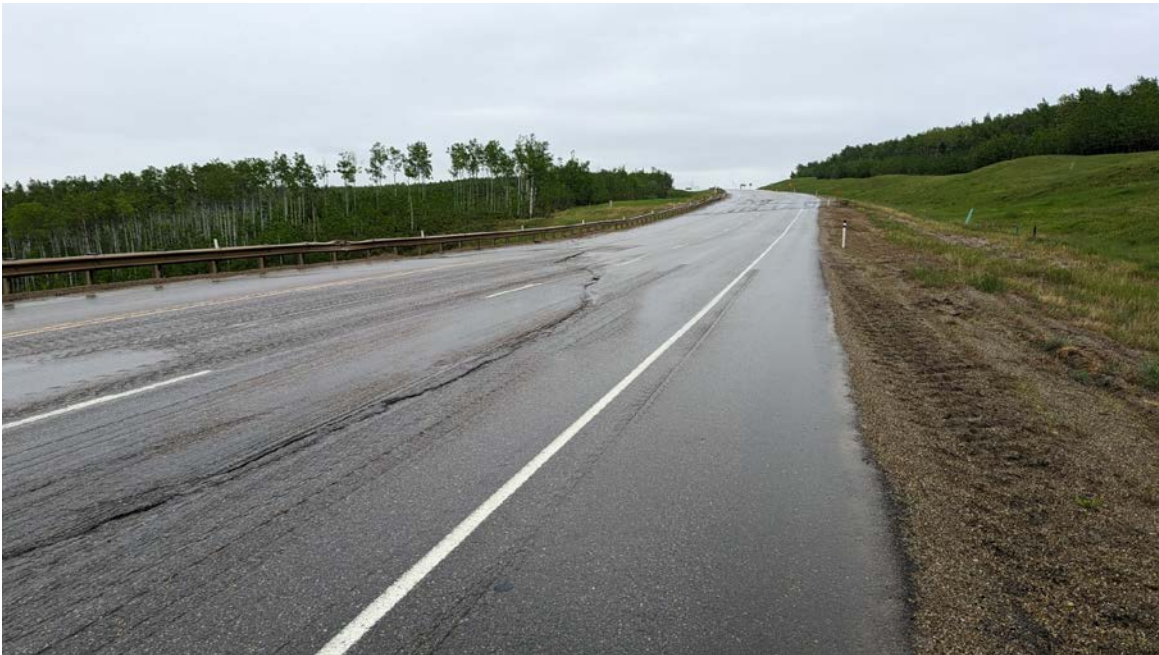
Photo 8 – Looking northeast at the cracks of the east side of main scarp block at Sta. 0+770.

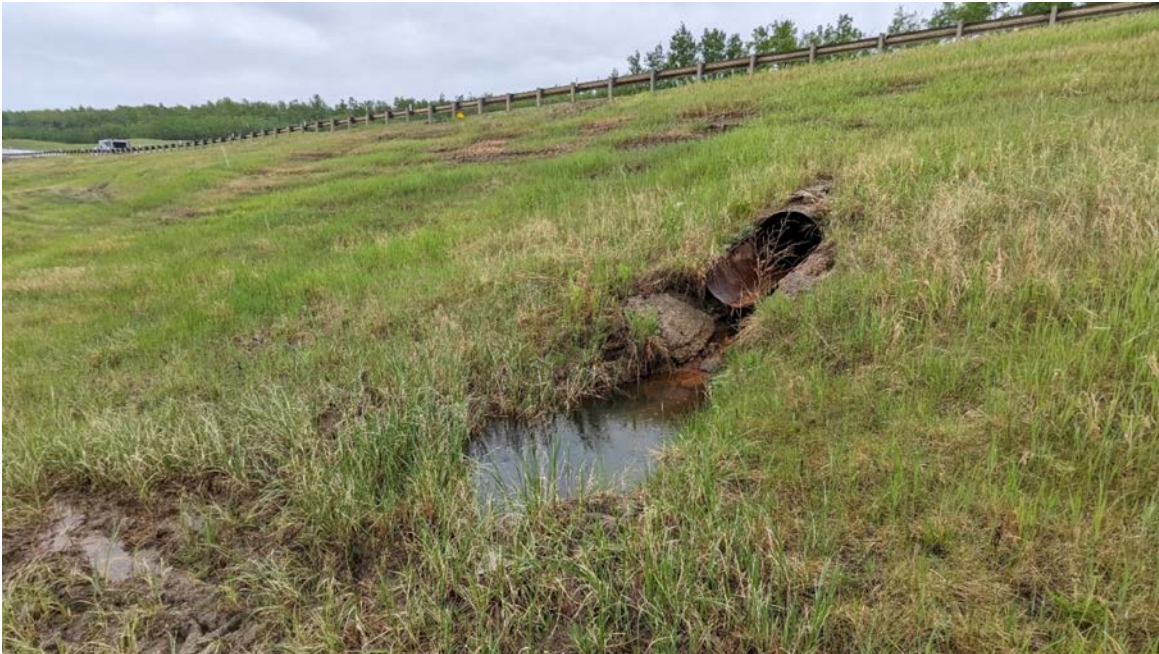
<input checked="" type="checkbox"/> Bridge/Culvert	Erosion bowl forming at outlet of culvert at 0+810 Slumping obstructing culvert inlet at Sta. 0+460	<input type="checkbox"/>
<input type="checkbox"/> Other		<input type="checkbox"/>

**Photo 9 – Developing erosion bowl at outlet of the 750 mm-dia. culvert at about Sta. 0+810.**

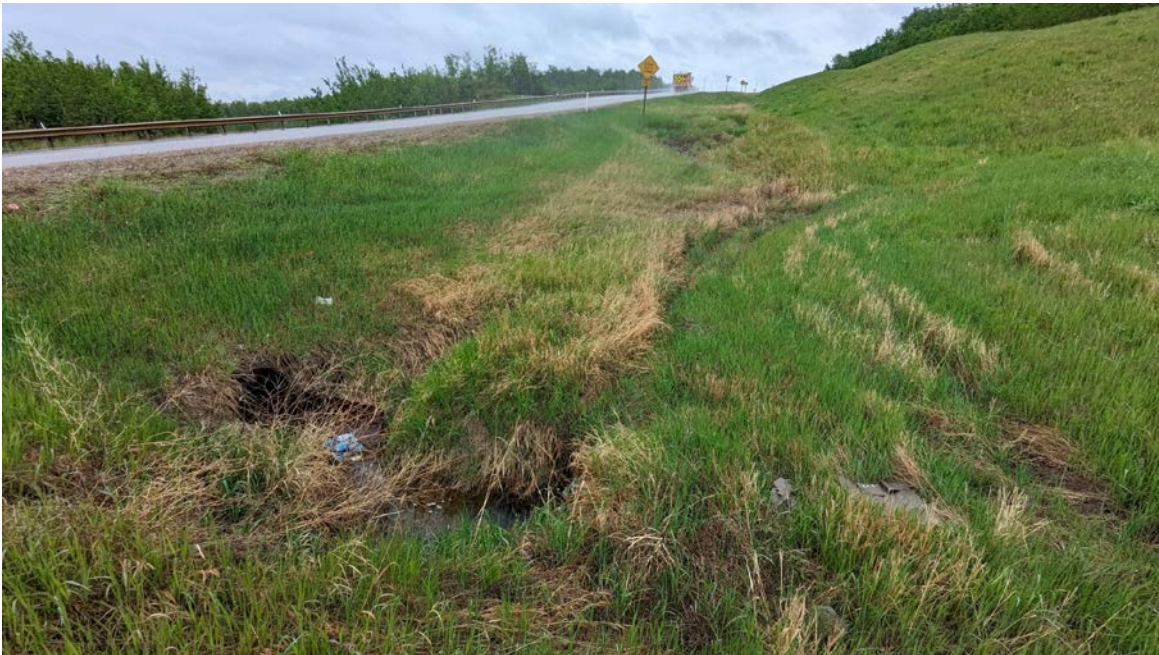
**Photo 10 – Erosion at the culvert inlet (left side) and scour bowl (right side) at Sta. 0+430 is starting to encroach towards the highway.**

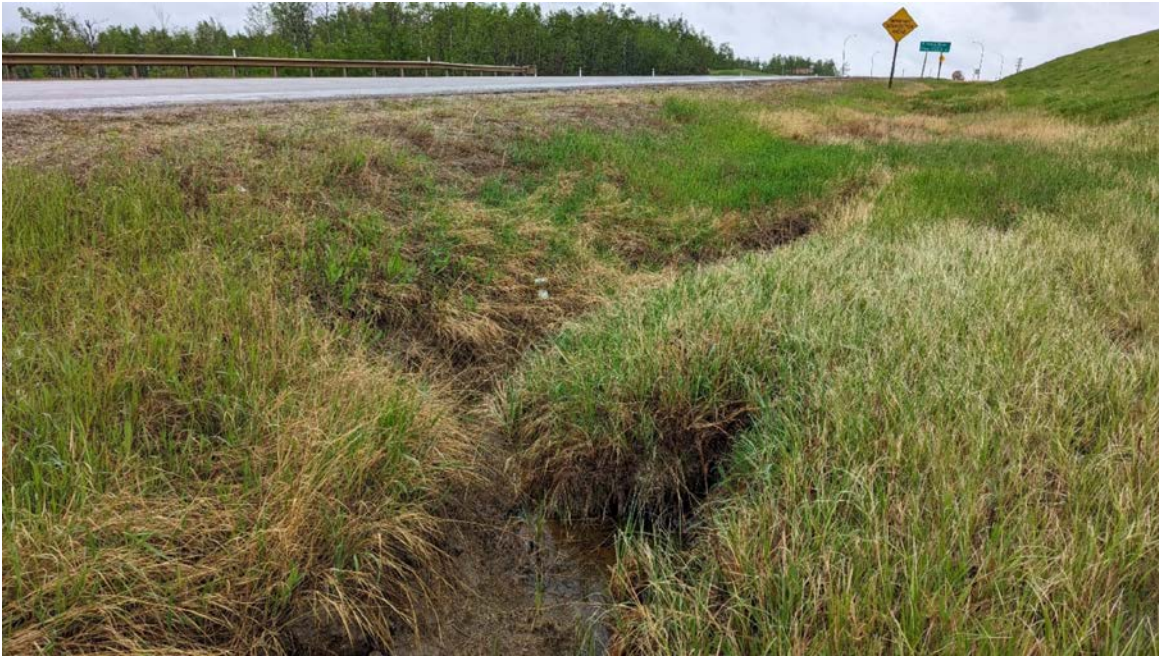
**Photo 11 – Scour bowl forming close to the edge of the highway at Sta 0+430.**

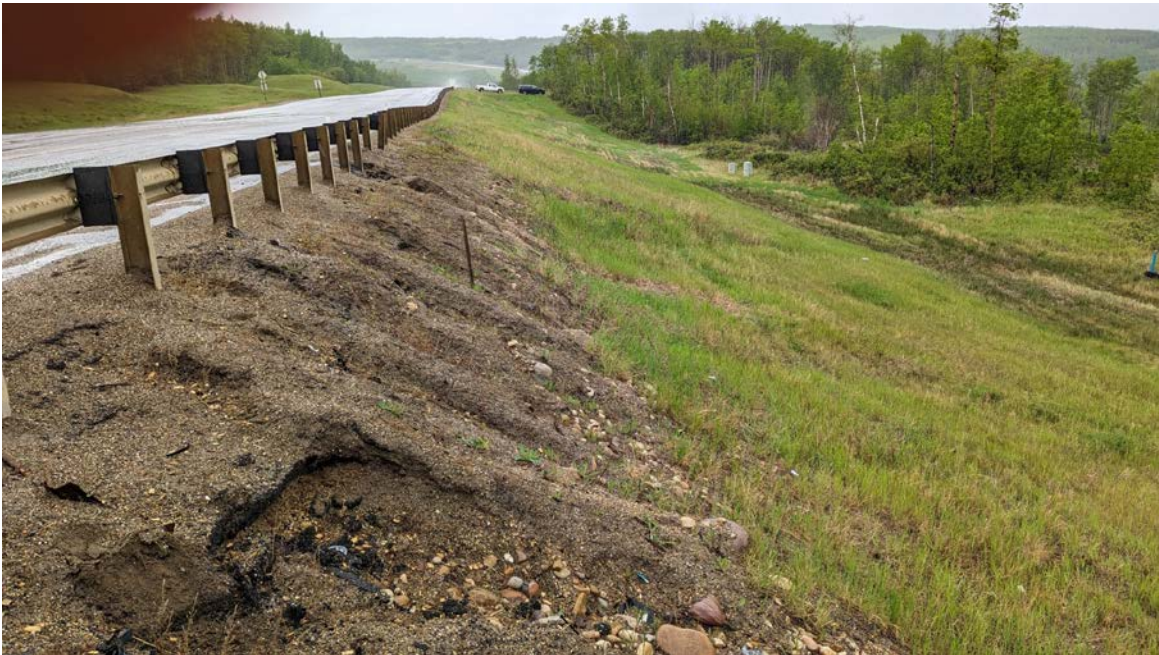
**Photo 12 – Erosion rills by the guardrail and ravelling of the north side slope backscarp between Sta. 0+650 and 0+700.**
