**ALBERTA TRANSPORTATION AND
ECONOMIC CORRIDORS
GEOHAZARD ASSESSMENT PROGRAM
PEACE REGION (PEACE RIVER DISTRICT)
2024 INSPECTION**

Site Number	Location	Name	Hwy	km
SH004-1	South of Little Smoky River	Little Smoky River (South of Bridge)	49:12	2.3-2.6
Legal Description		UTM Co-ordinates		
W33-074-21-W5M		11 E 489,224	N 6,145,128

Date	PF	CF	Total
Previous Inspection:	7-Jun-2023	13	6	78
Current Inspection:	3-Jun-2024	13	6	78
Road AADT:	1530		Year:	2024
Inspected By:	Rishi Adhikari, TEC Robert Senior, TEC		Ken Froese, Thurber Roger Skirrow, Thurber	
Report Attachments:	<input checked="" type="checkbox"/> Photographs		<input checked="" type="checkbox"/> Plans	<input type="checkbox"/> Maintenance

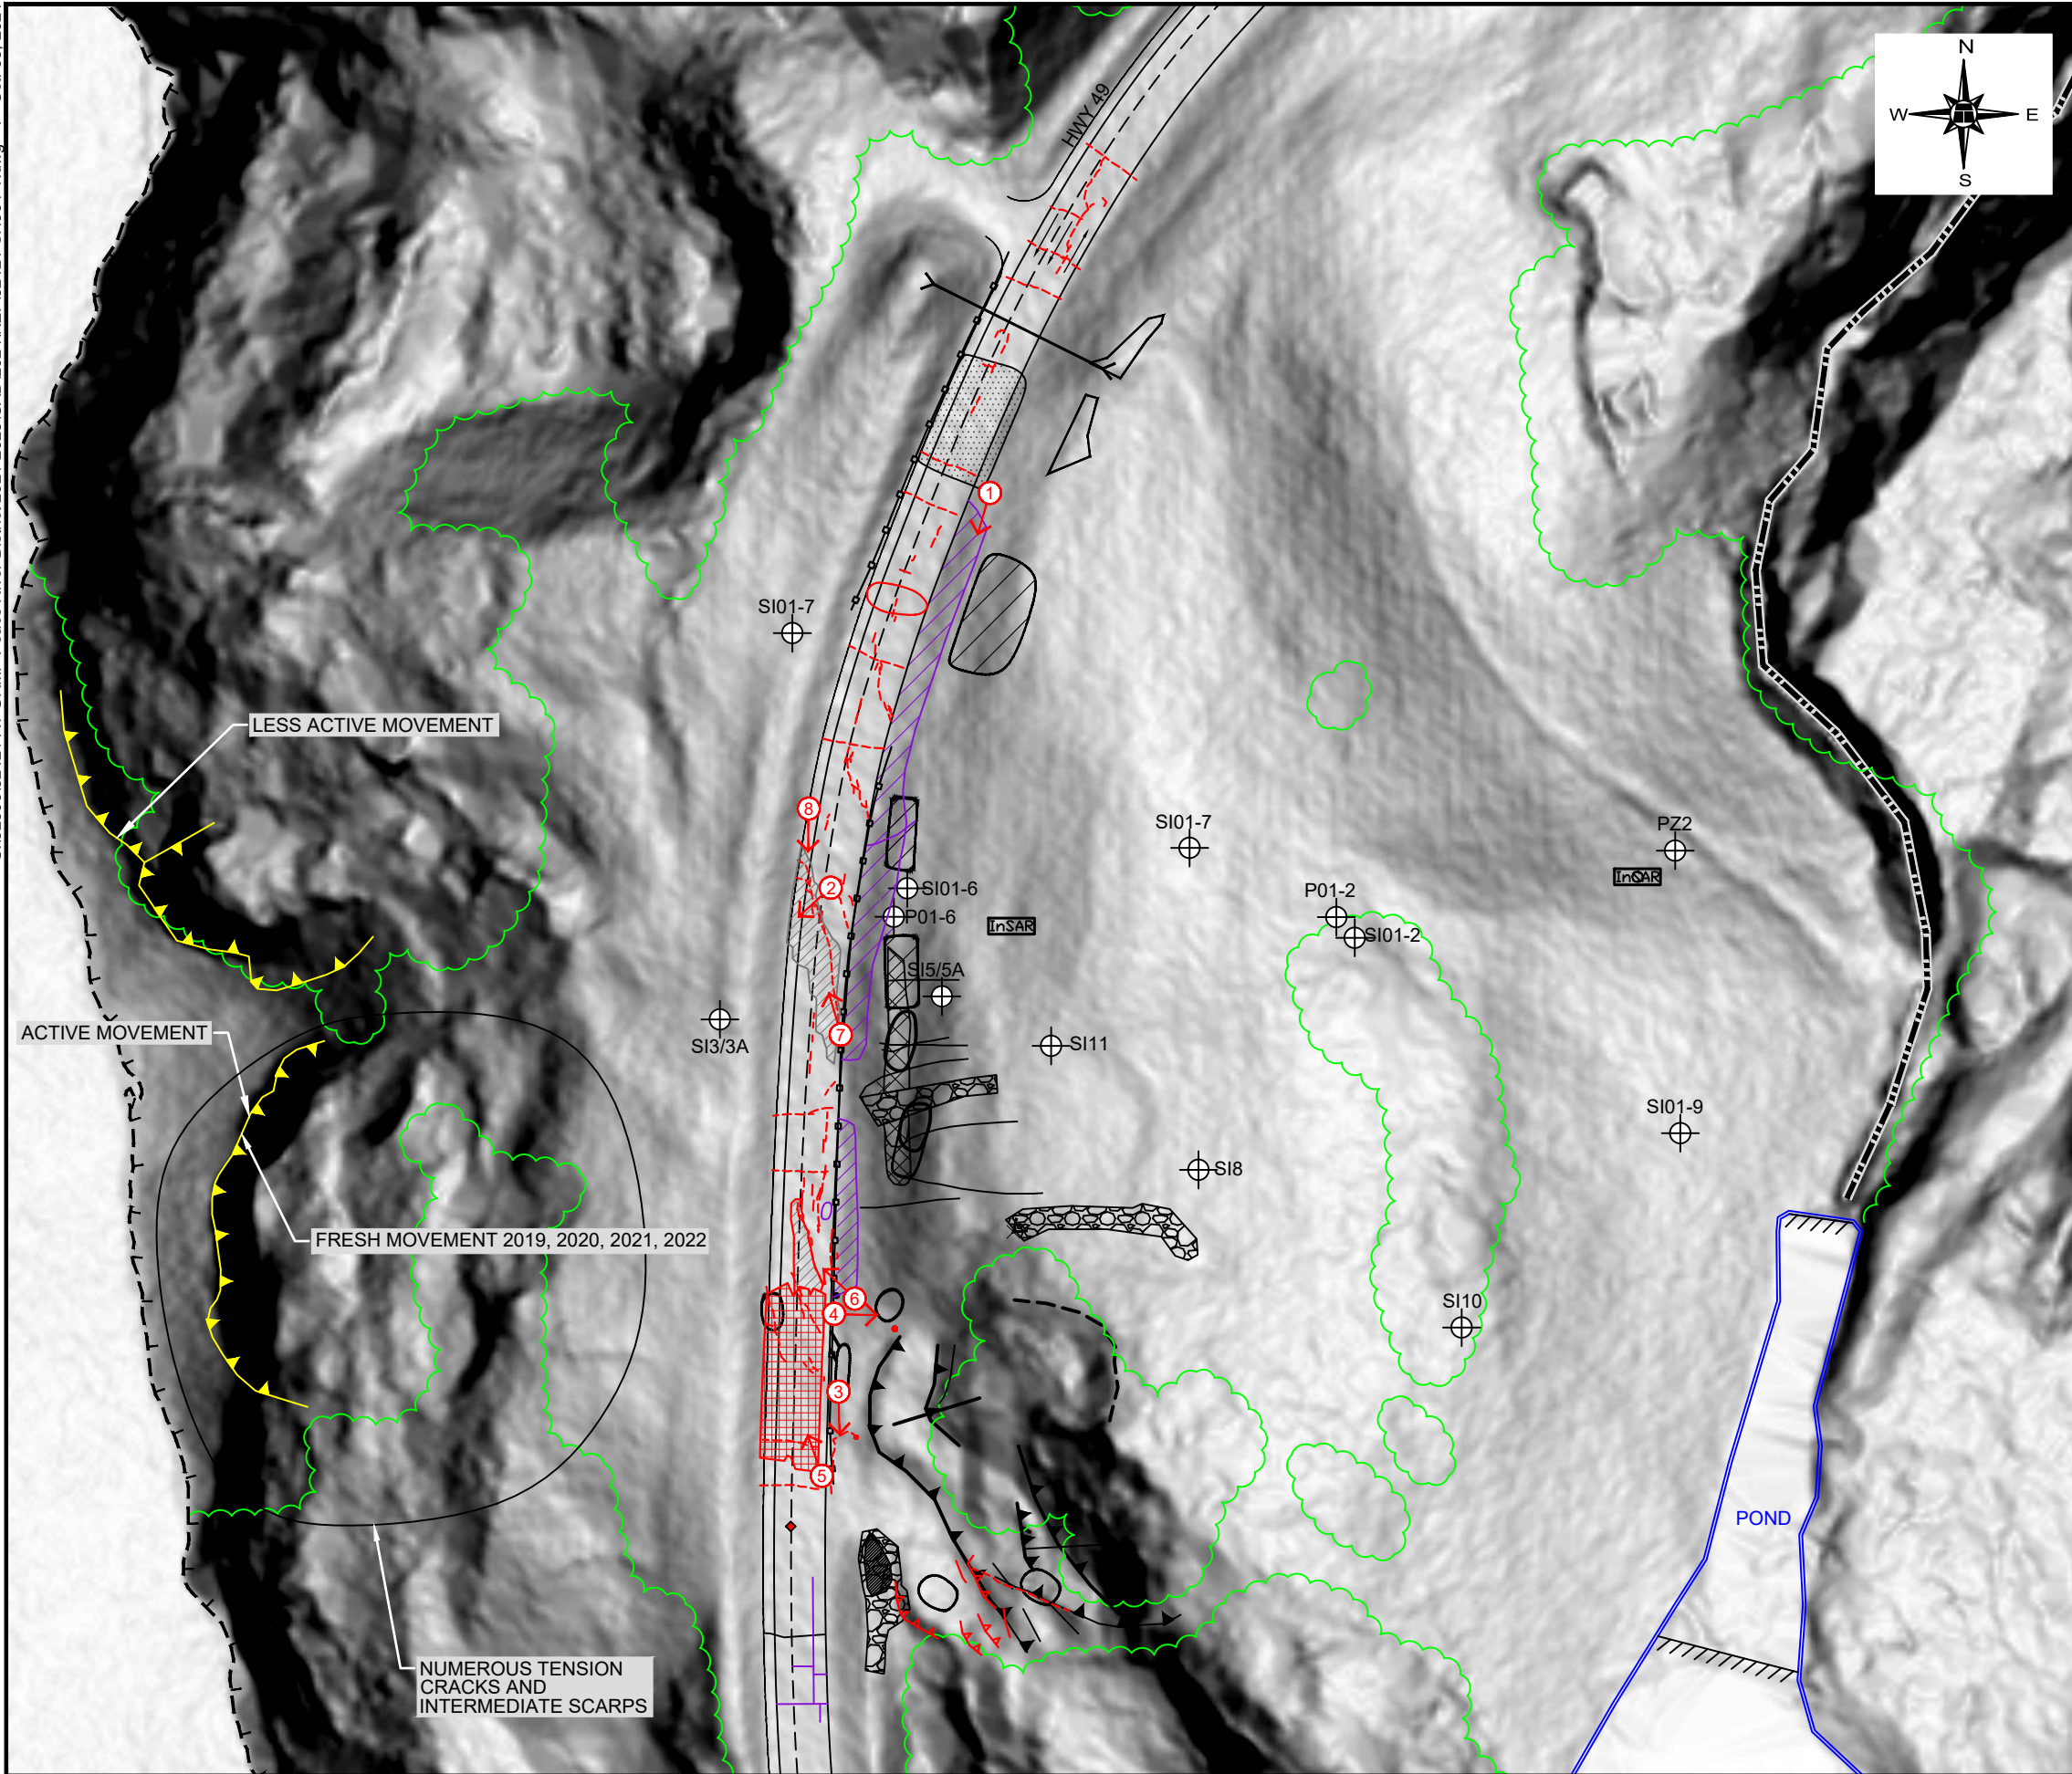
DWG No. 32121-SH004-1-1

**SH004-1: HWY 49:12 LITTLE SMOKY RIVER SOUTH OF BRIDGE
2024 SITE INSPECTION PLAN - OVERALL**

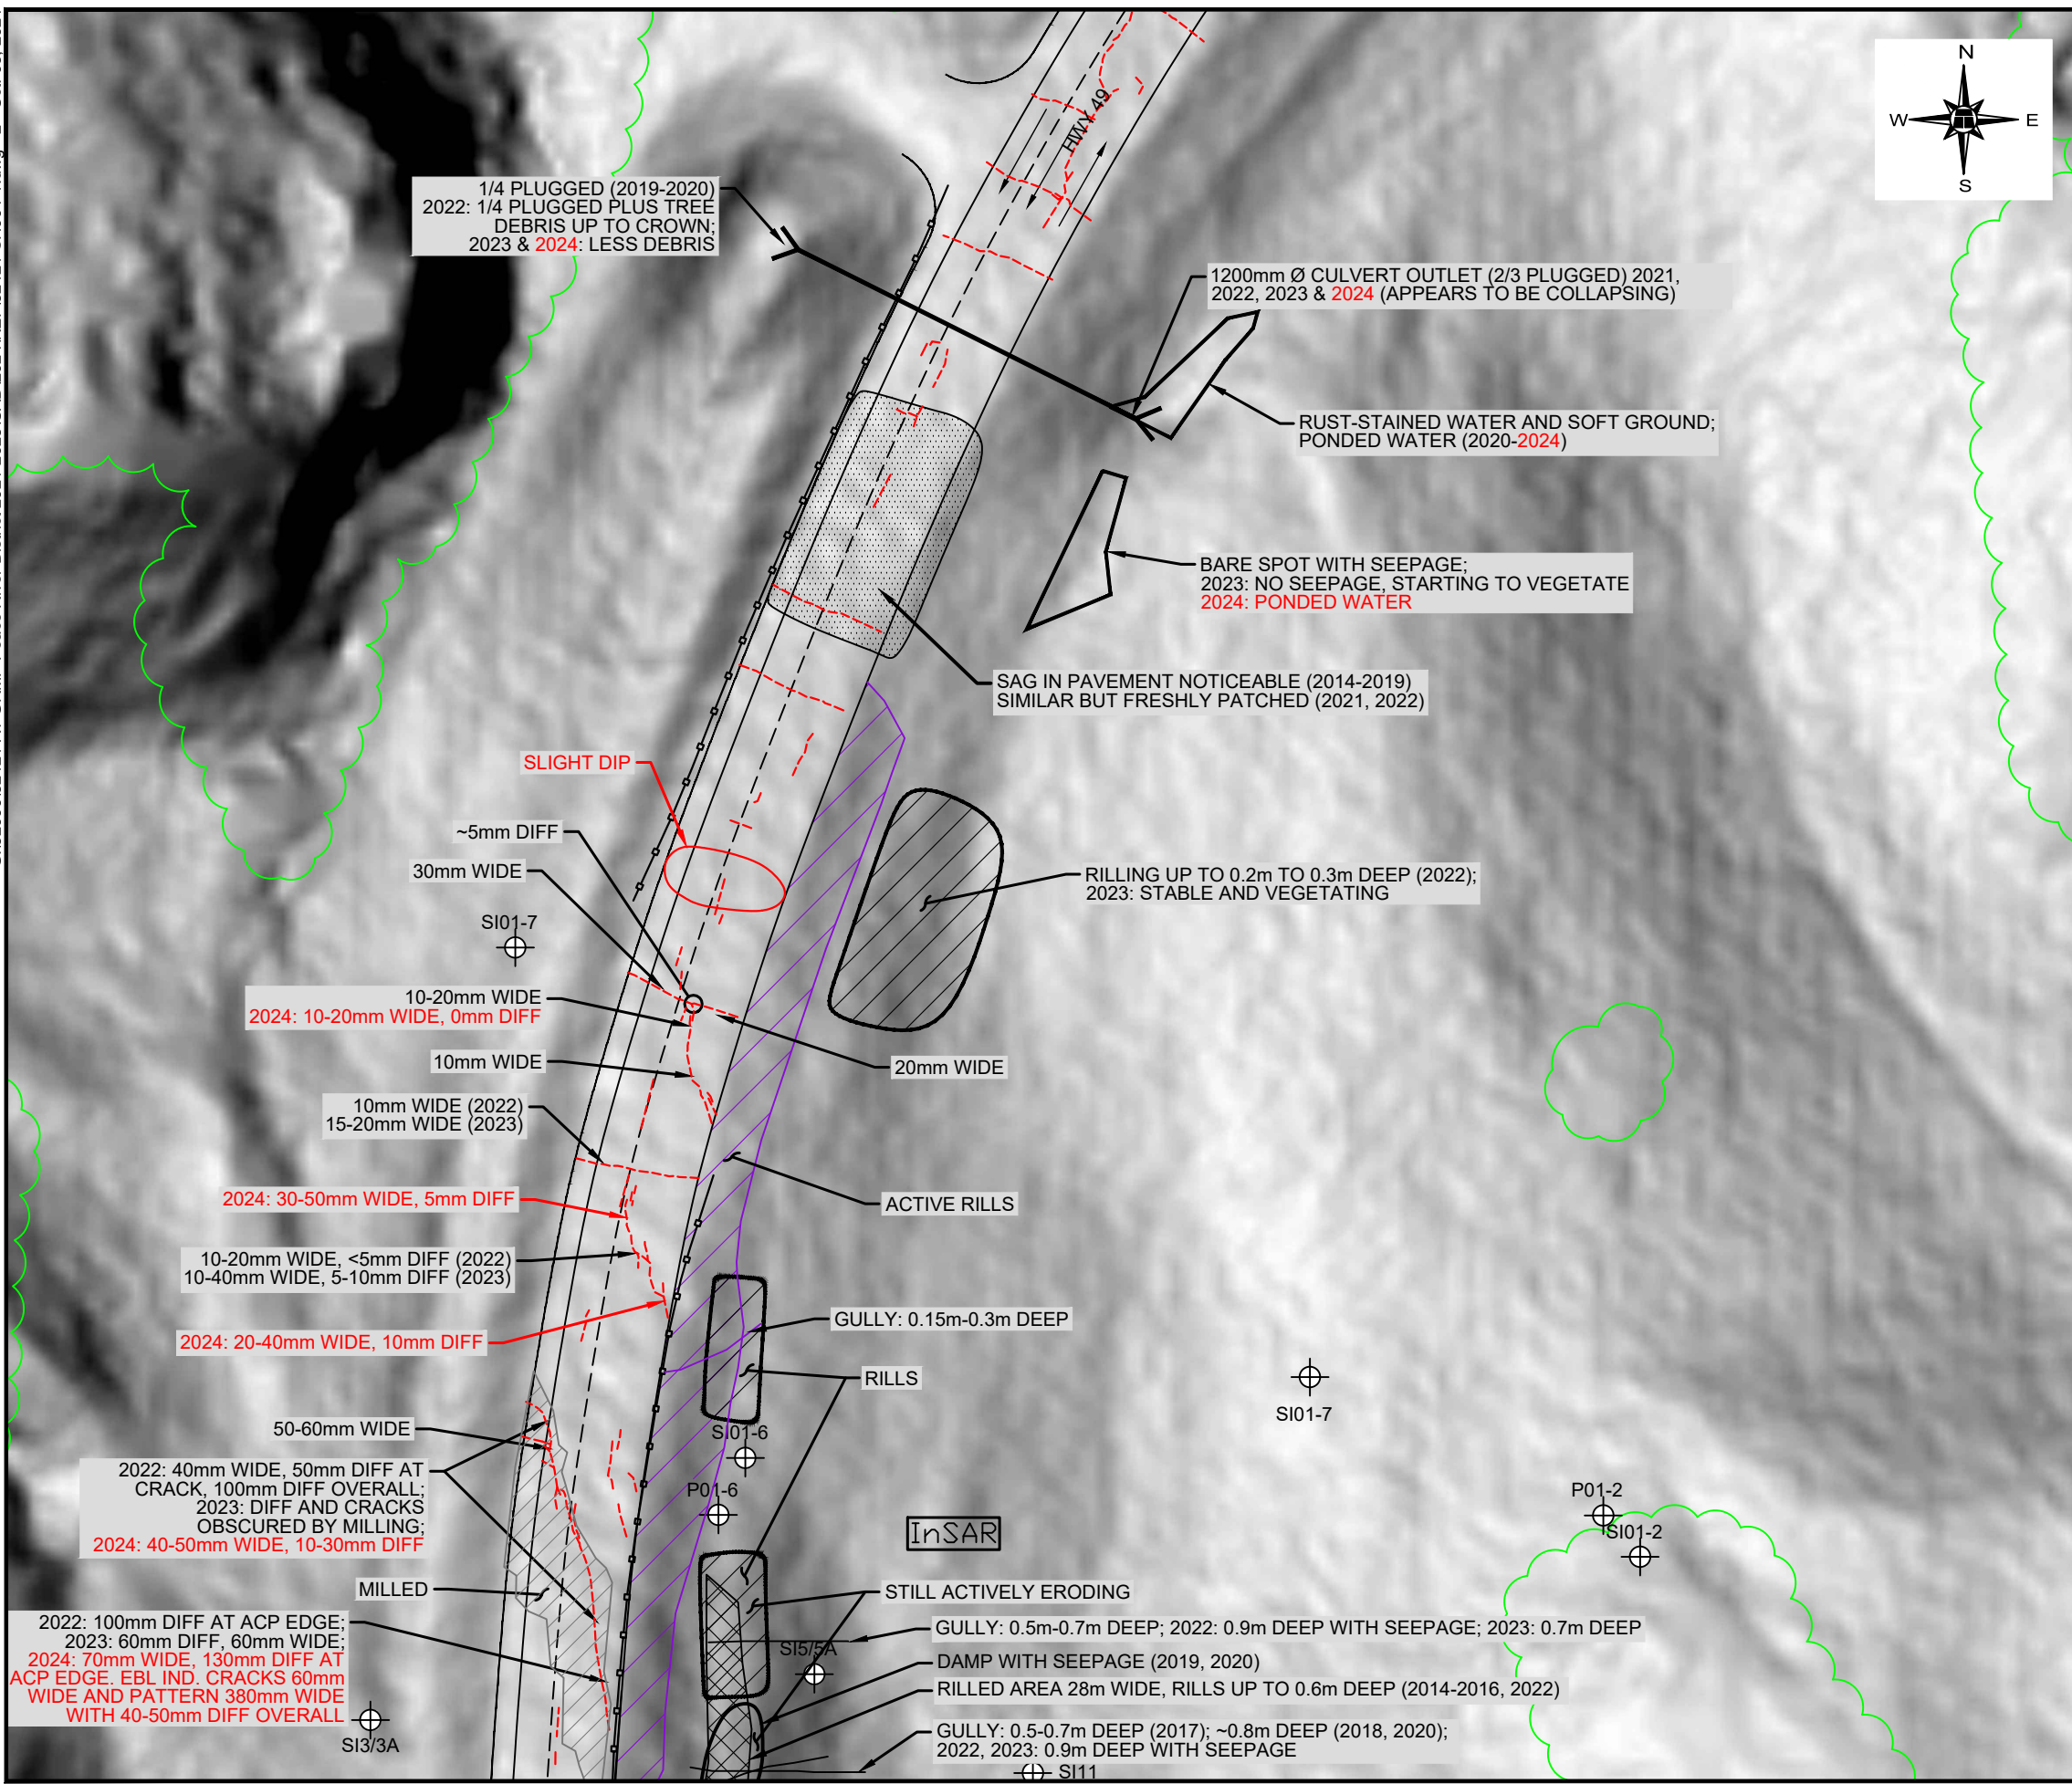
DWG No. 32121-SH004-1-2

**SH004-1: HWY 49:12 LITTLE SMOKY RIVER
SOUTH OF BRIDGE
2024 SITE INSPECTION PLAN - NORTH PORTION**

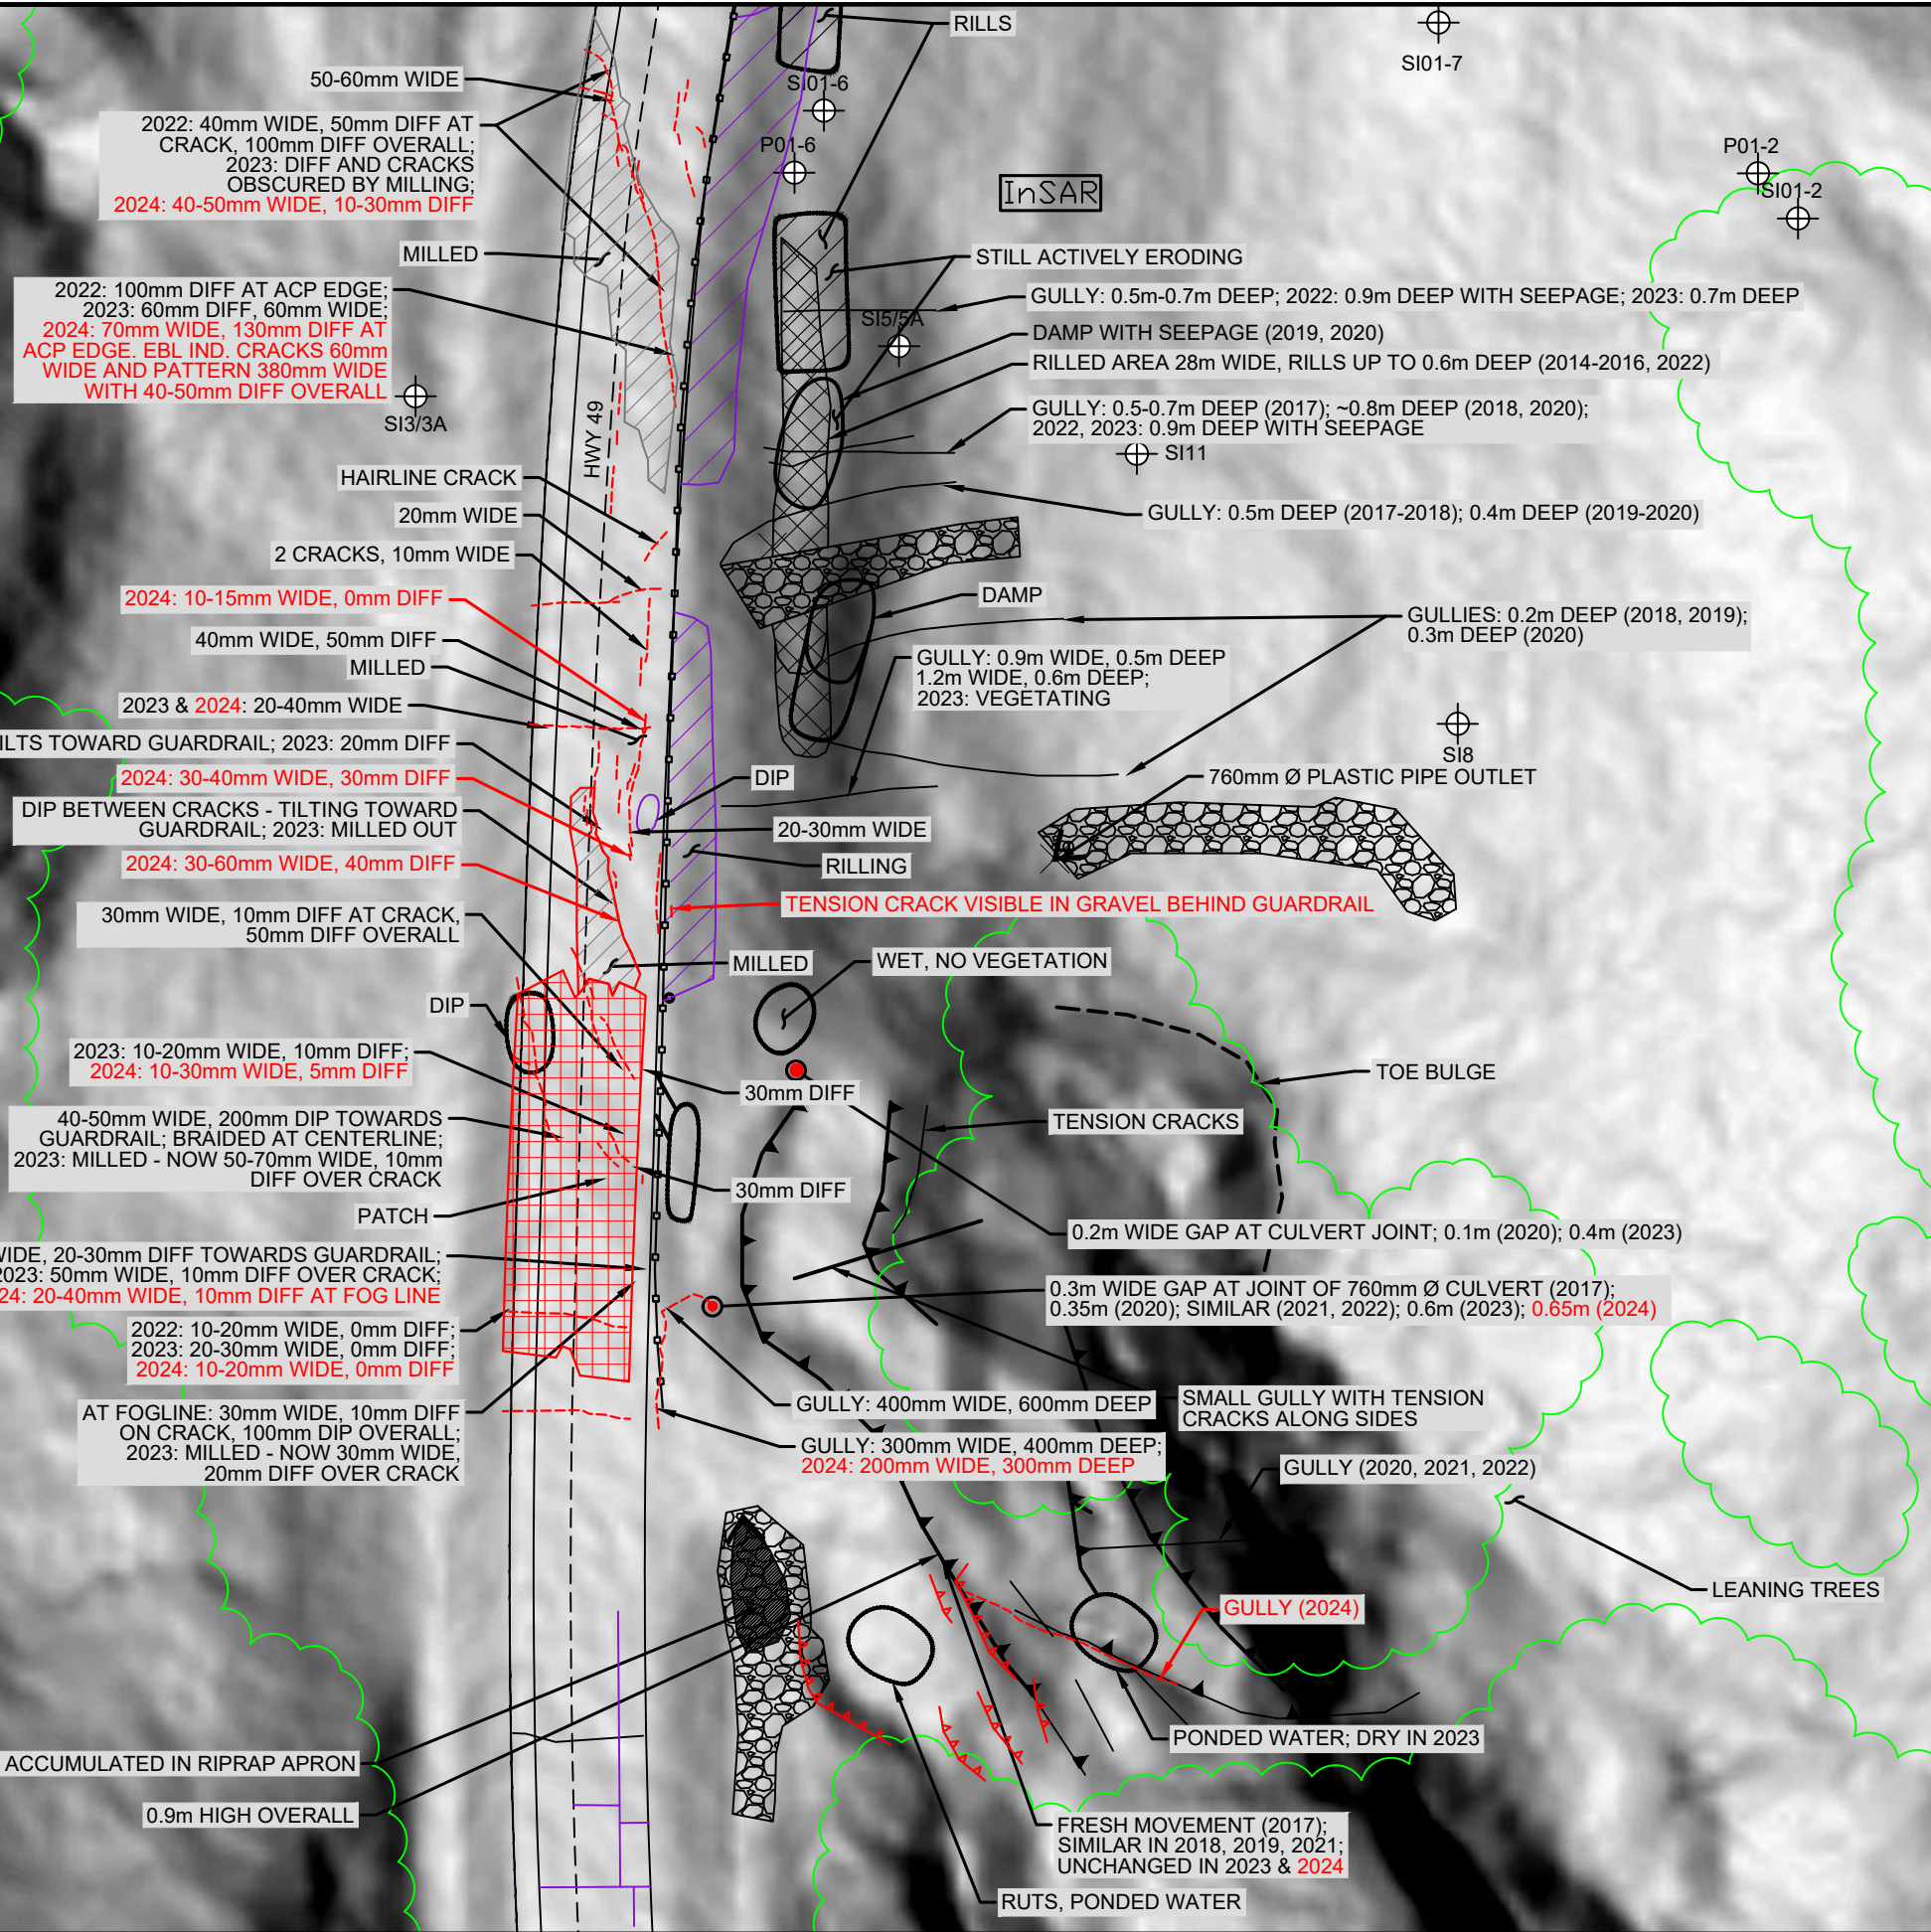
DWG No. 32121-SH004-1-3

**SH004-1: HWY 49:12 LITTLE SMOKY RIVER
SOUTH OF BRIDGE
2024 SITE INSPECTION PLAN - SOUTH PORTION**

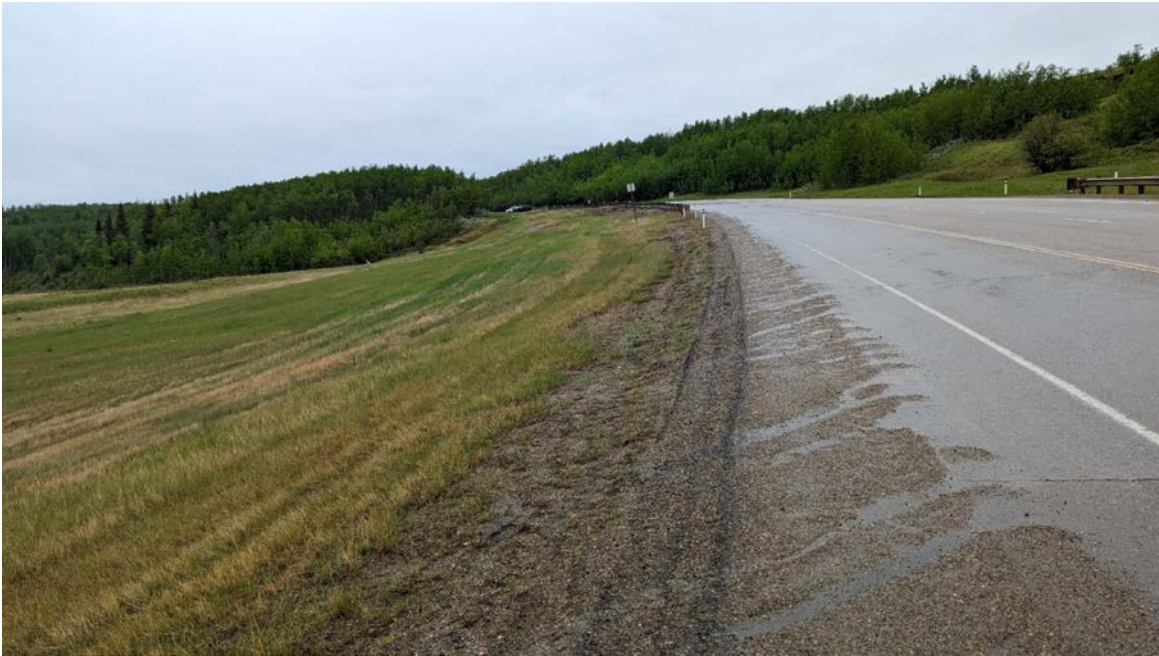
Photo 1 – Looking south at downslope side of highway from the north end of the site.

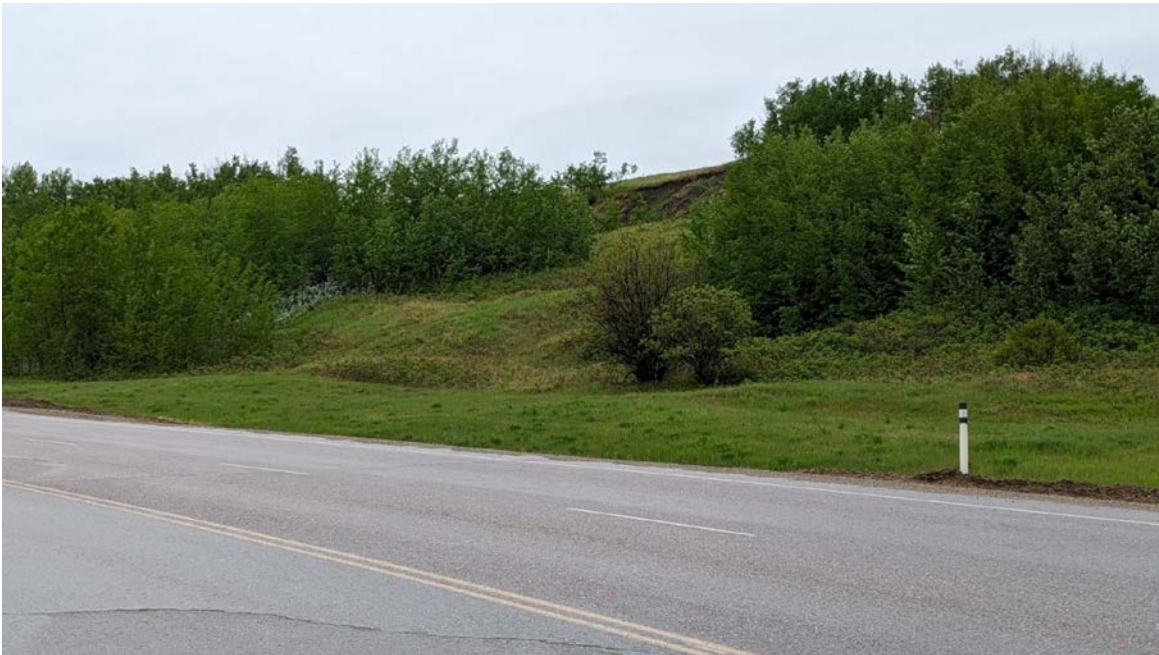
Photo 2 – Looking at the southwest slide movement in the backslope above the highway.

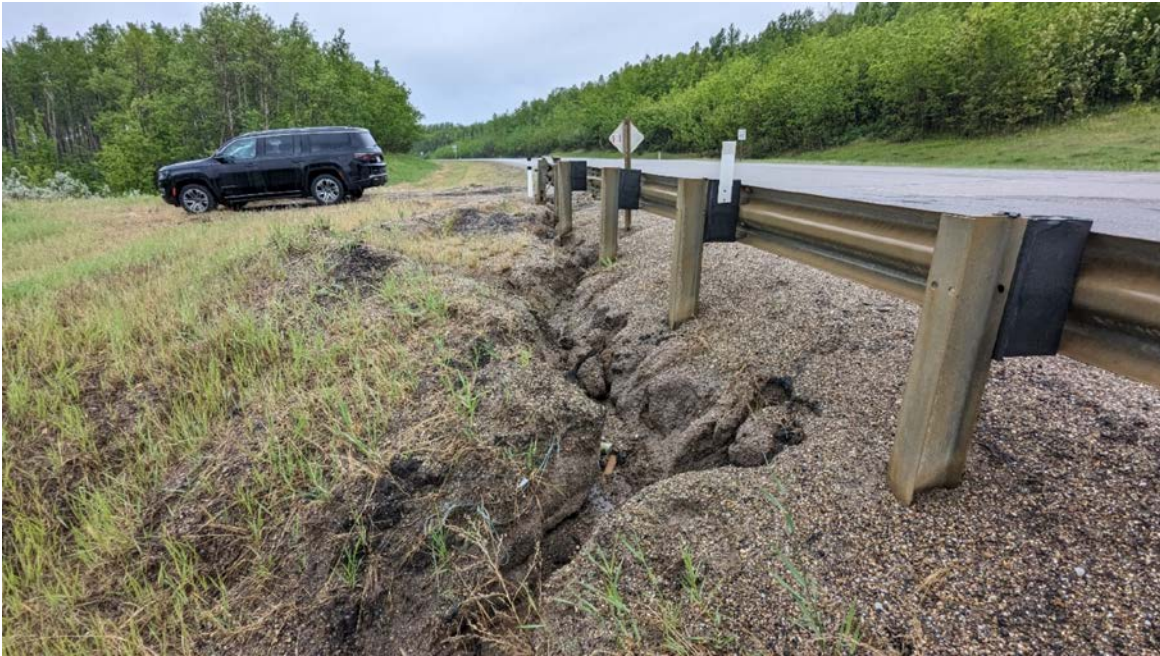
Photo 3 – Looking south at an erosion gully that has formed at the south end of the guardrail.

Recommendations:		
Short-term:		
<ul style="list-style-type: none"> ▪ Road maintenance consisting of milling and patching should continue as necessary (once or twice annually) to maintain the roadway surface in a safe condition. Crack sealing of the ACP should be done to limit infiltration of rain fall and snow melt into the extensive crack network. The bare areas on the downslope side of the highway to the north of the riprap apron have the potential to deteriorate further. This area could be regraded and covered with topsoil and seed, and further secured with an erosion control blanket or seed-impregnated compost blanket. The second rill area near the north end of the site and the new gully at the south end of the guardrail could be repaired at the same time with the same methodology.

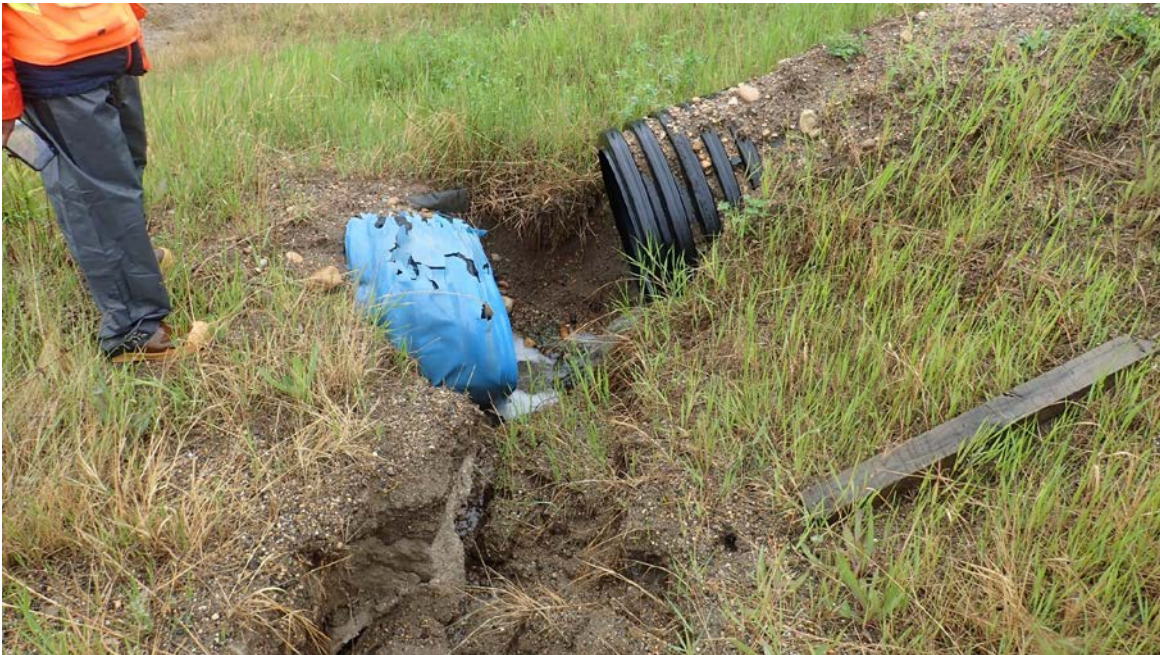
<input checked="" type="checkbox"/> Seepage	Evidence of seepage observed near culvert outlet at north end of site.	<input type="checkbox"/>
<input checked="" type="checkbox"/> Bridge/Culvert	Separation of plastic culvert.	<input type="checkbox"/>
<input type="checkbox"/> Other		<input type="checkbox"/>
Instrumentation (Spring 2024):		
VW07-2, VW07-2A, VW07-3, VW07-3A	Relatively stable and slightly decreasing over the last three years.	
Destroyed/Lost	VW07-2B and -3B (damaged Fall 2014); SI4A, SI01-6, SI01-7, SI01-2, SI07-3B, SI01-9, SI07-2B, PZ01-6, PZ01-2 (discontinued)	
Assessment:		
<p>The west and east valley slopes are prime examples of large scale, deep-seated retrogressive translational landslides. The overall west valley slope is moving as several separate slide blocks with numerous intermediate and main scarps, sag ponds, and differential movement zones. The highway alignment intersects these features which results in well established cracks crossing the highway and associated an uneven and tilted highway surface. The driving mechanism appears to be toe erosion by the Little Smoky River; a high ground water table may also be contributing. Based on GPS survey of the InSAR points conducted by Alberta Geological Survey (AGS Open Report 2013-14), this portion of the highway is located on landslide blocks moving relatively slower (5 mm to 40 mm per year) as compared to the eastside (SH003) or the bridge site (SH016). Drawing 32121-SH004-1-1 shows some of the local slide features that have been interpreted from the 2008 LiDAR imagery. Regrading of the slopes at this site has obscured the scarps of the larger slide blocks that are likely present beneath the highway alignment.</p> <p>The ongoing movement of the valley slope results in continued deformation of the highway surface that requires frequent widespread patching. An overlay was placed in the summer of 2020 to maintain the smoothness of the highway. Reportedly, the crack pattern in the highway started reflecting through the overlay in less than 24 hours. As the crack pattern became fully established, the increasing differential across the cracks required milling in 2021, 2022, and 2023. Patching was required in 2024 and, as shown on the Drawings, the crack pattern quickly became re-established: there are three main sets of scarp cracks crossing the highway on a NW-SE orientation and likely represent retrogressive movements of the valley-scale landslide blocks.</p> <p>The areas of rilling have slowly stabilized over the last two years. The new erosion gully that formed at the south end of the site at the end of guardrail in 2023 has deepened somewhat.</p> <p>There is a break in the plastic culvert that handles downslope ditch flow from the south that creating a sinkhole up to the ground surface. The sinkhole has not changed in size significantly in the last few years. A second gap at a culvert joint was observed in 2019 about 25 m further north. Both of these gaps in the culvert were slightly wider in 2023 and again in 2024.</p> <p>The slope below an approach located at the south end of the site started to deteriorate in 2019. There was increased displacement and extension of the tension and scarp cracks on this slope and the gully in the centre of the feature continued to deepen. This area seems to have stabilized in 2023 and 2024. This area warrants continued monitoring as retrogression of the features toward the highway could occur relatively rapidly.</p>

Photo 4 – Looking at 760 mm culvert joint separation. The gully in the foreground is the one shown in Photo 3.

- The break in the culvert should be excavated and repaired to limit infiltration into the slope which could potentially result in slope movement or significant erosion. Alternatively, this culvert could be replaced with an above-ground half-culvert or welded steel pile.

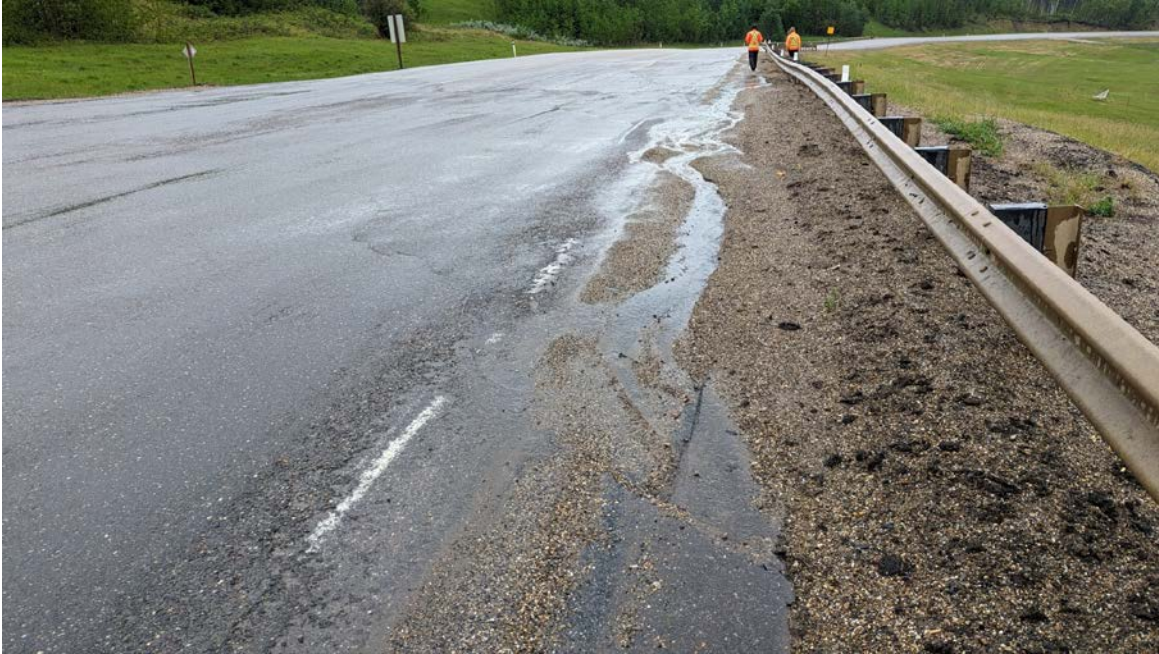
Photo 5 – Looking north at the first set of scarp cracks at south end of the site.

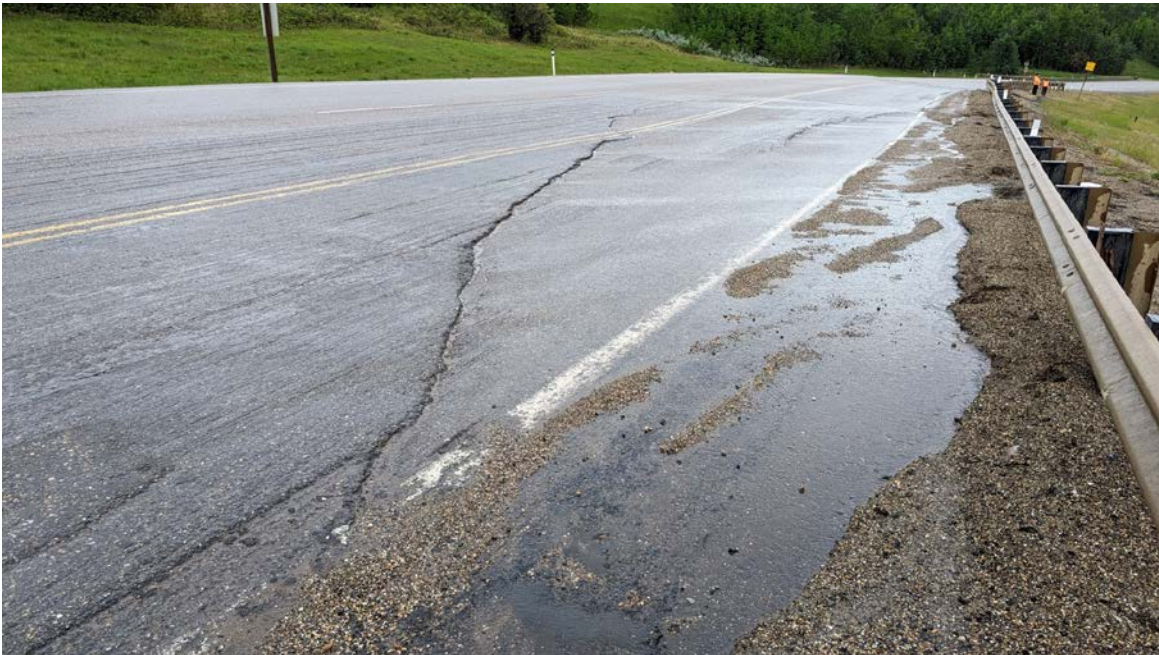
Photo 6 – The second set of scarp cracks just north of Photo 5.

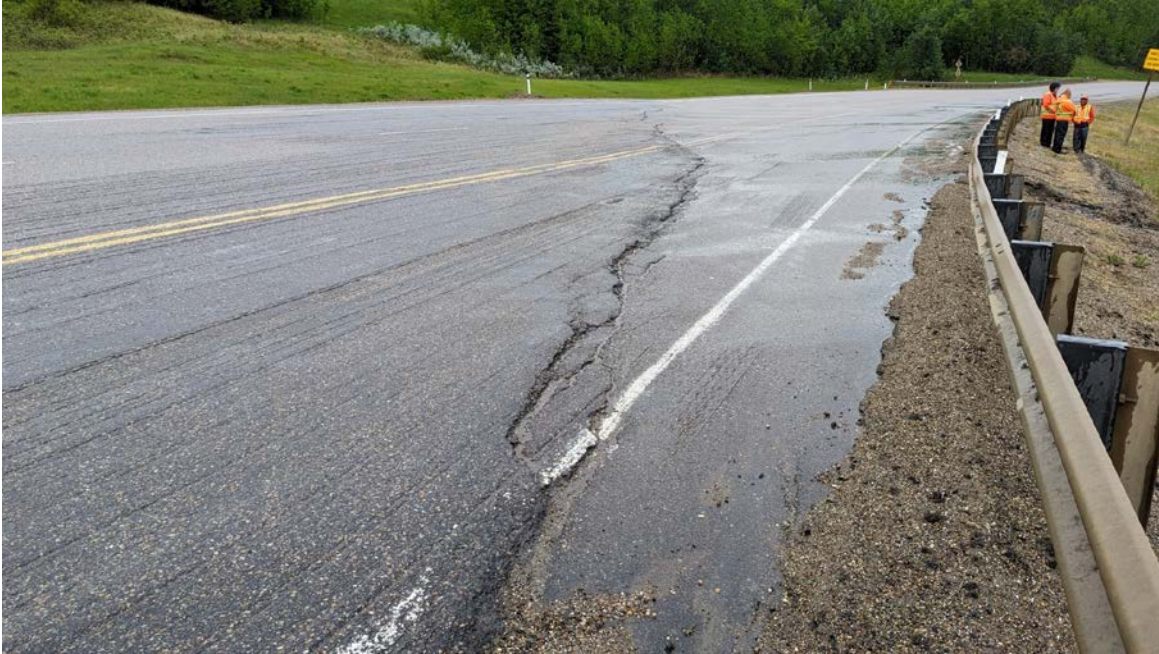
Photo 7 – The third set of scarp cracks further north of the second set and near the north end of the east guardrail.

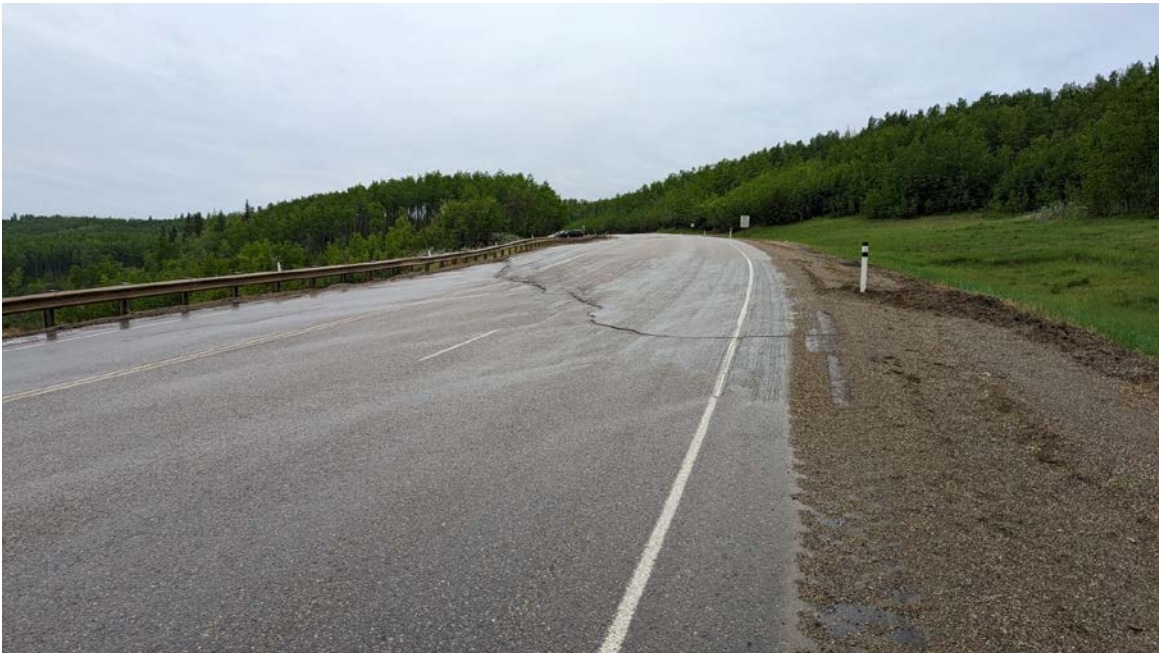
Photo 8 – Looking north back across all three sets with the third set in foreground.
