Site Number	Location	Name	Hwy	km
PH048	HWY 88:18 C1 29.441	Abutments Fort Vermilion Bridge	88:18	29.4
<b>Legal Description:</b>		<b>UTM Co-ordinates</b>		
1-29-108-13 W5		11U E 550921	N	6473794

**ALBERTA TRANSPORTATION AND ECONOMIC CORRIDORS GRMP (CON0022164)  
PEACE REGION (PEACE RIVER DISTRICT)  
INSTRUMENTATION MONITORING RESULTS**

**SPRING 2024**

**SITE PH048: HWY 88:18, FORT VERMILION BRIDGE**

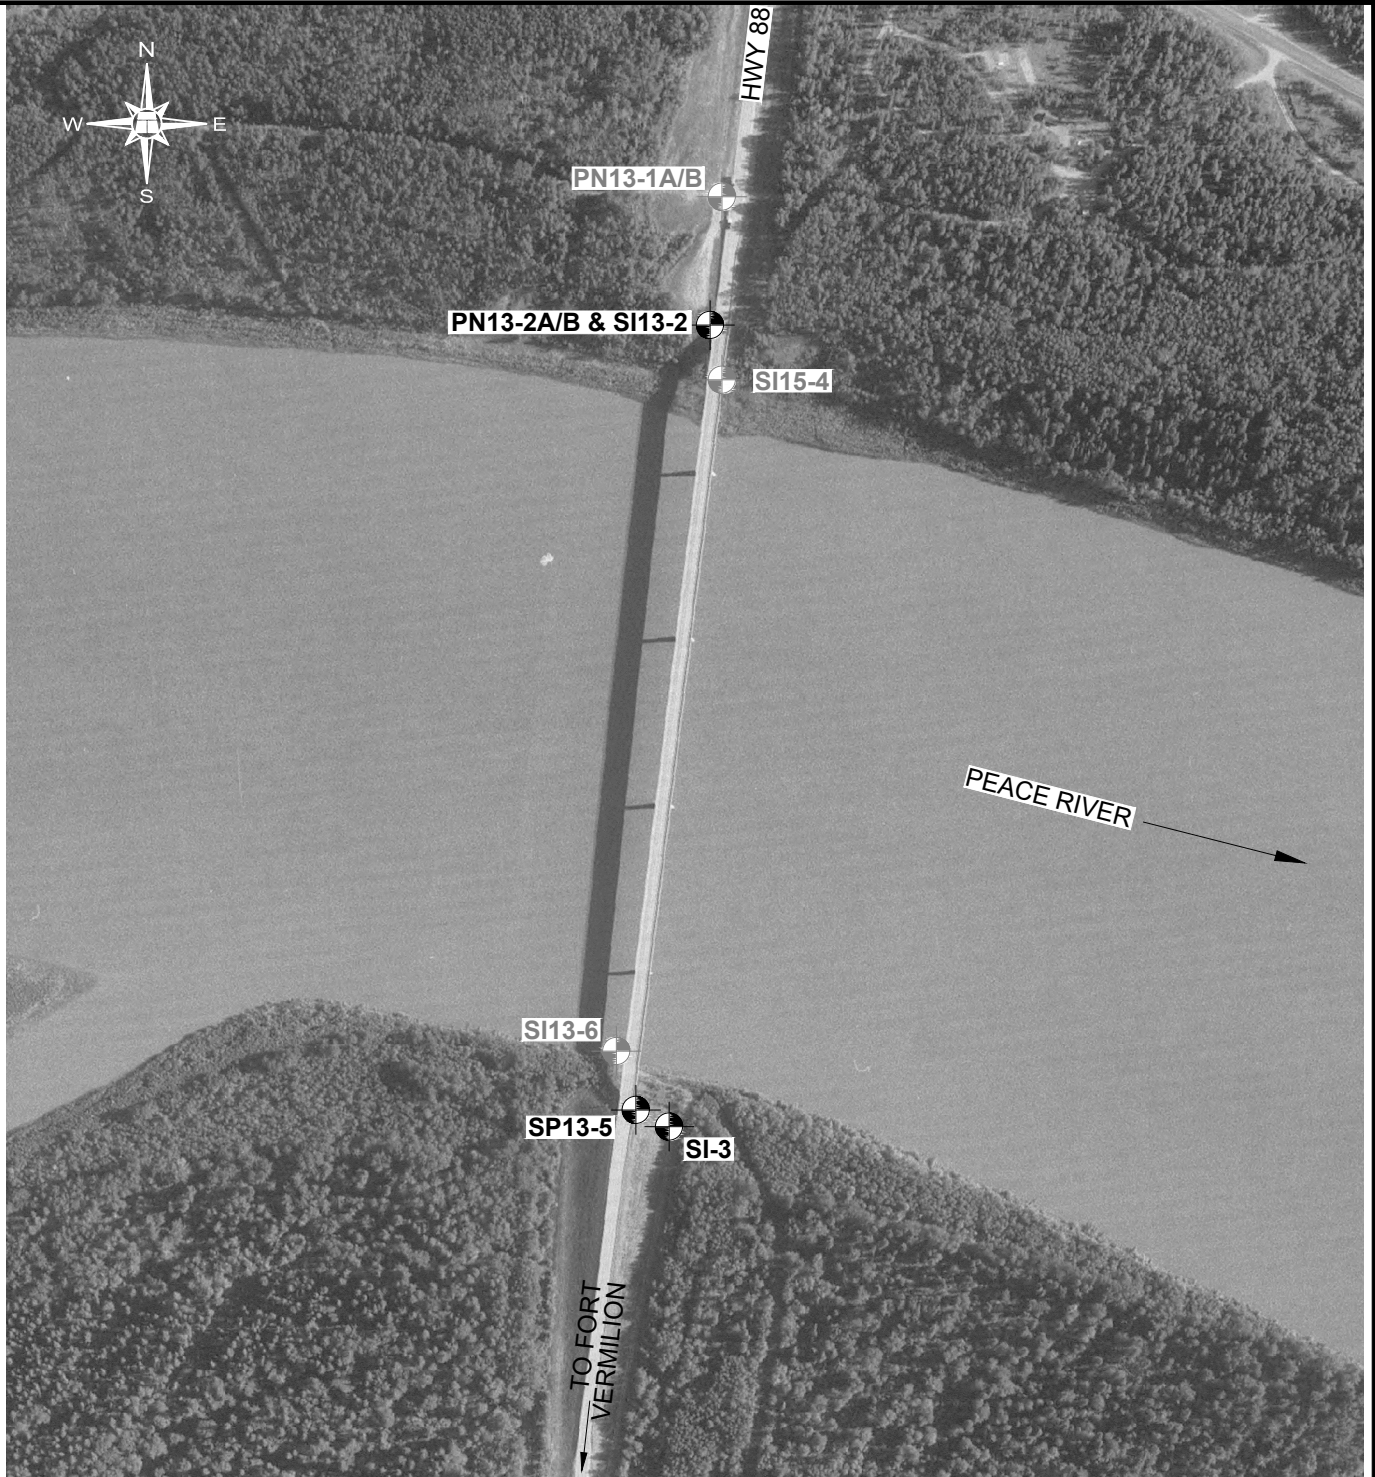
**DWG No. 32121-PH048**

SP13-5 Standpipe broken by lawnmower, see photo.

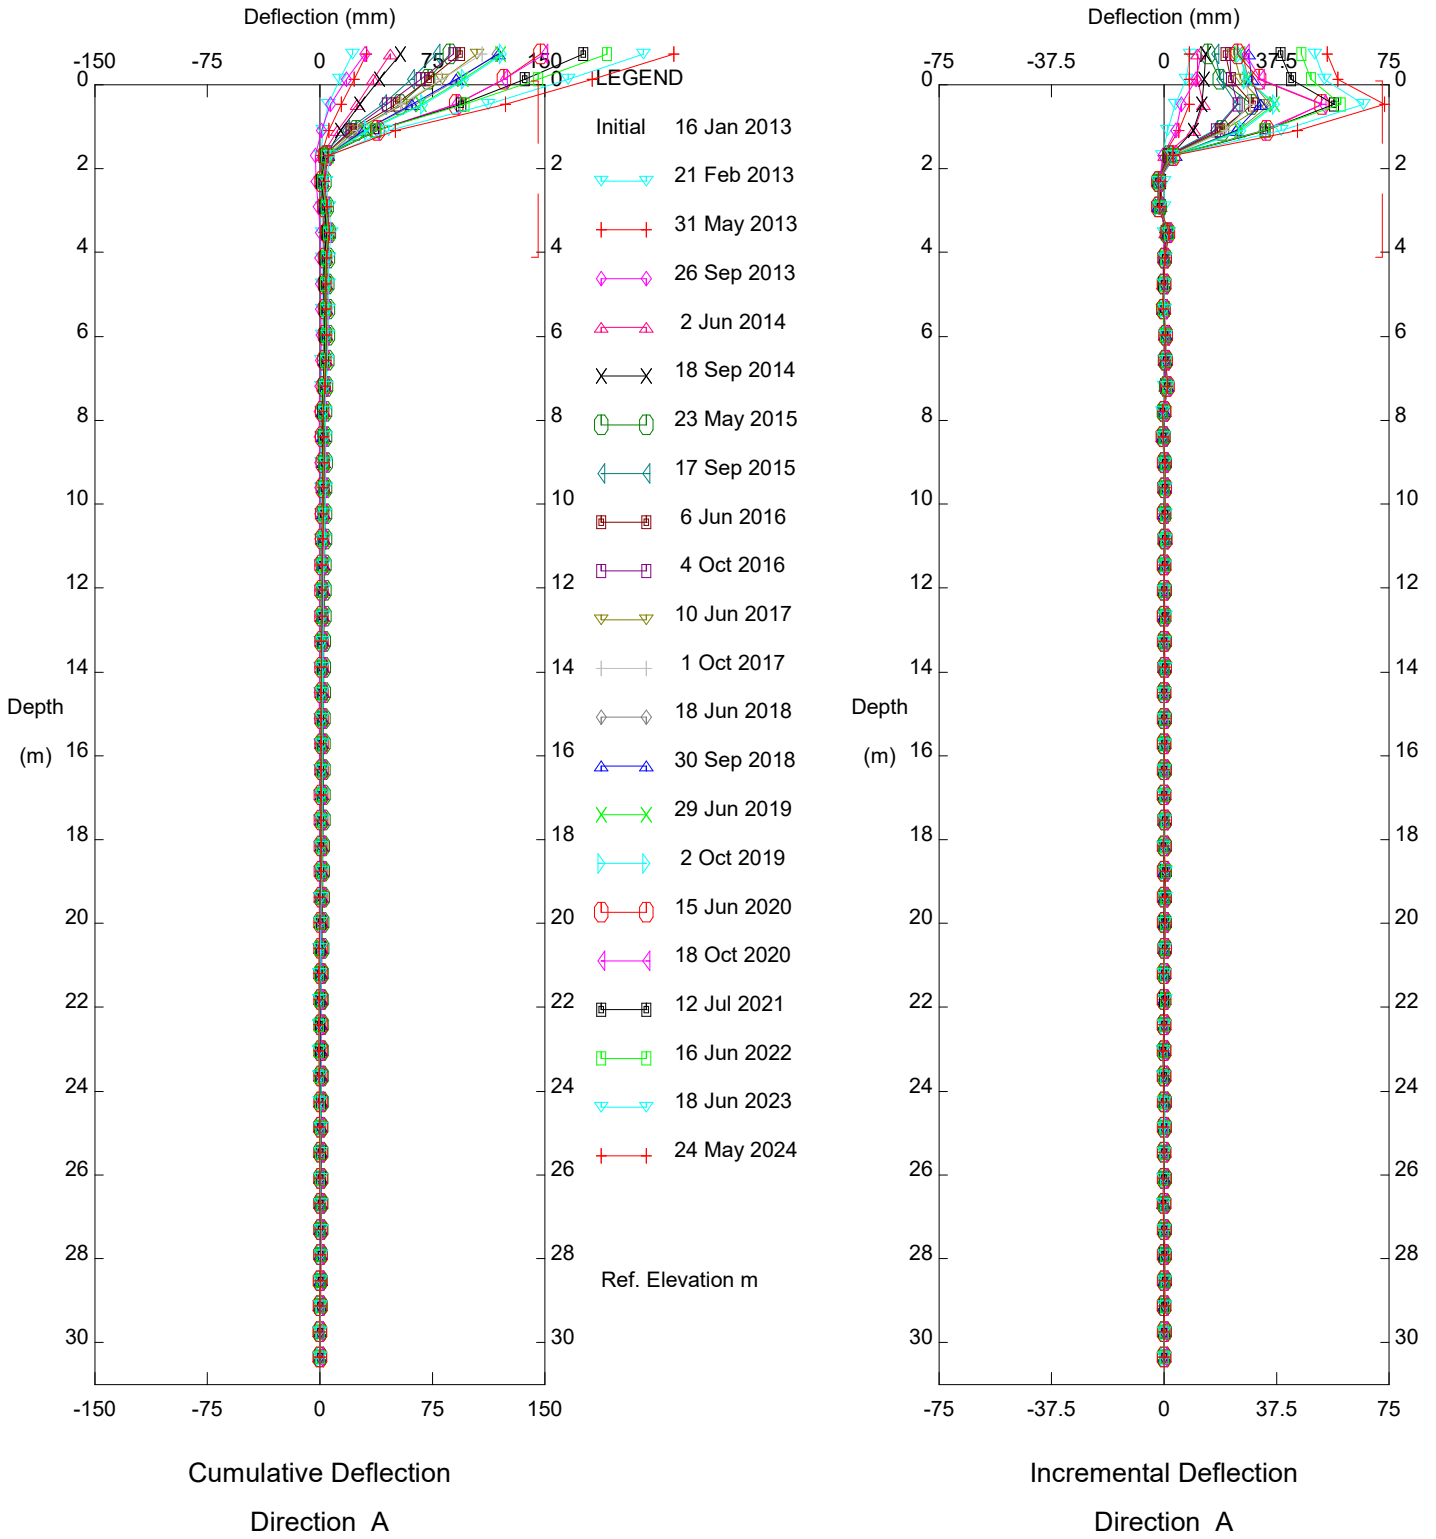
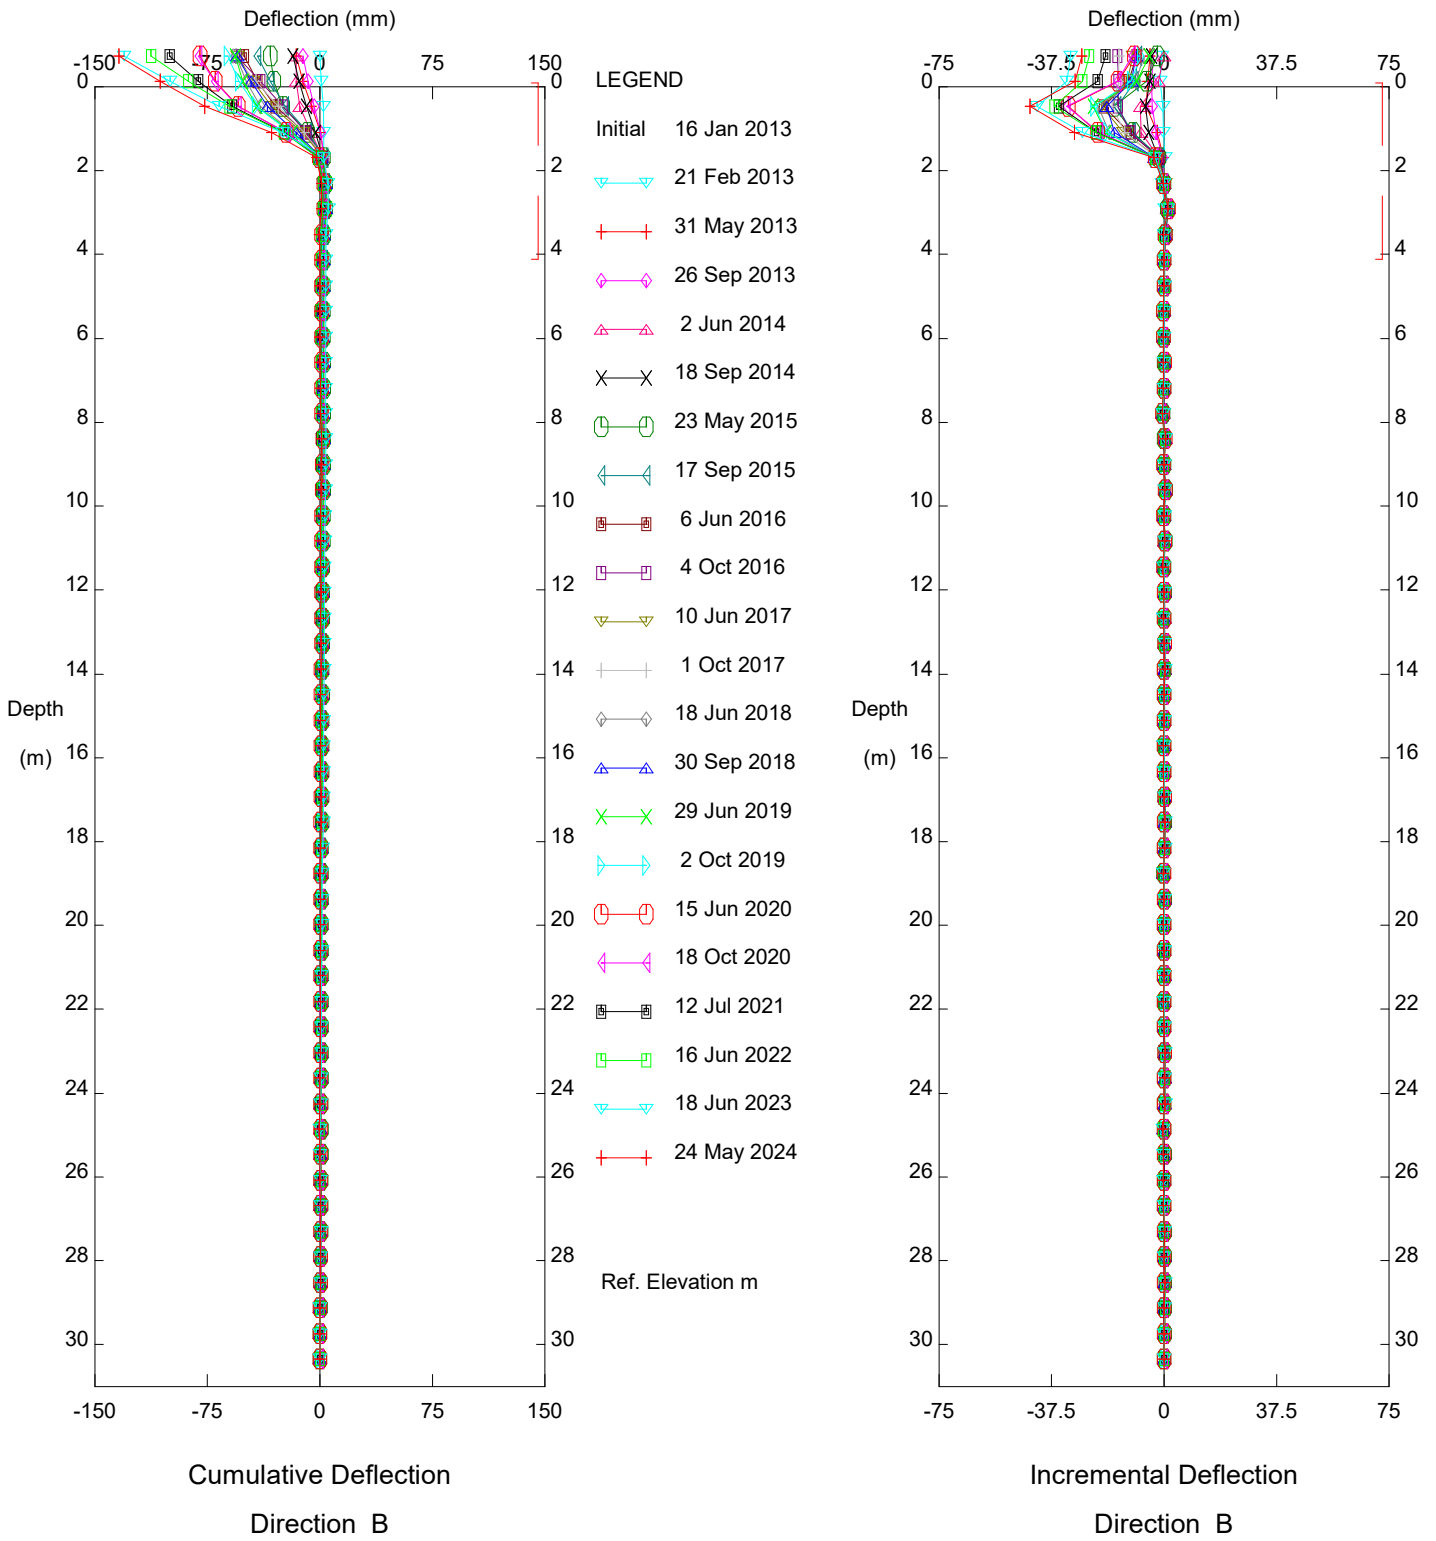
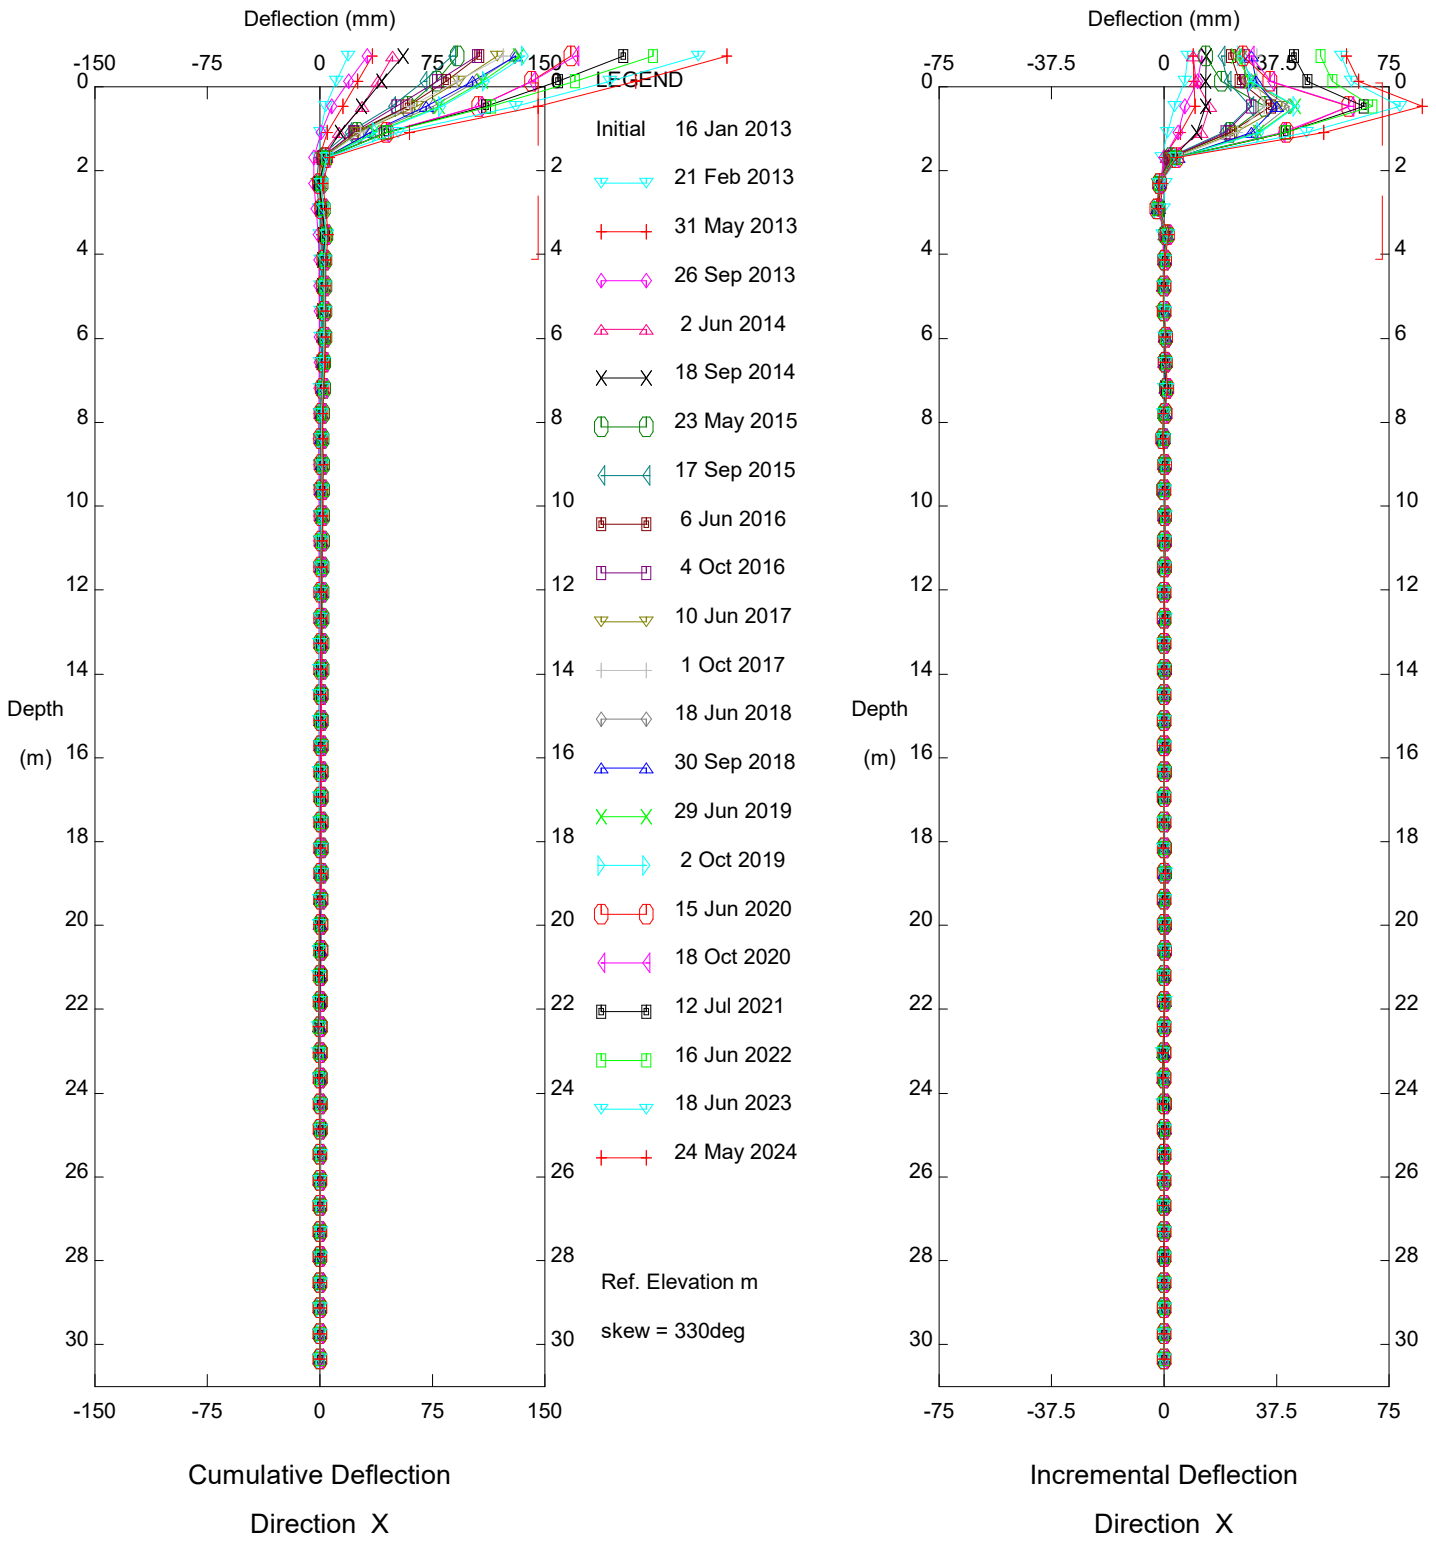
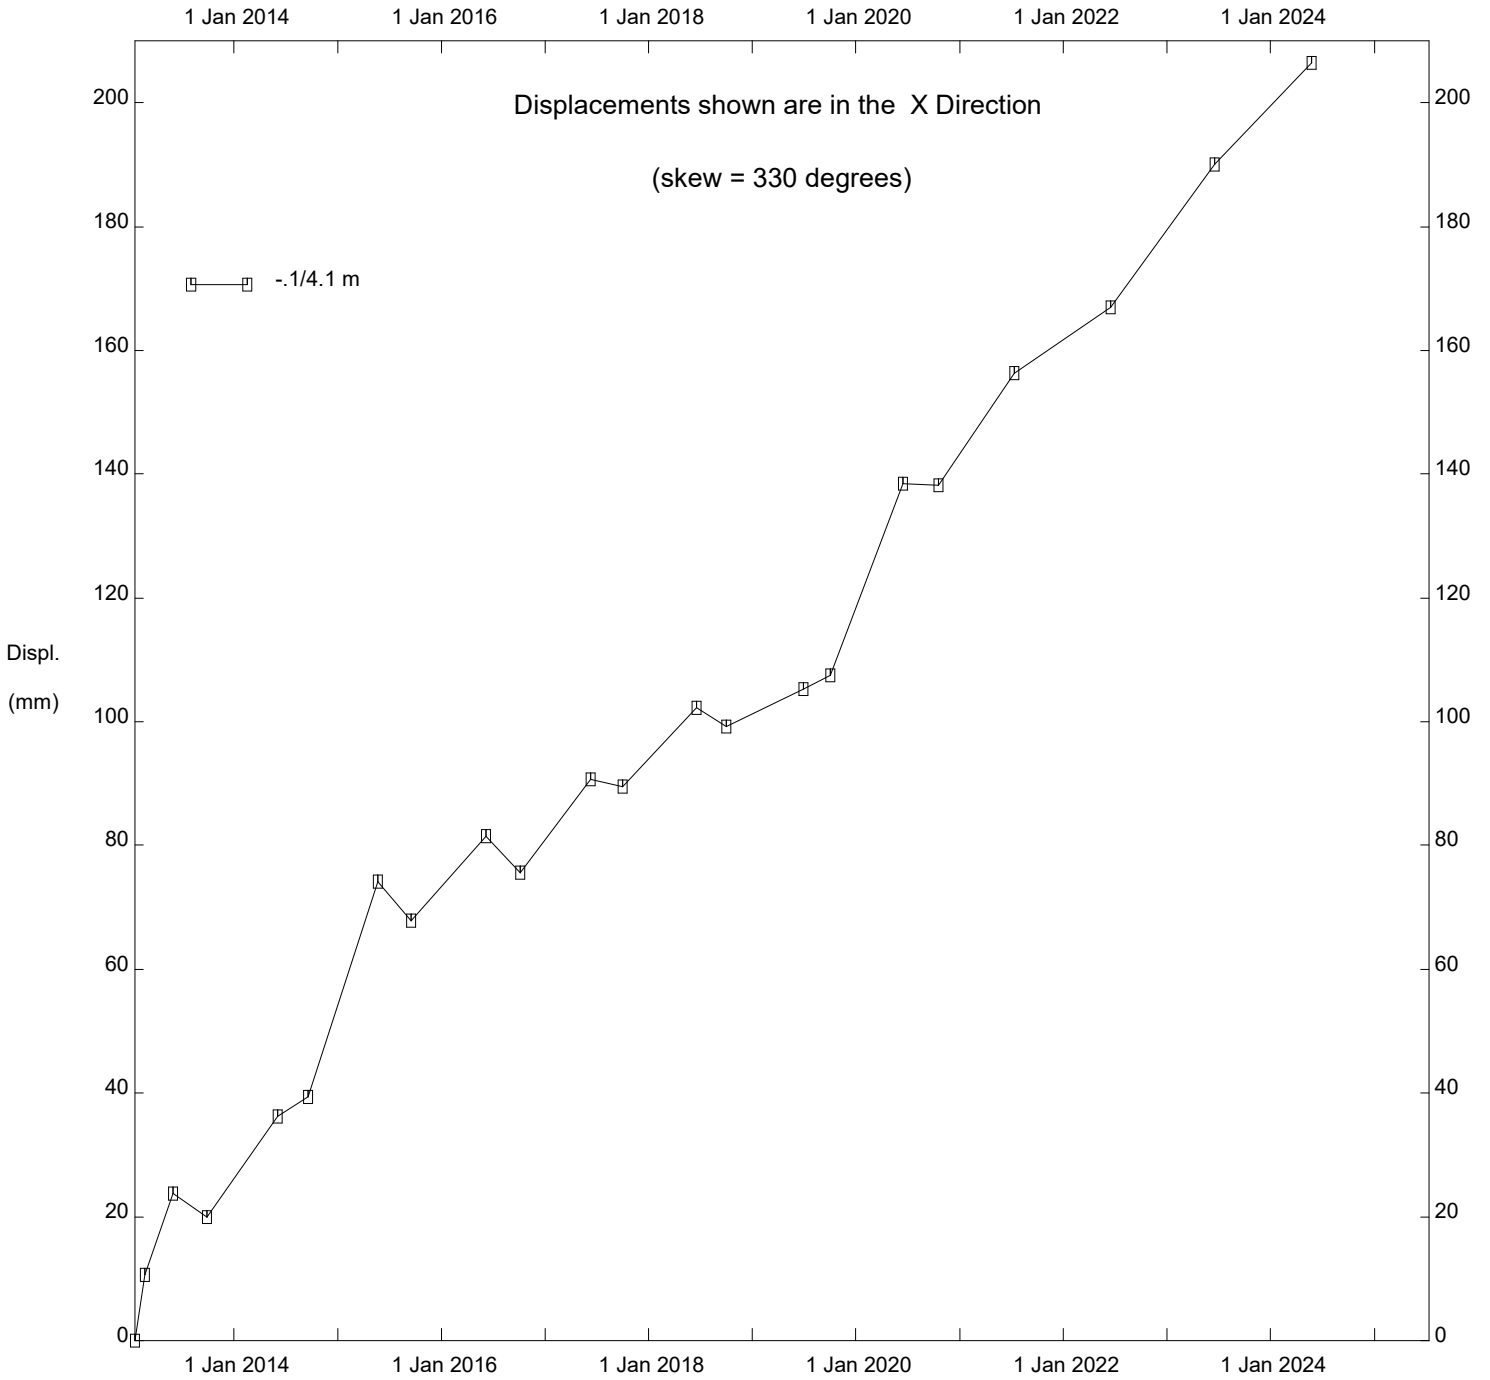
Fort Vermillion Bridge (PH048), Inclinator SI13-2  
 Alberta Transportation

Discussion	
<b>Zones of New Movement:</b>	None
<b>Interpretation of Monitoring Results:</b>	<p>Slope inclinometer SI-3 continued to show no discernible movement.</p> <p>Slope inclinometer SI13-2 showed a rate of movement of 17.6 mm/yr over 0.0 m to 4.1 m depth since the spring of 2023 readings. The overall rate of movement in SI13-2 (since initialization) is 18.2 mm/year. SI13-2 has shown a cumulative movement of 206.5 mm over this shallow zone.</p> <p>The movement in SI13-2 has been somewhat cyclical with a higher movement rate in the spring and a slower movement rate in the fall (based on historic monitoring events prior to 2021). The movement pattern will be reviewed once this inclinometer is lowered following regrading of the north headslope.</p> <p>SI24-7 was initialized during the June 25, 2024, site visit; no movement zones have been determined yet.</p> <p>Pneumatic piezometer PN13-2A showed an increase in groundwater level of 0.14 m since the spring of 2023 readings, while PN13-2B</p>

Readout Equipment Used			
<b>Slope Inclinometers:</b> RST Digital Inclinometer probe with a 2 feet wheelbase and a RST Pocket PC readout	<b>Pneumatic Piezometers:</b> RST C108 pneumatic piezometer reader	<b>Vibration Wire Piezometers:</b> Geokon 404 VW Readout	<b>Standpipe Piezometers:</b> DGSI Dipmeter
<b>Load Cell:</b>	<b>Strain Gauges:</b>	<b>SAAs:</b>	<b>Others:</b>
<b>Note:</b> * Read on June 25, 2024. SI13-2 will also be cut down to match the new headslope grading.

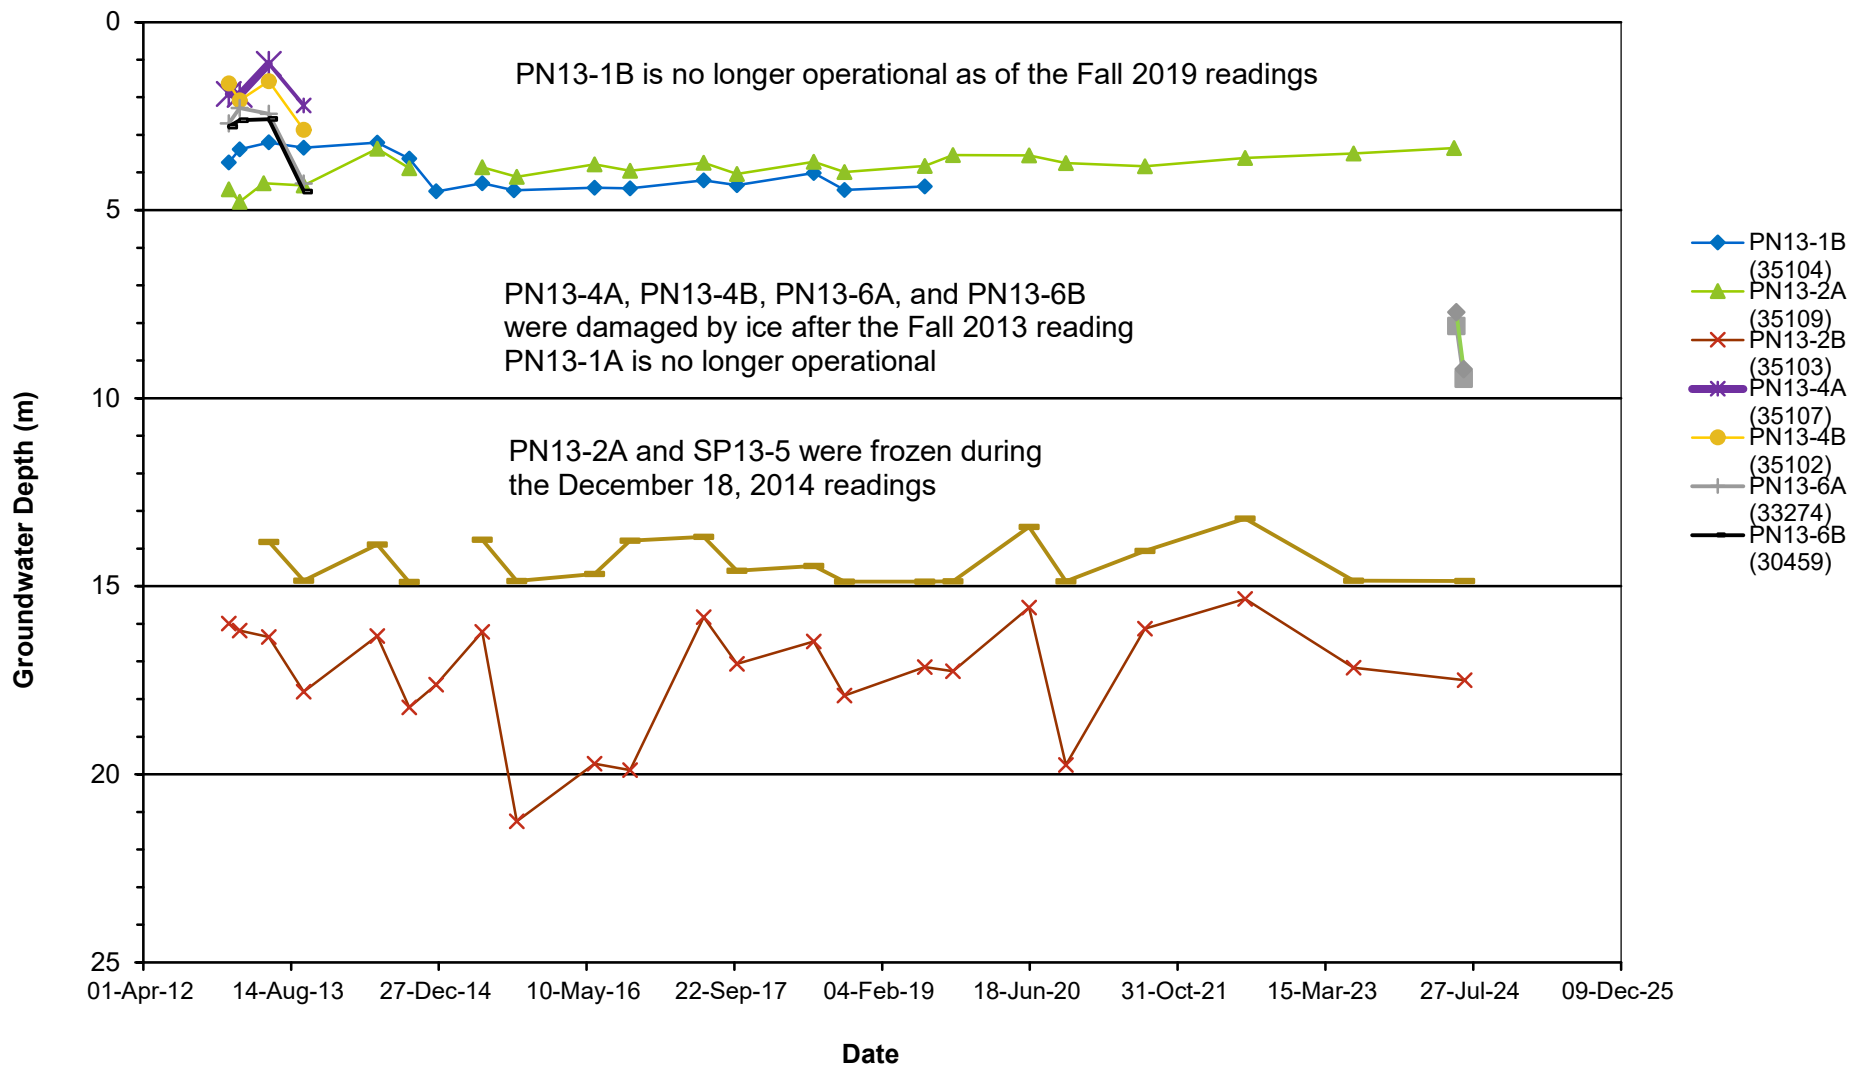
**FIGURE PH048-1  
PIEZOMETER DATA FOR HWY 88:18: FORT VERMILION BRIDGE**

<p>showed a decrease in groundwater level of 0.33 m since the spring of 2023 readings. Vibrating wire piezometers VW23-7A and VW23-7B showed decrease of 1.41 m and 1.51 m, respectively, since the previous readings on May 31, 2024. The May 31, 2024 readings were taken 1 day after installation, so the groundwater level may not have been stabilized. These preliminary readings indicate hydrostatic groundwater conditions in the bedrock.</p> <p>Standpipe piezometer SP13-5 showed a decrease in groundwater level of 0.01 m since the spring of 2023 readings.</p>
<b>Future Work:</b>	The instruments will be read again in the spring of 2025.
<b>Instrumentation Repairs:</b>	No instrument repairs are required at this time.
<b>Additional Comments:</b>	<p>Following the spring of 2024 reading, slope inclinometer SI24-7, and two vibrating wire piezometers VW24-7A and VW24-7B were installed as part of north headslope improvements being undertaken as part of a large bridge repair contract. This replaced the damaged SI15-4. The logging of the test hole and installation of the instrumentation was done by Beairsto &amp; Associates Engineering &amp; Survey (BARE). The test hole log for BH-01 is attached which was renamed SI24-7 by Thurber when these instruments were read on June 25, 2024.</p>
