**ALBERTA TRANSPORTATION
GEOHAZARD ASSESSMENT PROGRAM
PEACE REGION (PEACE RIVER DISTRICT)
2023 INSPECTION**

Site Number	Location	Name	Hwy	km
SH032-1	Northeast of High Prairie	Salt Prairie	679:06	26.2
Legal Description		UTM Co-ordinates		
SE28-76-14-W5		11U E 556,162	N 6,163,235

SH032: HWY 679:06, km 26.2
2023 SITE INSPECTION PLAN

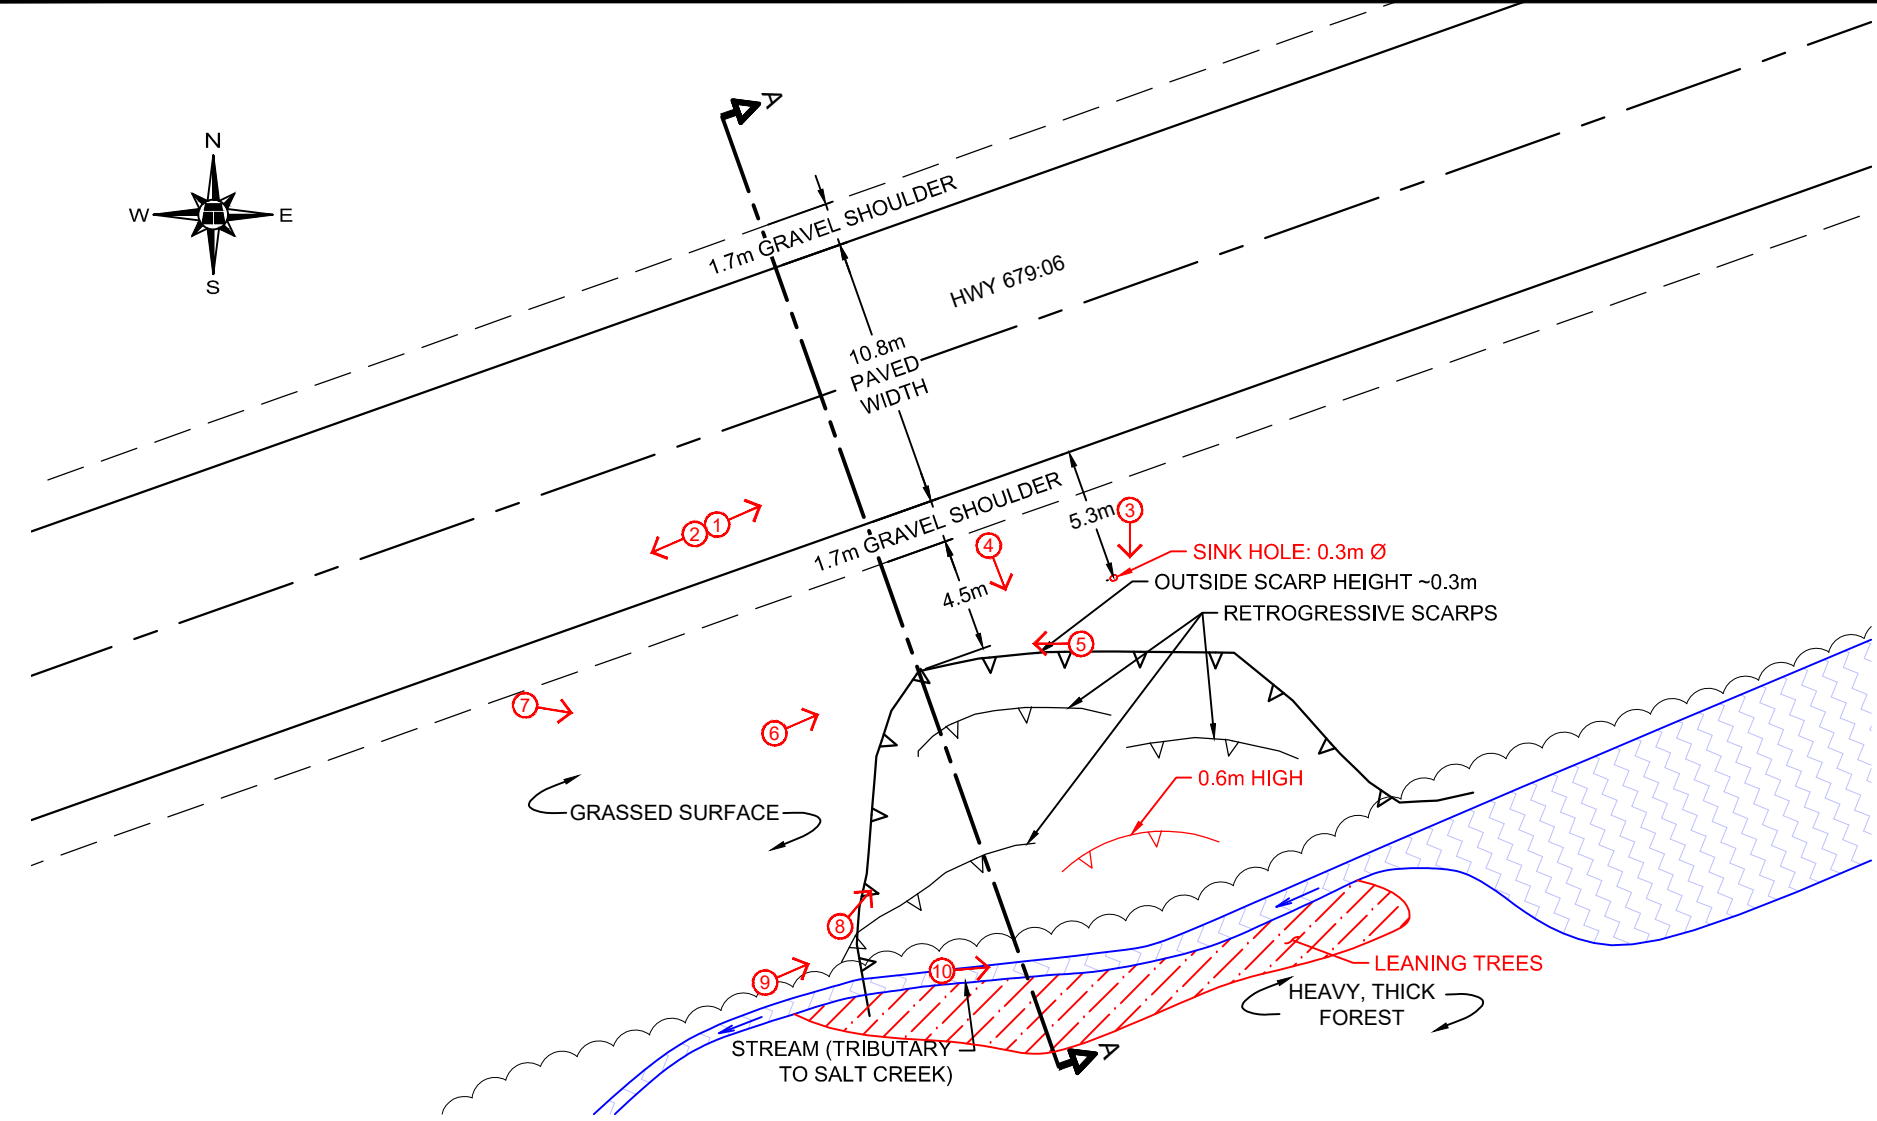
SITE PLAN
SCALE 1:300

- NOTES:**
1. SITE FEATURES ARE APPROXIMATE
 2. HIGHWAY PAVED JULY 2019, ACP PLACED: 600mm OVER 200mm.
 3. JUNE 2023 OBSERVATIONS SHOWN IN RED

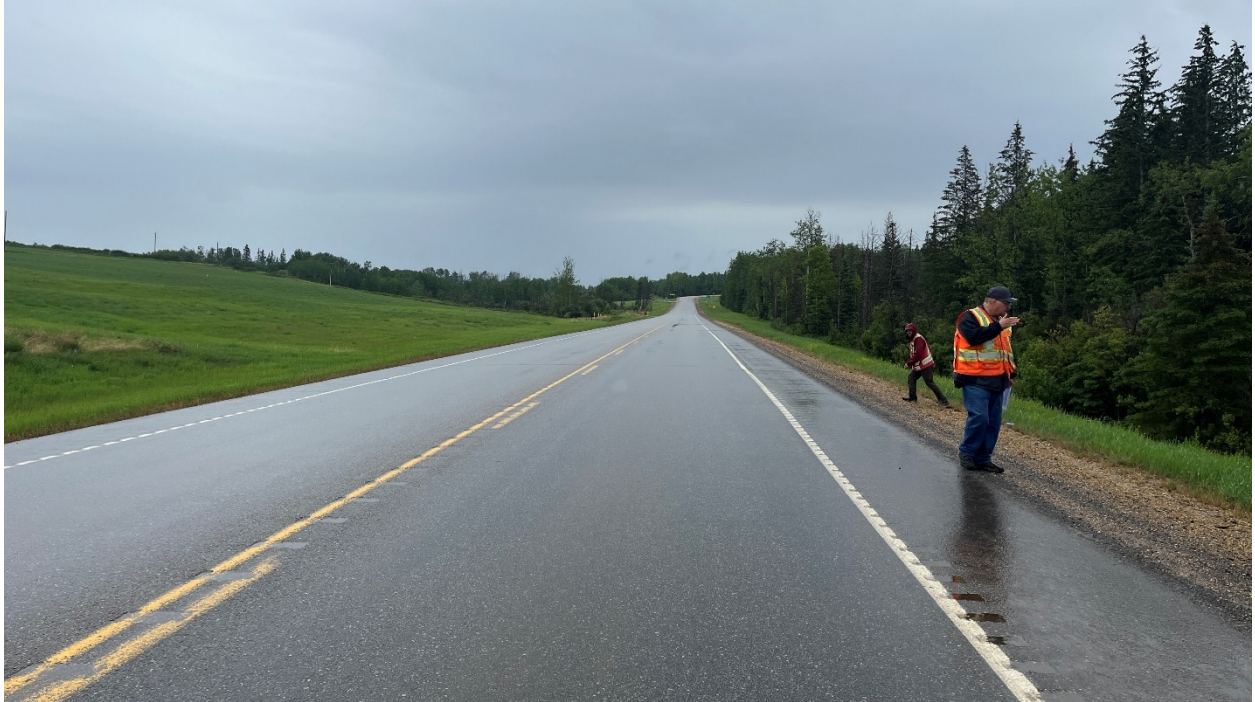
Photo 1 – Looking east along Hwy 679 above the slide site towards the intersection at Hwy 750.

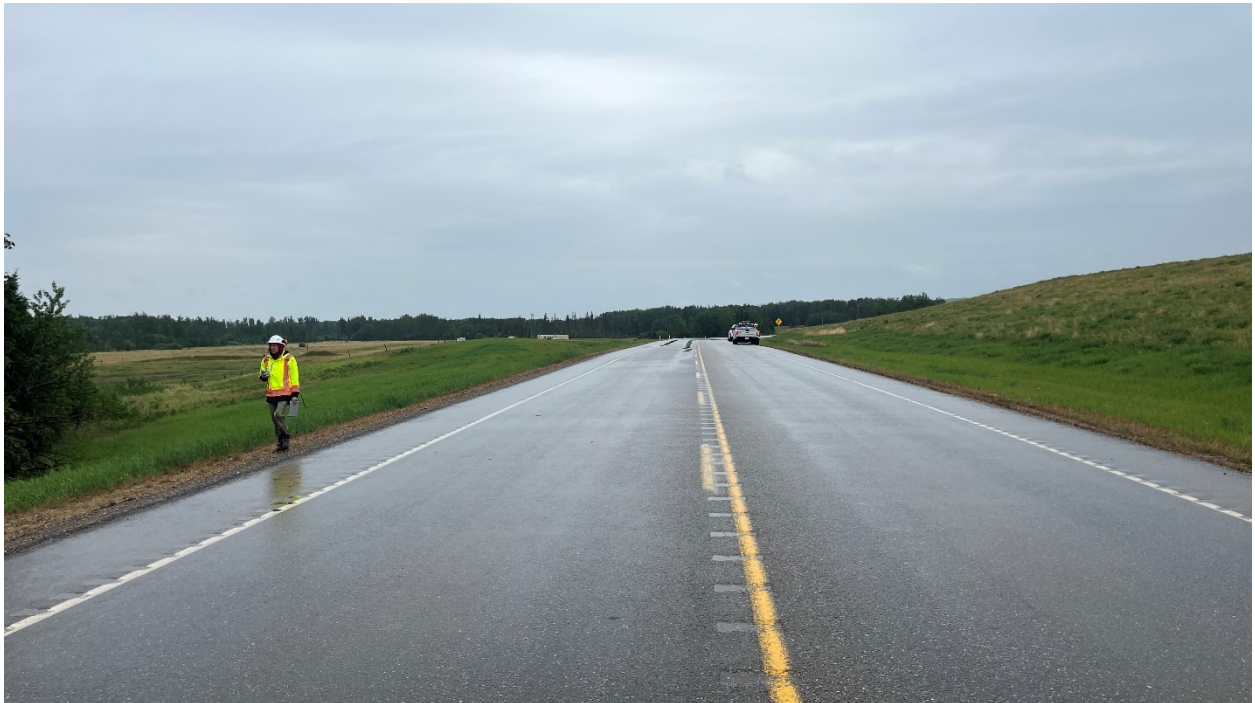
Photo 2 – Looking west along Hwy 679 above the slide site.

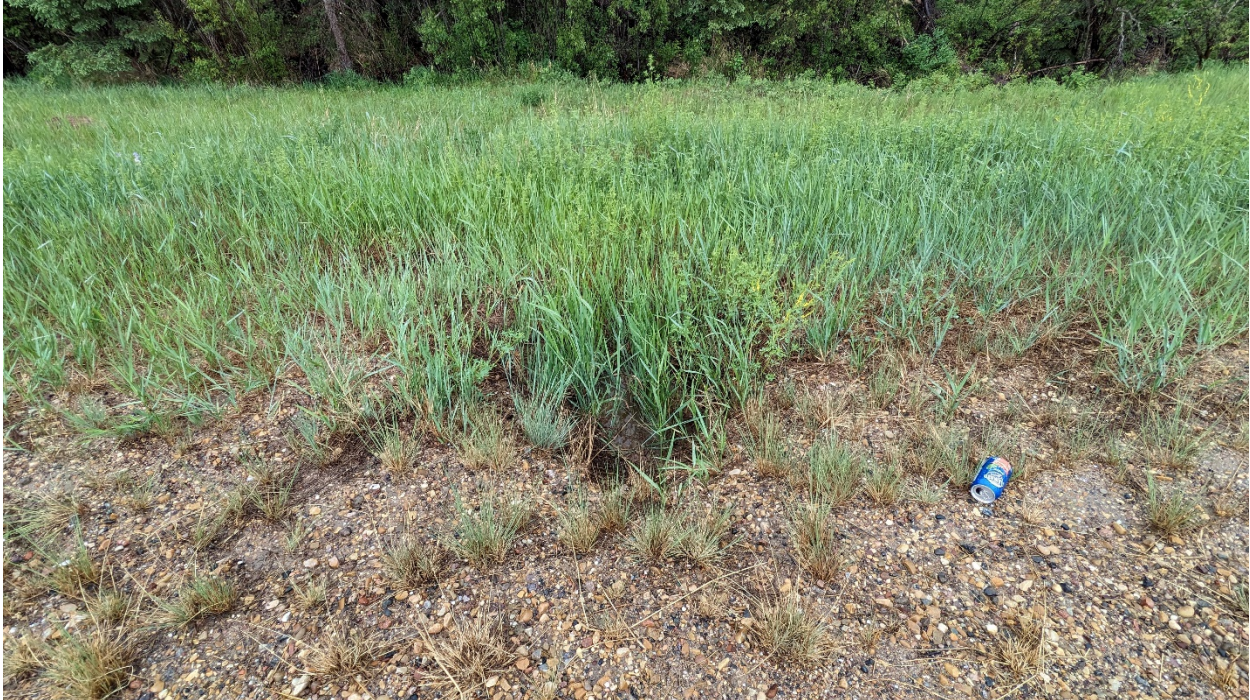
<input checked="" type="checkbox"/> Erosion	Stream erosion on both banks causing localized slumping. A sinkhole was observed on the south sideslope during the 2023 inspection.	<input checked="" type="checkbox"/>	
<input type="checkbox"/> Seepage		<input type="checkbox"/>	
<input type="checkbox"/> Bridge/Culvert Distress		<input type="checkbox"/>	
<input type="checkbox"/> Other		<input type="checkbox"/>	
Instrumentation: None			
Assessment:			
The landslide is about 25 m wide parallel to the highway at the toe, and about 12 m long perpendicular to the highway alignment. It is located downslope of the highway WBL within an approximately 6 m high embankment that has an average inclination of about 2.7H:1V. The sideslope is well grassed (except where disturbed by recent slide movements), and there are intermediate scarps within the

Photo 3 – Looking south at small sinkhole that has started to form on the embankment side slope.

The observed sink hole should be monitored and get backfilled before it gets bigger in size.

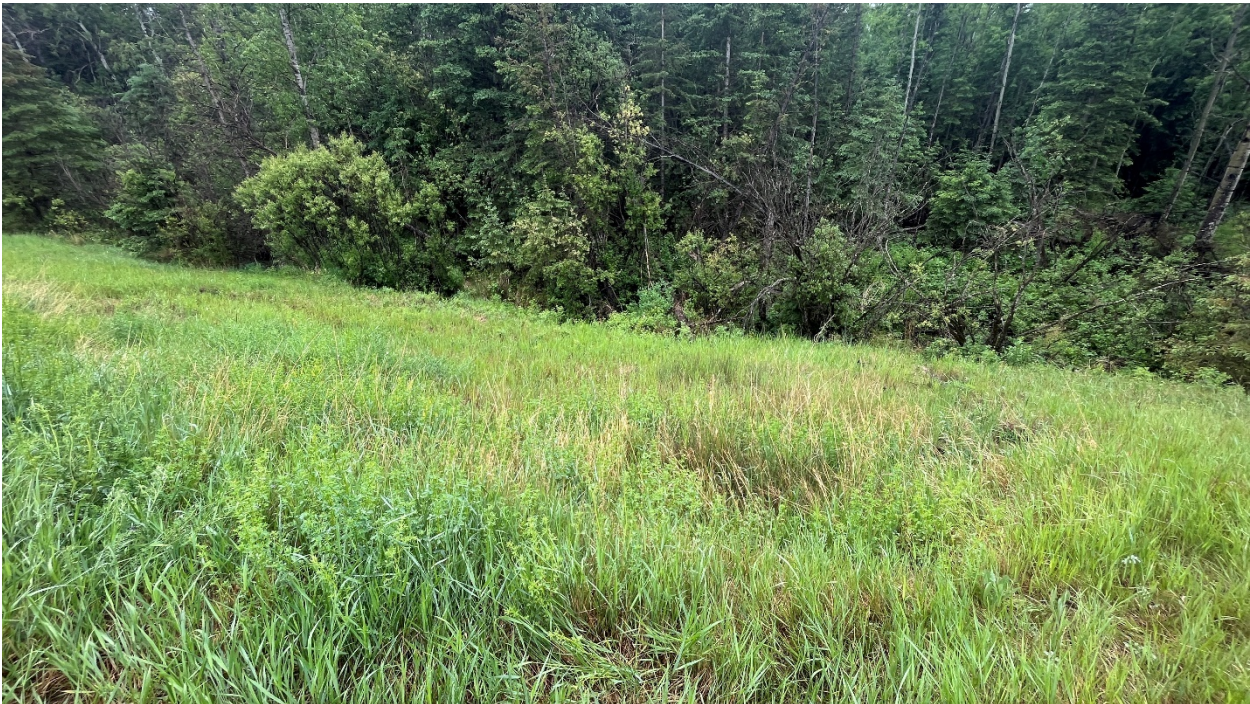
Photo 4 – Looking south down along the slide from the edge of the highway.

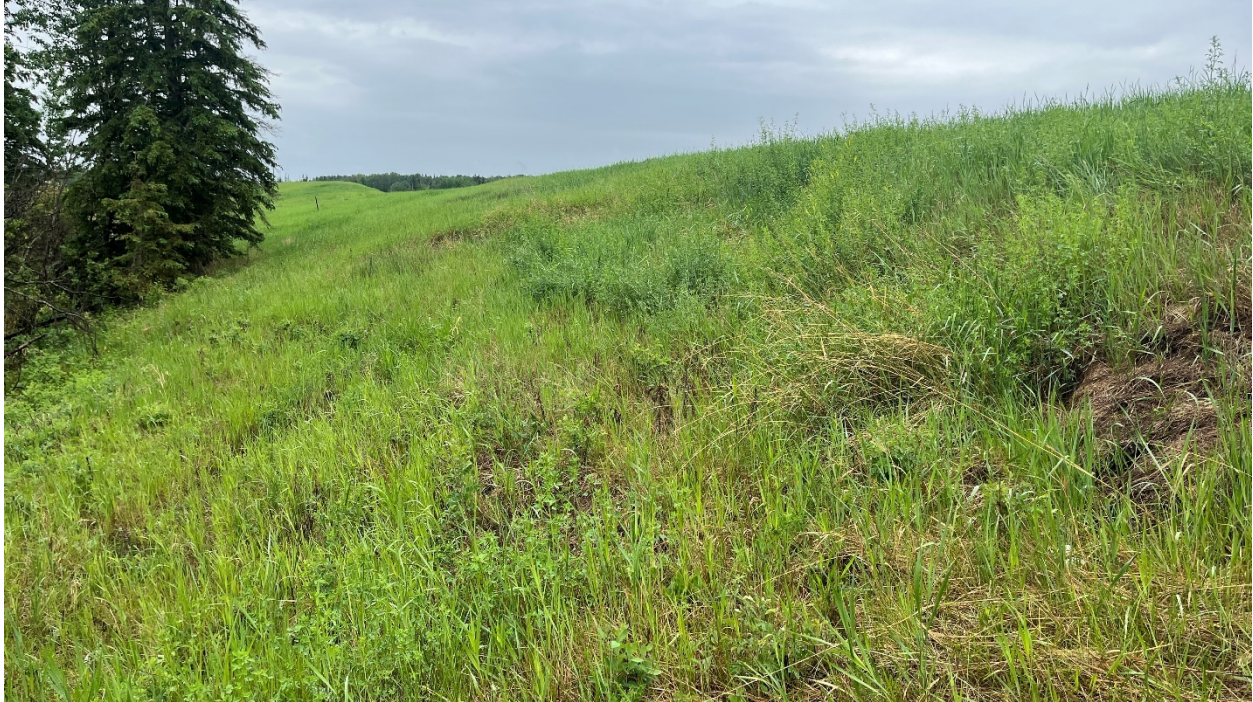
The main slide scarp crack did not appear to have retrogressed further towards the highway since the last inspection. However, there was a recent movement observed in the landslide mass, which indicates the potential for future retrogression into the highway lane.

Photo 5 – Looking west at the slide scarp in the highway south embankment.

The Maintenance Contractor should regularly monitor this area for further movements and measure the distance between the main scarp crack and the edge of gravel shoulder.

Consideration may be given to installing soil nails along the exposed head scarp face to reduce the rate of landslide retrogression into the highway.

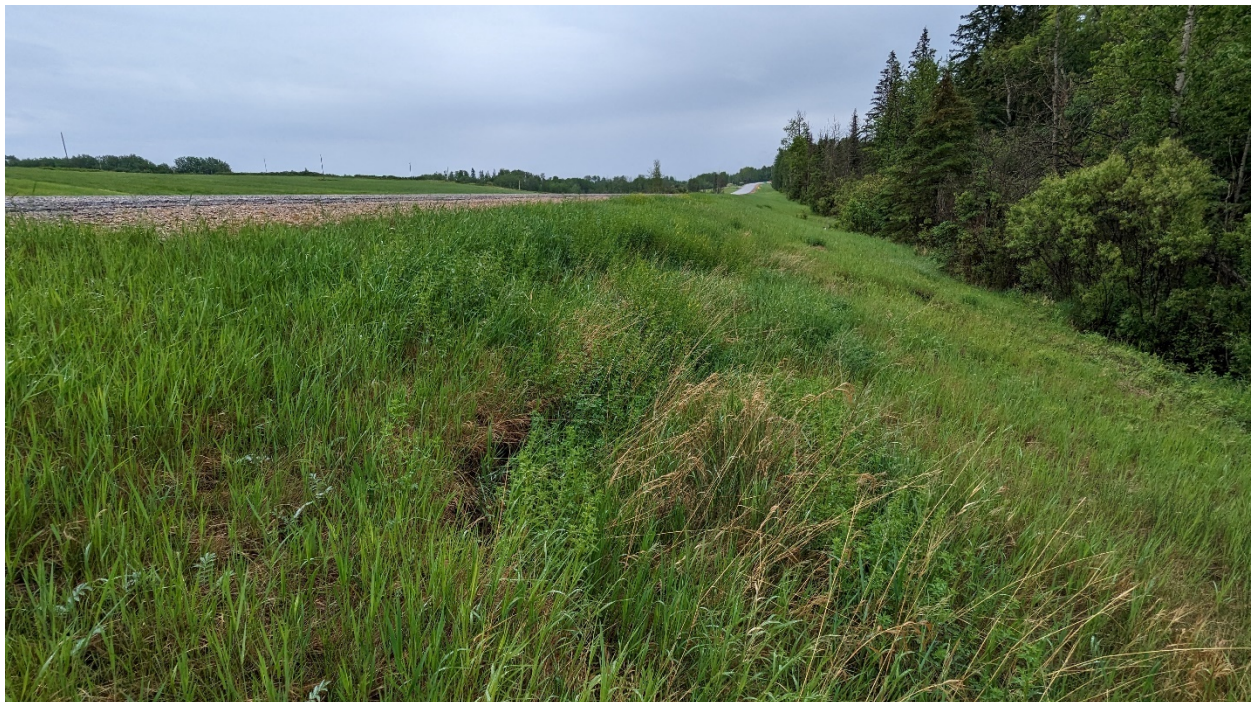
Photo 6 – Looking east across the slide site.

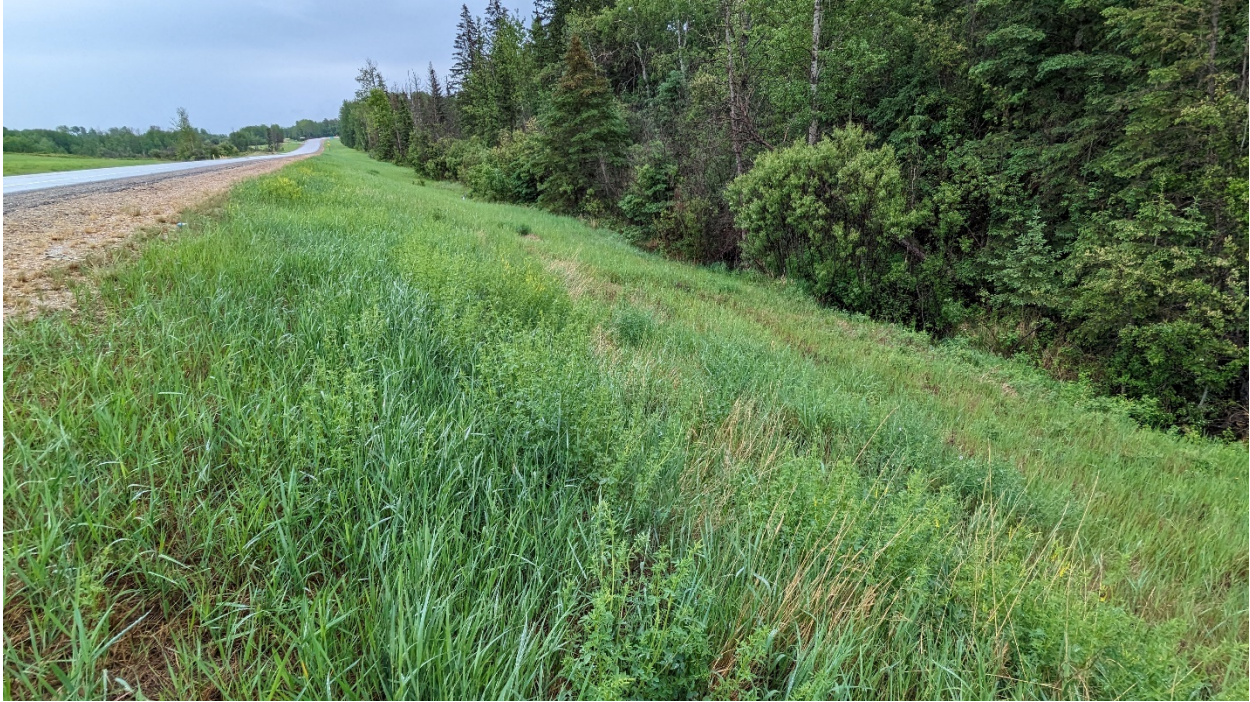
Photo 7 – Looking southeast across the slide. The dense forest extends over the stream and right up to the toe of the south highway embankment.

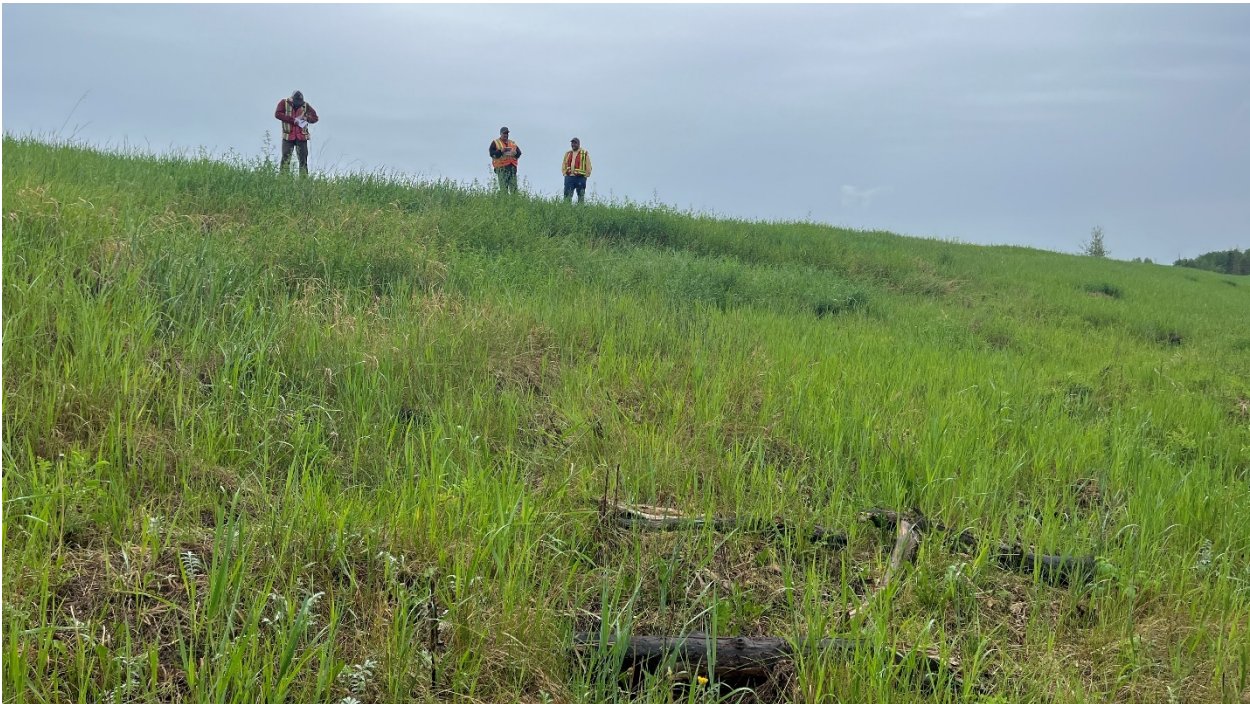
Photo 8 – Looking north up at the slide from the toe of the highway embankment.

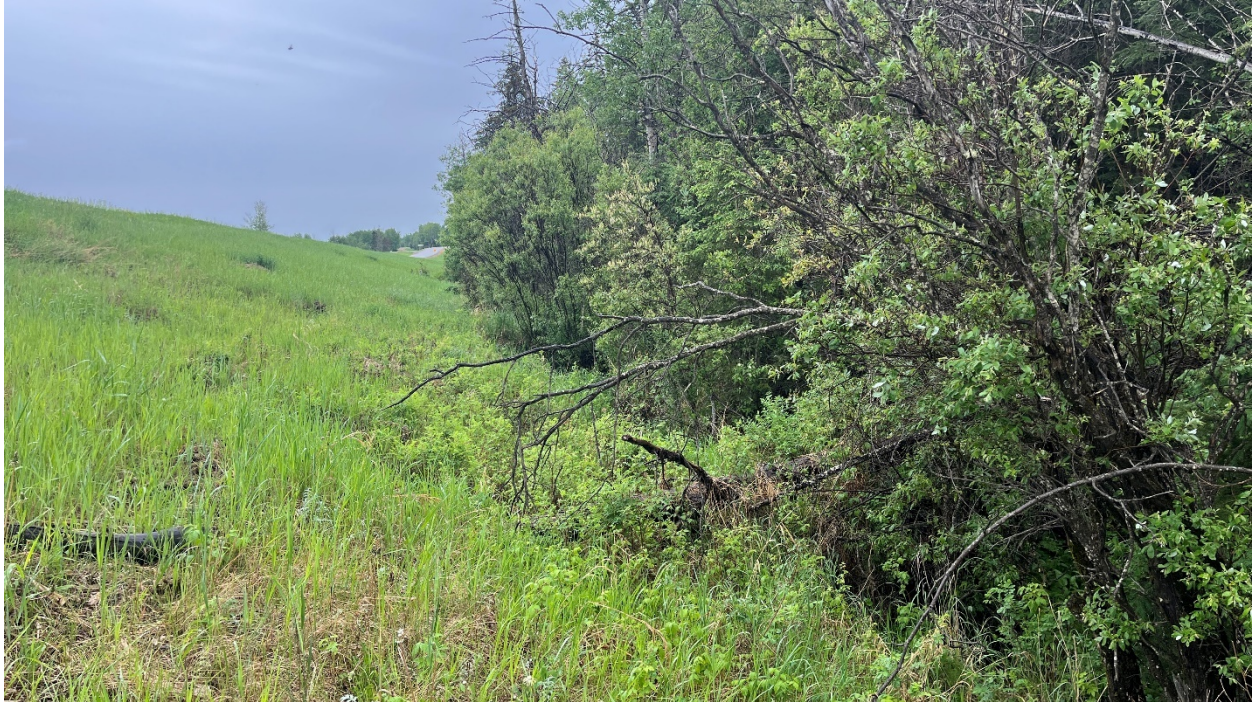
The toe of the slide is located at the toe of the highway embankment, immediately adjacent to a stream channel. The stream channel is less than 1 m in width and less than 1 m deep adjacent to most of the landslide area, except towards the east end where the stream widened/flattened out to about 8 m wide. The stream flows westwards towards the Salt Creek, located about 300 m to the southwest of the site.

Photo 9 – Looking east along the toe of the highway embankment and edge of the stream from the west edge of the slide.

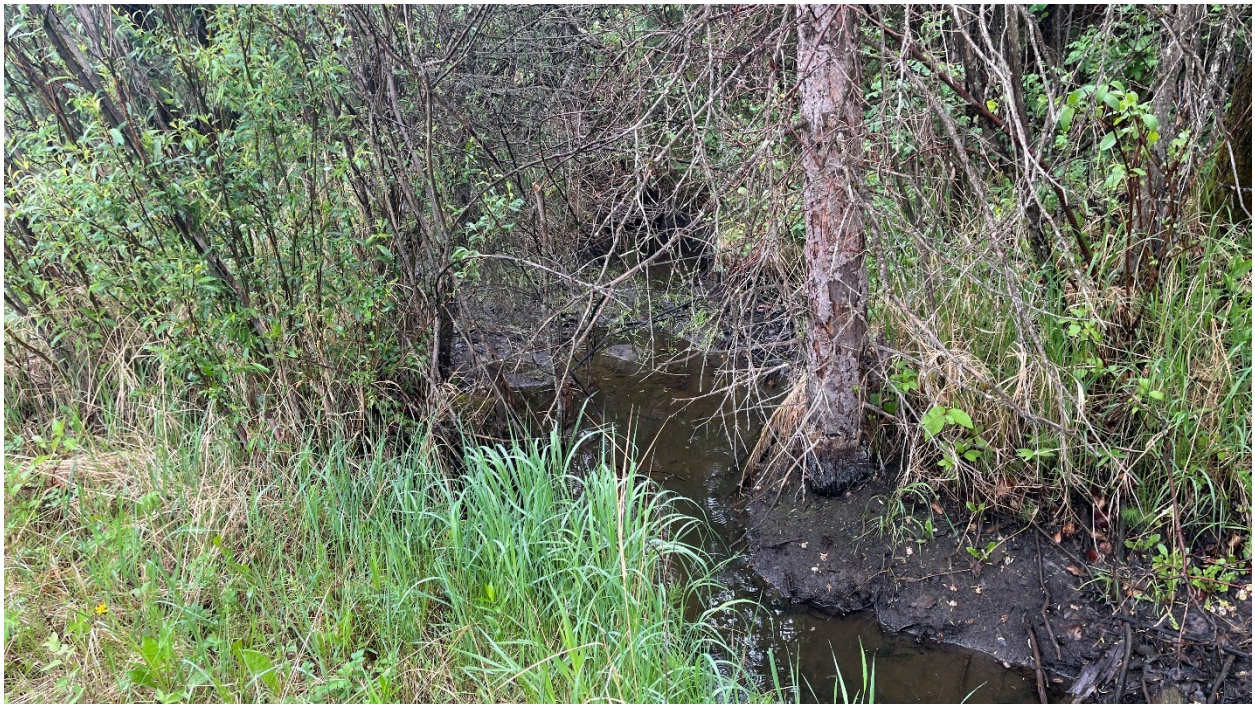
It appears that the landslide may have occurred due to stream channel erosion along the toe of the embankment slope. The slide appears to have retrogressed further up the embankment slope due to the progressive loss of toe support. It is postulated that the embankment is composed of highly plastic clay, and gradual loss of cohesion is likely another contributing cause of the failure. In addition, the overall embankment inclination of 2.7H:1V is marginally acceptable for long-term stability of slopes comprised of high plastic clay material.

Photo 10 – Looking east at the stream at the toe of the embankment.
