THURBER ENGINEERING LTD.

October 18, 2022

File No.: 32121

**GEOHAZARD RISK MANAGEMENT PROGRAM (CON0022164)
PEACE REGION (PEACE RIVER DISTRICT)
SECTION D CALL-OUT REPORT
PRAIRIE ECHO: HWY 679:06 km 8.18 to 8.24**

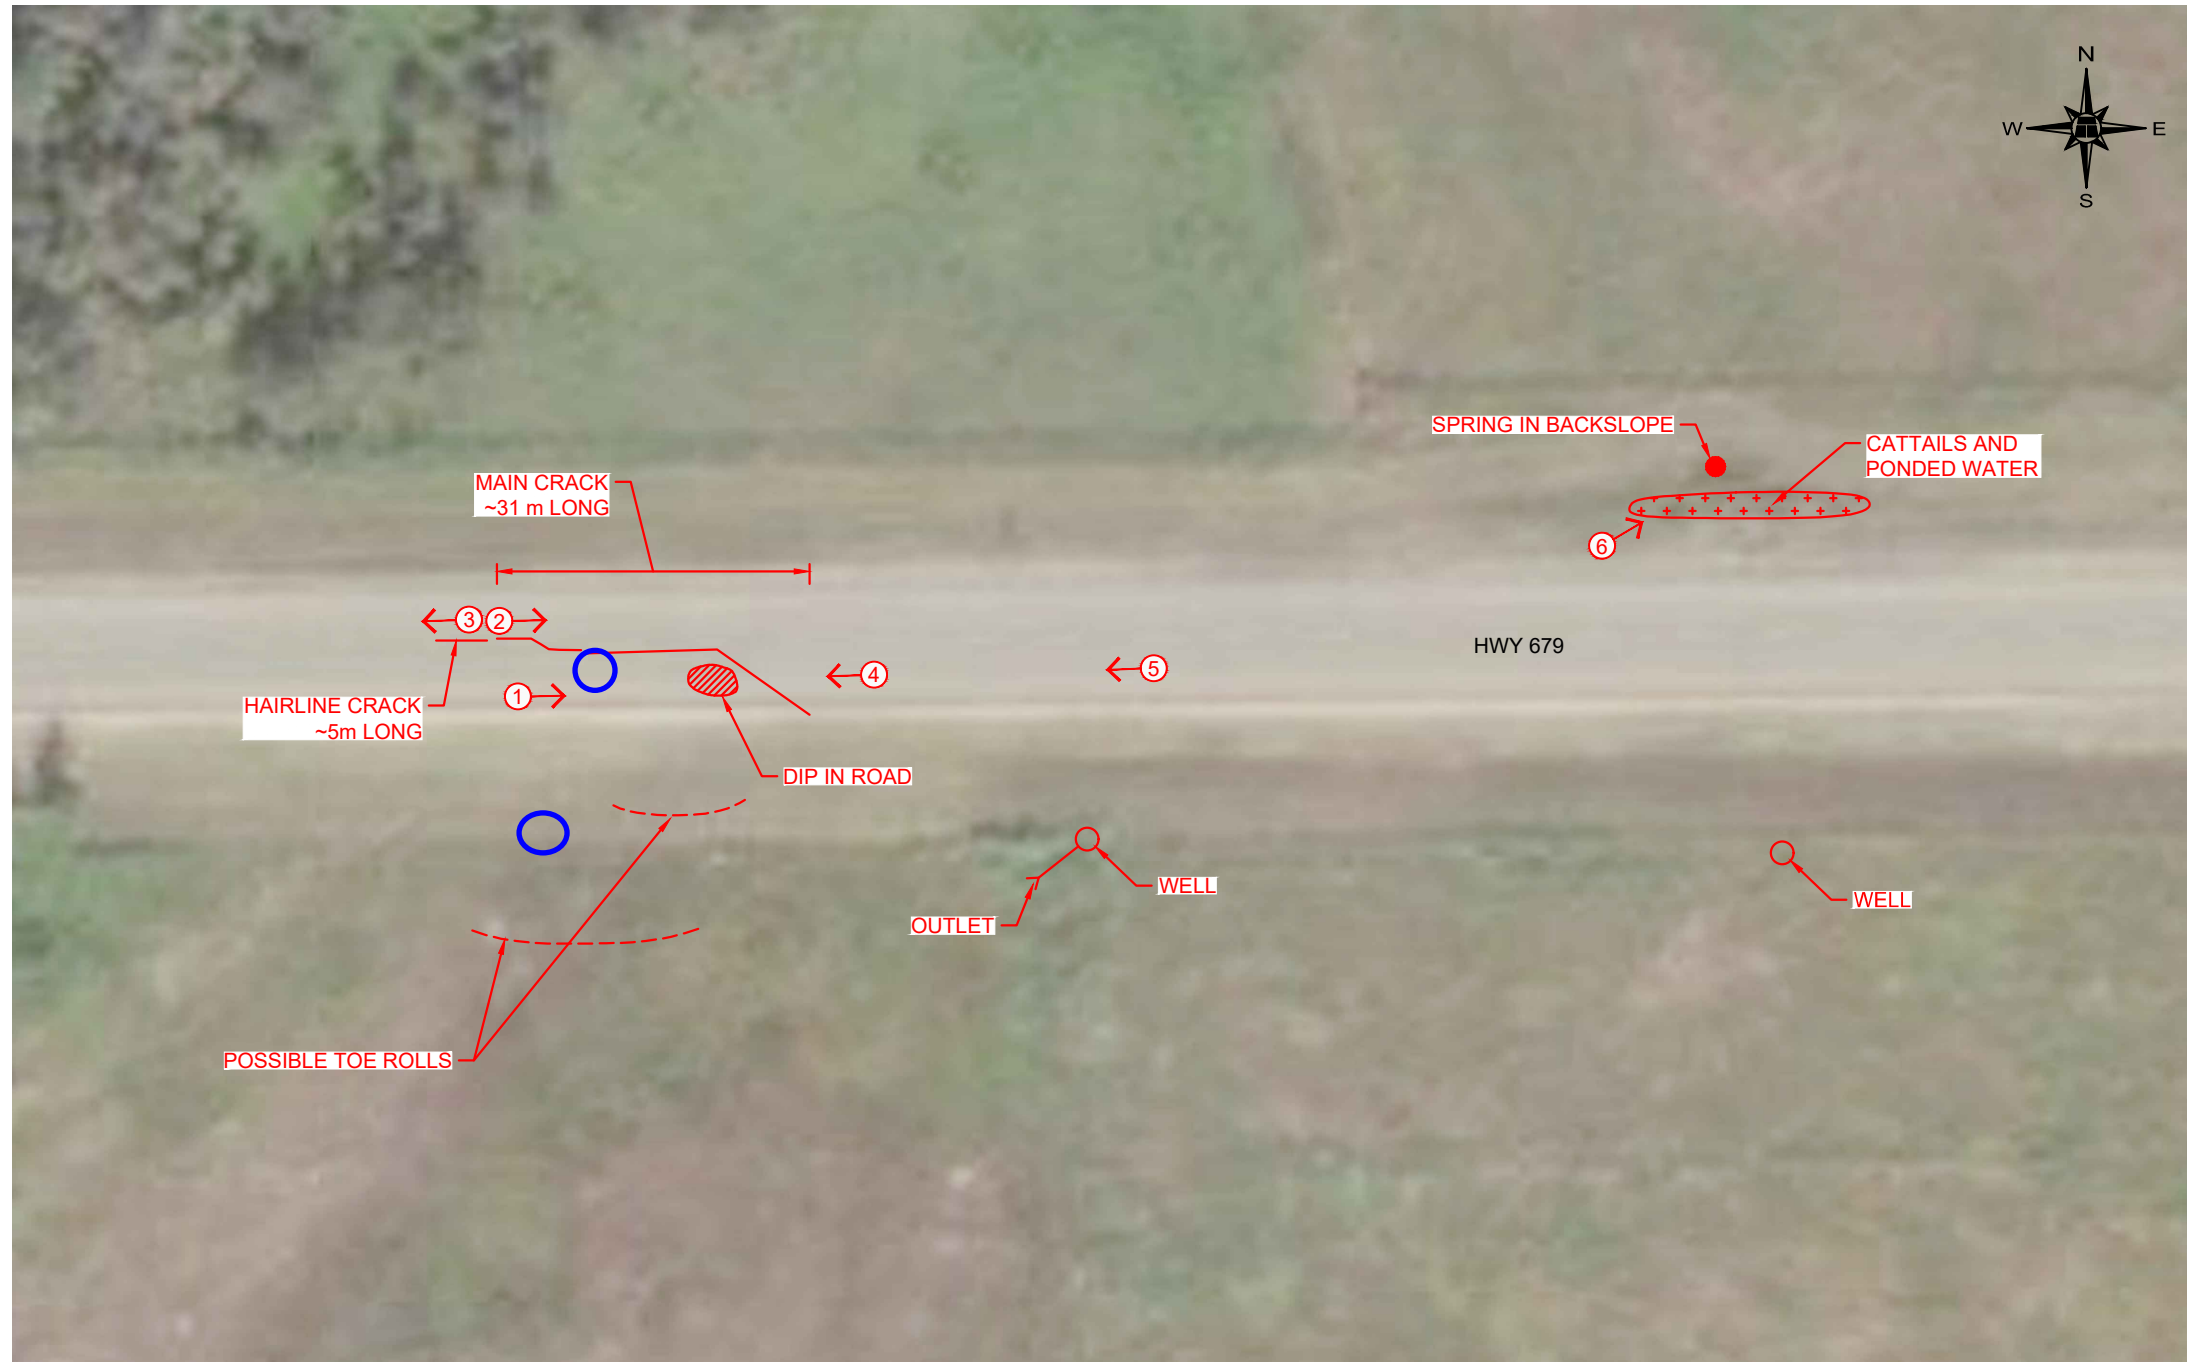
DWG No. 32121-HWY 679:06 CALLOUT-1

At the time of the call-out inspection, there was an arc-shaped, 31 m-long crack cutting across the east-bound lane (EBL) and partway into the west-bound lane (WBL) at the east side of the site. There was a hairline crack extending 5 m further west; however, the arc back to the south across the EBL was not observed at the time but may develop in the future. Possible toe rolls were observed downslope of the main crack north of the fence and south of the fence.

There is a dugout or pond located downhill about 130 m southwest of the site where the water level was less than 1 m below ground surface. There were two old culvert-style wells observed on the south side of the highway as shown on the Drawing. The first was near the east end of the crack and had a water level 0.47 m below ground surface which appeared to be controlled by a drain pipe whose outlet was located about 7 m southwest of the well. The second was about 70 m east, slightly higher in elevation, and the water level was at ground surface and was visible around the outside of the well. There was also a spring located in the backslope cut on the north side of the highway in this same area. These two older wells could indicate that past remediation has been attempted at this site by use of deeper dewatering.

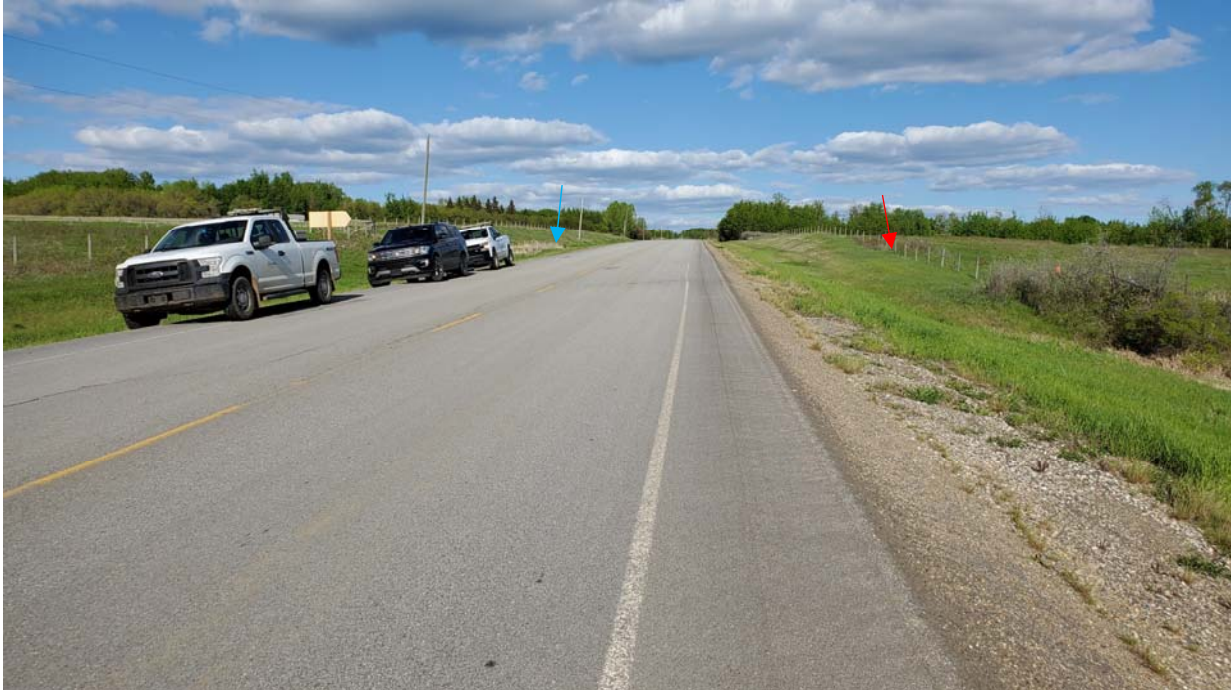
Photo 1 – Looking east along slight rise in the highway as there is a low backslope cut on the north side behind the trucks. The cattails are roughly where the seep was observed (blue arrow). The second groundwater well was on the higher ground to the south (red arrow)

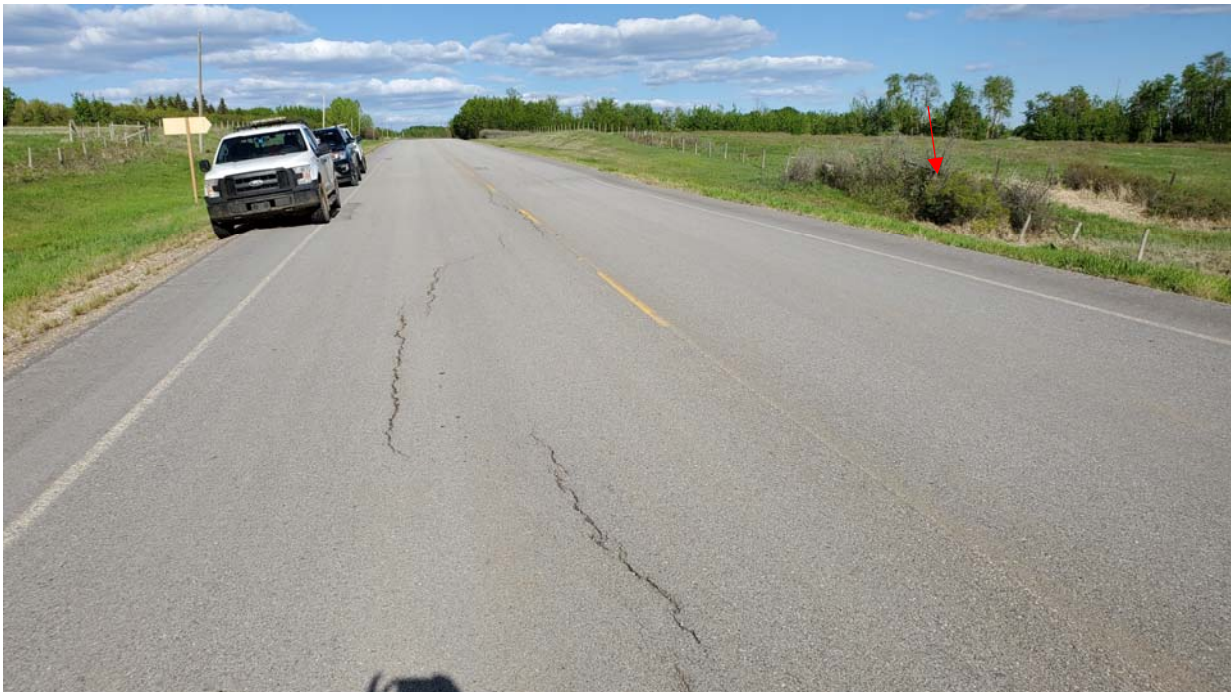
Photo 2 – Looking east at the west end of the arc-shaped crack. The second well is located in the bush on the south side of the highway (red arrow).

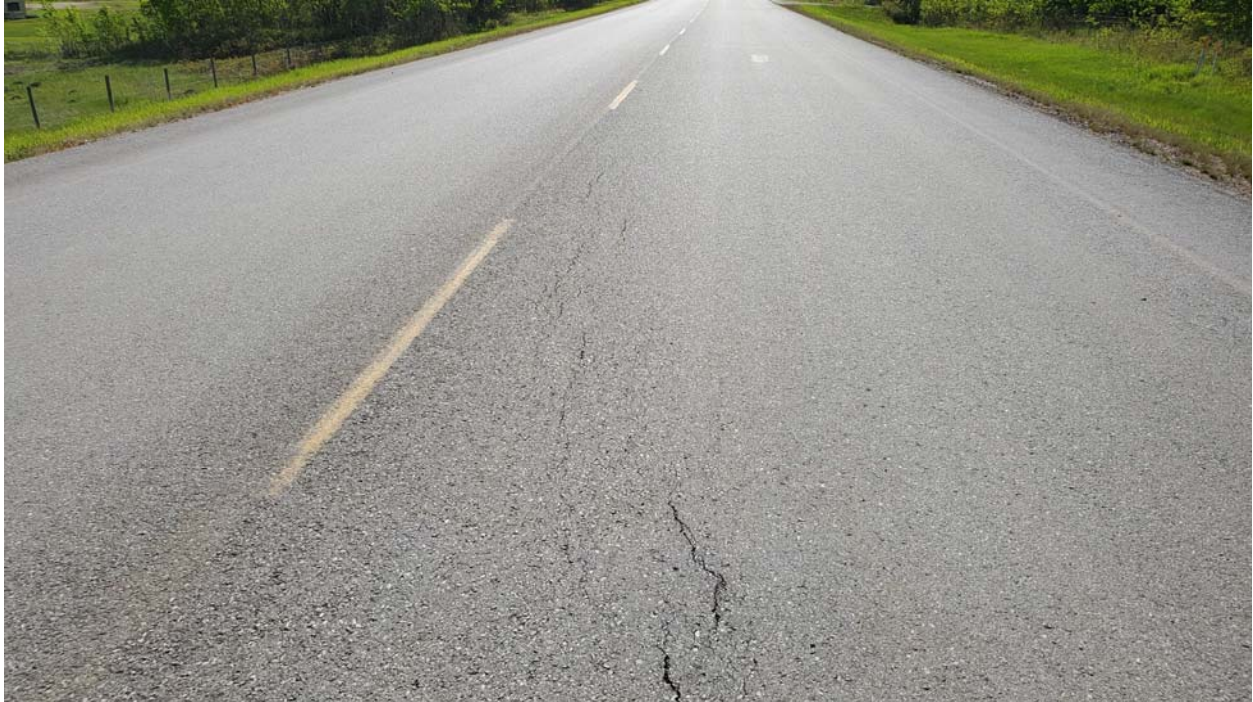
Photo 3 – Looking west at hairline cracks forming west of the main scarp crack.

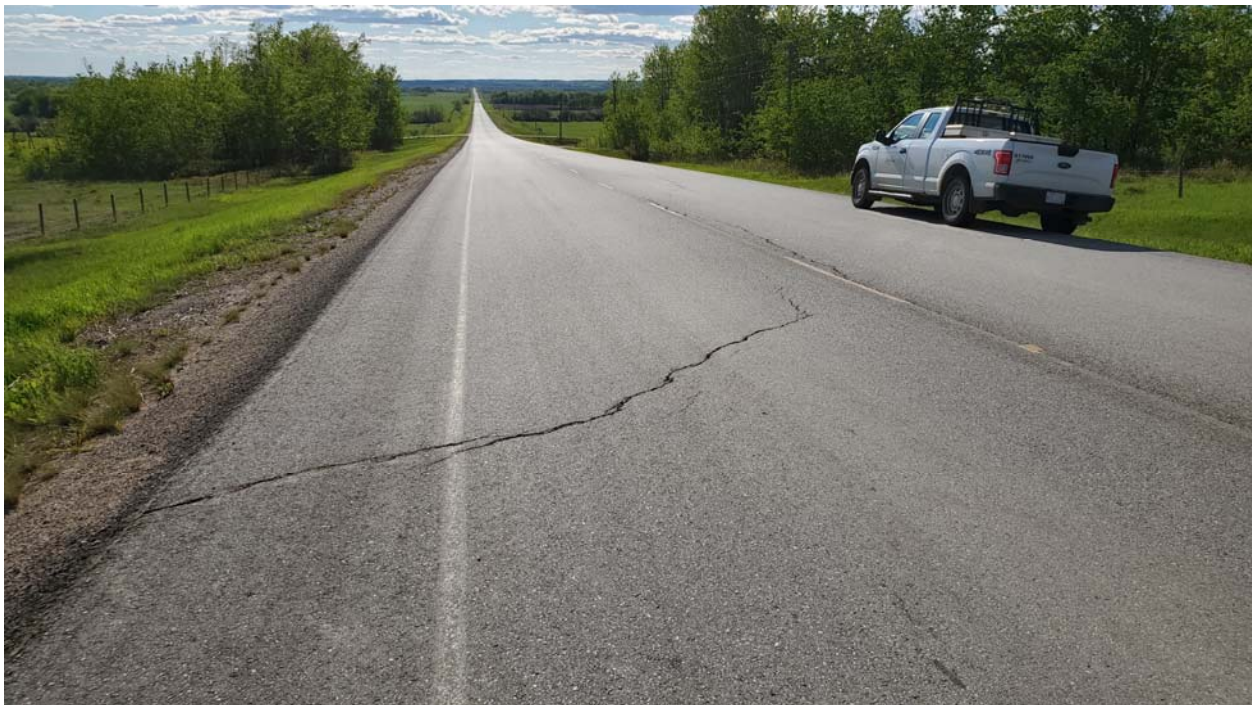
Photo 4 – Looking west at the main scarp crack where it crosses the EBL.

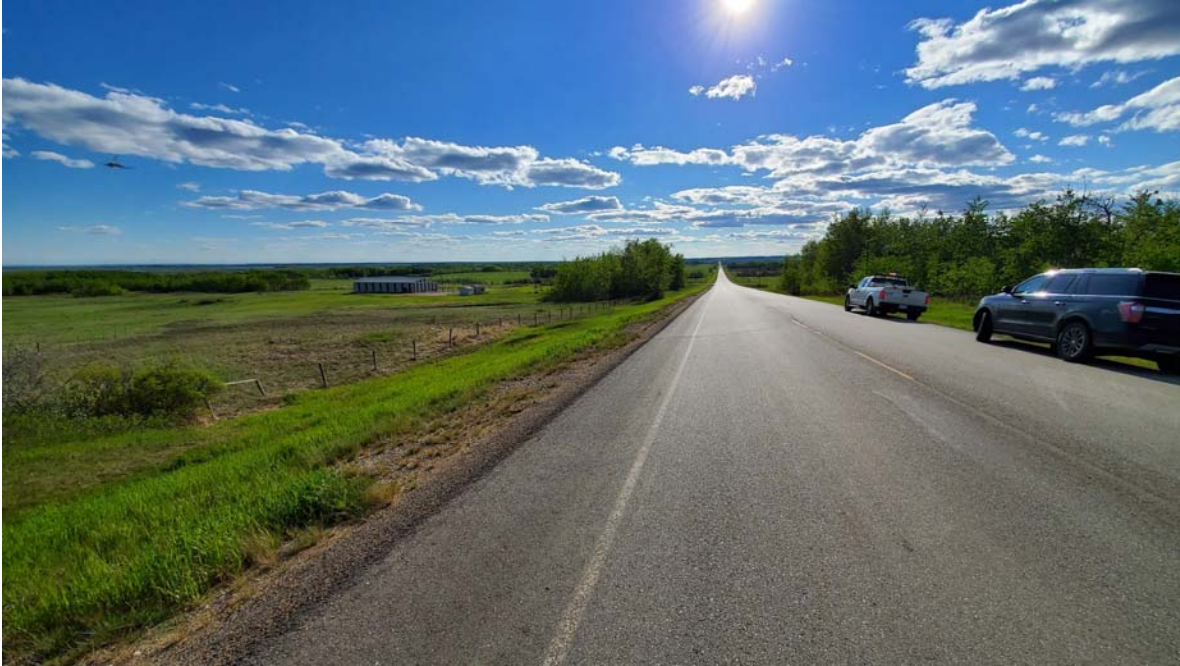
Photo 5 – Looking west across the site at the general topography sloping down toward the southwest.

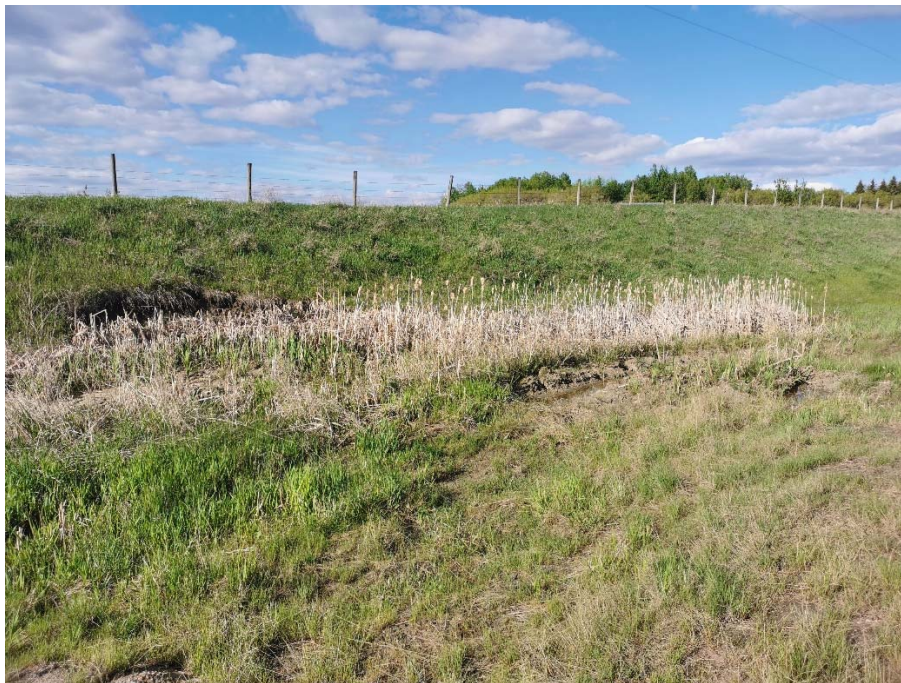
Photo 6 – Looking northeast at spring observed in backslope east of the site. Cattails and ponded water present in the ditch.
