**ALBERTA TRANSPORTATION  
GEOHAZARD ASSESSMENT PROGRAM  
PEACE REGION (PEACE RIVER DISTRICT)  
2023 INSPECTION**

Site Number	Location	Name	Hwy	km
SH036-1	Northeast of High Prairie	Prairie Echo Community Hall Slide	679:06	8.18 – 8.24
Legal Description		UTM Co-ordinates		
SW26-76-16-W5M		11U E 539,209	N 6,162,497

**PRAIRIE ECHO: HWY 679:06 km 8.18 TO km 8.24  
2023 INSPECTION PLAN**

**DWG NO. 32121-SH036-1**

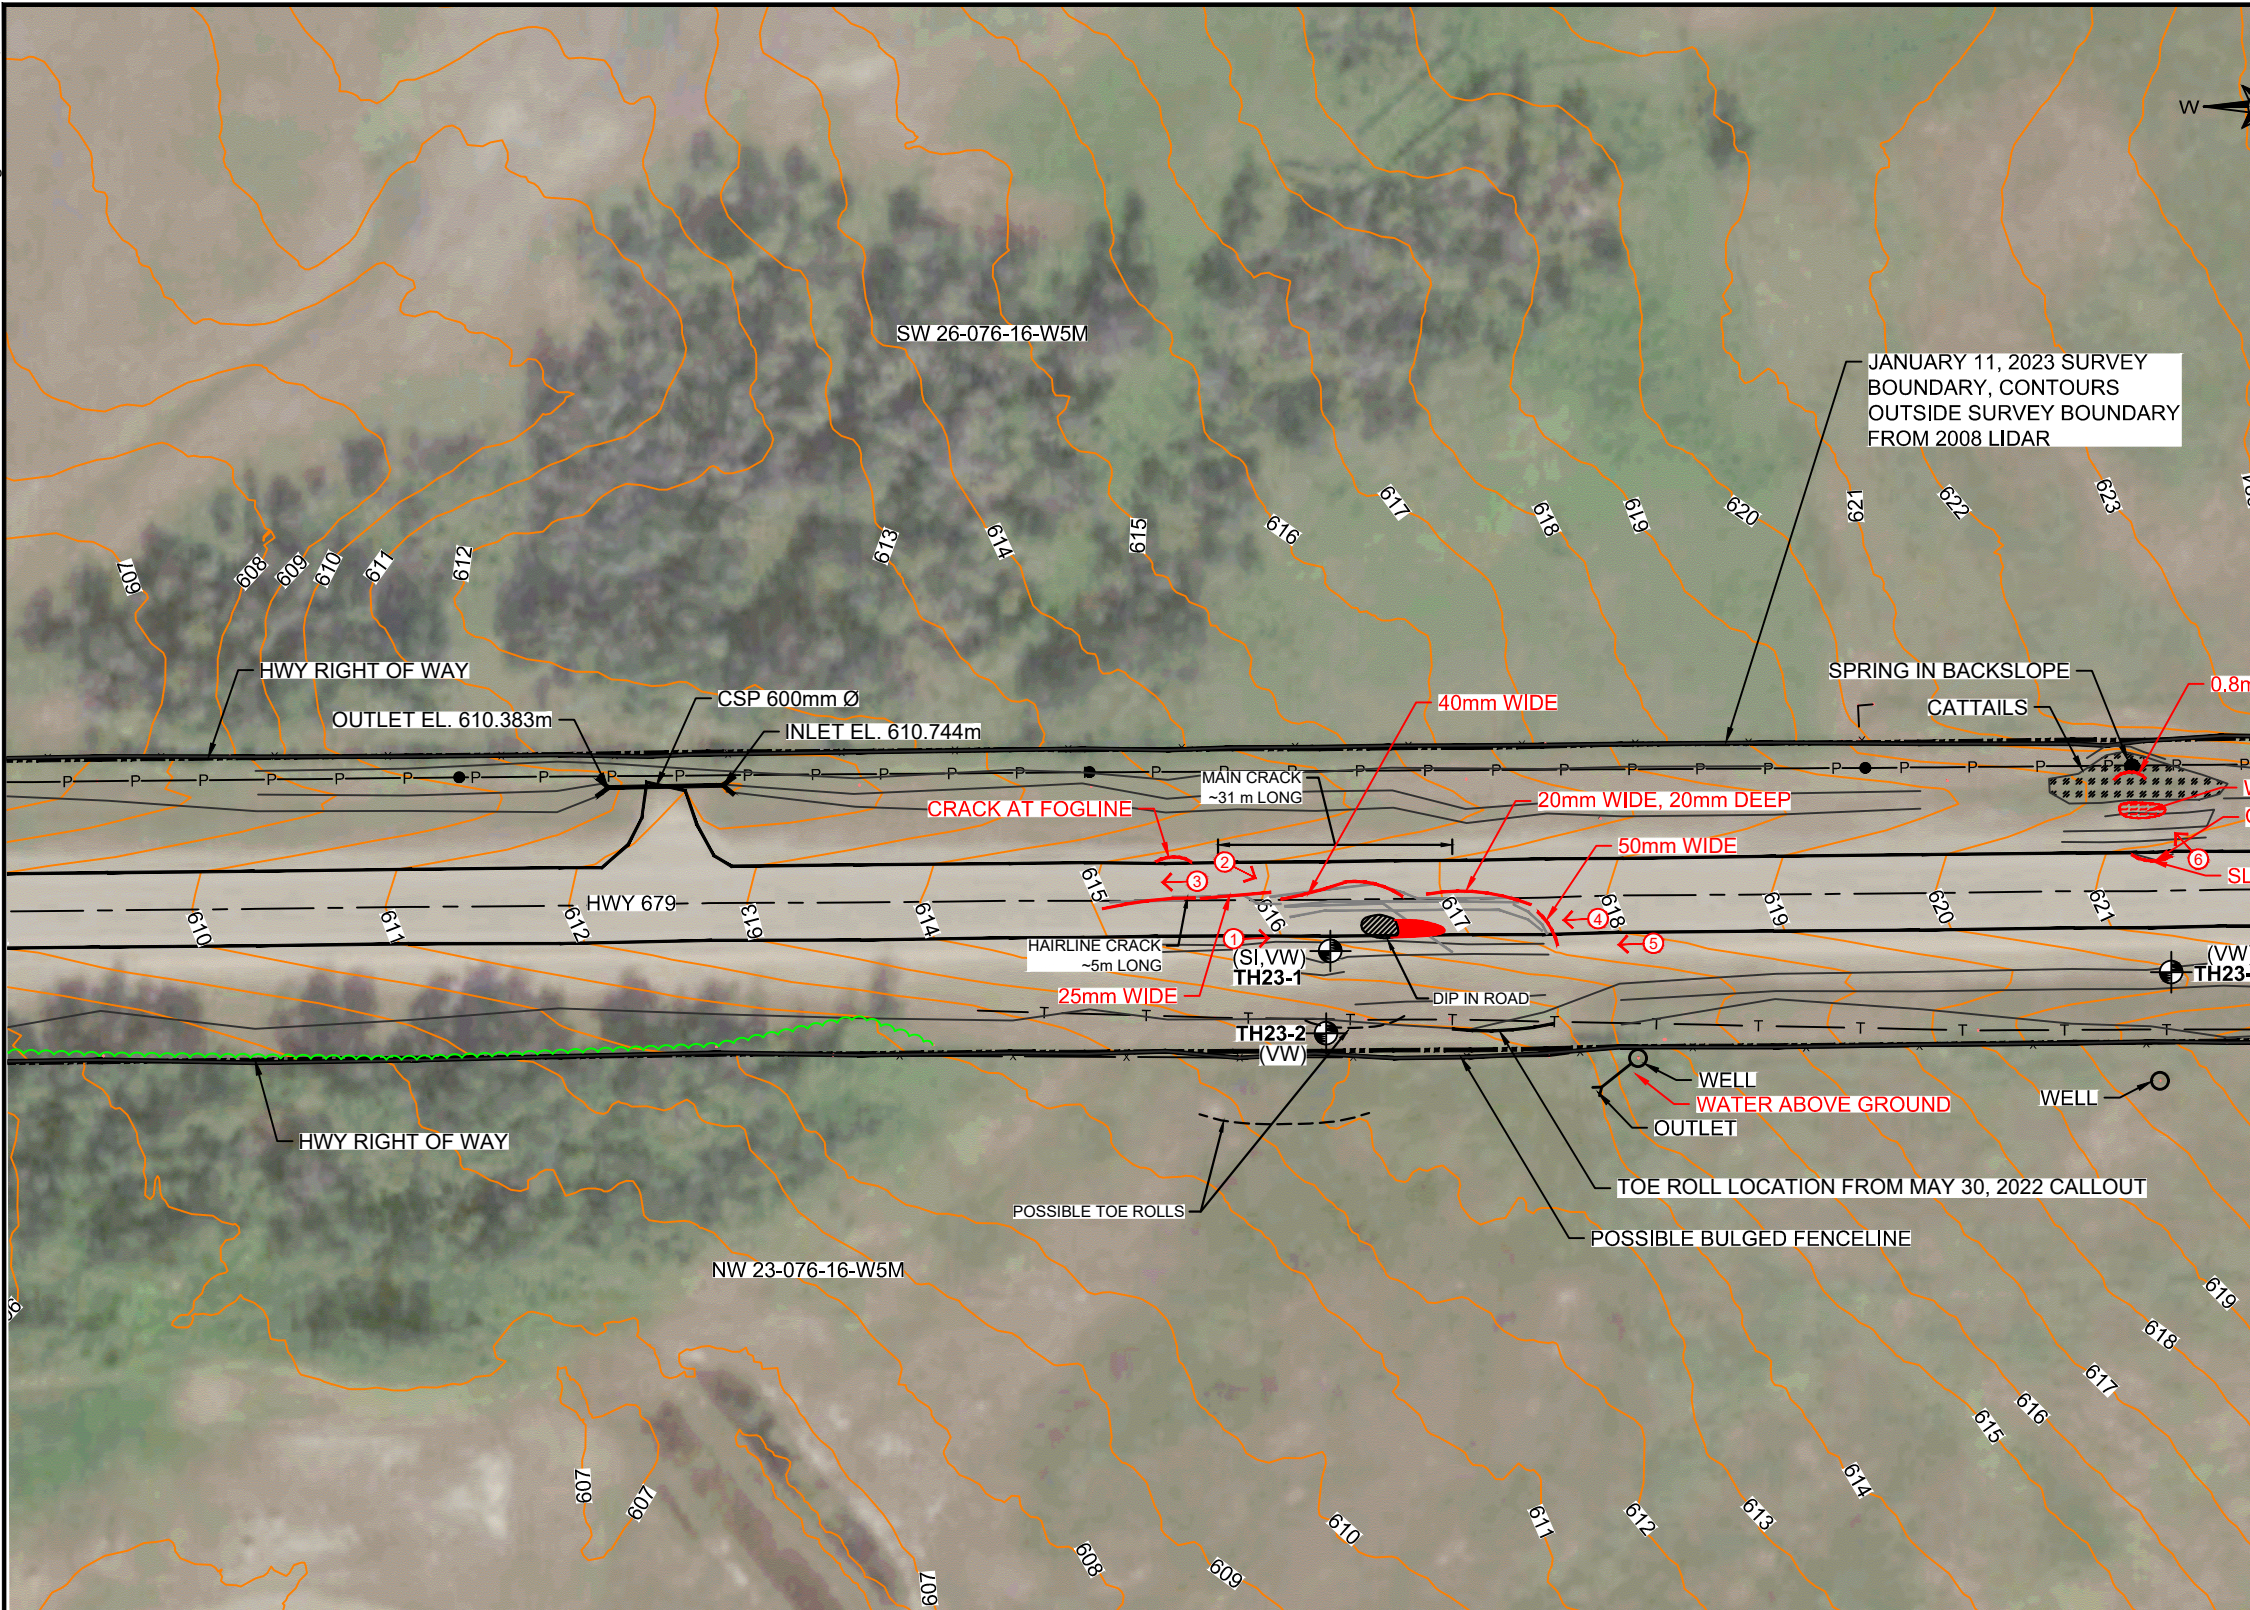
During the 2023 geohazard inspection, the arc-shaped crack cutting across the east-bound lane (EBL) and partway into the west-bound lane (WBL) extended further west where hairline cracks were previously observed. The possible toe rolls observed downslope of the main crack north of the fence and south of the fence during the call-out inspection did not appear to have worsened. However, the dip on the highway appears to have worsened since the call-out inspection. The two old culvert-style wells on the south side of the highway had water present at the ground surface. A scarp has formed at the spring located in the backslope cut on the north side of the highway at the east end of the site. Cracks were also observed at two locations at the fogline along the WBL: one adjacent to the spring and backslope slumping at the east end of the site, and one north of the main arc-shaped crack at the west end of the site.

- Install wick drains and 24 m wide (on skew) clay berm at the toe, and excavate 2 m deep into highway embankment and replace with 1 m washed rock
- Install wick drains and 65 m wide (on skew) clay berm
- Install wick drains, excavate 3 m deep into highway surface and replace with gravel and geogrid, and 40 m wide (on skew) clay berm

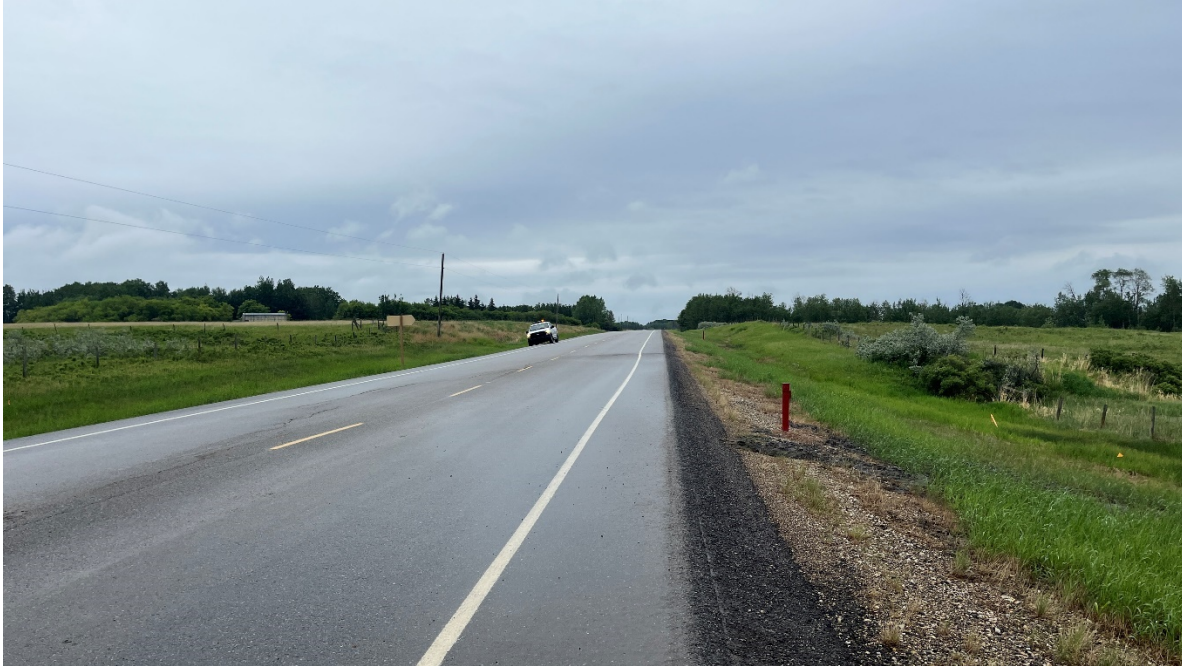
The presence of high plastic clay and high groundwater table are the main triggers to the observed landslide movement at this site. It is anticipated that now the landslide has been activated, that movement will continue until it is remediated. The current dip on the highway surface could create a rough driving condition and reduce the ride quality to motorists as the deformation of the embankment continues. Frequent maintenance may be required.

Photo 1 – Looking east along the EBL of the highway where there is a slight dip in the road.

- Road maintenance should continue as necessary to maintain a safe roadway surface and may consist of milling, patching, and crack sealing of the ACP.

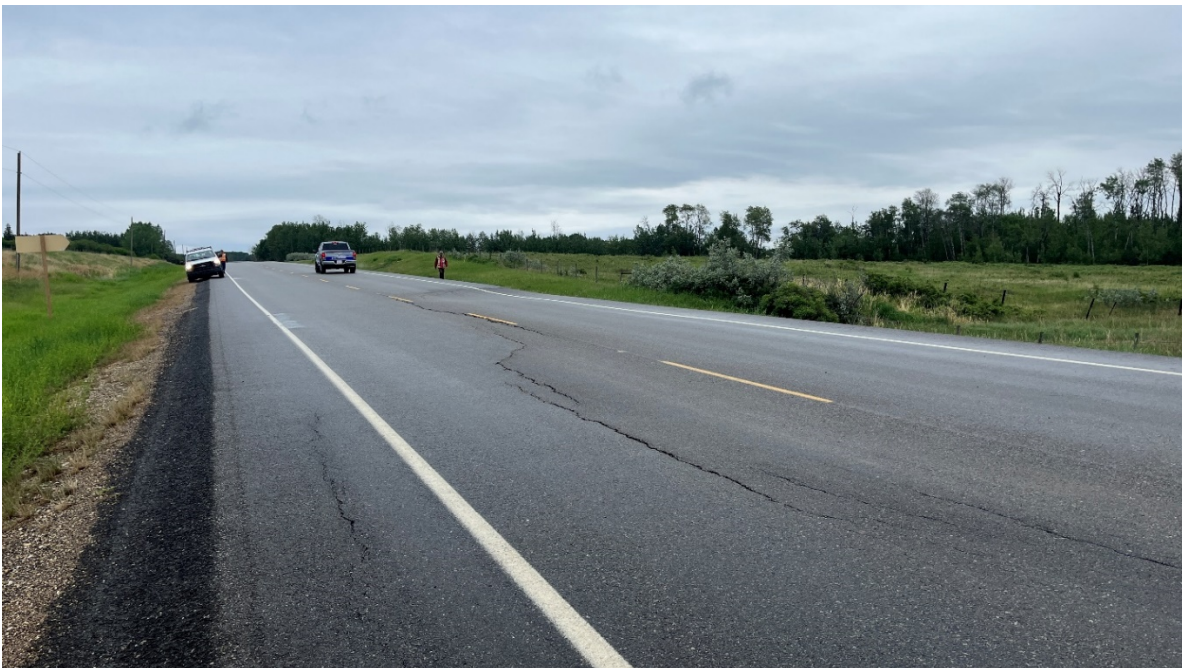
Photo 2 – Looking east at the west end of the arc-shaped crack. A crack is also forming on the shoulder of the WBL.

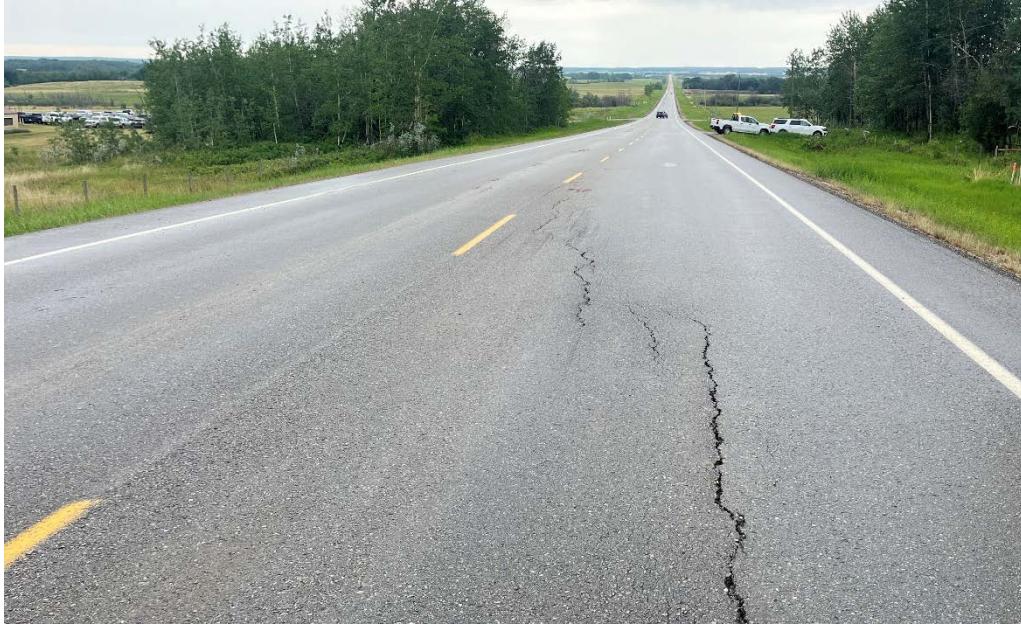
Photo 3: Looking west at cracks propagating west of the main scarp crack where previous hairline cracks were observed.

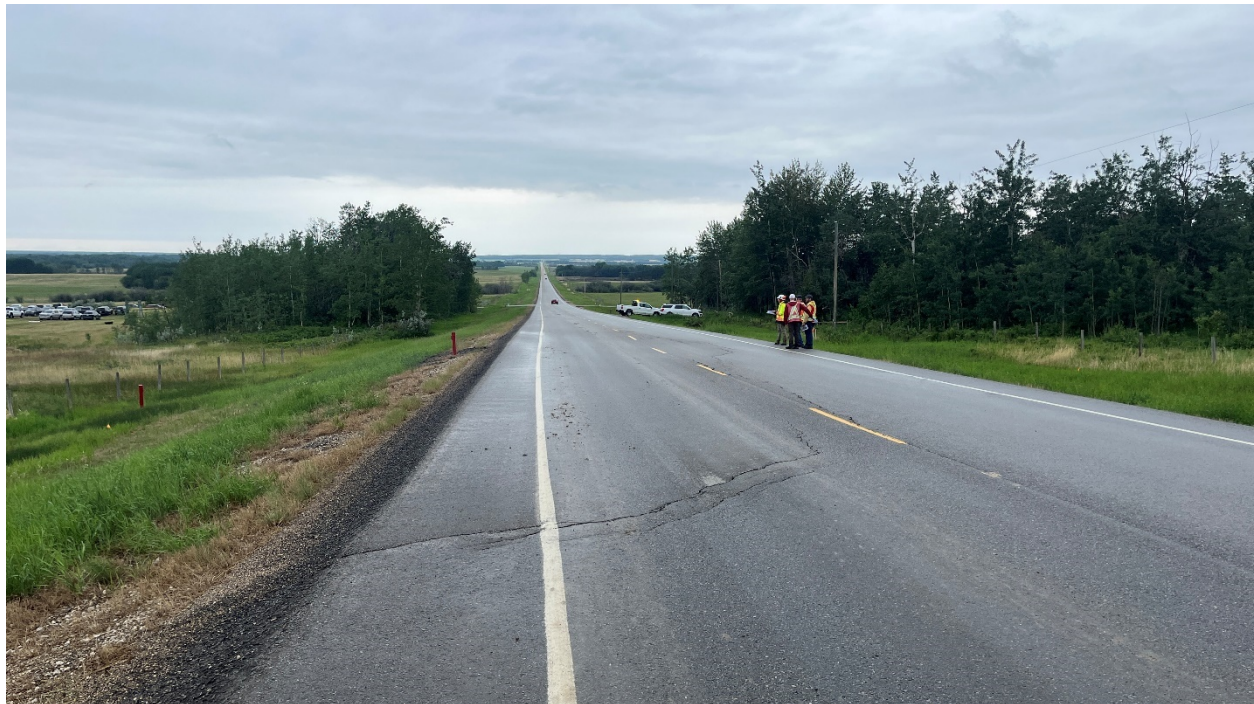
Photo 4: Looking west at the main scarp crack where it crosses the EBL.

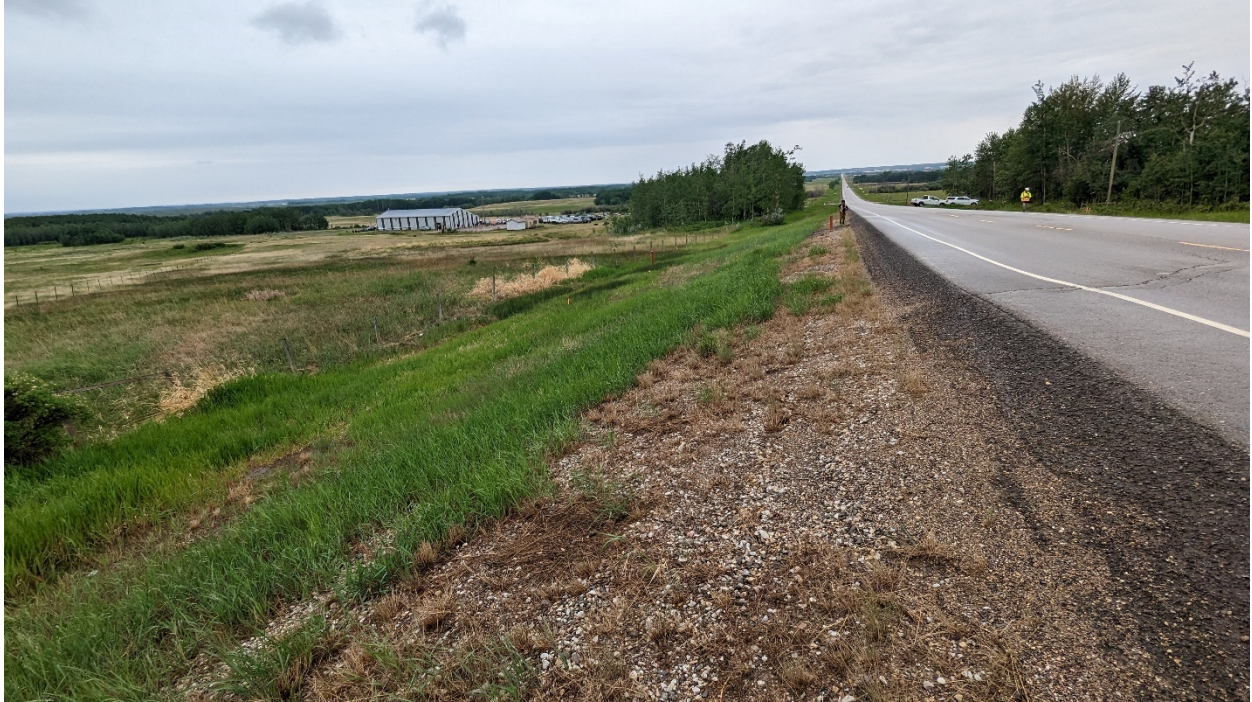
Photo 5: Looking west across the site at the general topography sloping down toward the southwest.

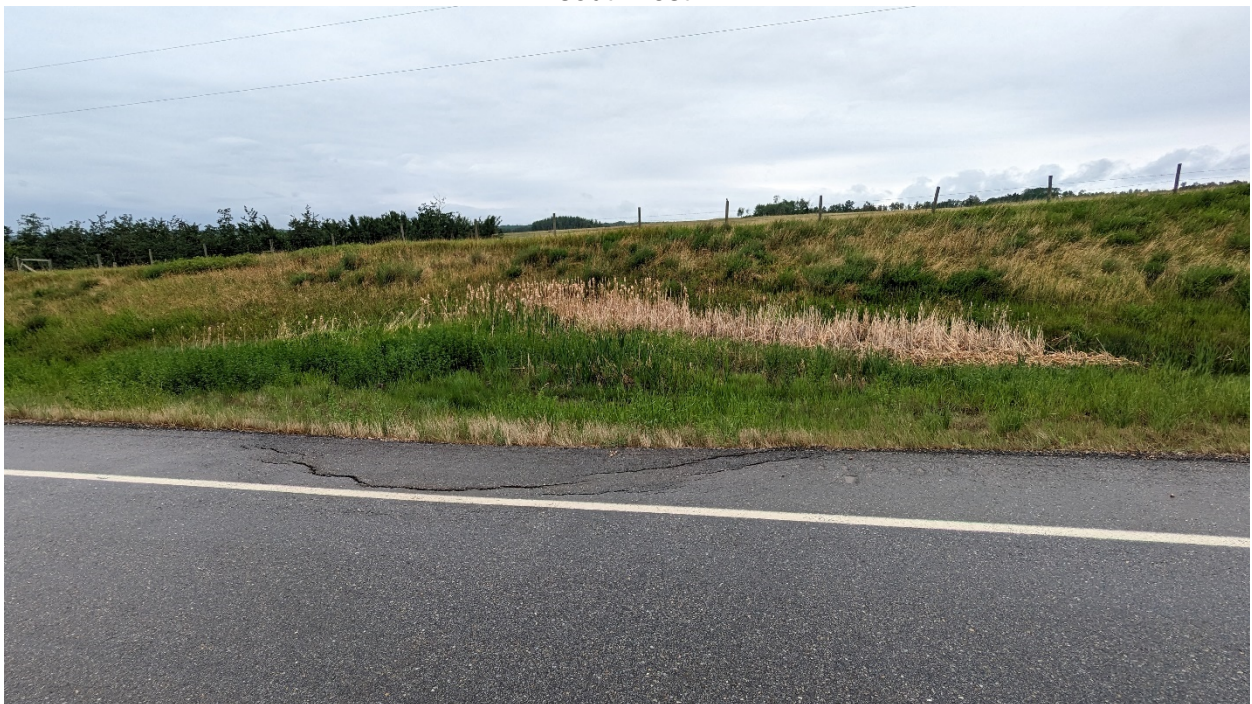
Photo 6: Looking northeast at a spring slumping observed in backslope to the east of the site. Cattails and ponded water are present in the ditch and cracking is developing on the shoulder.
