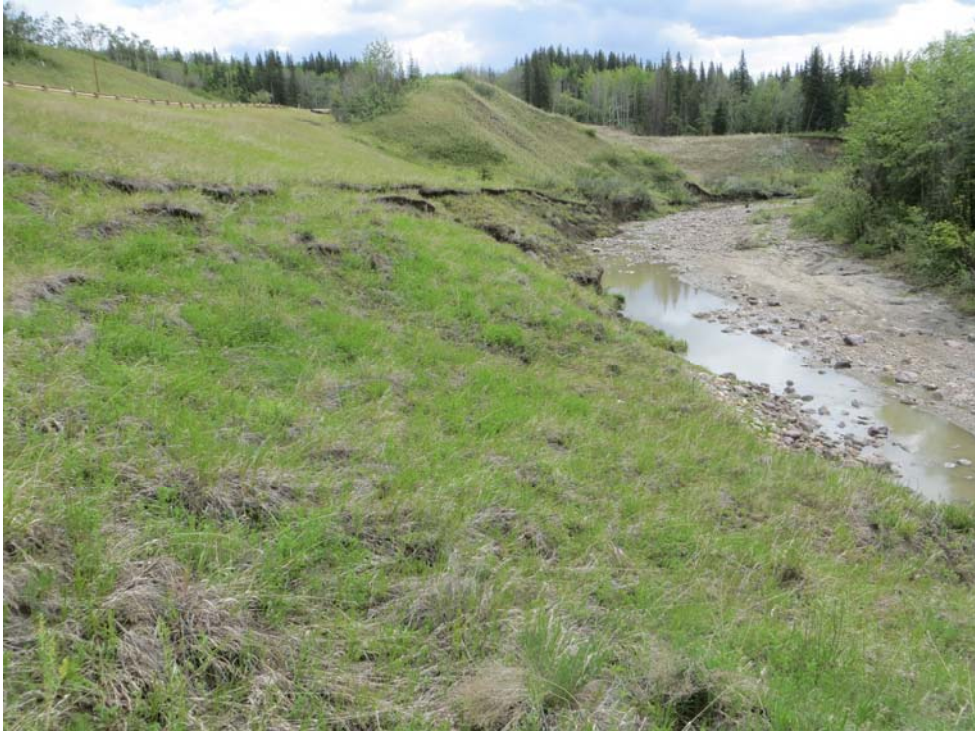
Photo 1 – Looking east at Slide site 1 along the north side of the Creek.

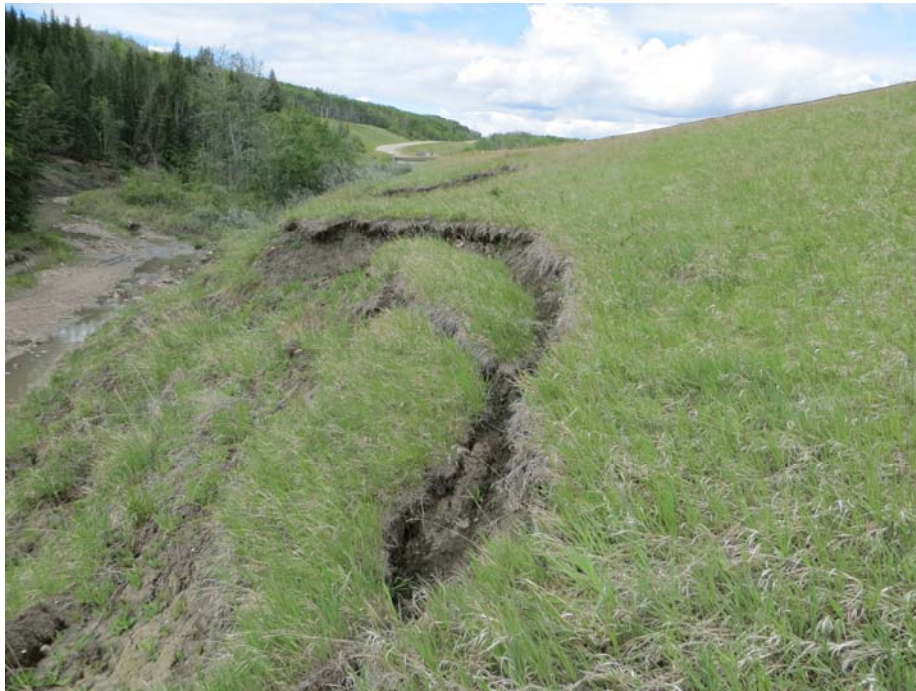
Photo 2 – Looking west at slumping above the creek at Site 1 in the south highway embankment.

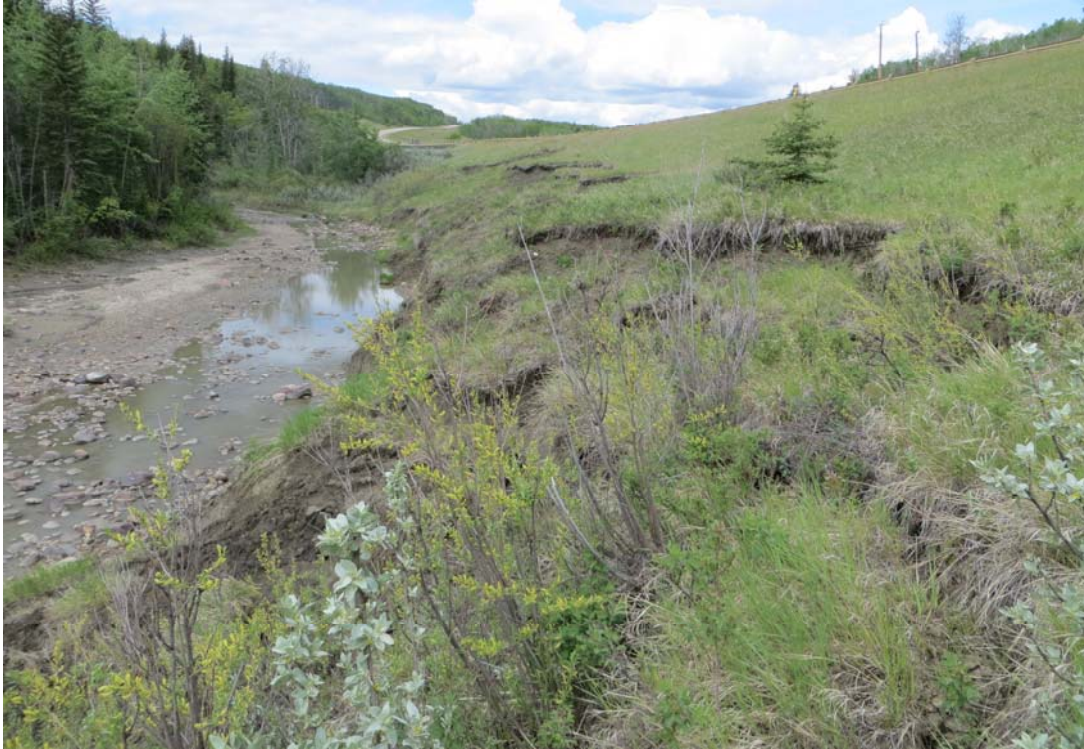
Photo 3 – Looking west along the slide scarp adjacent to the Creek at Site 1.

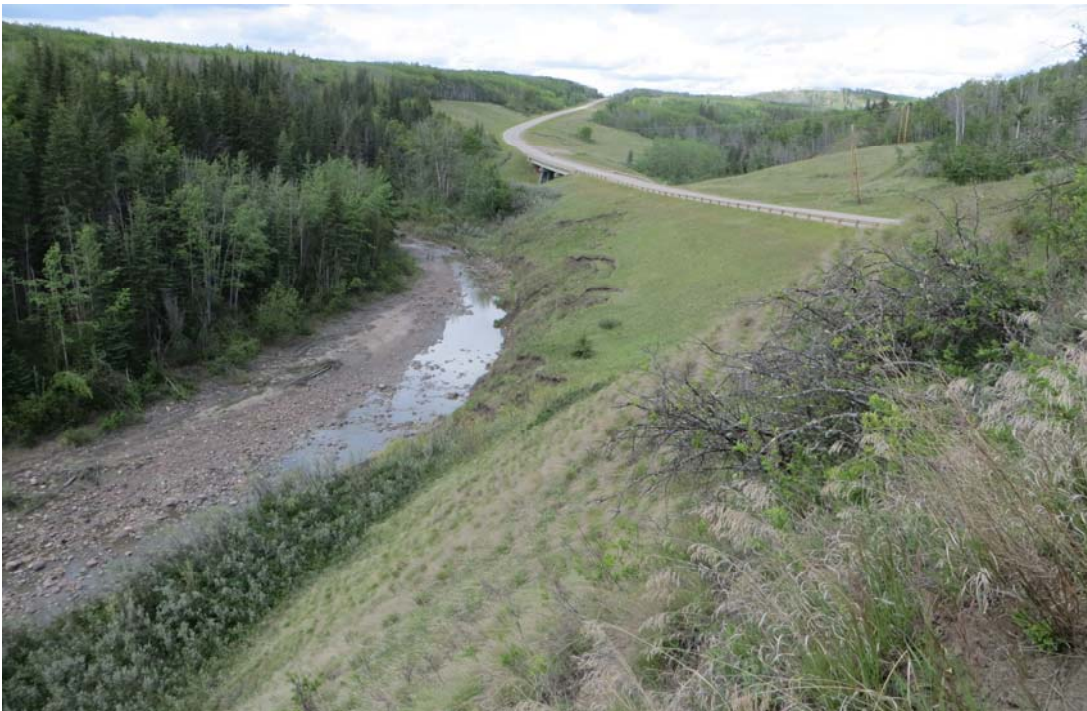
Photo 4 - Looking northwest at a slide lobe of Site 1 extending close to the highway.

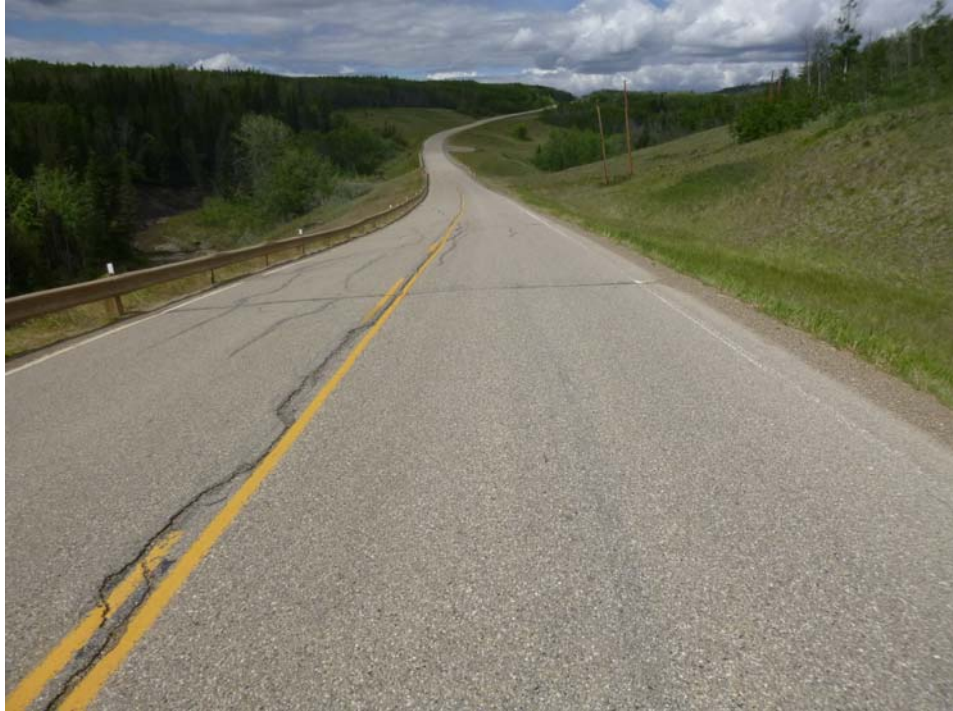
Photo 5 – Looking west along the highway at the crack/dip in the highway above Slide 1.

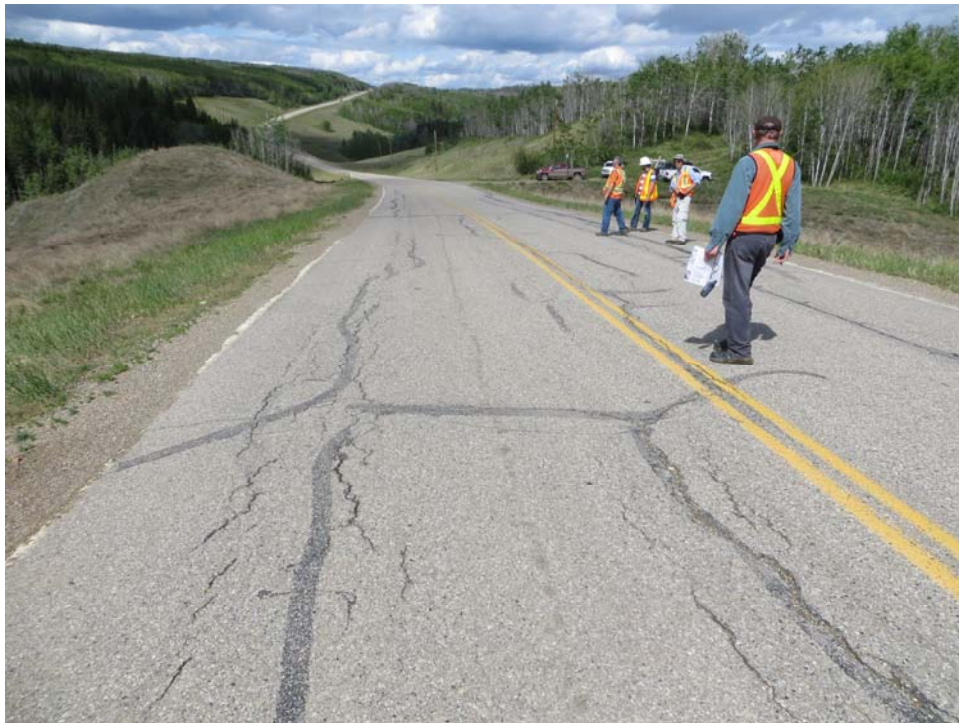
Photo 6 - Looking west along the highway and south embankment of Site 2. Note the settlement in both the highway and the embankment.

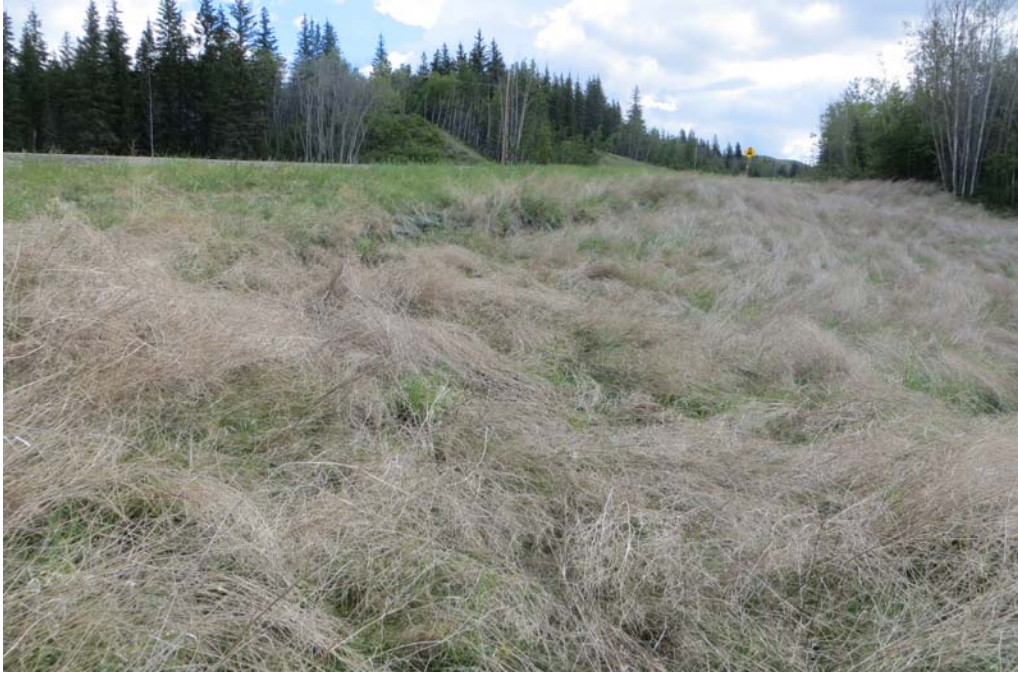
Photo 7 – Looking east at the slide scarp adjacent to the highway in the south embankment of Site 2.

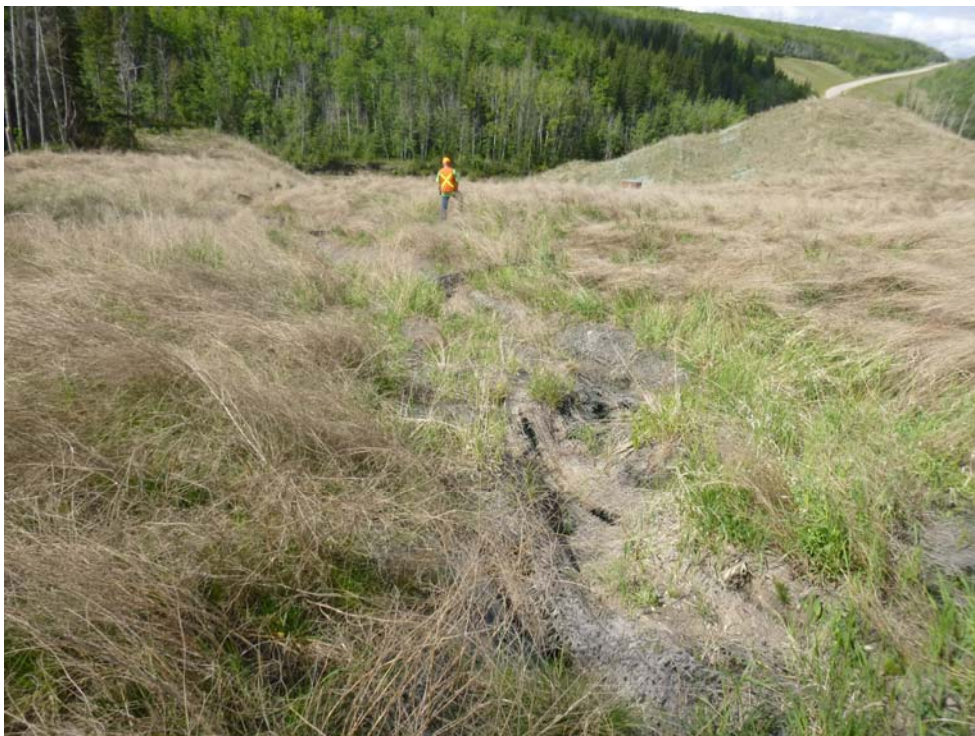
Photo 8 - Looking at the surface erosion through the existing erosion control soil covering and ditch barriers on the south embankment of Site 2.

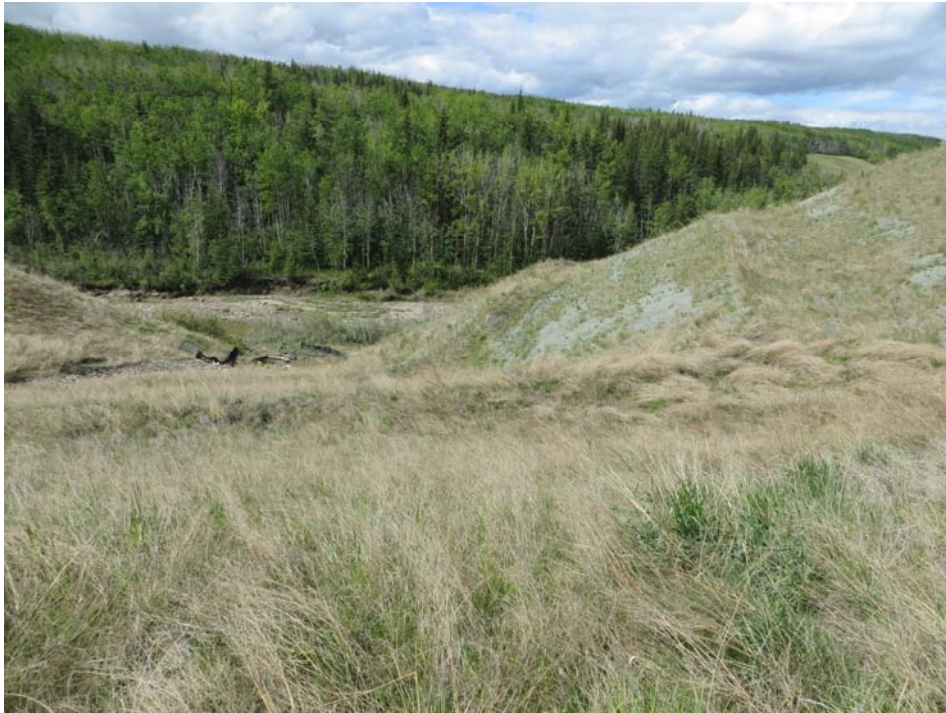
Photo 9 – Looking west along the south embankment of Site 2. Note the benched hillside and the subsidence near to the highway over the culvert.

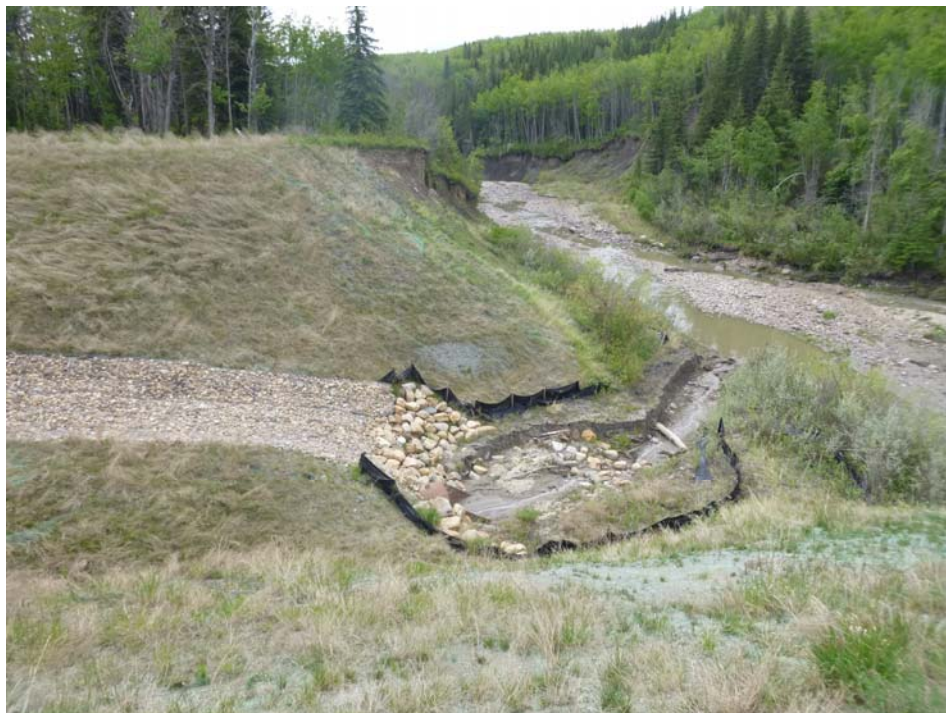
Photo 10 - Looking east at the culvert outlet area of Site 2, Hines Creek.

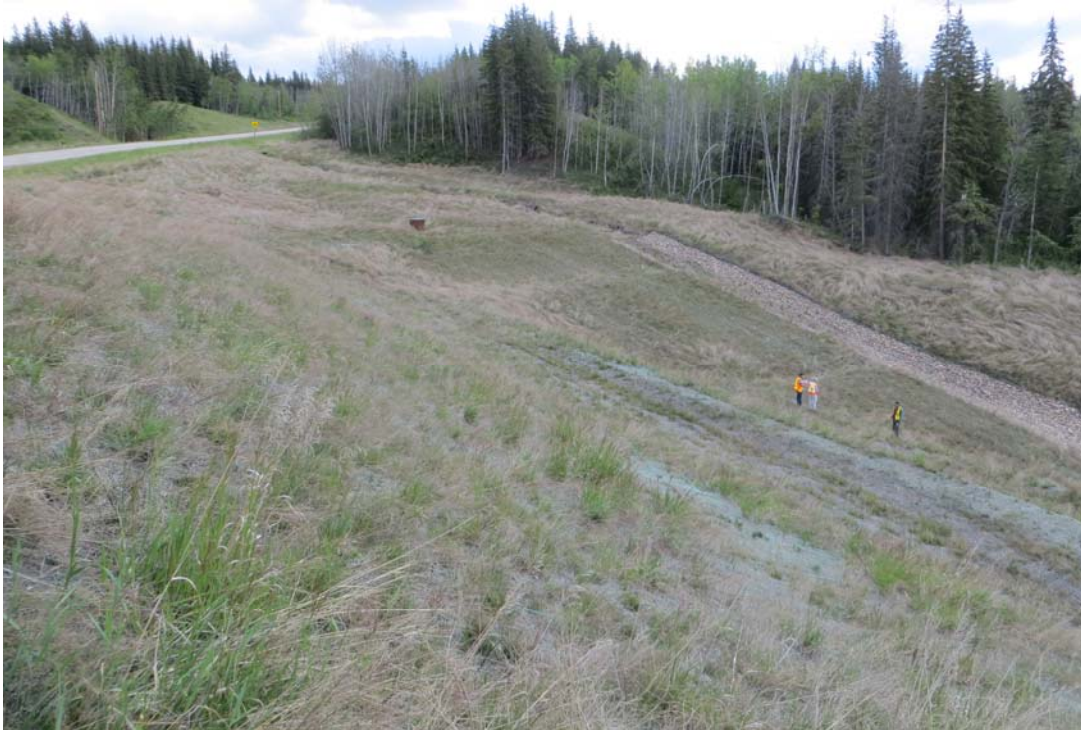
Photo 11 – Looking east along the upper south embankment of Site 2.

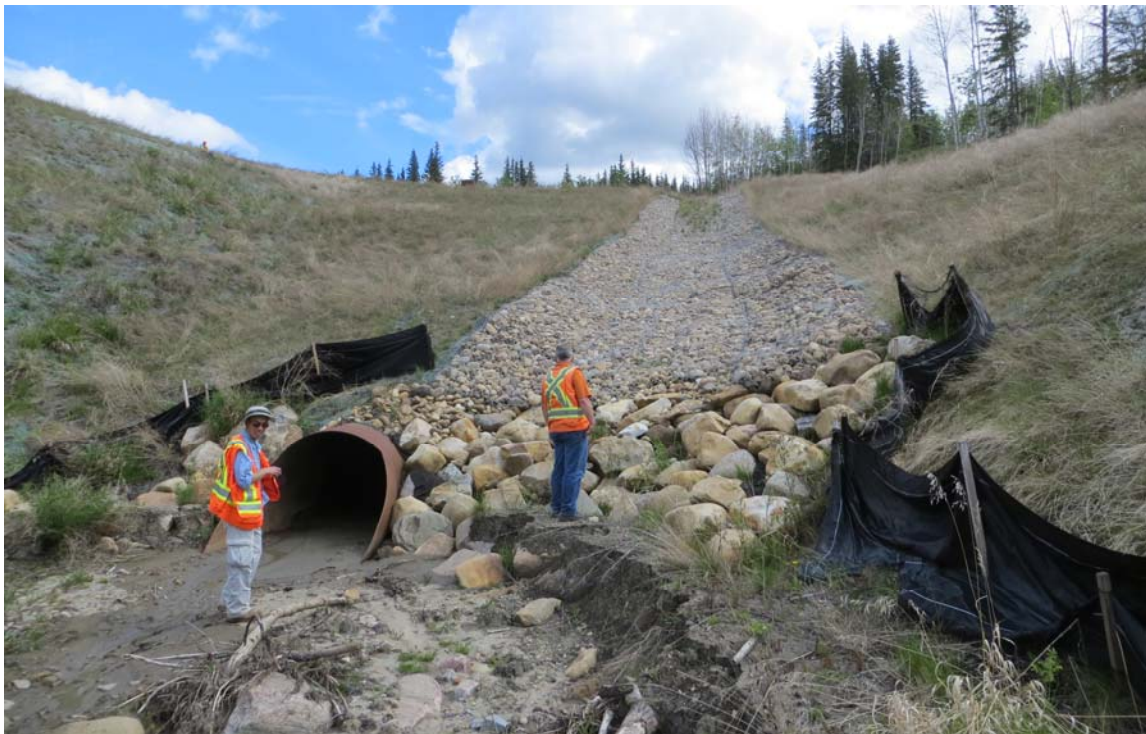
Photo 12 - Looking northeast at the culvert outlet area and south embankment of Site 2.

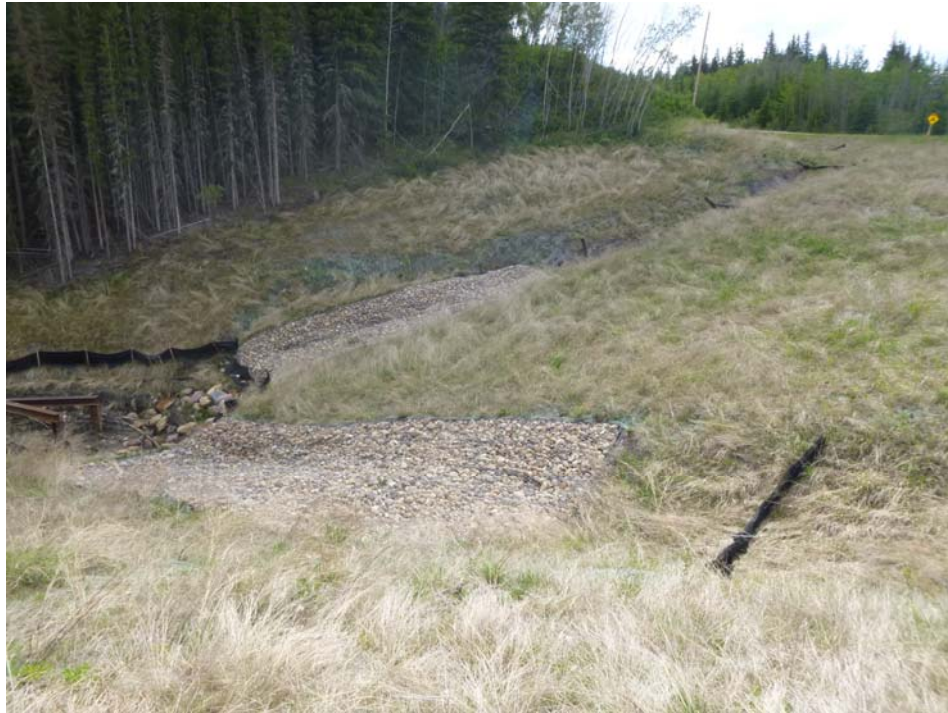
Photo 13 – Looking east across the culvert inlet area of the north embankment of Site 2.

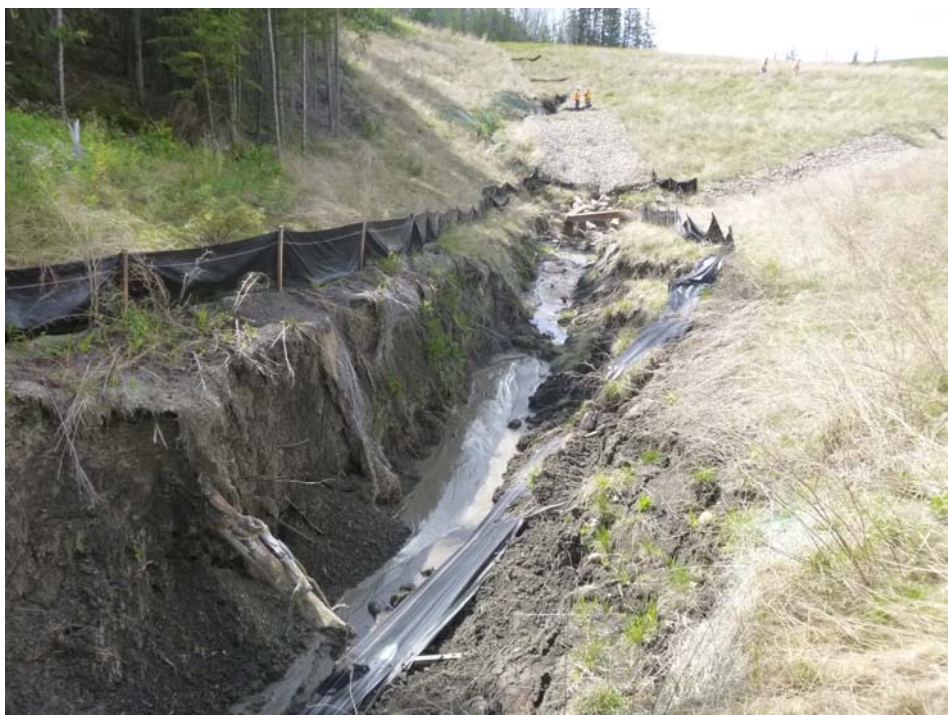
Photo 14 - Looking south from upstream of the culvert inlet area at the severe channel erosion north of the highway at Site 2.

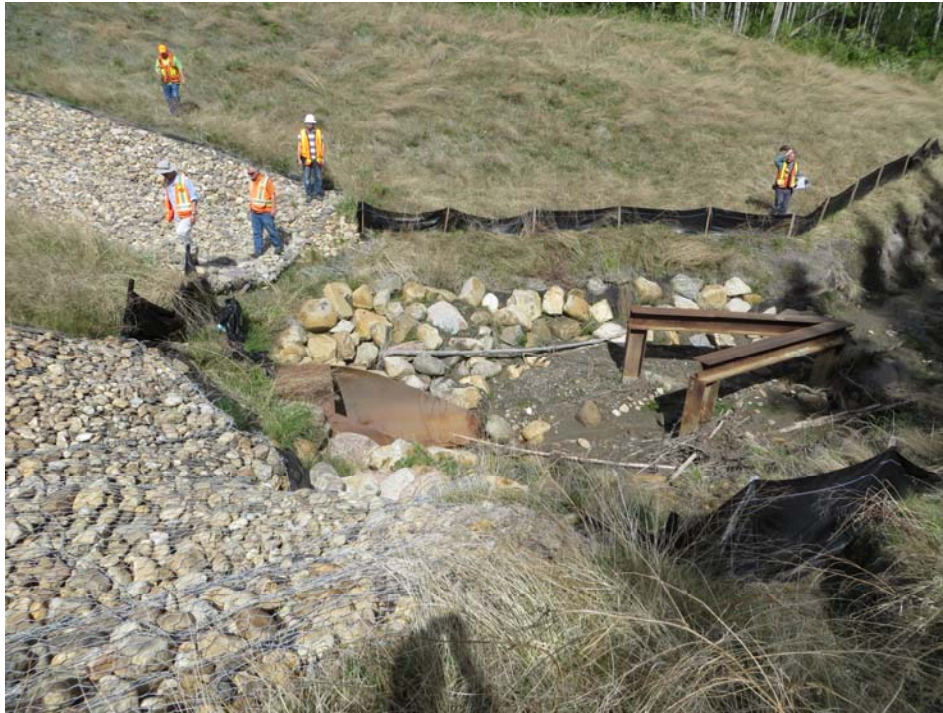
Photo 15 – Looking west across the culvert inlet area of the north embankment of Site 2. Note the undermining of the end of the gabions east of the culvert inlet.

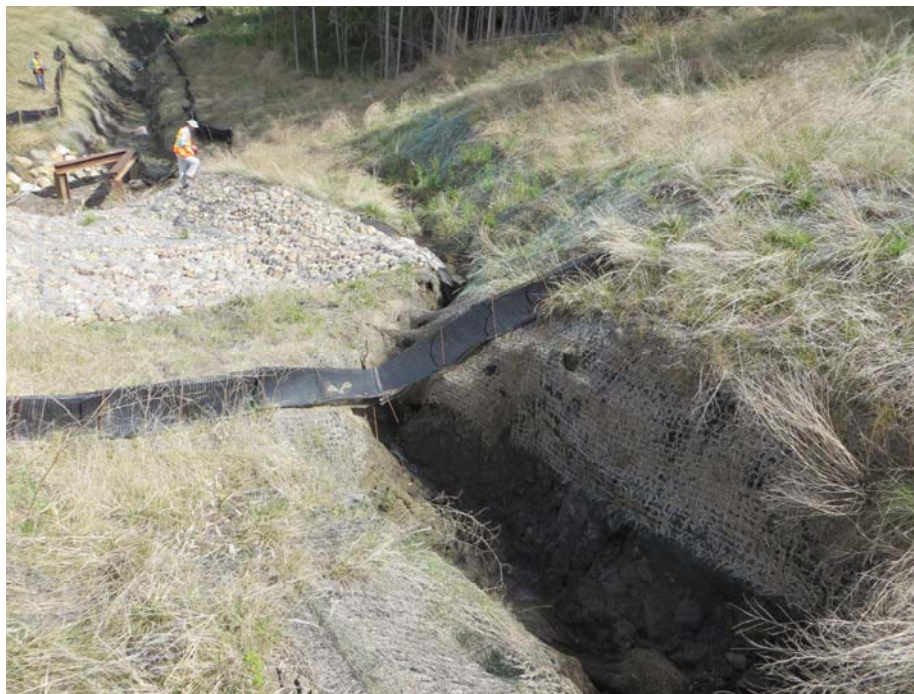
Photo 16 - Looking north at the eroded northeast TRM ditch above the culvert inlet area north of the highway at Site 2. Note the severe ditch erosion up-gradient of the gabions.

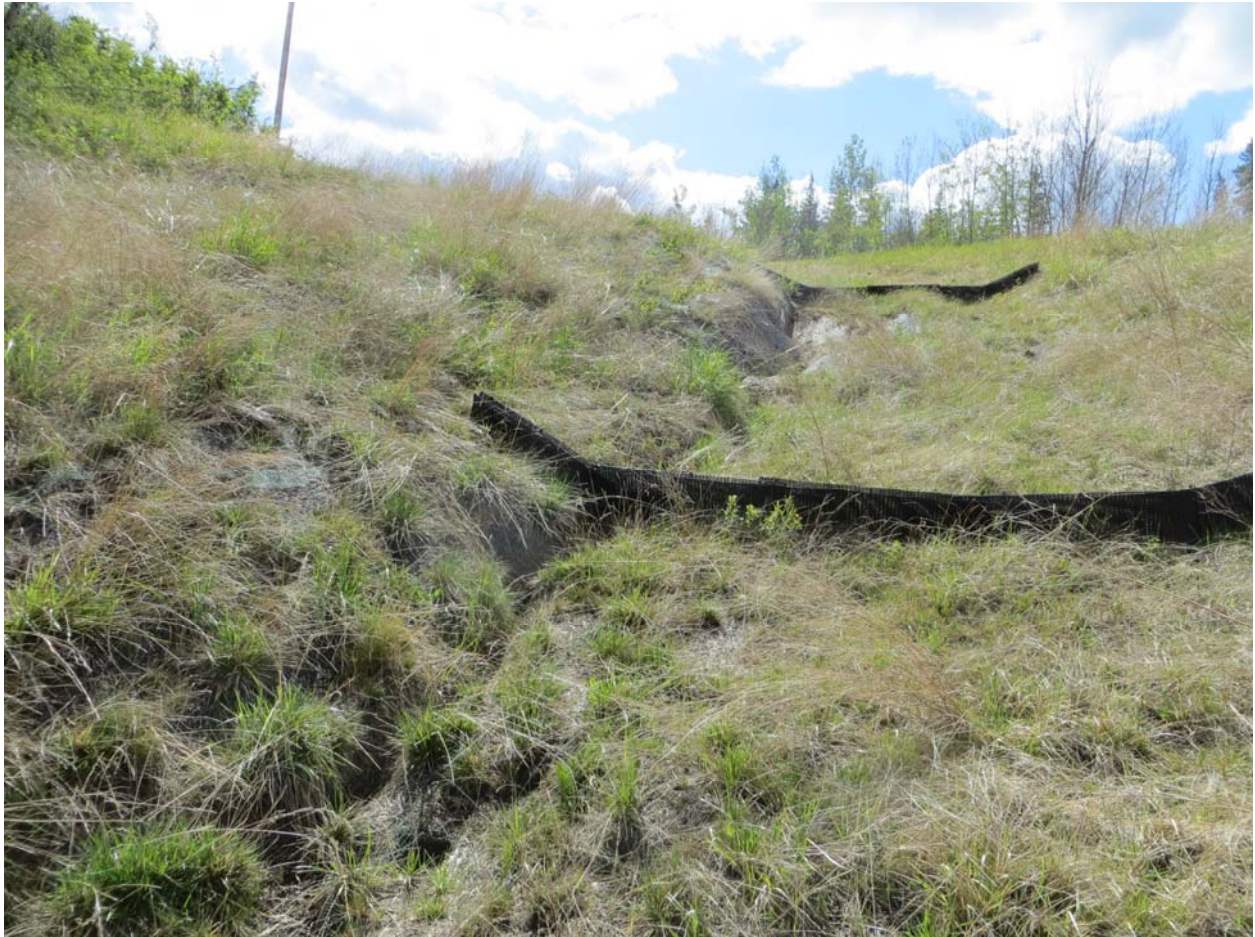
Photo 17 - Looking up at the eroded northeast TRM ditch of Site 2.
