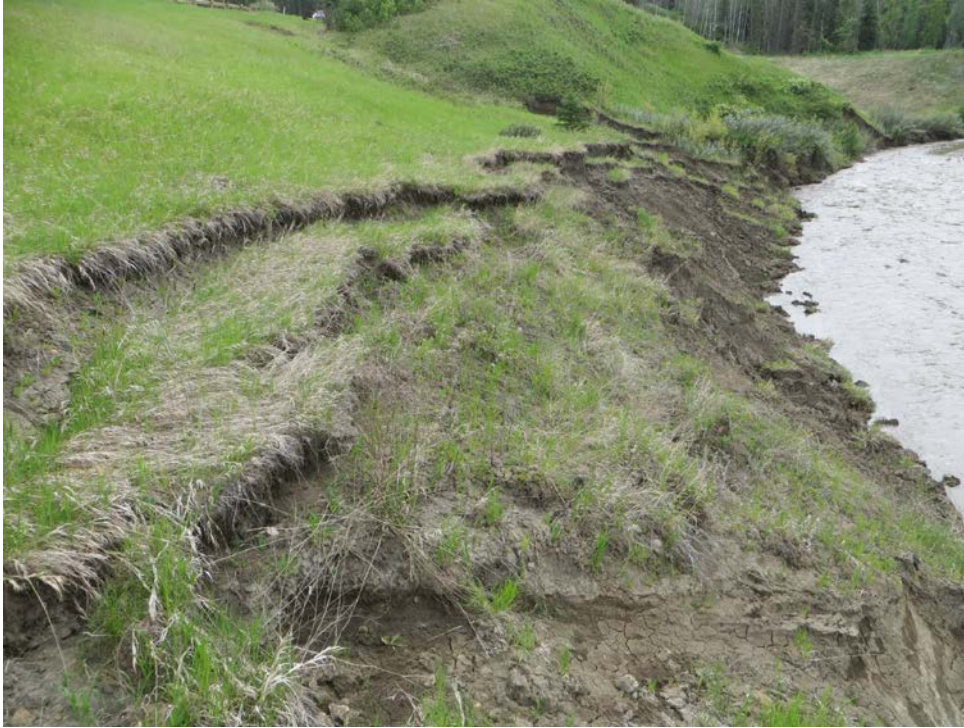
Photo 1 – Looking east at Slide site 1 at active erosion along the north side of the Creek.

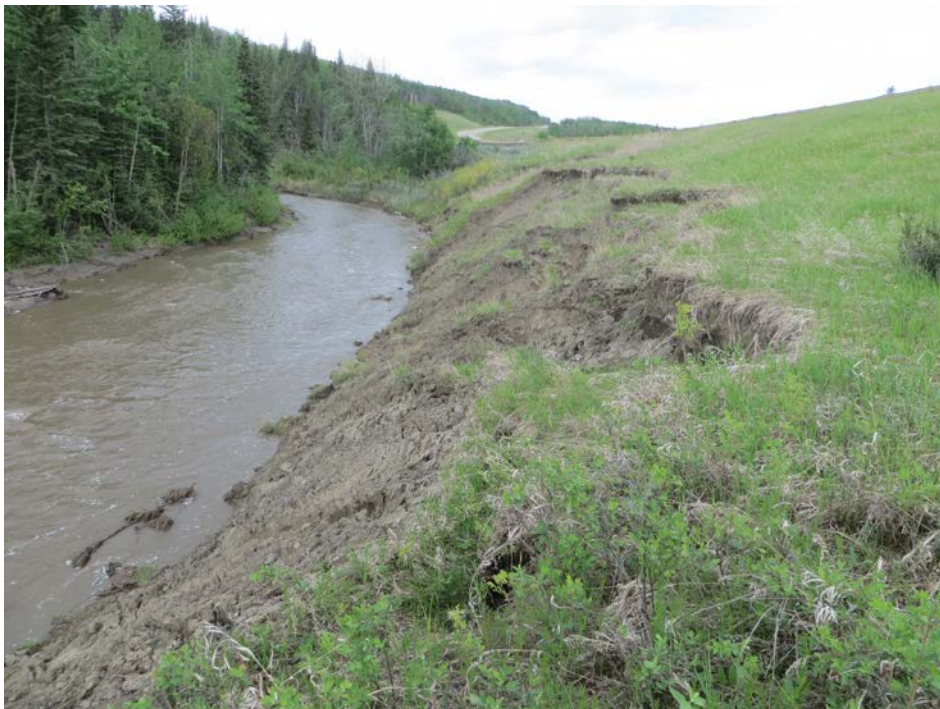
Photo 2 – Looking west at slumping above the creek at Site 1 in the south highway embankment.

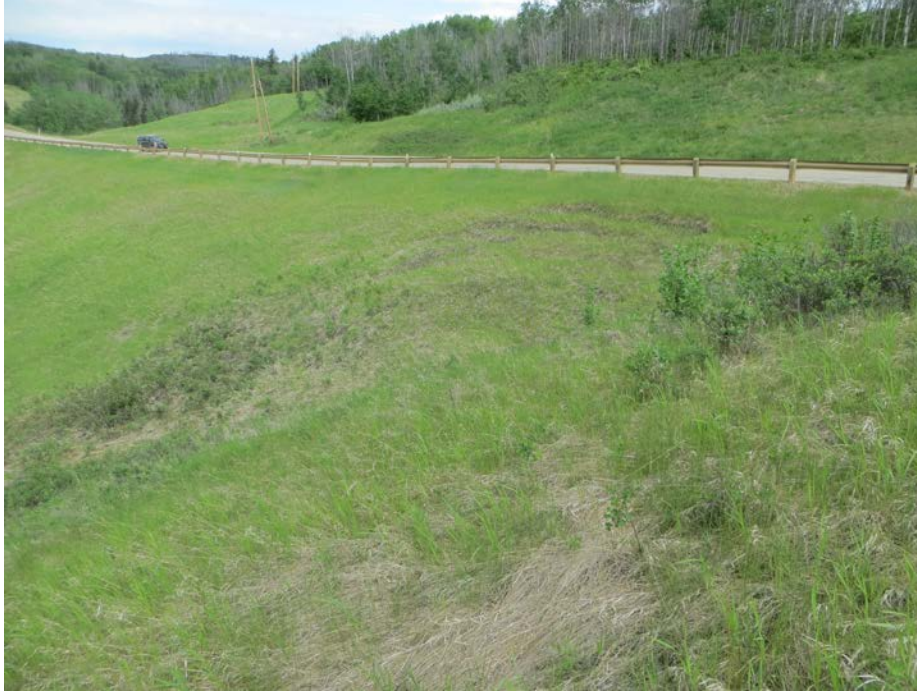
Photo 3 – Looking northwest at the slide lobe adjacent to the highway at Site 1.

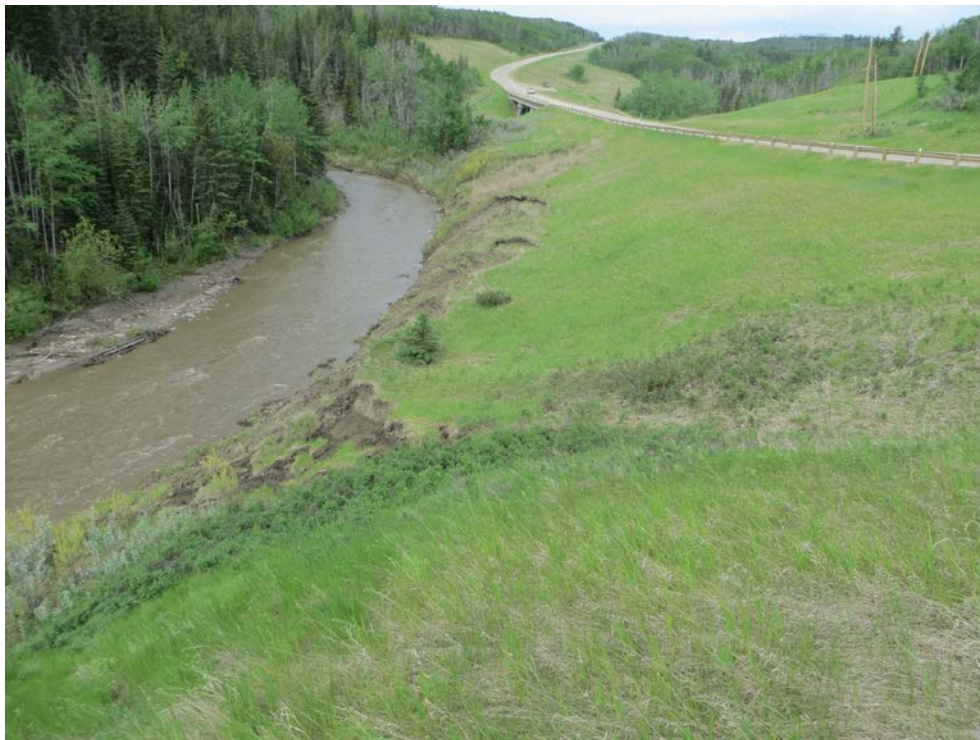
Photo 4 - Looking west along the Creek at the erosion at Site 1.

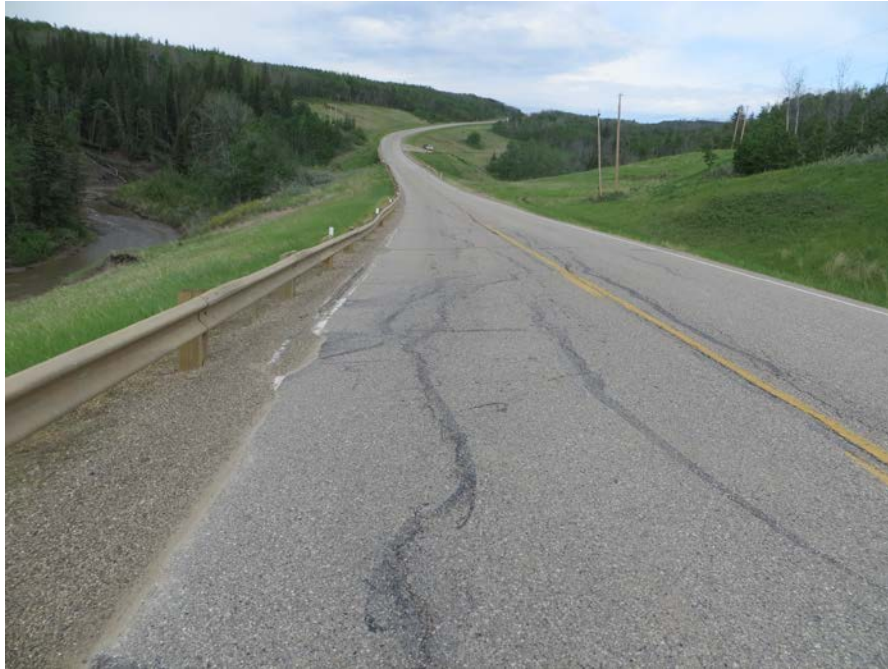
Photo 5 – Looking west along the highway at the crack/dip in the highway above the Slide at Site 1.

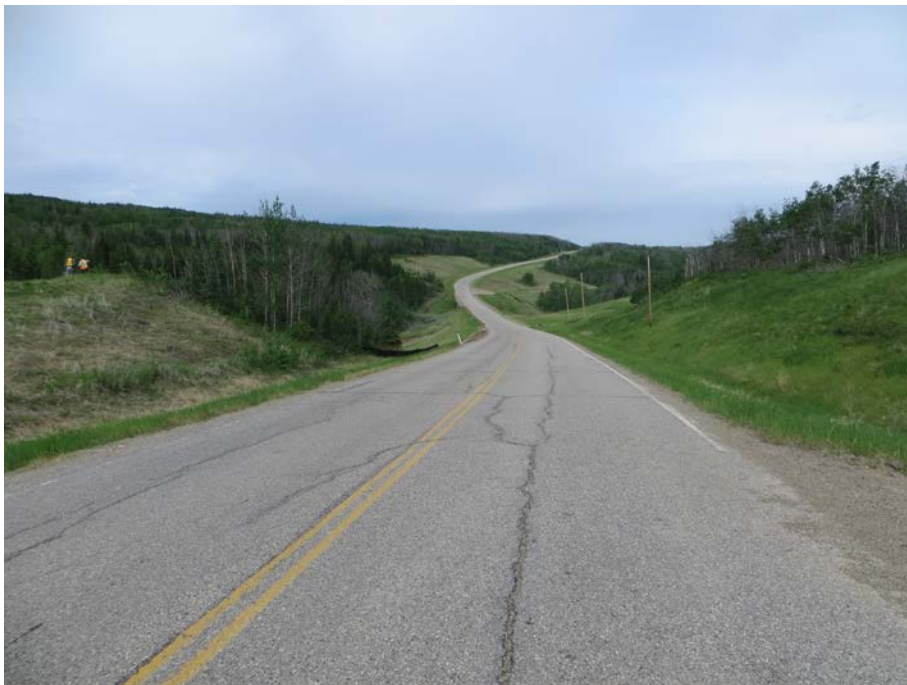
Photo 6 - Looking west along the highway and south embankment of Site 2. Note the settlement in both the highway and the embankment.

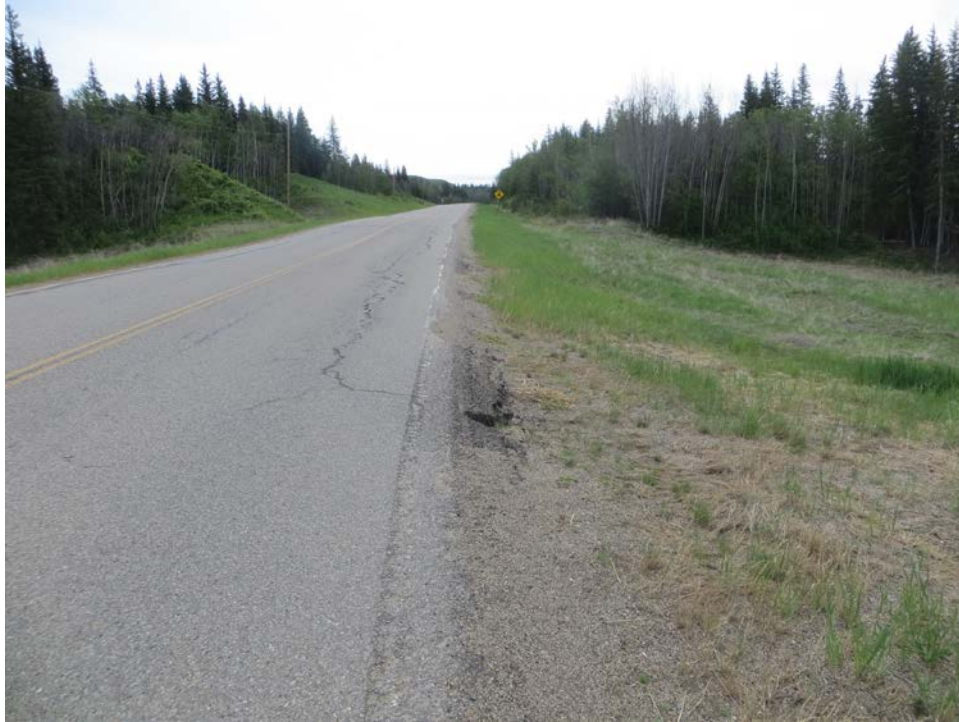
Photo 7 – Looking east along the highway at the cracks and dip overtop the culvert crossing at Site 2.

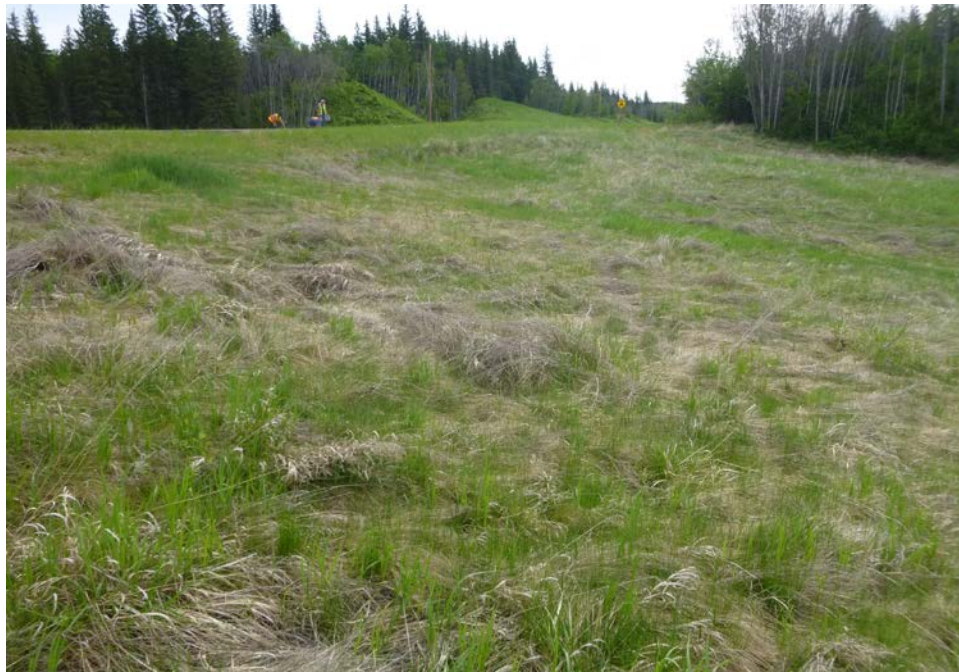
Photo 8 – Looking east at the slide scarp adjacent to the highway in the upper south embankment of Site 2.

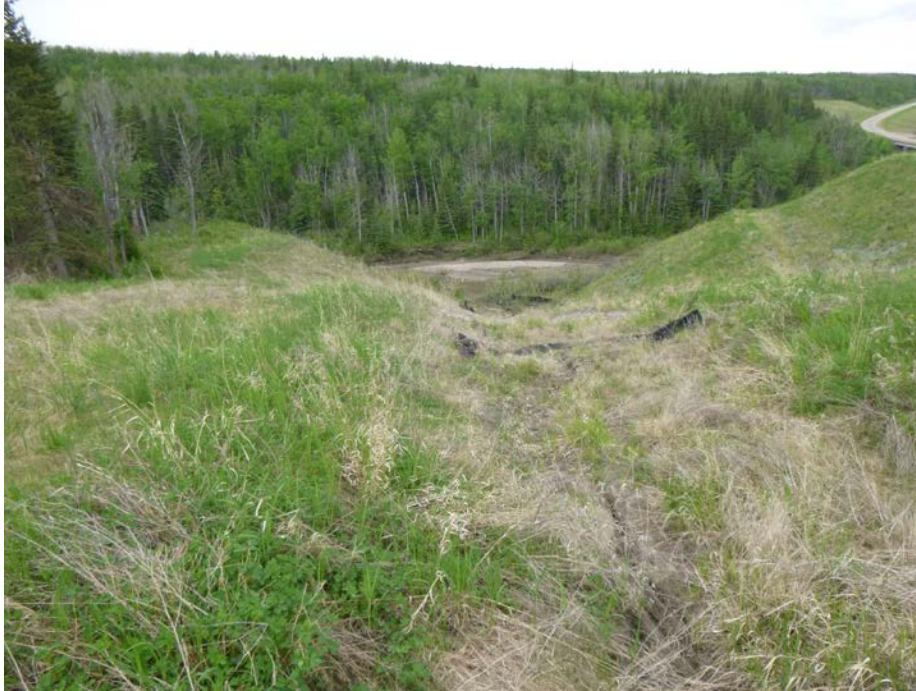
Photo 9 – Looking southwest down along the south embankment and ditch channel of Site 2. Note the erosion and the benched hillside to the west.

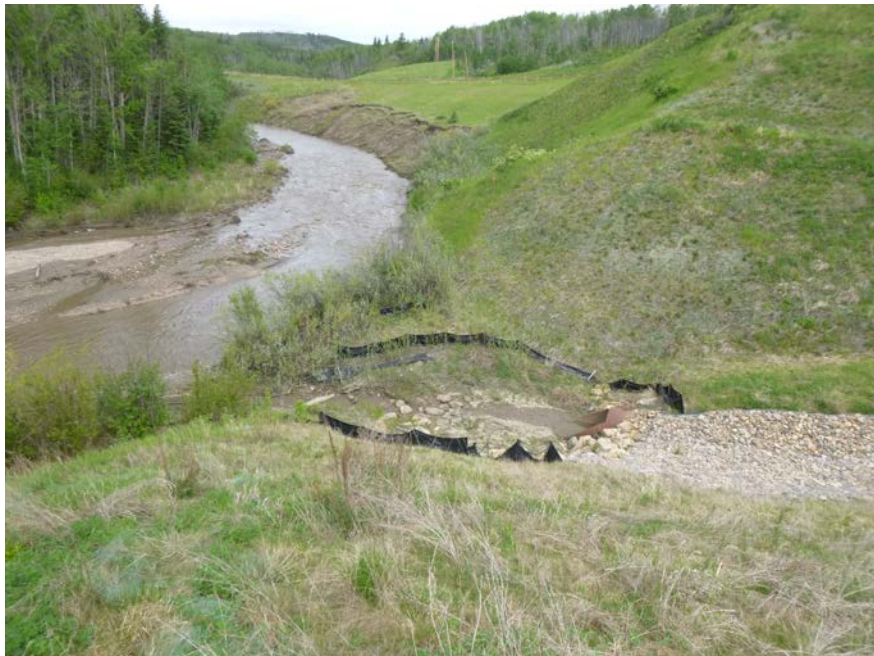
Photo 10 - Looking west at the culvert outlet area of Site 2, Hines Creek.

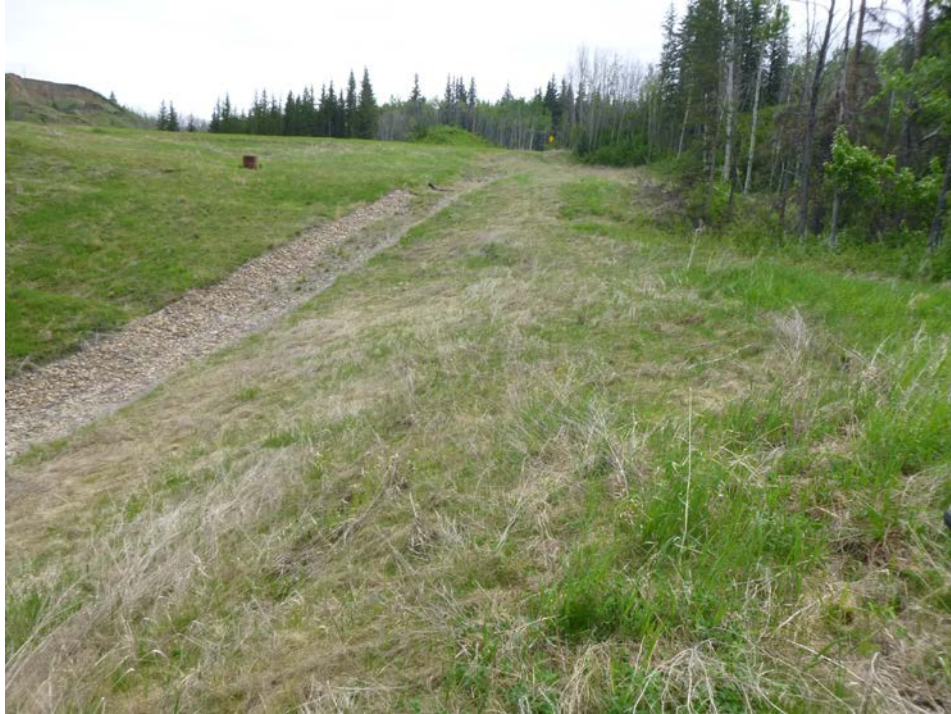
Photo 11 – Looking northeast along the ditch channel of the upper south embankment of Site 2.

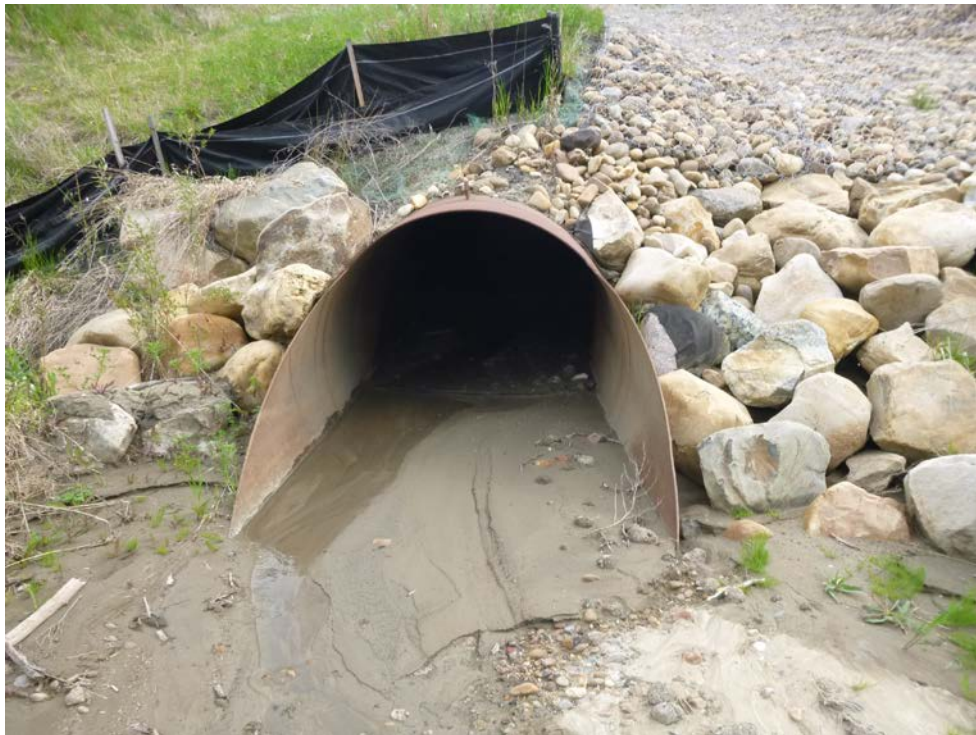
Photo 12 - Looking northeast at the culvert outlet area of Site 2.

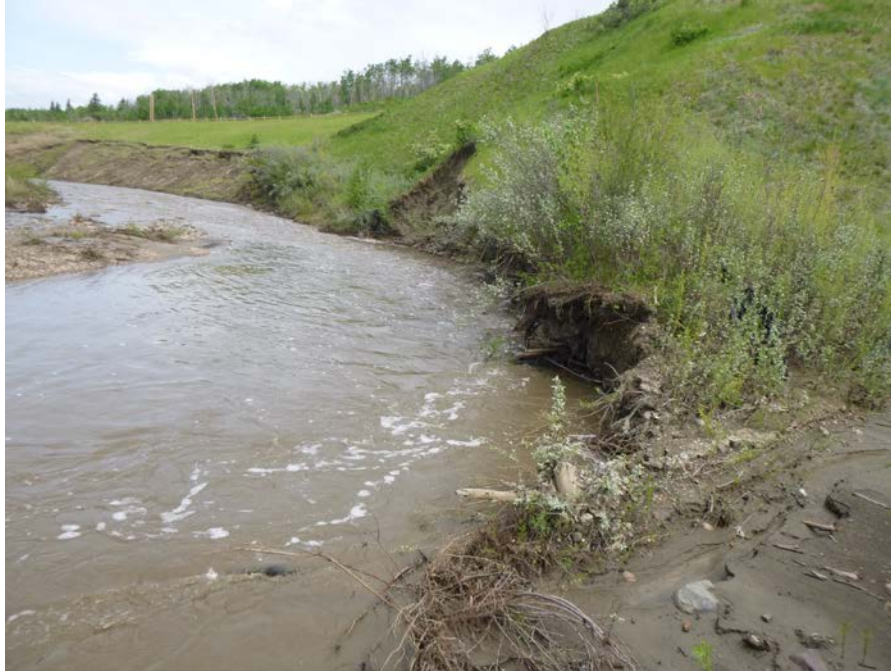
Photo 13 – Looking northwest at the erosion along the north edge of Hines Creek by the culvert outlet area of the south embankment of Site 2.

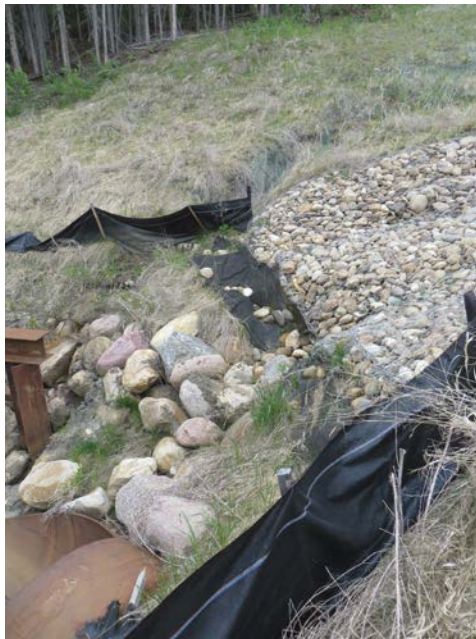
Photo 14 - Looking west at the culvert inlet area north of the highway at Site 2. Note the undermining of the end of the gabion ditch channel, and the slumping above.

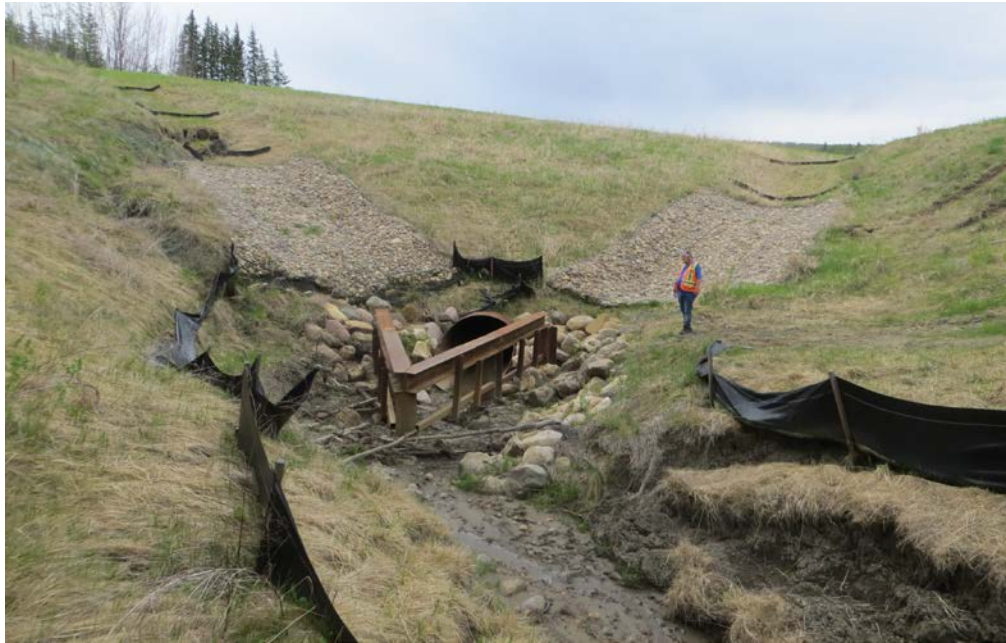
Photo 15 – Looking south across the culvert inlet area of the north embankment of Site 2. Note the undermining of the end of the gabions and associated ditch channel slumping.

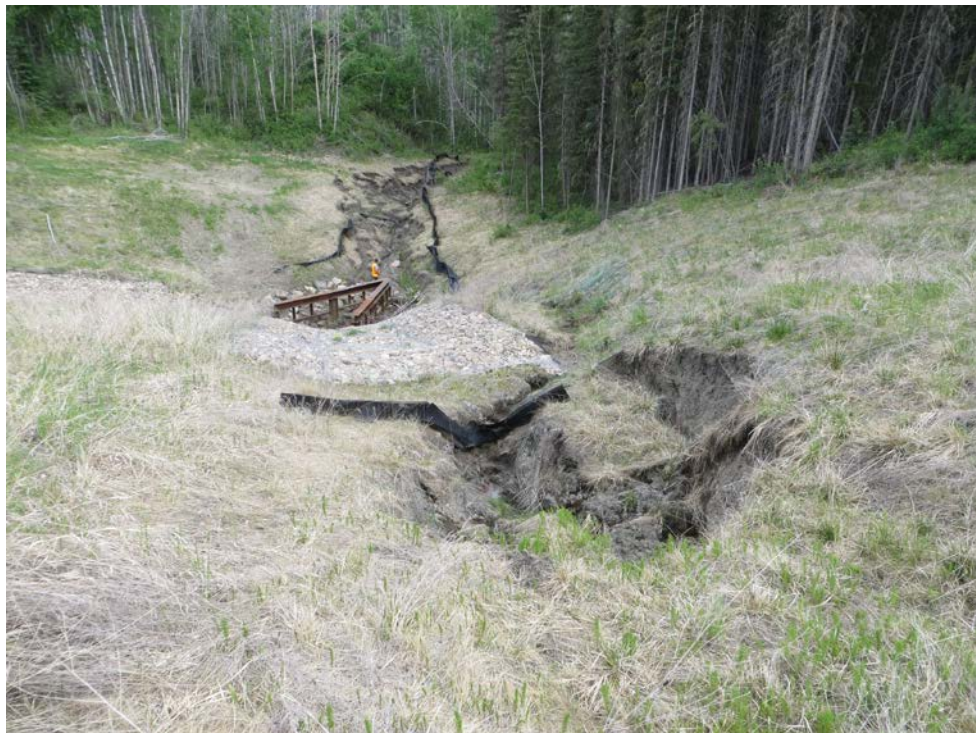
Photo 16 - Looking north at the eroded northeast TRM ditch above the culvert inlet area north of the highway at Site 2. Note the severe channel erosion leading into the culvert inlet.
