**PEACE REGION (PEACE RIVER/HIGH LEVEL)
PH077-1 & PH077-2 EAST SIDE OF HINES CREEK BRIDGE
HWY 682:02, km 12.6-12.7**

PH077-1: EAST SIDE OF HINES CREEK BRIDGE
 HWY 682:02, km 12.6~12.7
 2018 INSPECTION PLAN - SITE 1

**PH077-2: EAST SIDE OF HINES CREEK BRIDGE
HWY 682:02, km 12.6~12.7
2018 INSPECTION PLAN - SITE 2**

**WATERCOURSE CULVERT
ON HWY 682, 17 km W OF FAIRVIEW
GENERAL LAYOUT**

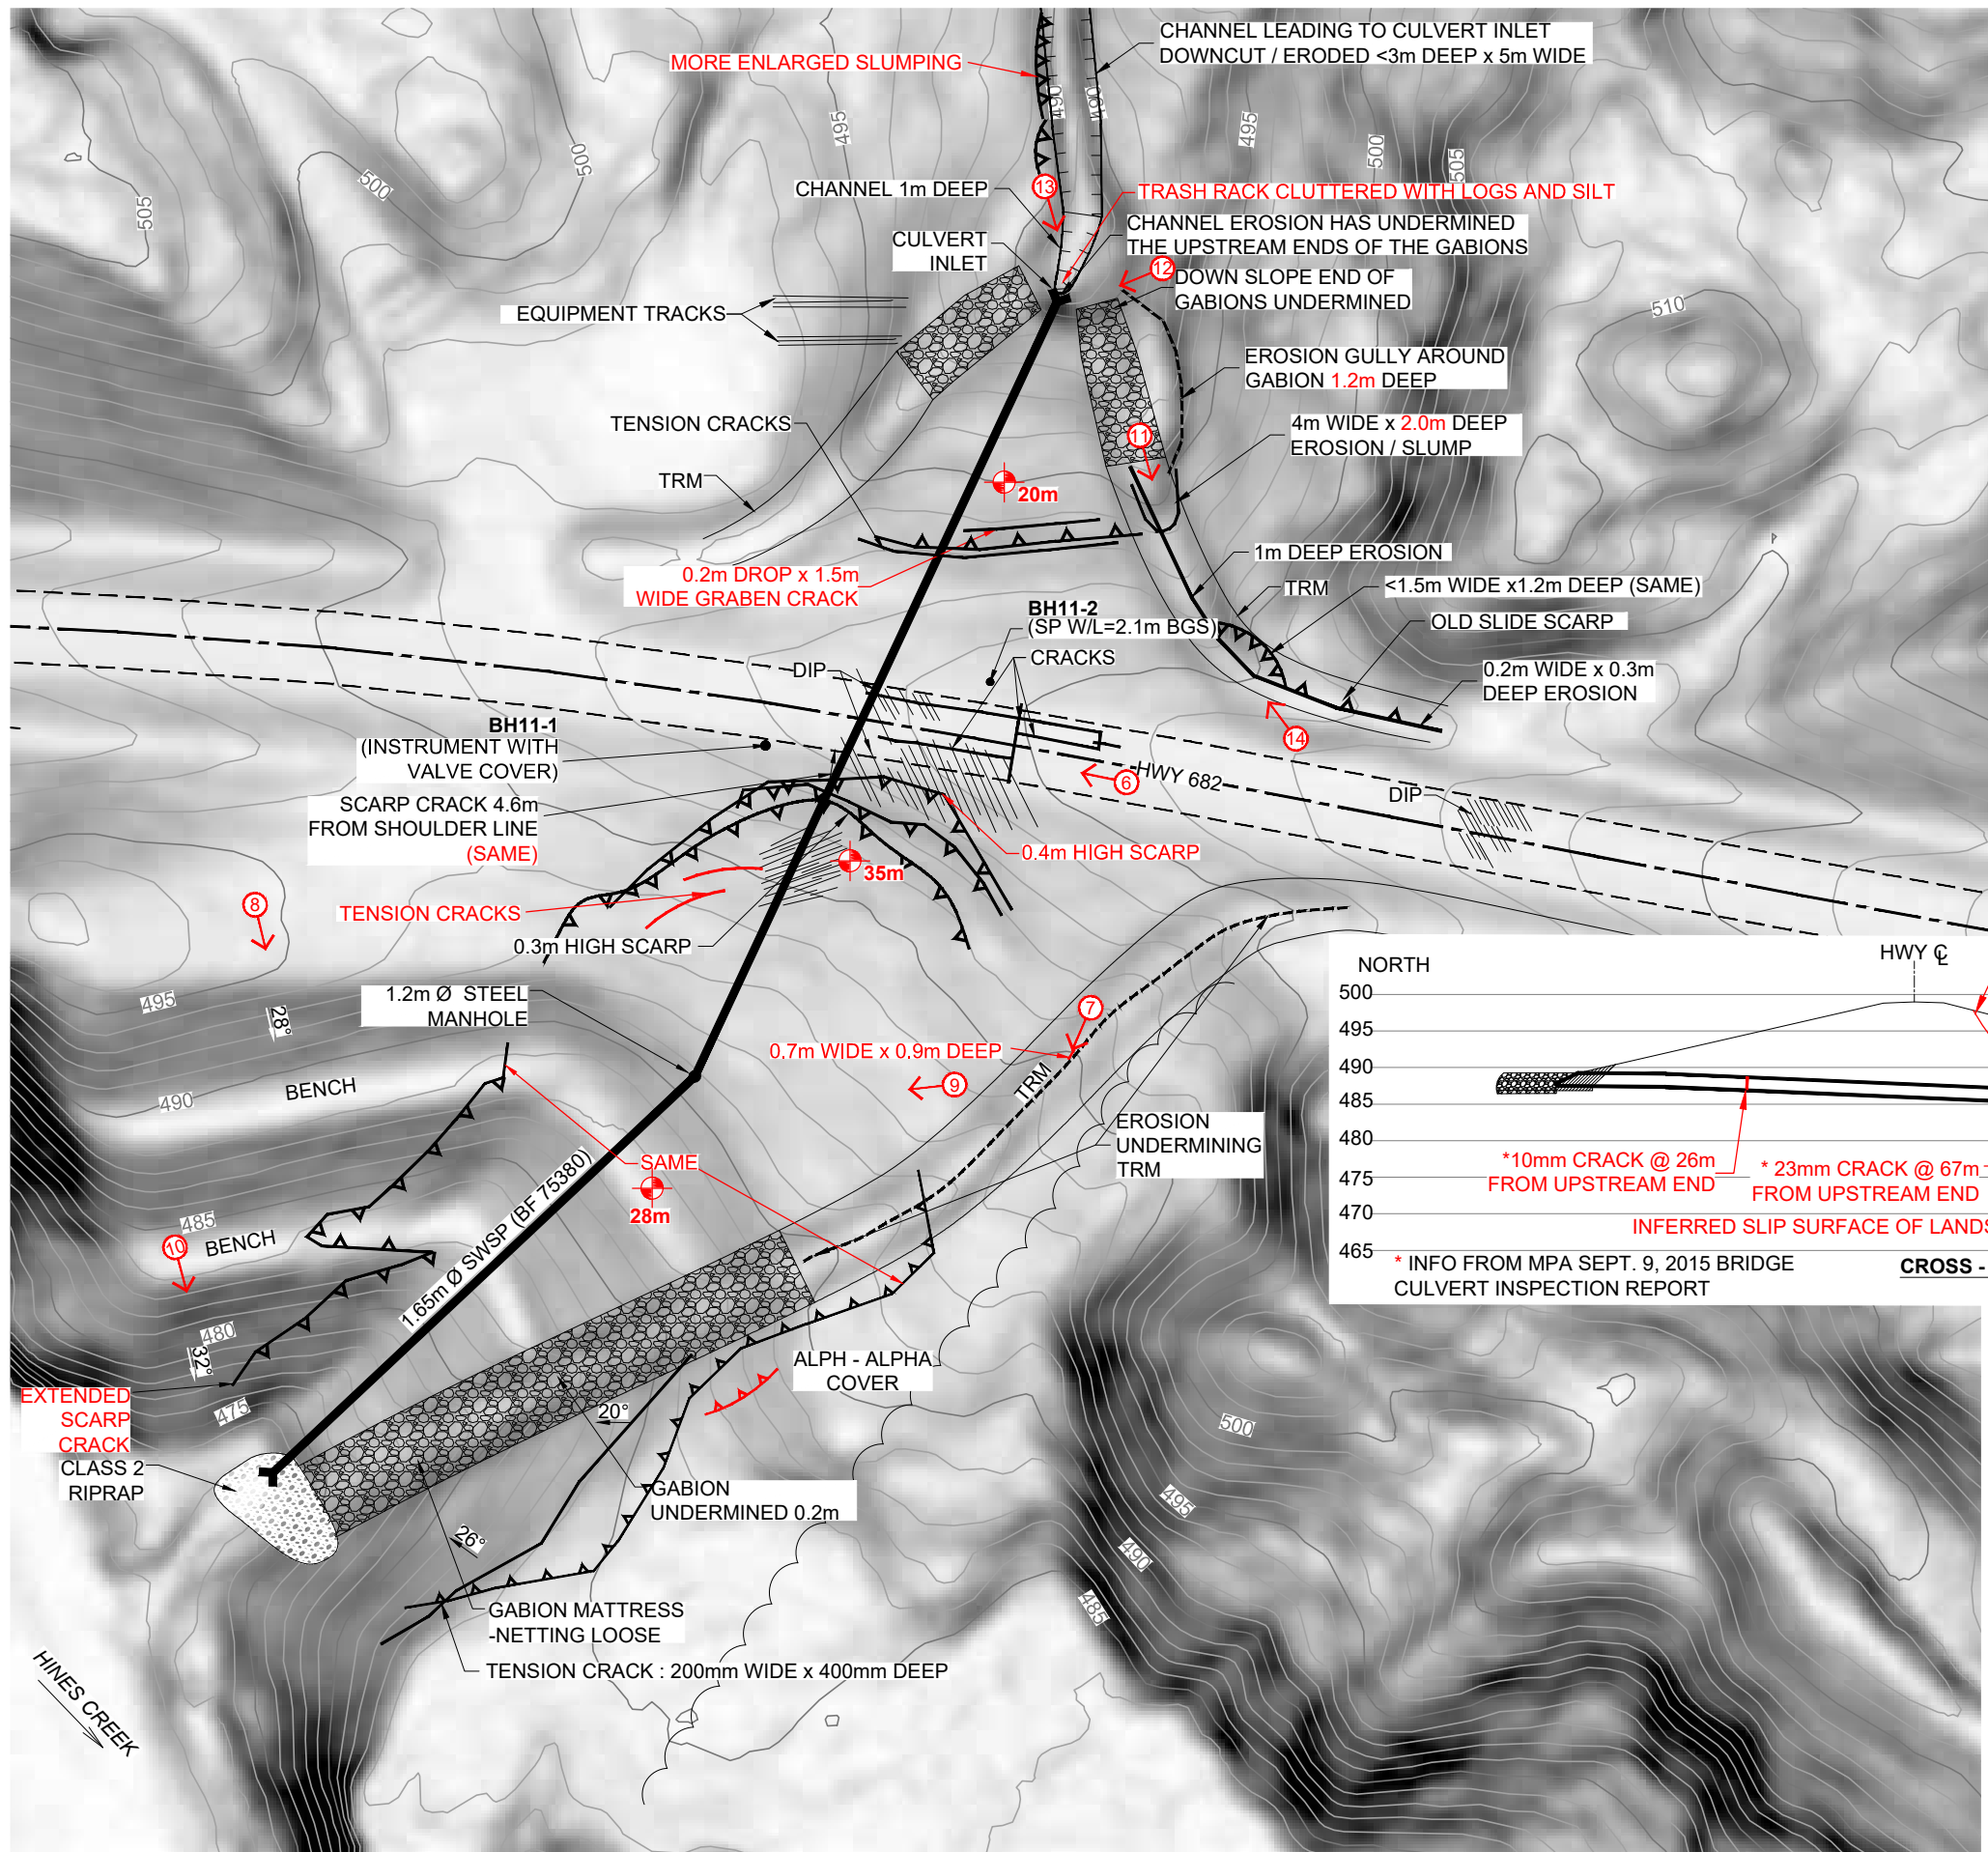
DWG No. 13351-PH077-2-1

- NOTES**
1. GABIONS LACKING INTERMEDIATE BAFFLES AND LIDS NOT ADEQUATELY TIED.
 2. MAY 16, 2018 OBSERVATIONS SHOWN IN RED.

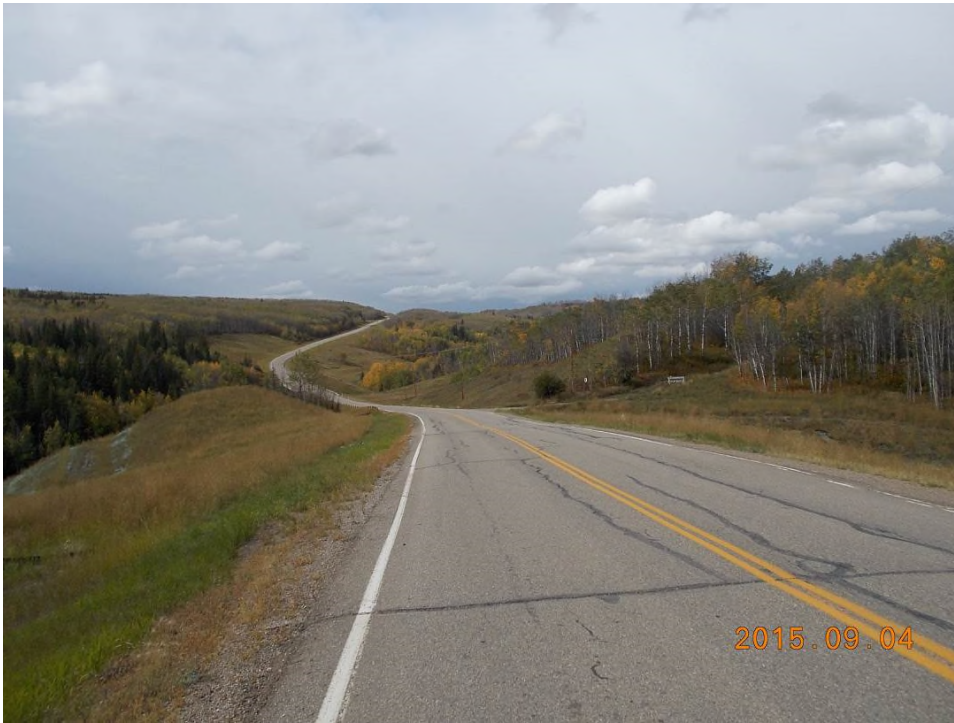
Looking west

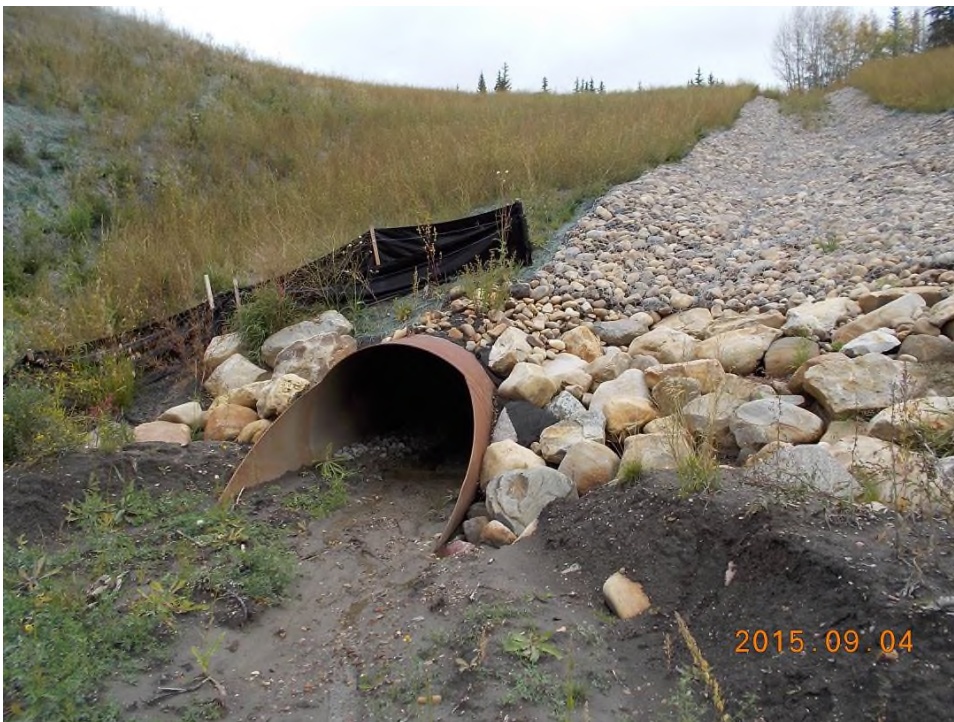
Looking east at downstream end

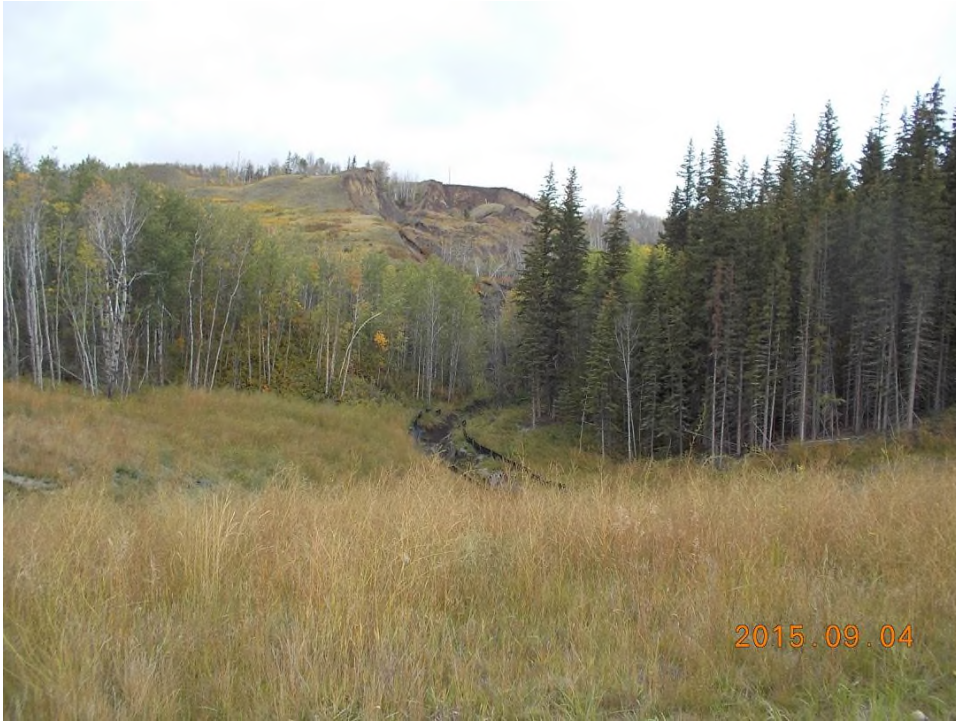
Looking north (upstream end)

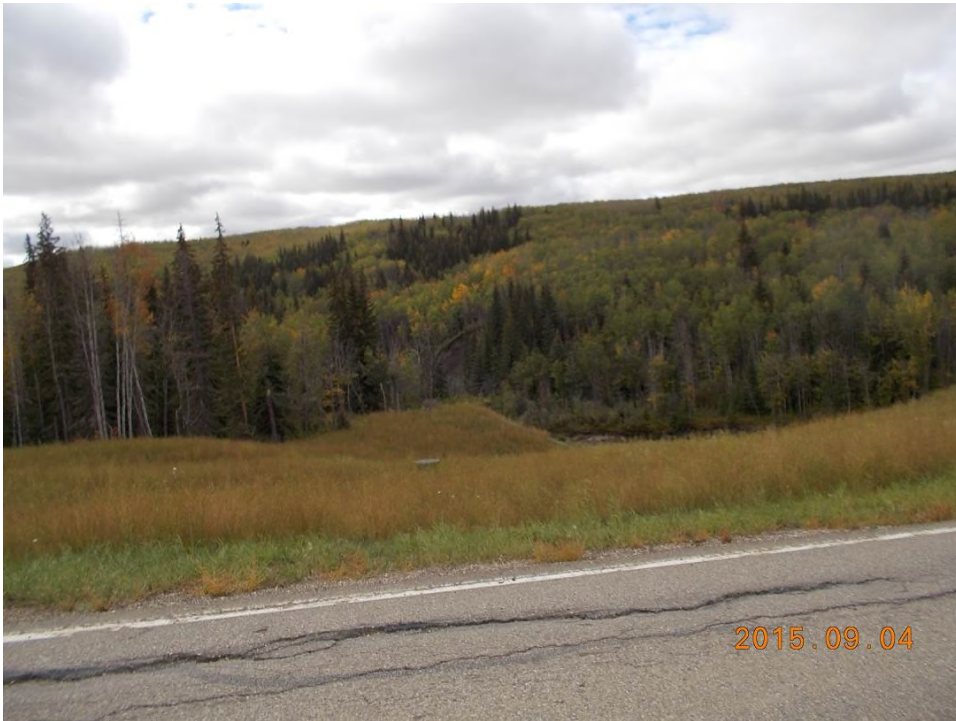
Looking east (downstream end)

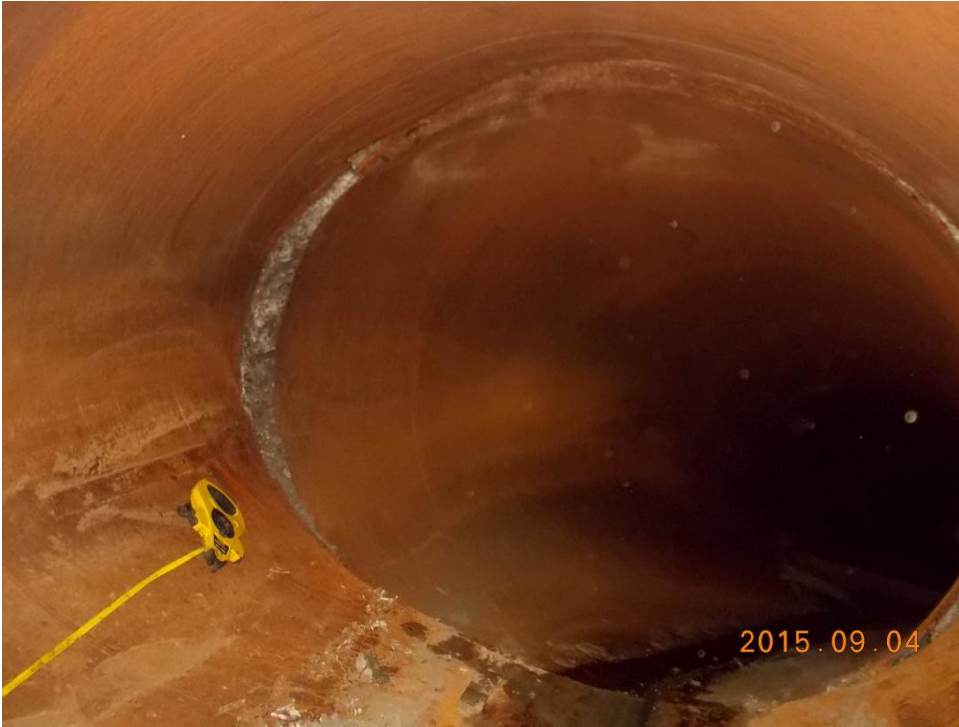
Upstream End				
Culvert Component		Last	Now	Explanation of Condition
Bevel End		9	9	
Heaving (mm)				
Invert Above/Below Stream Bed	BELOW			
Above/Below (mm)	450			
Scour Protection		8	8	Gabion mattresses (0.3m thick) leading to rock riprap.
(Type : RIP RAP)				
(Avg. Rock Size(mm) : 500)				
Scour/Erosion		8	8	
Beavers (Y/N)	Yes			
Upstream End General Rating		8	8	
Bridge Culvert Barrel				
Culvert Component		Last	Now	Explanation of Condition
(Pipe # : 1 , Primary Span, Location Code: MAIN , Span (mm): , Rise (mm): 1800 , Type: SSP)				
Barrel Last Accessible Date	04-Sep-2015			
Special Features				
Special Feature		9	9	Drift catcher
(Type : BARREL ELBOW)				
Special Feature				
(Type :)				
Roof		N	2	4m u/s of access pipe 86m from u/s end
Measured Rise (mm)	1367			
Measured At Ring No.				
Sag (mm)	433			
Percent Sag	24			
Sidewall		6	2	4m u/s of access pipe 86m from u/s end
Measured Span (mm)	2172			
Measured At Ring No.

Deflection (mm)	372			
Percent Deflection	21			
Floor		9	3	Steel plate wiers welded to the floor on the d/s 60m of culvert. 100mm gap in floor ~93m from u/s end
Bulge (mm)	0			
Measured At Ring No.				
Abrasion (Y/N)	No			
Circumferential Seams		X	2	10mm crack between pipe sections - 23m from u/s end - photo
Separation (mm)	100			
Longitudinal Seams		X	X	23mm crack between pipe sections - 67m from u/s end - photo
Total No. of Cracked Rings				100mm cracks between pipe sections - 93m from u/s
Total No. of Rings with Two Cracked Seams				Pipe sections - 93m from u/s end moving in.
Min. Remaining Steel Between Cracks (mm)				
Proper Lap (Y/N)				
Longitudinal Stagger (Y/N)				
Coating		9	9	d/s direction
Corrosion By Soil (Y/N)	No			
Corrosion By Water (Y/N)	No			
Camber POS/ZERO/NEG	ZERO			
Ponding (Y/N)	No

View of typical deflection 3 m d/s from access hole

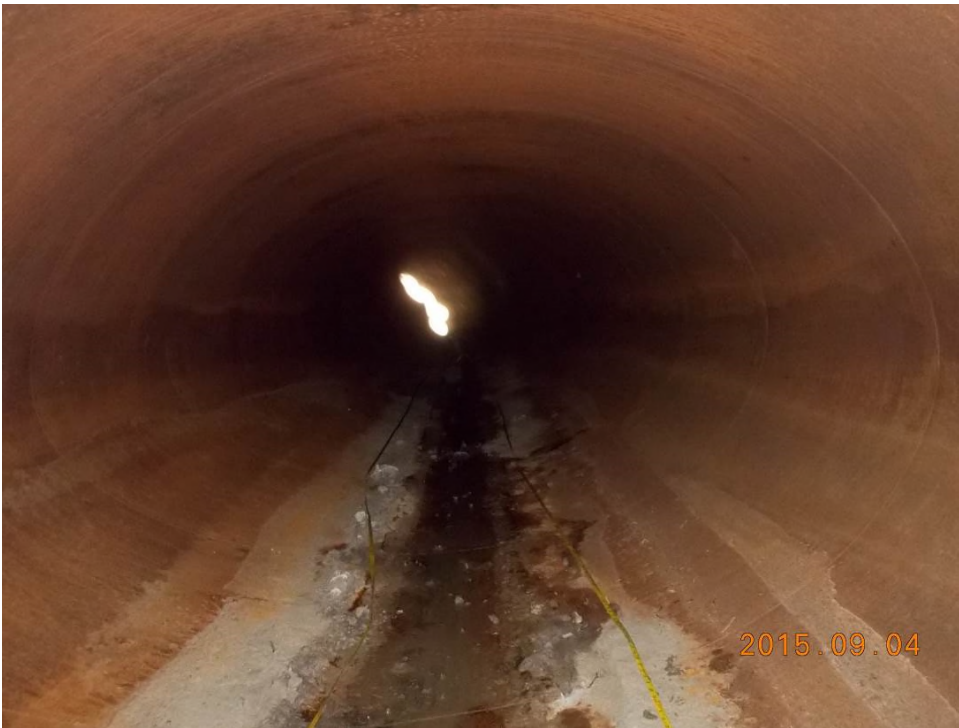
View of typical deflection looking u/s from access hole

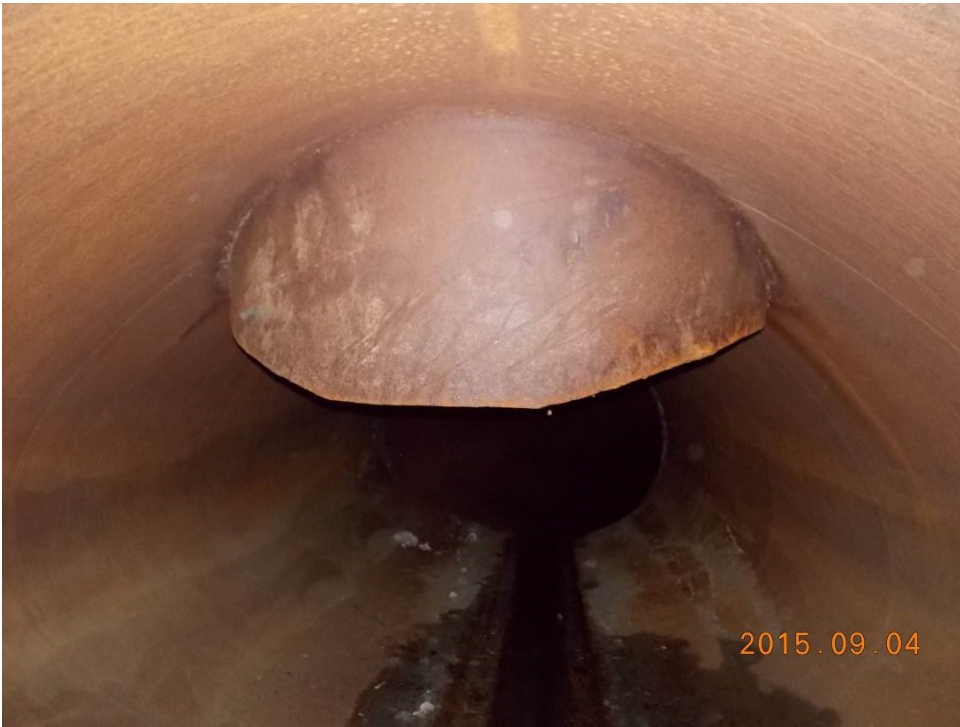
View of typical deflection looking at access hole

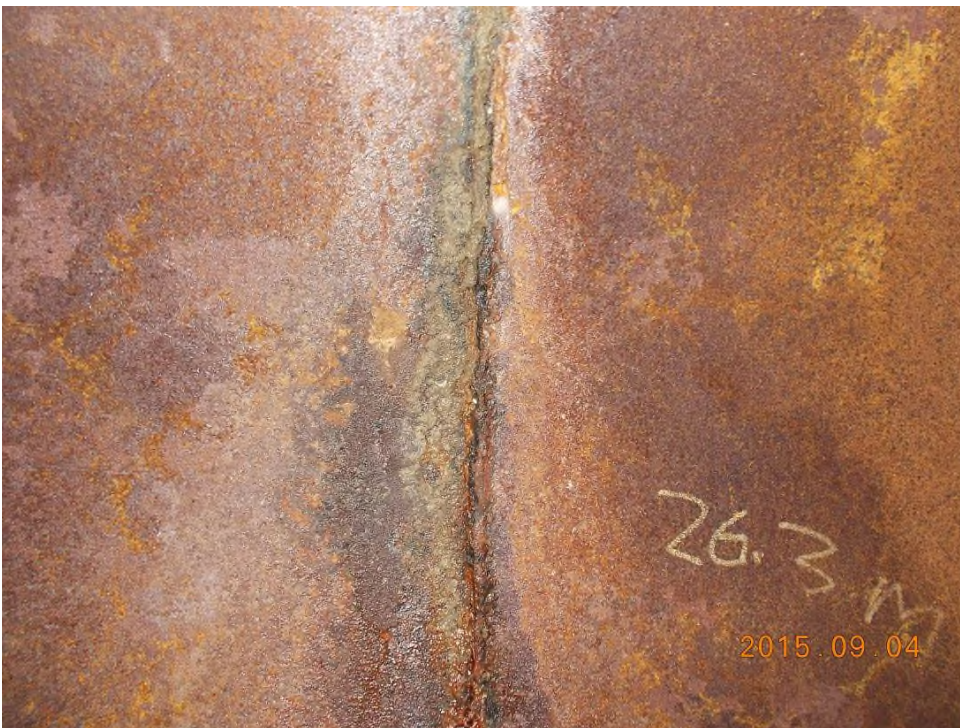
10 mm crack along circumferential seam approx. 26.3 m from u/s end

Maintenance Recommendations							
Inspector Recommendations	Year	Inspector Comments	Department Comments	Target Year	Est. Cost	Cat #	
SHOTCRETE REPAIRS							
PLACE ADDITIONAL RIP RAP							
REMOVE DRIFT ACCUMULATION							
INSTALL CONCRETE/STEEL LINING							
INSTALL STRUTS							
INSTALL CONCRETE COLLAR/CUTOFF							
REPAIR SEAMS	2015	Re-weld cracked circumferential seams - H					
OTHER ACTION	2015	Repair deflection near access hole - H and complete engineer review and level 2 inspection					
OTHER ACTION							
OTHER ACTION							
OTHER ACTION							
OTHER ACTION							
Structural Condition Rating (Last/Now) (%)	100.0/22.2	Sufficiency Rating (Last/Now) (%)	82.5/38.6	Est. Repl. Yr	2064	Maint. Req. (Y/N)	Yes
Special Comments for Next Inspection	Reduce inspection cycle to every 6 months. Notified David Morrison of low rating on Sept 9, 2015		Department Comments				
Maintenance Reviewed By			Date			Estimated Total	0

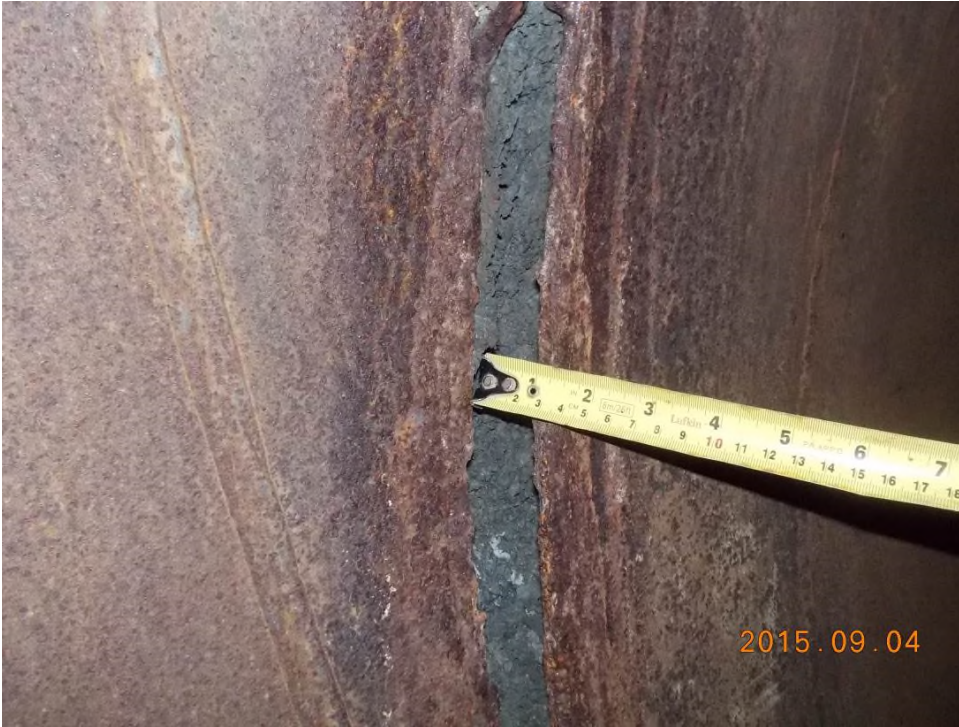
23 mm crack along circumferential seam approx. 67 m from u/s end

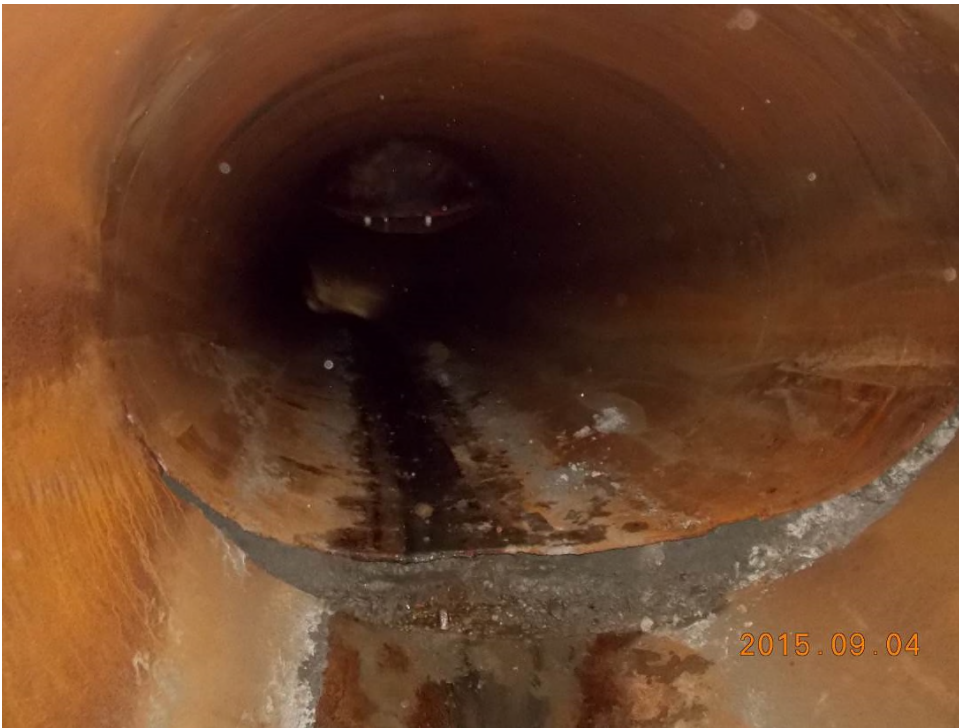
100 mm crack along circumferential seam approx. 93 m from u/s end

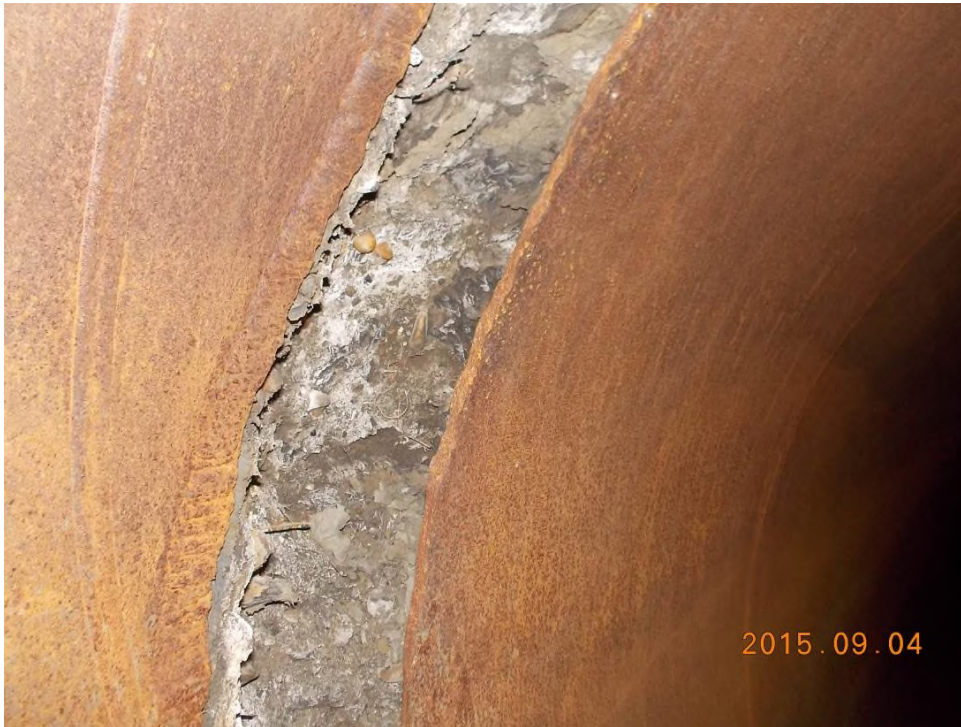
100 mm crack along
circumferential seam approx.
93 m from u/s end
