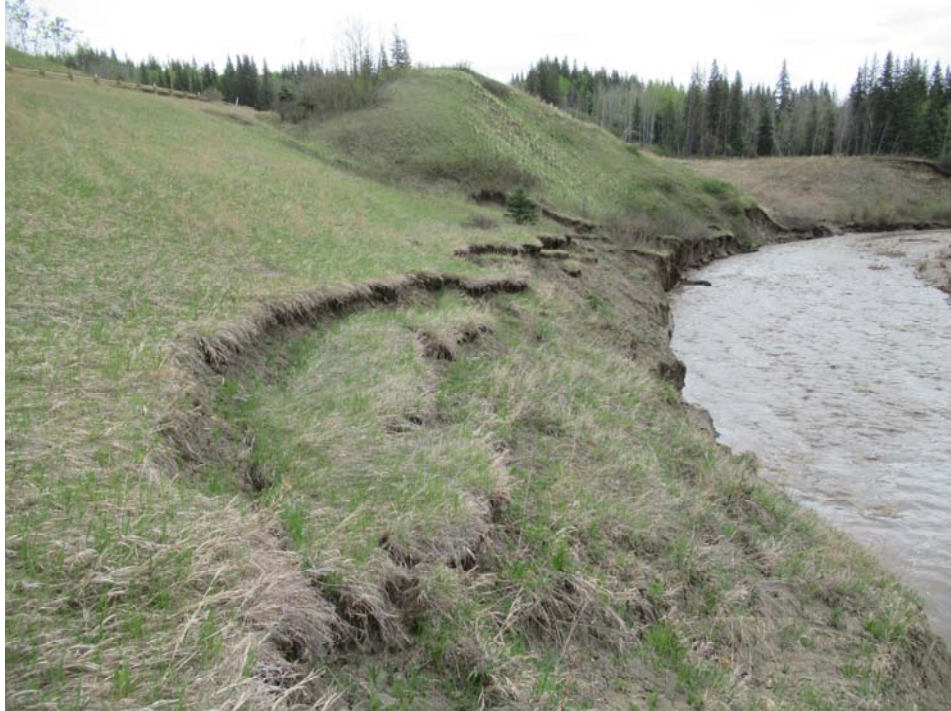
Photo 1 – Looking east at Slide PH77-1 at the active erosion along the north side of the Creek.

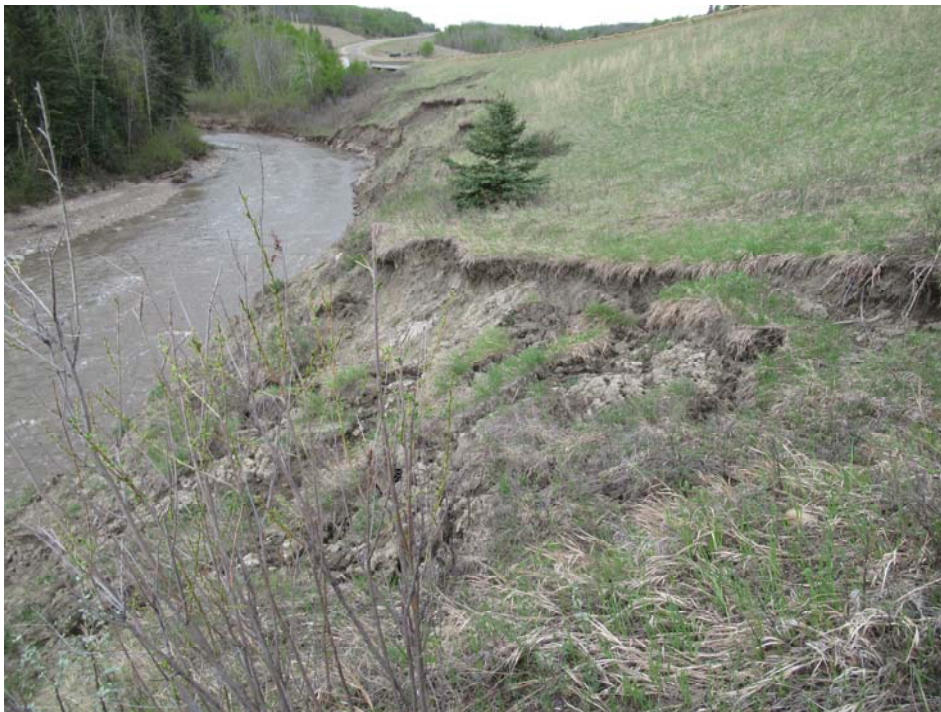
Photo 2 – Looking west at the slumping above the creek at PH77-1 in the south highway embankment.

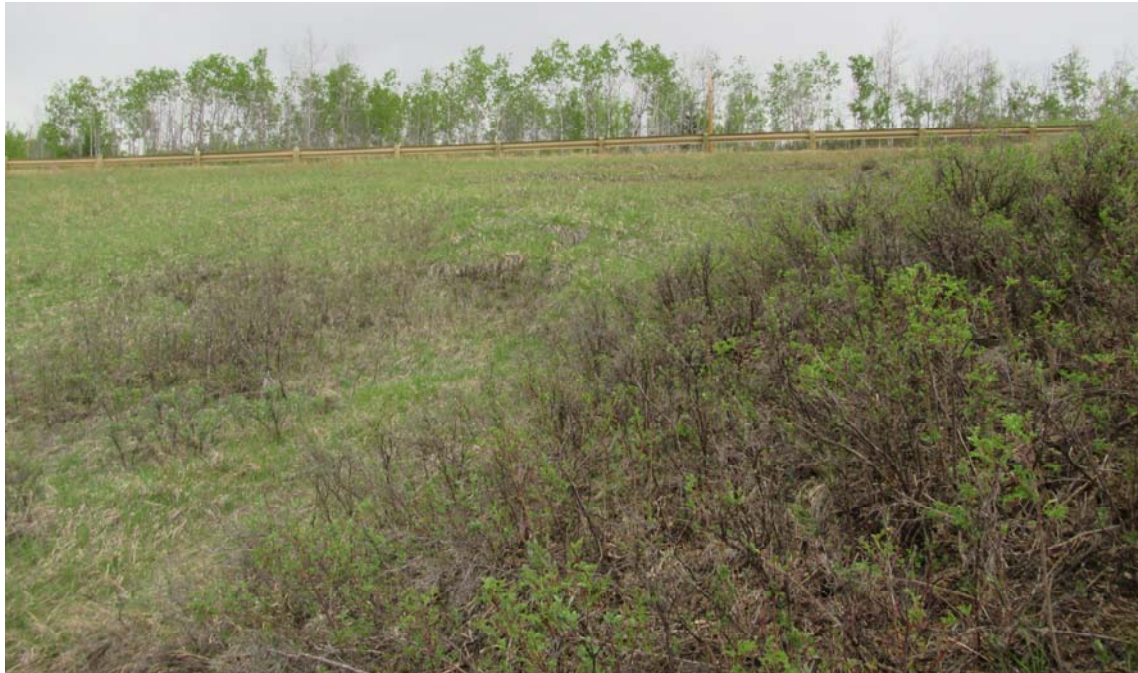
Photo 3 – Looking northwest at the slide lobe adjacent to the highway at PH77-1.

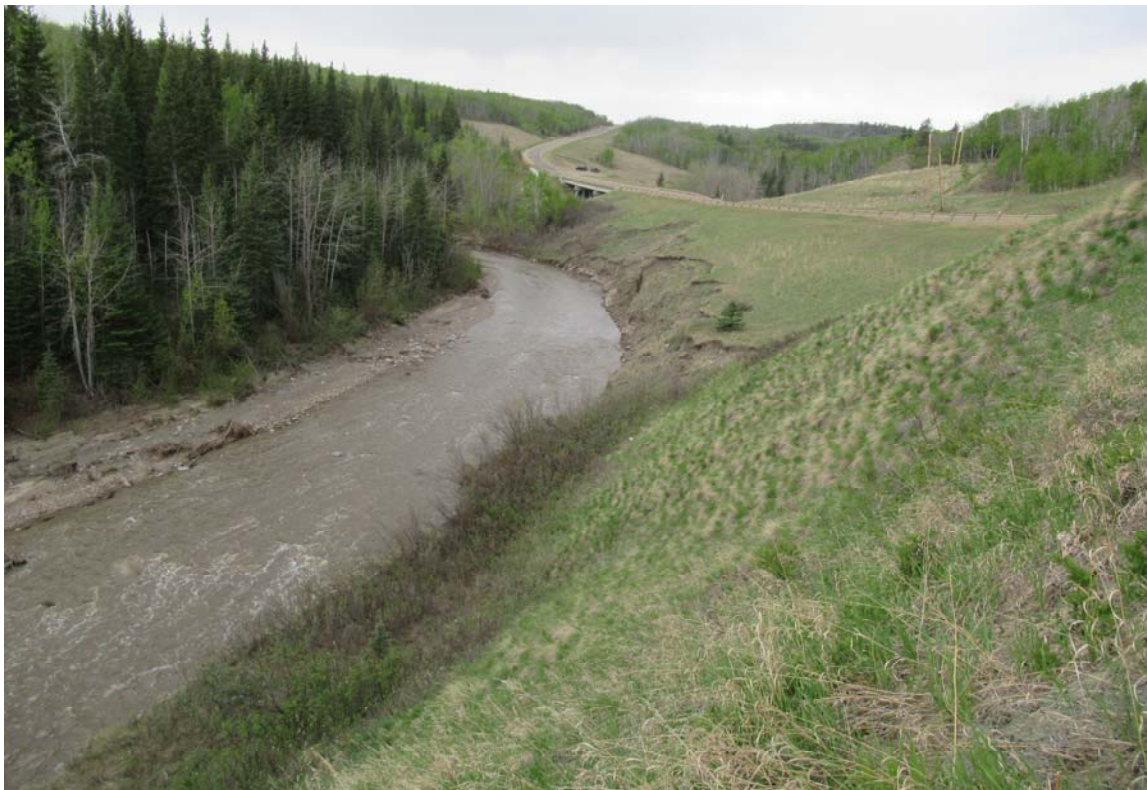
Photo 4 - Looking west along the Creek at the erosion at PH77-1.

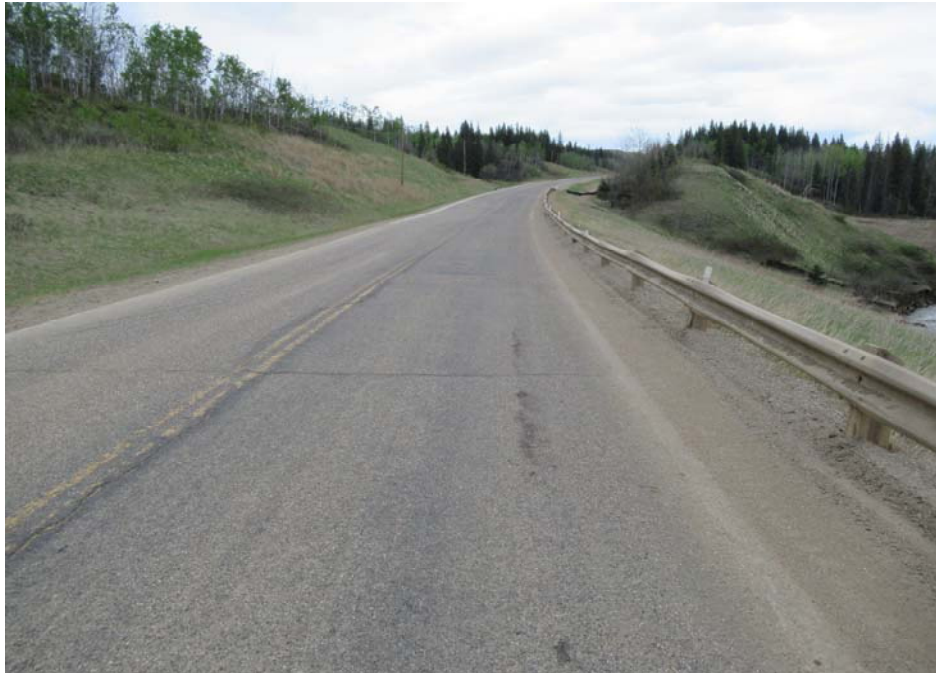
Photo 5 – Looking east along the highway at the crack/dip in the highway above the Slide at PH77-1.

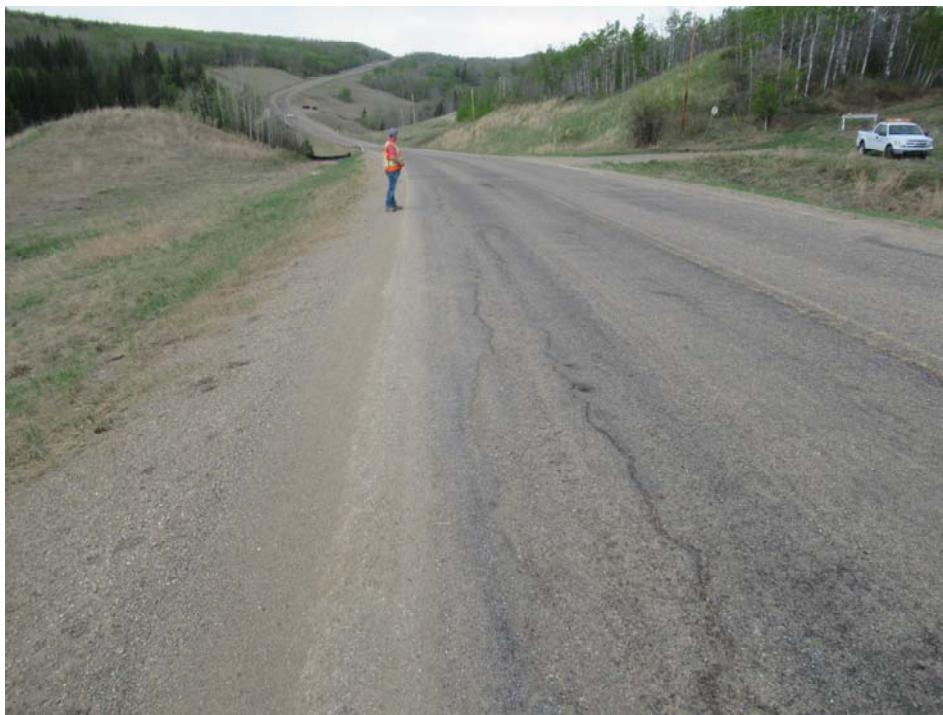
Photo 6 - Looking west along the highway and south embankment of PH77-2. Note the settlement in both the highway and the embankment.

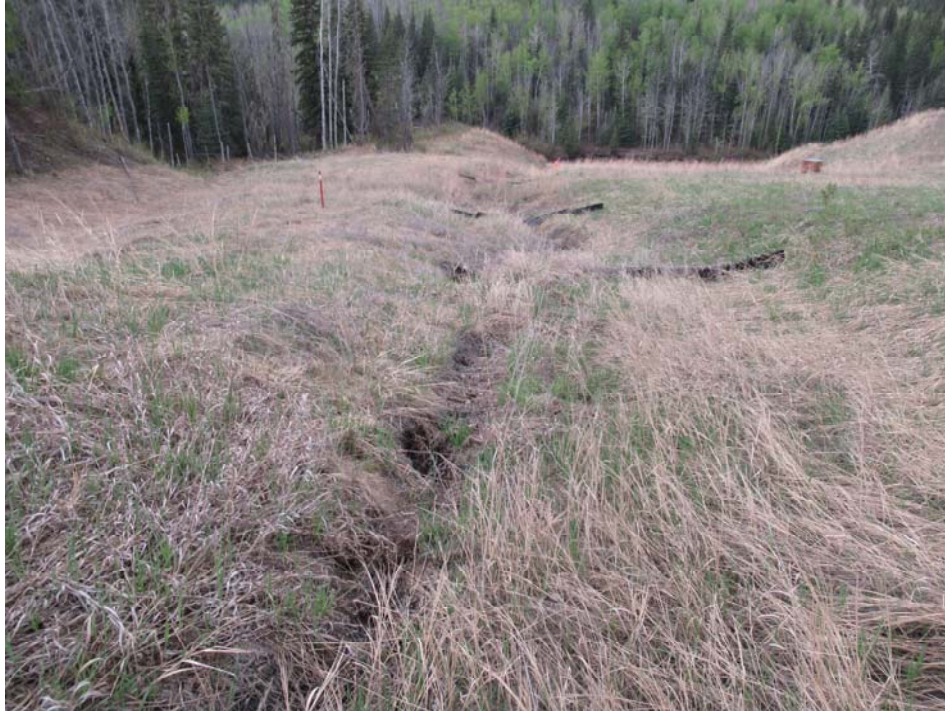
Photo 7 – Looking south along the ditch channel of PH77-2. Note the erosion, and the benched hillside to the west.

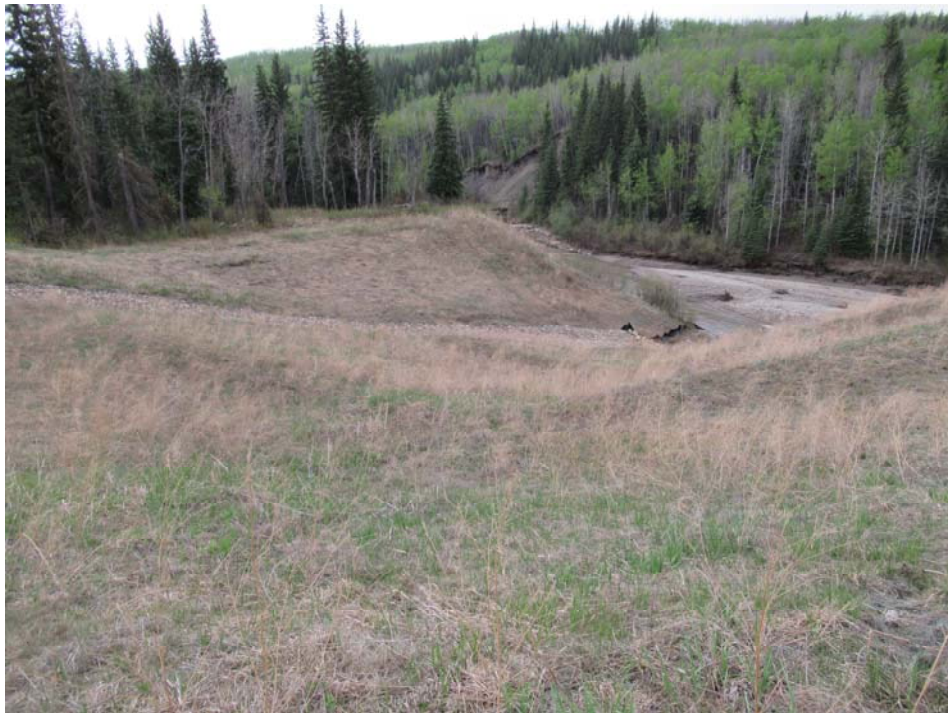
Photo 8 - Looking southeast at the culvert outlet area of PH77-2, Hines Creek.

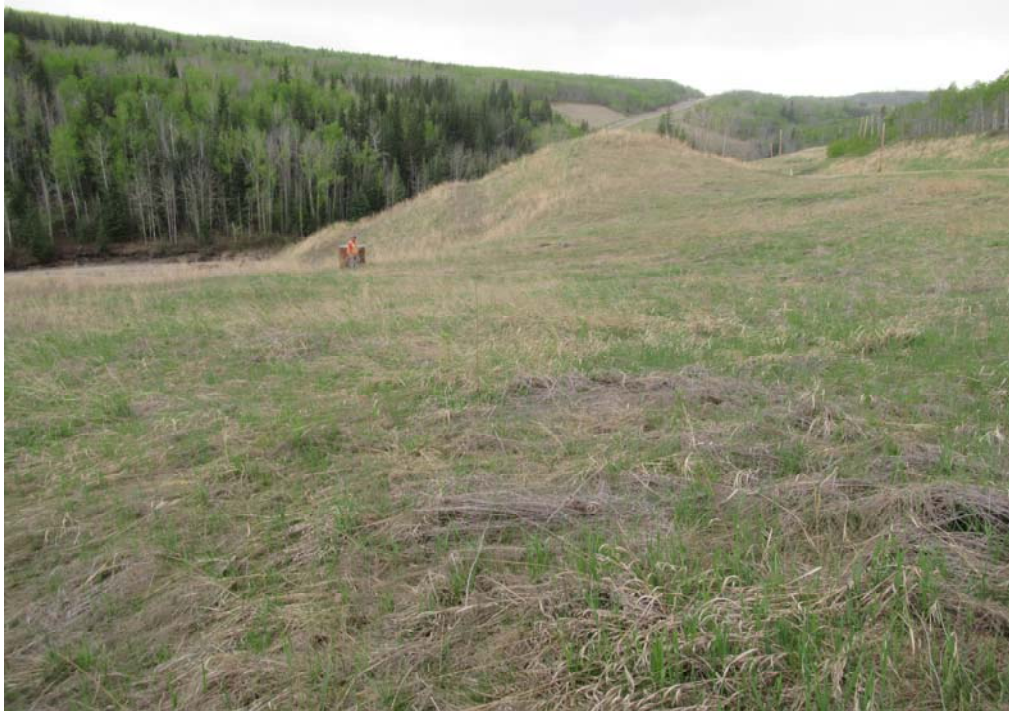
Photo 9 – Looking southwest across the south embankment of PH77-2.

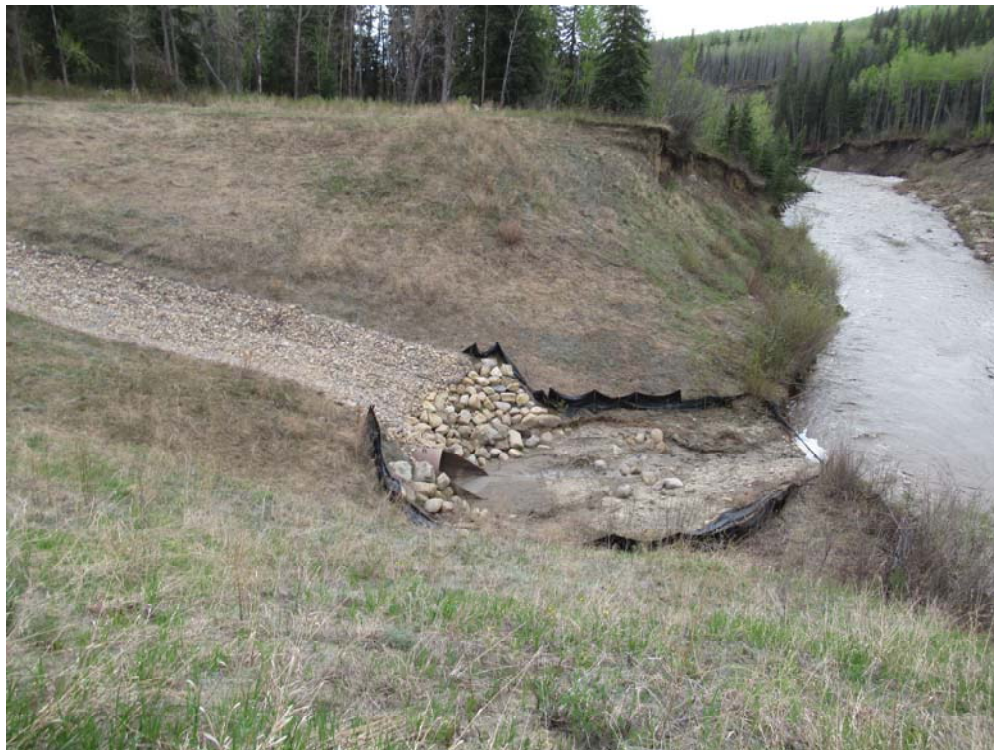
Photo 10 - Looking southeast at the culvert outlet area of PH77-2.

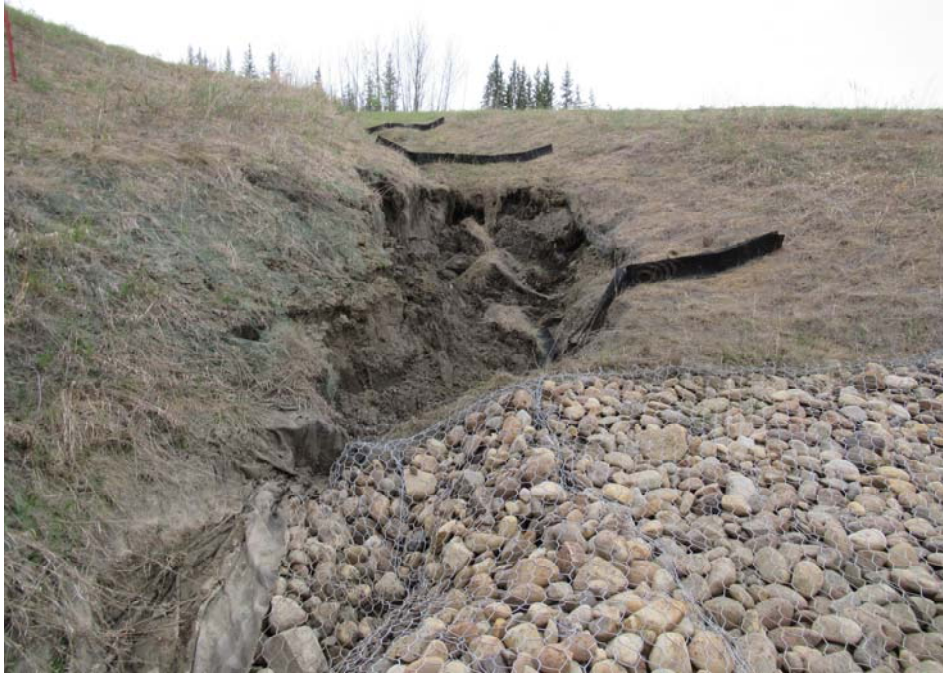
Photo 11 – Looking southeast at the erosion along the northeast ditch crotch leading to the culvert inlet area of the north embankment of PH77-2.

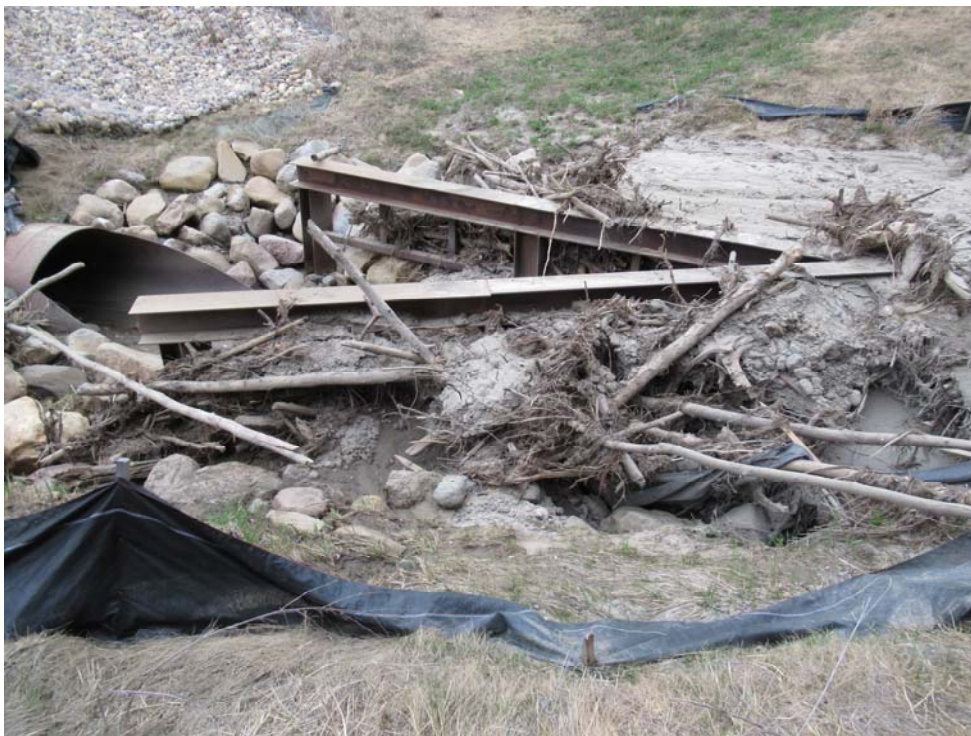
Photo 12 - Looking west at the culvert inlet area north of the highway at PH77-2. Note the debris accumulation around the trash rack from the extreme 2018 spring flow.

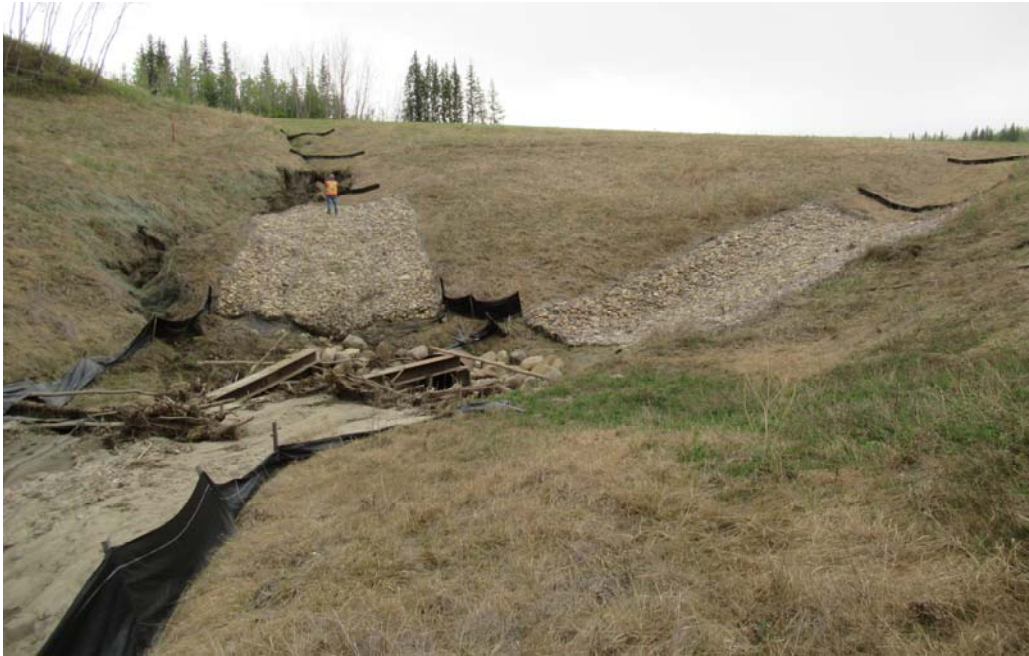
Photo 13 – Looking south at the culvert inlet area of the north embankment of PH77-2. Note the undermining of the end of the gabions and associated ditch channel slumping.

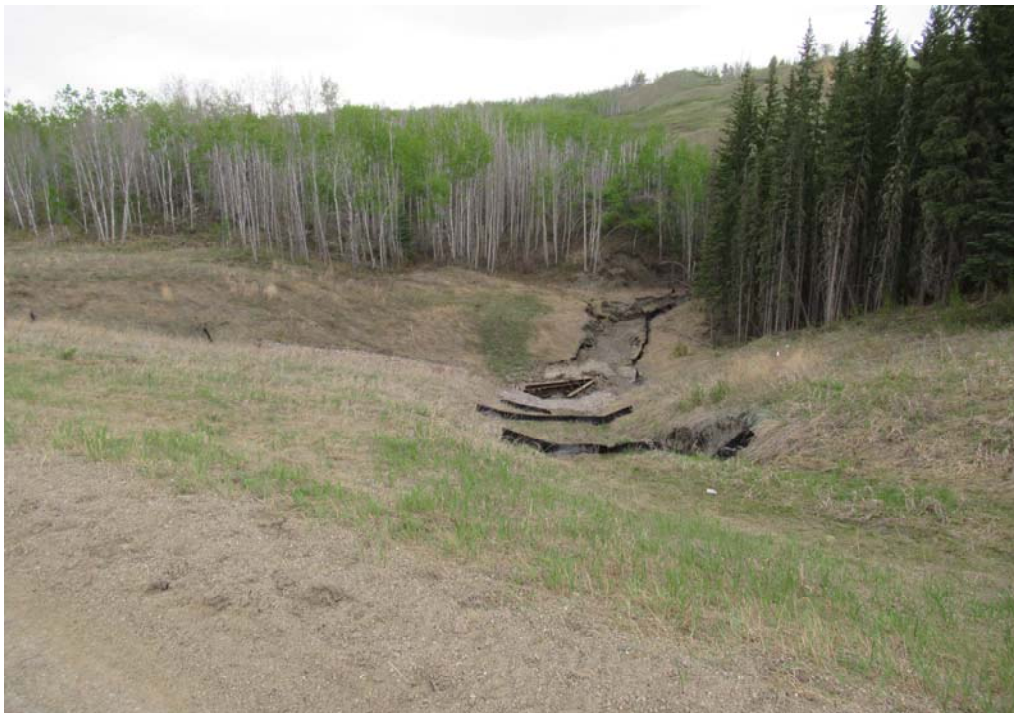
Photo 14 - Looking north along the eroded northeast TRM ditch crotch channel above the culvert inlet area north of the highway at PH77-2. Note the severe channel erosion leading into the culvert inlet in the background.
