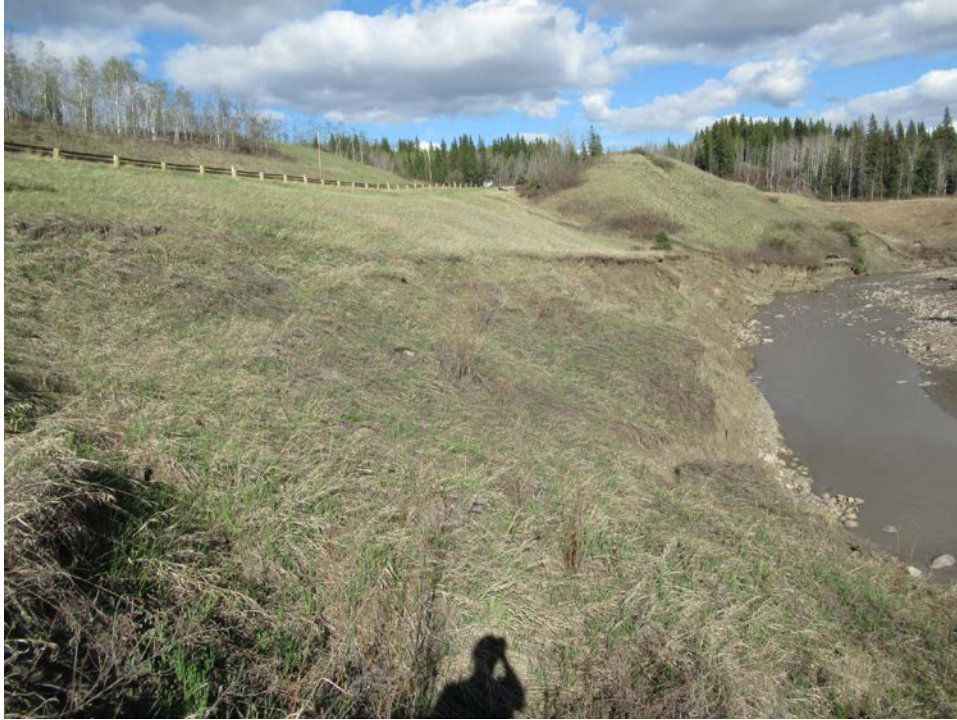
Photo 1 – Looking east at Slide PH77-1 at the active erosion along the north side of the Creek.

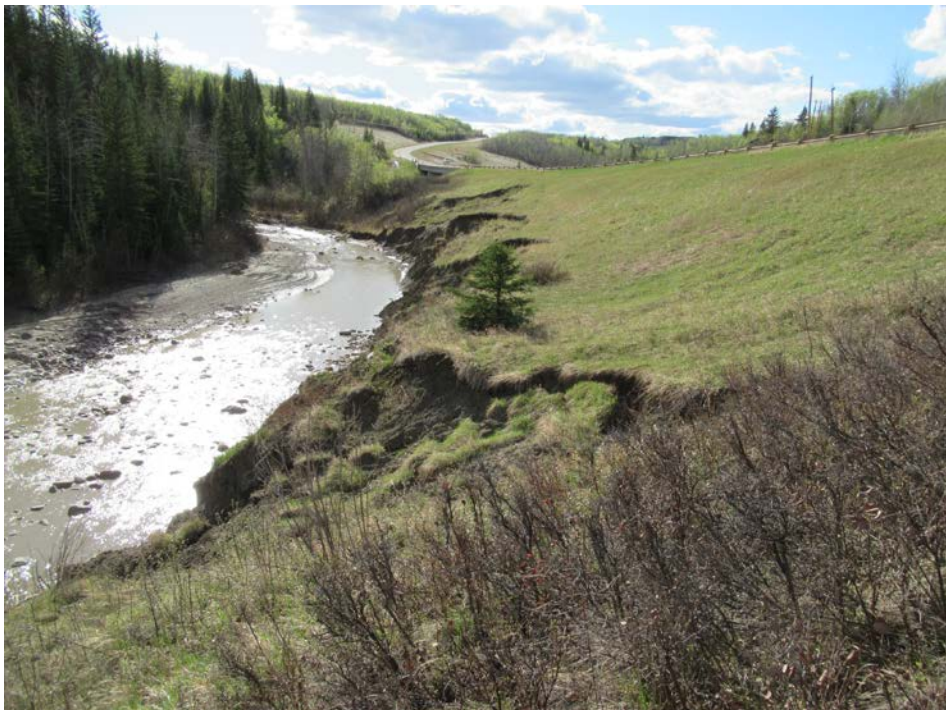
Photo 2 – Looking west at the slumping above the creek at PH77-1 in the south highway embankment.

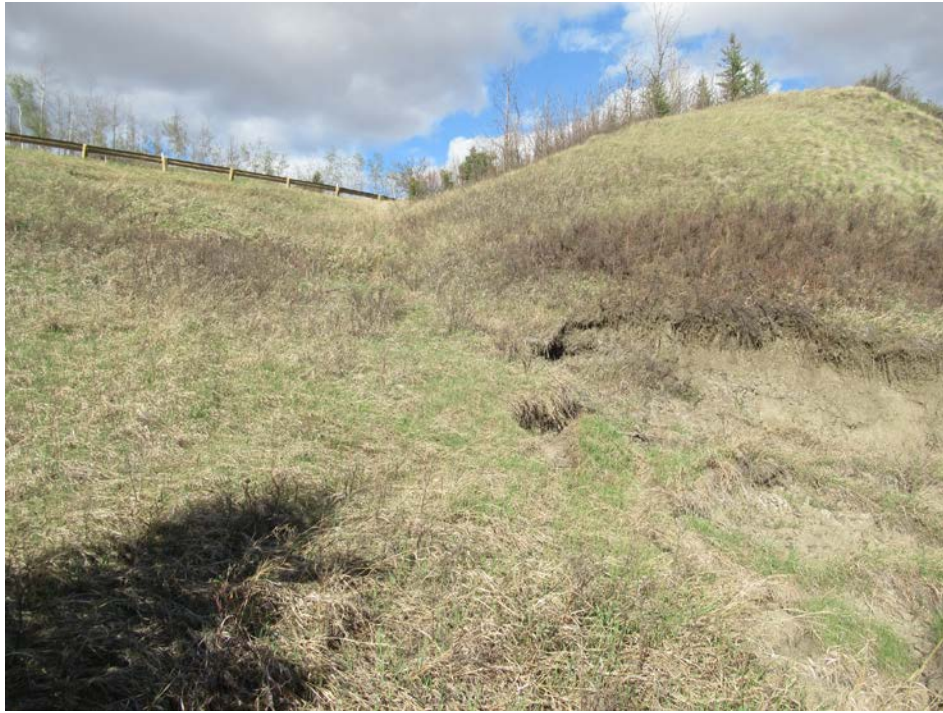
Photo 3 – Looking northwest at the slide lobe adjacent to the highway at PH77-1.

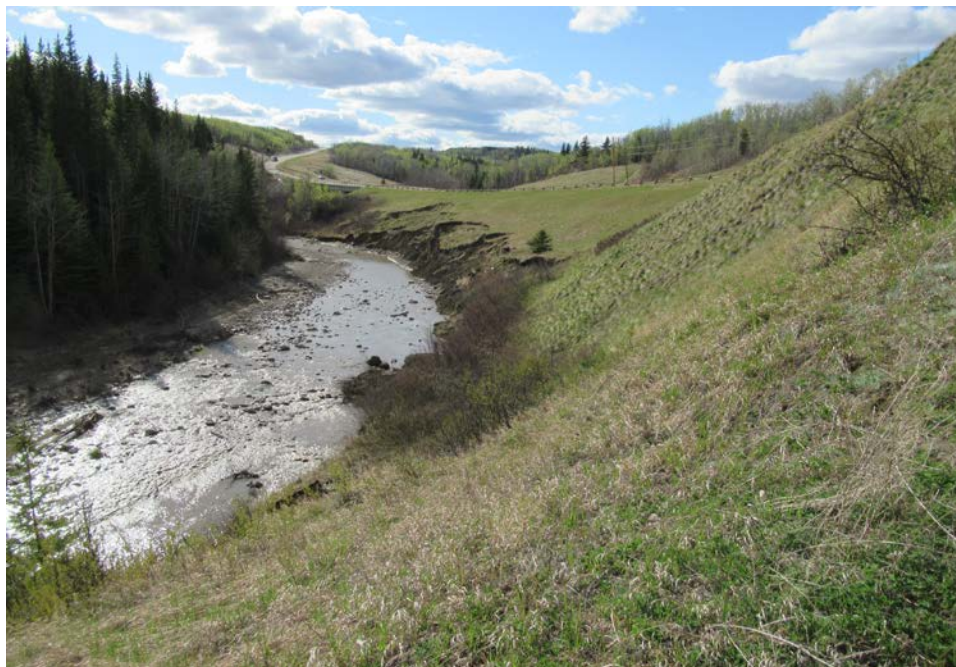
Photo 4 - Looking west along the Creek at the erosion at PH77-1.

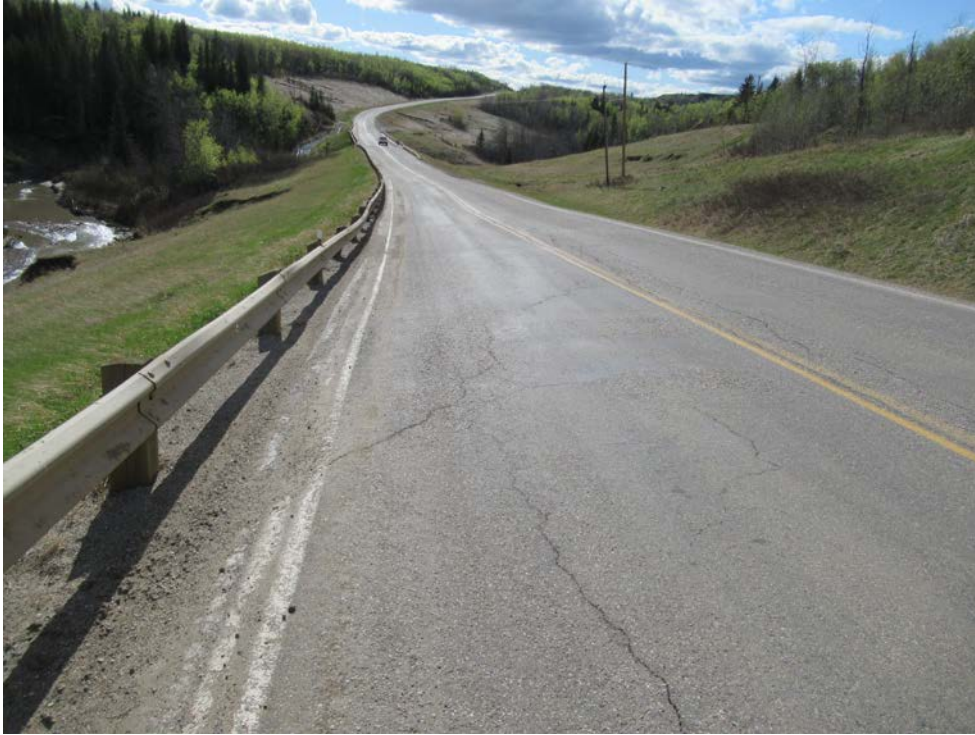
Photo 5 – Looking east along the highway at the crack/dip in the highway above the Slide at PH77-1.

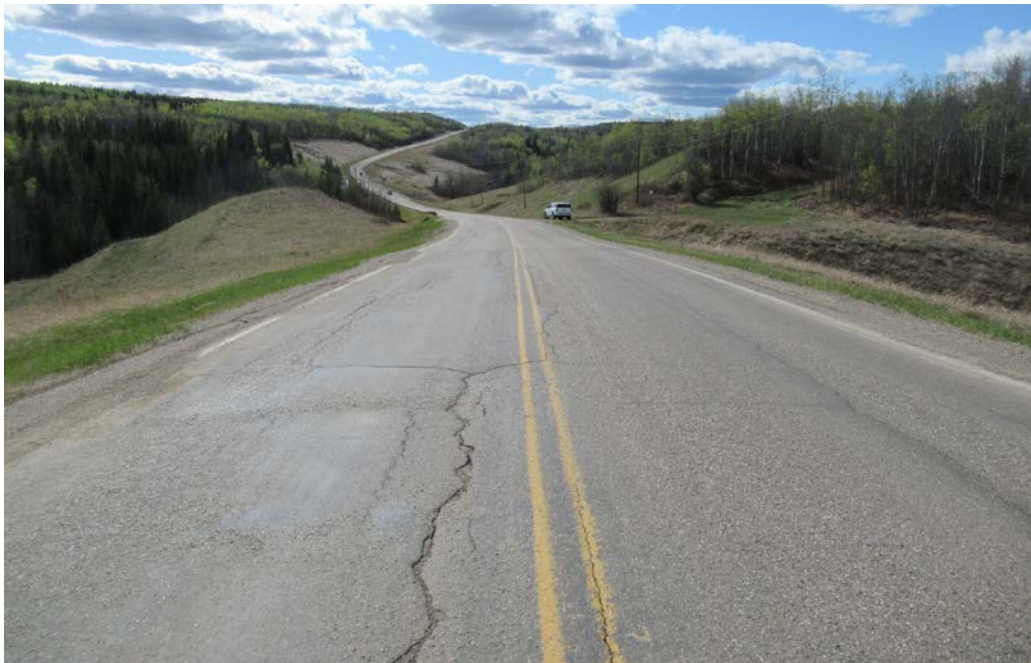
Photo 6 - Looking west along the highway across PH77-2. Note the settlement and cracking in the highway.

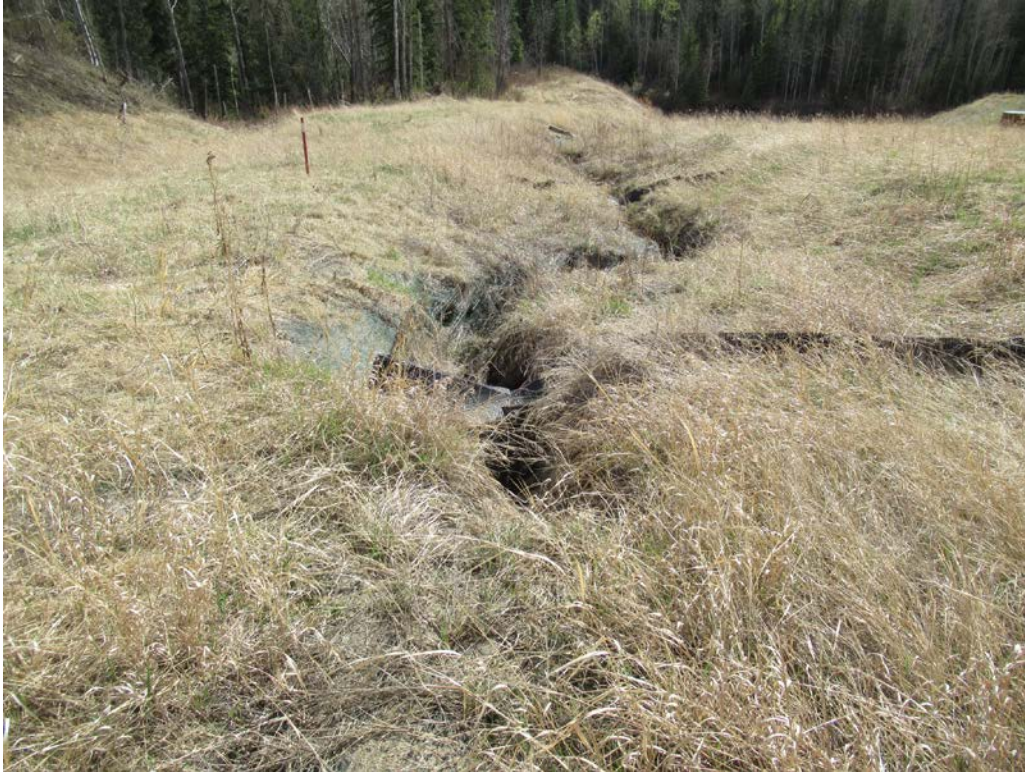
Photo 7 – Looking south along the eroded TRM ditch channel of PH77-2.

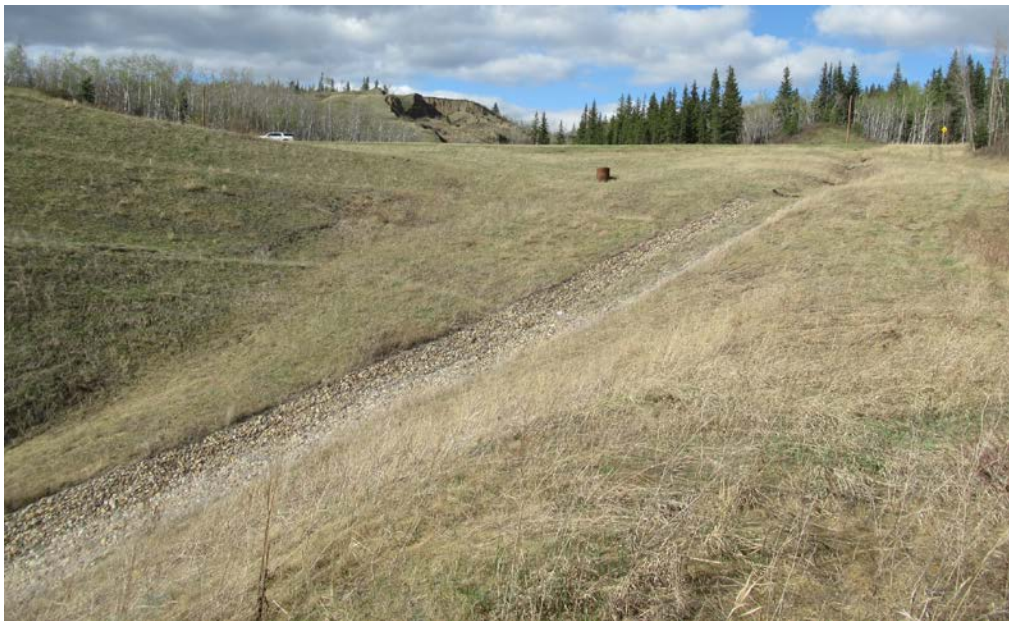
Photo 8 - Looking northeast at the south embankment and southeast ditch drainage channel of PH77-2, Hines Creek.

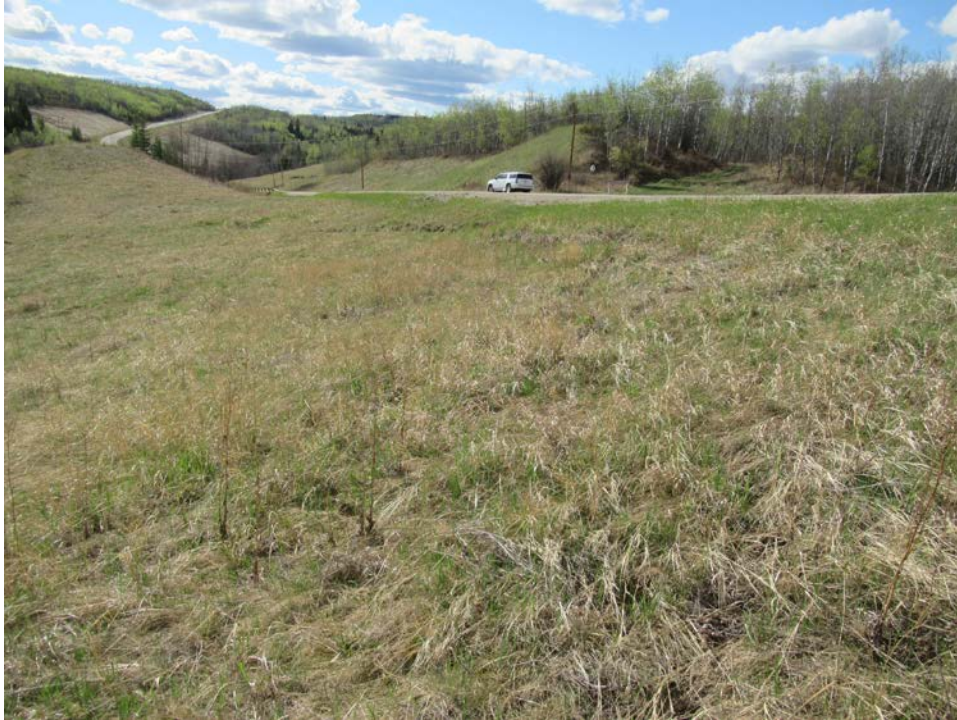
Photo 9 – Looking west across the south embankment of PH77-2, at the slide scarp in proximity to the highway.

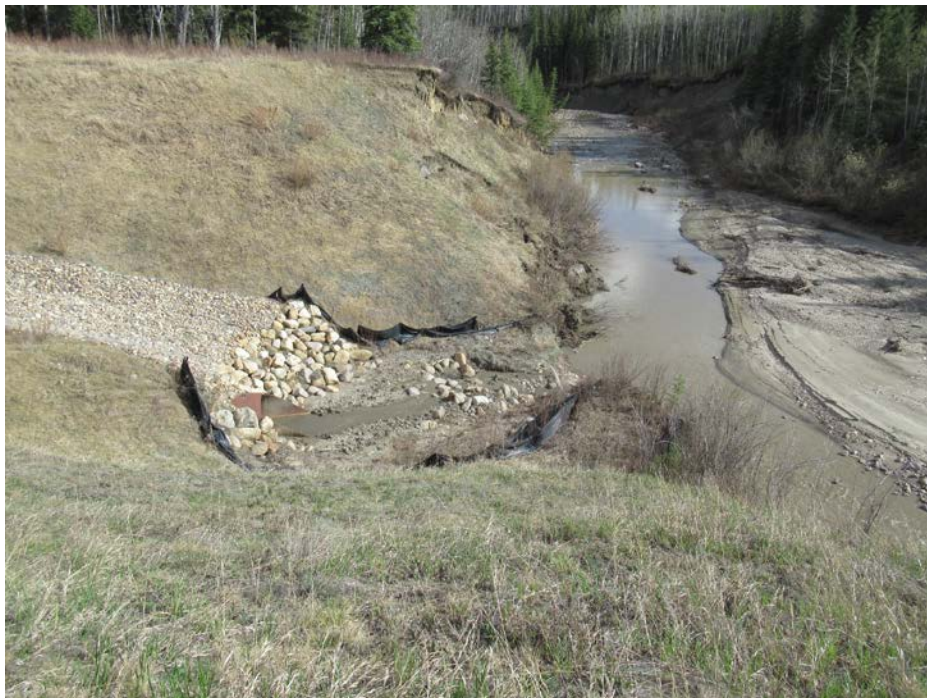
Photo 10 - Looking southeast at the culvert outlet area of PH77-2.

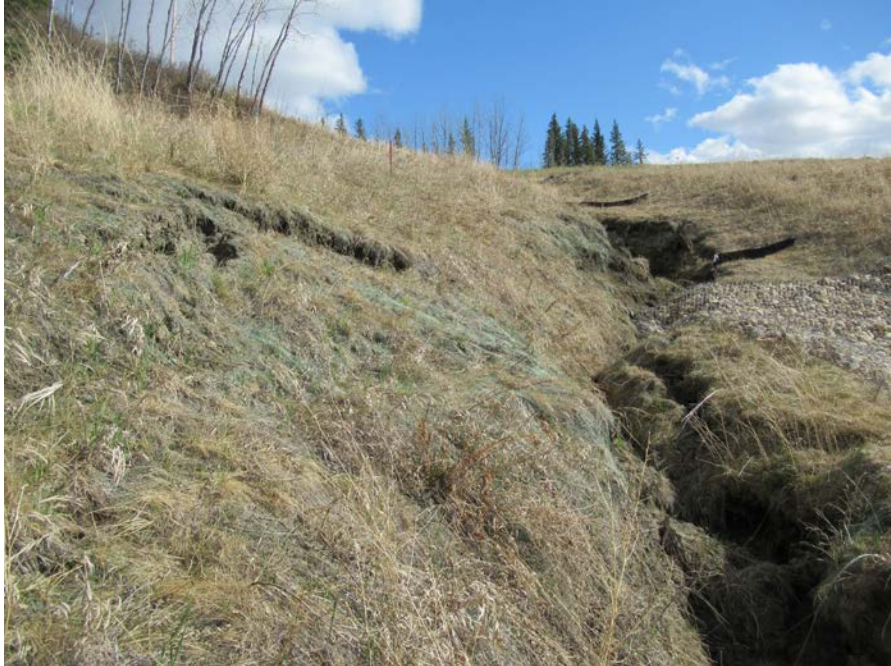
Photo 11 – Looking southeast at the erosion along the northeast ditch crotch leading to the culvert inlet area of the north embankment of PH77-2.

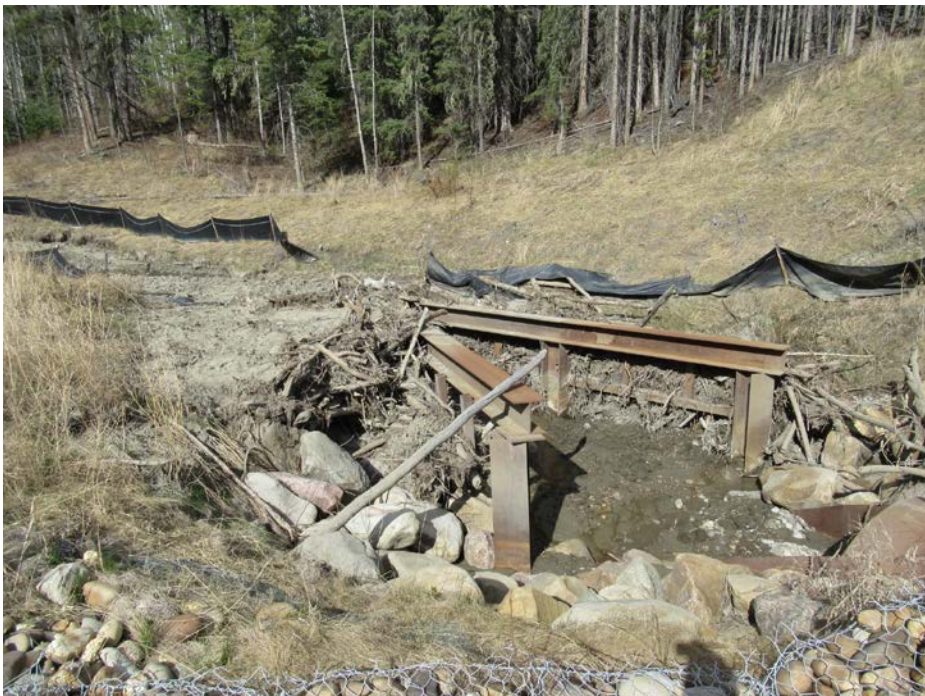
Photo 12 - Looking northeast at the culvert inlet area north of the highway at PH77-2. Note the debris accumulation around the trash rack that is nearly blocking flow.

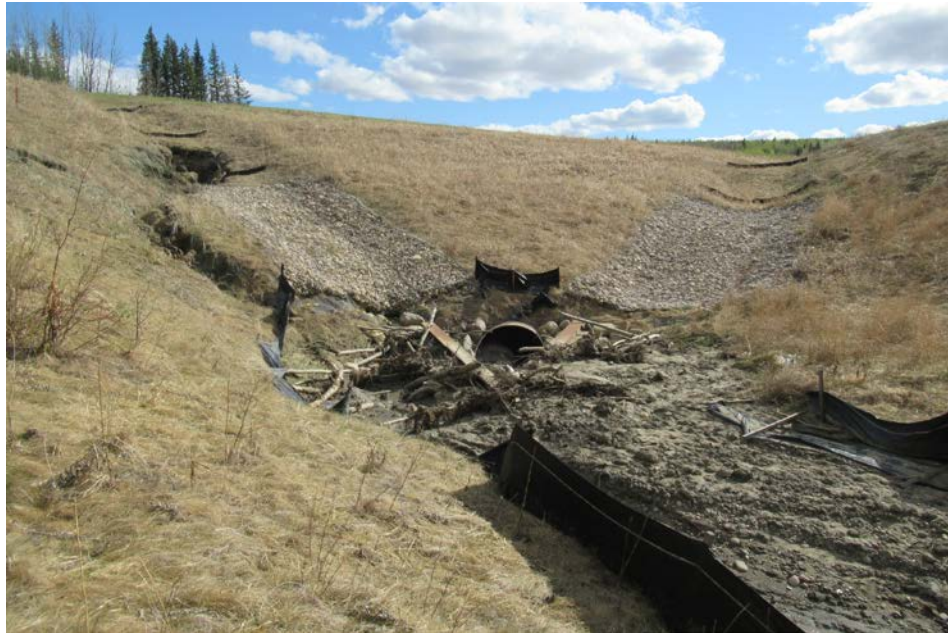
Photo 13 – Looking south at the culvert inlet area of the north embankment of PH77-2. Note the undermining of the end of the gabions and associated ditch channel slumping.

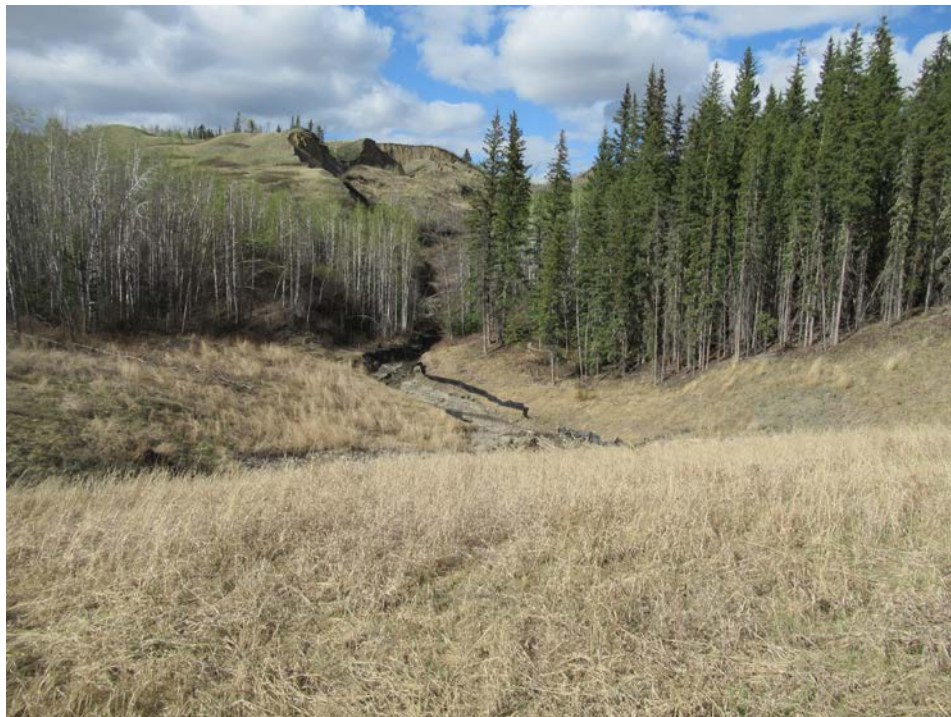
Photo 14 - Looking north at the severe channel erosion leading into the culvert inlet, and the eroded ditch crotch channels above the culvert inlet area north of the highway at PH77-2.
