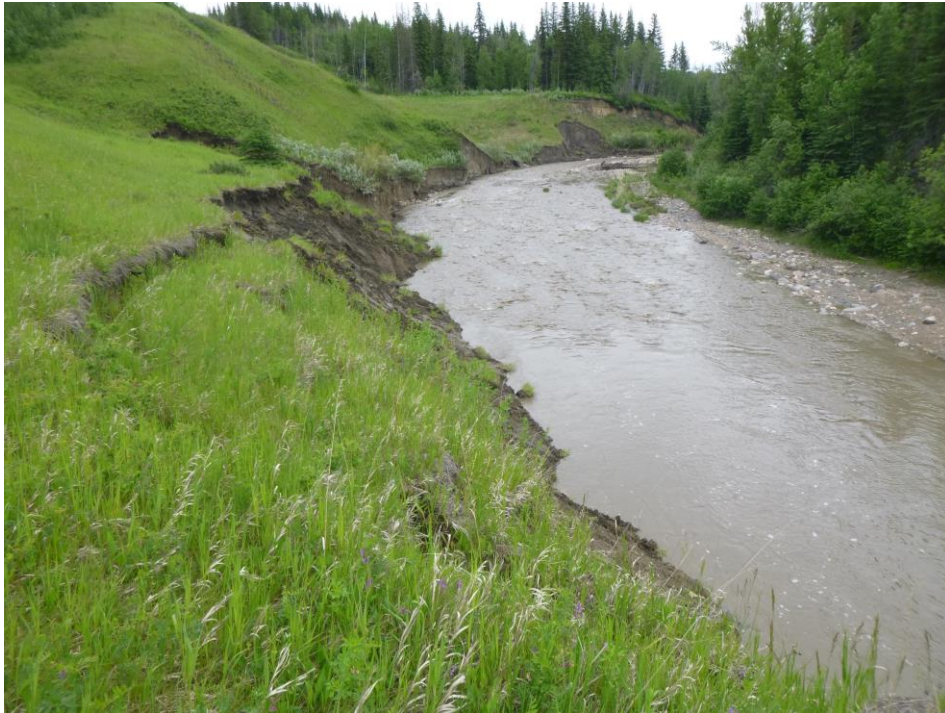
Photo 1 – Looking east at Slide PH77-1 at the active erosion along the north side of the Creek.

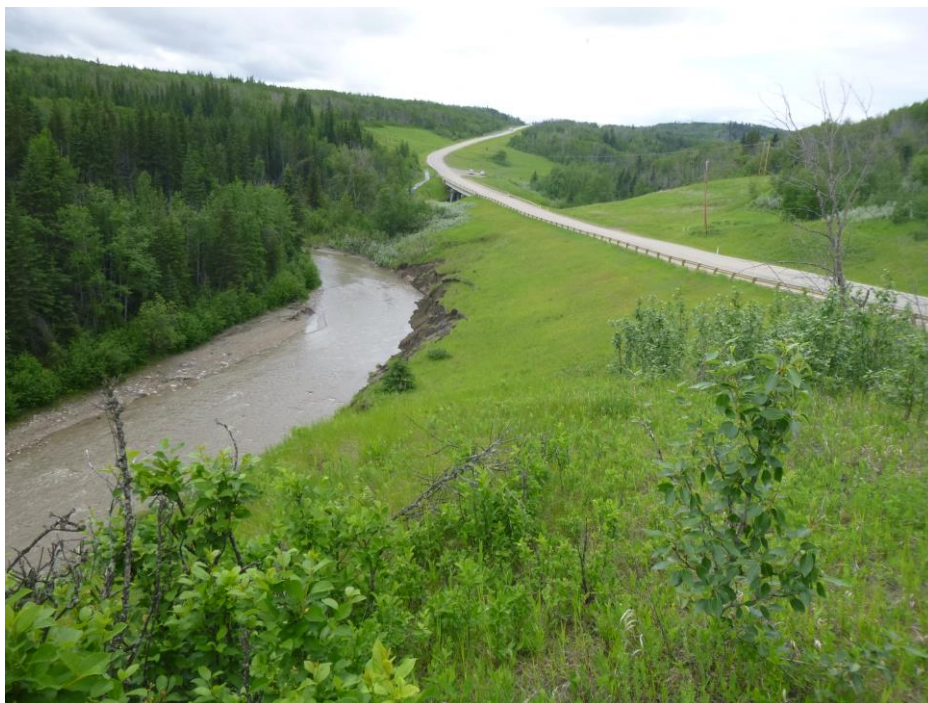
Photo 2 – Looking west at the fresh toe slumping above the creek at PH77-1 in the south highway embankment.

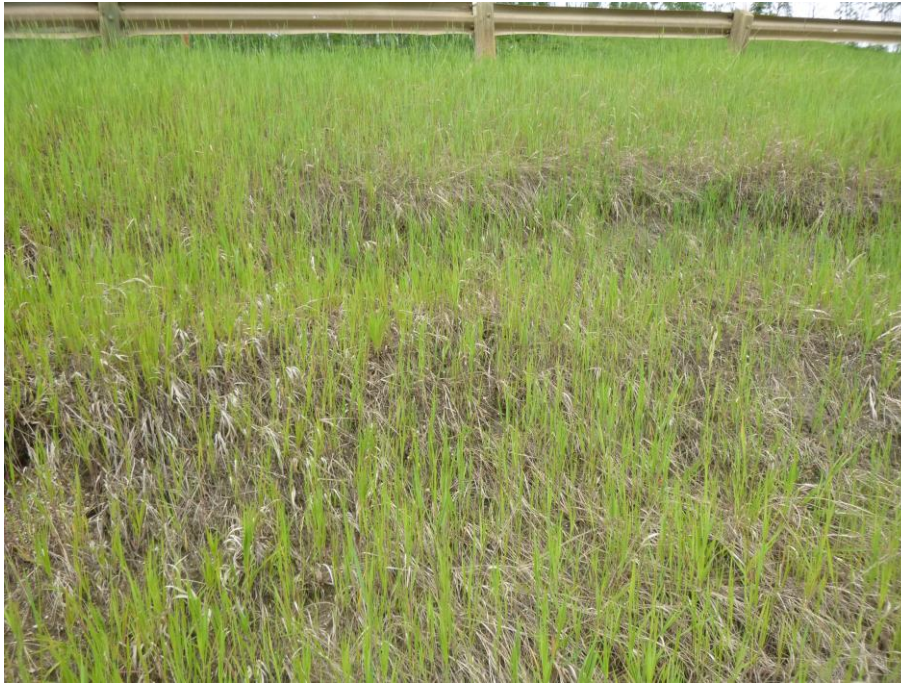
Photo 3 – Looking north upslope at the slide scarp adjacent to the highway at PH77-1.

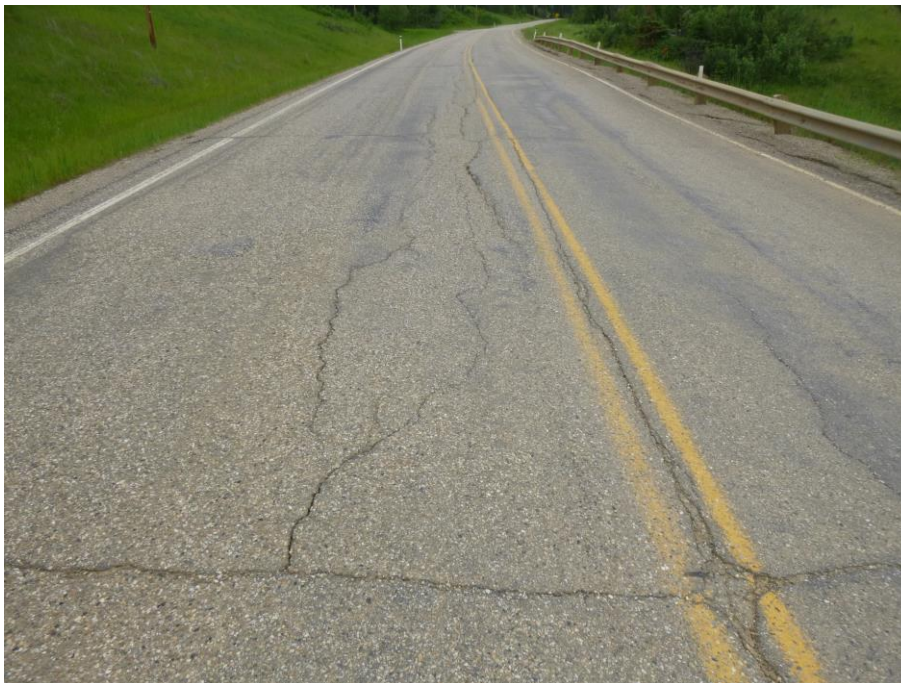
Photo 4 - Looking east along the highway at the crack/dip in the highway above the Slide at PH77-1.

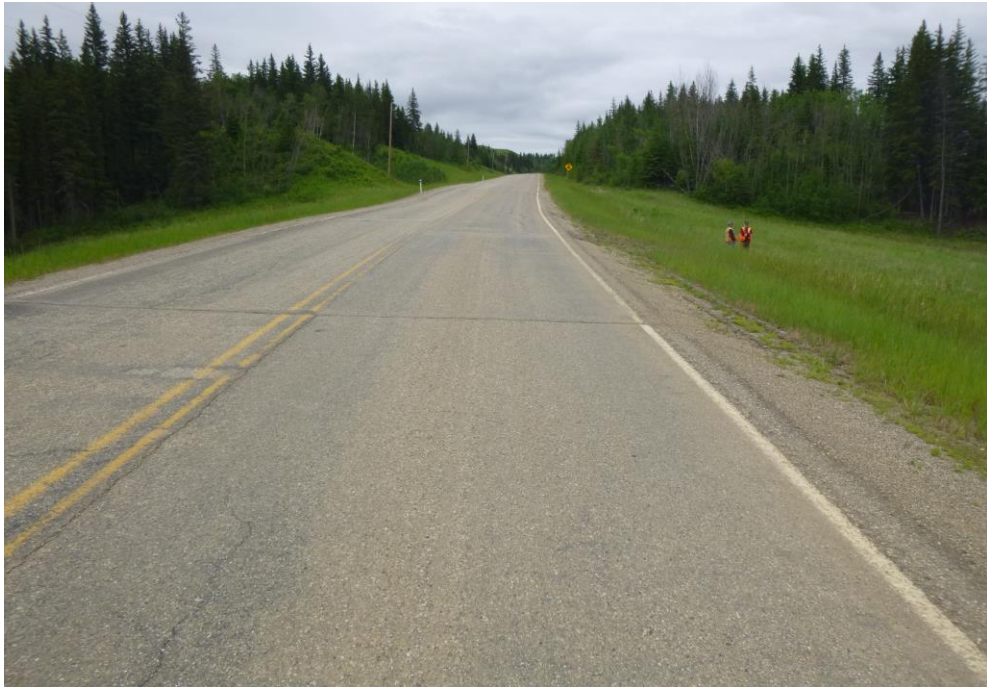
Photo 5 - Looking east along the highway across PH77-2. Note the settlement and cracking in the highway.

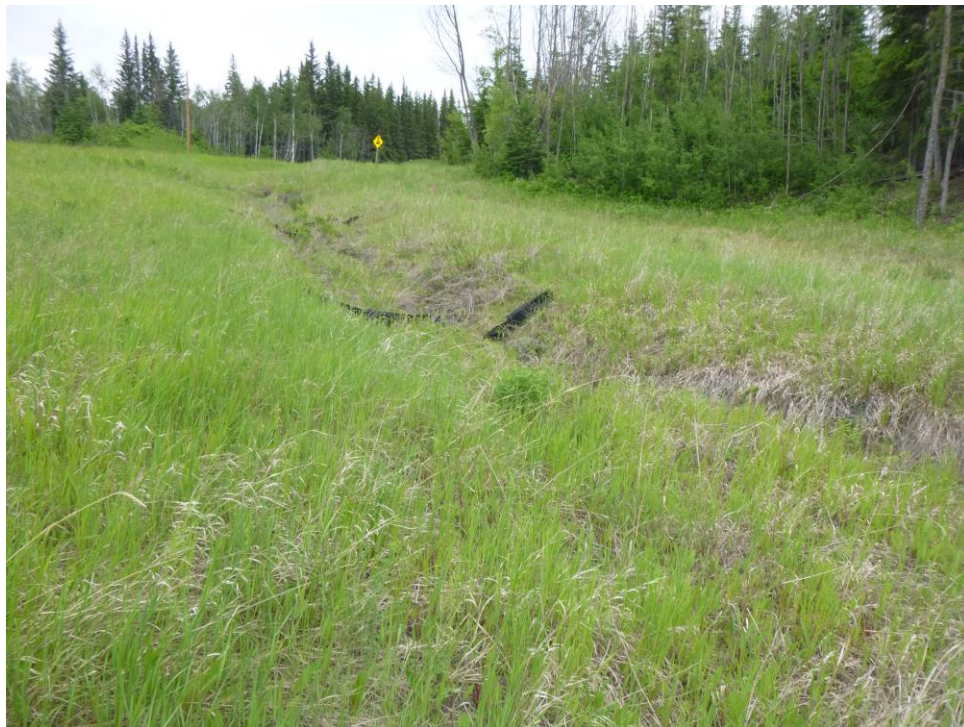
Photo 6 – Looking north along the eroded TRM ditch channel of PH77-2.

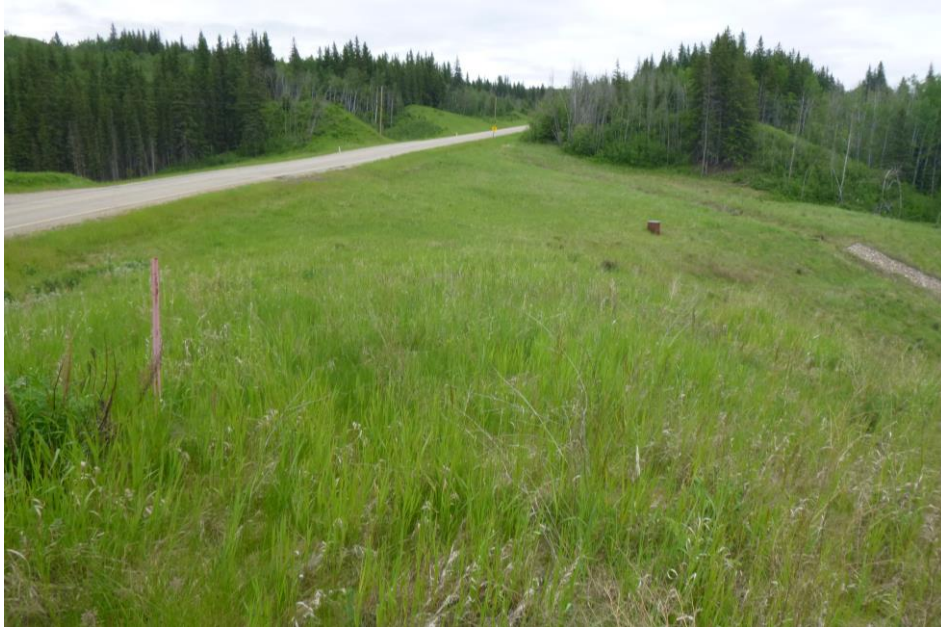
Photo 7 - Looking east along the south hwy embankment and southeast ditch drainage channel of PH77-2, Hines Creek.

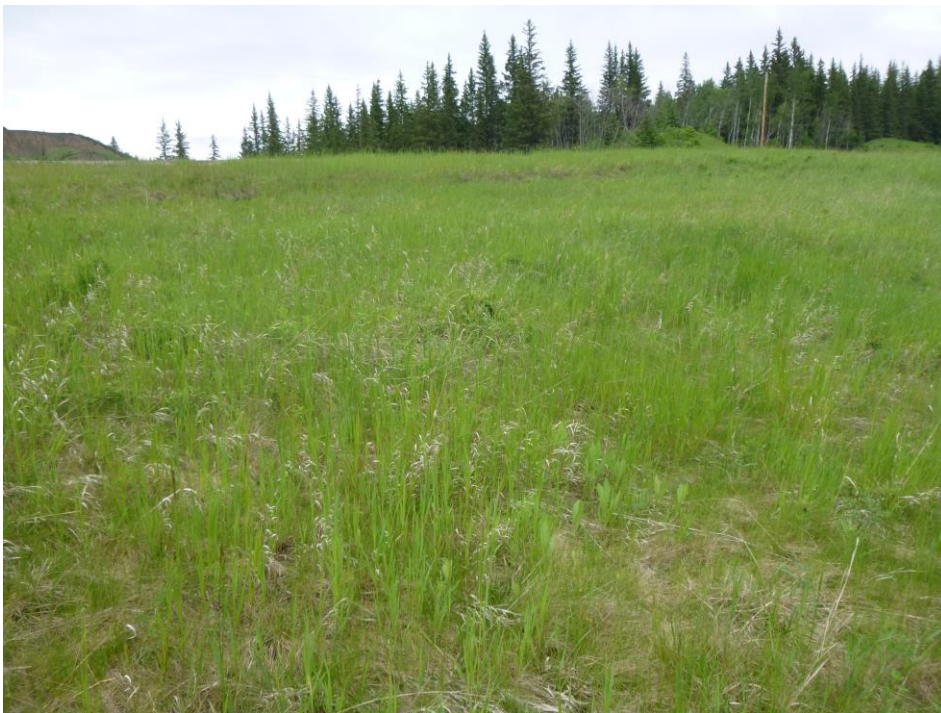
Photo 8 – Looking north towards the hwy from the south embankment of PH77-2, at the slide scarp in proximity to the highway.

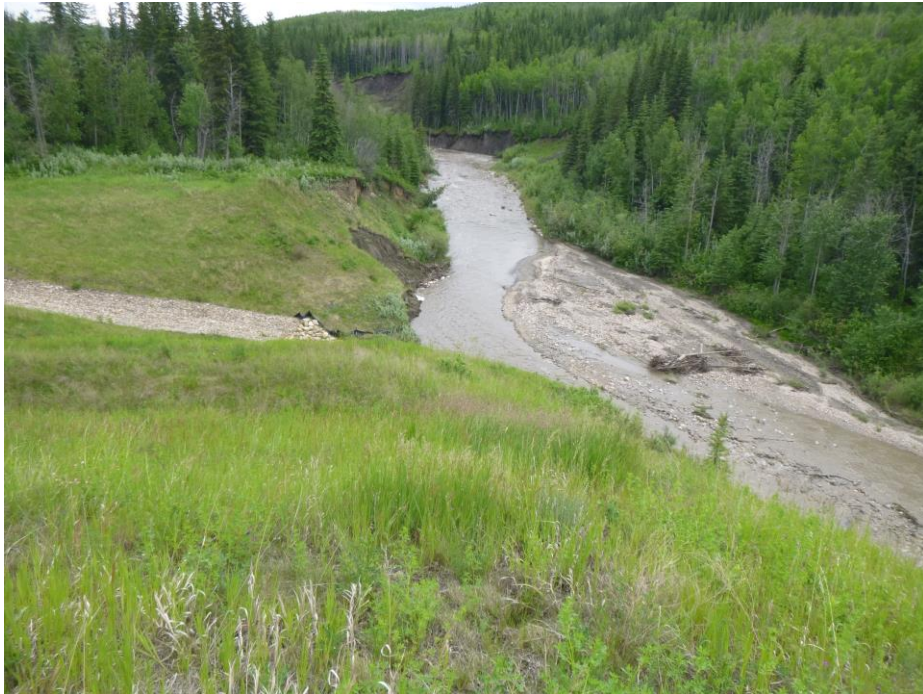
Photo 9 - Looking southeast at the culvert outlet area of PH77-2. Note the riverbank slumping east of the culvert outlet.

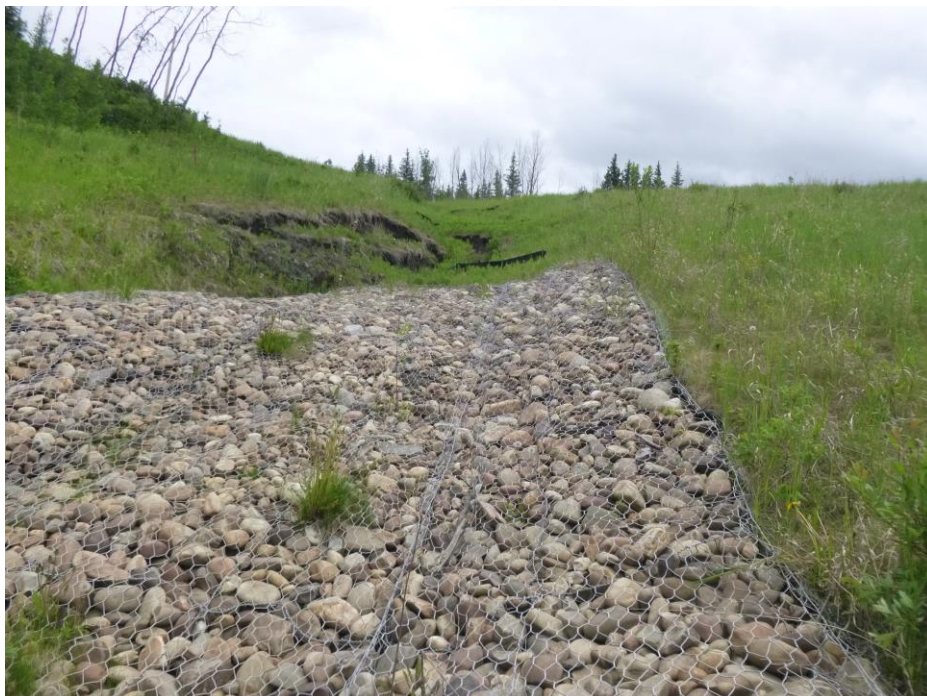
Photo 10 – Looking south at the erosion along the northeast ditch crotch leading to the culvert inlet area of the north embankment of PH77-2.

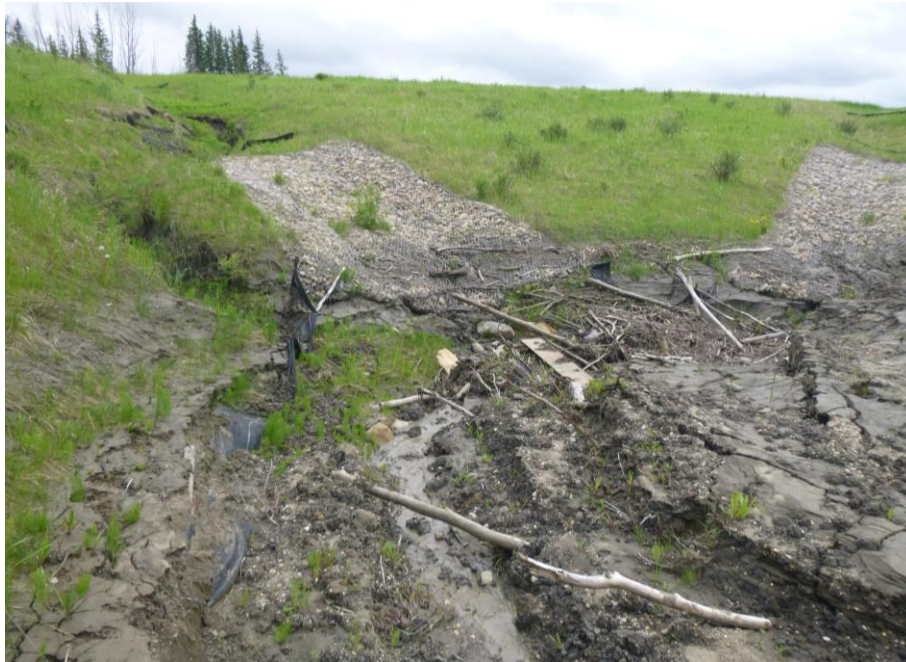
Photo 11 – Looking south at the culvert inlet area of the north embankment of PH77-2. Note the infilled channel with logs and debris, which has completely covered the trash rack and culvert inlet.

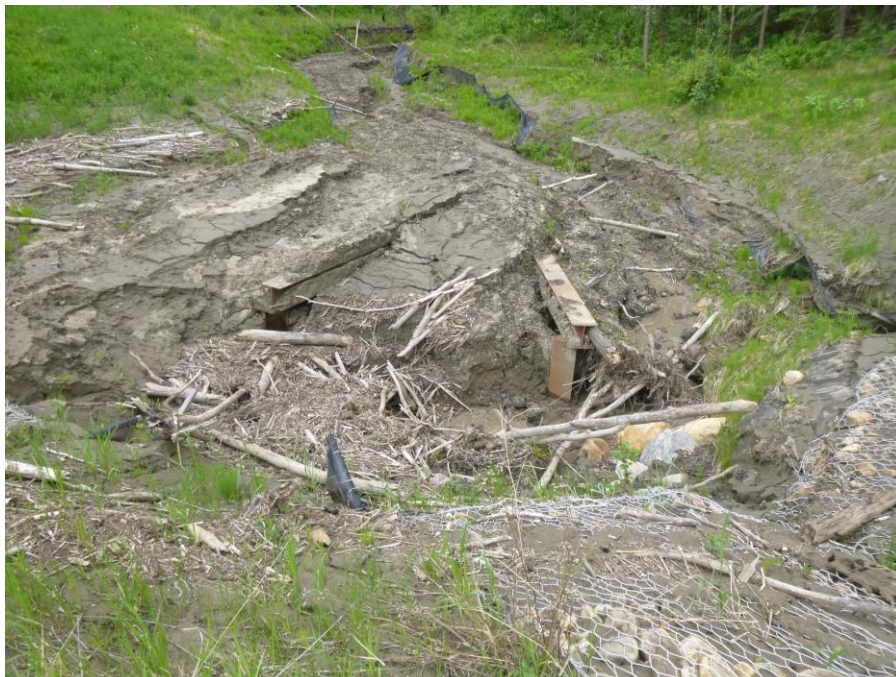
Photo 12 - Looking north along the infilled channel leading into the culvert inlet north of the highway at PH77-2.
