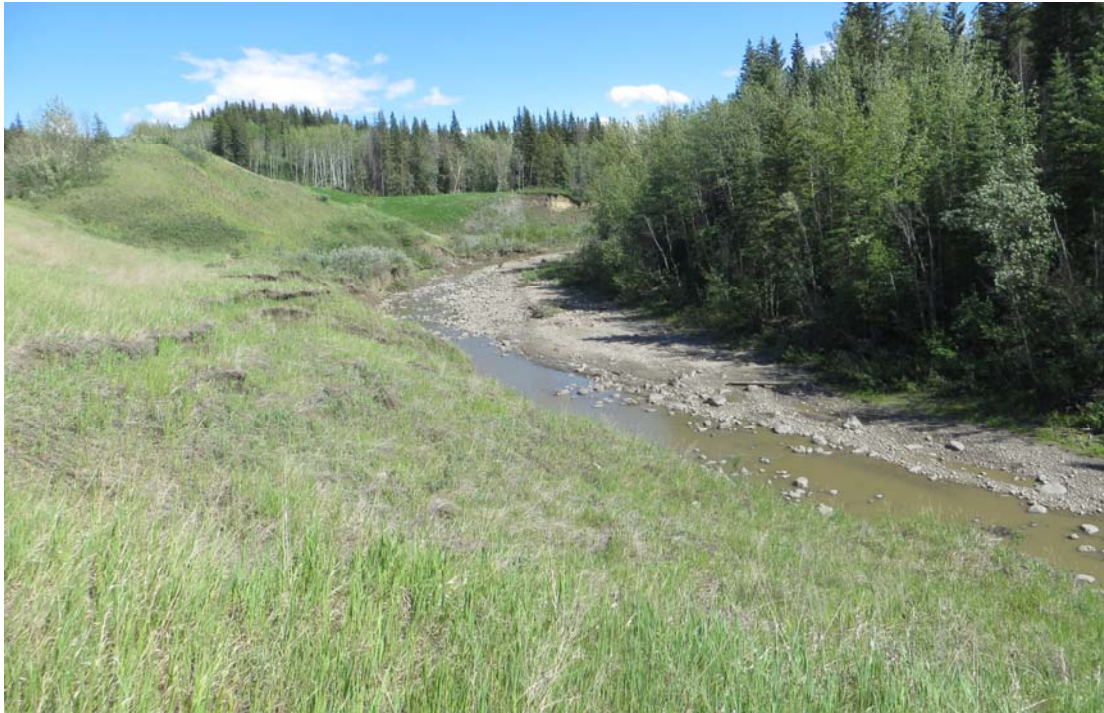
Photo 1 – Looking east at the Slide A site along the north side of the Creek.

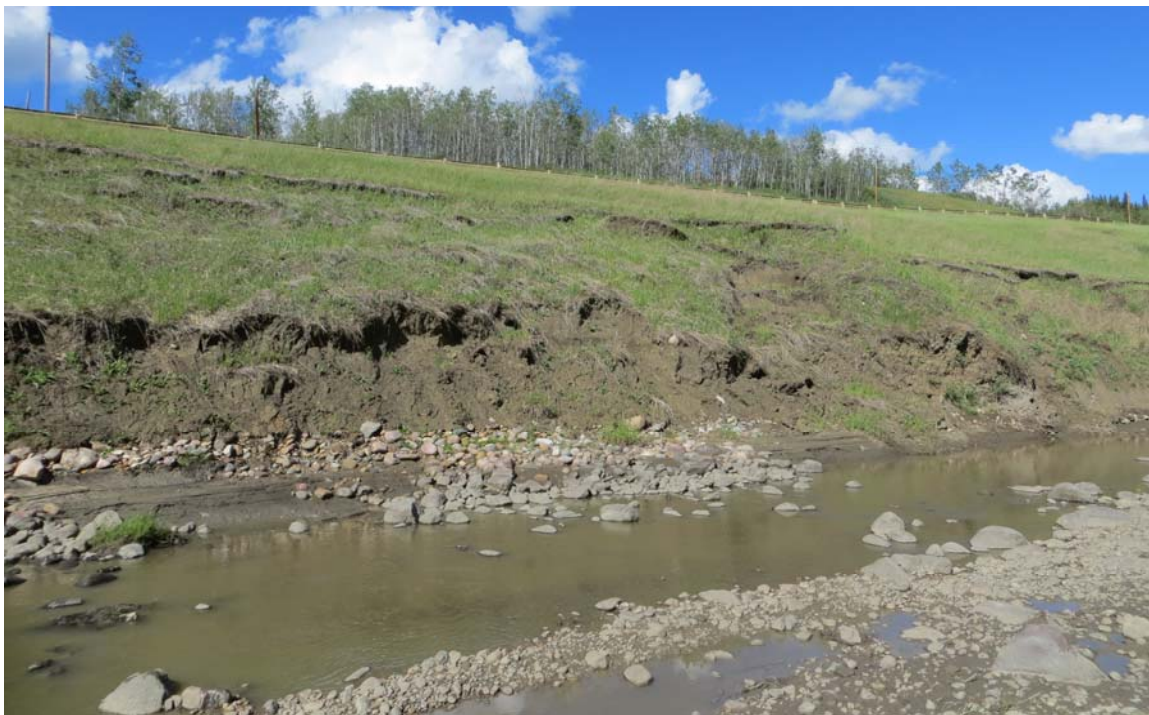
Photo 2 – Looking northeast from the Creek up at the slide at Site A in the south highway embankment.

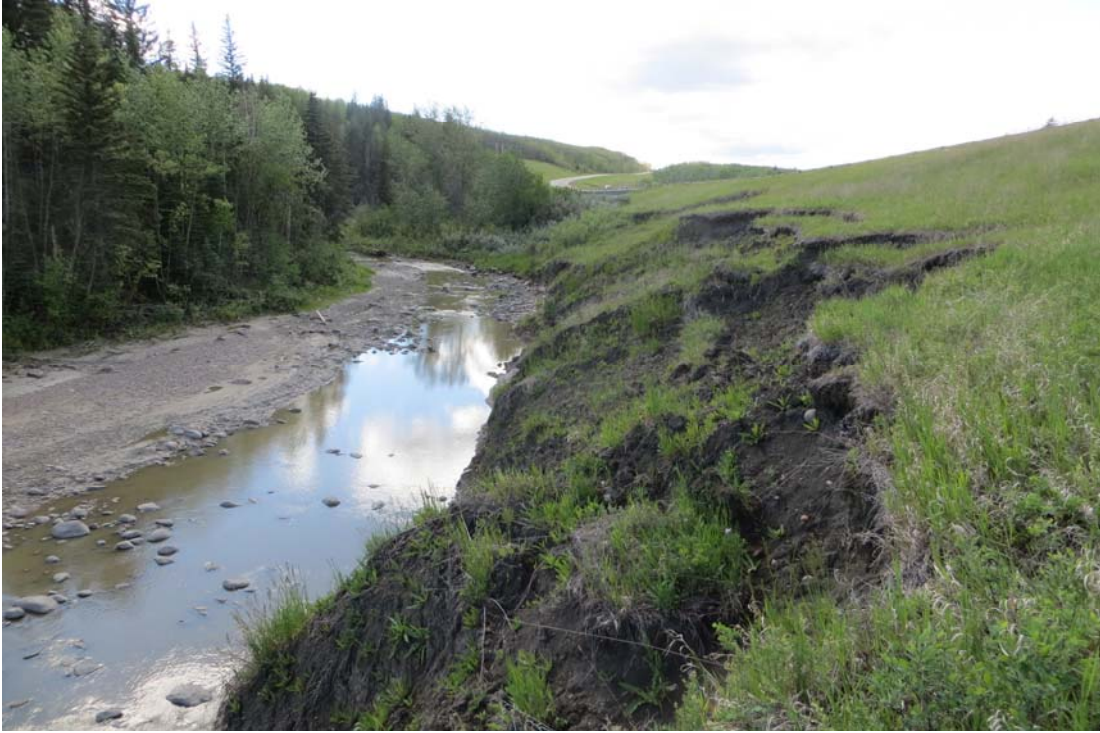
Photo 3 – Looking west along the slide scarp adjacent to the Creek at Site A.

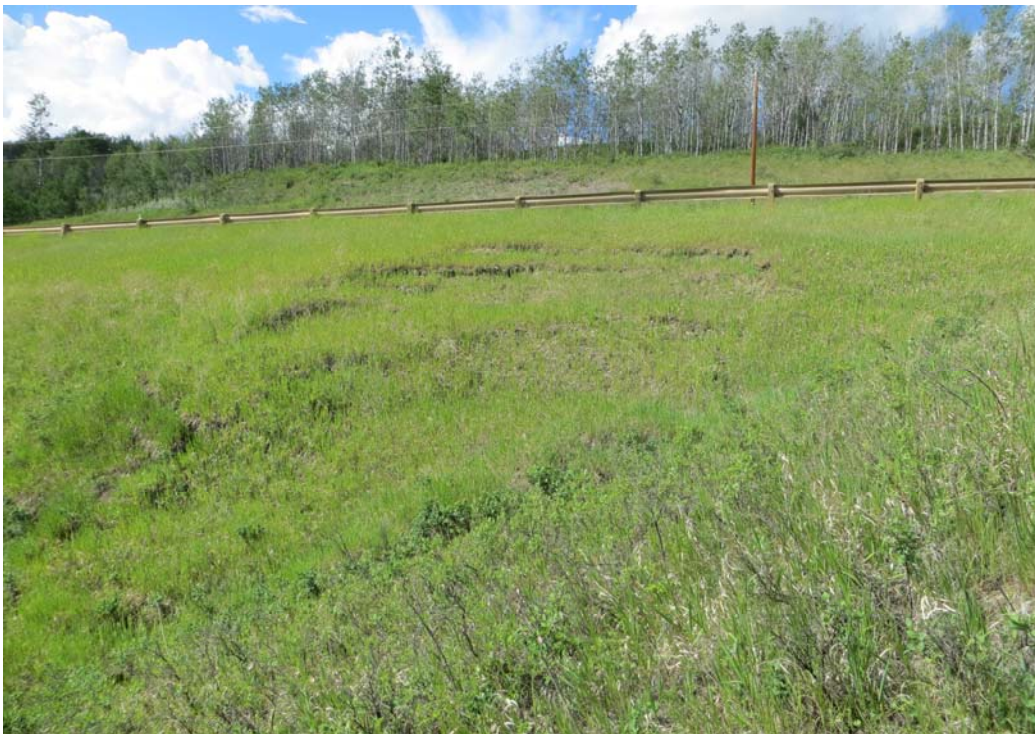
Photo 4 - Looking northwest at a slide lobe of Site A extending close to the highway.

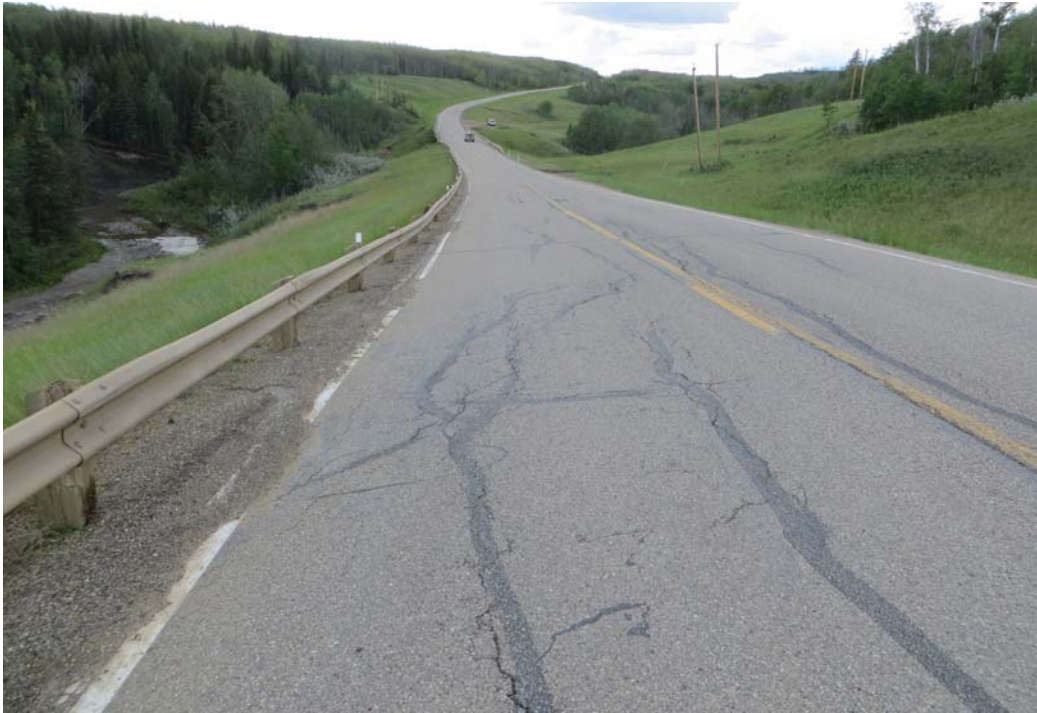
Photo 5 – Looking west along the highway at the crack/dip in the highway above Slide A.

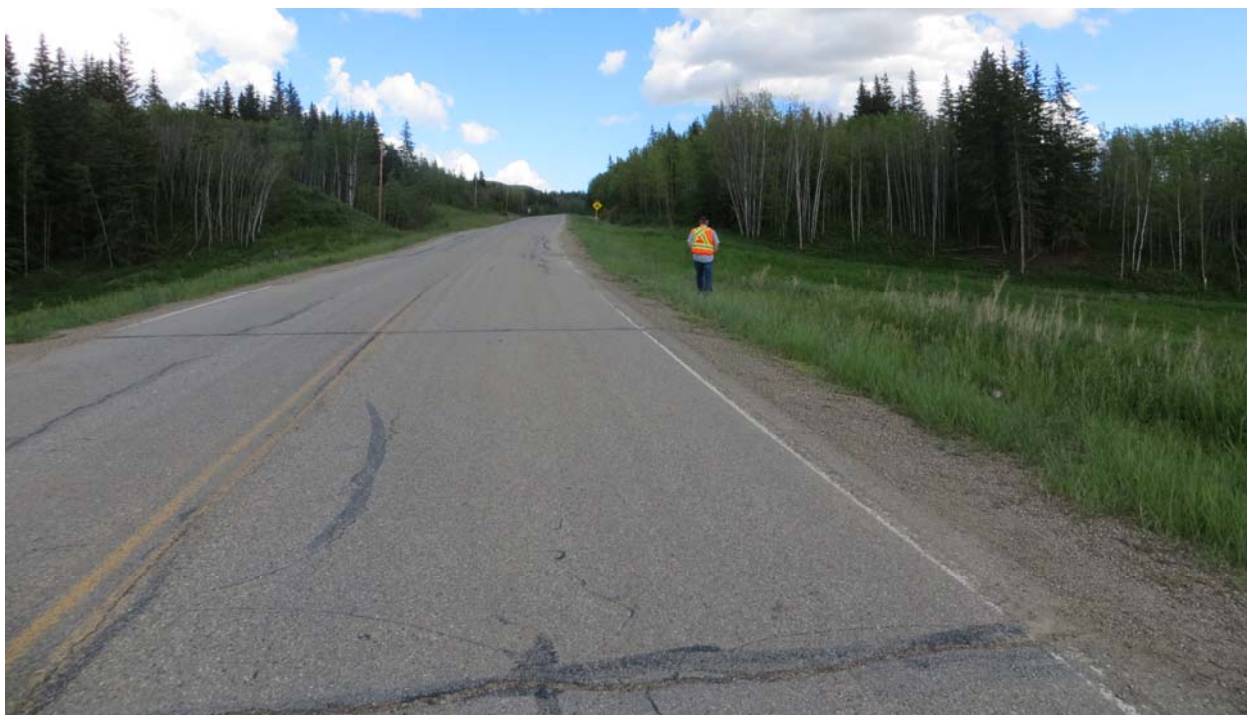
Photo 6 - Looking east along the highway and south embankment Site B. Note the settlement in both the highway and the embankment.

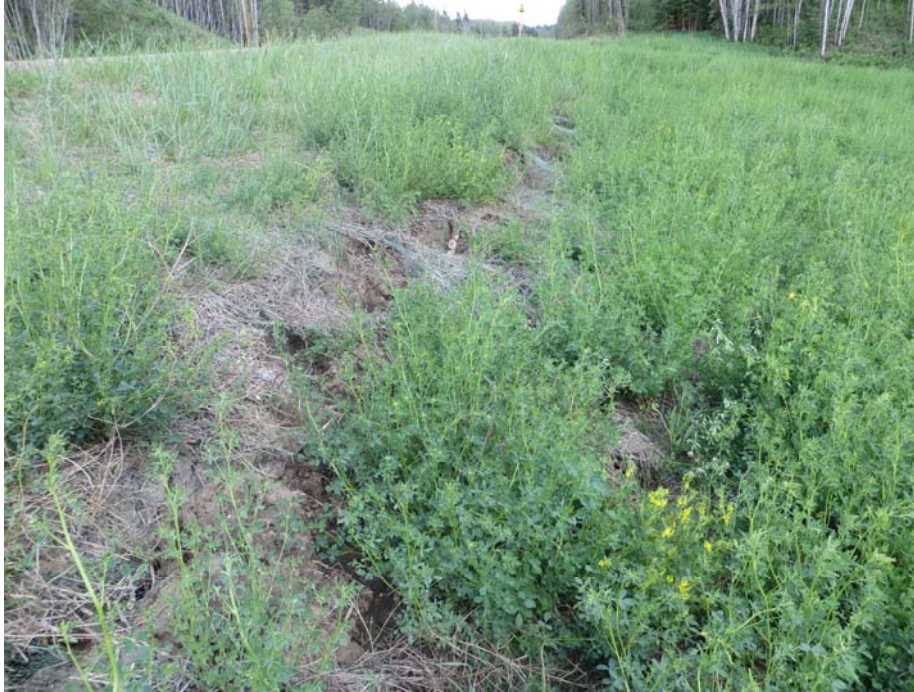
Photo 7 – Looking east at the slide scarp adjacent to the highway in the south embankment of Site B.

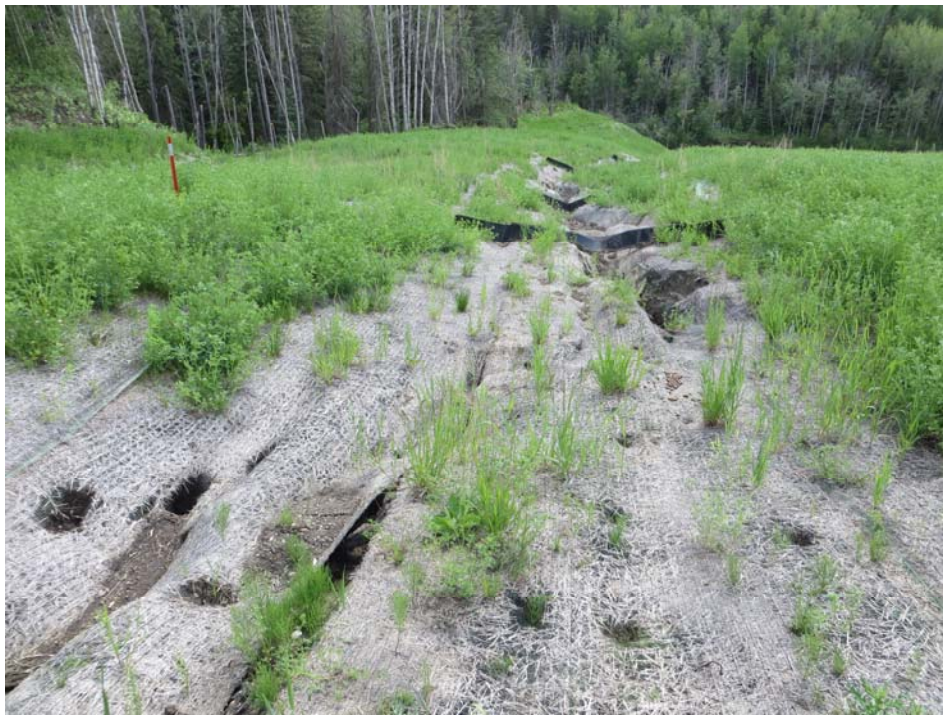
Photo 8 - Looking at the surface erosion through the existing erosion control soil covering and ditch barriers on the south embankment of Site B.

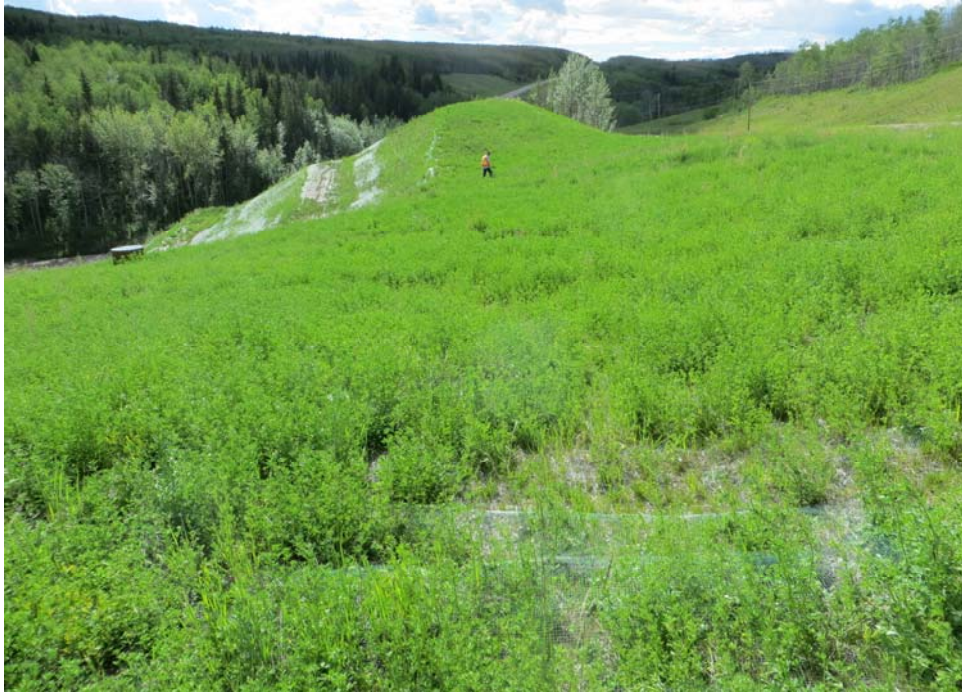
Photo 9 – Looking west along the south embankment of Site B. Note the benched hillside in the background and the subsidence near to the highway over the culvert.

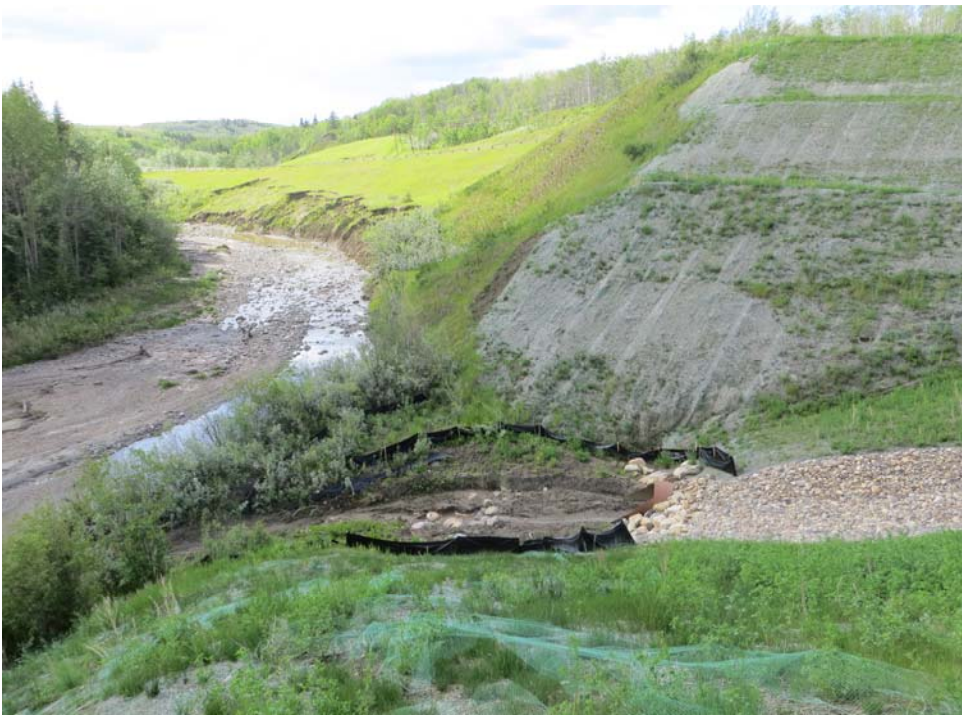
Photo 10 - Looking northwest at the culvert outlet area of Site B, Hines Creek, and Site A in the background.

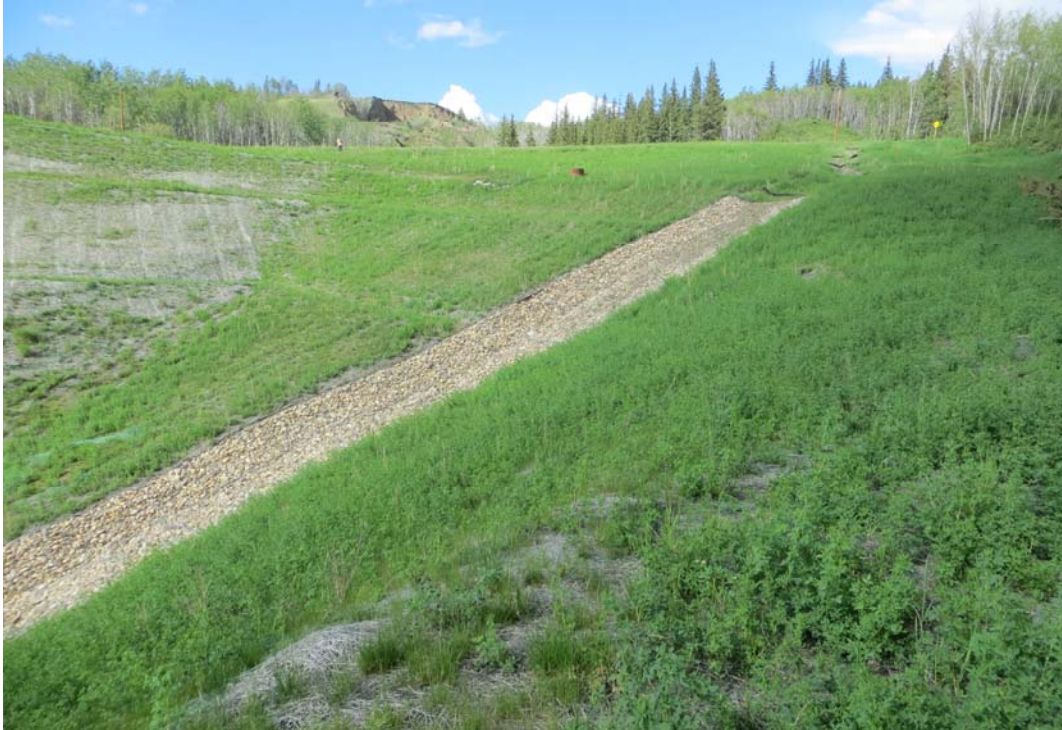
Photo 11 – Looking north up along the south embankment of Site B.

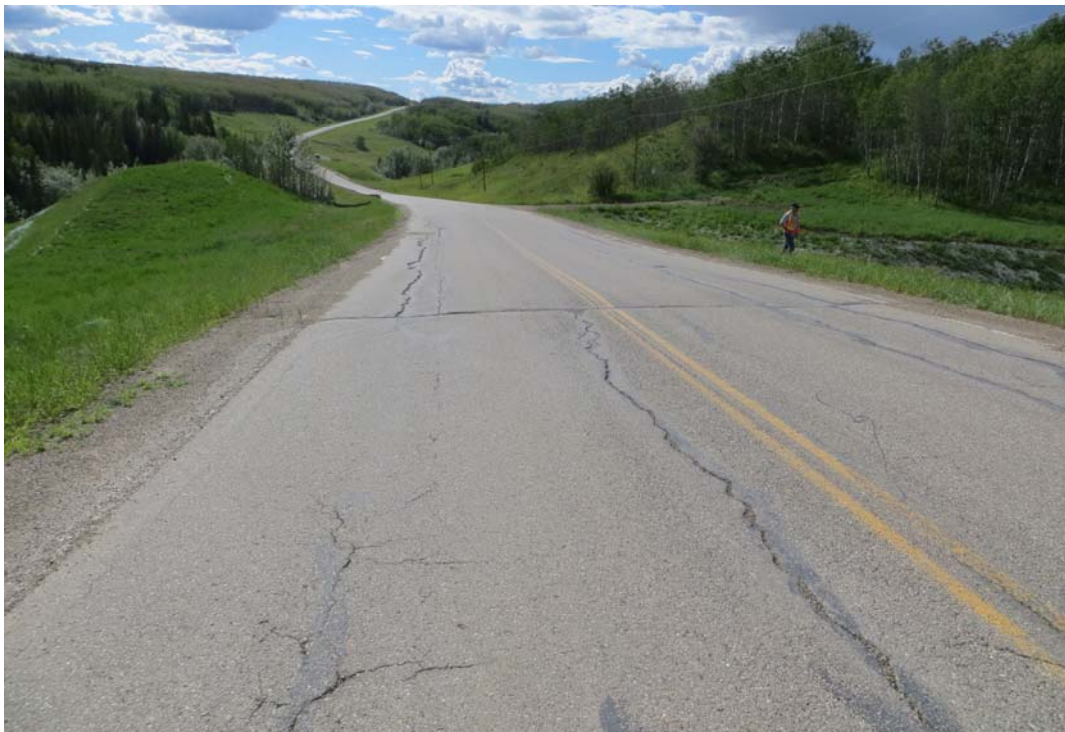
Photo 12 - Looking west along the highway at the dip and cracks of Site B.

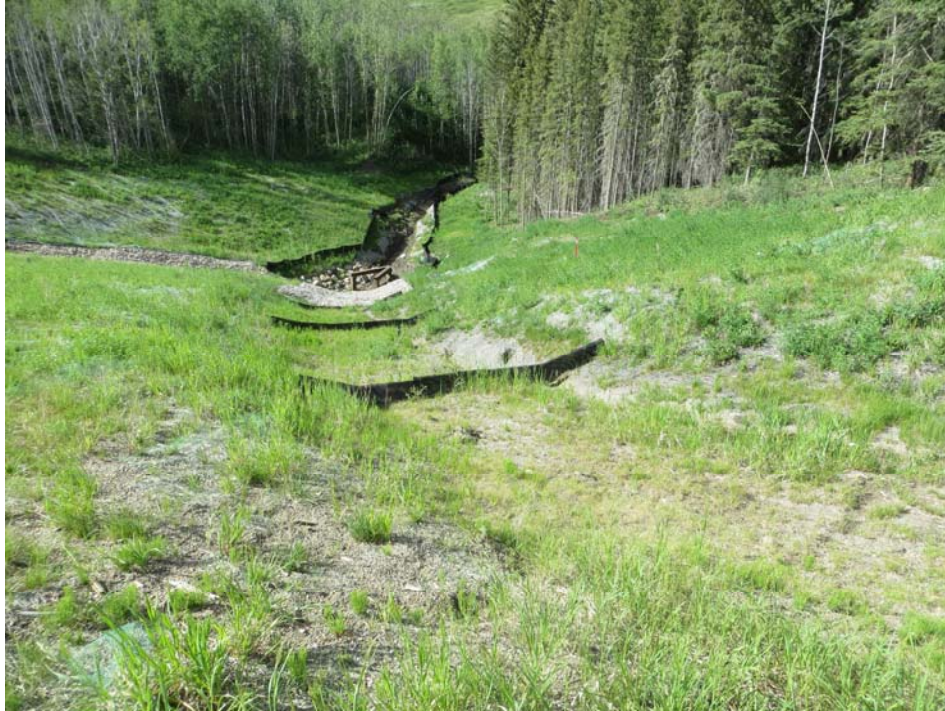
Photo 13 – Looking north along the east ditch of the north embankment of Site B.

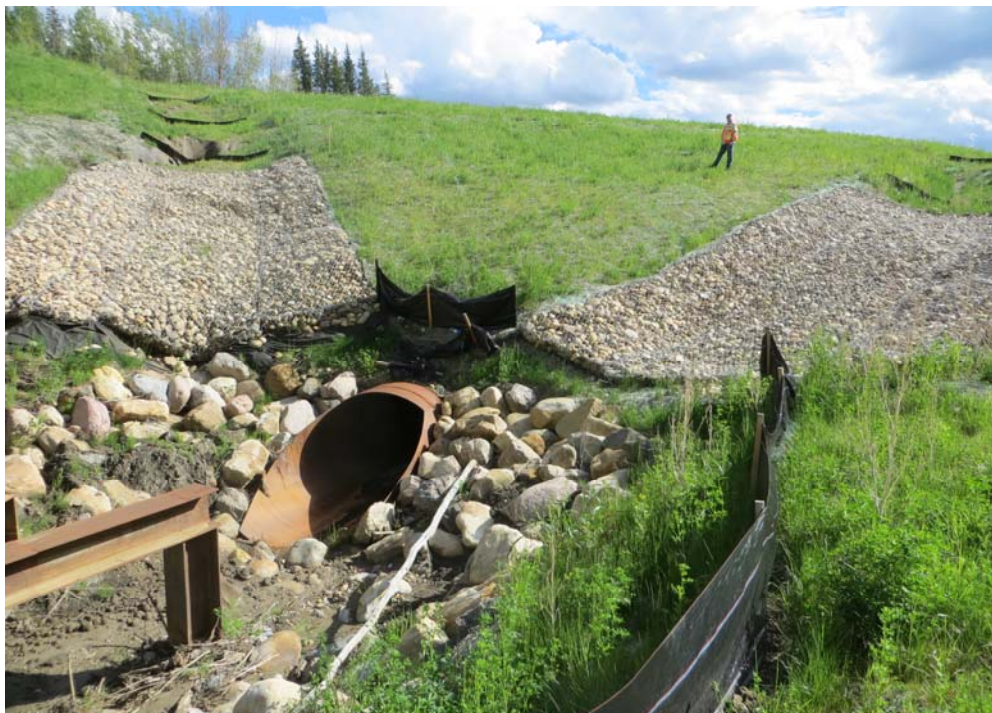
Photo 14 - Looking south at the culvert inlet area north of the highway at Site B. Note the severe ditch erosion up-gradient of the gabions.
