**ALBERTA TRANSPORTATION AND
ECONOMIC CORRIDORS
GEOHAZARD ASSESSMENT PROGRAM
PEACE REGION (PEACE RIVER DISTRICT)
2024 INSPECTION**

Site Number	Location	Name	Hwy	km
PH081	Shaftesbury Trail	Shaftesbury Trail North Slides	684:02	28.4
Legal Description		UTM Co-ordinates (NAD 83)		
NW¼ 19-083-021 W5M		11U E 481381	N 6230300

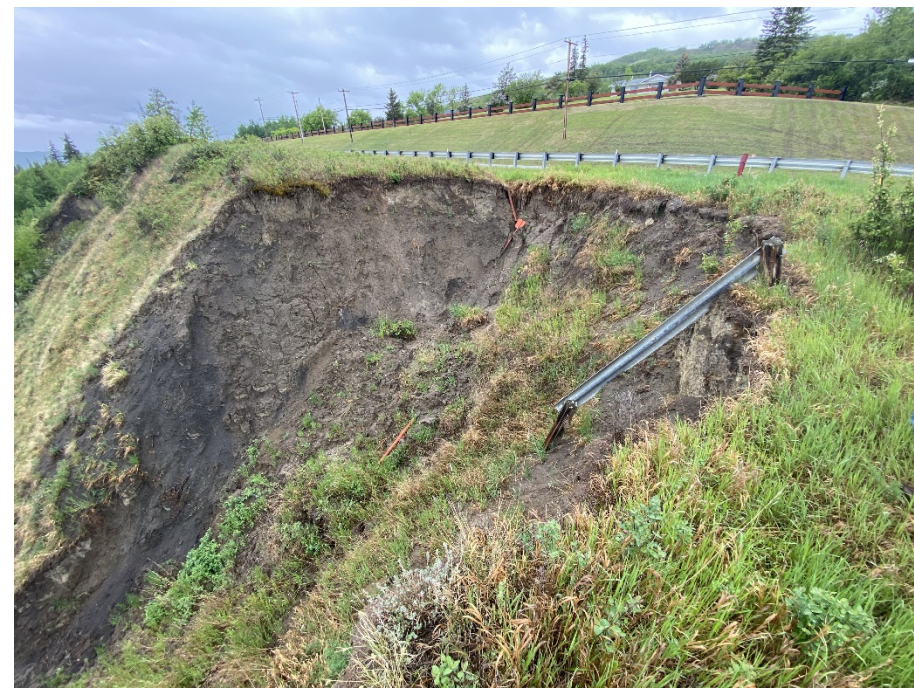
Primary Site Issue:	<p>South Slides: Two landslide features are present to the east of Hwy 684:02 in the crest of the steep high riverbank slope above an arm in the Peace River. The backscarps have sharp 3 m drop offs and are retrogressing into the highway right-of-way (Photos 1 to 3).</p> <p>Both landslides have failed down to the sandy till ledge which is about 5 m below the existing ground surface.</p> <p>There is a marked gas utility pipeline at the backscarp of Slide 1.</p> <p>North Slide: A landslide (first observed in 2019), evidenced by a dip and cracking in the pavement, was observed to the north of Slides 1 and 2. The location of this slide is above a subdivision at km 28.6. (Photo 4).</p>
Dimensions:	<p>Slide 1 is about 13 m wide, with a 3 m drop off along the backscarp which is about 3.2 m east of the NBL guardrail.</p> <p>Slide 2 is about 14 m wide, with a 3 m drop off along the backscarp which is about 7.6 m east of the NBL guardrail.</p> <p>The slide at km 28.6 is approximately 25 m wide. Tension cracking had been observed to the highway centreline prior to the 2021 overlay.</p>

Photo 1.
Looking southwest from the north flank of Slide 1. Some fresh soil was visible in the upper scarp/south flank and there was 0.2 m retrogression since 2023. Minimum offset from the main scarp to the guardrail was measured at 3.2 m. Gas marker post has now fallen into the slide area.

- Regularly inspect the road and crest of the riverbank to check for cracks and possible backscarp retrogression.
- Post slide warning signs and be prepared to build an emergency detour in the upslope ditch if the landslides retrogress closer to within a few meters of the NBL of the highway.

- The most feasible remedial solution is likely a pile wall at each of the south landslide locations to protect the road from the landslides given the proximity of the highway to the steep riverbank slope, and the presence of private residences on the west side of the highway. (\$1M - 2M)
- At the north landslide, a concrete pile wall anchored into bedrock is a potential remedial option. (\$1M)

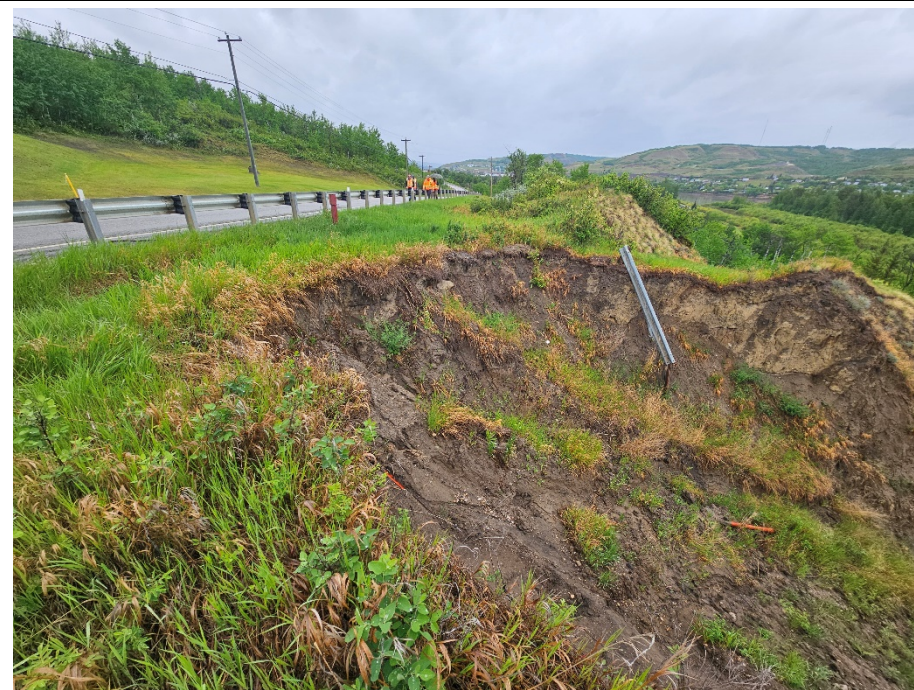
Photo 2.
Looking northeast from the south side of the main scarp of Slide 1. Minor lateral expansion of the north slide flank since 2023.

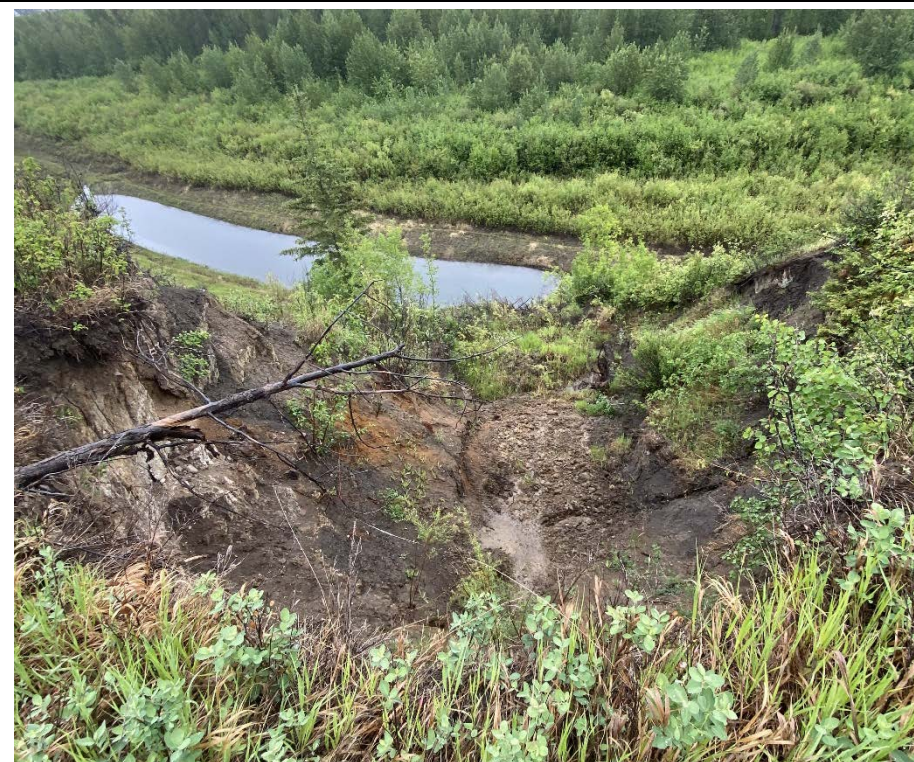
Photo 3.
Looking east and downslope from the top of the main scarp of Slide 2. Ongoing erosion within the exposed and disturbed soils but no significant expansion or retrogression towards the highway since 2023. Main scarp was offset 7.6 m from the guardrail.

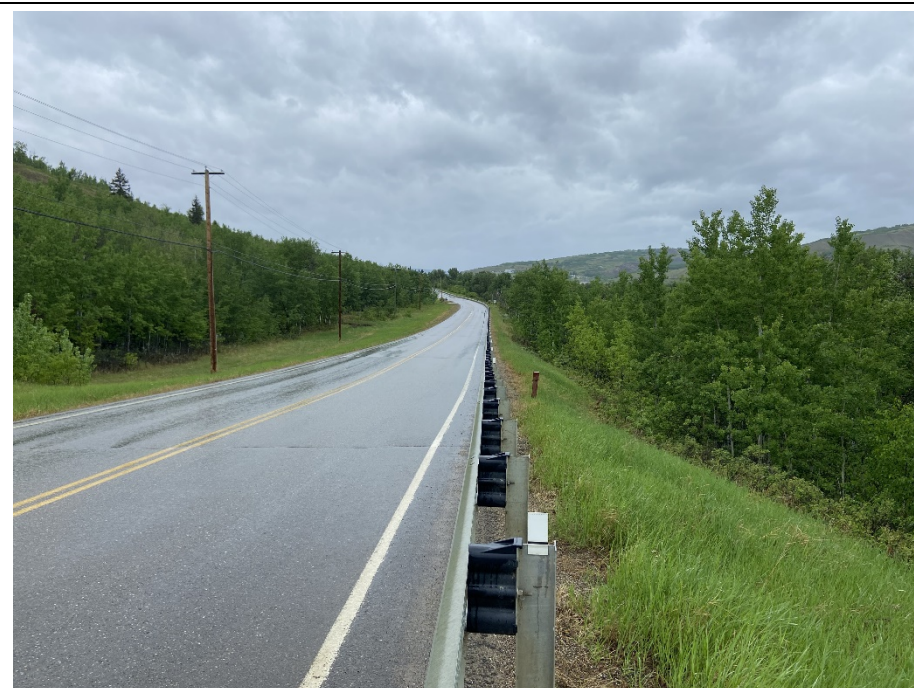
Observations:	Description:	Worsened?	
		Yes	No
<input checked="" type="checkbox"/> Pavement	<p>There are no signs of any cracking in the pavement structure above Slides 1 and 2.</p> <p>Transverse cracks were visible in the asphalt north and south of the km 28.6 slide across both lanes (Photo 4). Previous tension cracks were not observed since road was repaved in 2021 and there was no apparent expansion from the previous inspection.</p>	<input type="checkbox"/>	<input checked="" type="checkbox"/>
<input checked="" type="checkbox"/> Slope Movement	<p>Active slumping is occurring at the south landslides with bare backslopes (Photos 1 to 3). Slide 1 has shown some signs of minor ravelling and retrogression in the southern flank since 2023. The minimum offset from the headscarp to the guardrail reduced by approximately 0.2 m since 2023 and measured 3.2 m. The gas pipeline marker post has now fallen into the slide bowl.</p> <p>The backscarp at Slide 2 did not appear to have significant change and there is a 7.6 m offset to the guardrail which is unchanged from the 2023 inspection.</p> <p>The vertical dip in the pavement and guardrail at the slide at km 28.6 since the 2021 repaving appeared unchanged from the 2023 condition (Photo 4).</p>	<input checked="" type="checkbox"/>	<input type="checkbox"/>

Photo 4.
Looking north at the slide at km 28.6. No visible changes to the slope below the road. No change to pavement damage or dip at the guardrail except for a new transverse crack noted south of the road section with previous cracking prior to the 2021 overlay.
