**ALBERTA TRANSPORTATION AND
ECONOMIC CORRIDORS GRMP
PEACE REGION – (PEACE RIVER DISTRICT)
INSTRUMENTATION MONITORING - FALL 2024**

Site Number	Location	Name	Hwy	km
PH009-3	Hwy 684:02 km 30.99, Town of Peace River	Shaftesbury Trail - Shop Slide	684:02	30.9-31.1
			Old 2:02	0.0-0.4
Legal Description:		UTM Co-ordinates		
4-31-83-21 W5		11V E 480321	N	6232126

Current Monitoring:	19 & 20-Sep-2024	Previous Monitoring	22-May-2024
Instruments Read By:	Mr. Niraj Regmi, G.I.T., and Mr. Nixson Mationg, of Thurber

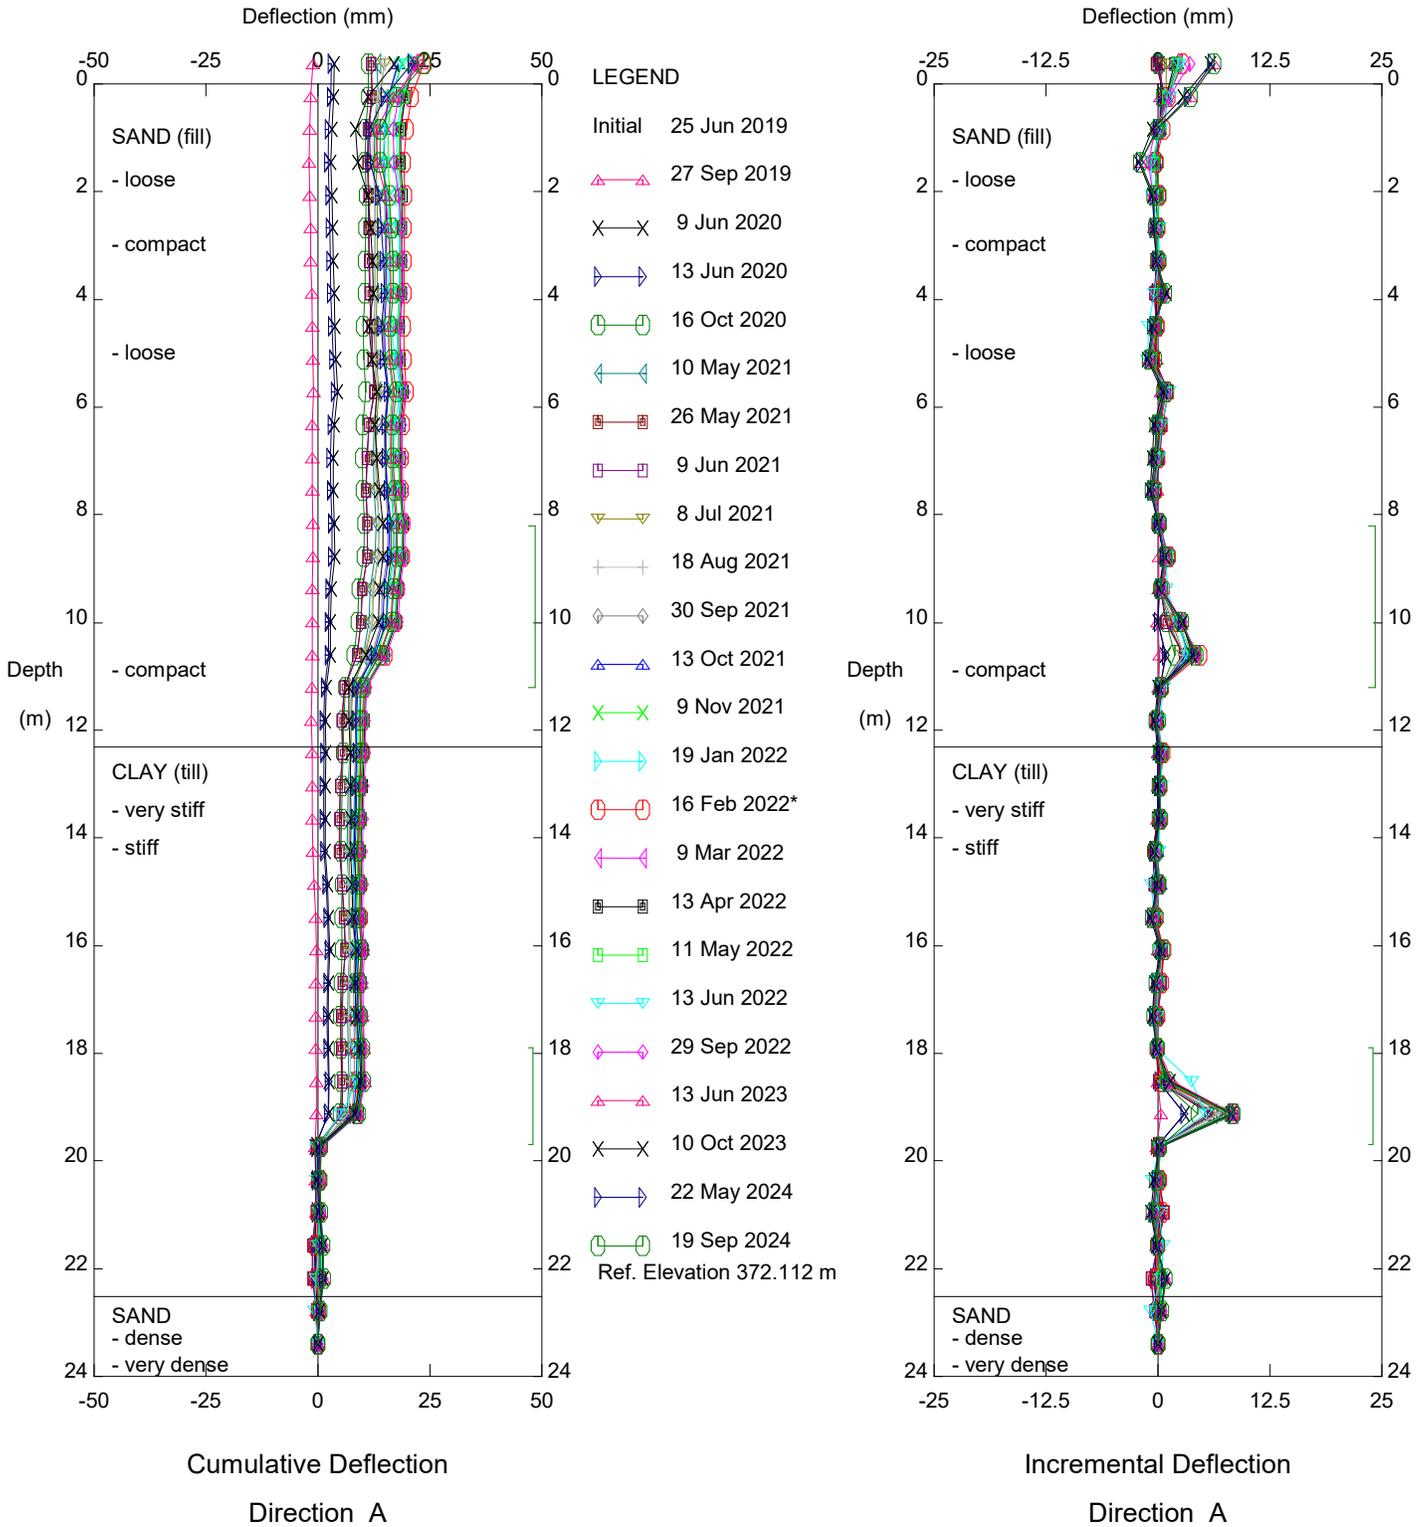
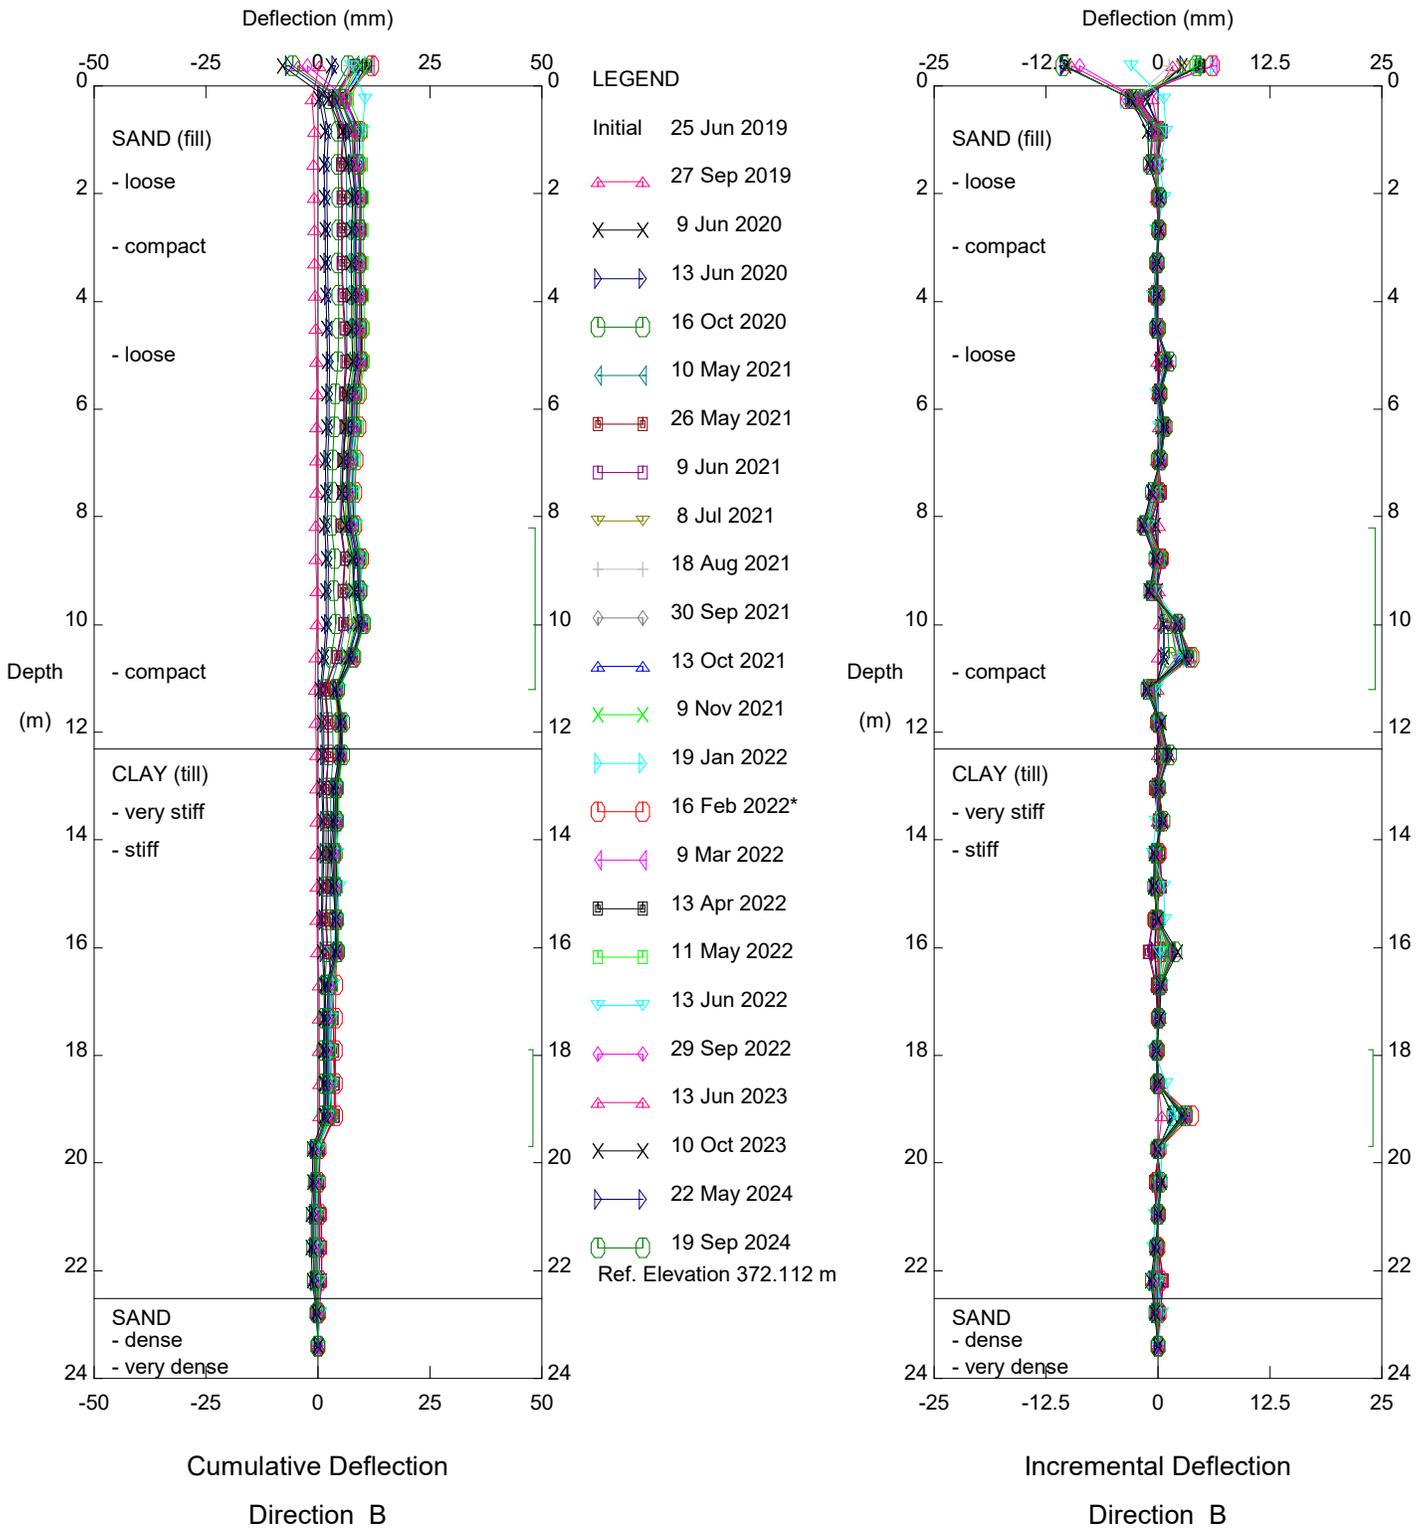
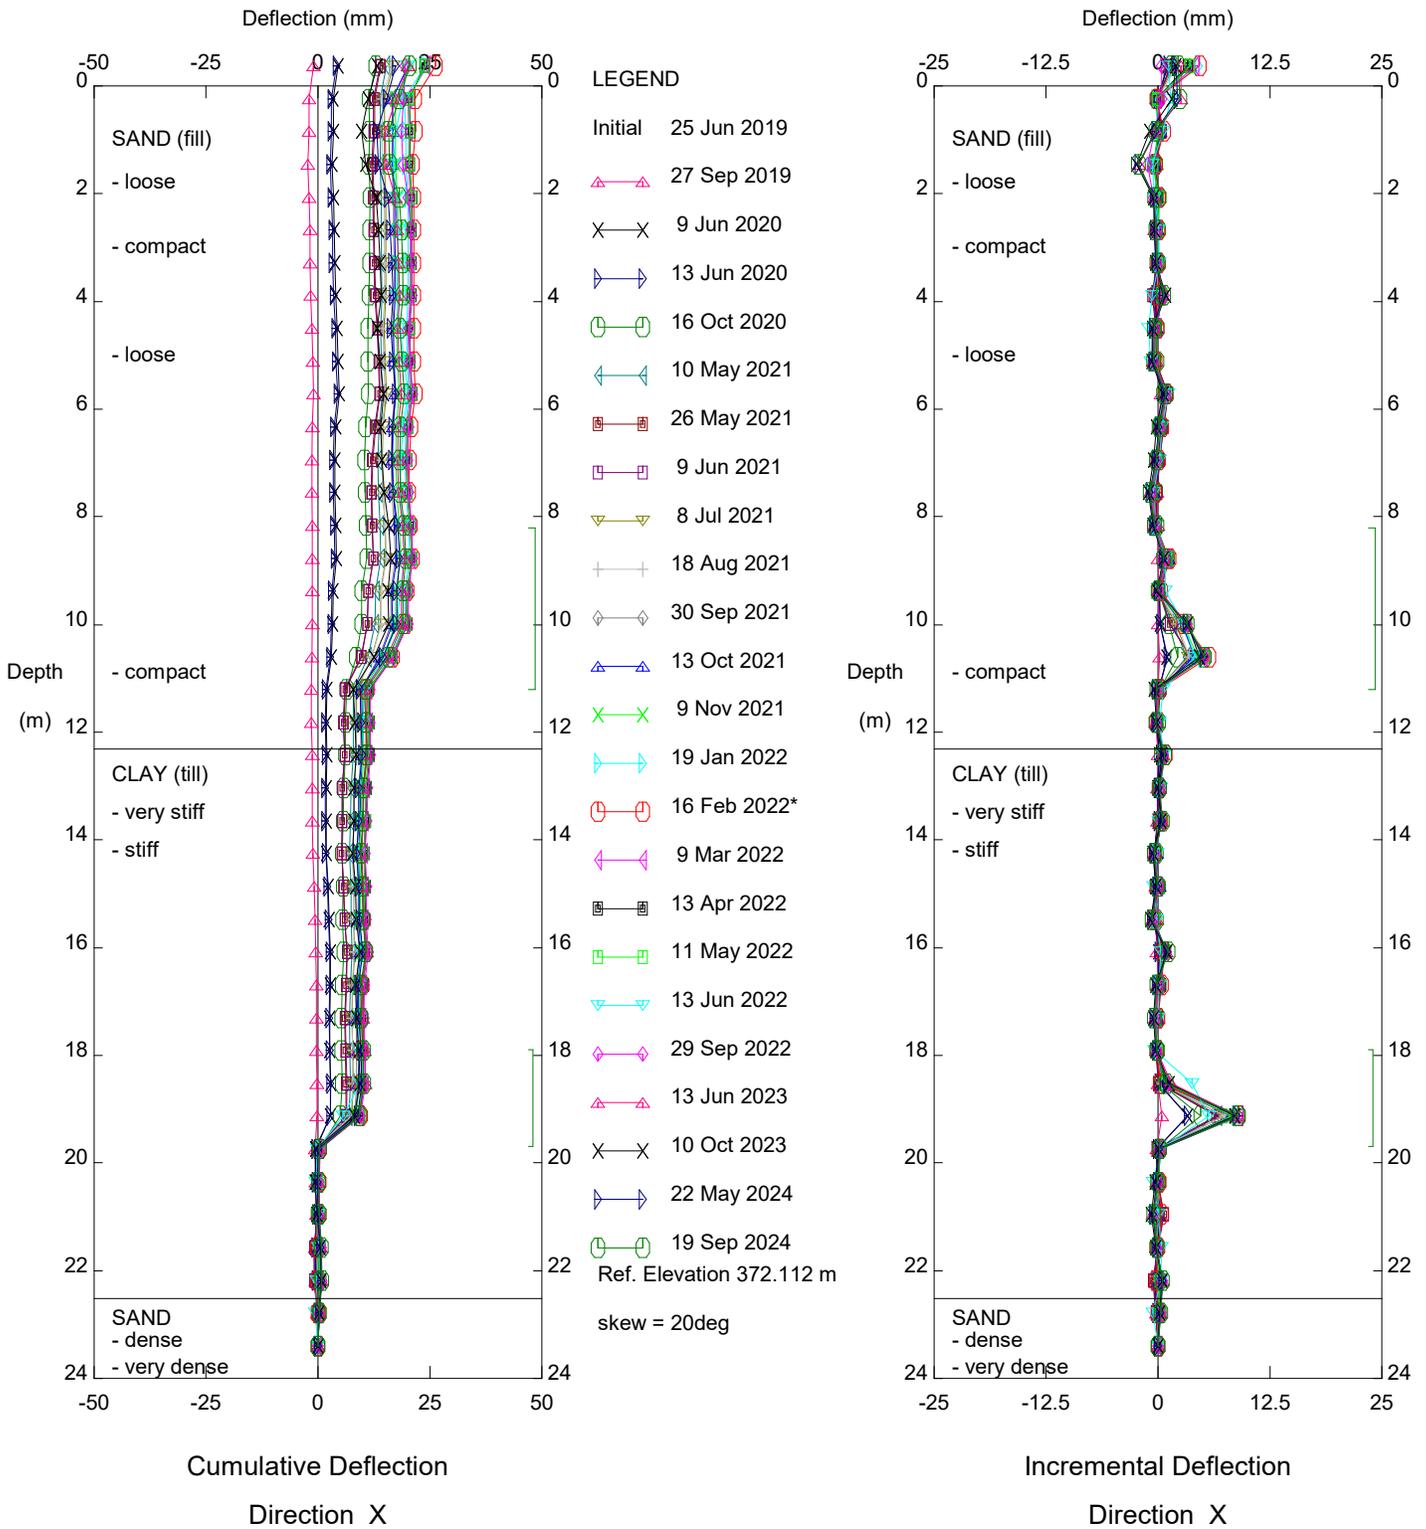
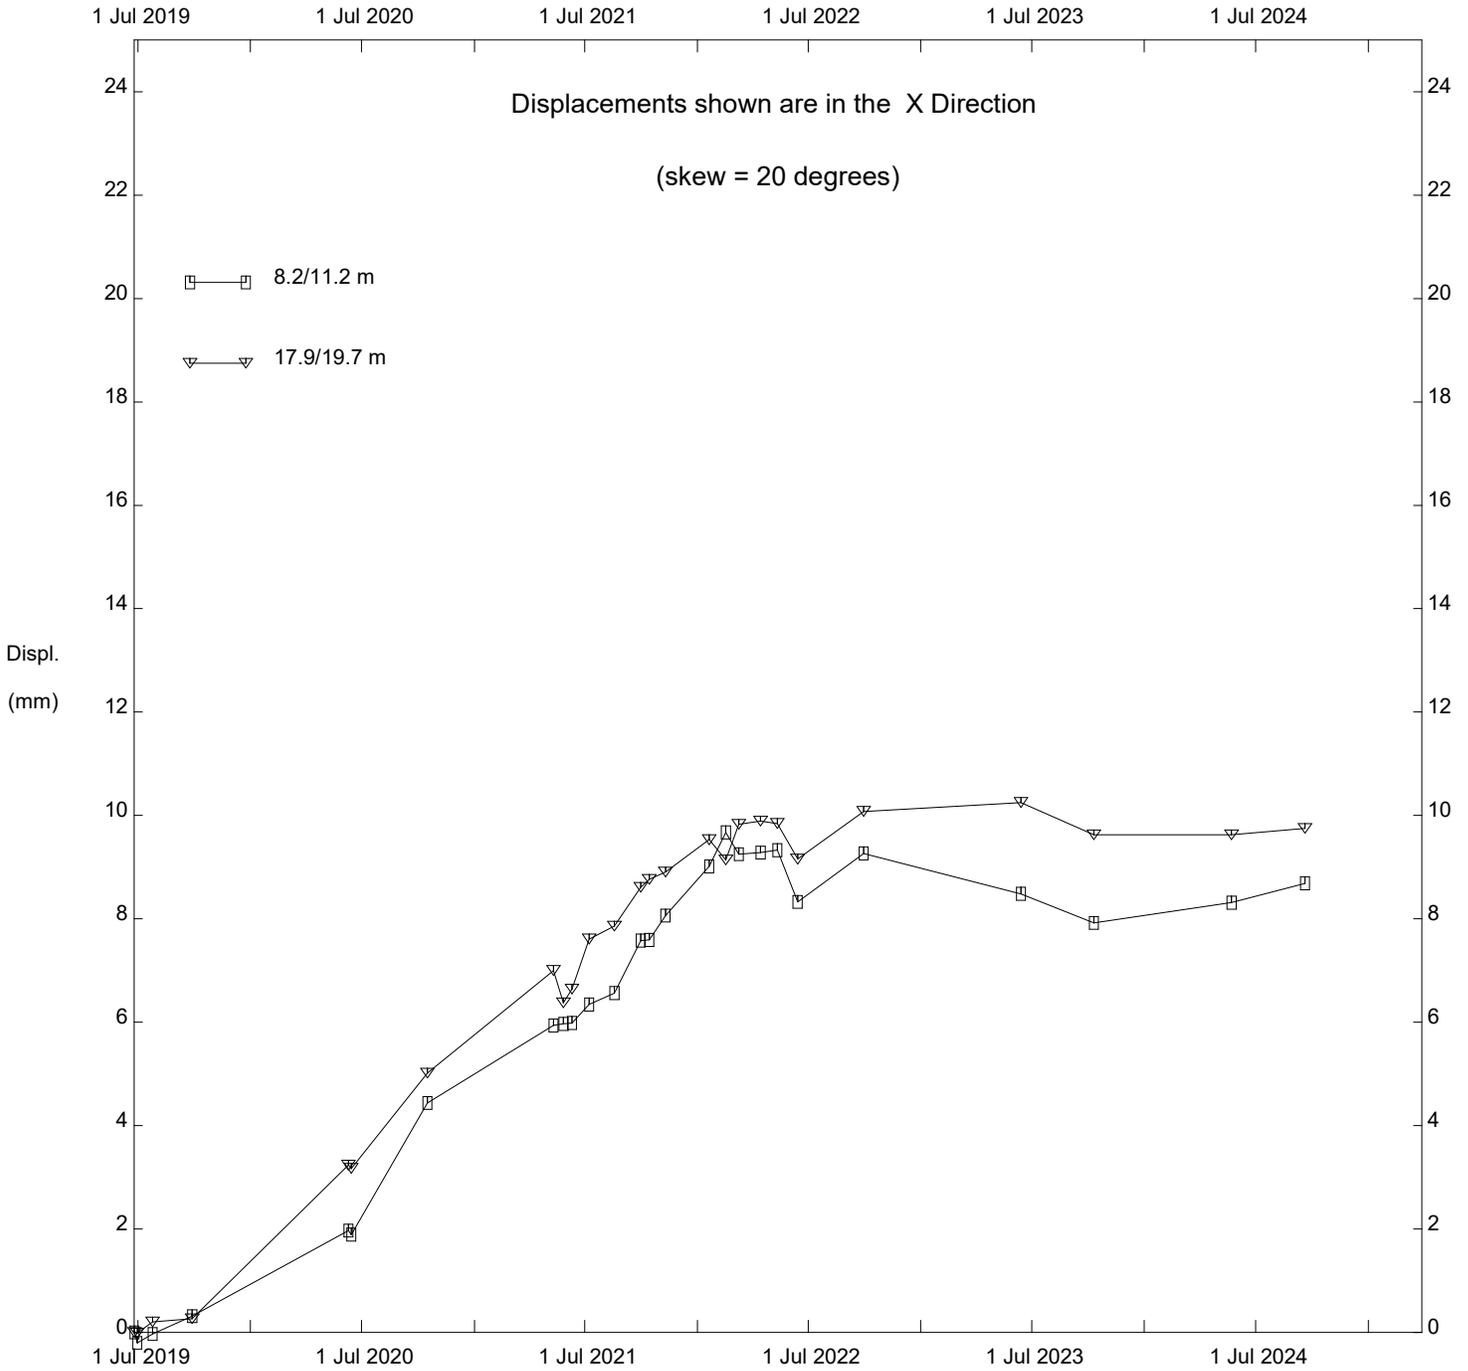
SI19-5 is located in the lower portion of the slide, near the centerline of the slide. It showed a rate of movement of 1.1 mm/yr over 8.2 m to 11.2 m depth and a rate of movement of less than 0.4 mm/yr over 17.9 m to 19.7 m depth. The overall movement in SI19-5 has slowed significantly since slope offloading and the completion of construction although, like SI09-4, there has been a slight increase in the movement in the last year.

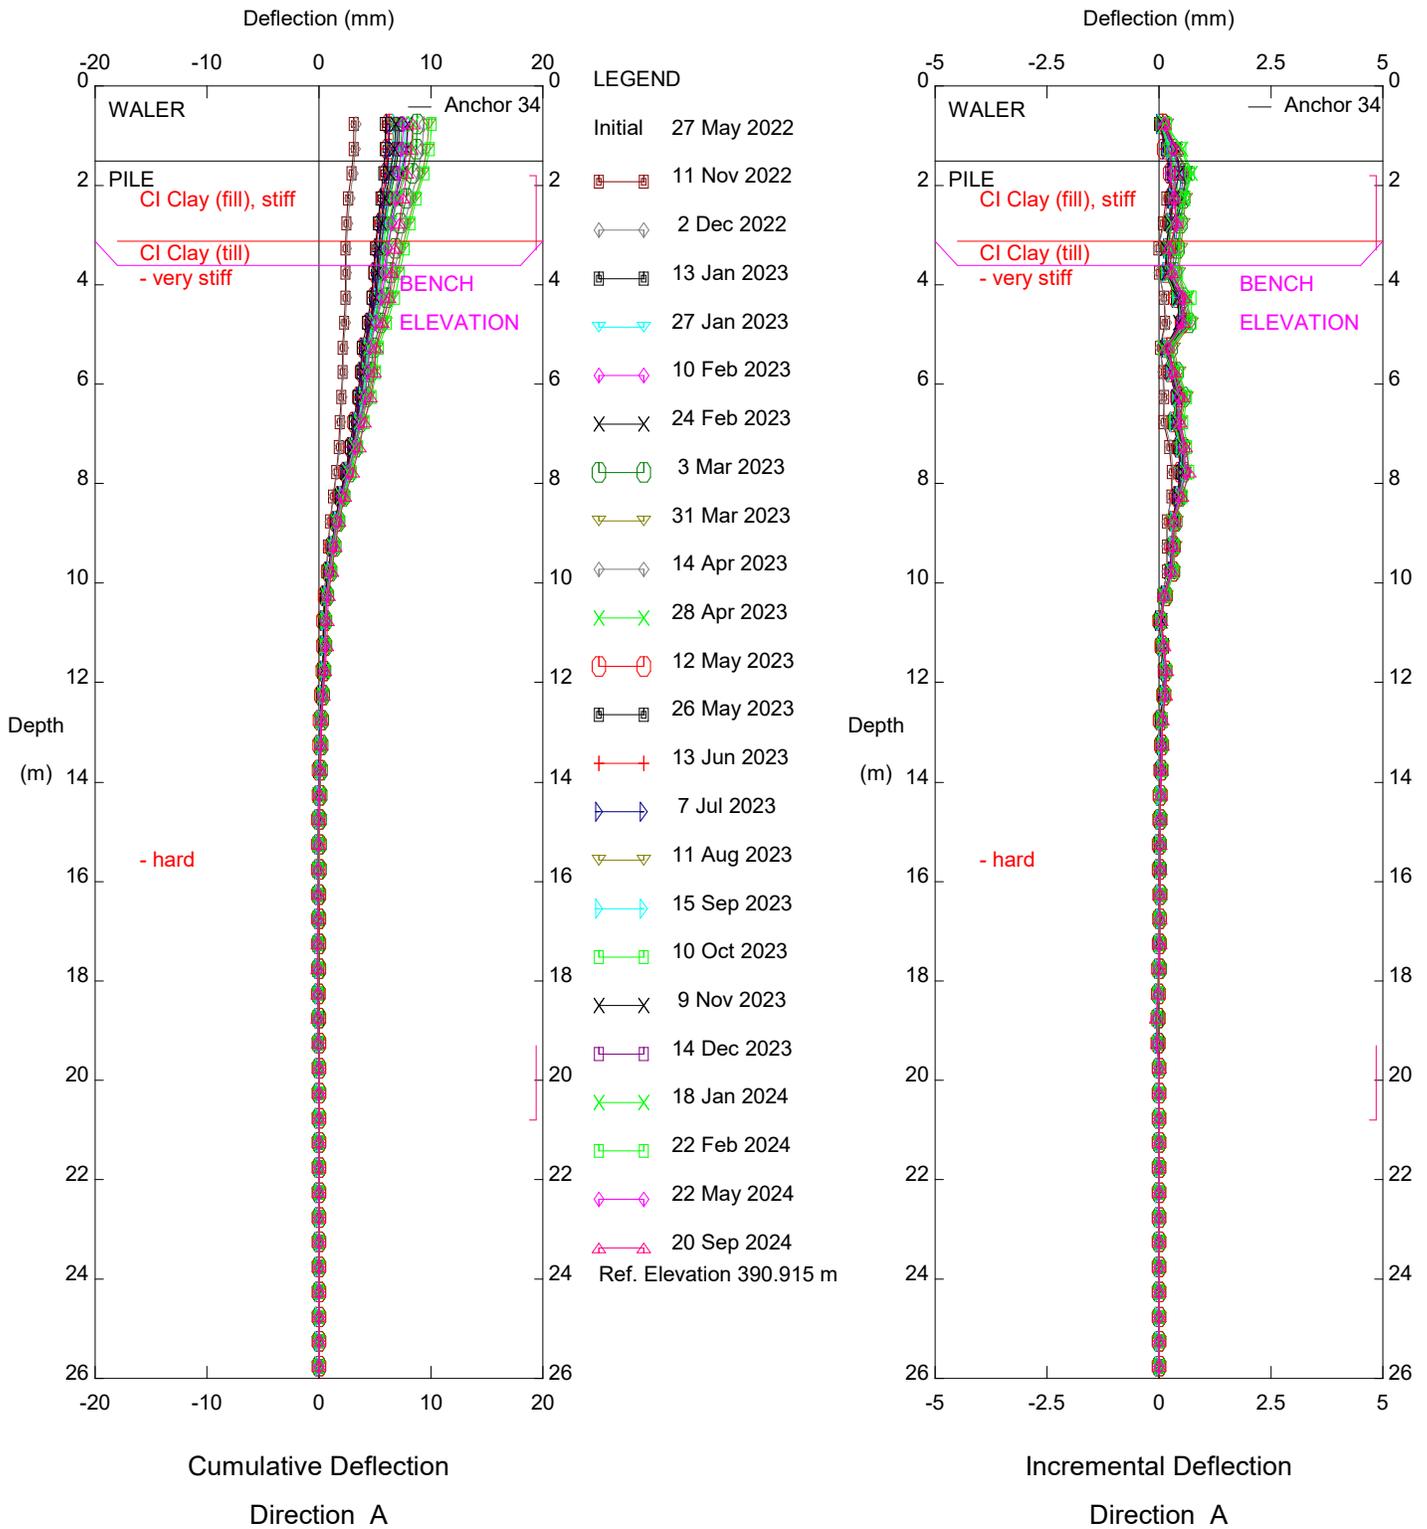
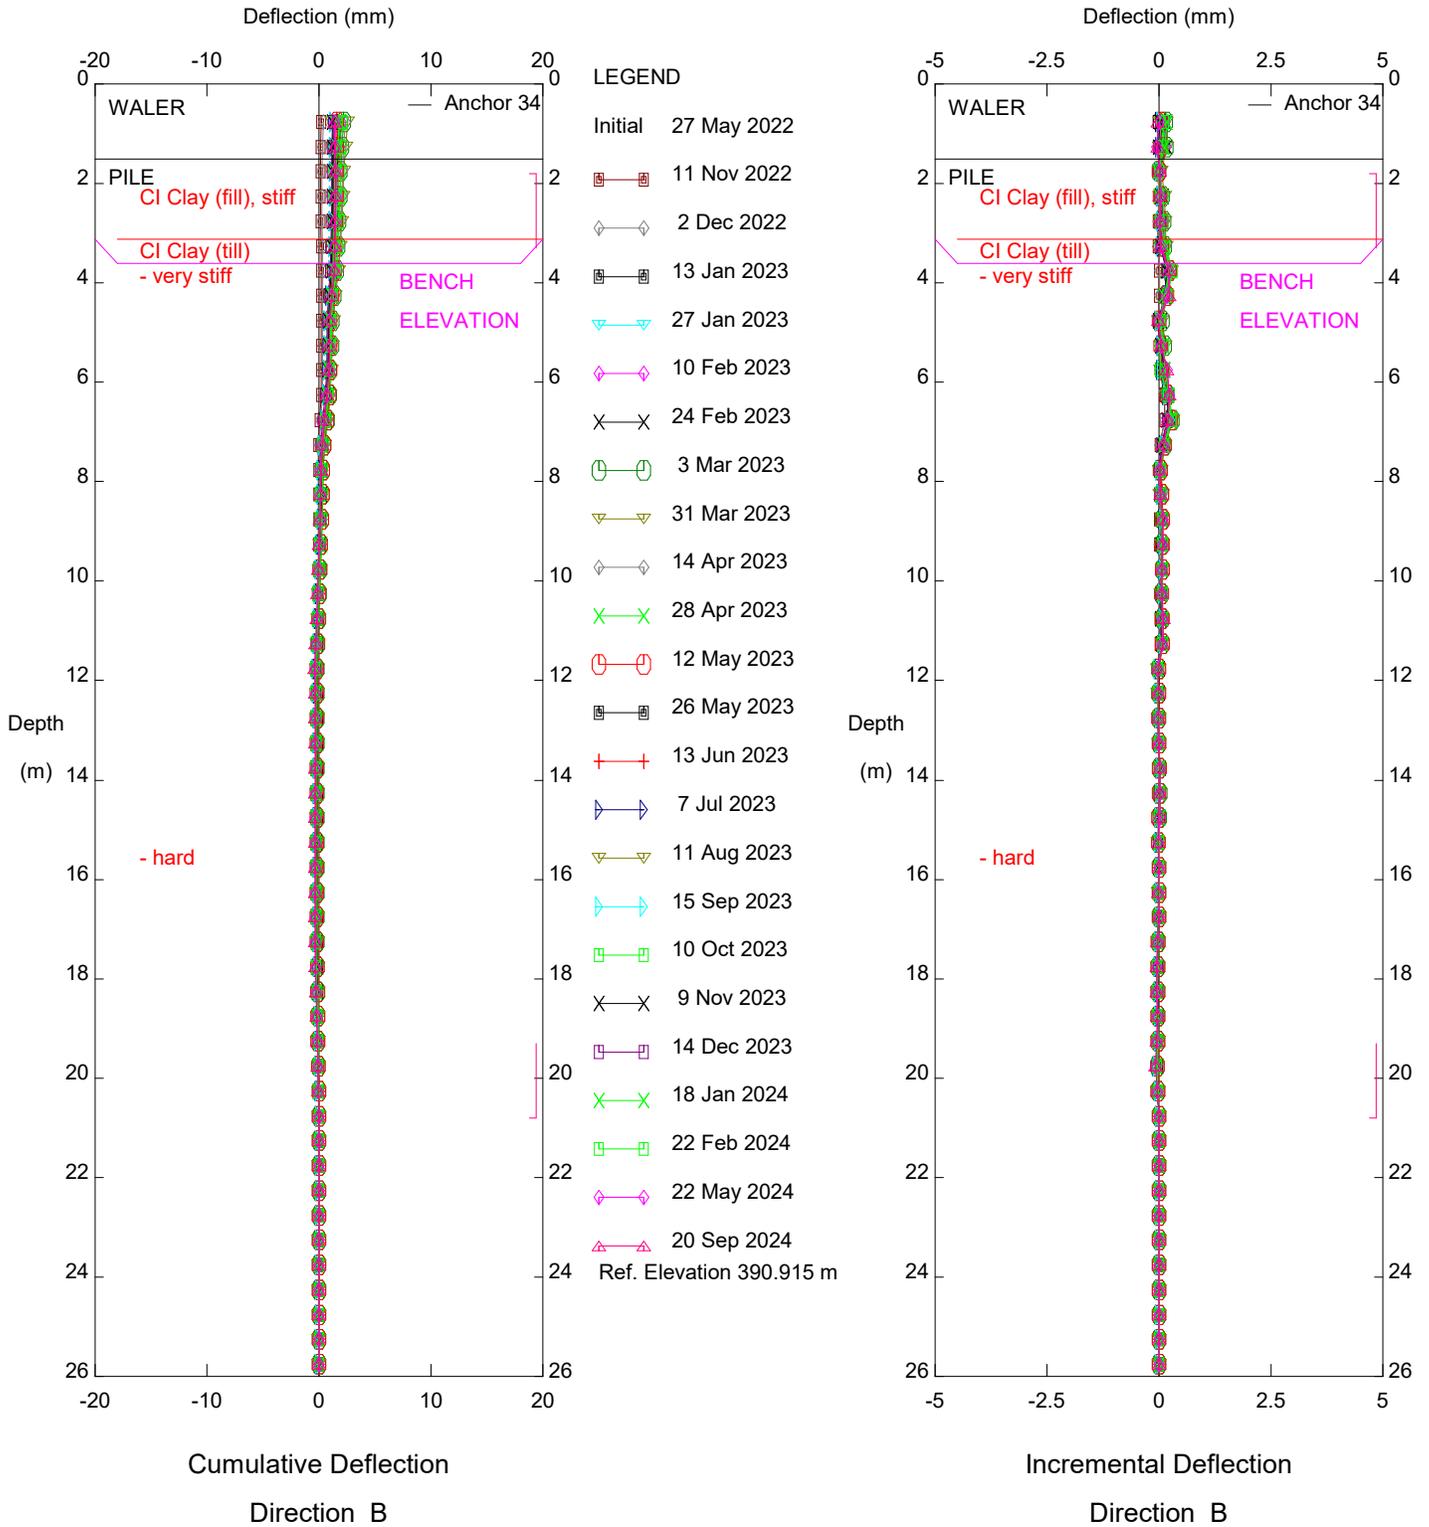
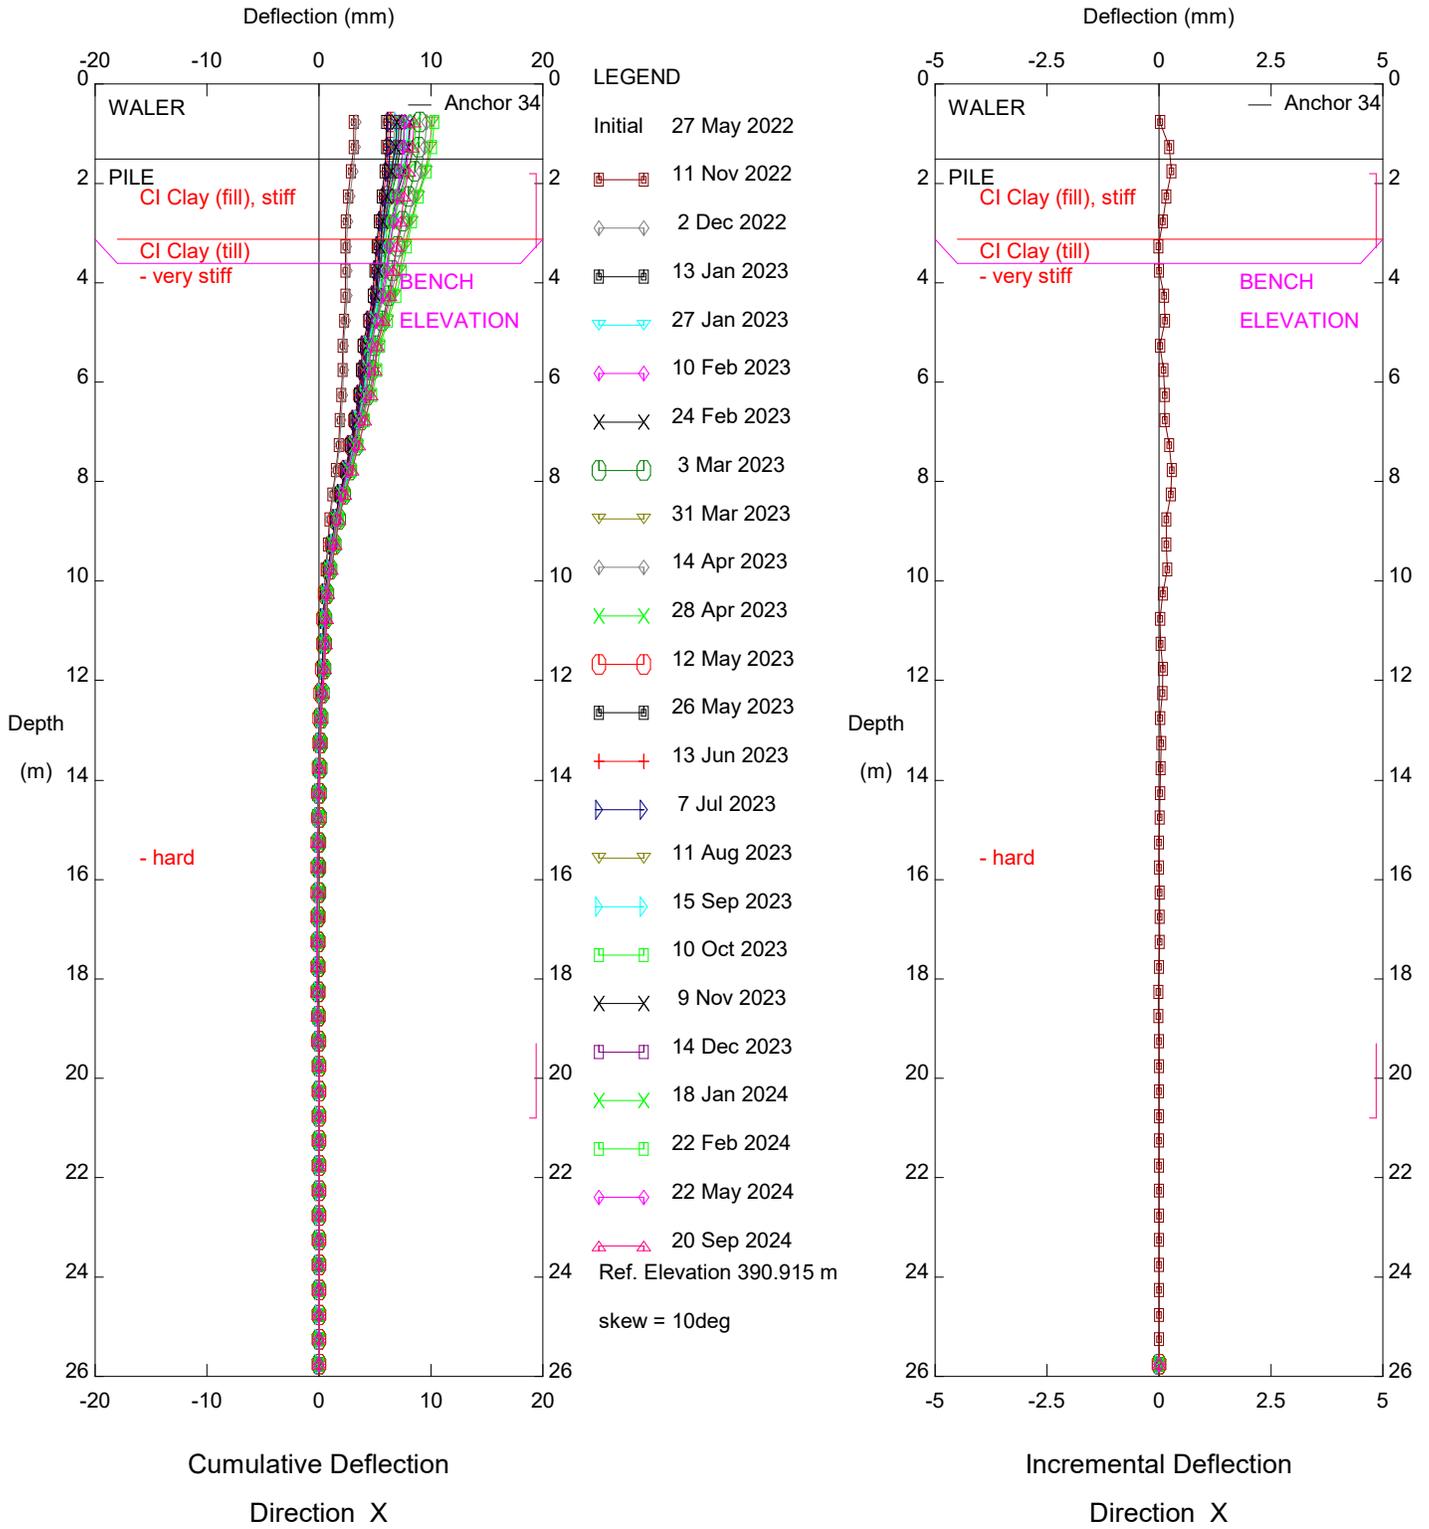
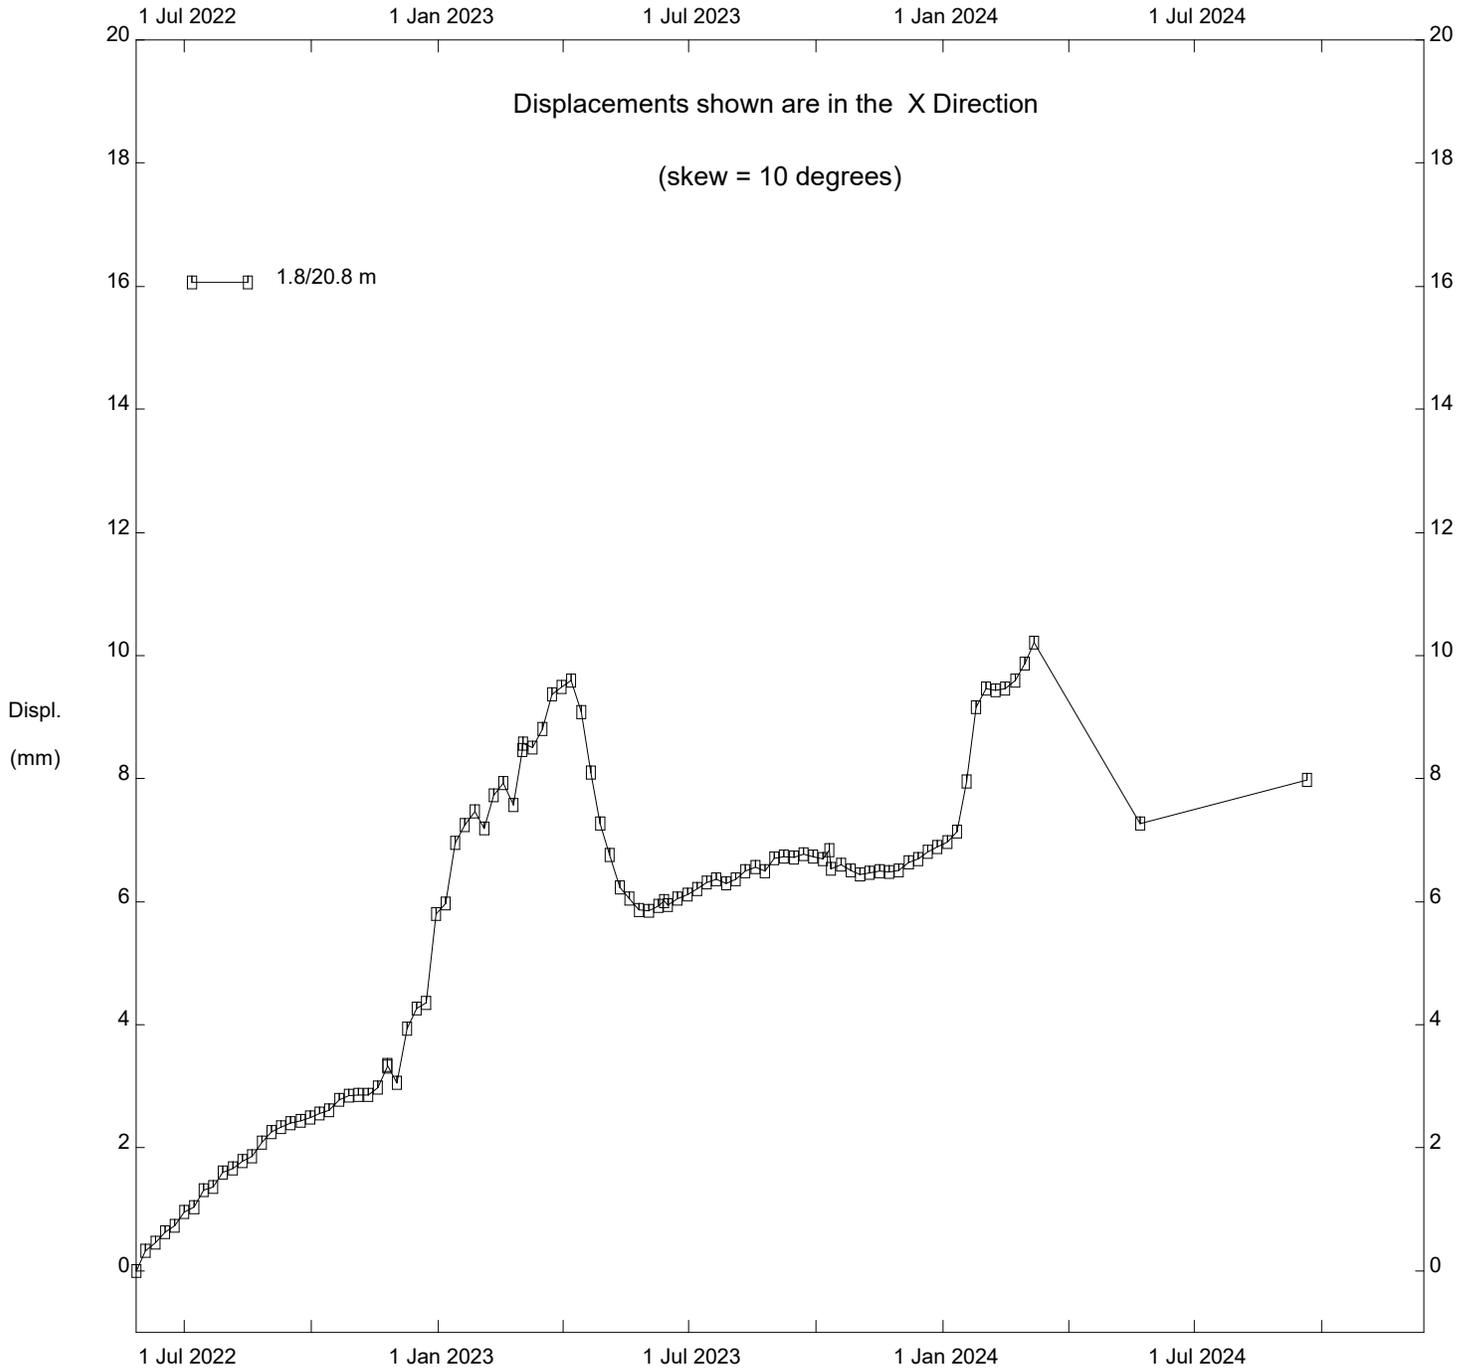
Surface accelerometer arrays (SAA) were installed in three concrete piles during construction. SAA-P34 has shown an average rate of movement of 2.2 mm/yr in the downslope direction since the spring of 2024 readings, with a current pile head deflection of 8.0 mm since datalogger readings began for this instrument on May 27, 2022. SAA-P34 shows seasonal trends of greater pile deflection through winter months and a relaxation in summer months in response to the seasonal behaviour of anchors. The maximum pile head deflection of 10.2 mm was measured in March 2024. The gap in data noted on the plot is due to theft of the datalogger battery.

Pile head deflections measured by the SAA are within an acceptable range (below the estimated SLS Design Values, measured since anchor lock-off: of 18 mm for SAA-P34, 7 mm for SAA-P77, and 39 mm for SAA-P113). More deflection is noted, as expected, in the cantilever section of

<p>the wall (SAA-P113). The additional deflection in SAA-P34 may be due to the deeper amount of cut as compared to the slope below SAA-P77. This will require additional readings and analysis to interpret and will be considered as part of the ongoing development of threshold criteria for this pile wall.</p> <p>PIEZOMETER</p> <p>Standpipe piezometers SP05-1 and SP05-5 showed decreases in groundwater level of 0.51 and 0.54 m respectively, since the spring of 2024 readings. Standpipe piezometers SP05-4, SP09-10, and SP19-3 showed increases in groundwater level of 1.11 m, 1.69 m, and 1.04 m, respectively, since the spring of 2024 readings. SP11-06, SP09 8, and SP09-9 continued to be dry (SP09-8 and SP09-9 have been dry since installation). The water levels measured in the standpipes have not demonstrated a trend. The results of the standpipe piezometers are summarized in Table PH009-5, and are plotted in Figure PH009-14 in Appendix A. Historical standpipe piezometer readings are presented in Figure PH009-15.</p> <p>VW09-4 showed a slight decrease in ground water level of 0.11 m since the spring of 2024 readings; the groundwater levels have been trending downward since 2012. VW09-3 has been dry since August 2009. The vibrating wire piezometer results are summarized in Table PH009-6, and are plotted in Figure PH009-16 in Appendix A.</p> <p>Pneumatic piezometer PN15-5A showed a decrease in groundwater level of 0.02 m since the previous reading in spring of 2024. PN19-5B showed an increase in groundwater level of 0.02 m since the spring of 2024 readings and has had a slight increasing trend overall since installation (February 2019). Pneumatic piezometer results are summarized in Table PH009-7, and are plotted in Figure PH009-16 in Appendix A.</p>
