**ALBERTA TRANSPORTATION AND
ECONOMIC CORRIDORS GRMP
PEACE REGION – (PEACE RIVER DISTRICT)
INSTRUMENTATION MONITORING - FALL 2024**

Site Number	Location	Name	Hwy	km
PH009-3	Hwy 684:02 km 30.99, Town of Peace River	Shaftesbury Trail - Shop Slide	684:02	30.9-31.1
			Old 2:02	0.0-0.4
Legal Description:		UTM Co-ordinates		
4-31-83-21 W5		11V E 480321	N	6232126

Current Monitoring:	19 & 20-Sep-2024	Previous Monitoring	22-May-2024
Instruments Read By:	Mr. Niraj Regmi, G.I.T., and Mr. Nixson Mationg, of Thurber

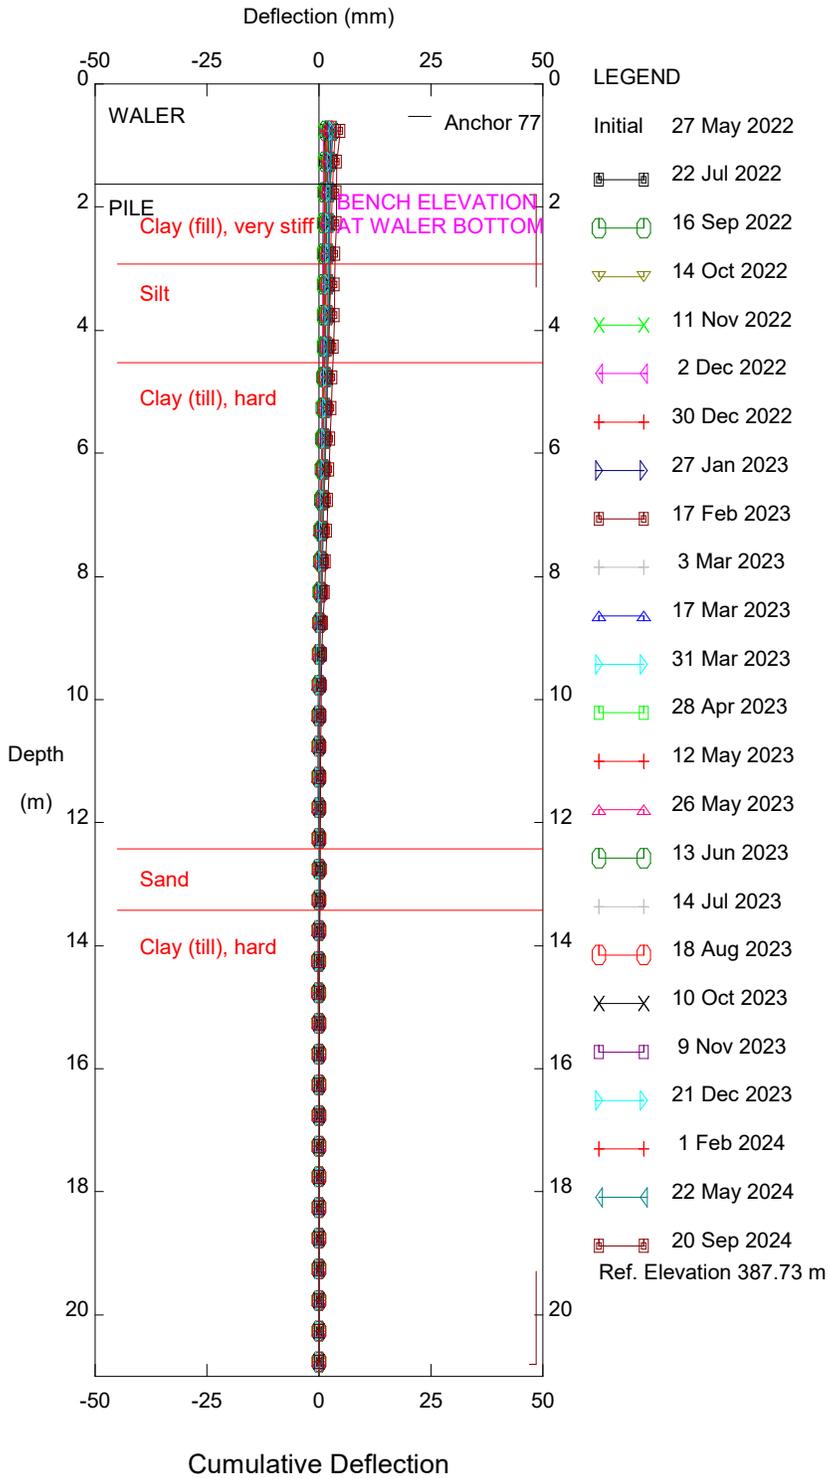
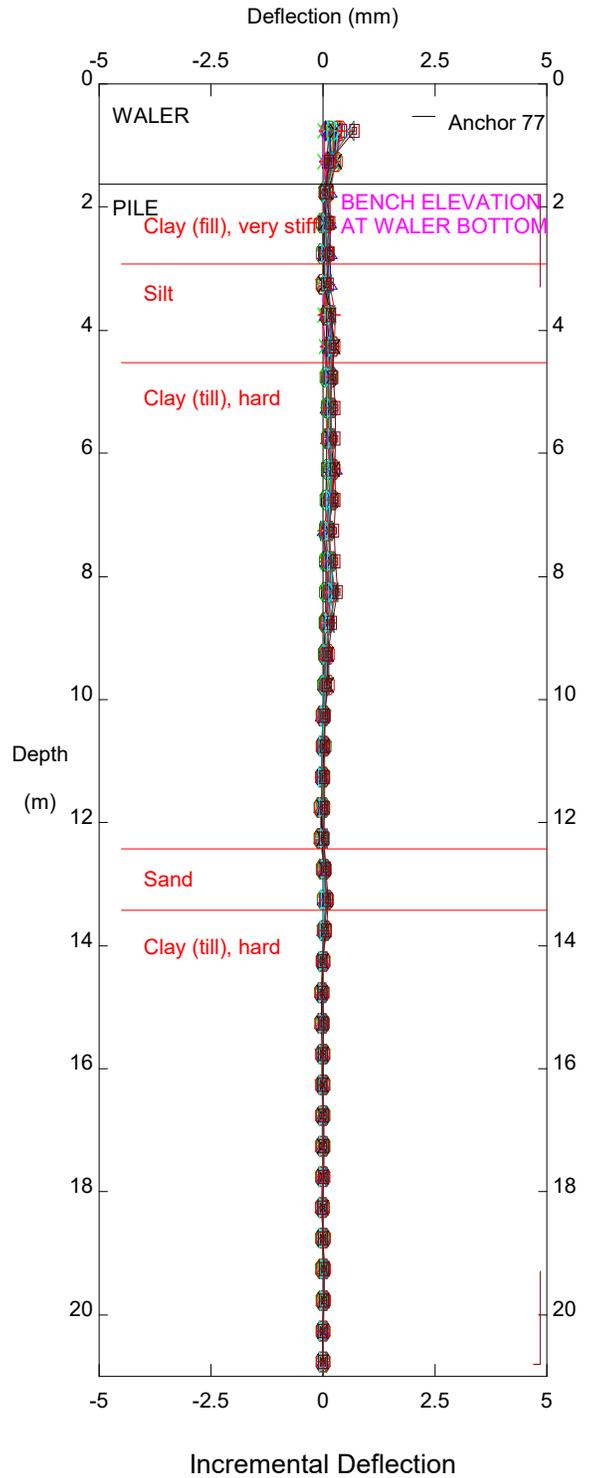
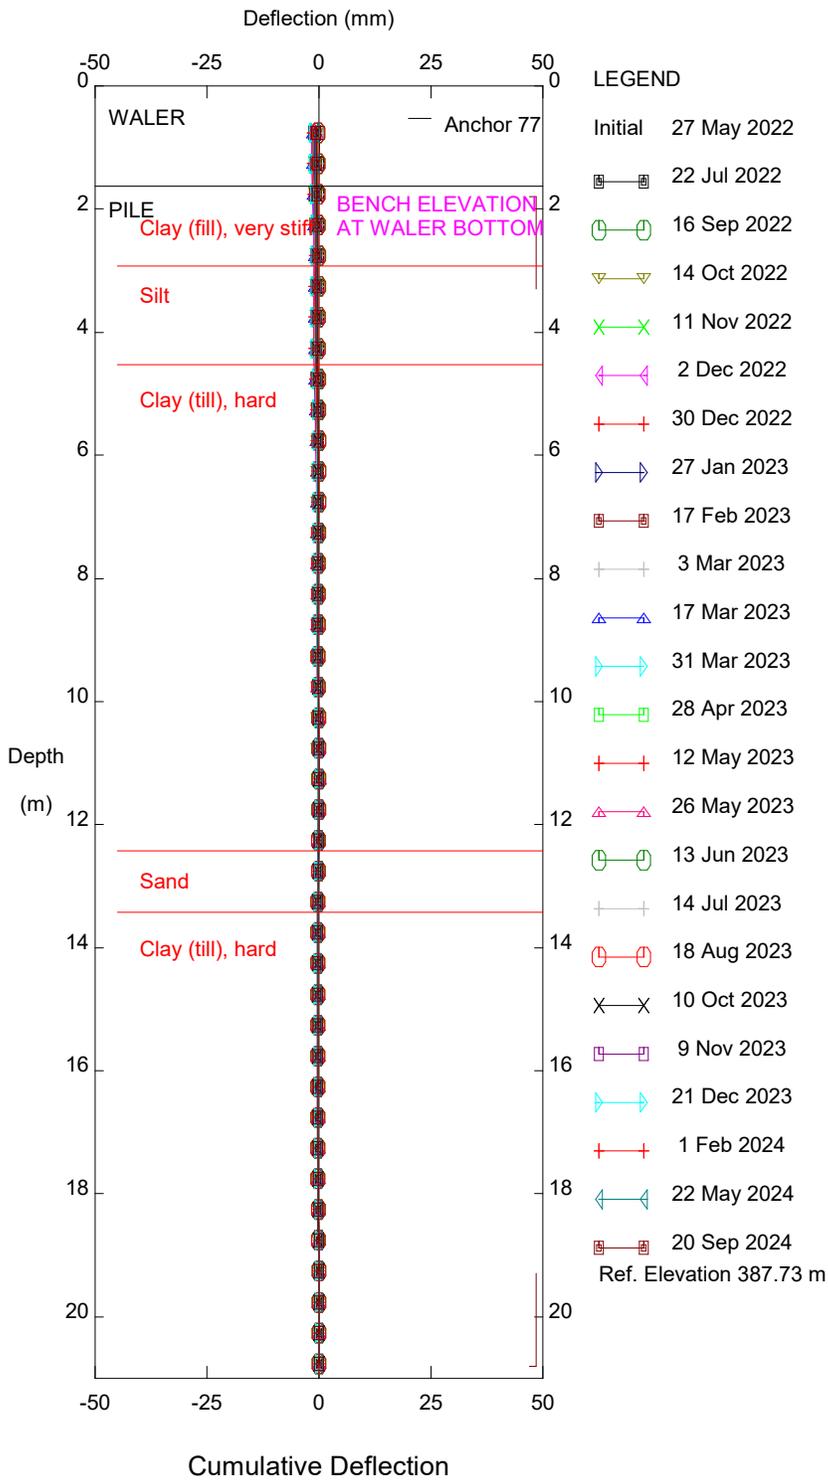
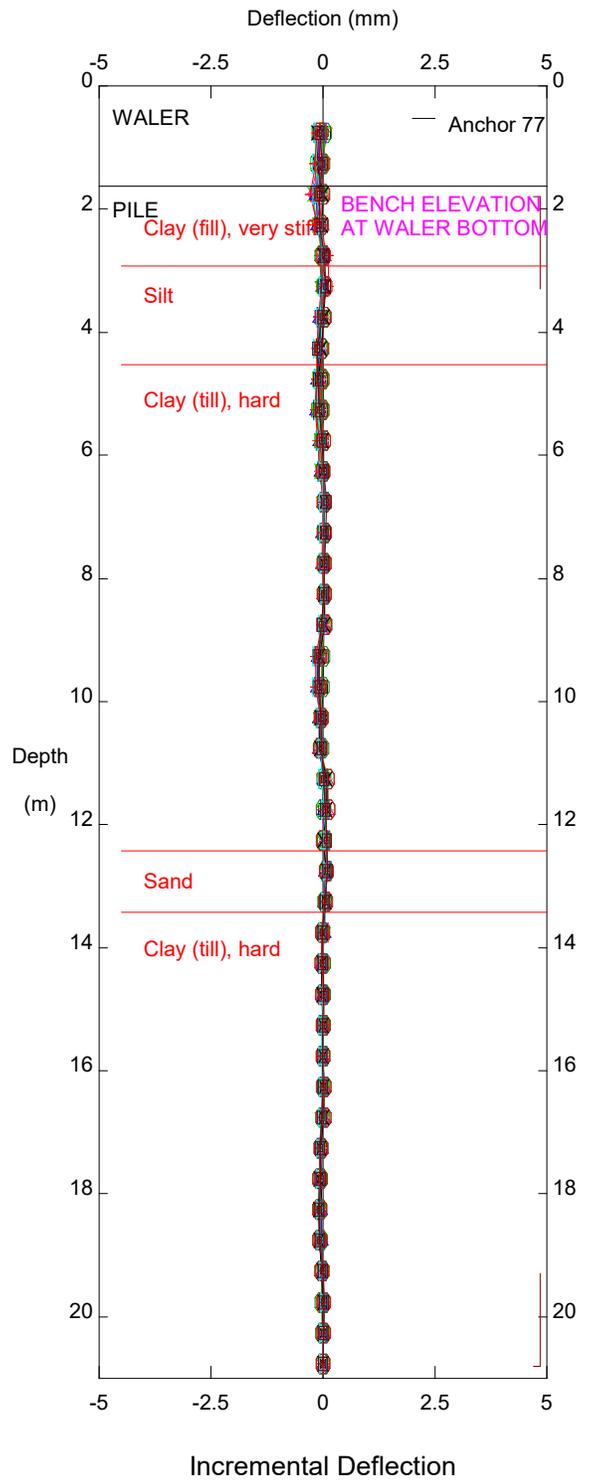
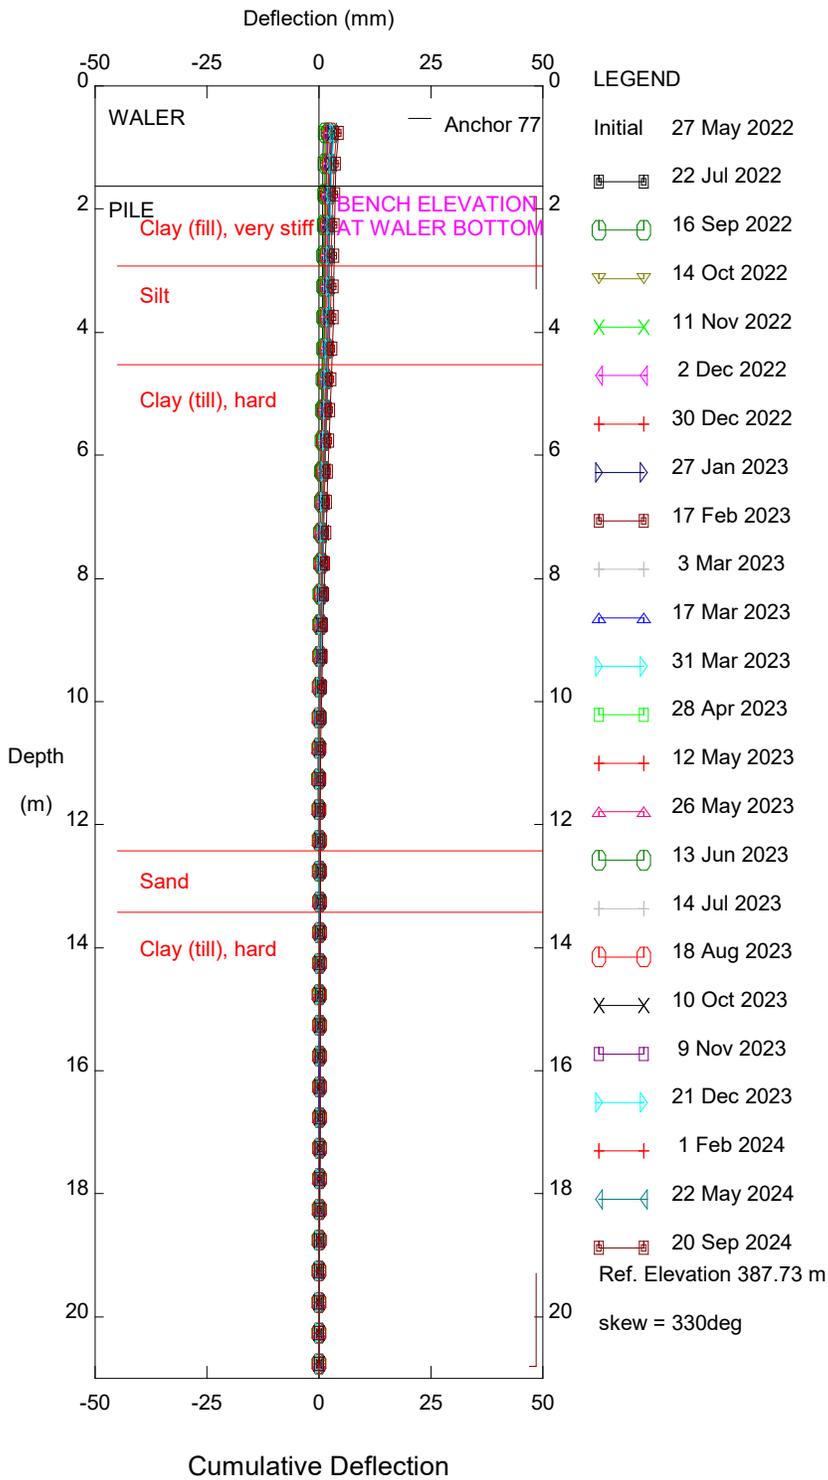
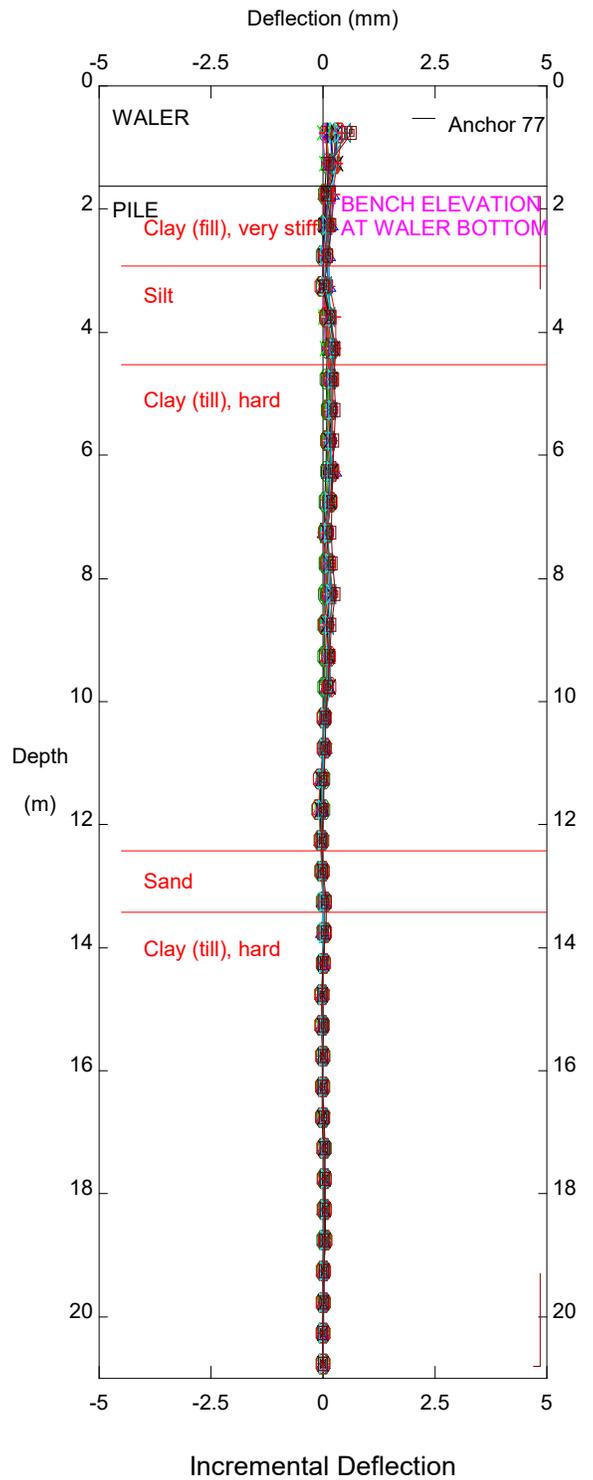
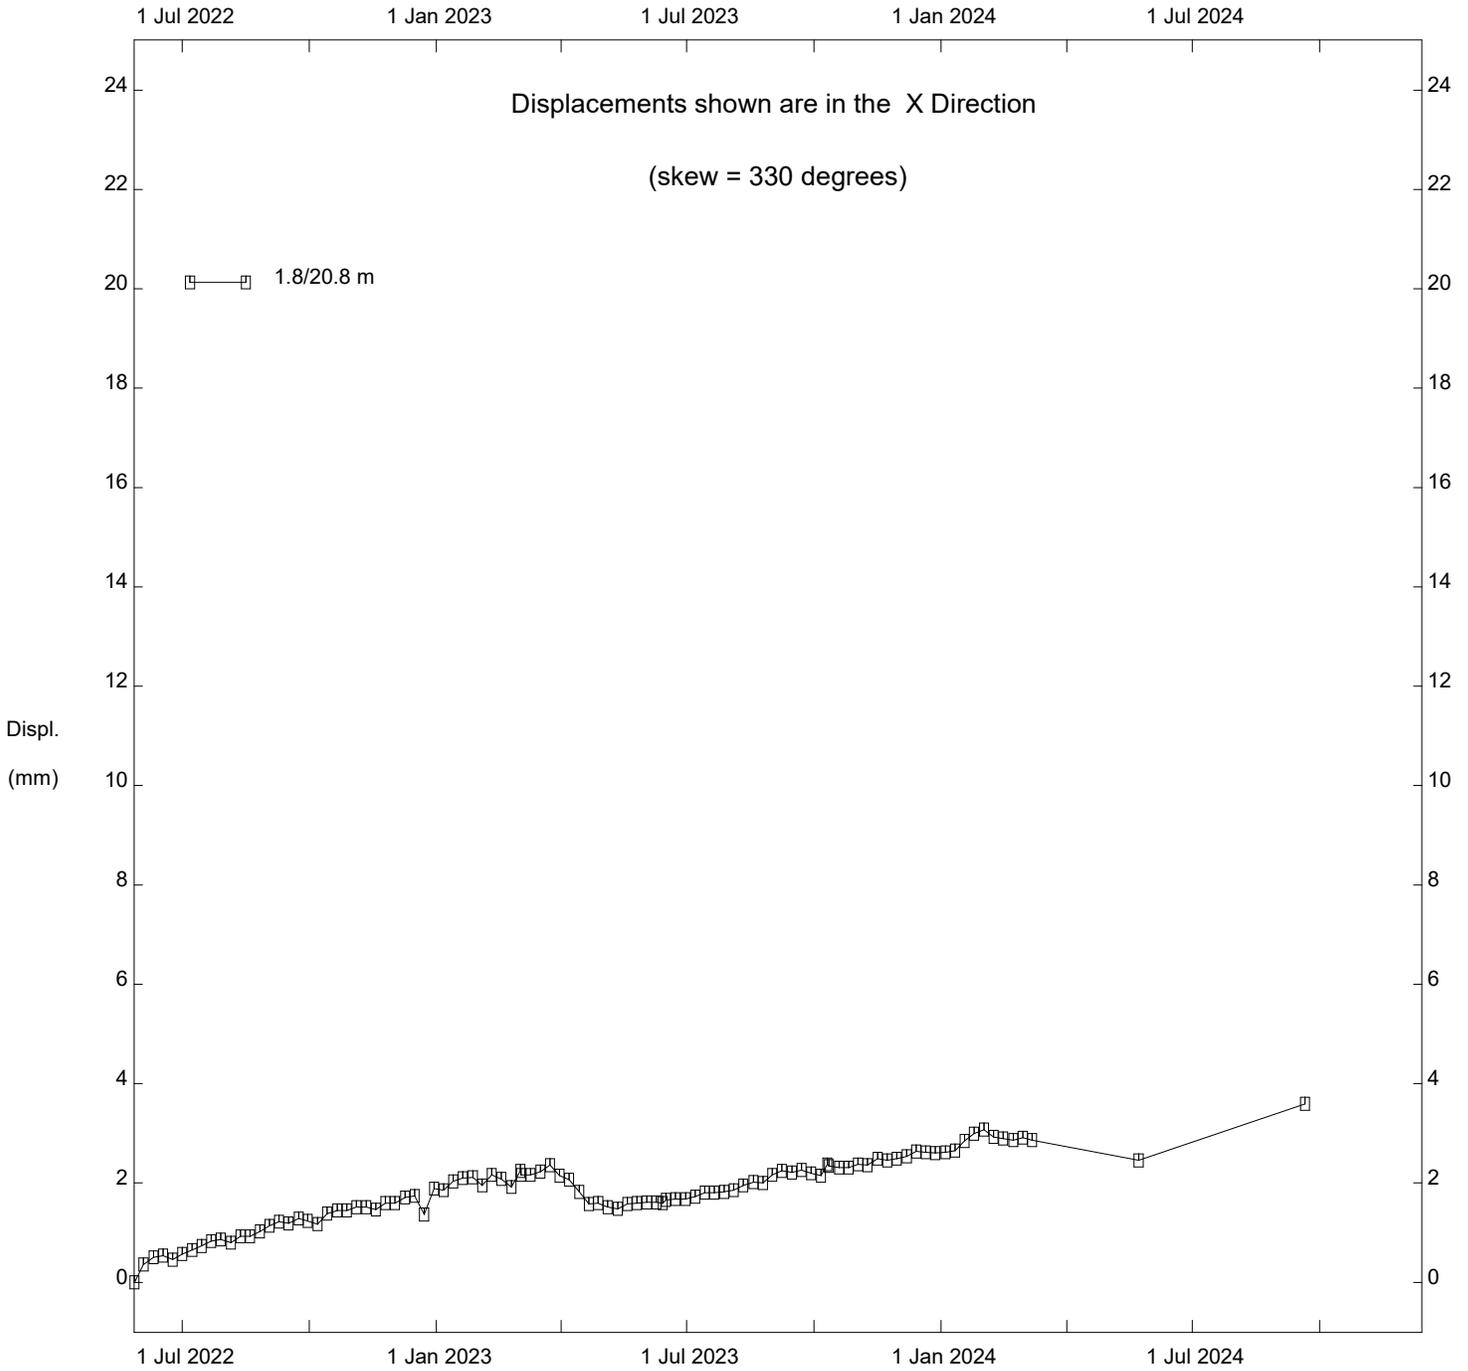
SAA-P77 showed a rate of movement of 3.4 mm/yr since the spring of 2024 readings. SAA-P77 has shown a total pile head movement of 3.6 mm since datalogger readings began on May 27, 2022. The currently recorded pile head movement of 3.6 mm is the maximum pile head deflection recorded in the instrument. There seasonal movement trend at SAA-P77 is less pronounced compared to SAA-P34 which is due to the lower height of the wall at this location (roughly 3 m compared to 6 m to 7 m at P34).

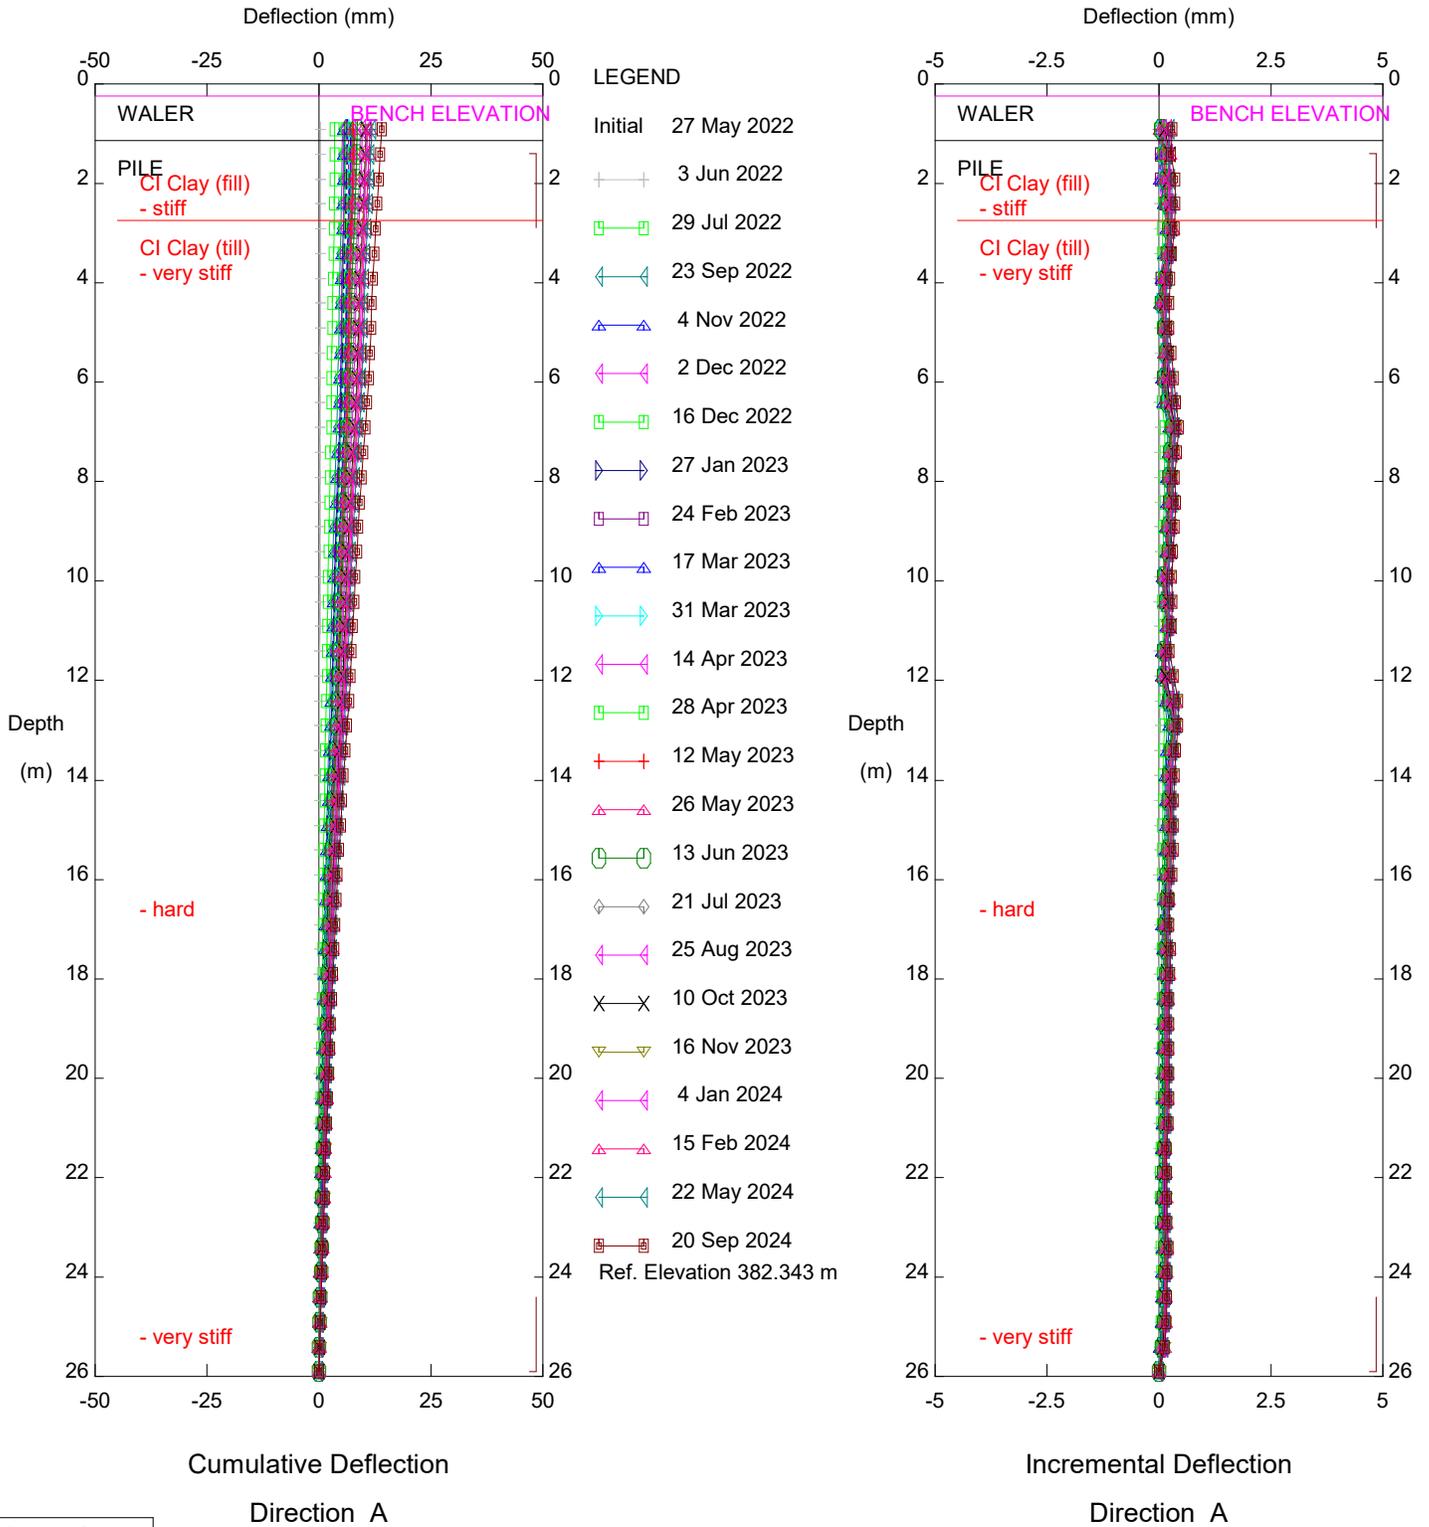
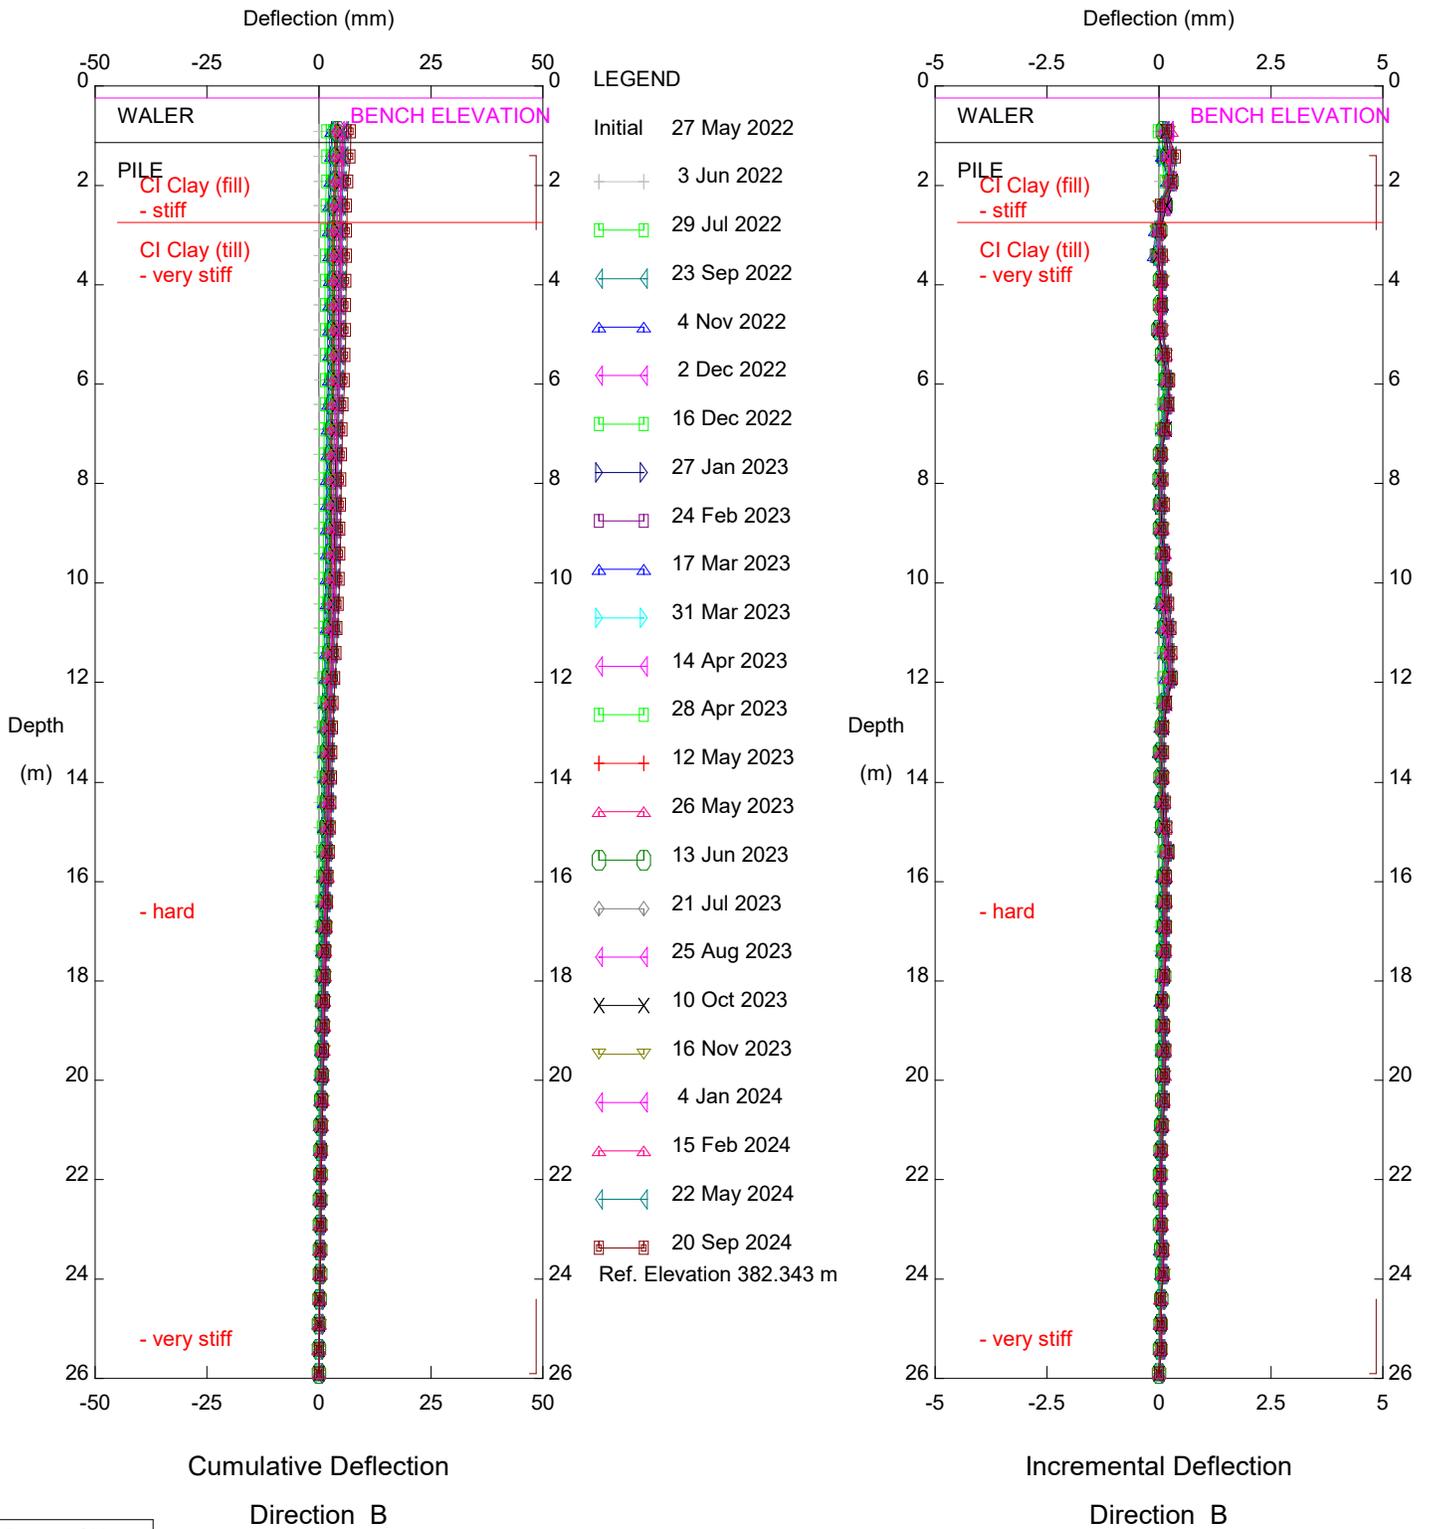
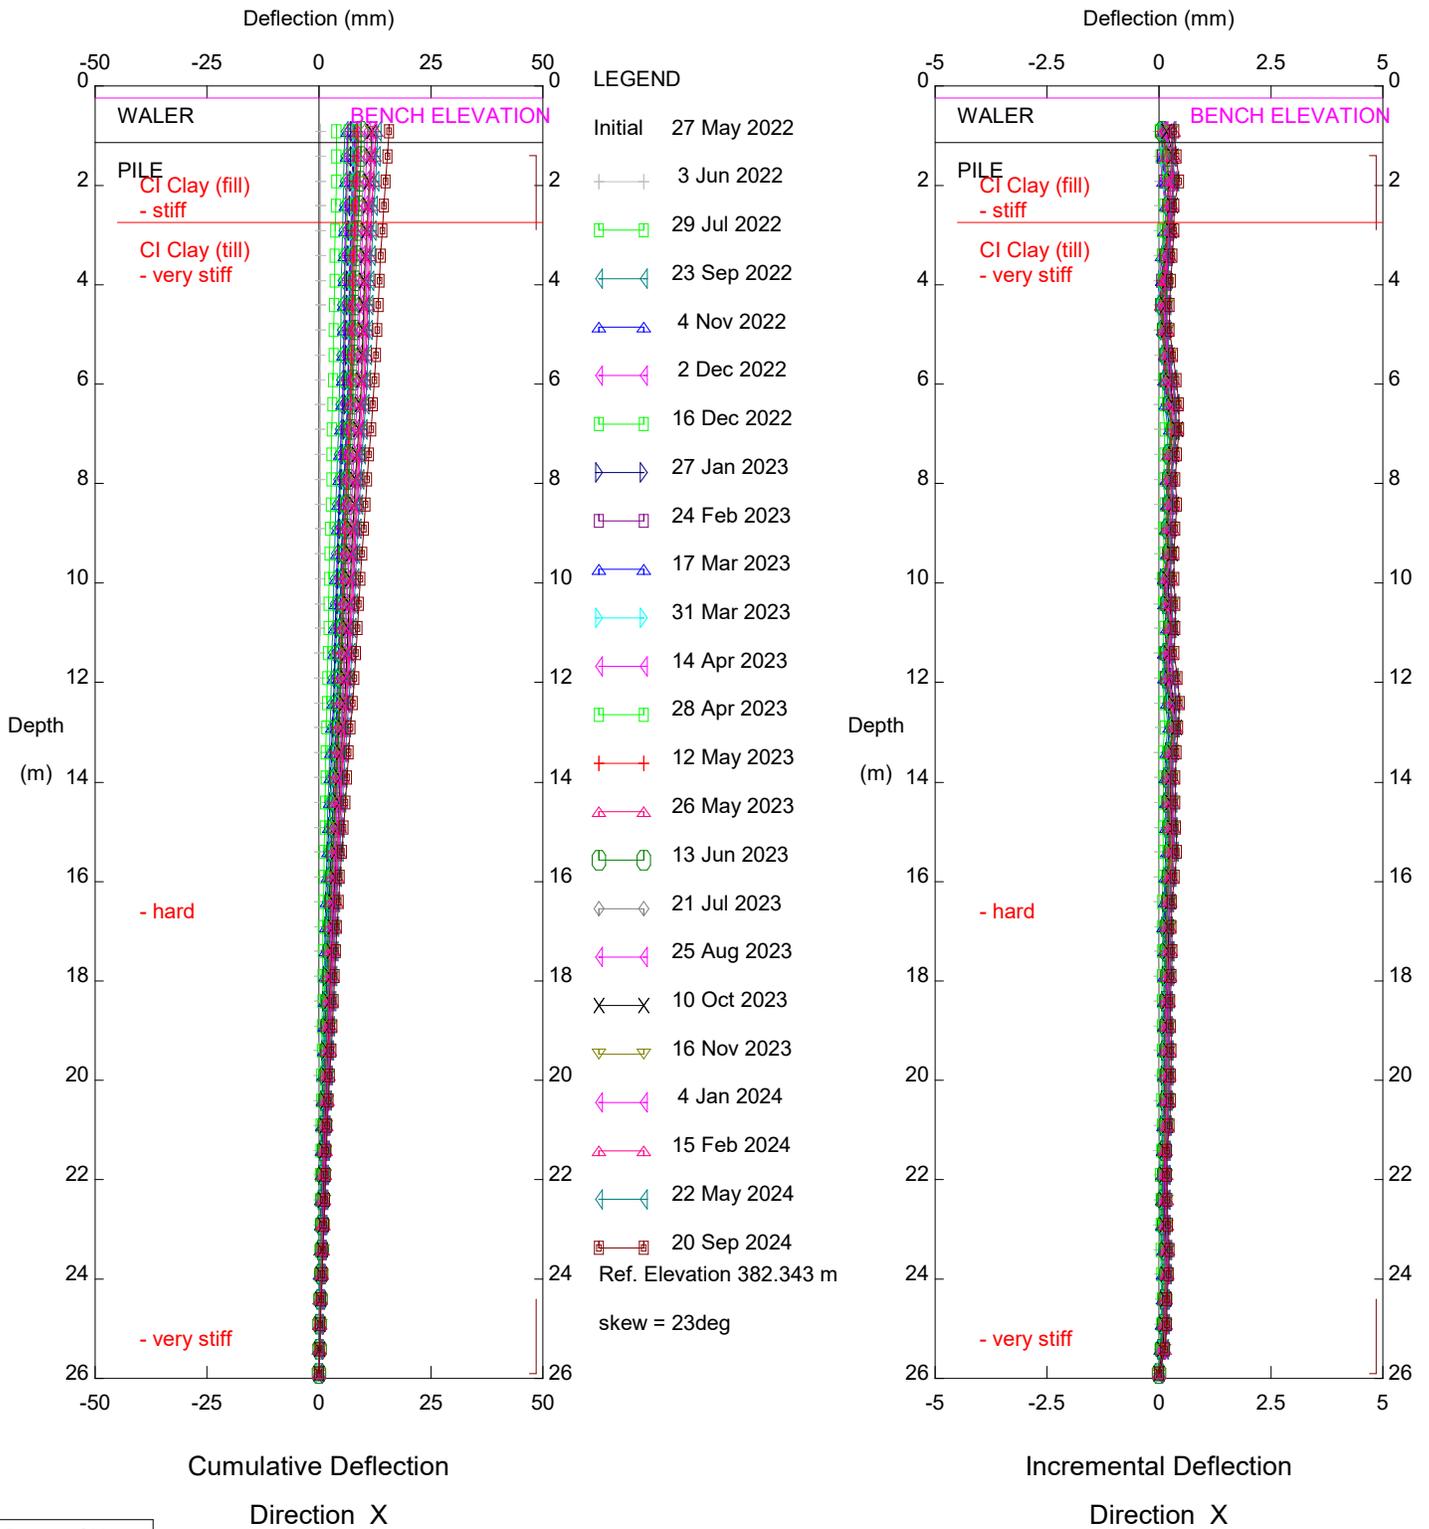
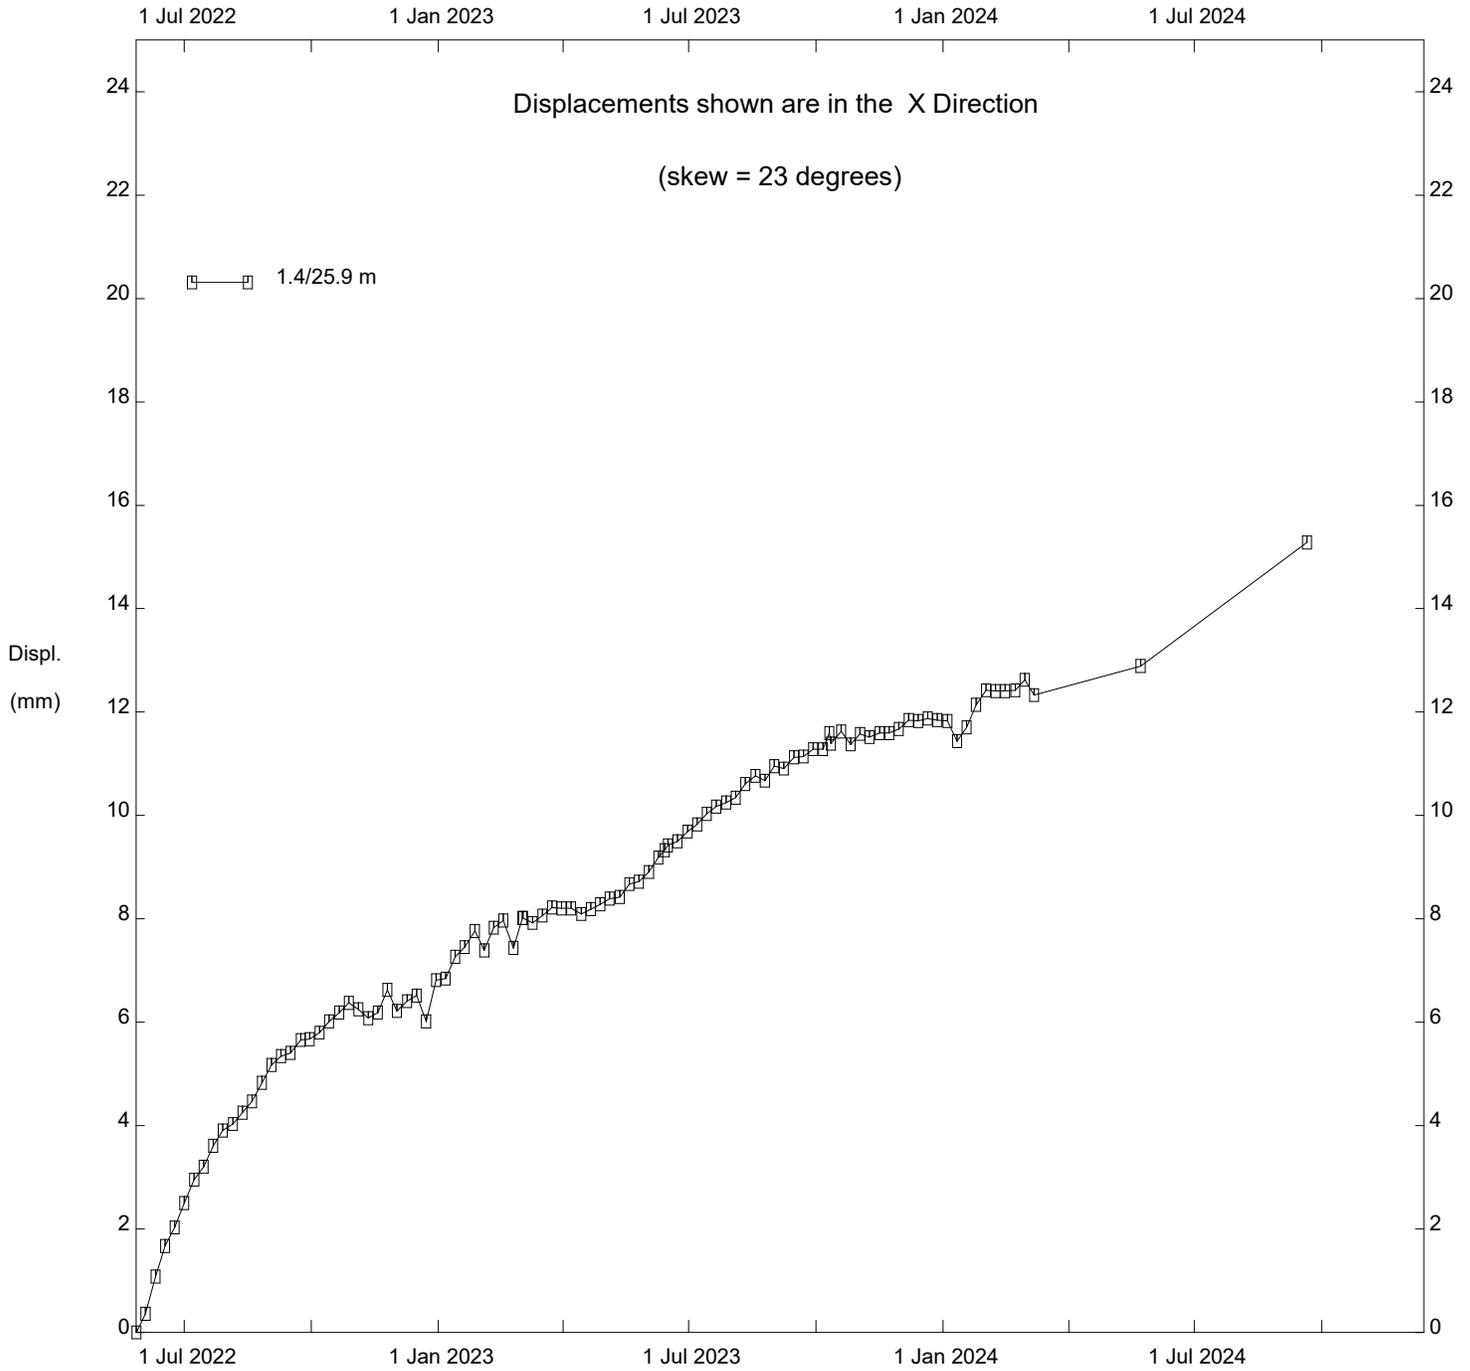
SAA-P113 has shown an average rate of movement of 7.3 mm/yr in the downslope direction since the spring of 2024 readings, with a total pile head deflection of 15.3 mm since datalogger readings began on May 27, 2022. The higher observed movement in SAA-P113 can be attributed to the fact that the pile wall at this location is cantilevered rather than tied-back like the other portions of the wall. The movement rate measured in the instrument has increased since the spring of 2024 readings by 4.6 mm/yr. SAAP-113 does not show clear seasonal movement trends as

SAA-P34 or SAA-P77 since there are no anchors in this portion of the wall.

Pile head deflections measured by the SAA are within an acceptable range (below the estimated SLS Design Values, measured since anchor lock-off: of 18 mm for SAA-P34, 7 mm for SAA-P77, and 39 mm for SAA-P113). More deflection is noted, as expected, in the cantilever section of

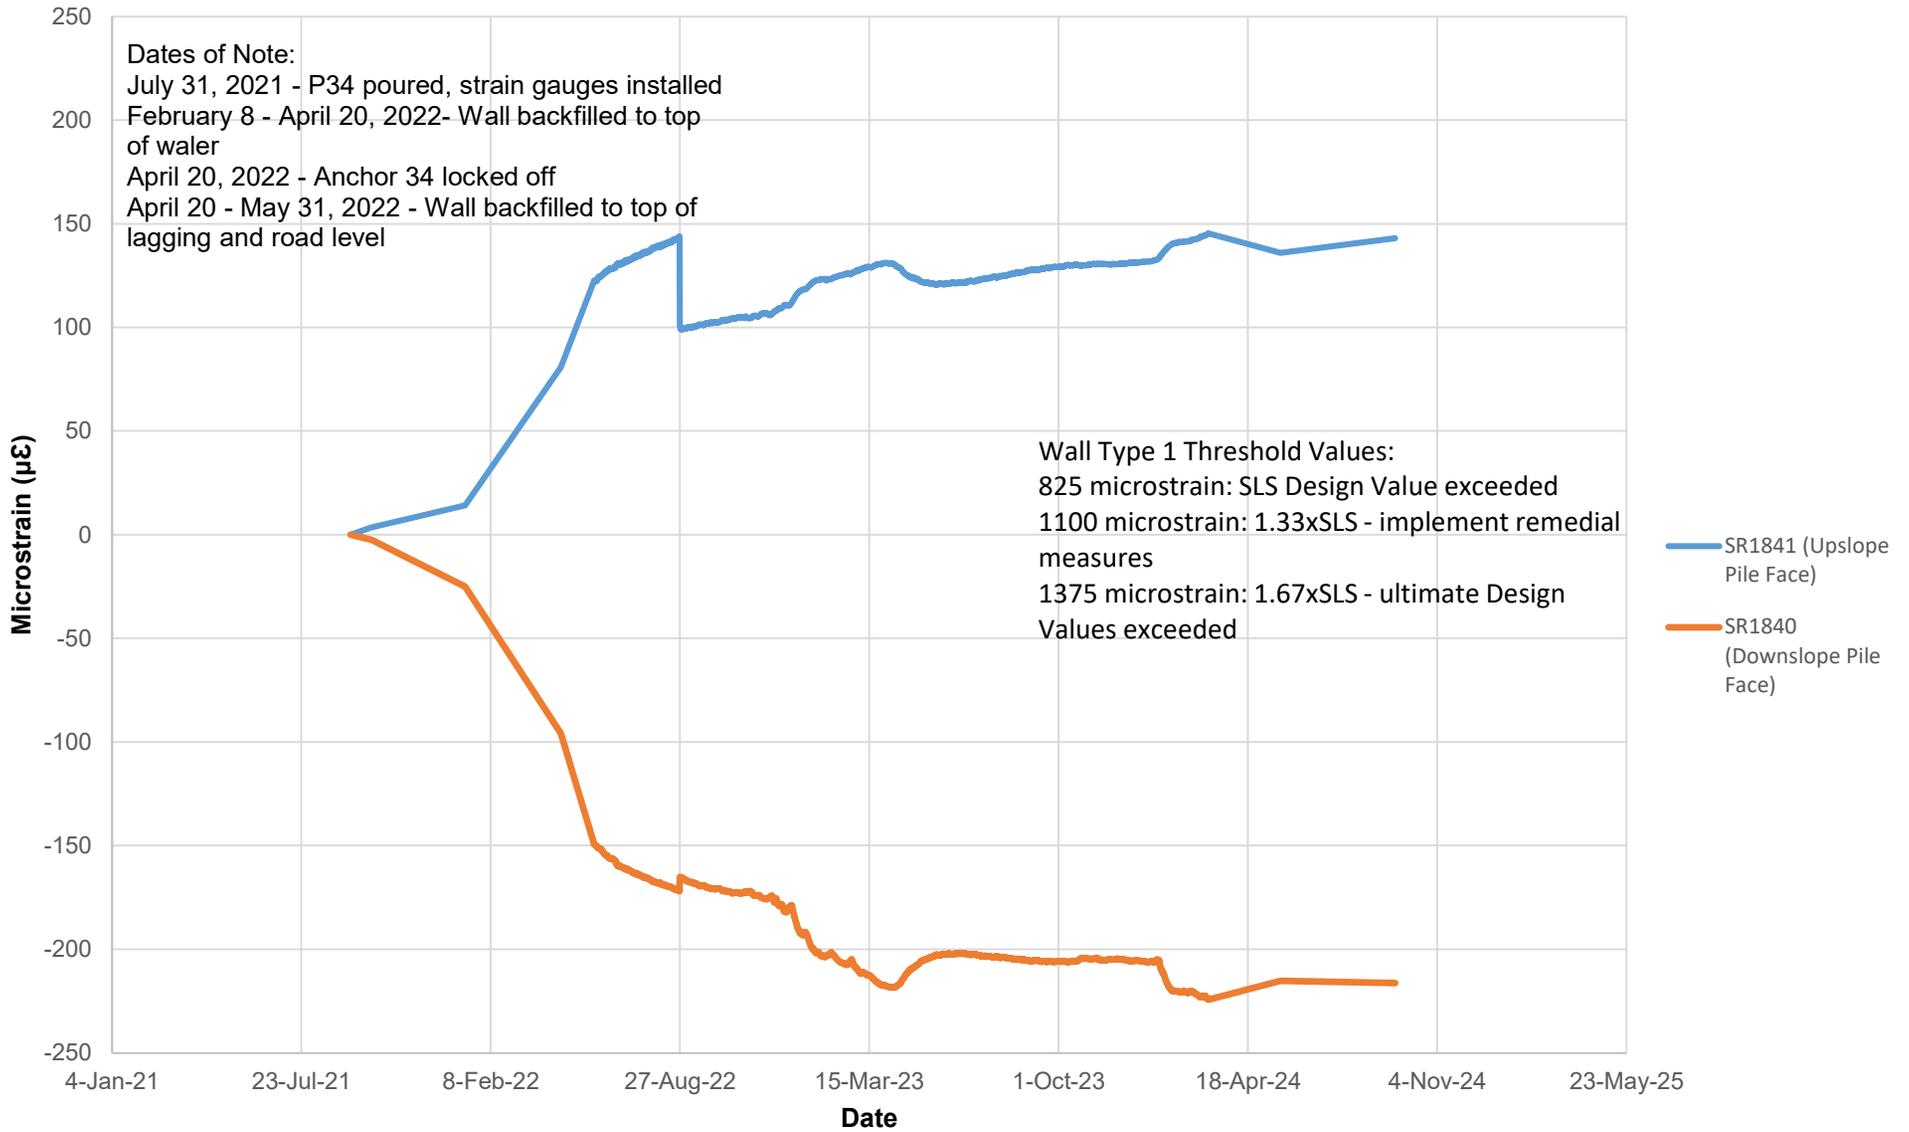
**FIGURE PH009-3: PEACE RIVER SHOP SLIDE
P34 MAXIMUM STRAIN VS TIME (9.3 m DEPTH)**

Strain gauge arrays were installed in pile P34, P77 and P113. The strain profiles along all three piles are well below the established threshold for implementation of remedial measures and show strain rate profiles consistent with anticipated trends. The strain gauges in P34 (Figures PH009-1 and -2) show their maximum positive (tension) strain (143.1 microstrain) on the upslope pile face at 9.3 m depth, with a corresponding trend of negative (compression) strain (-216.3 microstrain) on the downslope pile face at the same depth. This seems to correspond to the observed deflection of the pile in the downslope direction noted in SAA-P34 above 9 m depth. The strains measured at this depth are plotted against time in Figure PH009-3.Th

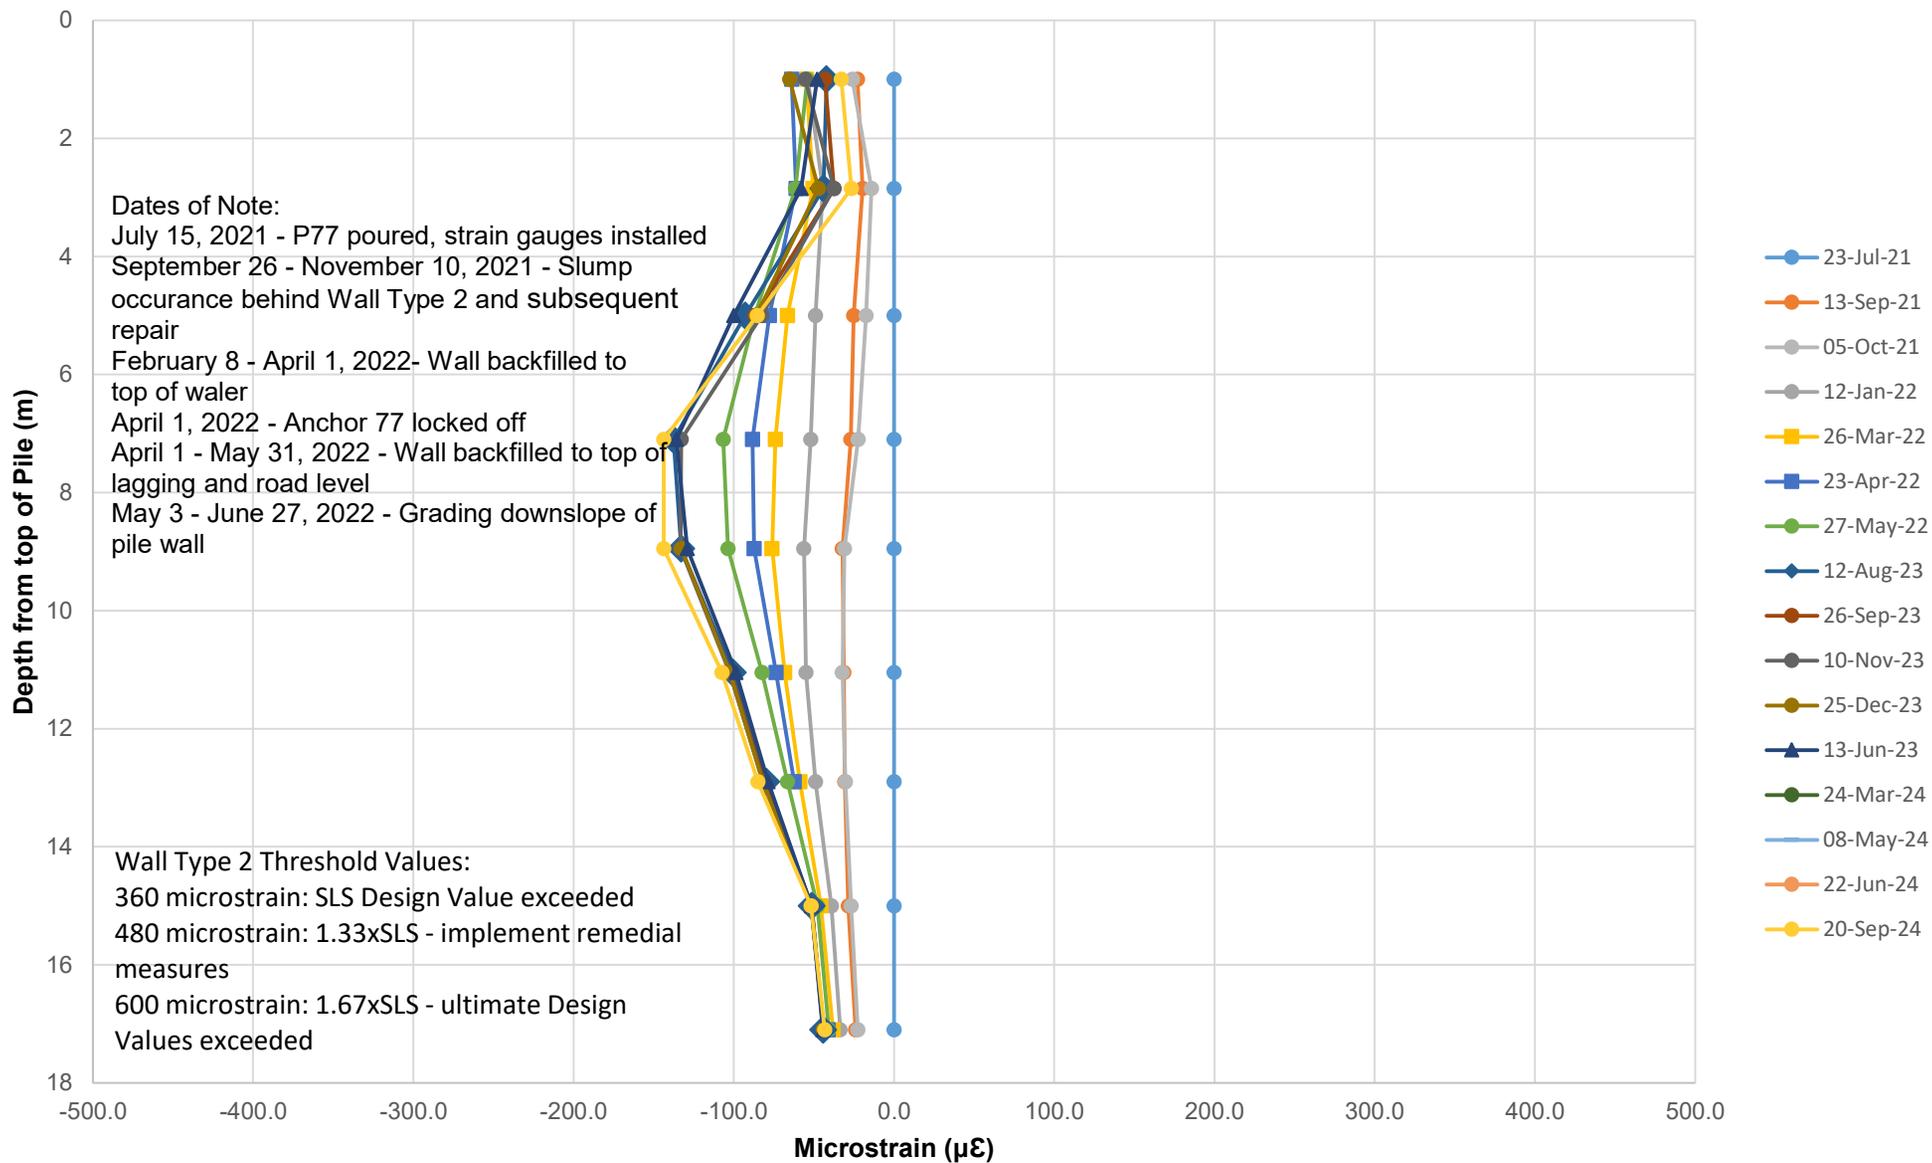
**FIGURE PH009-5: PEACE RIVER SHOP SLIDE
P77 DOWNSLOPE SIDE STRAIN GAUGE VALUES VS DEPTH**

The strain gauges on the downslope side of P77 (Figure PH009-5) indicate a maximum negative strain of -143.8 microstrain at a depth of 8.95 m. P77 does not show as clear of a trend of strain in the upslope pile strain gauges (Figure PH009-4) compared to P34: the maximum positive strain was 18.4 microstrain at 8.95 m (which corresponds with the maximum negative strain on the downslope side) and the maximum negative strain was -29.8 microstrain at 12.9 m. The strains measured at 9.0 m (rounded up from 8.95 m) and 12.9 m are plotted against time in Figure PH009-6 and -7, respectively.
