**ALBERTA TRANSPORTATION AND
ECONOMIC CORRIDORS GRMP
PEACE REGION – (PEACE RIVER DISTRICT)
INSTRUMENTATION MONITORING - FALL 2024**

Site Number	Location	Name	Hwy	km
PH009-3	Hwy 684:02 km 30.99, Town of Peace River	Shaftesbury Trail - Shop Slide	684:02	30.9-31.1
			Old 2:02	0.0-0.4
Legal Description:		UTM Co-ordinates		
4-31-83-21 W5		11V E 480321	N	6232126

Current Monitoring:	19 & 20-Sep-2024	Previous Monitoring	22-May-2024
Instruments Read By:	Mr. Niraj Regmi, G.I.T., and Mr. Nixson Mationg, of Thurber

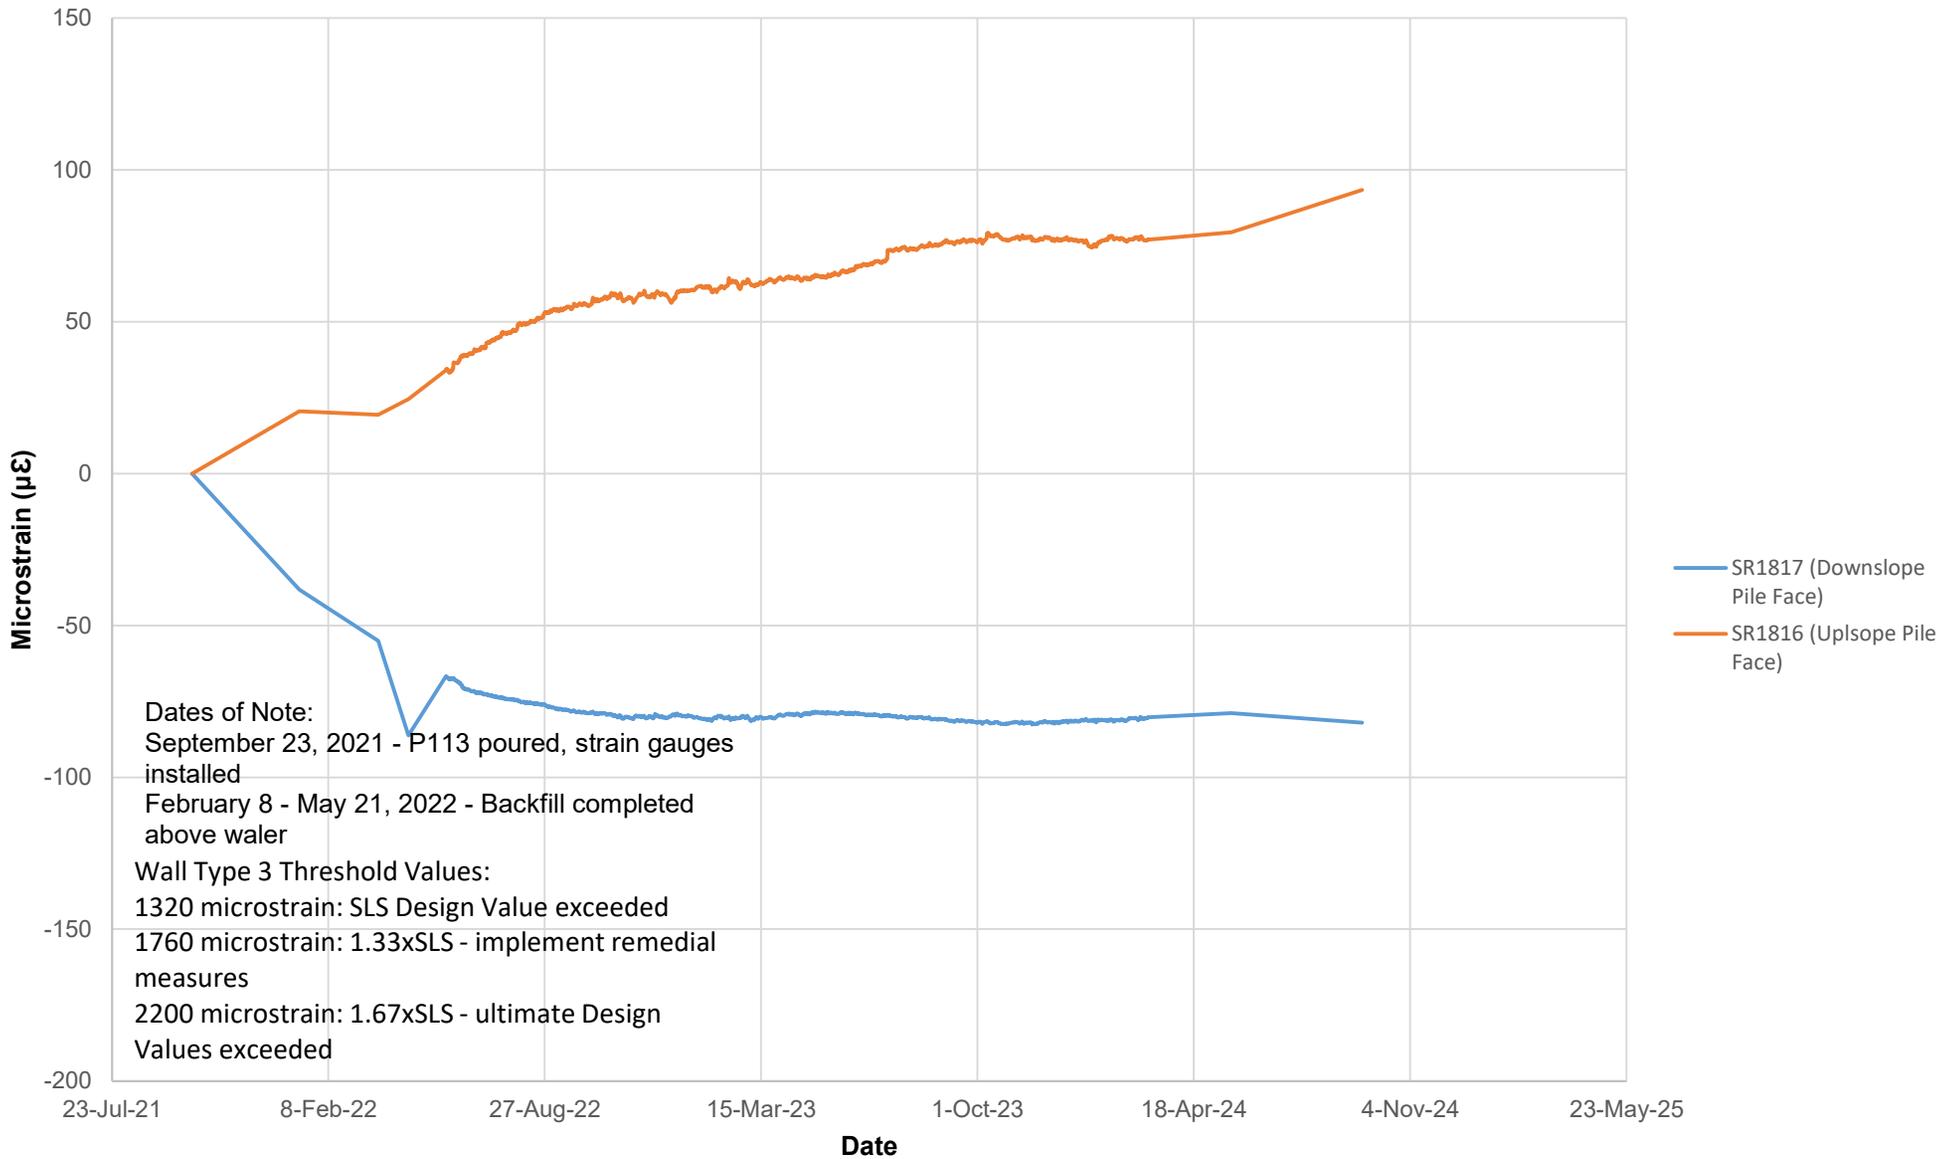
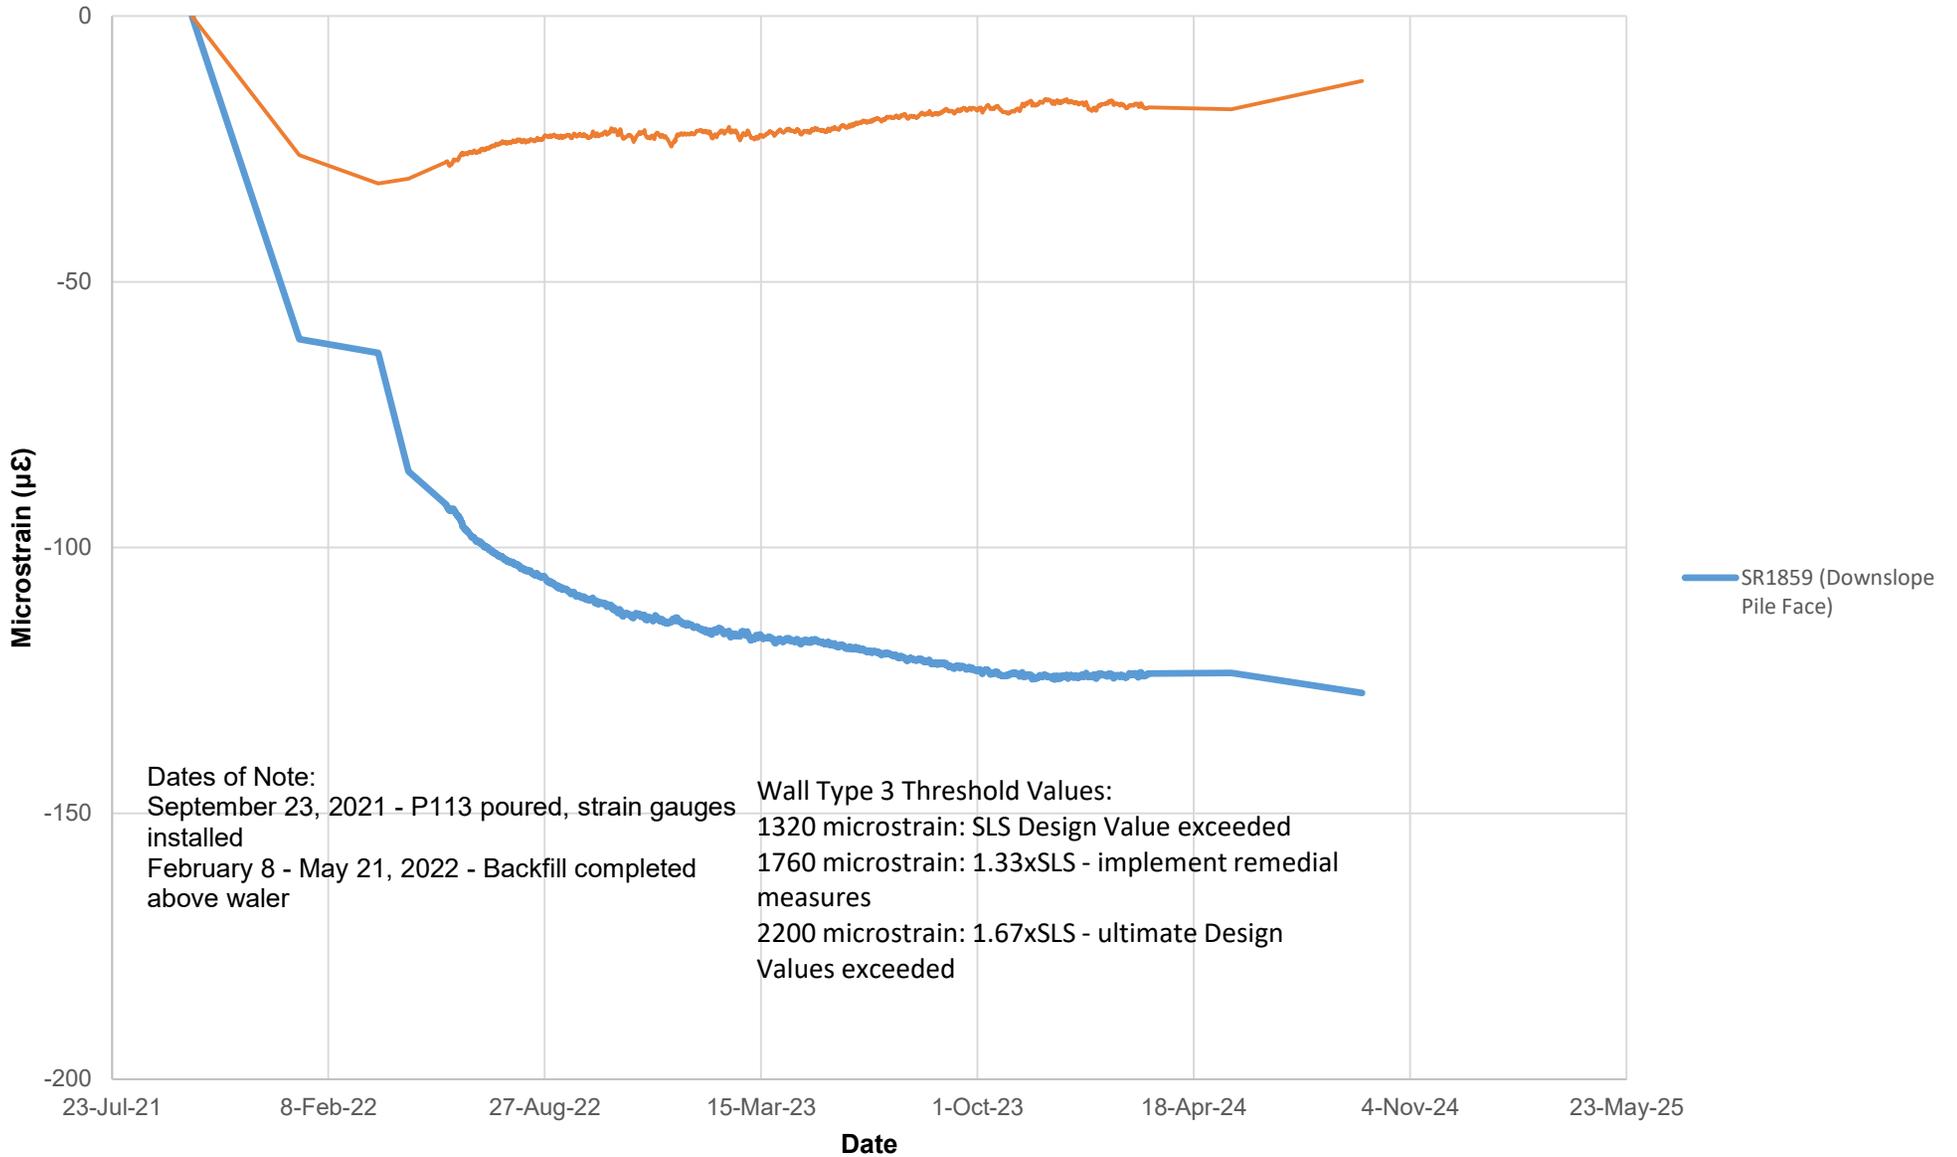
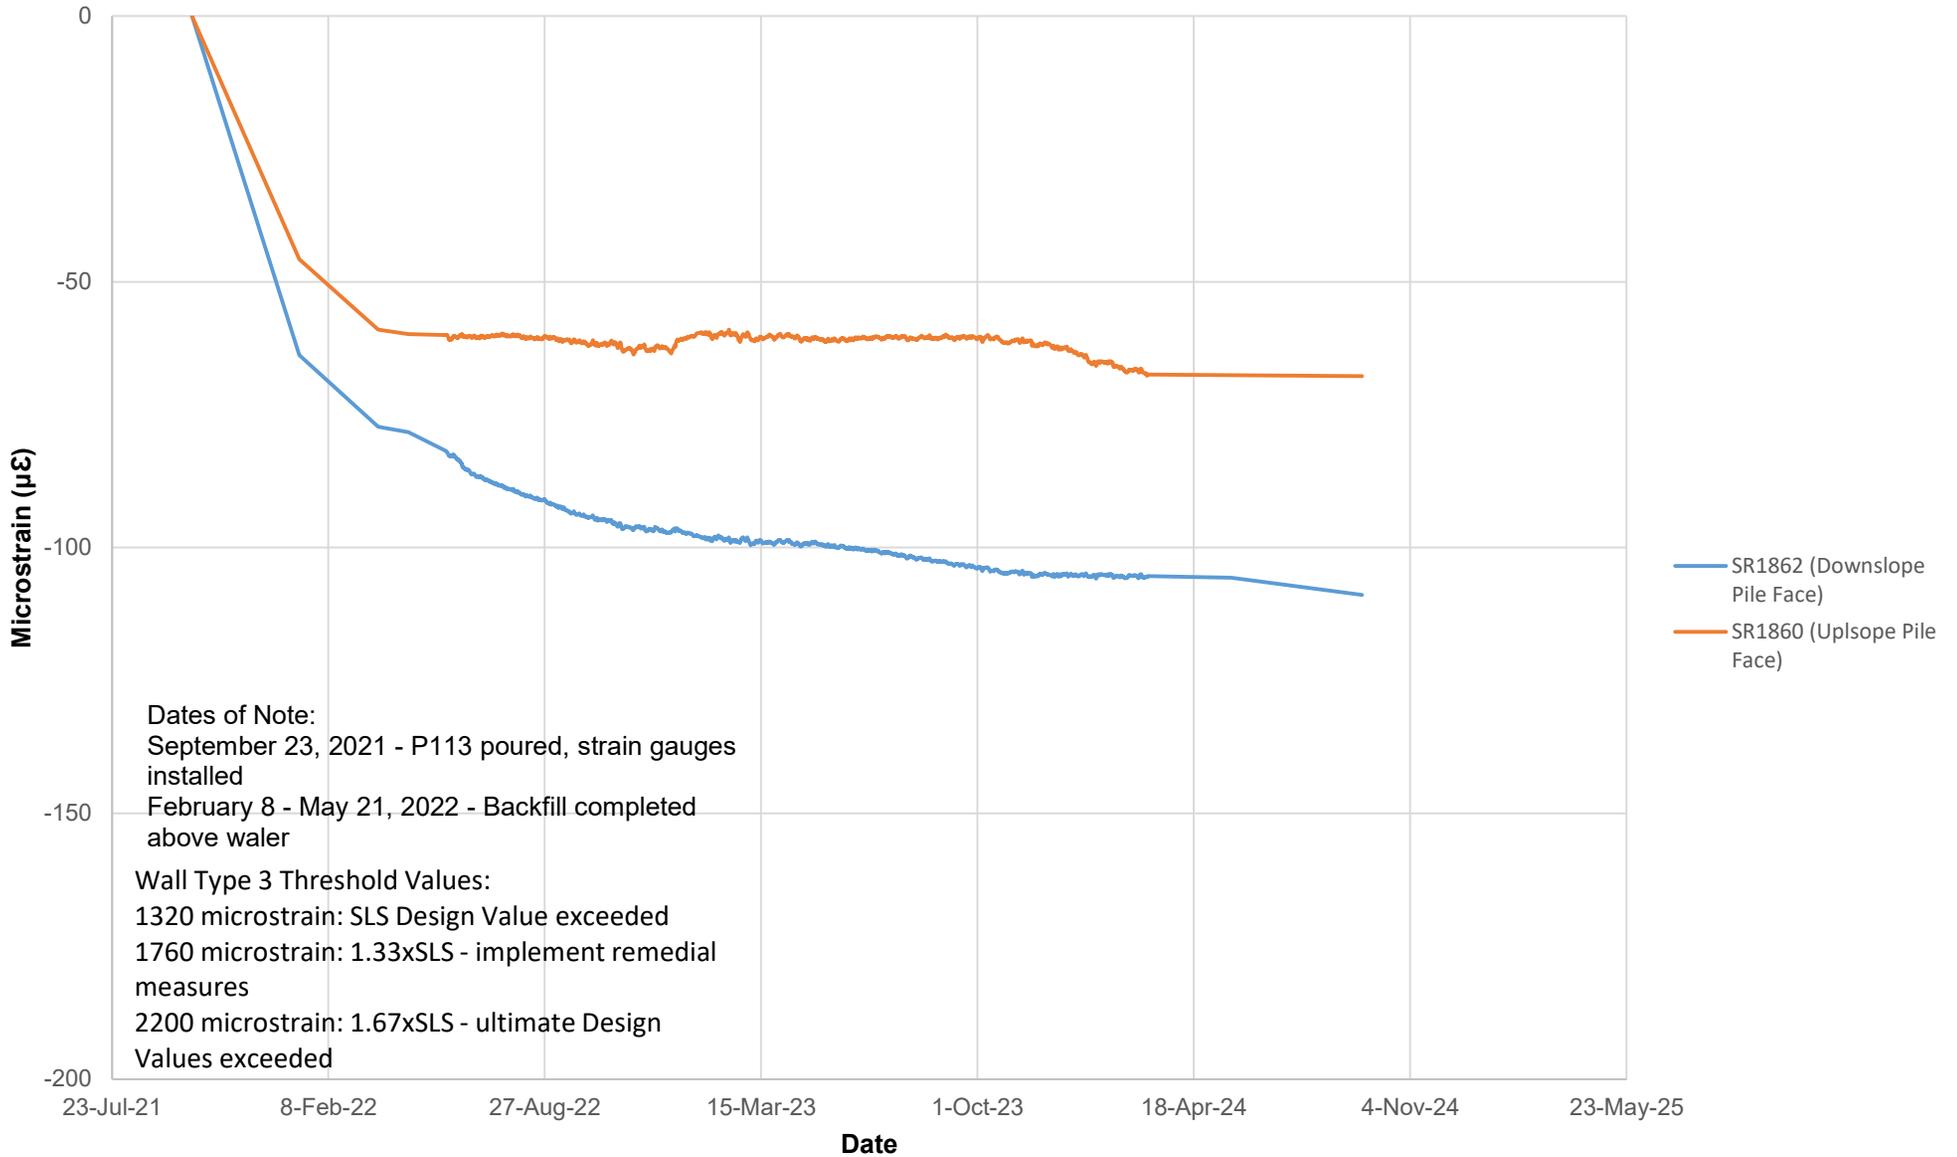
**FIGURE PH009-10: PEACE RIVER SHOP SLIDE
P113 MAXIMUM STRAIN VS TIME (15.3 m DEPTH)**

The maximum negative strain for P113, of -127.3 microstrain, was measured on the downslope side at 19.0 m depth (Figure PH009-9). On the upslope side (Figure PH009-8), the maximum negative strain was -67.7 microstrain measured at a depth of 21.2 m and the maximum positive strain was 93.4 microstrain measured at a depth of 15.3 m. The depth of the main slip surface of the deep-seated landslide at this location, as indicated by former SI05-3, was at 17.5 m below original ground prior to wall construction. The strains measured at 15.3 m, 19.0 m, and 21.2 m are plotted against time in Figure PH009-10, -11, and -12, respectively.

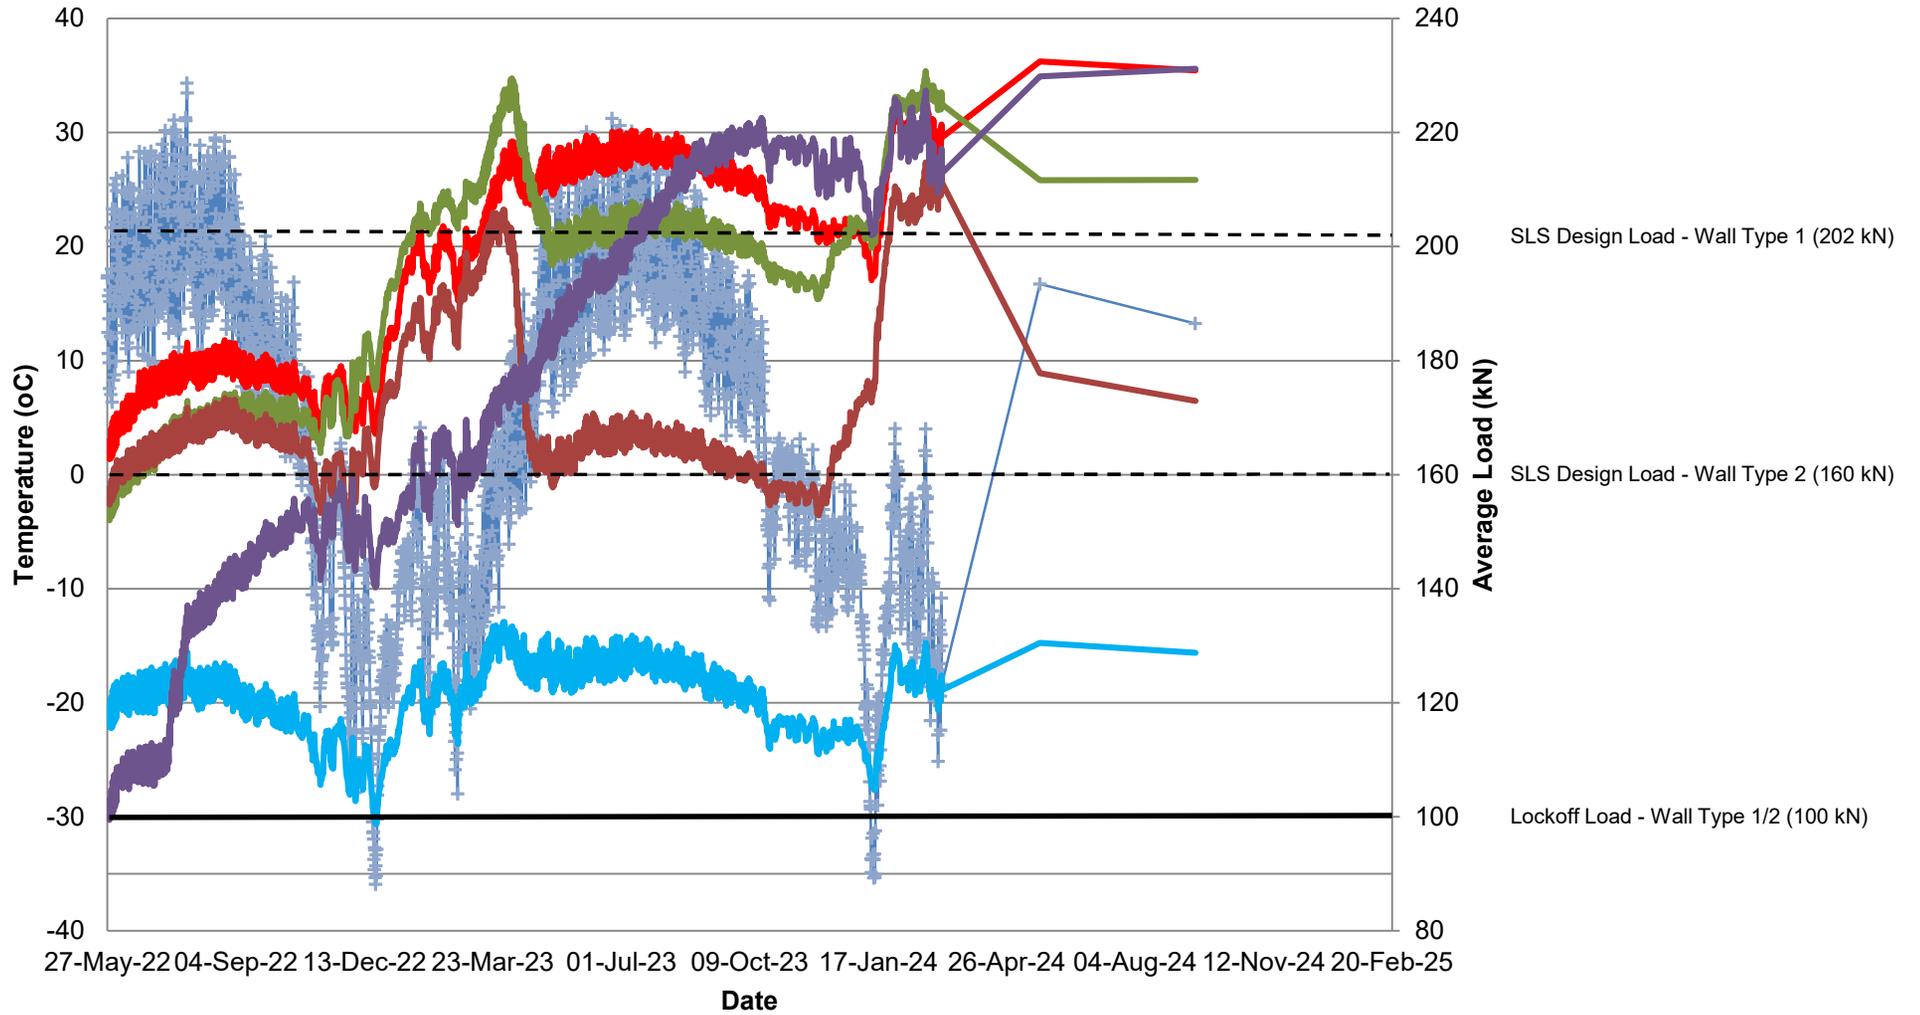
**FIGURE PH009-13
OLD HWY 2:02 SHOP SLIDE LOAD CELL READINGS**

The load cell readings are summarized in Table PH009-4. Anchors A19 (VC2340), A51 (VC2342), and A67 (VC2343) showed decreases in measured load of 1.58 kN, 4.84 kN, and 1.72 kN, respectively, compared to the spring of 2024 readings. Anchors A34 (VC2341) and A77 (VC2344) showed increases in measured load of 0.07 kN and 1.30 kN, respectively.

Anchor A77(Load cell VC2344) registered the highest maximum recorded load of 231.20 kN on September 20, 2024, after a battery was used to power up the datalogger for the readings.

The pattern of movements is attributed to frost pressures on the back of the wall. Anchor A19 (Load cell VC2340A19) measured its highest load after the spring thaw in July 2023, before relaxing slightly. Anchor A77 (Load cell VC2344) has continued showing an overall trend of increasing load with a smaller post-winter relaxation than seen in the other anchors. Overall, the anchor loads have risen significantly since they were locked off, and anchors A19, A34, and anchor A77 are currently above their SLS design loads but have not exceeded the 270 kN load that would require remedial measures. The load cells will need to be closely monitored to see if the increased movement trend continues. The load cell readings are plotted on Figure PH009-13 in Appendix A.
