**ALBERTA TRANSPORTATION AND
ECONOMIC CORRIDORS
GEOHAZARD ASSESSMENT PROGRAM
PEACE REGION (PEACE RIVER DISTRICT)
2024 INSPECTION**

Site Number	Location	Name	Hwy	km
PH009-3	Town of Peace River	Shaftesbury Trail – Shop Slide	Old 2:02	0.025
			684:02*	30.990
Legal Description		UTM Co-ordinates		
SW31-083-21 W5M		11V E 480339	N 6232158

PH009-3 SHAFTESBURY TRAIL SHOP SLIDE

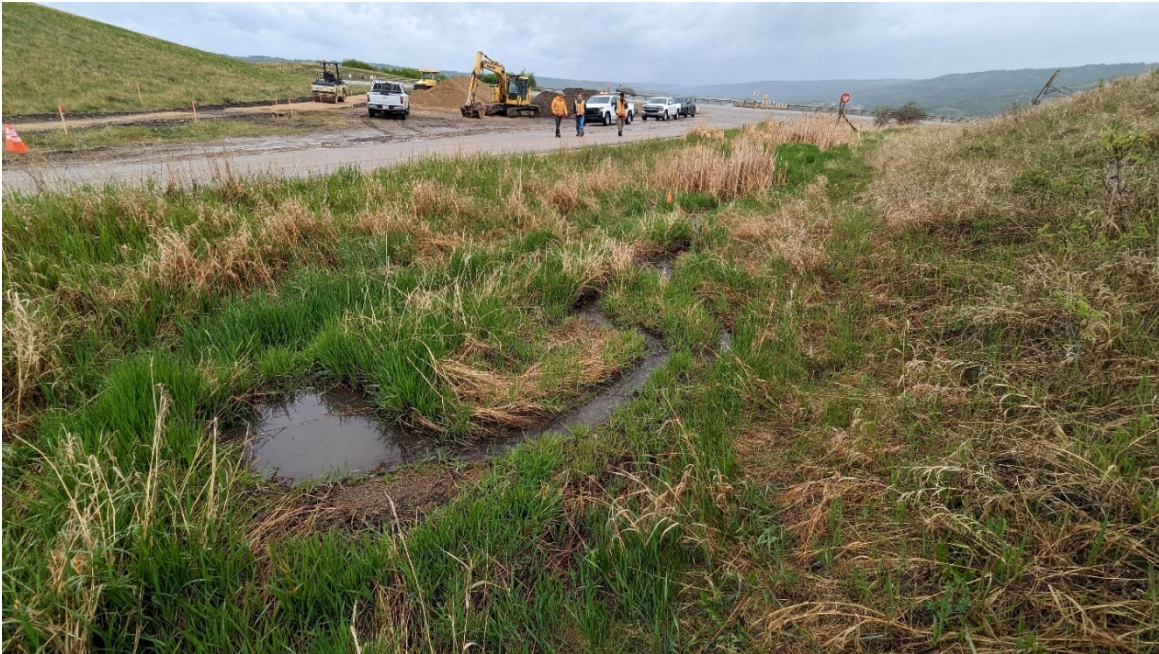
Photo 1: Looking north at spring along 99 Avenue and Town building new pedestrian pathway.

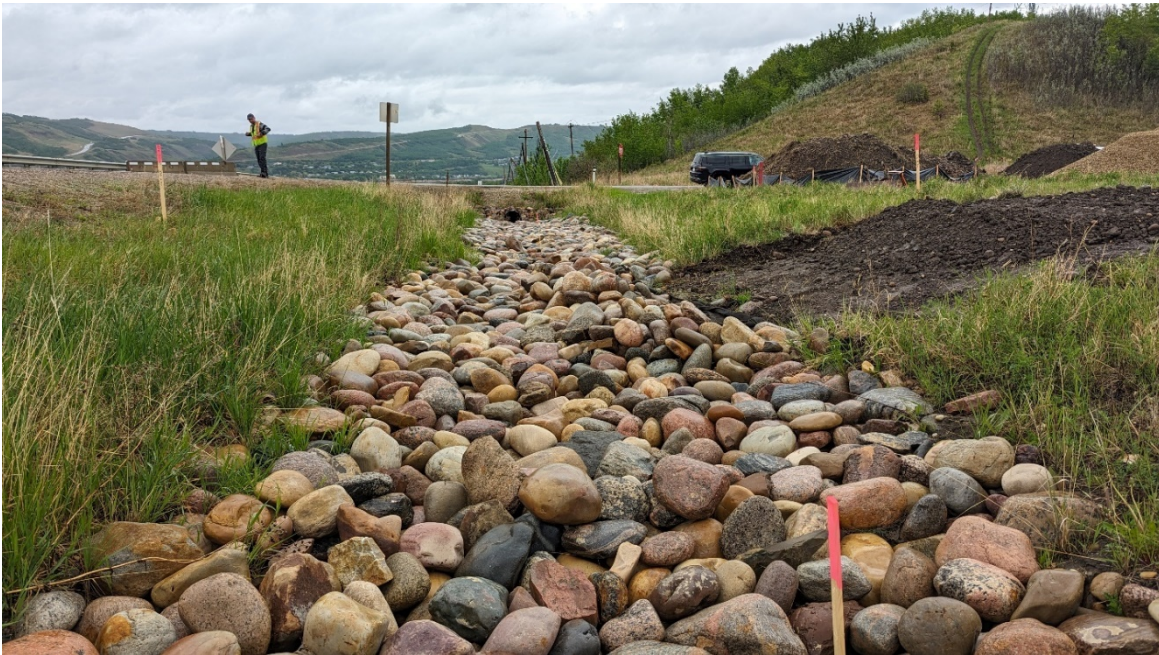
Photo 2: Looking southeast along grouted riprap in Hwy 2 off-ramp ditch at 99 Avenue culvert inlet

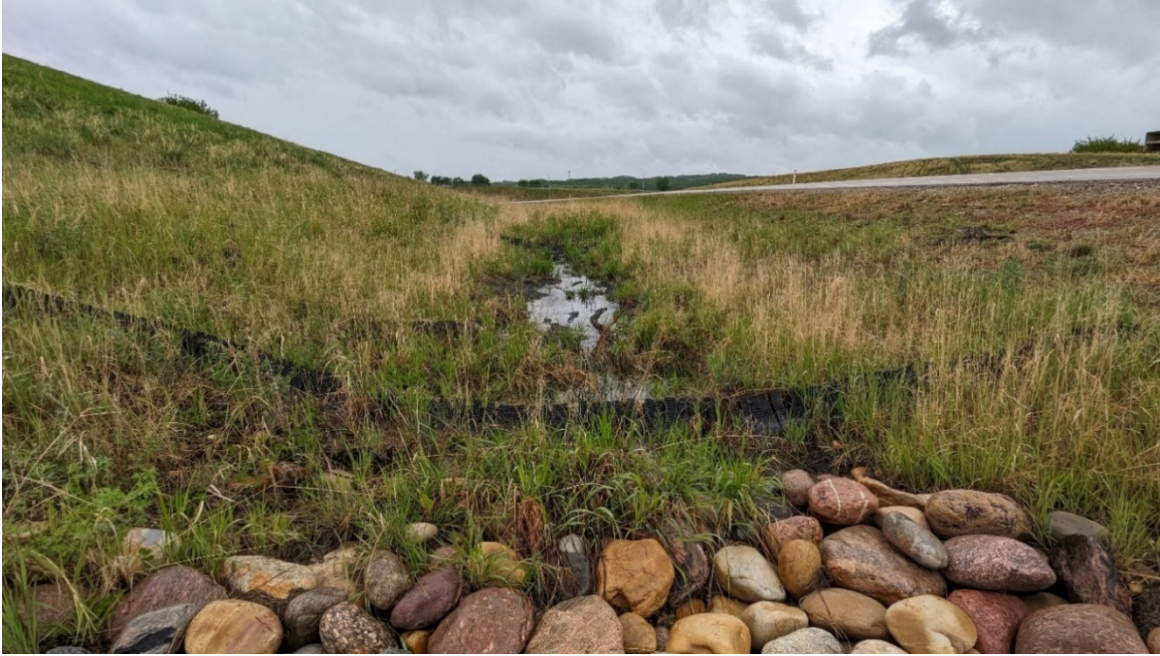
Photo 3 – Looking northwest at repaired ditched along Hwy 2 off-ramp.

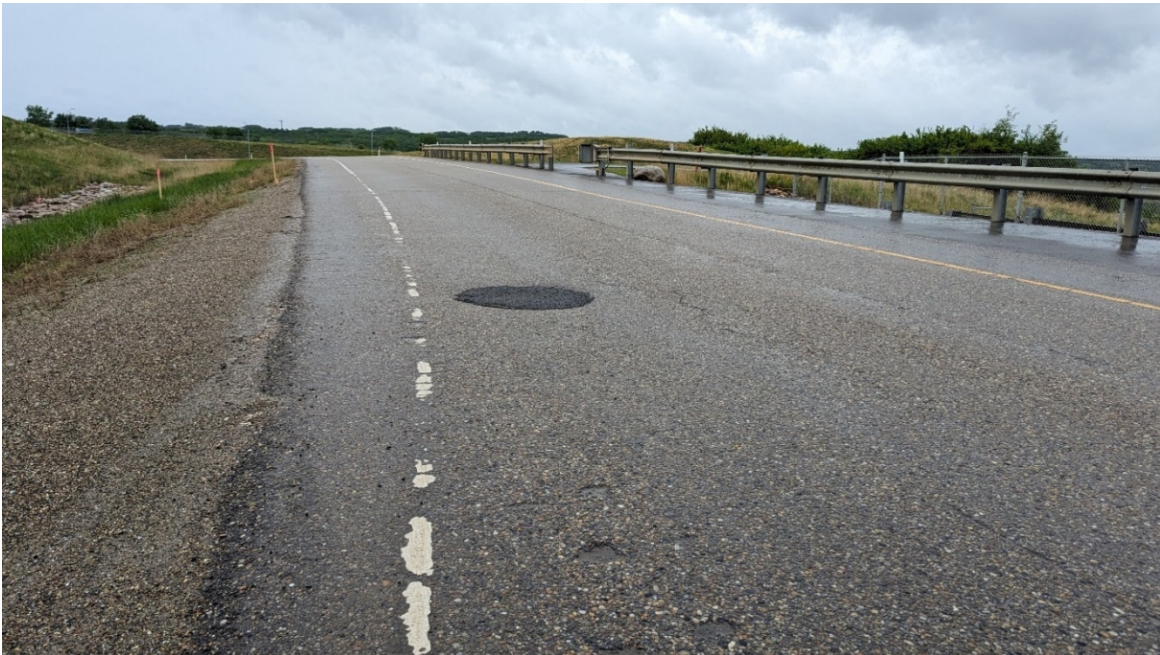
Observations:	Description	Worsened?
<input type="checkbox"/> Pavement Distress	The sinkhole near the NW end of the wall (due to subsidence over a tieback anchor) that formed in 2023 was patched again in Spring 2024.	<input type="checkbox"/>
<input checked="" type="checkbox"/> Slope Movement	Pavement cracks and unevenness SE of 99 Ave indicating ongoing creep movement of the deeper	<input checked="" type="checkbox"/>

Photo 4 – Looking northwest at patched sinkhole in Hwy 2 off-ramp surface northwest of 99 Avenue intersection.

- Road maintenance such as crack sealing of the ACP to limit infiltration.
- Routine inspection to confirm that the sinkhole has stabilized.

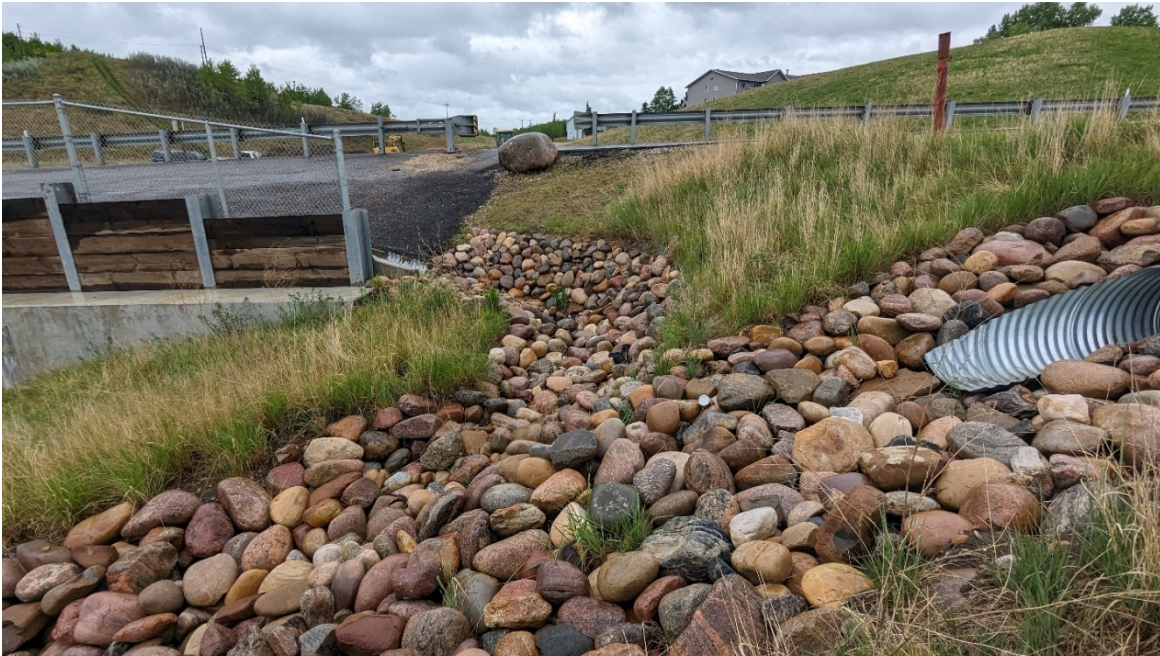
Photo 5: Looking south at NW end of wall just below S111-01 which continues to move even after construction is completed.

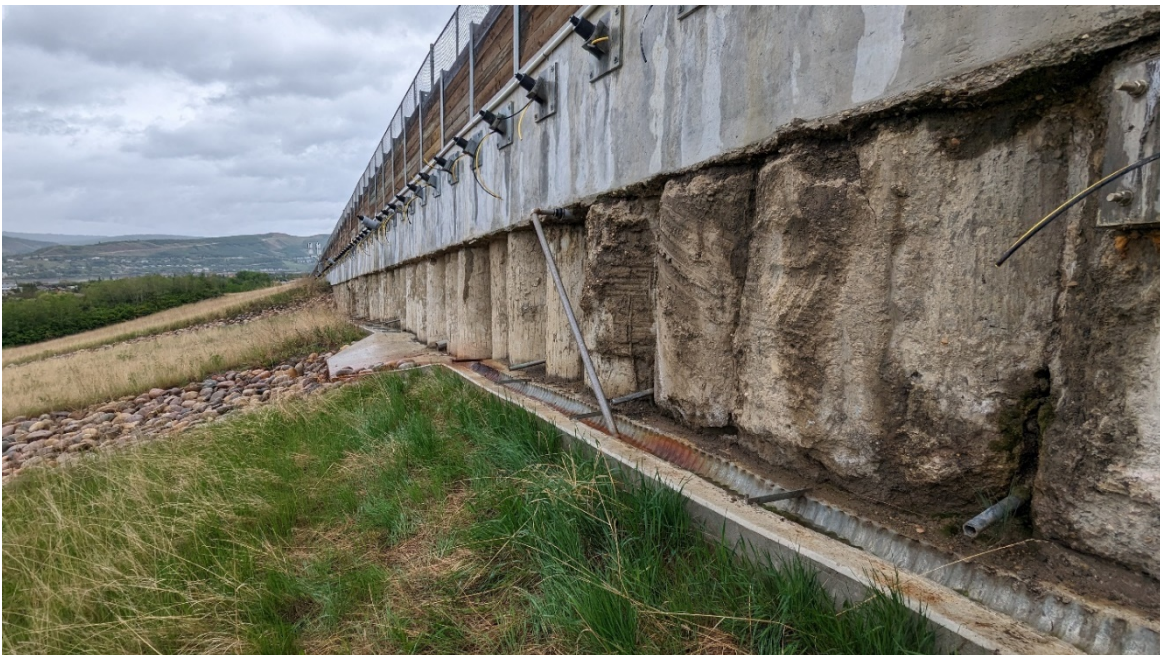
Photo 6: Accumulating rusty sediment from the existing subdrain flow. The pipe was flipped to flow the other way and some sediment blockage manually removed during the inspection.

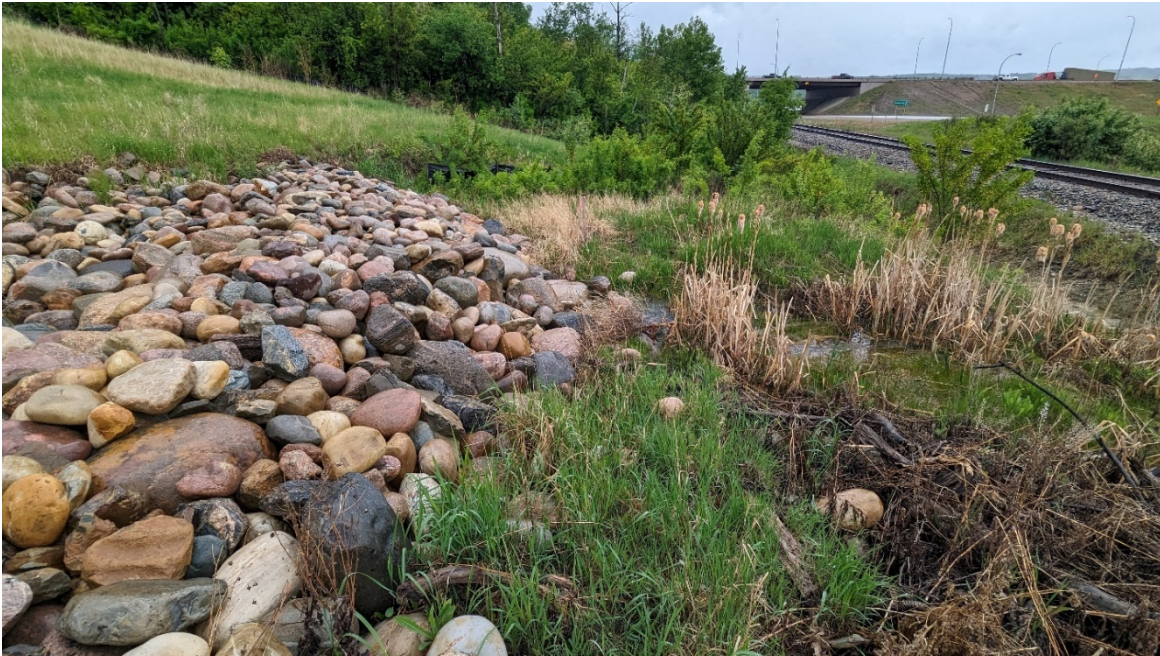
Photo 7: Looking north at bottom of the main riprap channel at the edge of the CN ROW.

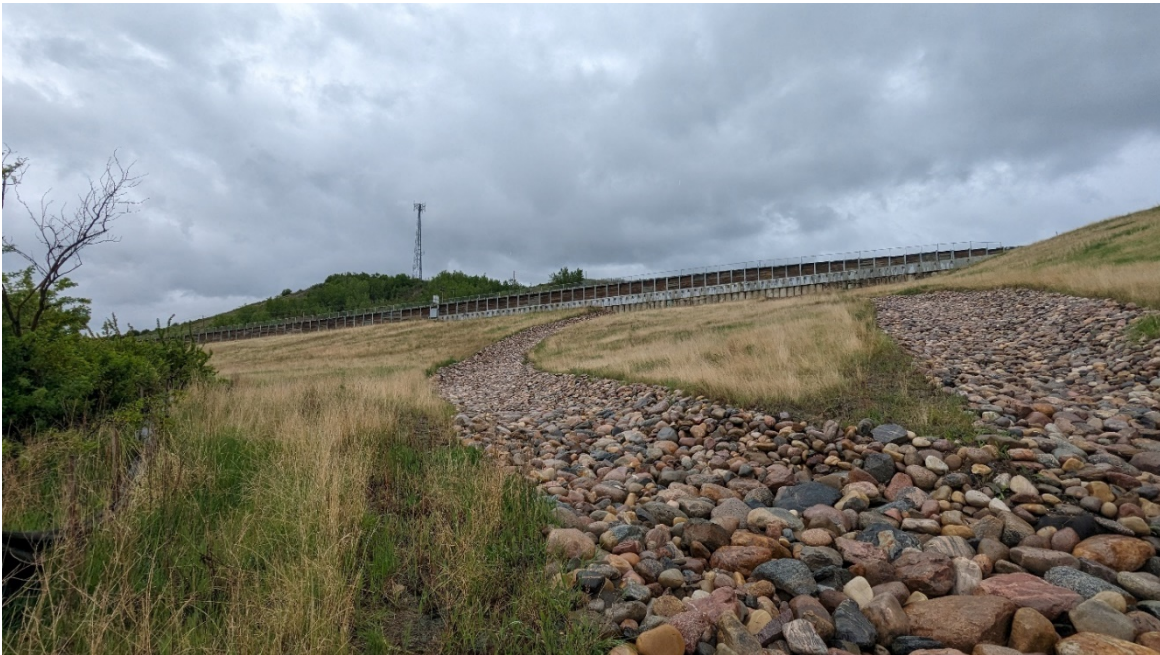
Photo 8: Looking southwest back up at the wall along the regraded slope and riprap drainage channels.

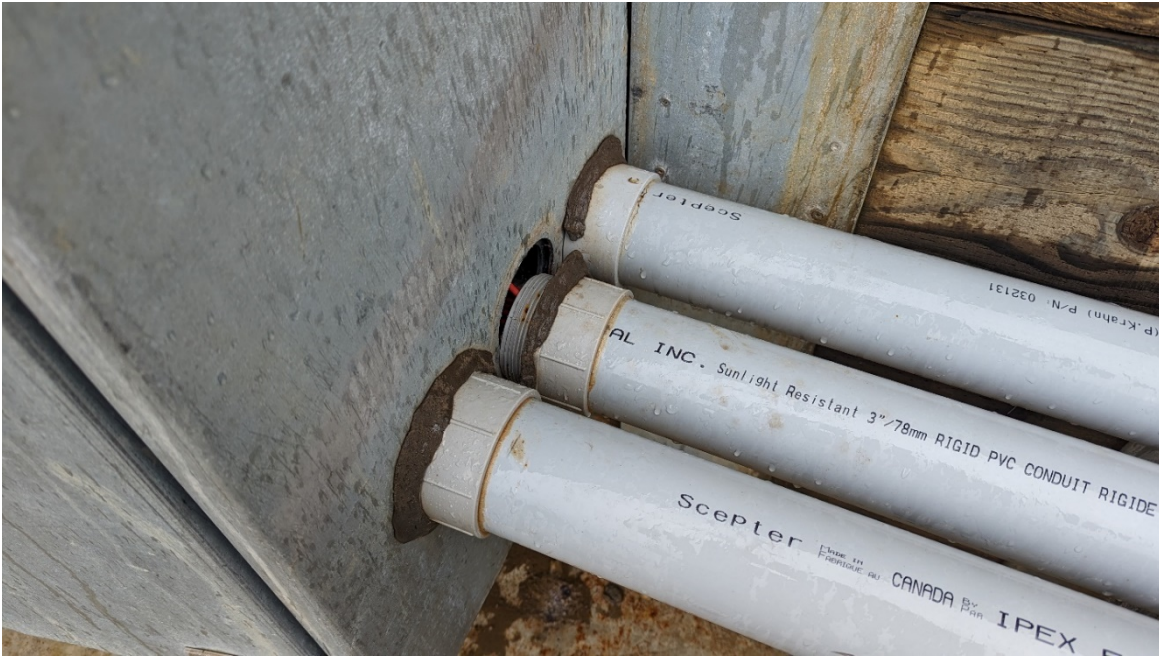
<input type="checkbox"/> Other	<p>The datalogger enclosure was broken into and the batteries stolen. Thermal expansion and contraction appear to have disconnected some conduit connections. These will be repaired in Fall 2024.</p>	<input type="checkbox"/>

Photo 9: Thermal expansion/contraction may have detached this conduit from the side of the data enclosure.

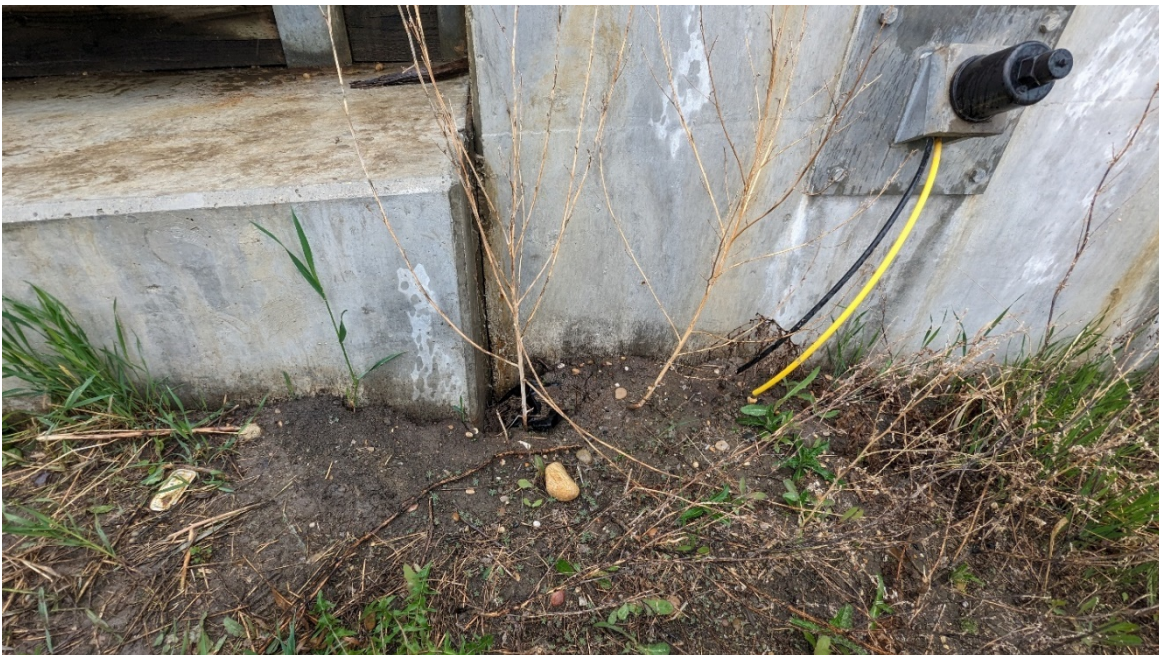
Photo 10: Small void or settlement at the junction between Wall Types 2 and 3.

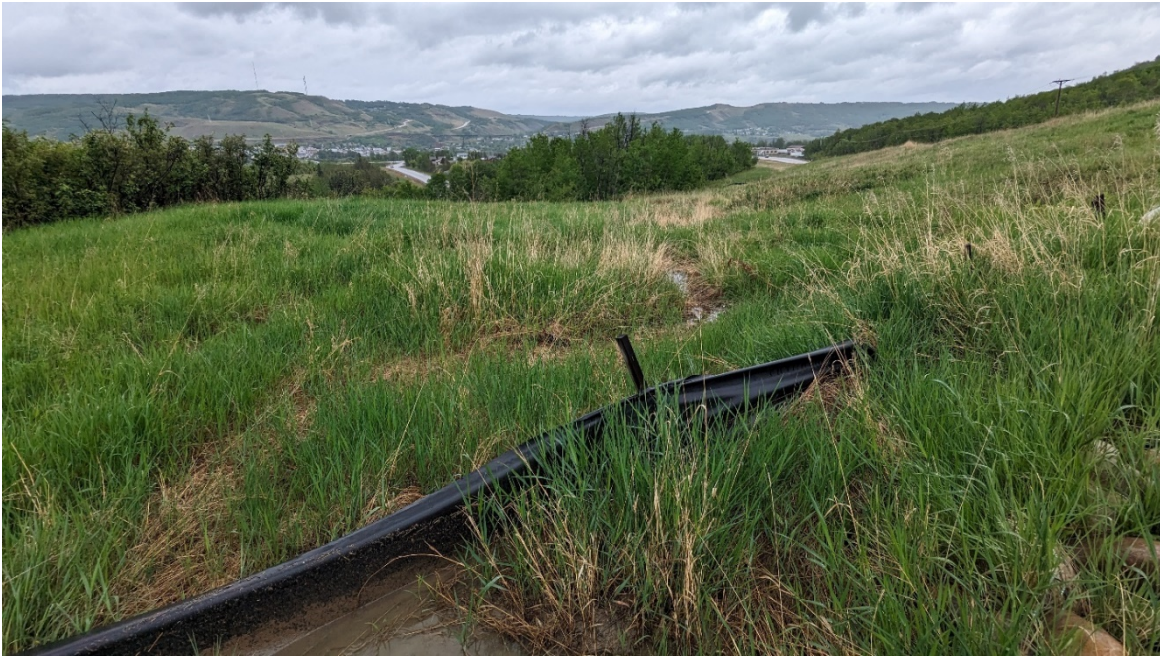
Photo 11: Looking southeast at the shallow gully forming beyond the silt fence at the end of the riprap dissipation bowl.

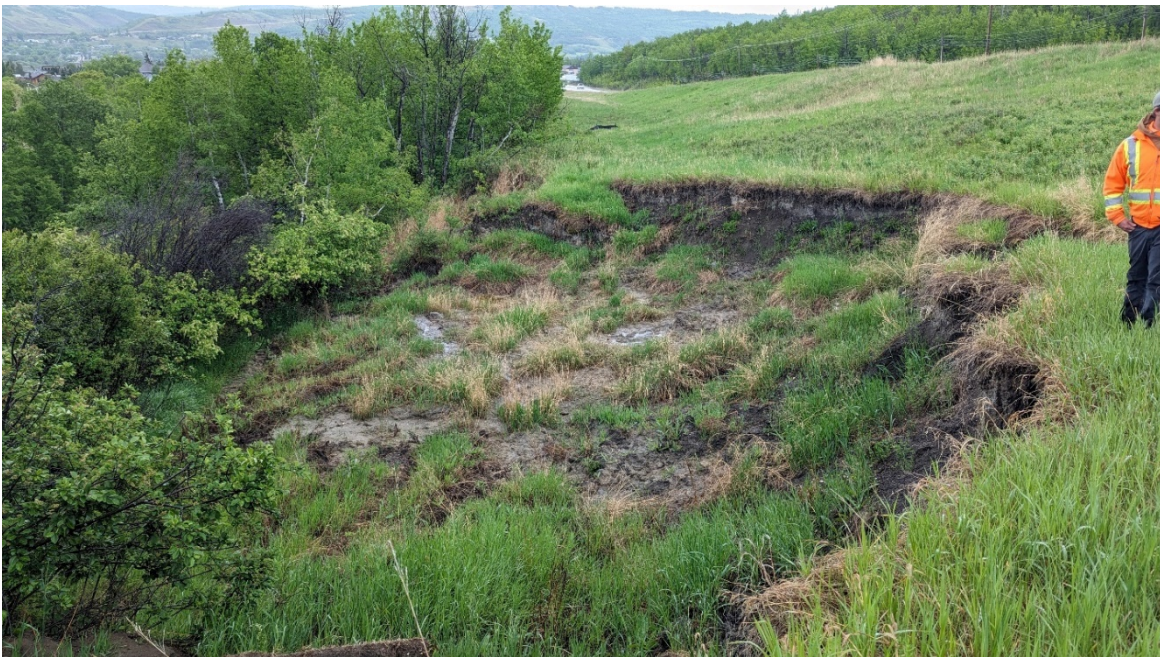
The slump located east of the wall just beyond the highway right-of-way was present before the construction of the pile wall and has gotten worse. However, it is outside of the highway ROW, is more than 30 m from the highway shoulder, and does not appear to be interfering with CN's operations.

Photo 12: Looking southeast at the active scarp just beyond the edge of the highway ROW.

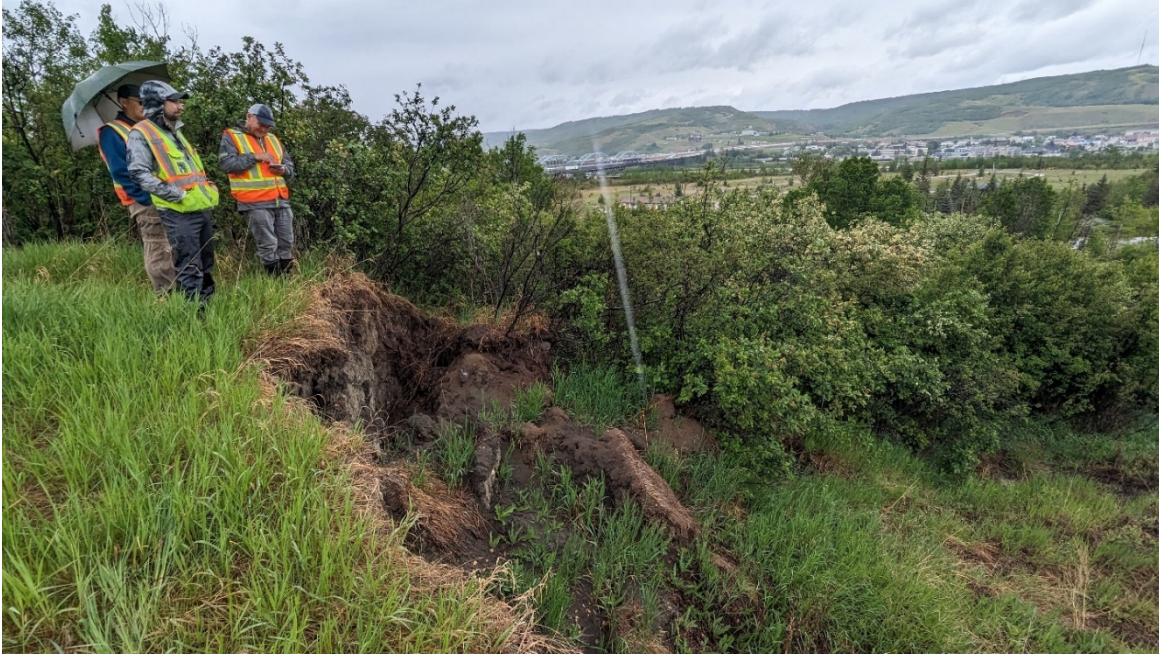
Photo 13: Looking north at the recent movement on the northwest flank of the active scarp. The CN rail line is located downslope of this landslide.

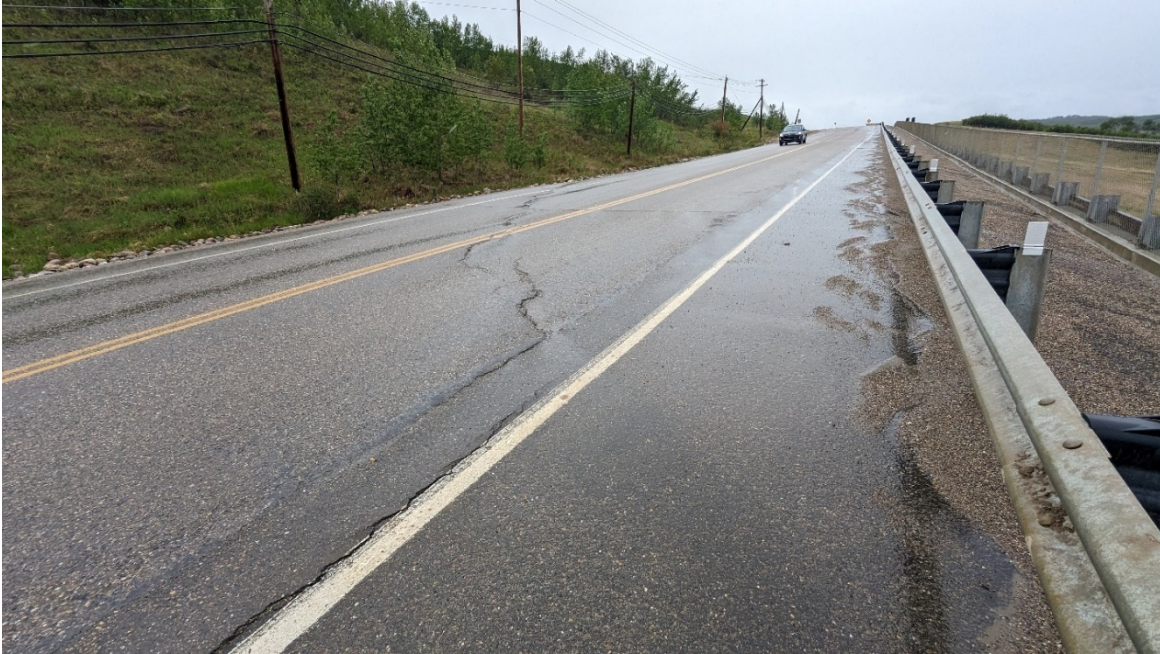
Photo 15: Looking west at the historical deep-seated crack location at the SE end of the pile wall.

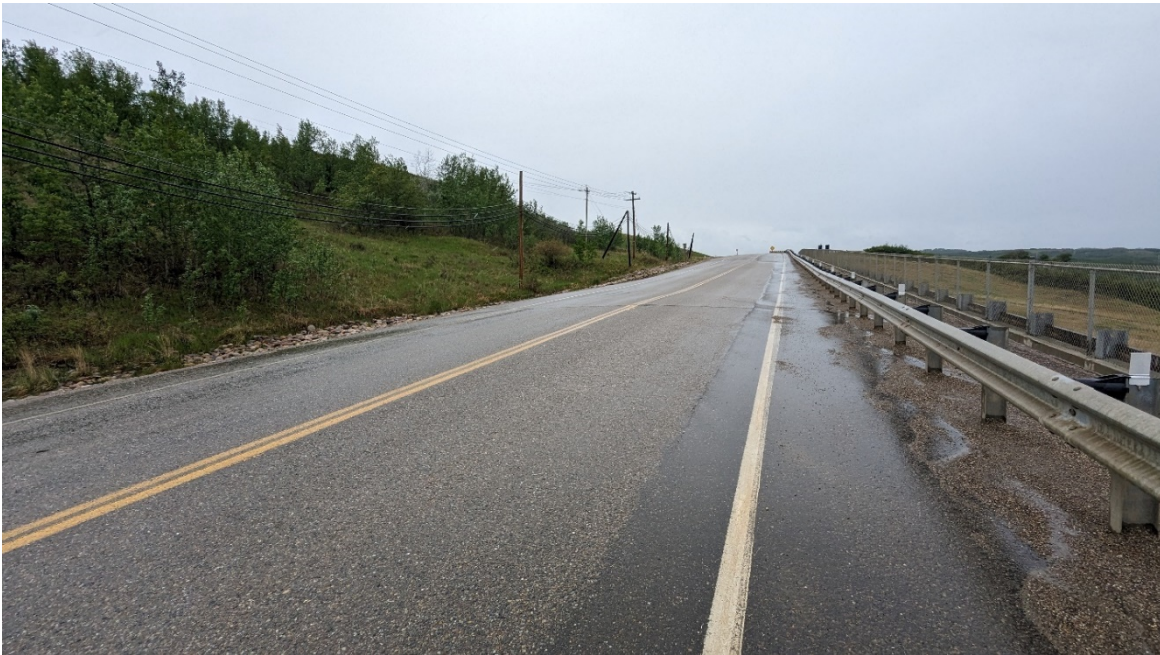
Photo 16: Looking northwest the dips in the roadway surface.

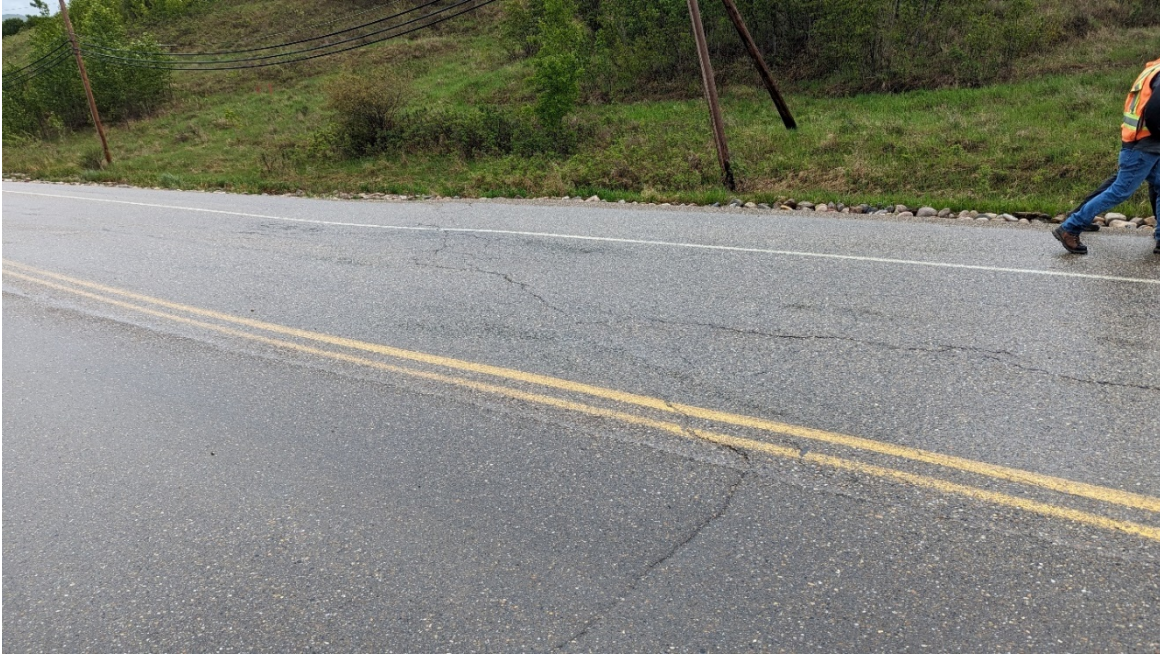
Photo 17: Looking south at the cracks coincident with the northwest flank of the deep-seated landslide.
