THURBER ENGINEERING LTD.

File No.: 32121

**GEOHAZARD RISK MANAGEMENT PROGRAM (CON0022164)
PEACE REGION (PEACE RIVER DISTRICT
SECTION D CALL-OUT REPORT
THE BIG EDDIE, BRICK'S HILL: HWY 684:02 km 8.86 to 8.98**

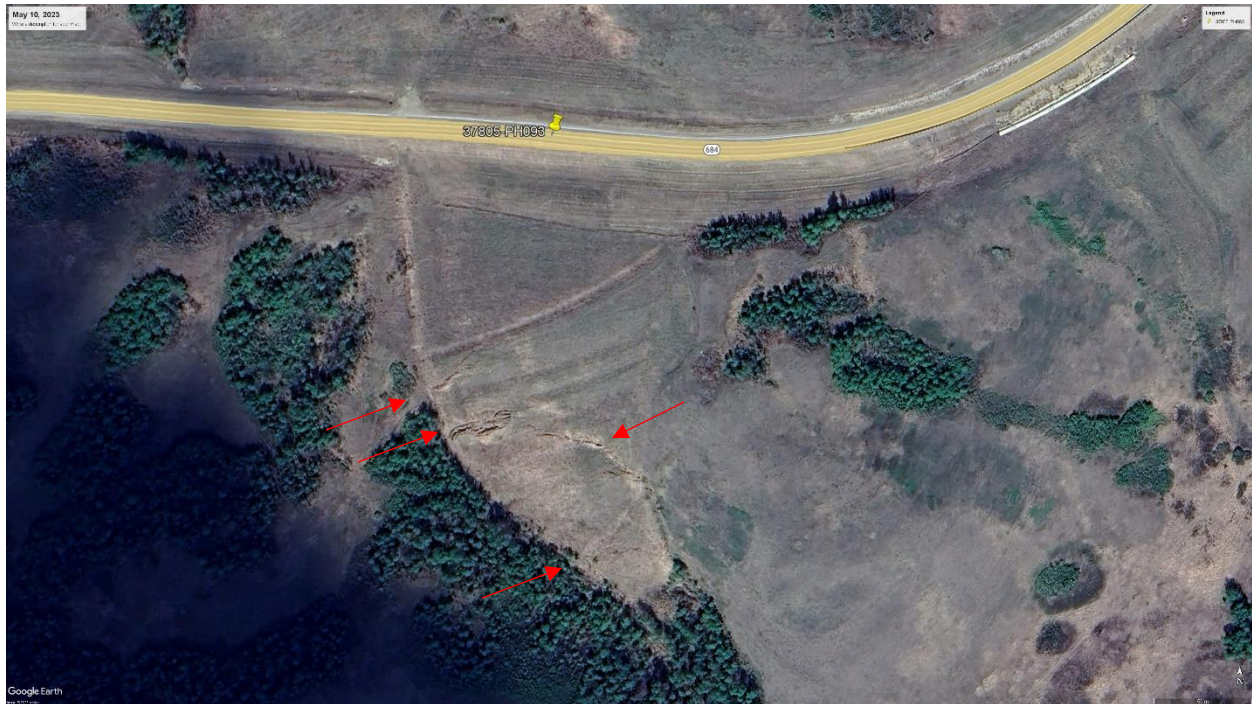
Figure 1.1 – Google Earth image dated May 10, 2023

Although there had not been distress noted at this location since the 1980s, Google Earth imagery from May 10, 2023, shows cracks starting to form in the lower half of the fill slope. These cracks, shown in Figure 1.1, have been approximately transferred on to the Drawings.

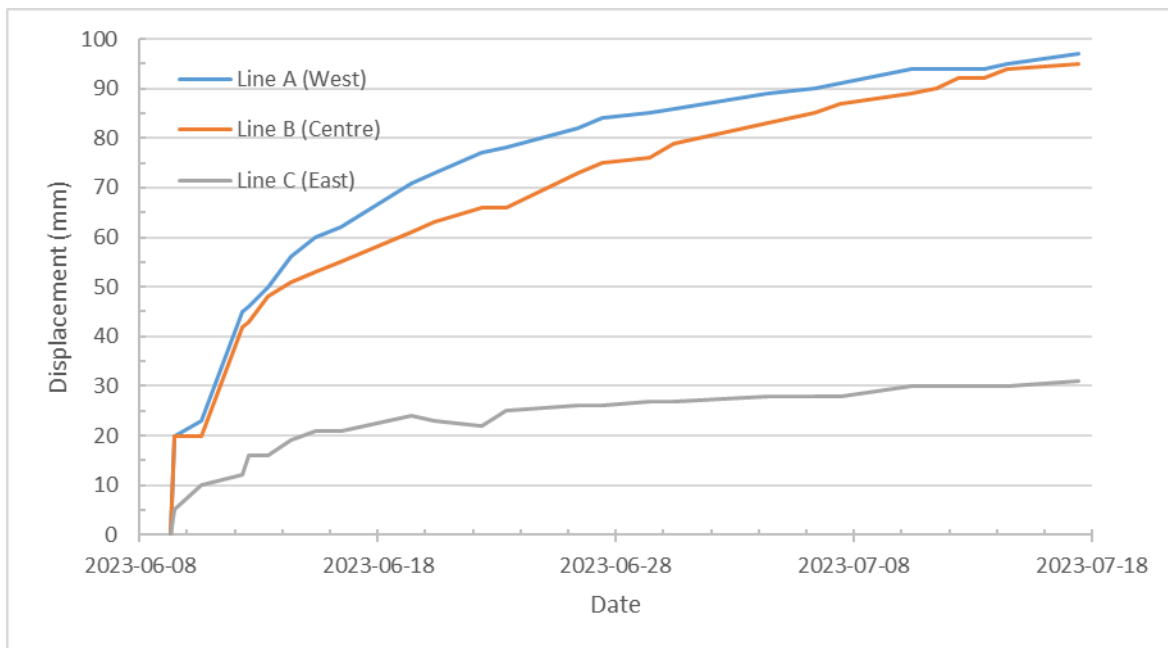
Figure 4.1: Displacement Between Survey Lathe On The Transects Established At The Main Crack Near The Highway

A tension crack was present behind the headscarp which cut into the highway sideslope and had east-west extents of similar width. This crack appears to be the next retrogression of the failure. The MCI established three transects across the crack on which to track the movement rates as the block below continued to move downslope. These lines are shown on the Drawing as A (west

It is expected that the slow movements will continue until there is a sudden, brittle failure and this next block slides out. This may be triggered by high rainfall raising the groundwater table and lubricating the slip surfaces or by steady erosion of the slide material below the headscarp leading to further stabilization of the overall slope. As such, McIntosh Perry (MP) was retained to develop a low-speed temporary detour that could be constructed upslope of the existing highway with

As discussed above, the short-term recommendation is to construct a low-speed detour as far upslope of the existing highway as can be done without cutting into the hill above the highway. This has already been designed by MP and can be constructed by the Maintenance Contractor as soon as funding is available. The proposed alignment is attached in Appendix C.

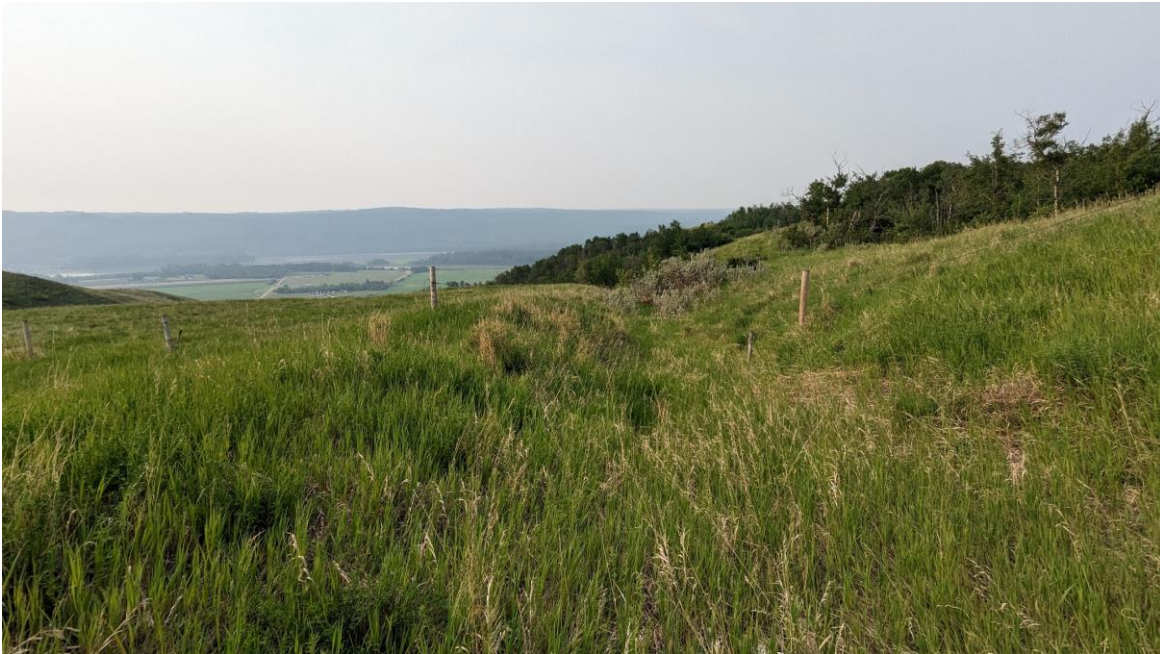
Photo 1: Looking south along grassed drainage channel below centerline culvert.

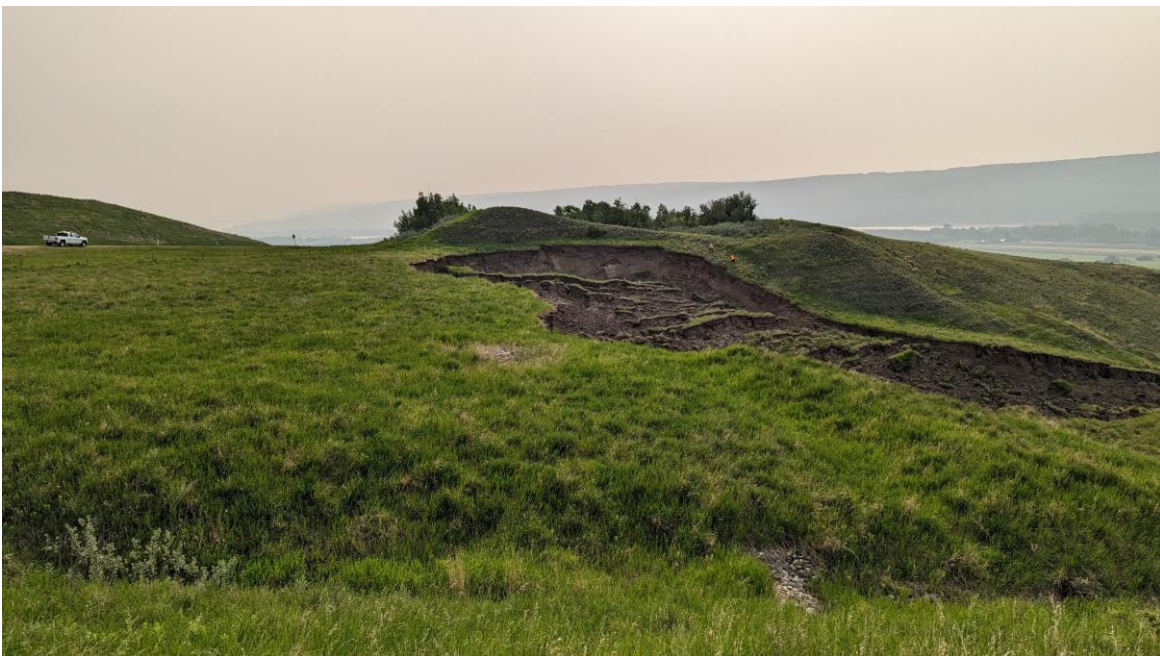
Photo 2: Looking east at main headscarp.

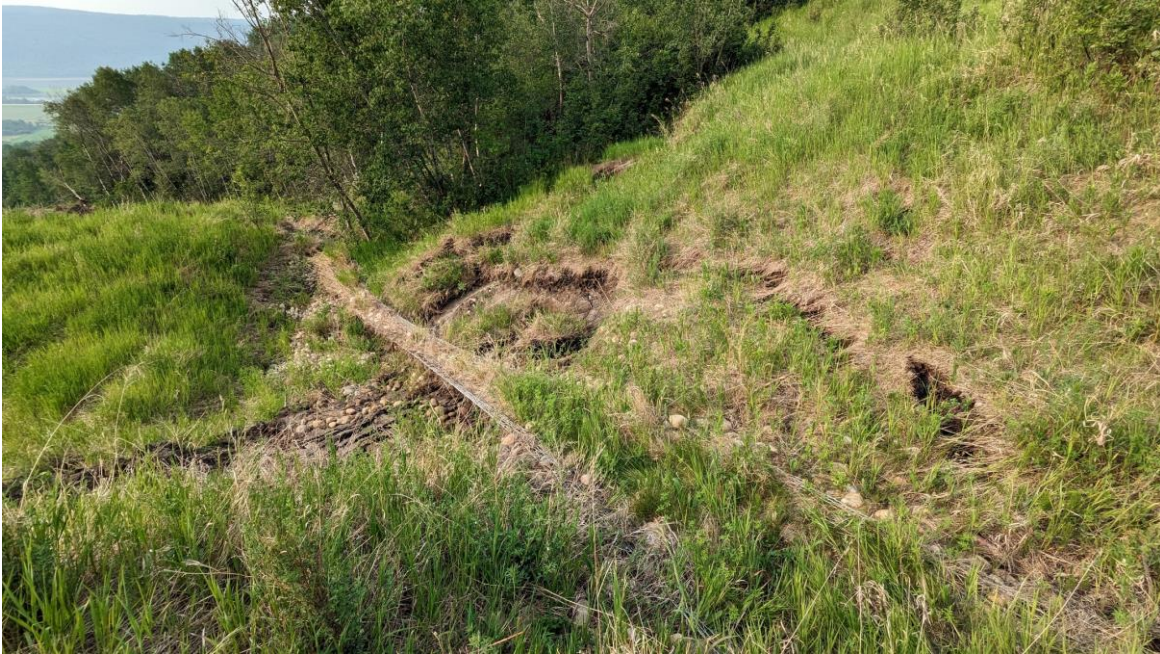
Photo 3: Looking south at stretched gabion mattress with west flank visible on the right side going into the trees.

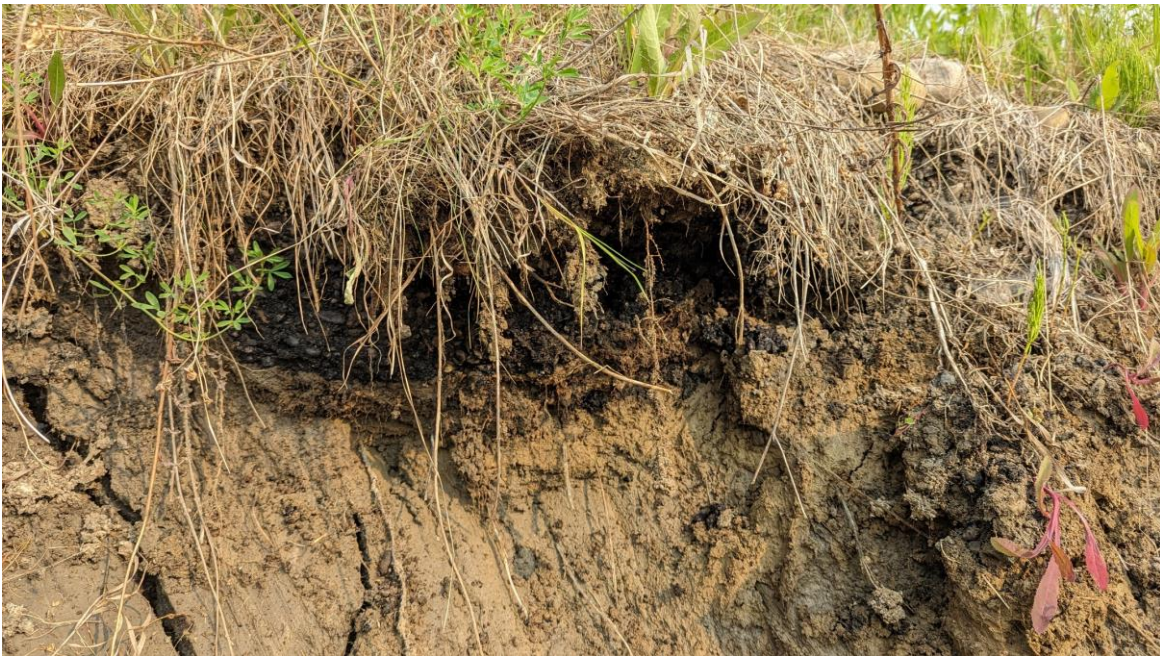
Photo 4: Seepage and asphalt exposed below drainage channel.

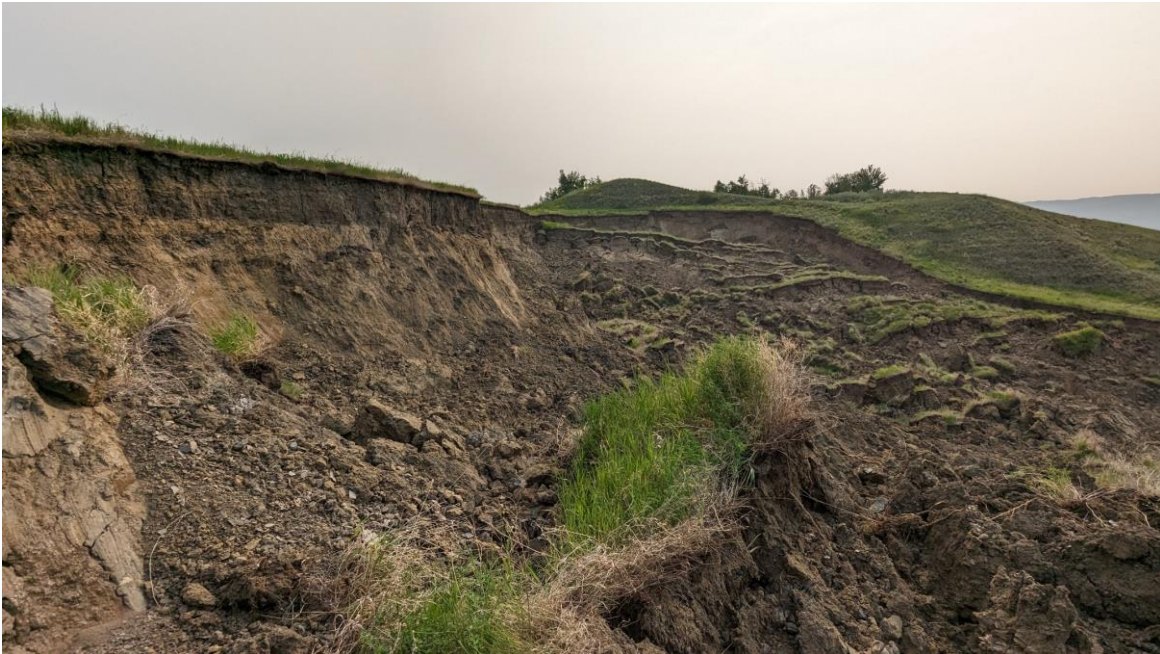
Photo 5: Looking northeast at the west portion of the main headscarp.

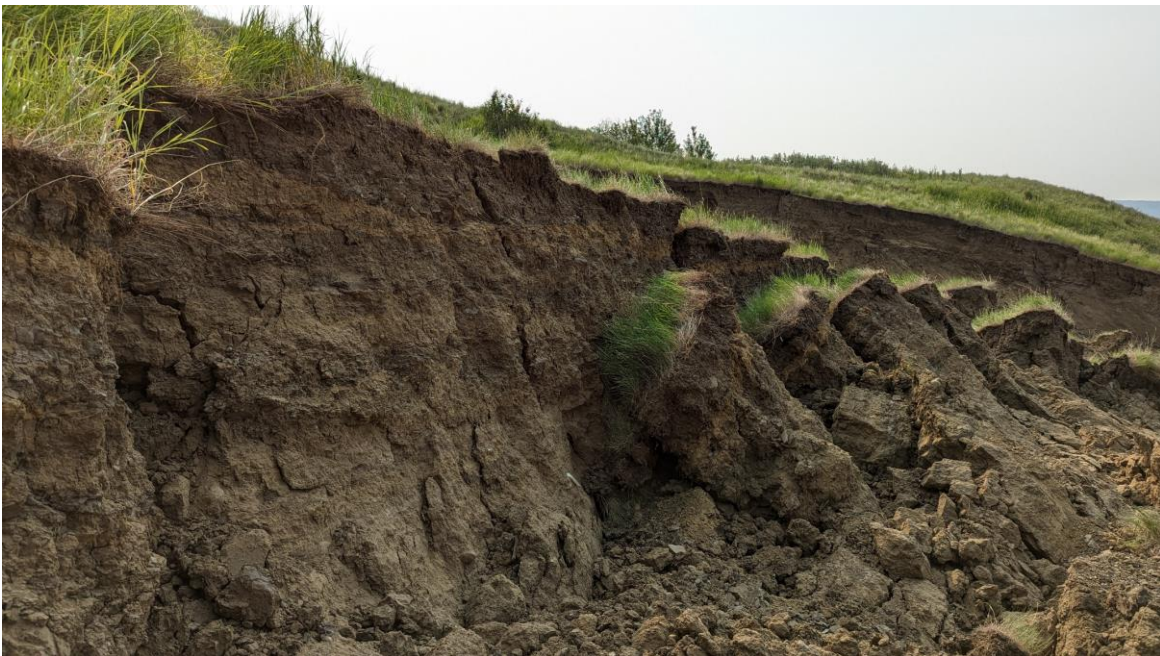
Photo 6: Looking east at eastern edge of main headscarp.

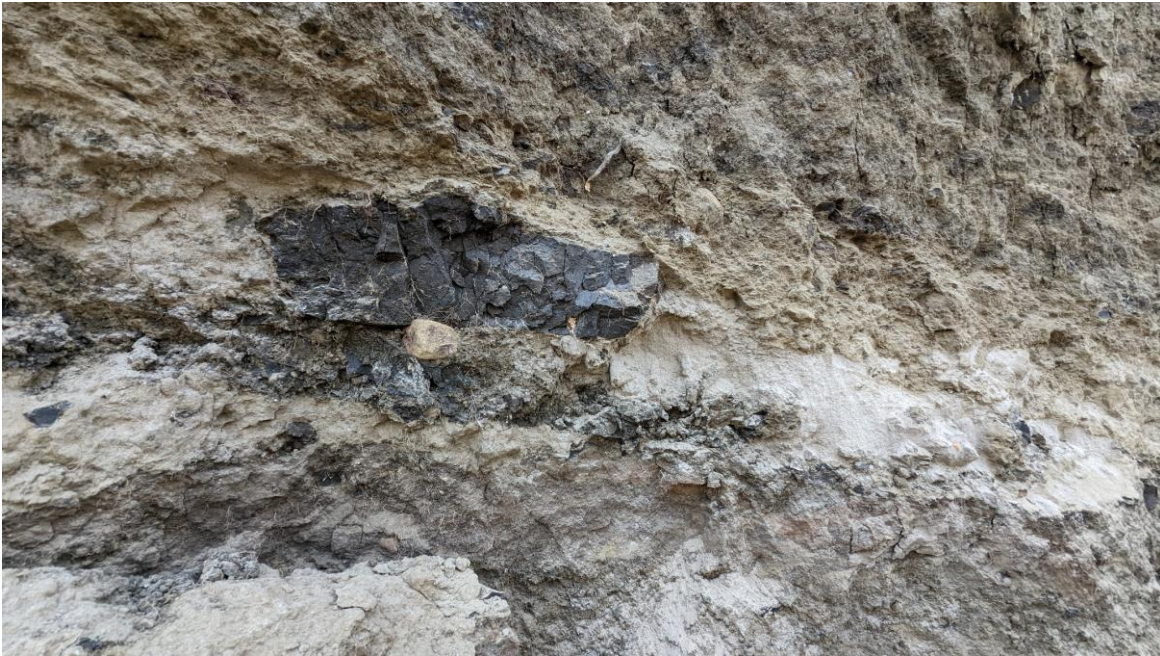
Photo 7: Pockets of fine sand and clay shale in the fill located on the east flank of the main headscarp.

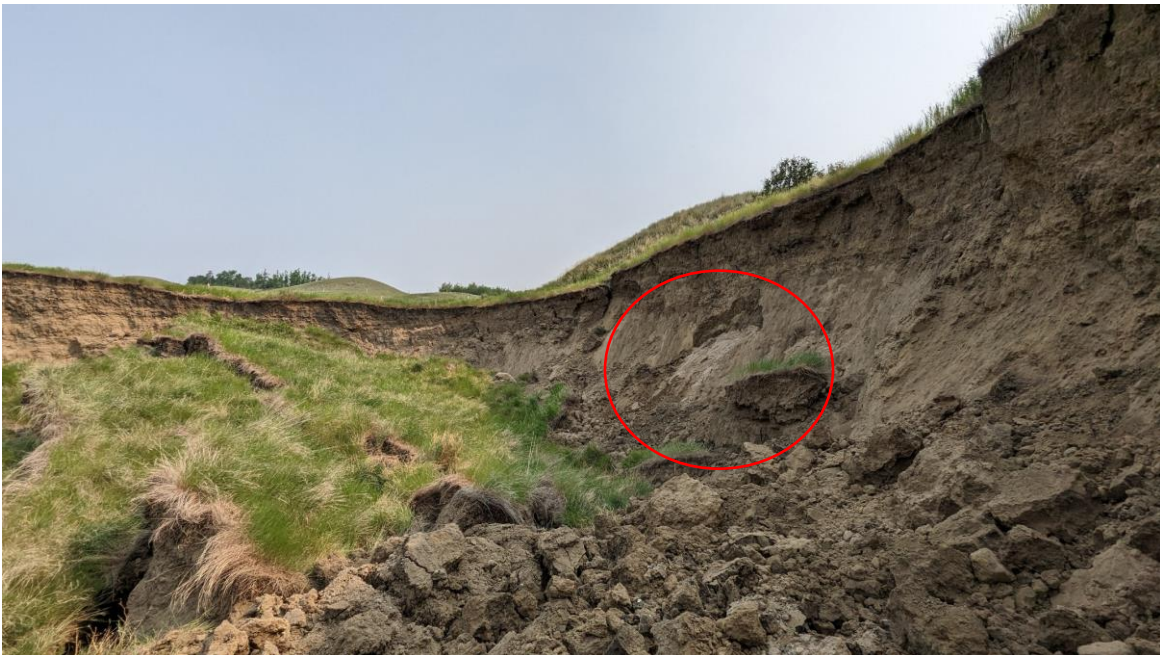
Photo 8: Looking north at the east flank of the main headscarp. Note large pocket (circled) of fine sand ravelling out of the face.

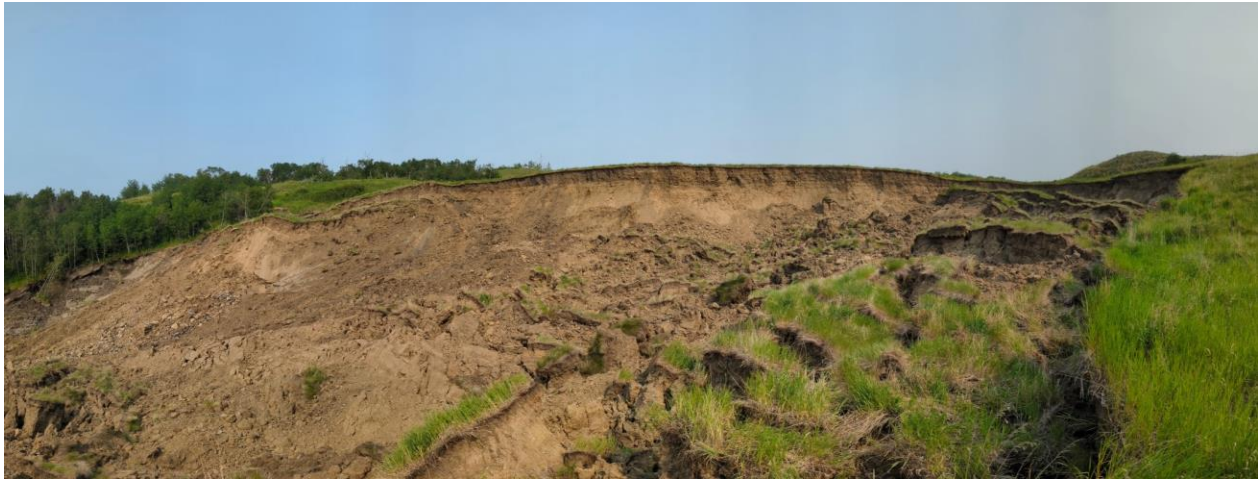
Photo 9: Panorama looking north at the main headscarp.

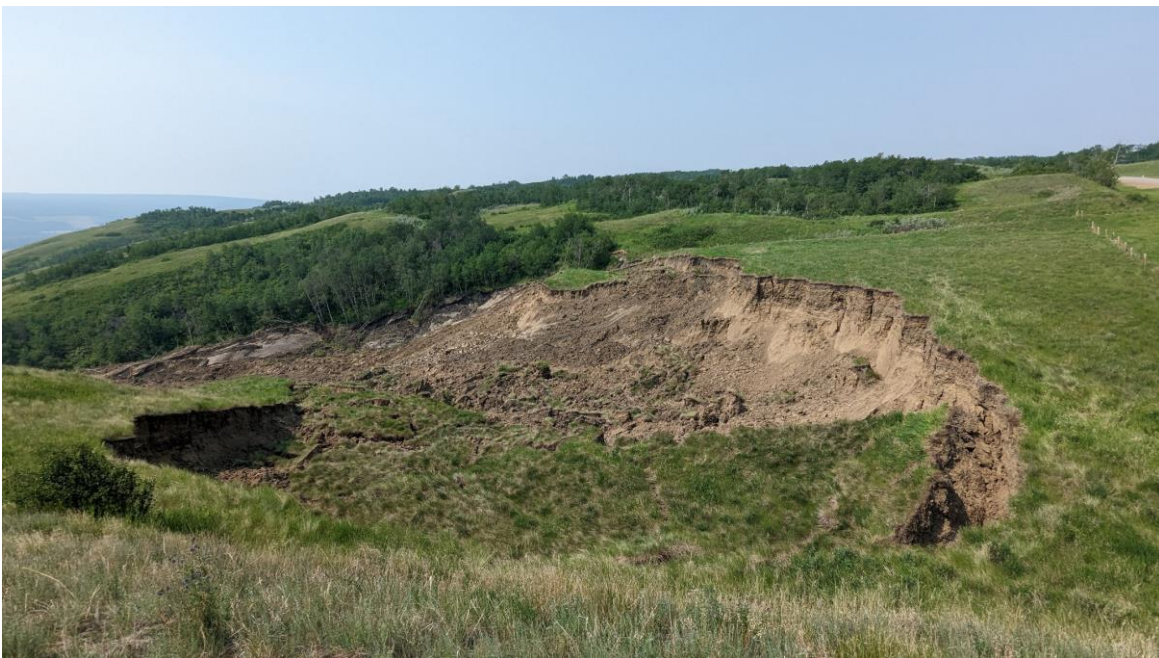
Photo 10: Looking down southwest at the main headscarp.

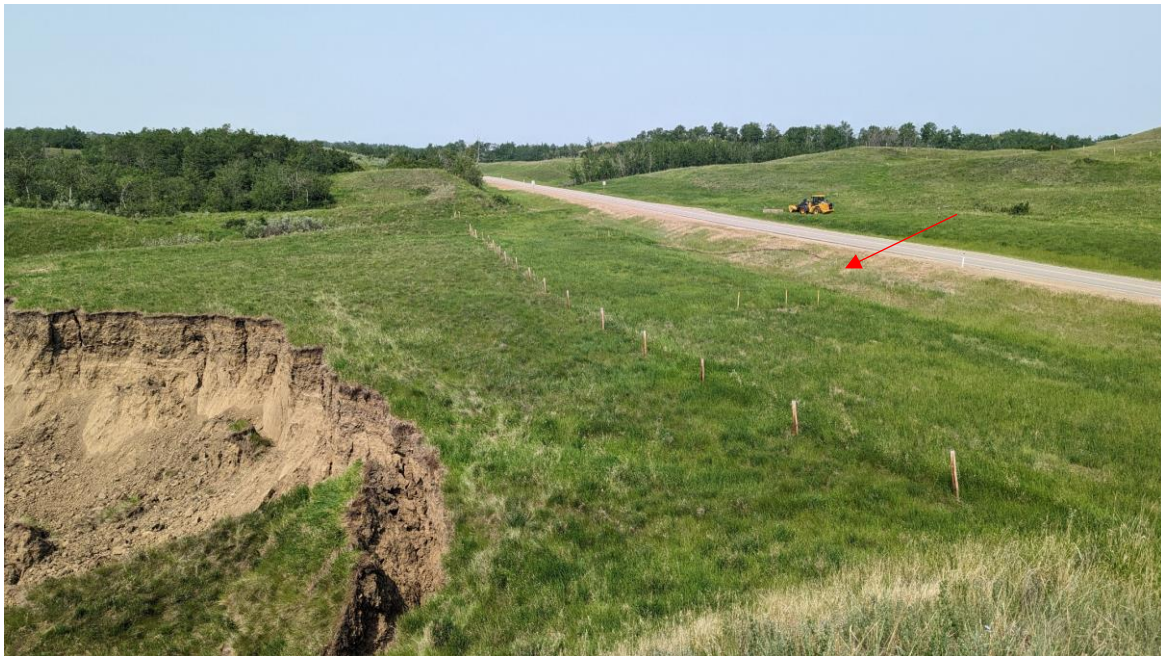
Due to the presence of the large tension crack in the sideslope of the highway (3.96 m from the fog line at the closest point), on site discussions included consideration of closing the road

Photo 11: Looking west at the main crack forming in the highway sideslope.

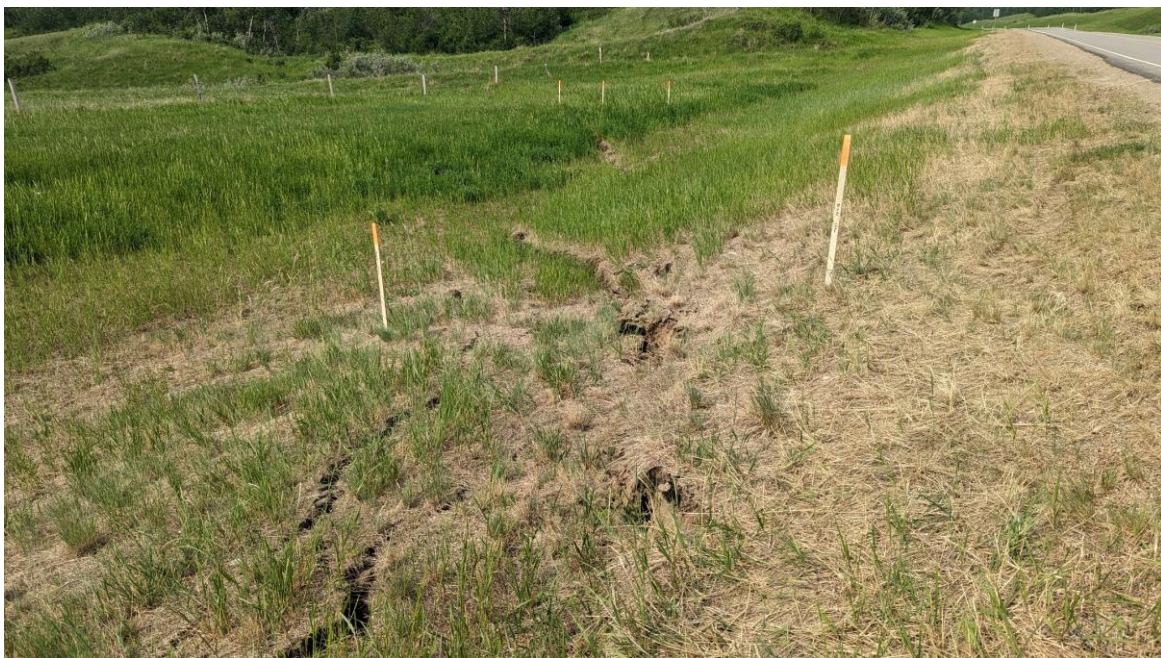
Photo 12: Looking southwest along the main crack in the highway sideslope. Line B stakes are in the foreground and Line A in the background. Measurements are made between the stakes.

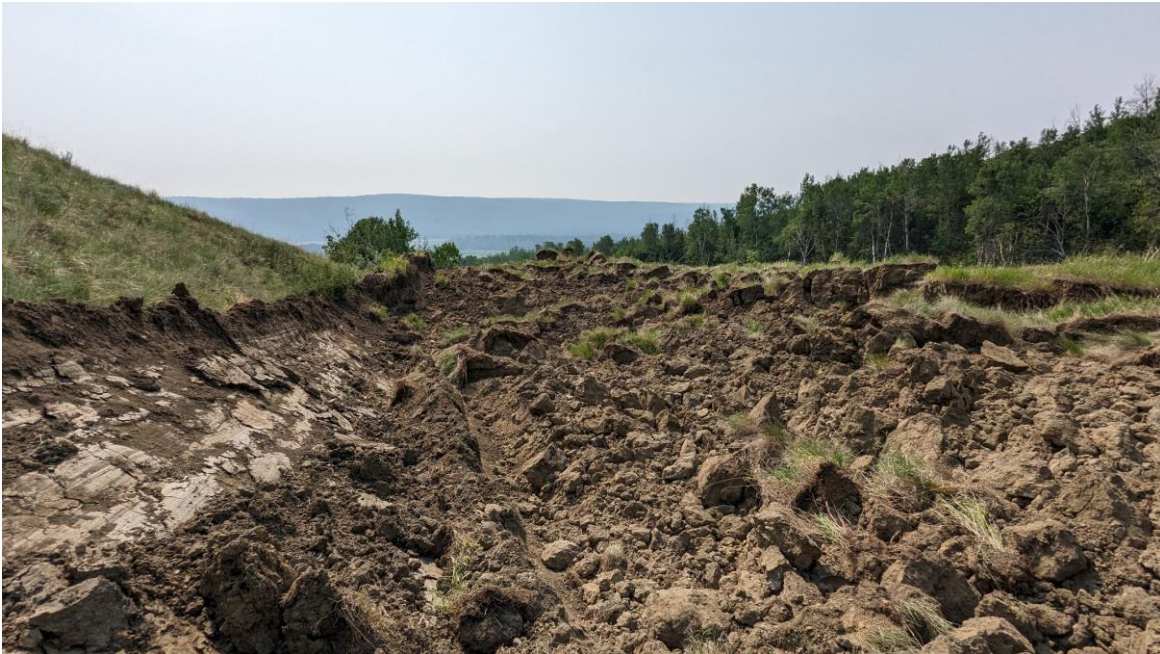
Photo 13: Looking south along east edge of the landslide body. The exposed slip surface on the left-hand side was desiccated.

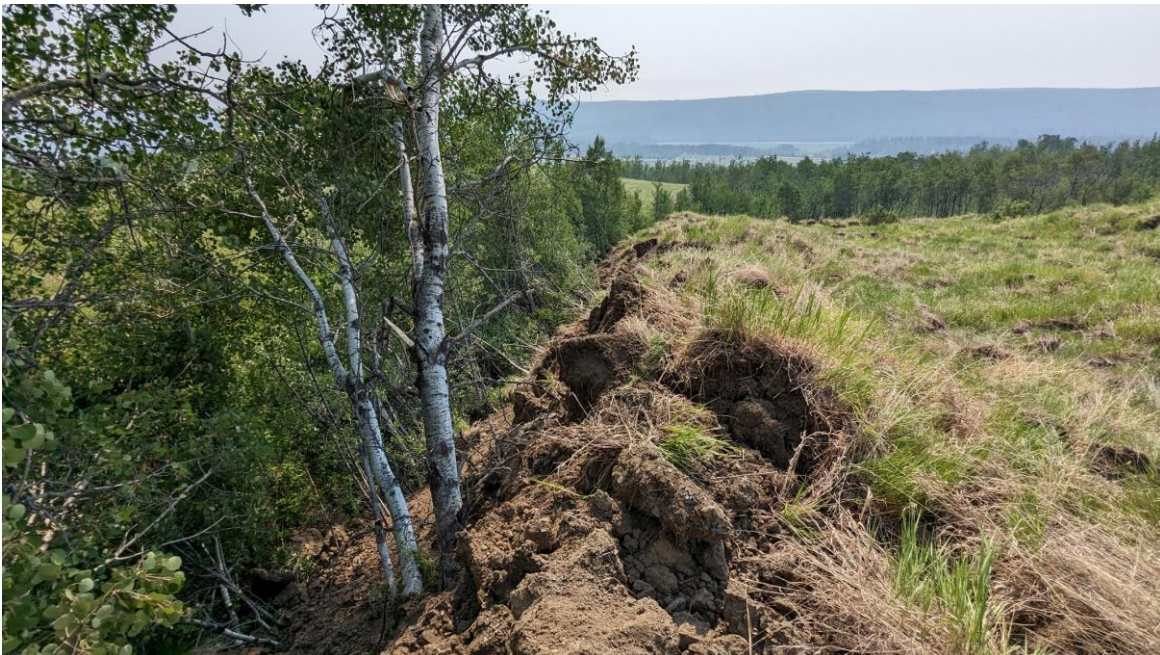
Photo 14: Looking south at eastern ridge of debris where it pushed over onto existing vegetation. The ridge is up to about 2 m high.

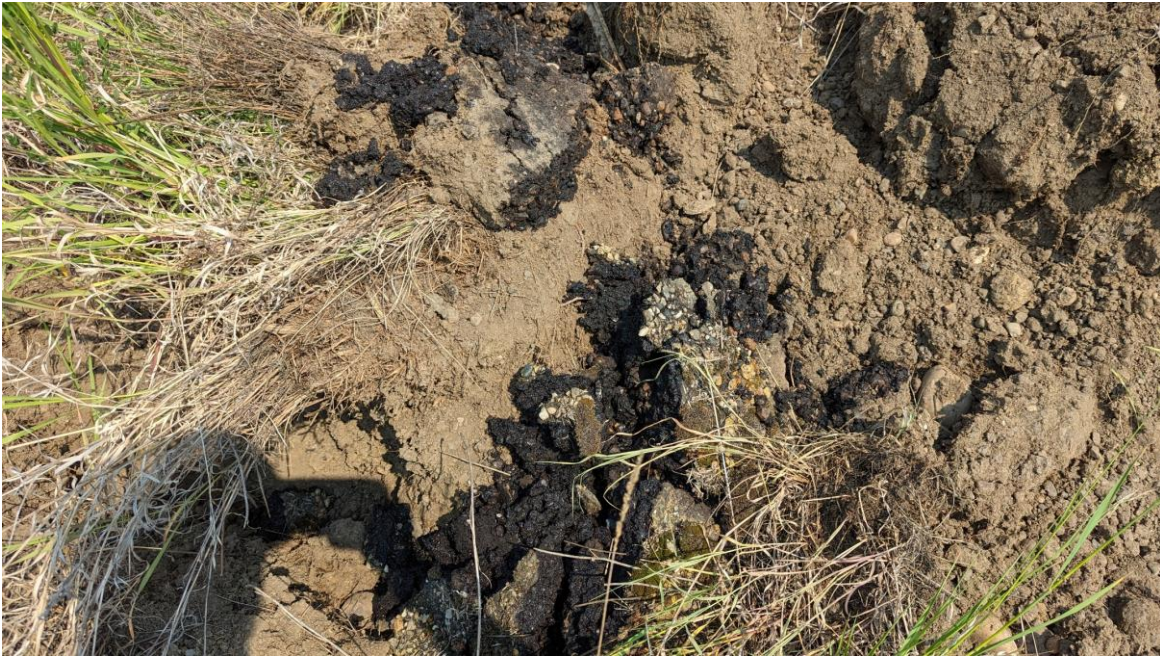
Photo 15A: Pieces of asphalt exposed in the slide debris.

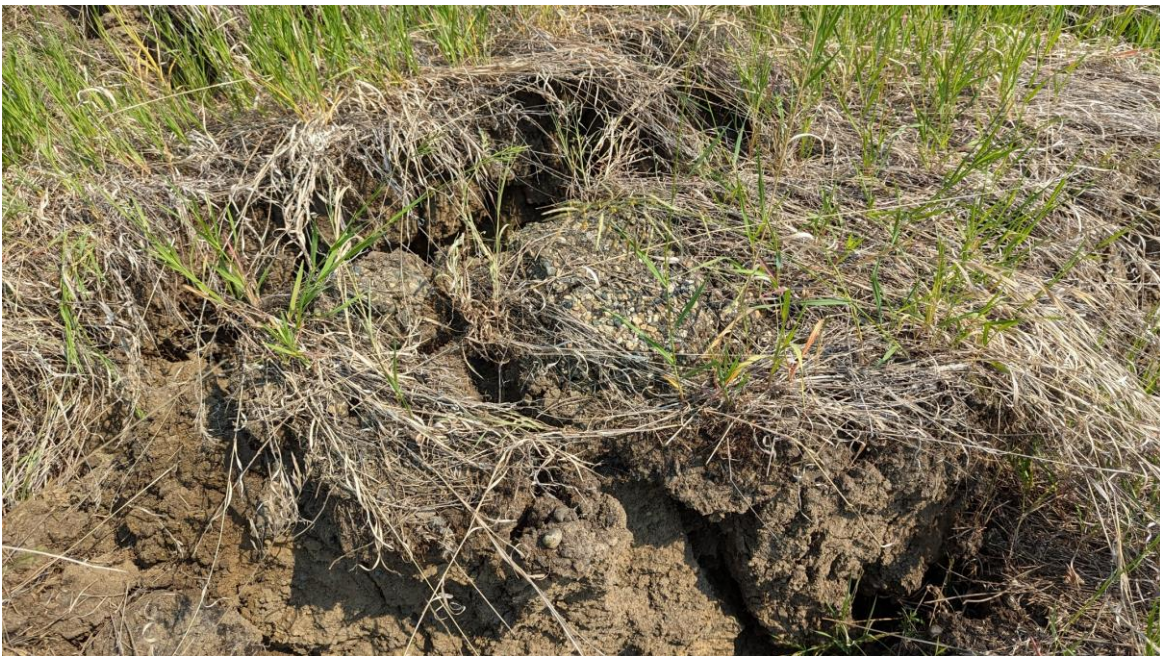
Photo 15B: Asphalt that appears to have been dumped or placed at ground surface and subsequently transported down the gully by the slide.

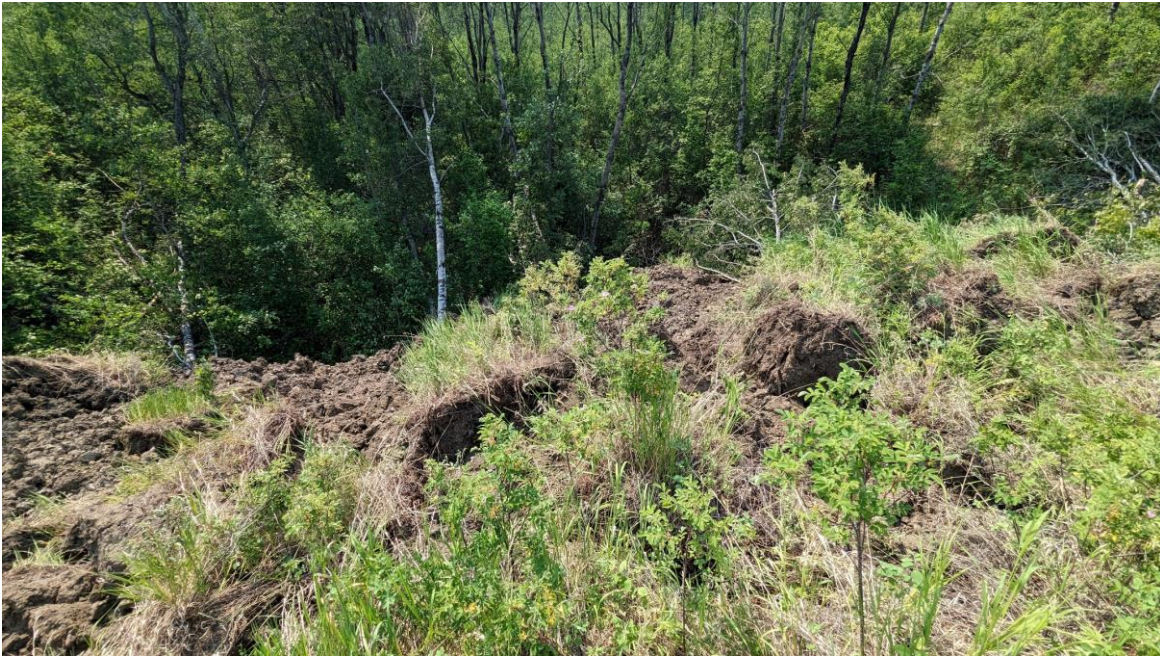
The toe of the slide debris was relatively steep: 30° near the crest becoming about 43° at the bottom. There were some small zones of seepage and wet soil noted near the bottom (Sample 4) but, interestingly, the gully floor beyond the toe appeared to be undisturbed.

Photo 16: Crest of the toe of the slide.

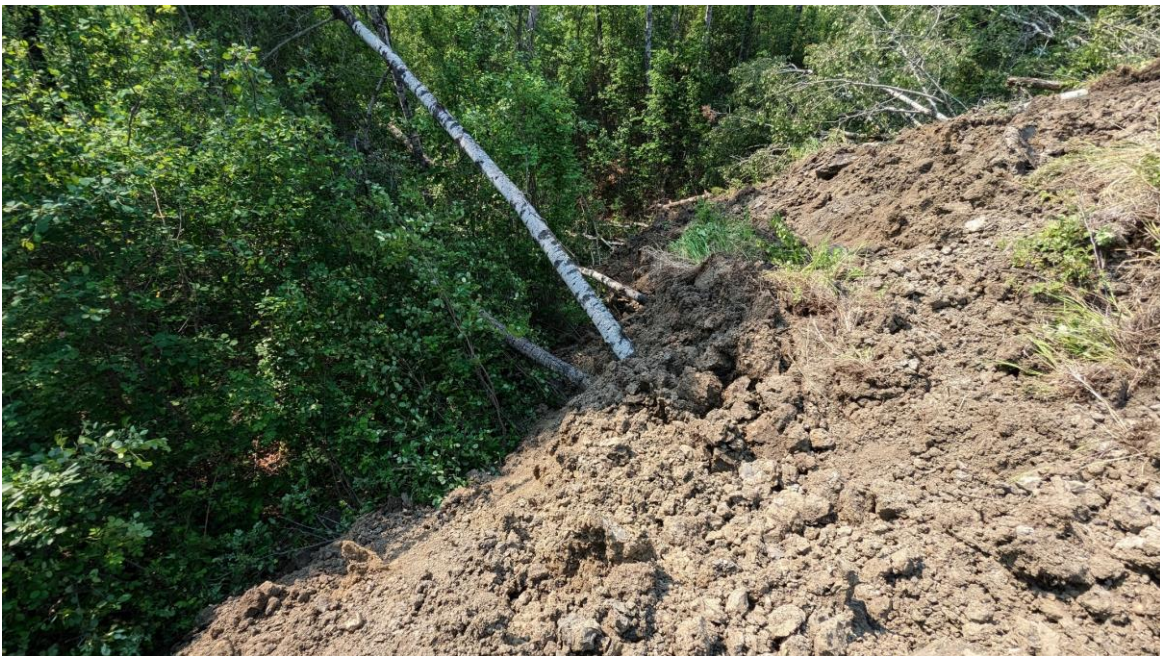
Photo 17: The lower portion of the toe of the slide.

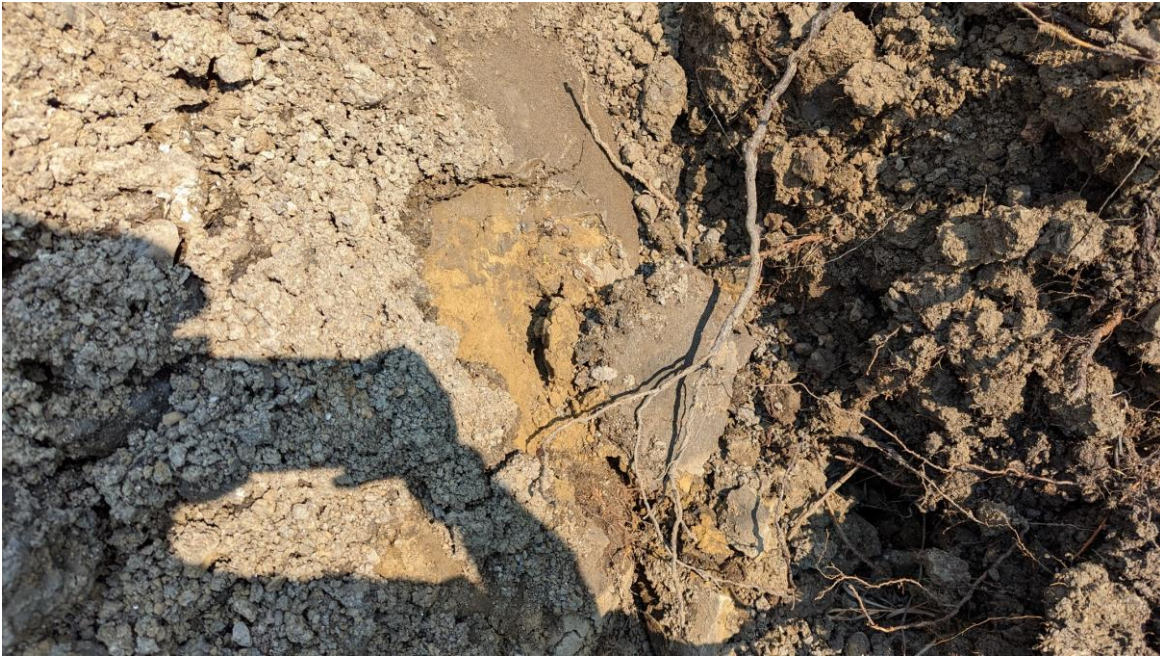
Photo 18: Wetter material down at the bottom of the toe.

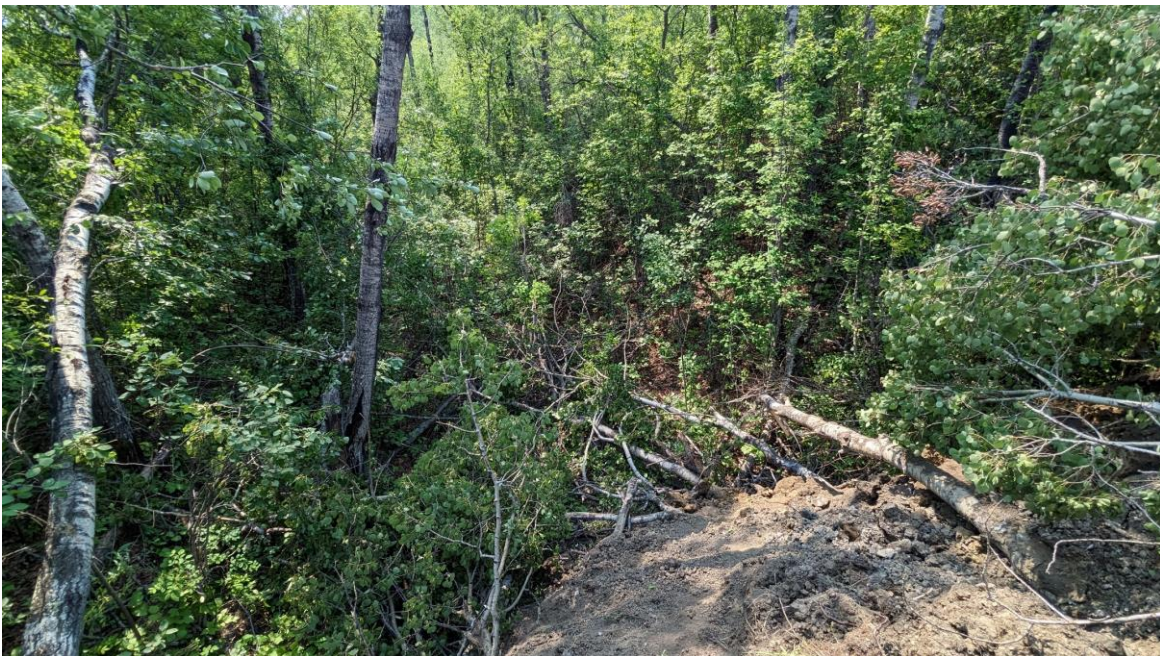
Photo 19: Looking south along undisturbed portion of the gully.

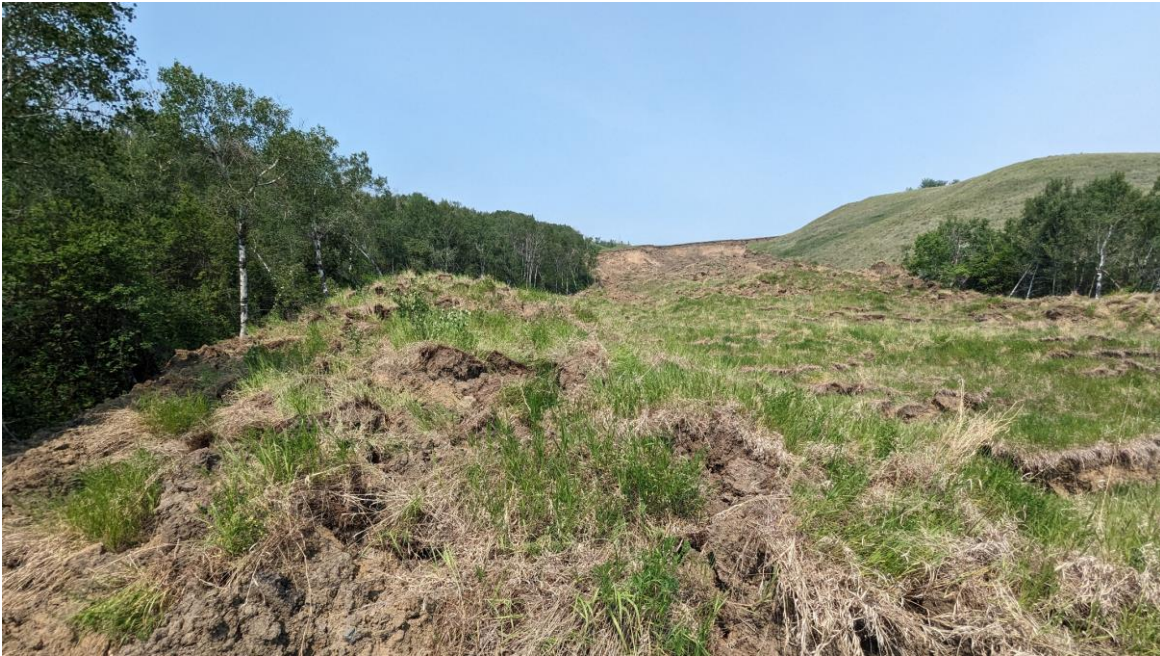
Photo 20: Looking north up the tongue of the debris toward the headscarp.

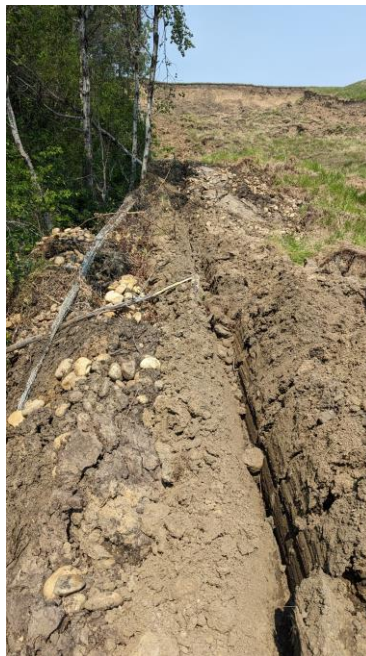
Photo 21: Looking north at possible secondary slip surface that cut through debris from an earlier phase of this slide. This groove ran for about 60 m on the west flank of the slide.

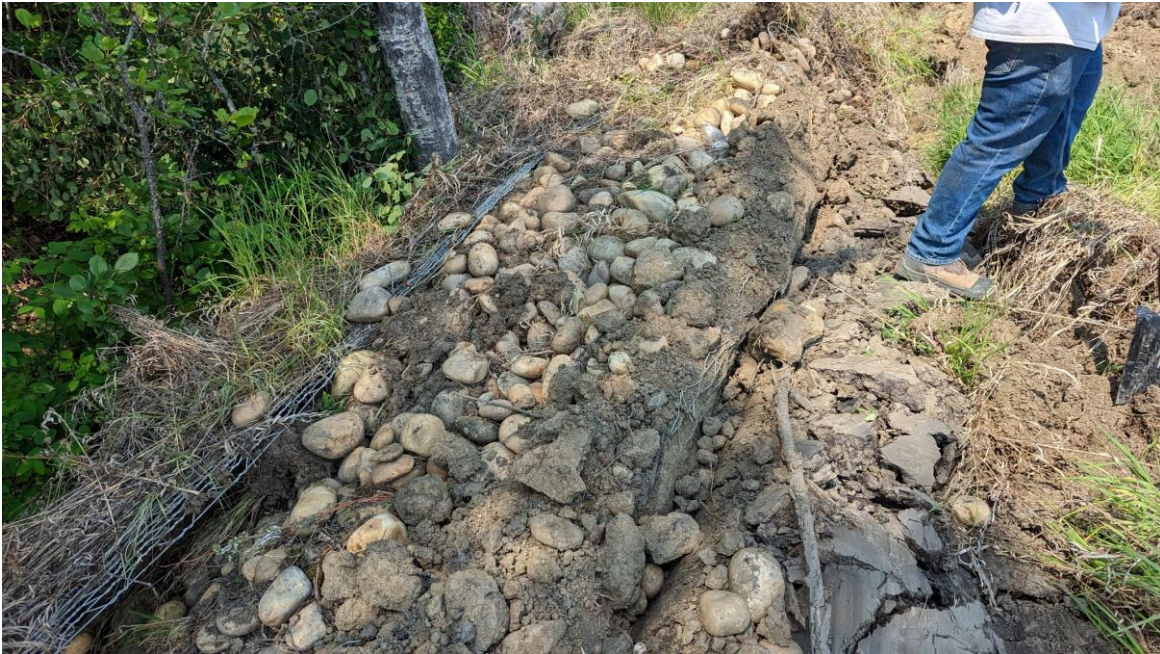
Photo 22: Distorted gabion mattress in the drainage channel. This suggests both that the drainage channel extended all the way to the bottom of the fill and that the lineal feature in Photo 21 could also have been gabion mattress being dragged.

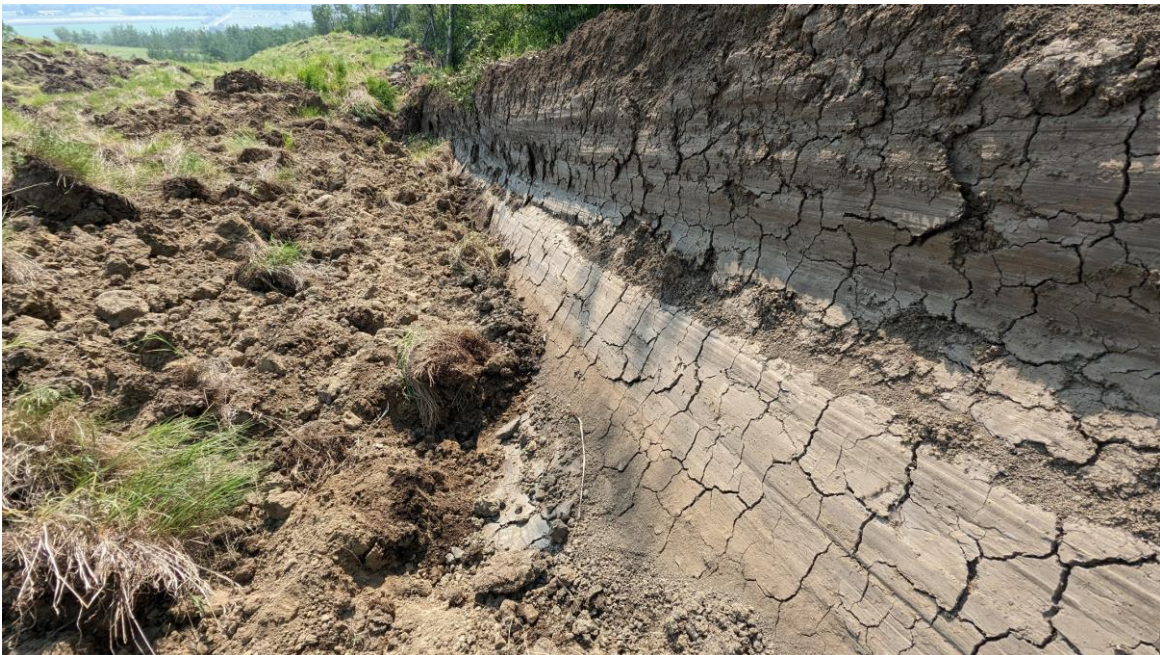
Photo 23: Exposed western flank of the desiccated slip surface.

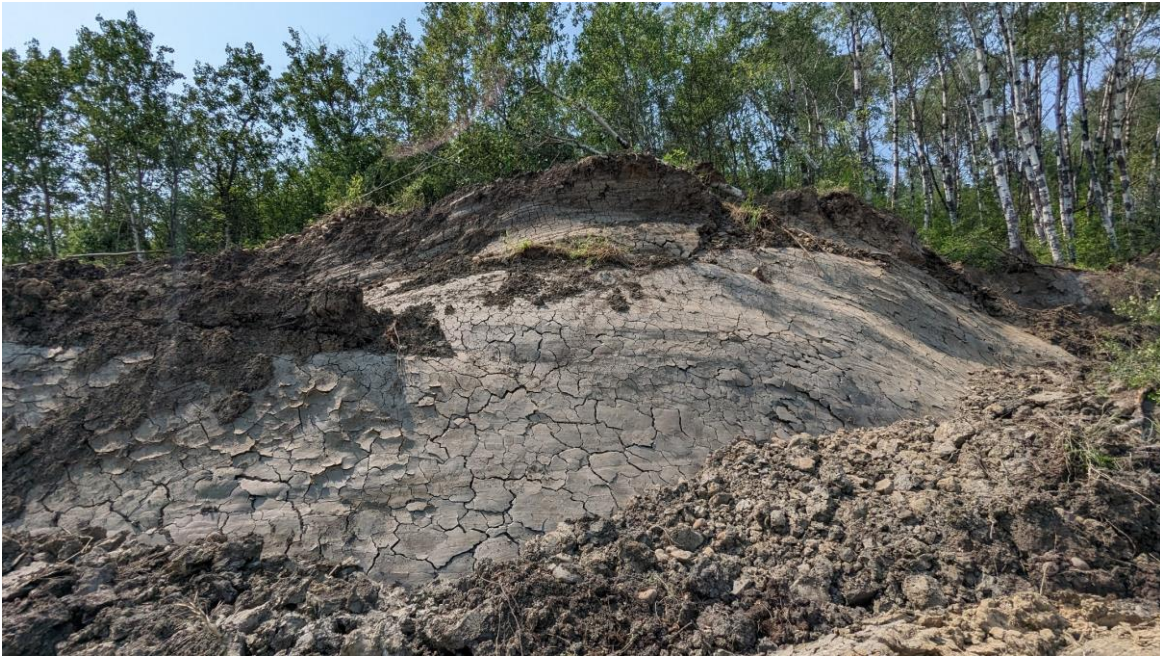
Photo 24: Looking southwest at a large portion of exposed, desiccated slip surface where drainage channel had been.

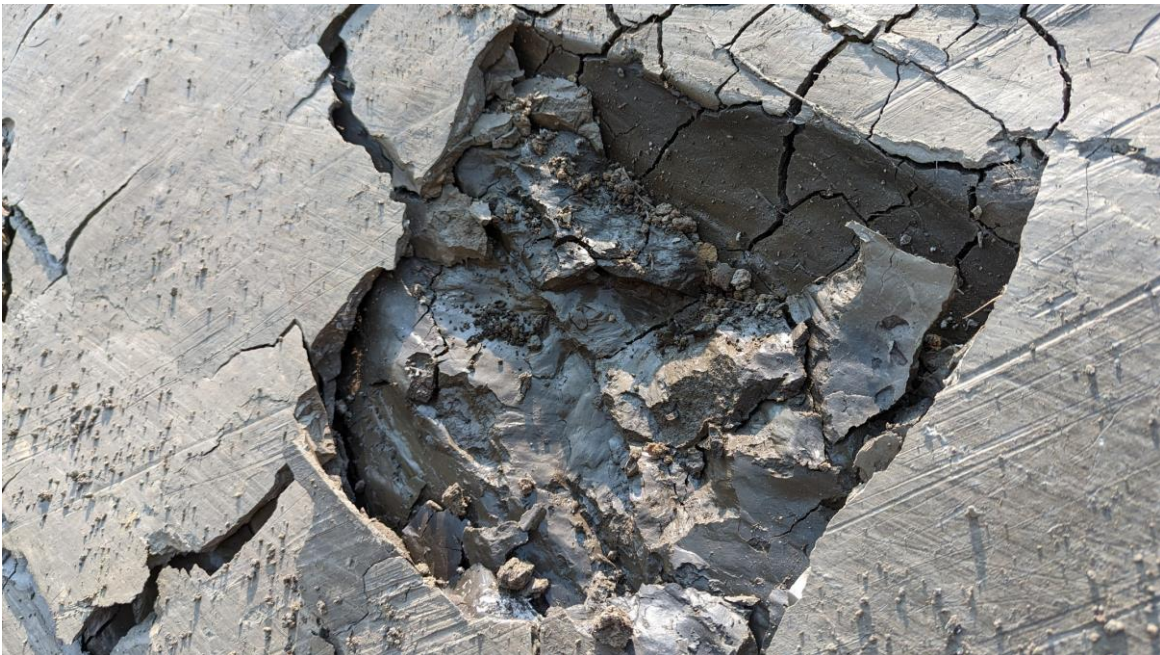
Photo 24B: Moisture on slickensides below the desiccated crust.

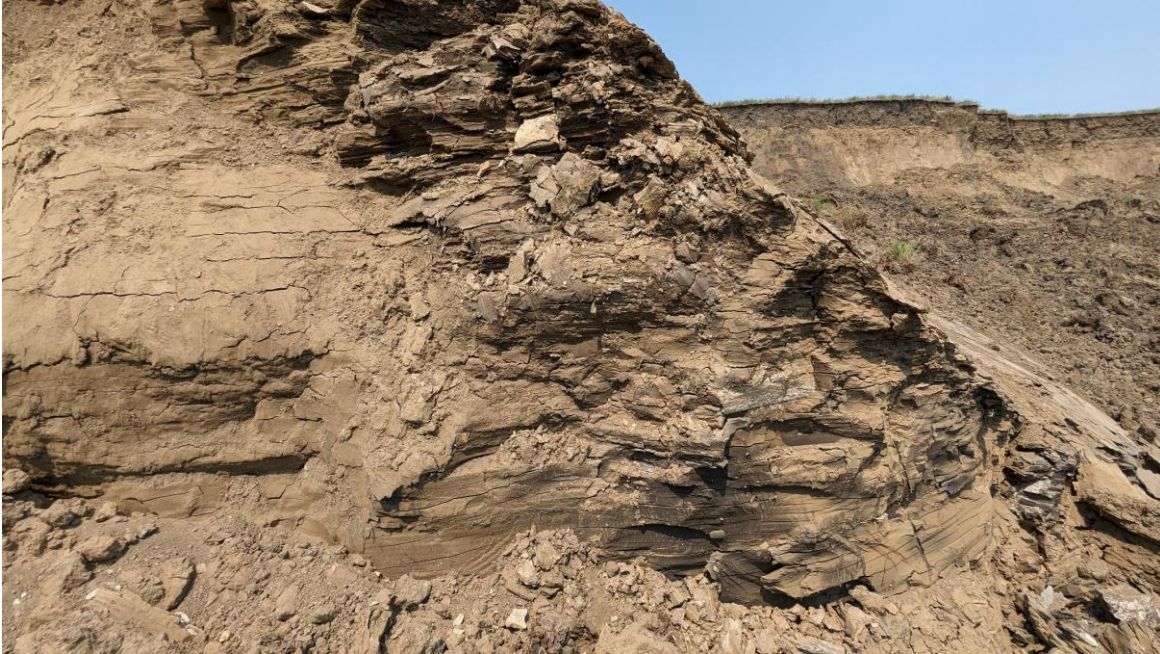
Photo 25: Intact outcrop of what appears to be varved clay (Sample 10).
