THURBER ENGINEERING LTD.

File No.: 32121

**GEOHAZARD RISK MANAGEMENT PROGRAM (CON0022164)
PEACE REGION (PEACE RIVER DISTRICT
SECTION D CALL-OUT REPORT
THE BIG EDDIE, BRICK'S HILL: HWY 684:02 km 8.86 to 8.98**

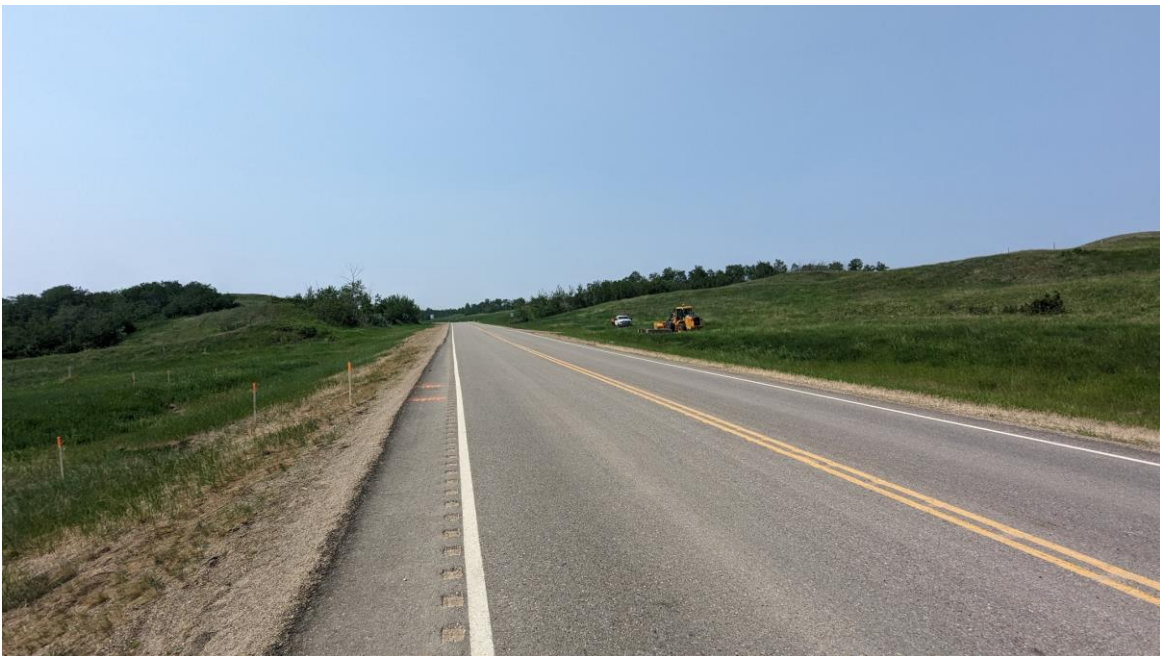
Photo 26: Looking west along as-yet undisturbed highway surface. The proposed temporary detour will be constructed to the right (north) on the flatter terrain. A probable long-term realignment would cut into the hillside further north.

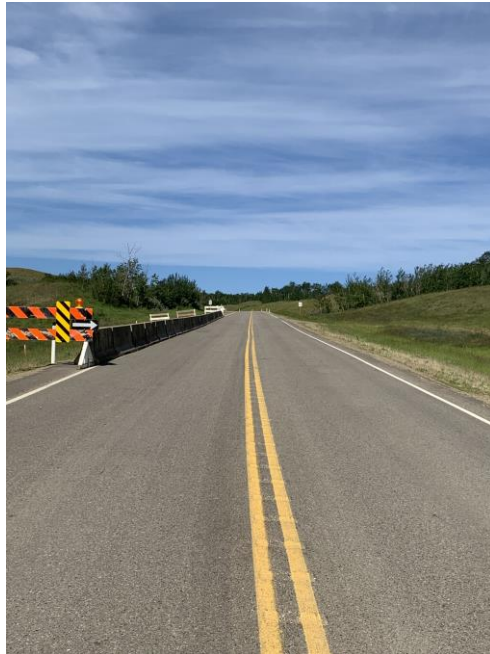
MCI Photo, June 29, 2023: Looking west along still-undisturbed highway with barricades added on the downslope side of the highway.

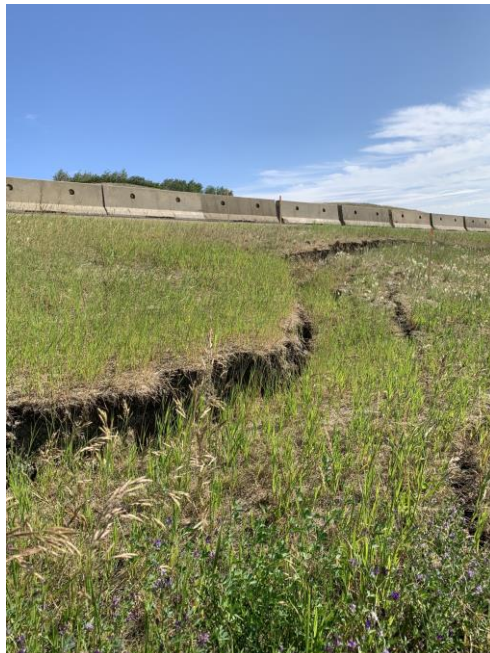
MCI Photo, June 29, 2023: Looking northeast at graben forming below tension crack in the highway sideslope.

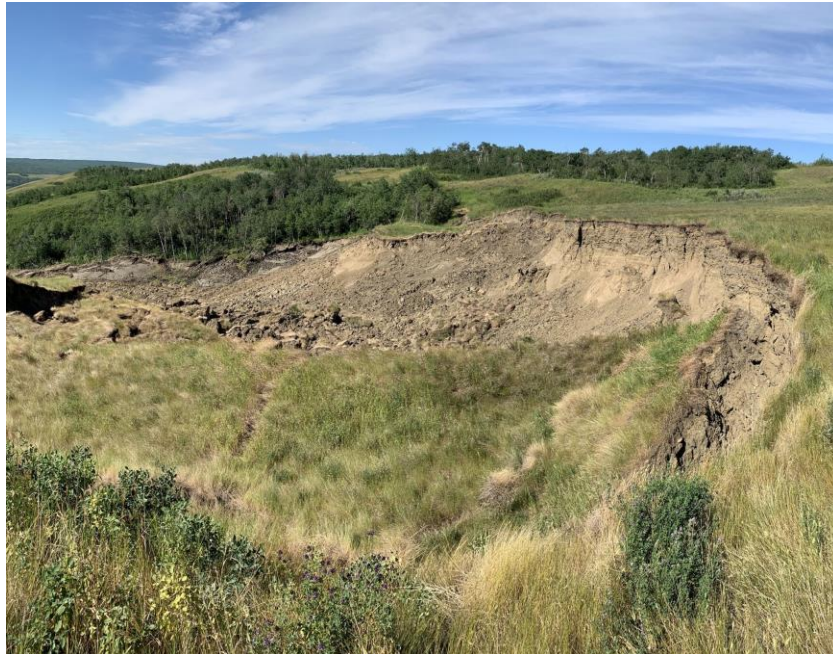
MCI Photo, June 29, 2023: Looking west at main headscarp which is mostly unchanged from the condition observed on June 9, 2023 (see Photo 10).
