**ALBERTA TRANSPORTATION AND
ECONOMIC CORRIDORS
GEOHAZARD ASSESSMENT PROGRAM
PEACE REGION (PEACE RIVER DISTRICT)
2024 INSPECTION**

Site Number	Location	Name	Hwy	km
PH093-1	Brick's Hill/Shaftesbury Trail	The Big Eddie	684:02	8.86-8.98
Legal Description		UTM Co-ordinates		
NW24/SW25-91-23-W5M		11 E 467,076	N	6,219,660

**PH093: BIG EDDIE: HWY 684:02 KM 8.86 TO KM 8.98
 2024 SITE INSPECTION PLAN**

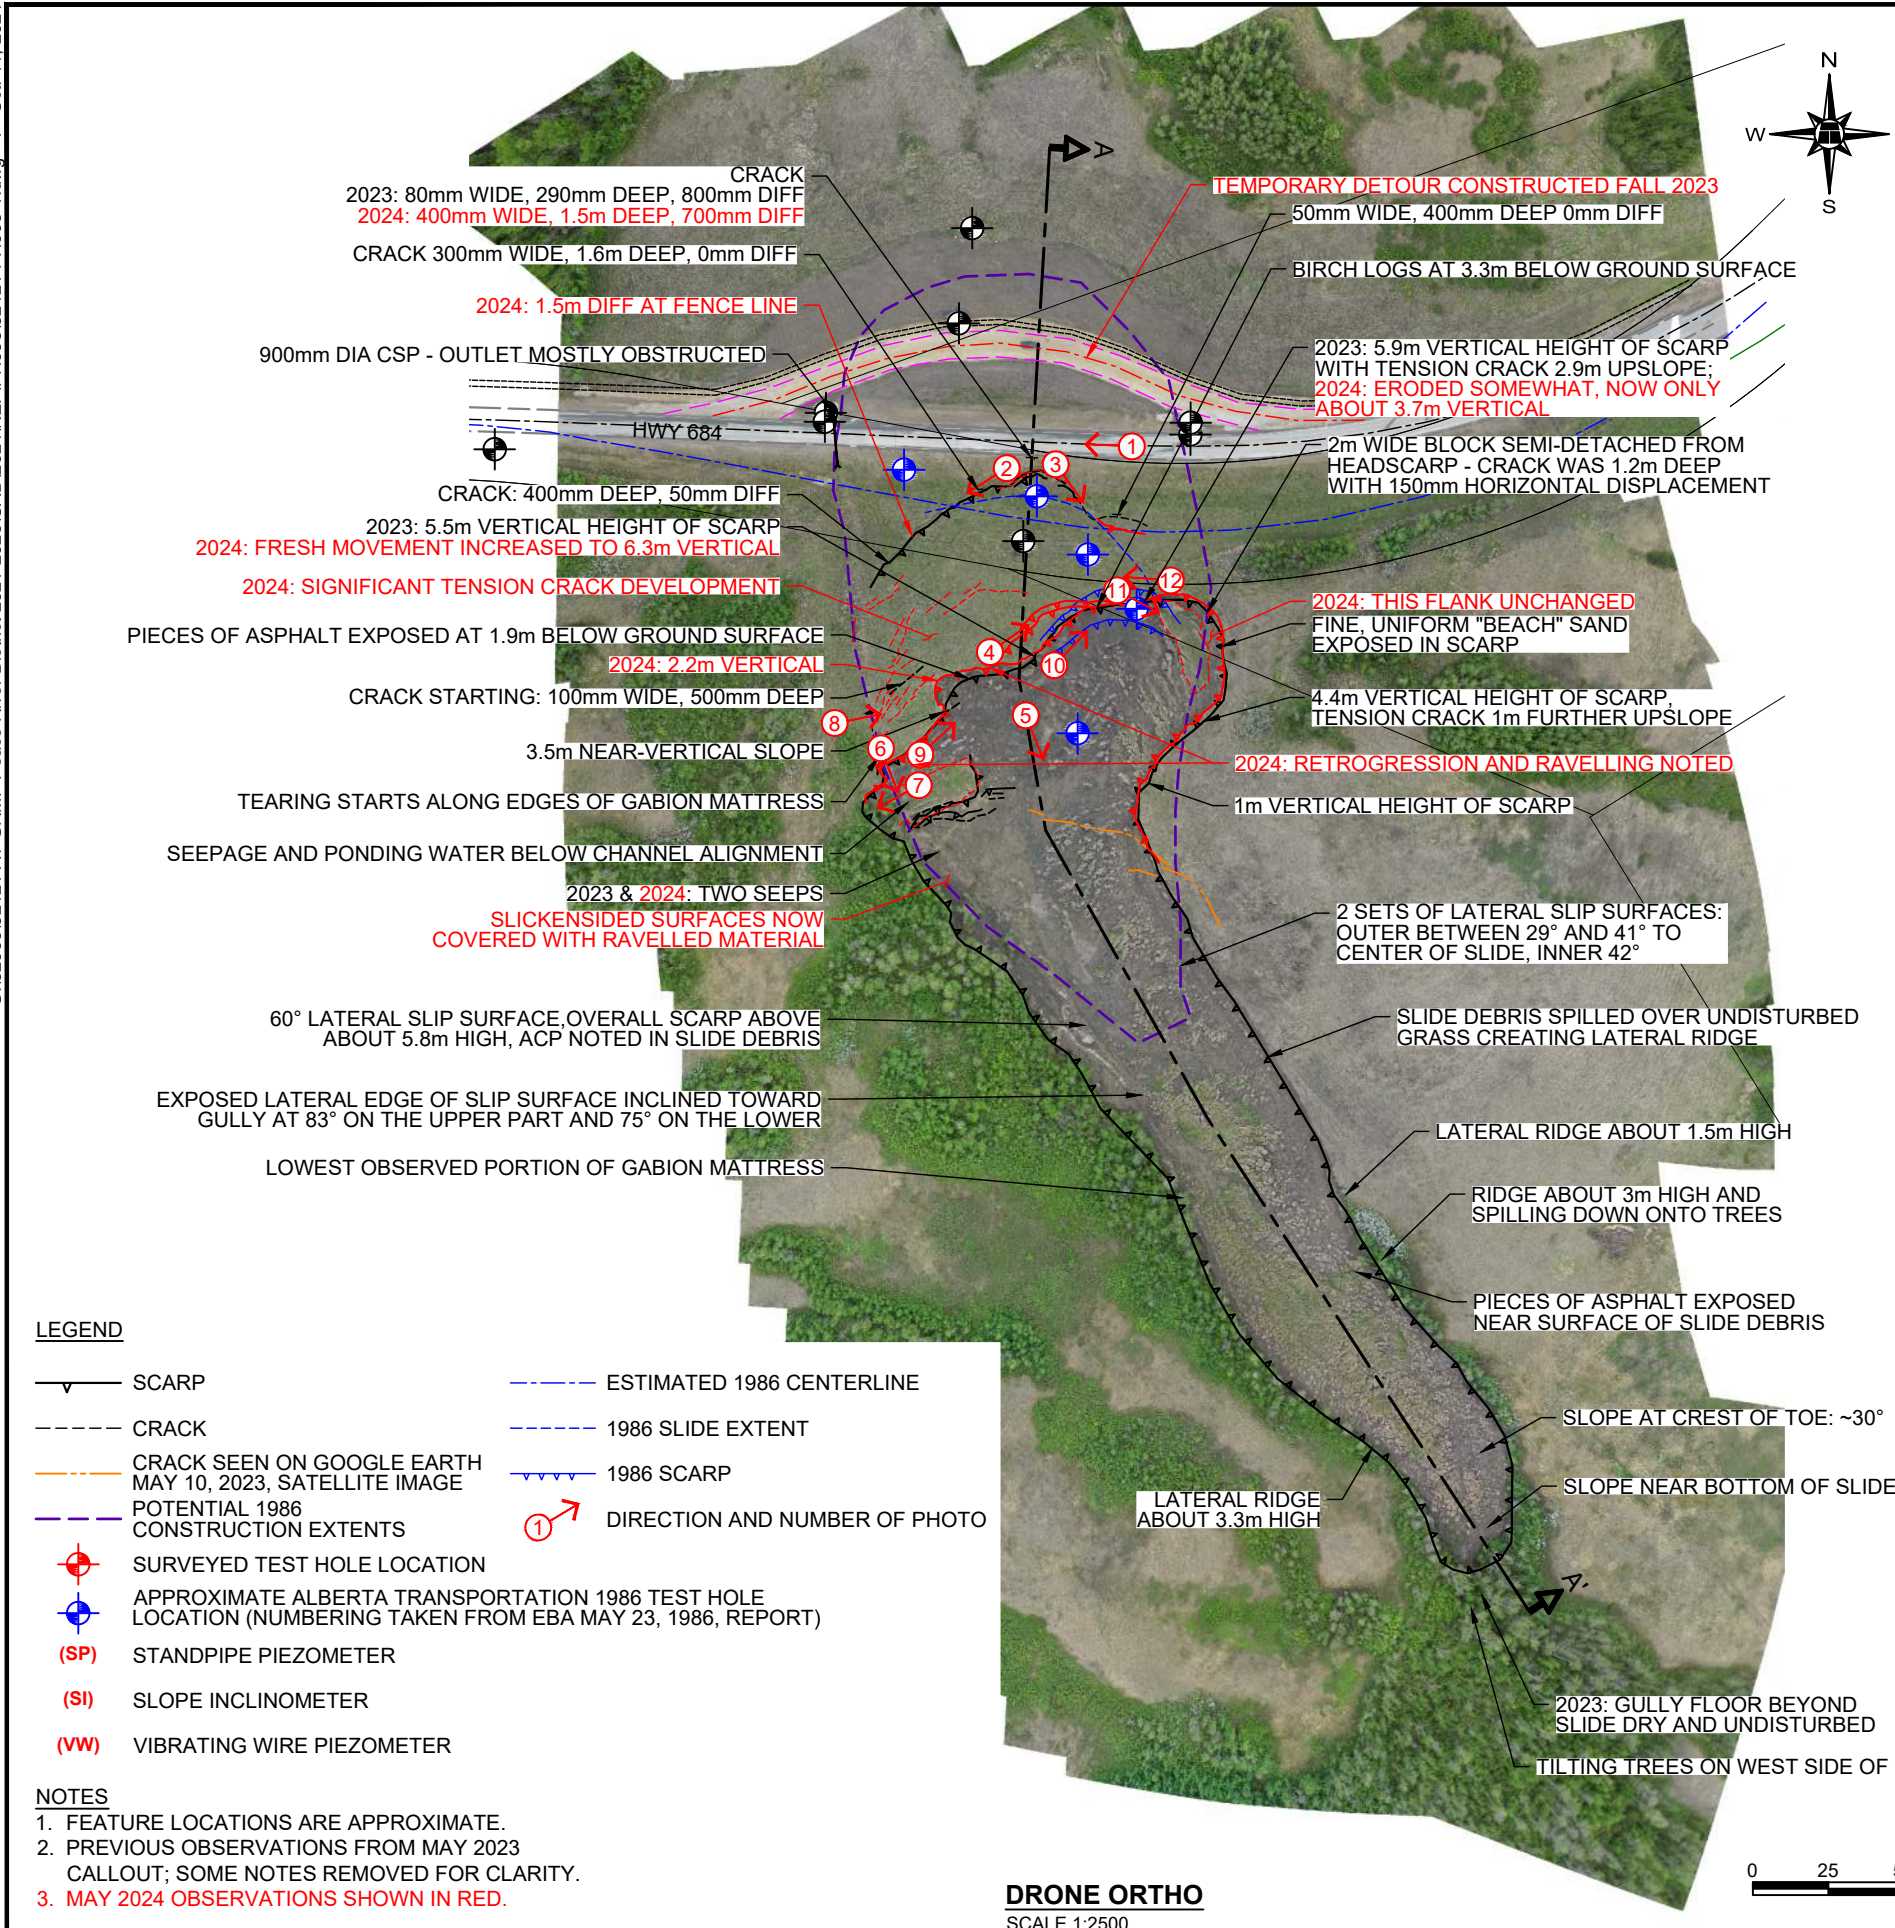
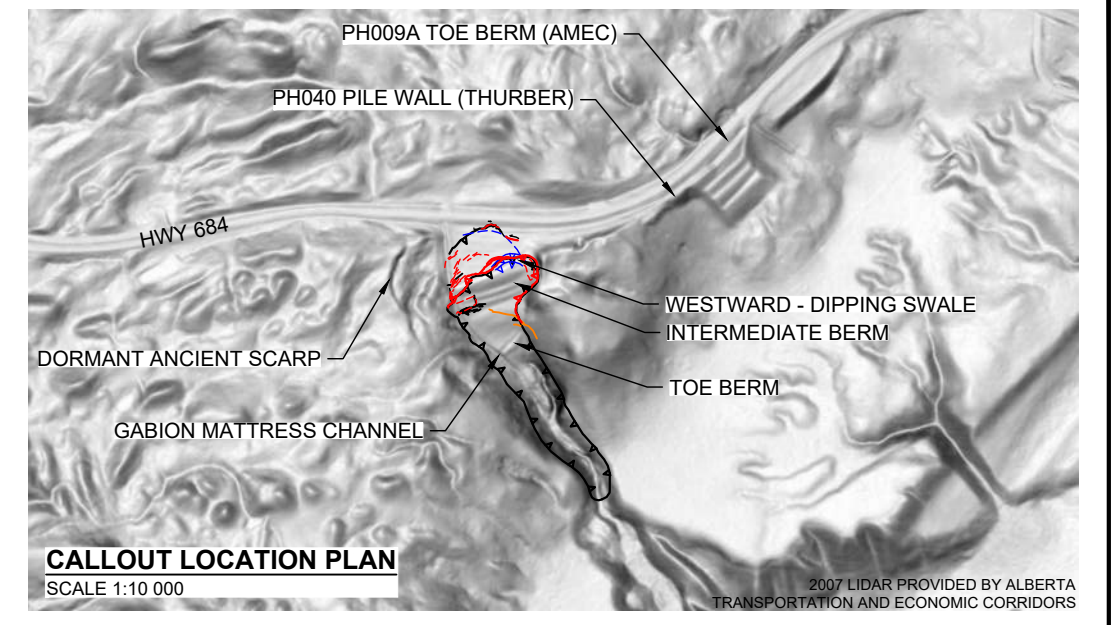
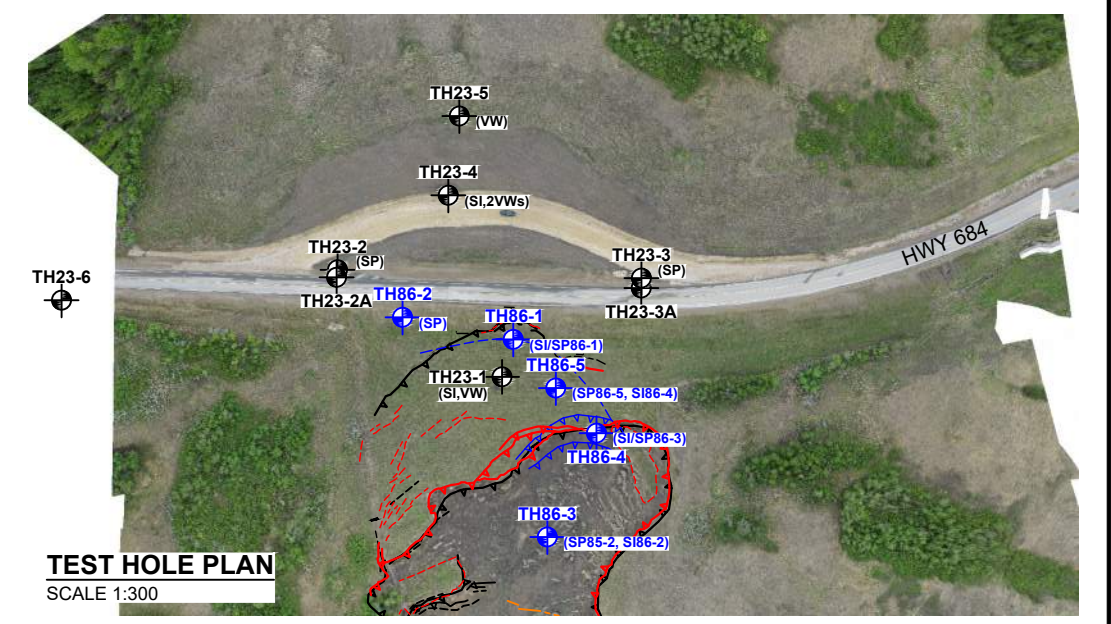
DWG No. 32121-PH093-1

Comparison between UAV imagery taken in 2023 and 2024 shows that there has been some regression of the main headscarp (up to about 5 m) as noted on the Drawing 32121-PH093-1) in the upper central portion of the slide area; the west and east flanks appeared relatively stable other than some dissociation and toppling of blocks that had already slumped. There are additional intermediate tension cracks between the main scarp and the highway mostly on the west portion of the site. All the cracks were wider and deeper than in 2023. It is expected that the slow movements will continue until there is a sudden, brittle failure and this next block slides or topples out. This may be triggered by high rainfall raising the groundwater table and lubricating the slip surfaces or by steady erosion of the slide material below the headscarp leading to further destabilization of the overall slope.

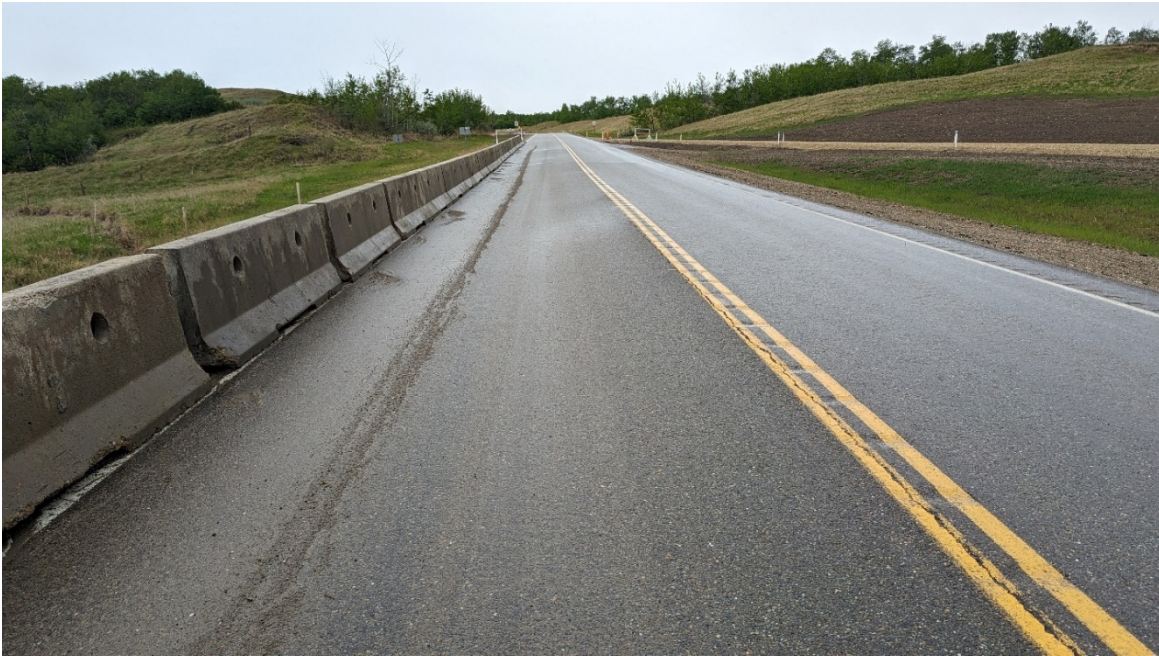
Photo 1: Looking west along as-yet uncracked highway surface.

- Routine monitoring to determine if tension cracking has started within the pavement. If this occurs, then the next step is to shift traffic onto the temporary detour.

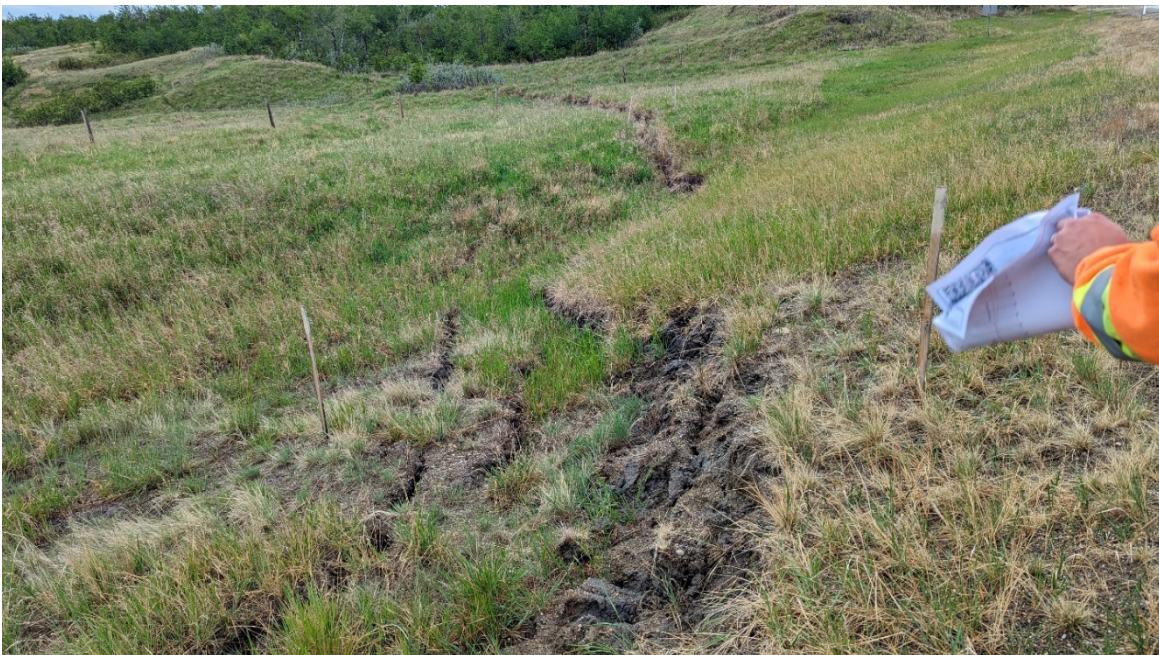
<input checked="" type="checkbox"/> Slope Movement	Tension crack arcs along south highway sideslope and continues to drop and widen. The headscarp is slowly retrogressing and may rapidly retrogress as water infiltrates the cracks.	<input checked="" type="checkbox"/>
<input type="checkbox"/> Erosion		<input type="checkbox"/>
<input checked="" type="checkbox"/> Seepage	There are damp areas on the west flank. The location of previously installed subdrains is not known.	<input type="checkbox"/>
<input checked="" type="checkbox"/> Bridge/Culvert	Outlet of 900 mm CSP on west side is mostly obstructed. Temporary detour has diverted ditch flow to the east along the north side of the highway.	<input type="checkbox"/>
<input type="checkbox"/> Other		<input type="checkbox"/>

Photo 2: Looking southwest along main tension crack at the highway sideslope with measuring transect stakes in foreground.

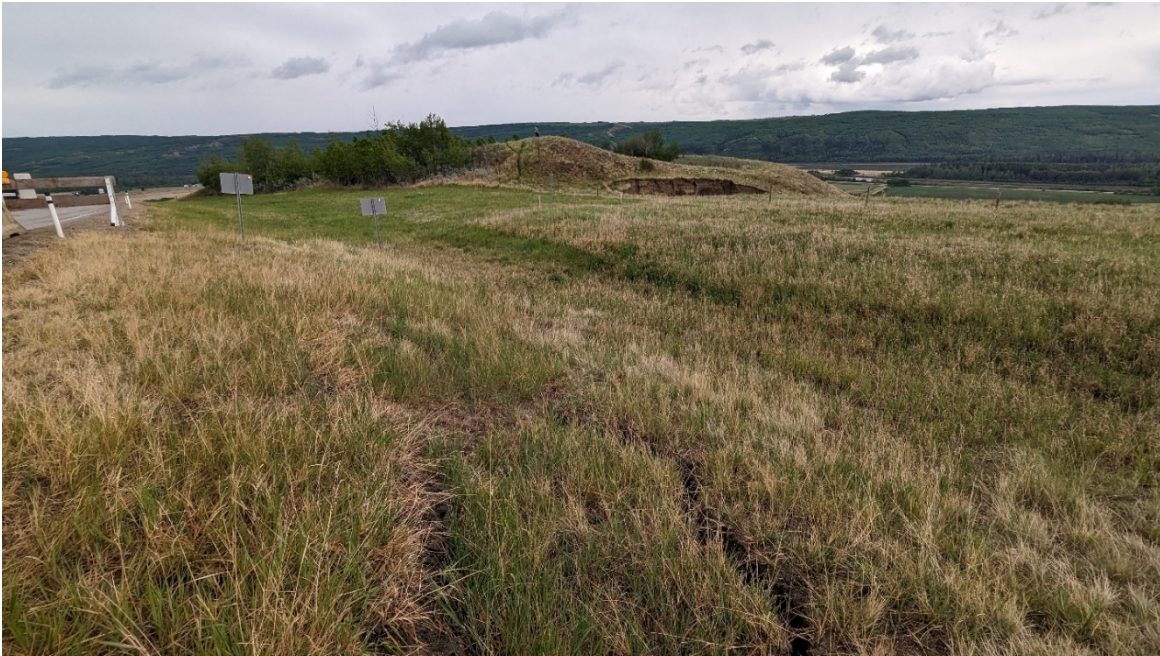
Photo 3: Looking southeast along the rest of the main tension crack at the highway sideslope.

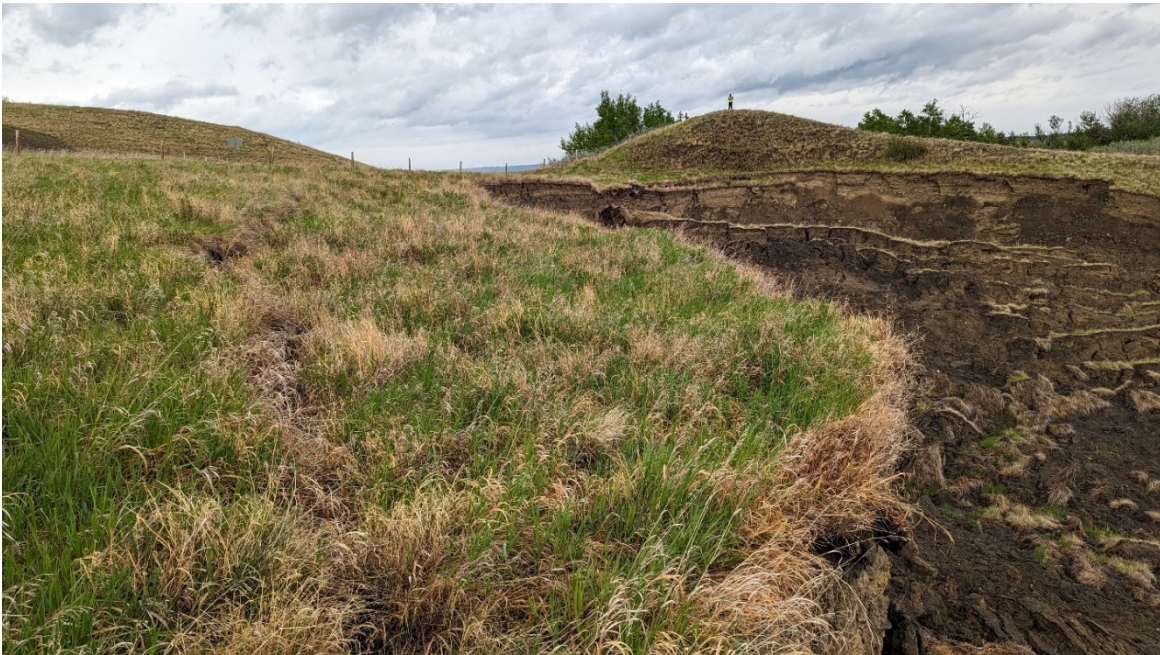
Photo 4: Looking east along the main headscarp where the portion is regressing towards the highway.

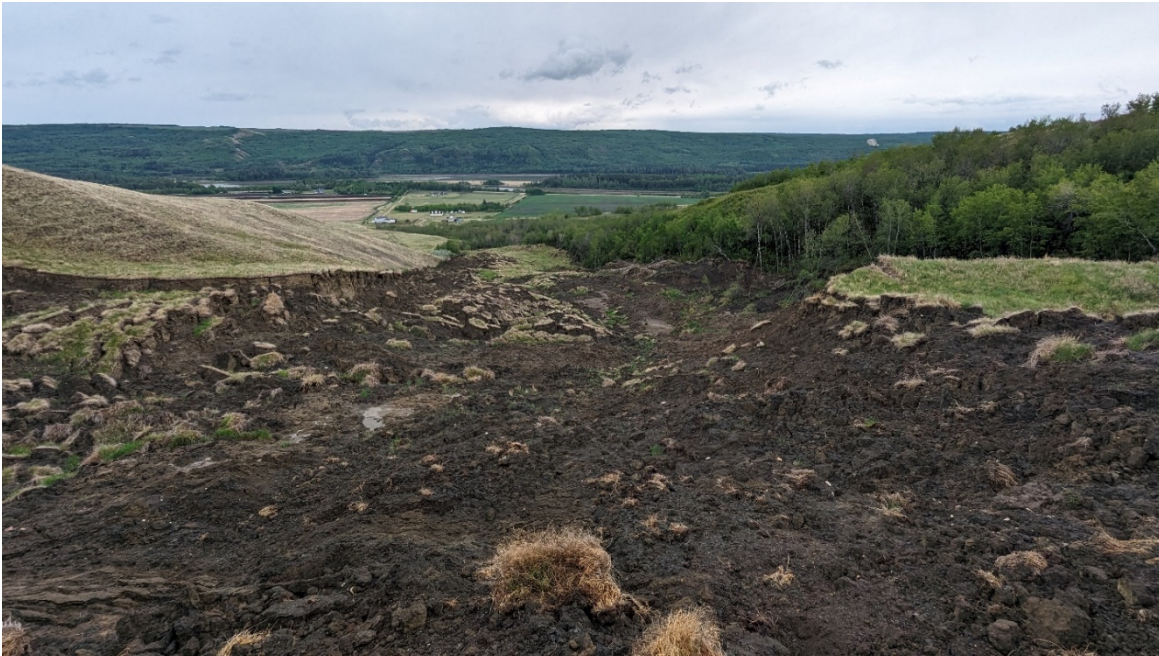
Photo 5: Looking south down the axis of the landslide mass.

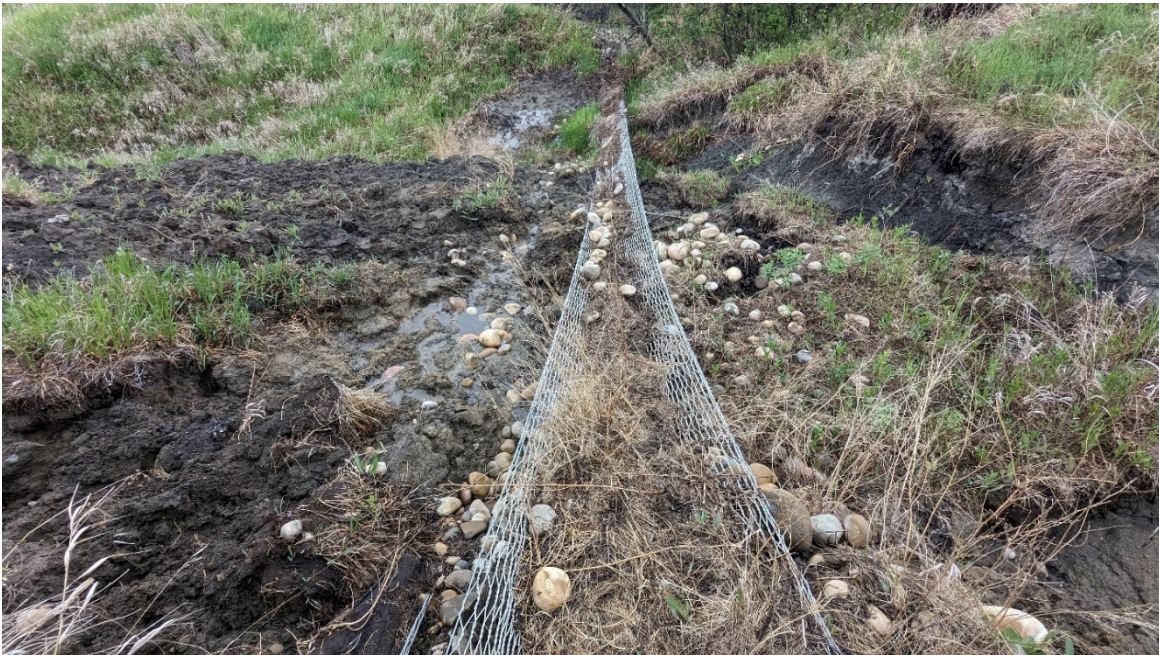
Photo 6: Stretching gabion mattress along the west flank of the landslide.

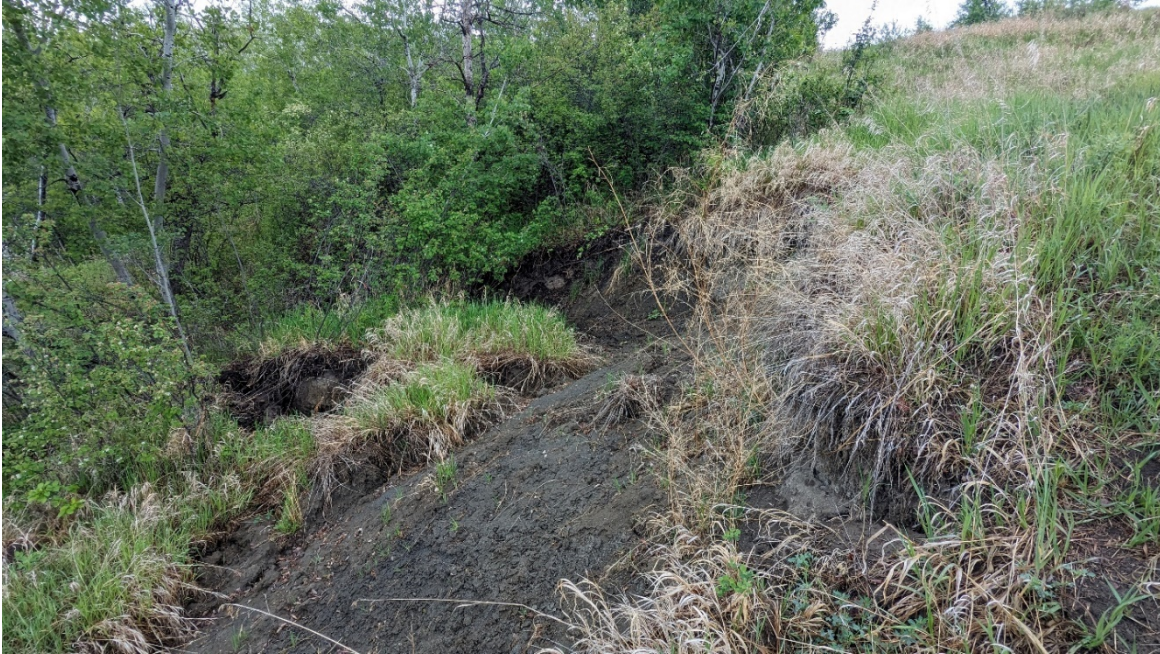
Photo 7: Additional scarps just beyond the west flank of the landslide.

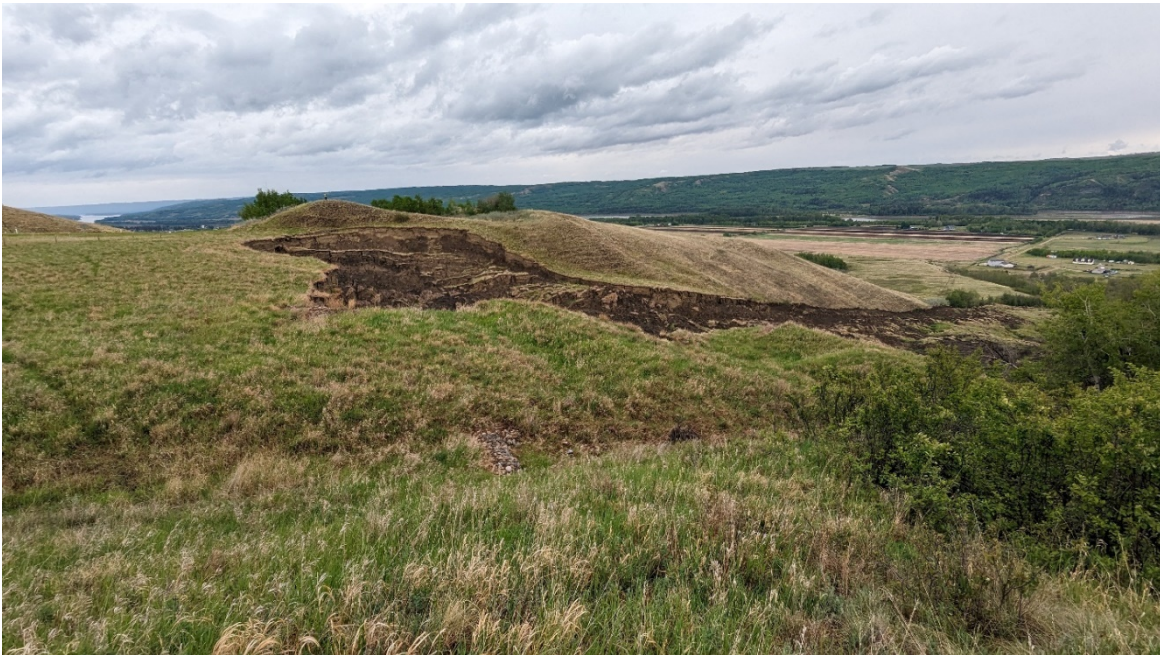
Photo 8: Looking east across the main landslide scarp.

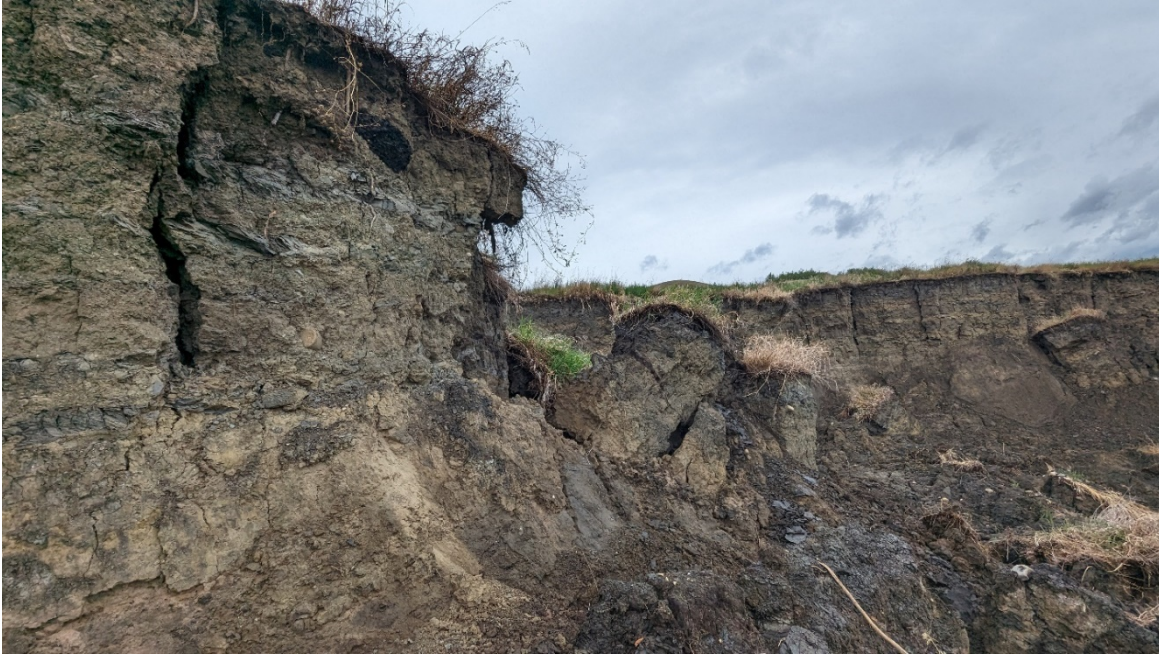
Photo 9: Toppling blocks at the face of the main headscarp.

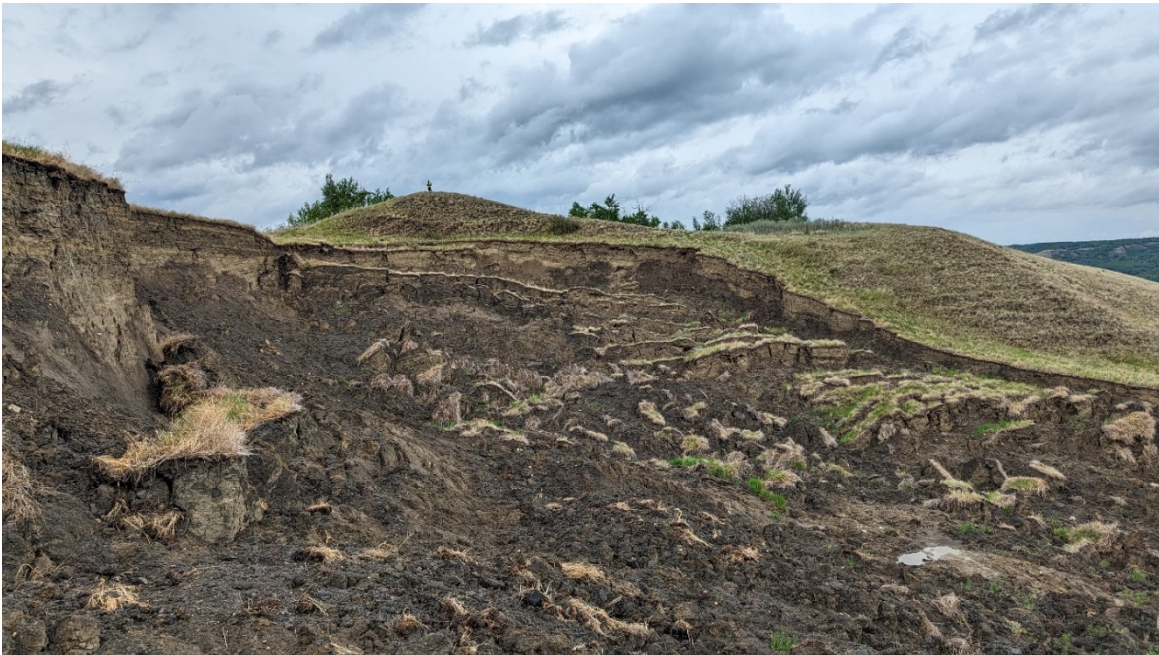
Photo 10: Looking east along face of the main headscarp.

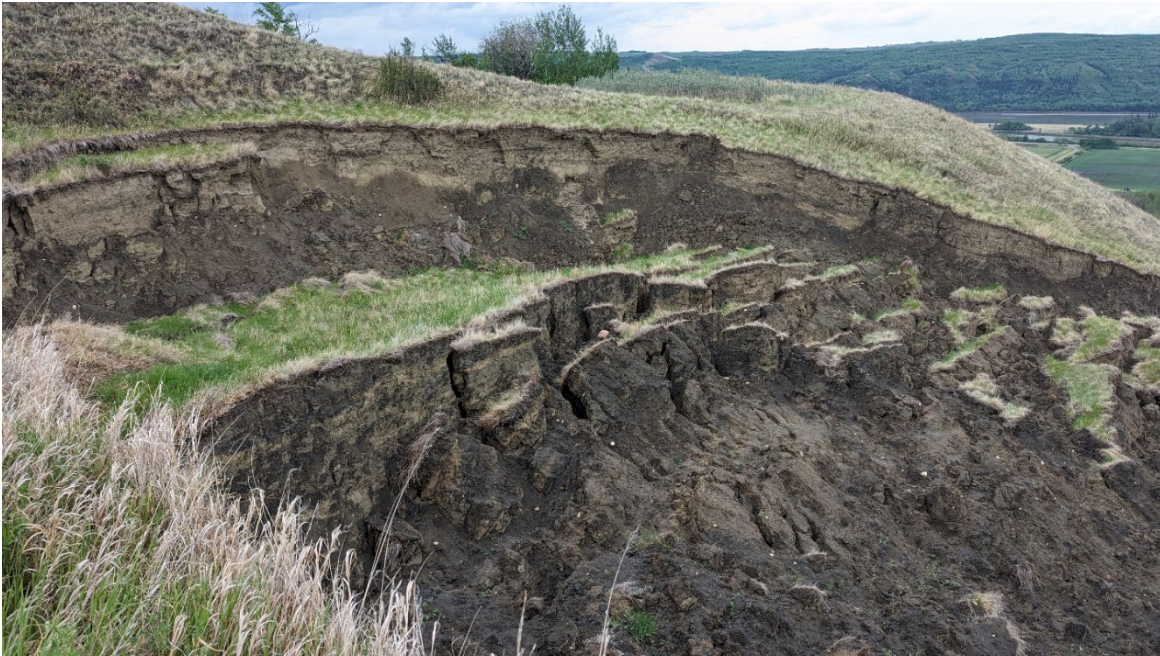
Photo 11: Looking southeast at the east flank of the main landslide.

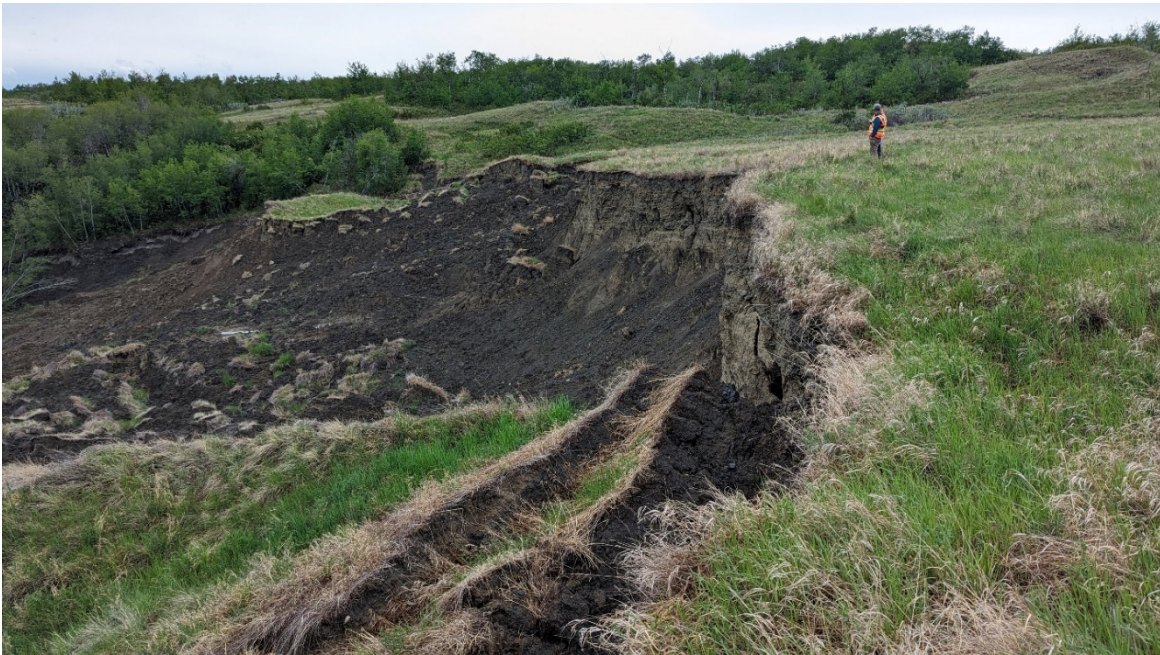
Photo 12: Looking west at the main landslide headscarp.
