**ALBERTA TRANSPORTATION  
GEOHAZARD ASSESSMENT PROGRAM  
PEACE REGION – PEACE RIVER DISTRICT  
2023 INSPECTION**

Site Number	Location	Name	Hwy	km
PH054	Peace River	Shaftesbury Trail North Sites	684:02	28.95
Legal Description		UTM Co-ordinates (NAD 83)		
SE-30-83-21-5		11U N 6 230 850	E 481 490

Date	PF	CF	Total Risk
<b>Previous Inspection:</b>	July 5, 2007	7	1	7 – (Relative to hwy.)
<b>Current Inspection:</b>	May 18, 2023	7	2	14 – (Relative to hwy.)
<b>Road AADT:</b>	1560		<b>Year:</b>	2022
<b>Inspected By:</b>	Don Proudfoot, Tyler Clay (Thurber) Max Shannon, Rocky Wang, Pramaya Kannel (AT)			
<b>Report Attachments:</b>	<input type="checkbox"/> Photographs <input checked="" type="checkbox"/> Plans <input checked="" type="checkbox"/> Maintenance Items

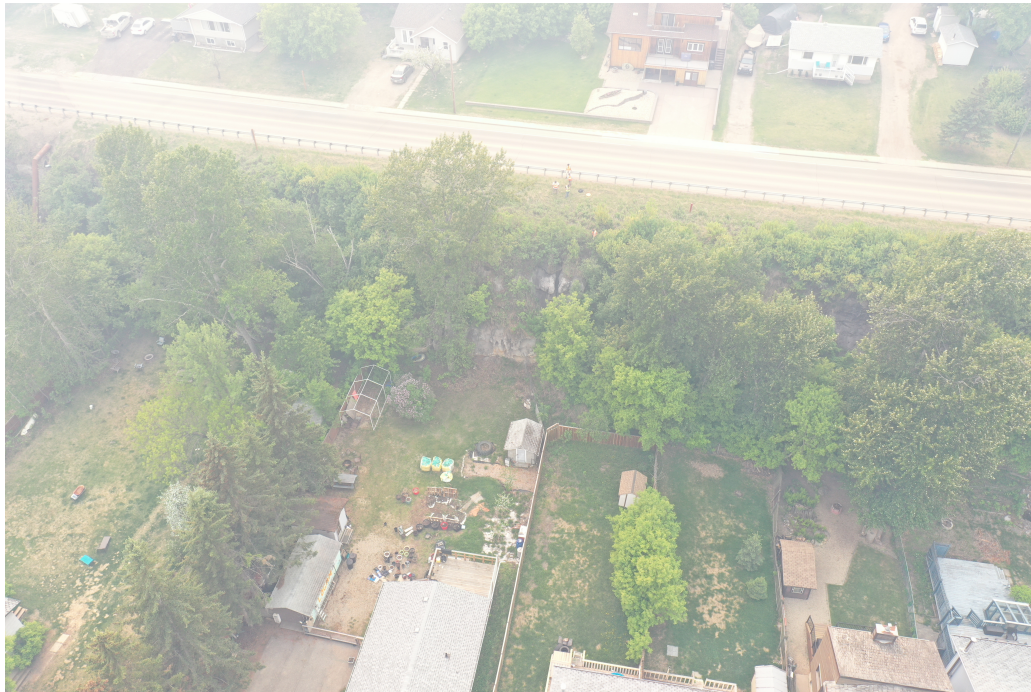
**Photo 54-1. Drone photo looking west at location where slope sloughed/eroded in past.**

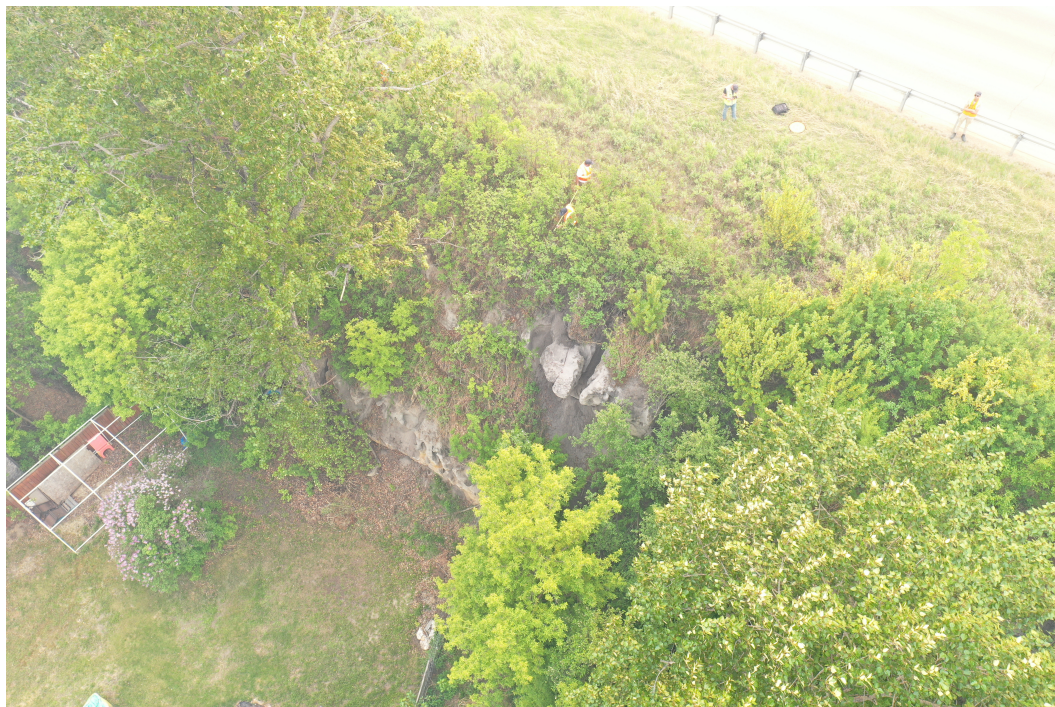
**Photo 54-2. Closer view of steep eroded slope.**

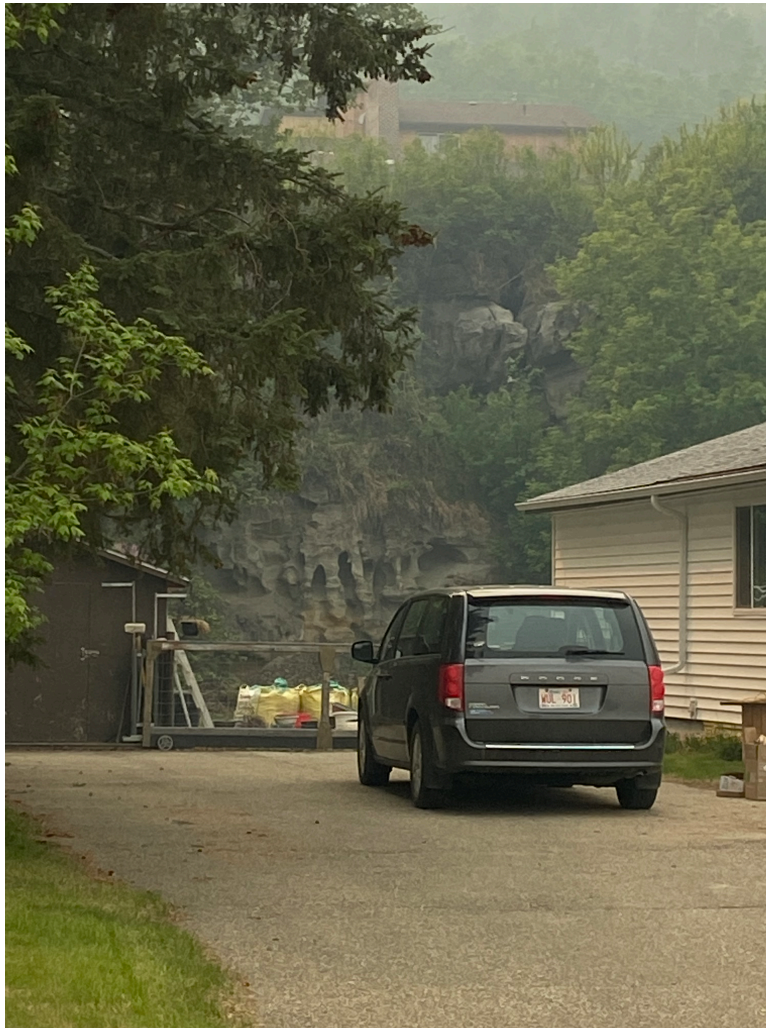
**Photo 54-3. Looking west toward lower part of eroded sandstone slope.**

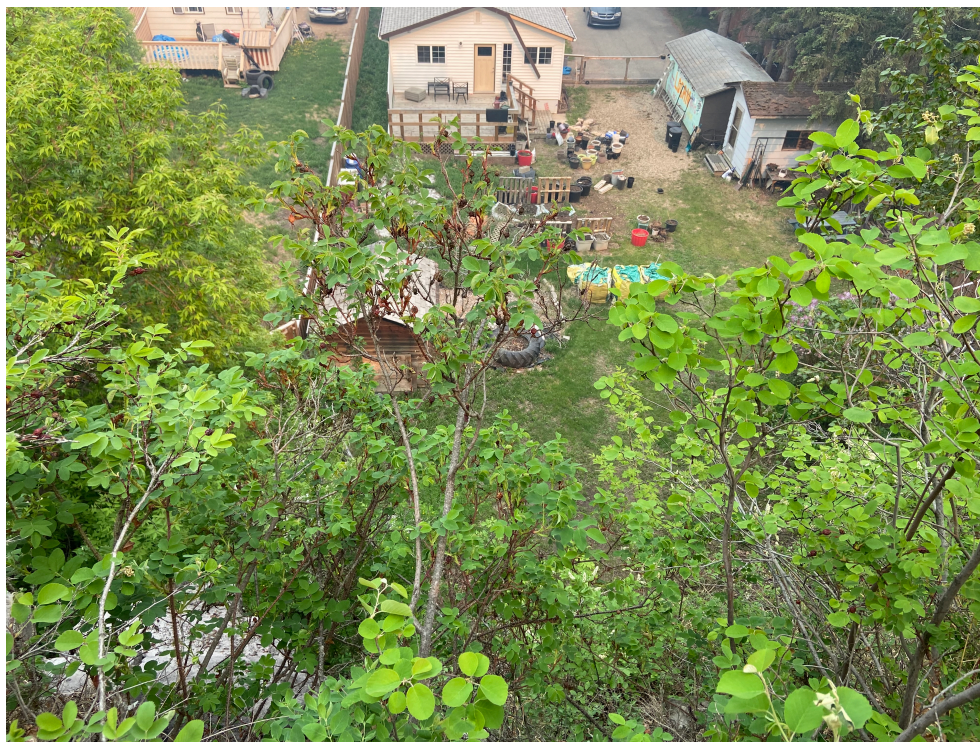
**Photo 54-4. Looking east from crest of slope.**

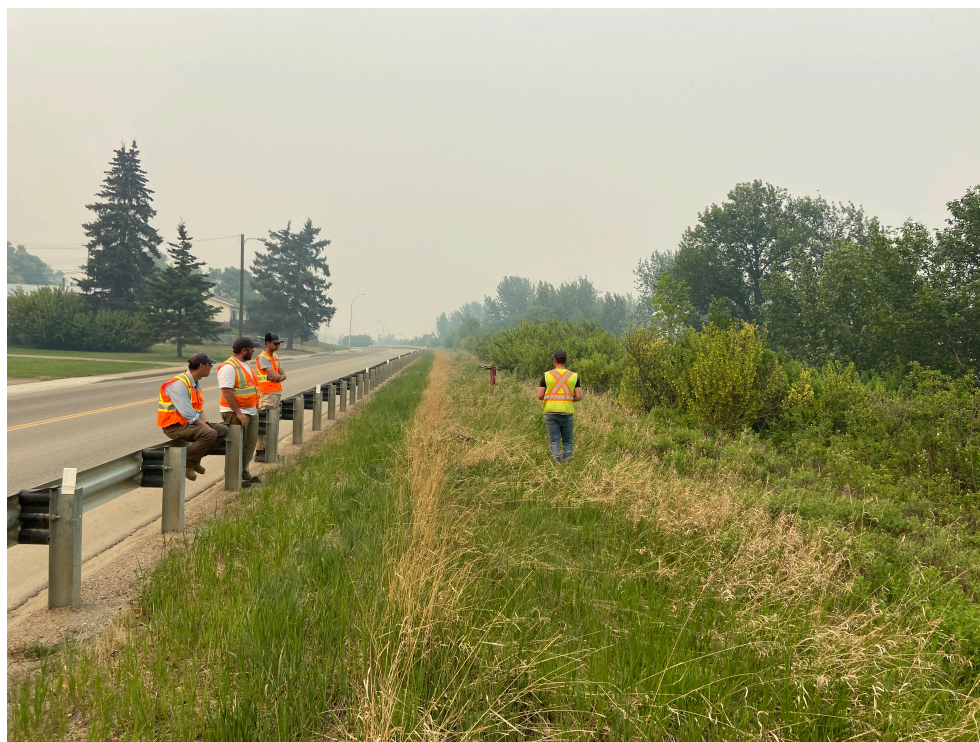
**Photo 54-5. Looking north at the area between highway and the top of slope drop off.**
