**ALBERTA TRANSPORTATION  
GEOHAZARD ASSESSMENT PROGRAM  
PEACE REGION – HIGH LEVEL  
2023 INSPECTION REPORT**

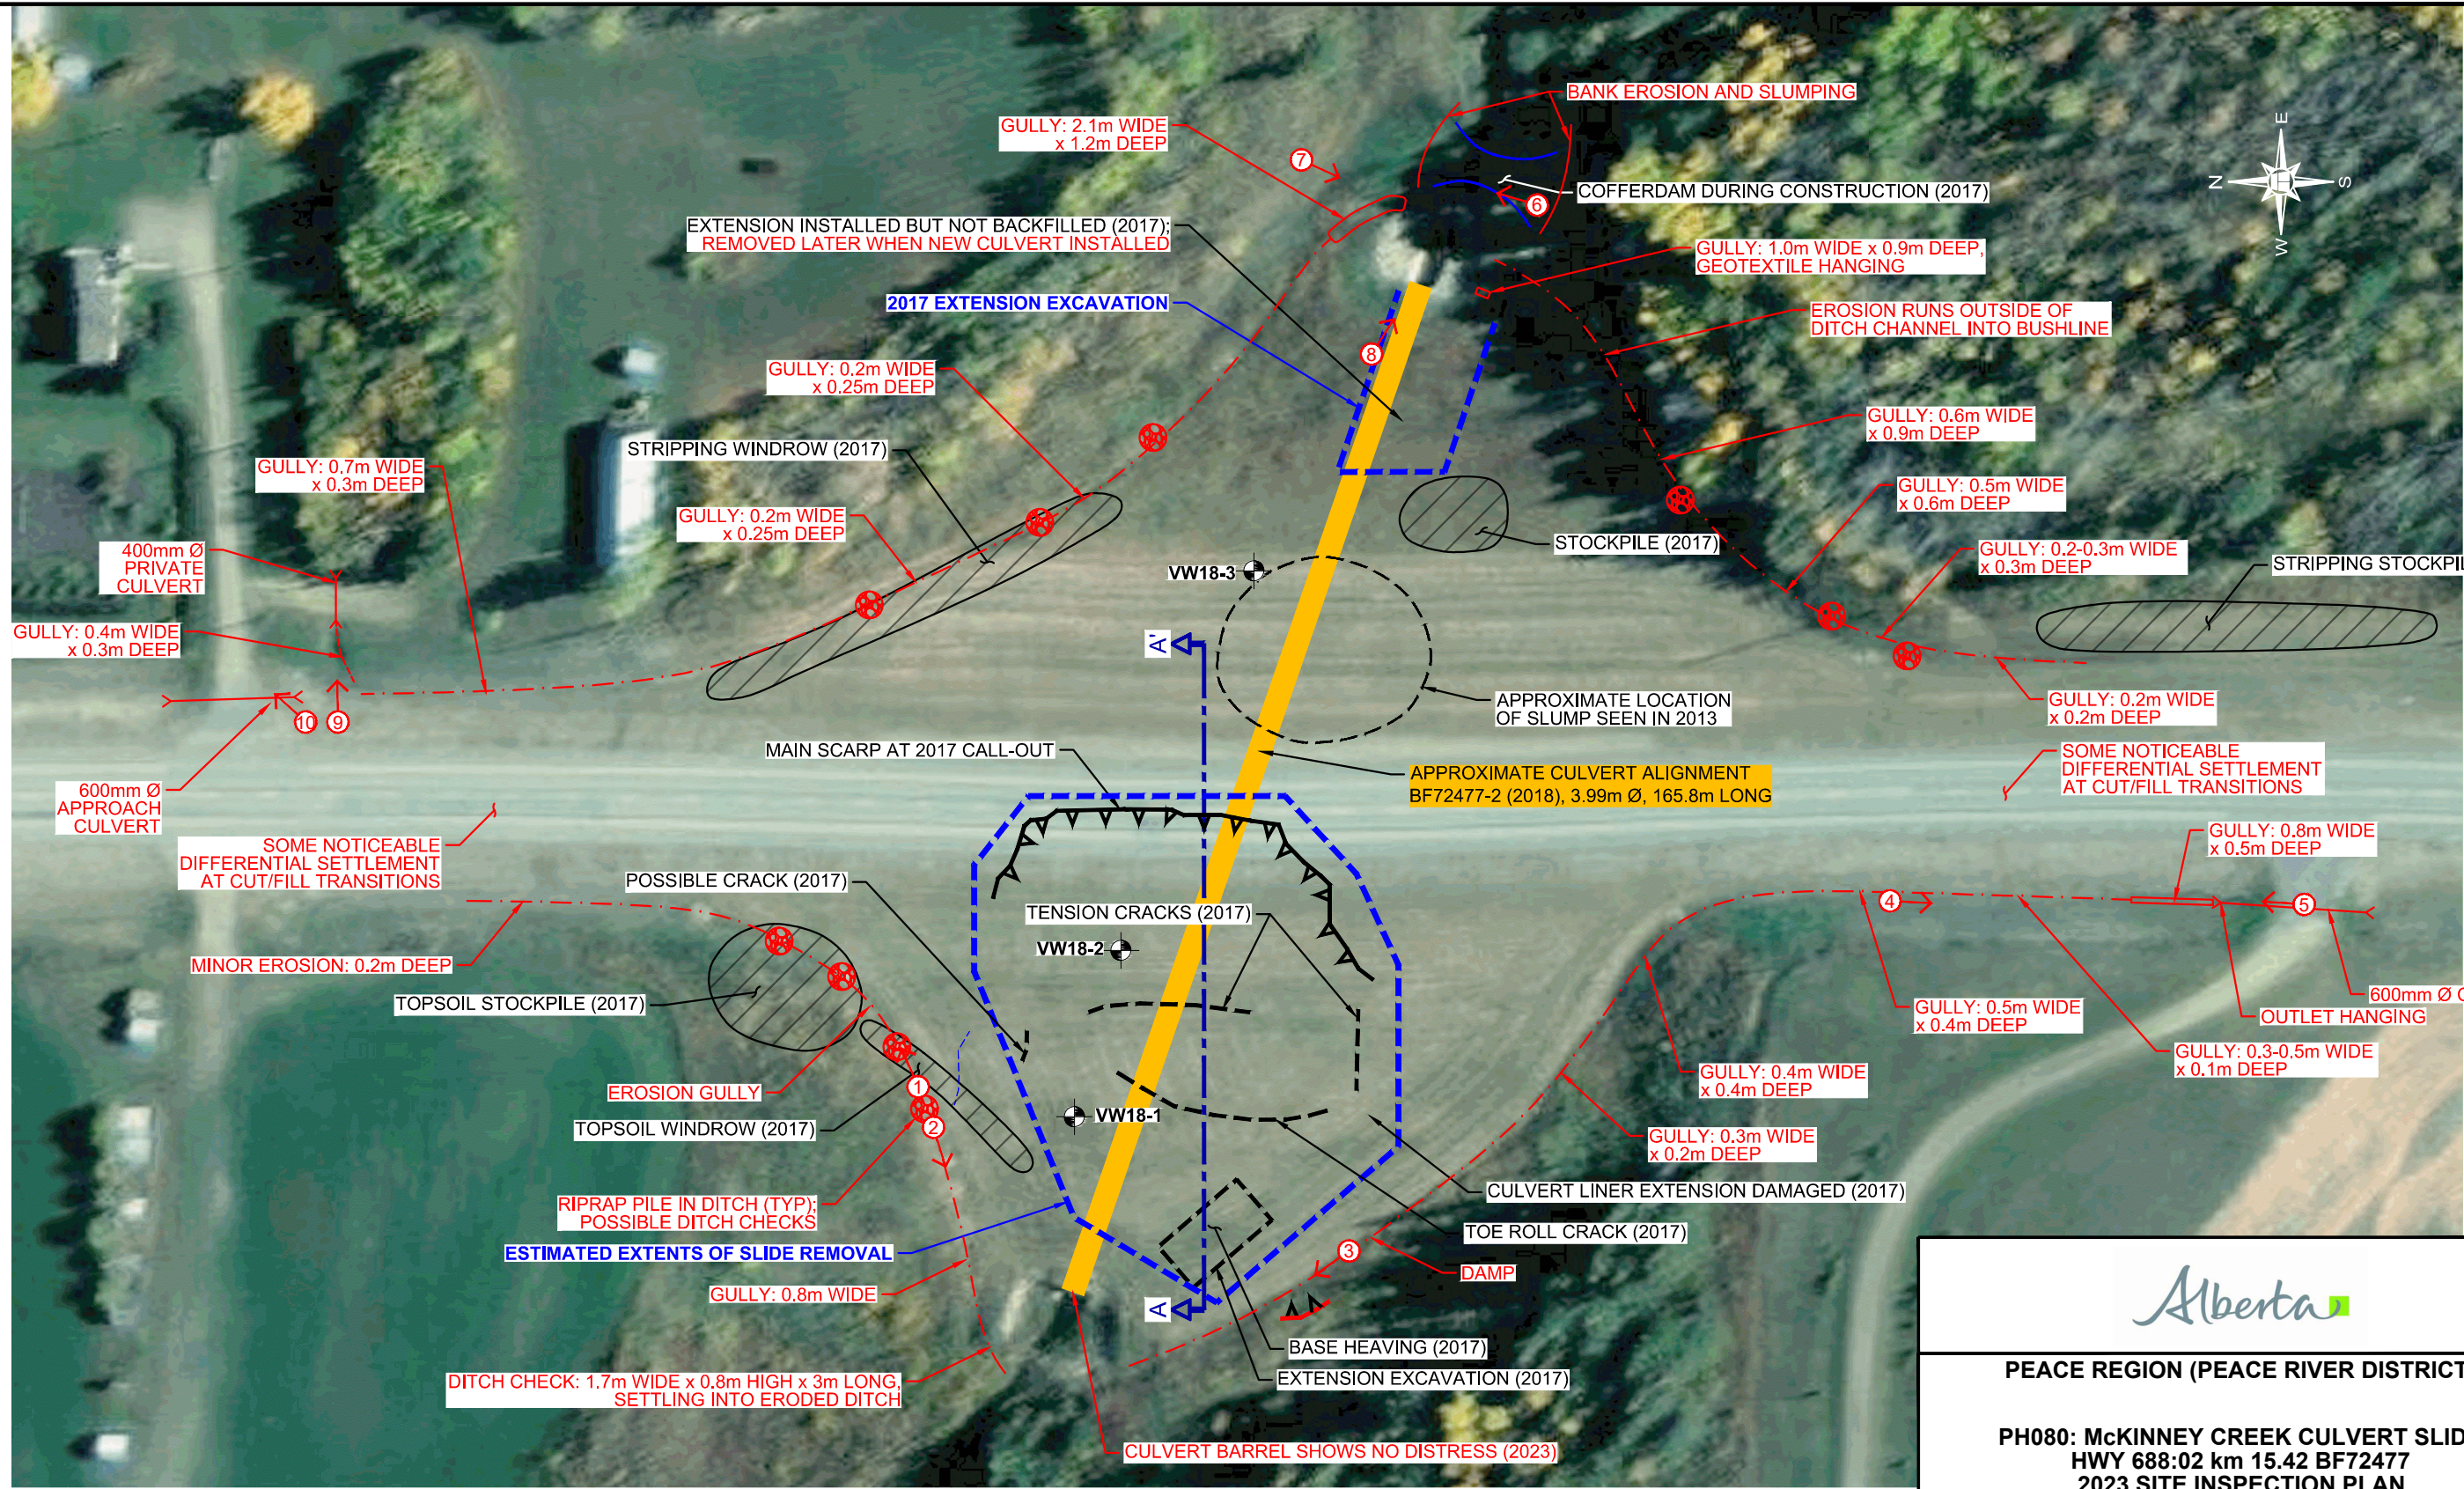
The information, interpretations and conclusions in the Report are based on Thurber's interpretation of conditions revealed through limited investigation conducted within a defined scope of services. Thurber does not accept responsibility for independent conclusions, interpretations, interpolations and/or decisions of the Client, or others who may come into possession of the Report, or any part thereof, which may be based on information contained in the Report. This restriction of liability includes but is not limited to decisions made to develop, purchase or sell land.
