ALBERTA TRANSPORTATION AND ECONOMIC CORRIDORS GRMP PEACE REGION – (PEACE RIVER DISTRICT) INSTRUMENTATION MONITORING - SPRING 2024

Table PH080-1: Spring 2024 – HWY 688:02 McKinney Creek Culvert (Km 15.4) - Bf72477 Vibrating Wire Piezometer Instrumentation Reading Summary Statement of Limitations and Conditions 					
Attachments:	 APPENDIX A - PH080-1 SPRING 2024 Field Inspector's report Site Plan Showing Approximate Instrument Locations (Drawing No. 32121 PH080) Figure PH080-1 (VW18-1 Readings) Figure PH080-2 (VW18-2 Readings) Figure PH080-3 (VW18-3 Readings) Figure PH080-4 (Combined VW Piezometer Readings)

SITE PH080: HWY 688:02 McKINNEY CREEK SLIDE (KM 15.4) - BF72477

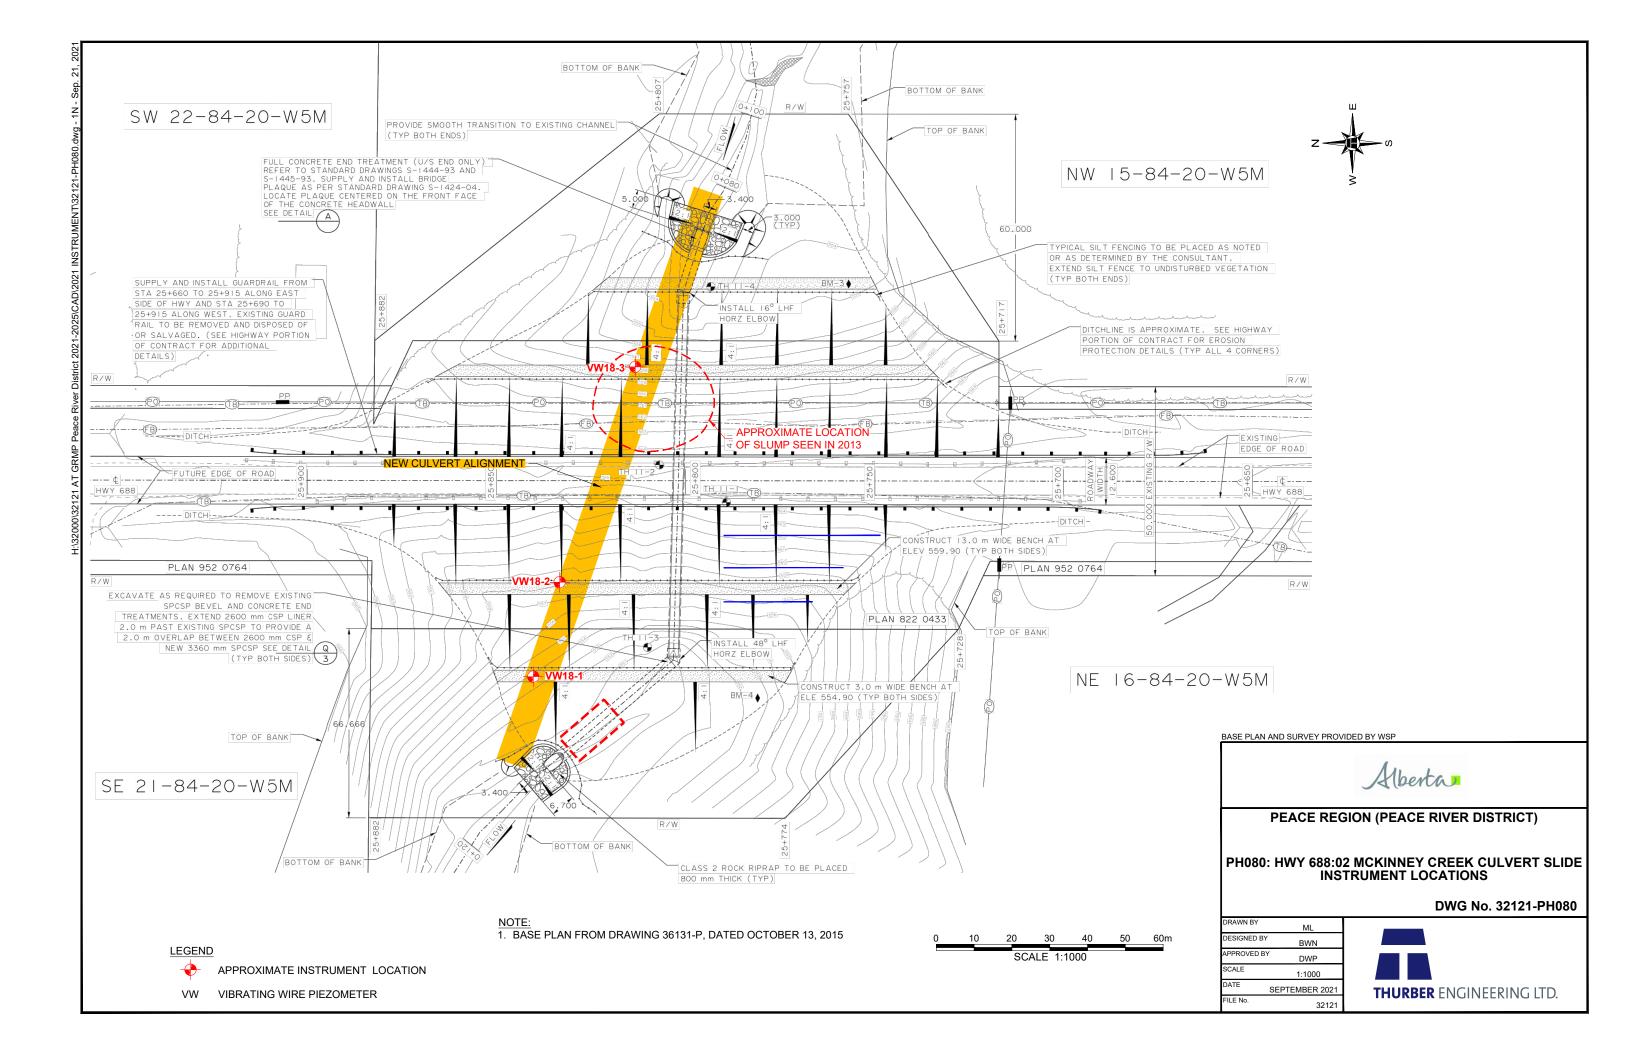
FIGURE PH080-1 HWY 688:02 McKINNEY CREEK CULVERT SLIDE - VW18-1 (WEST SIDE OF CULVERT)

Discussion					
Zones of New Movement:	None				
Interpretation of Monitoring Results:	Vibrating wire piezometers VW18-1 and VW18-3 showed increases in groundwater level of 0.28 m and 0.18 m, respectively, since the fall of 2023 readings. VW18-2 showed a decrease in groundwater level of 0.29 m since the fall of 2023 readings. VW18-1 and VW18-3 showed a prior trend of diminishing groundwater levels since the completion of construction and the groundwater levels at these instrument locations appear to have levelled out. The piezometers had all previously shown their highest groundwater levels during construction as fill was placed at their respective locations.				
	Figures PH080-1, PH080-2 and PH080-3 show the response of each of the piezometers relative to fill height during construction, as well as the subsequent decrease in pore water pressure. Figure PH080-4 shows a combined plot of the groundwater elevations of all three vibrating wire piezometers.
