THURBER ENGINEERING LTD.

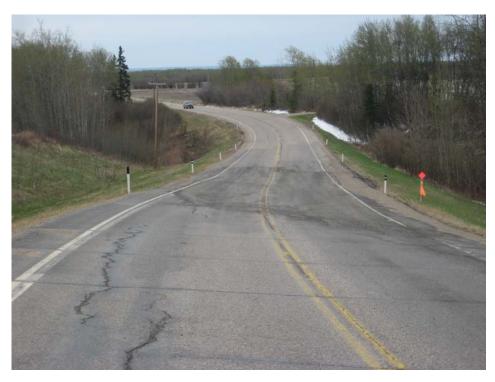
Photo 1 - View of Highway 690 showing the 2008 ACP patch, looking east.

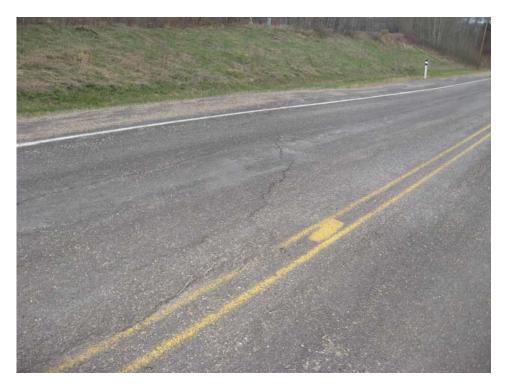
Photo 2 - View of crack reflecting through 2008 ACP patch, looking northeast.

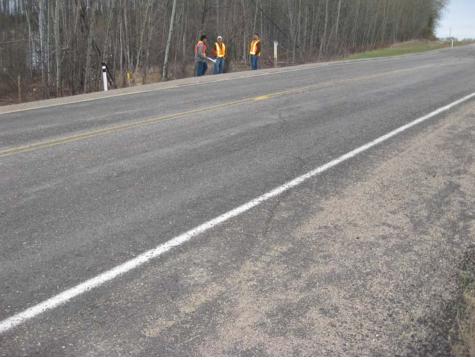
Photo 3 - View of crack reflecting through 2008 ACP patch, looking southwest.

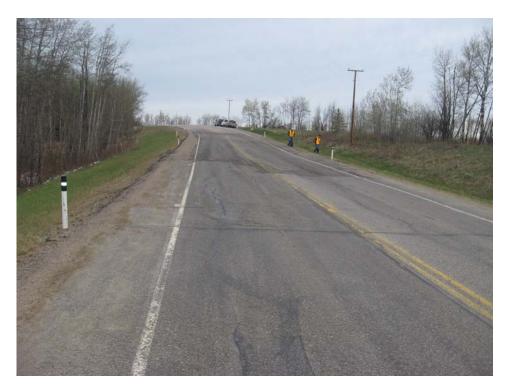
Photo 4 - View of Highway 690 showing the 2008 ACP patch, looking west.

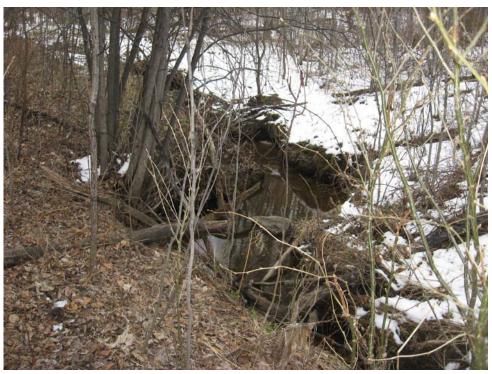
Photo 5 - View of creek looking east.

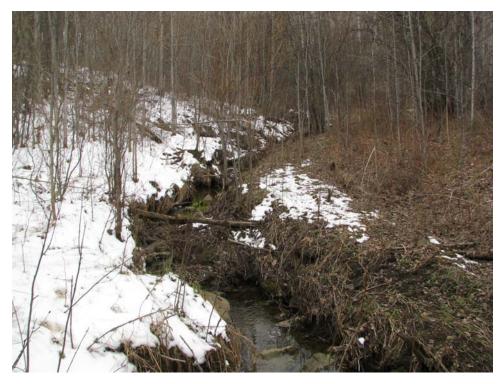
Photo 6 - View of creek looking west.
