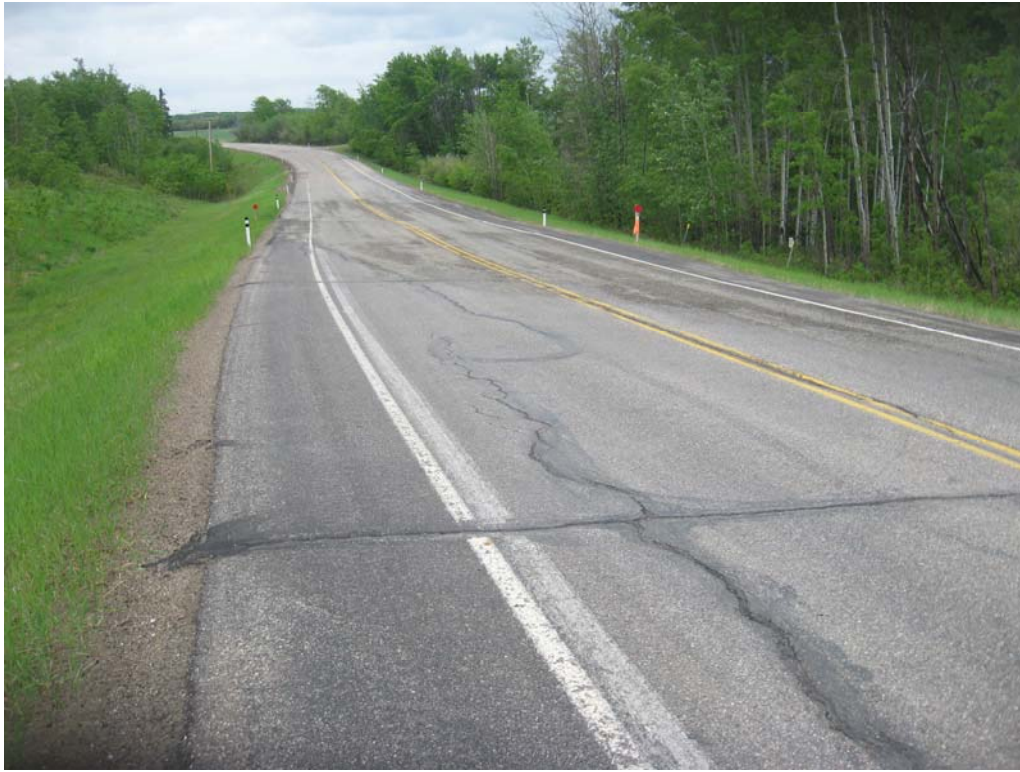
Photo 1 - View of Highway 690 showing the 2008 ACP patch, looking east.

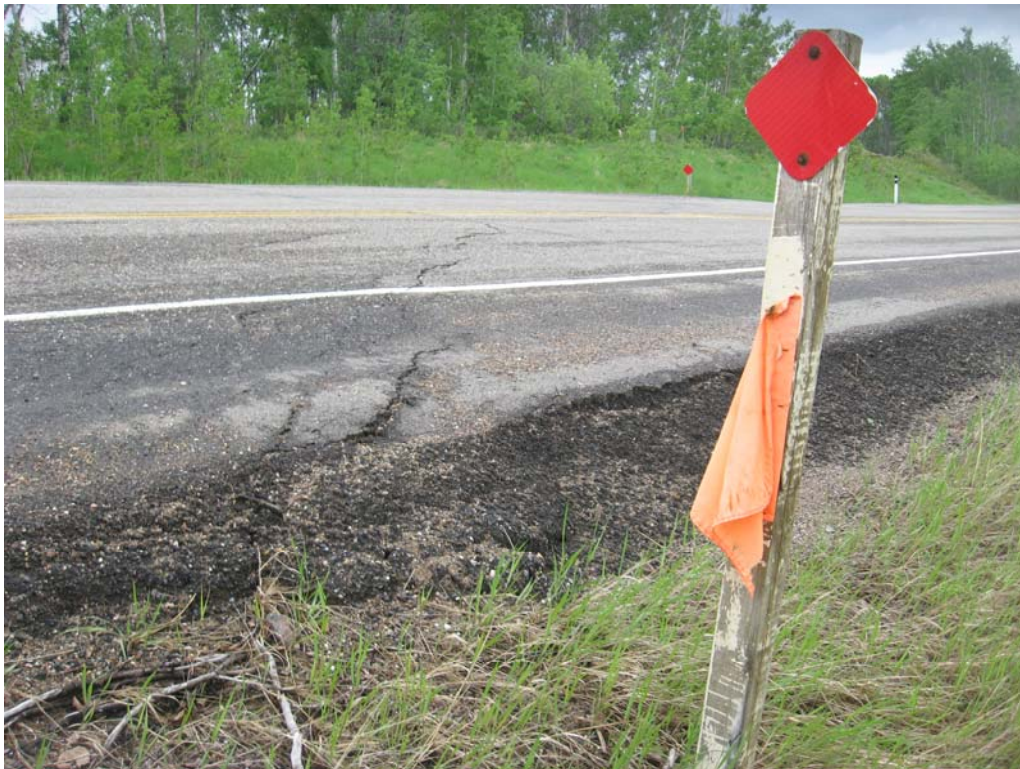
Photo 2 – View of the crack on the highway and asphalt thickness, looking northeast.

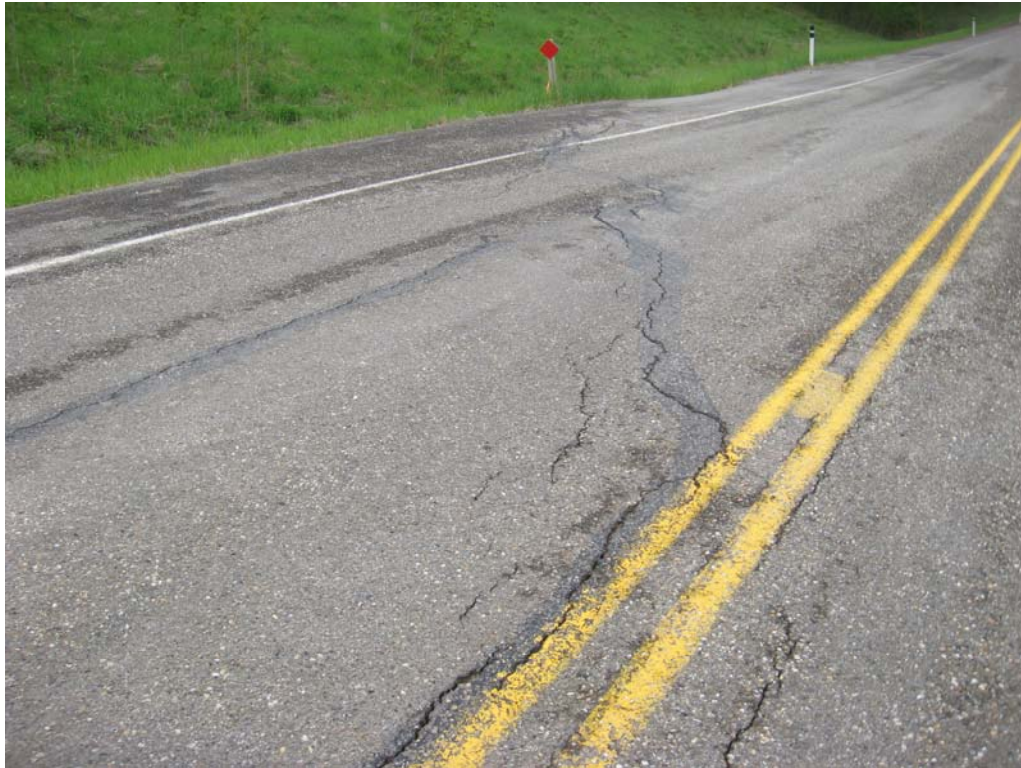
Photo 3 – Increased cracking on pavement looking southwest.

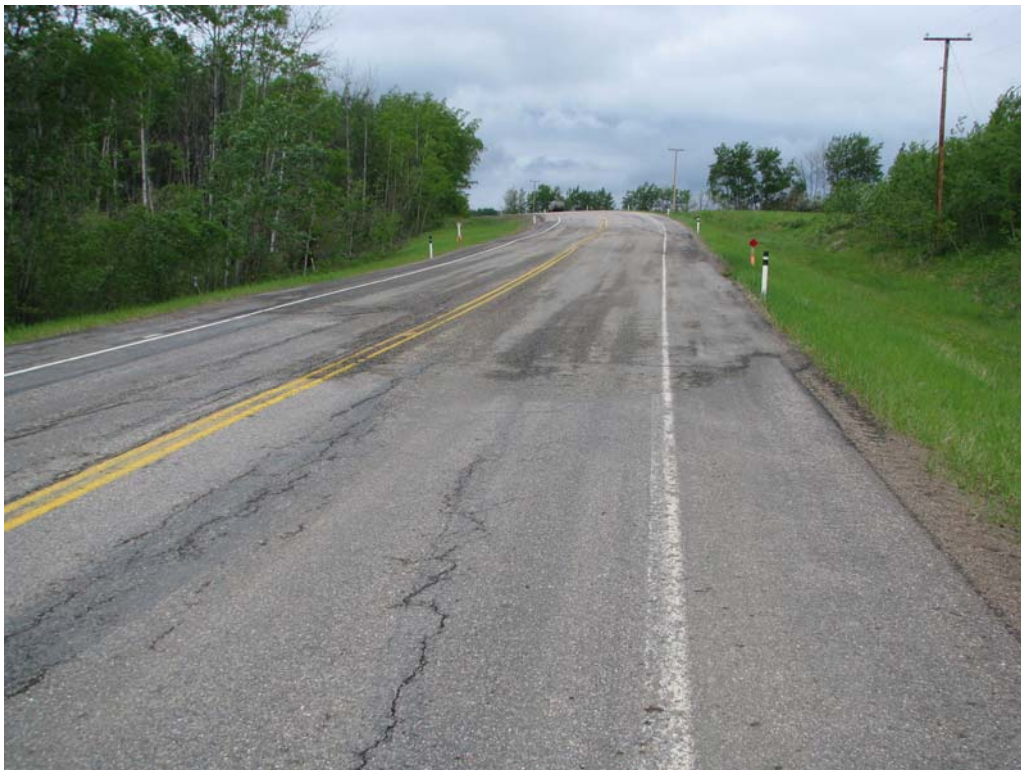
Photo 4 - View of Highway 690 showing the 2008 ACP patch, looking west.

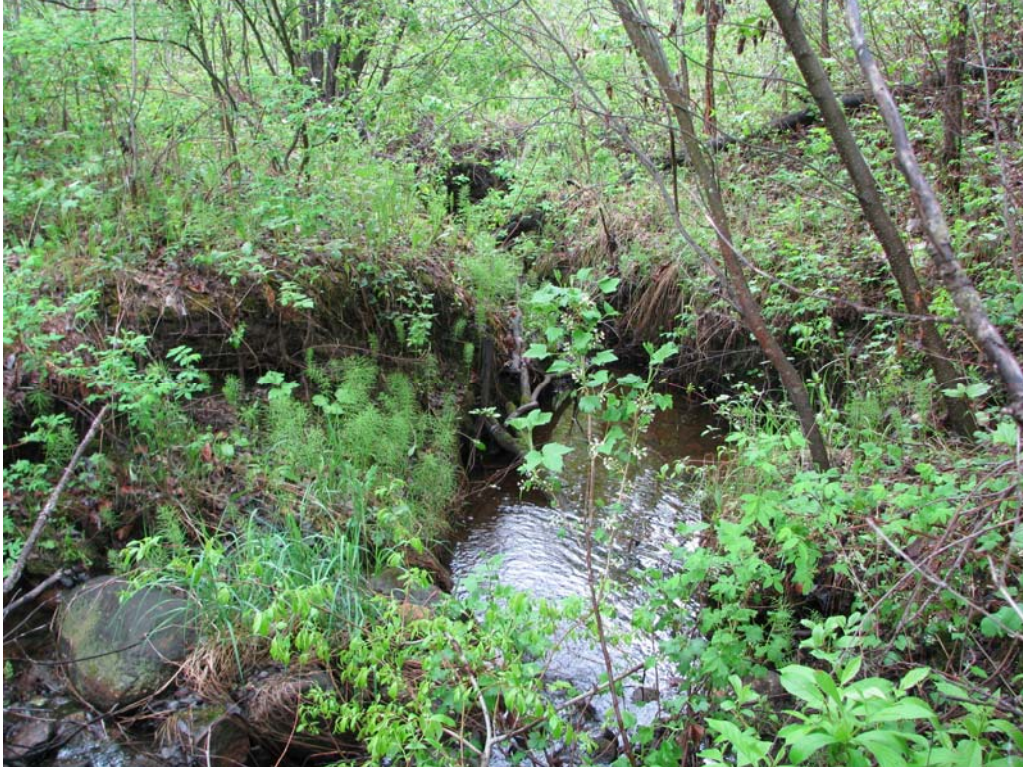
Photo 5 - View of creek looking east.

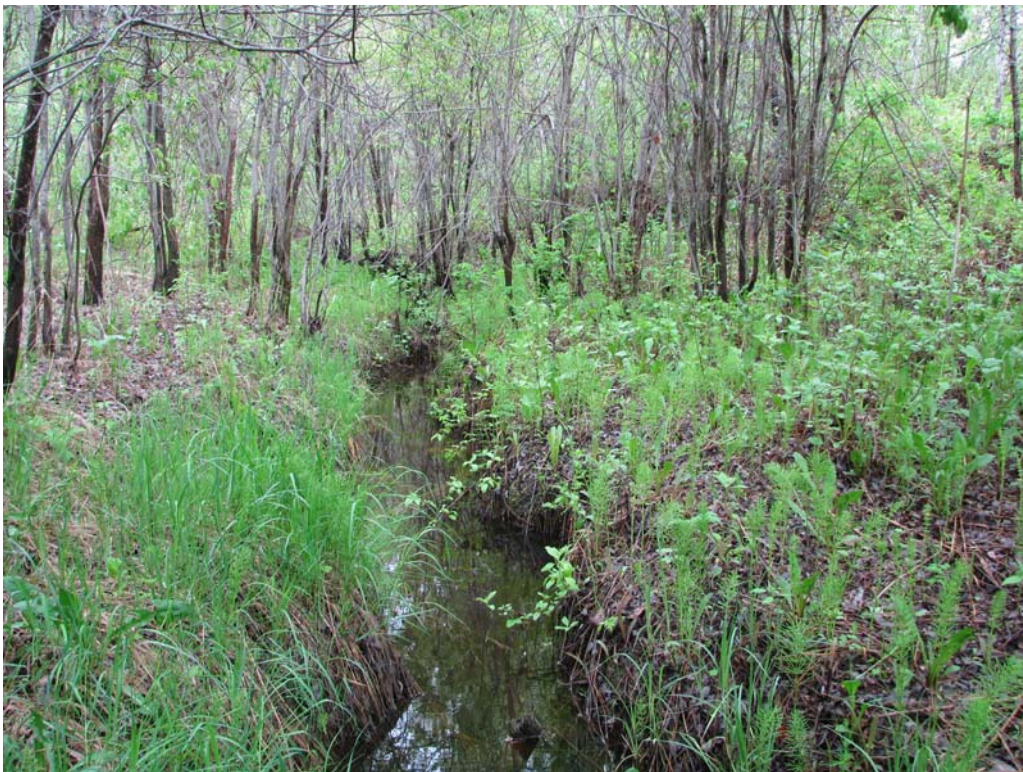
Photo 6 - View of creek looking west.
