GEOHAZARD ASSESSMENT PROGRAM

PEACE RIVER / HIGH LEVEL AREA

2011 INSPECTION

| Site Number | Location | Name | Hwy | km |
|---|---|---|---|---|
| PH47 | West of Deadwood, AB | Deadwood Slide | 690:02 | Approx. 2.2 |

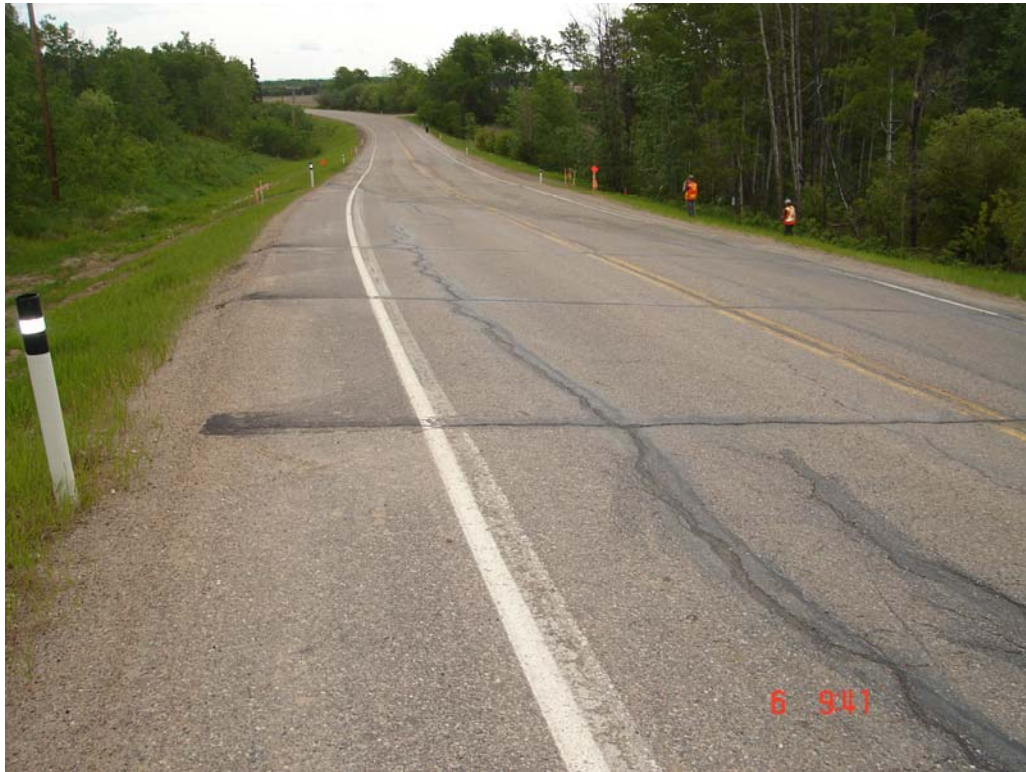
Photo 1 - View of Highway 690 showing the 2008 ACP patch, looking east.

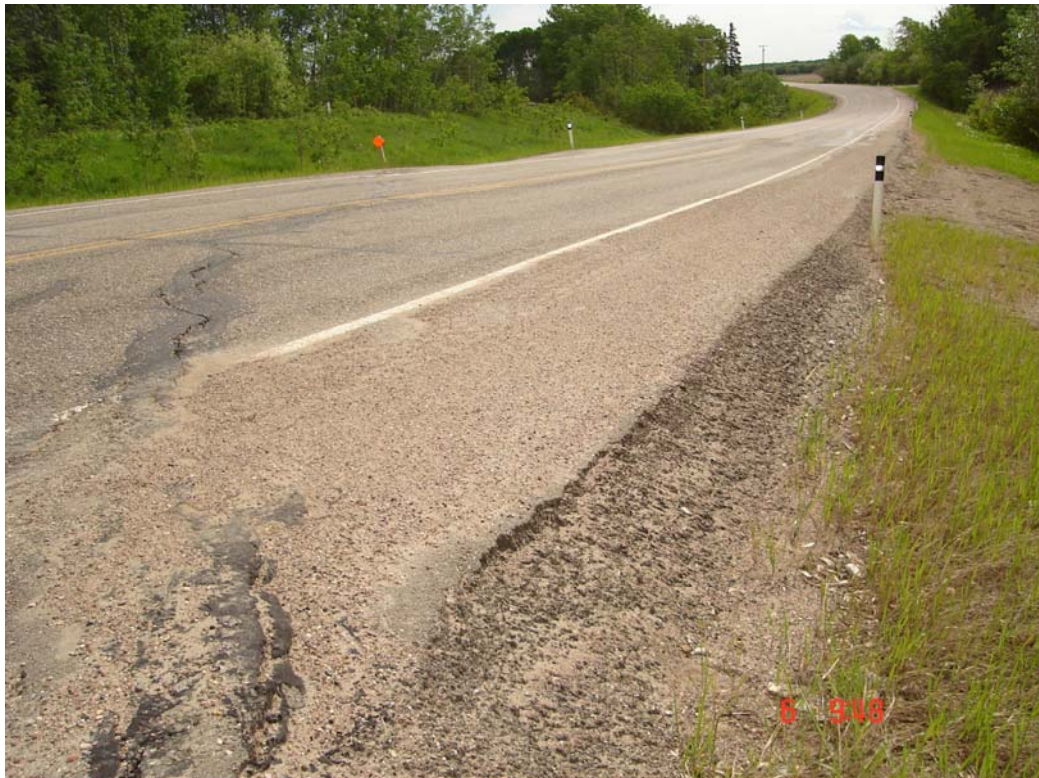
| Primary Site Issue: | Slope movement affecting highway | | |
|---|---|---|---|
| <input checked="" type="checkbox"/> Pavement Distress | Slight increase in crack width and drop, reflecting through 2008 ACP patch. Pavement cracking has extended beyond the patch limits to the west. | <input checked="" type="checkbox"/> | <input type="checkbox"/> |

Photo 2 – Increased cracking on pavement looking southwest.

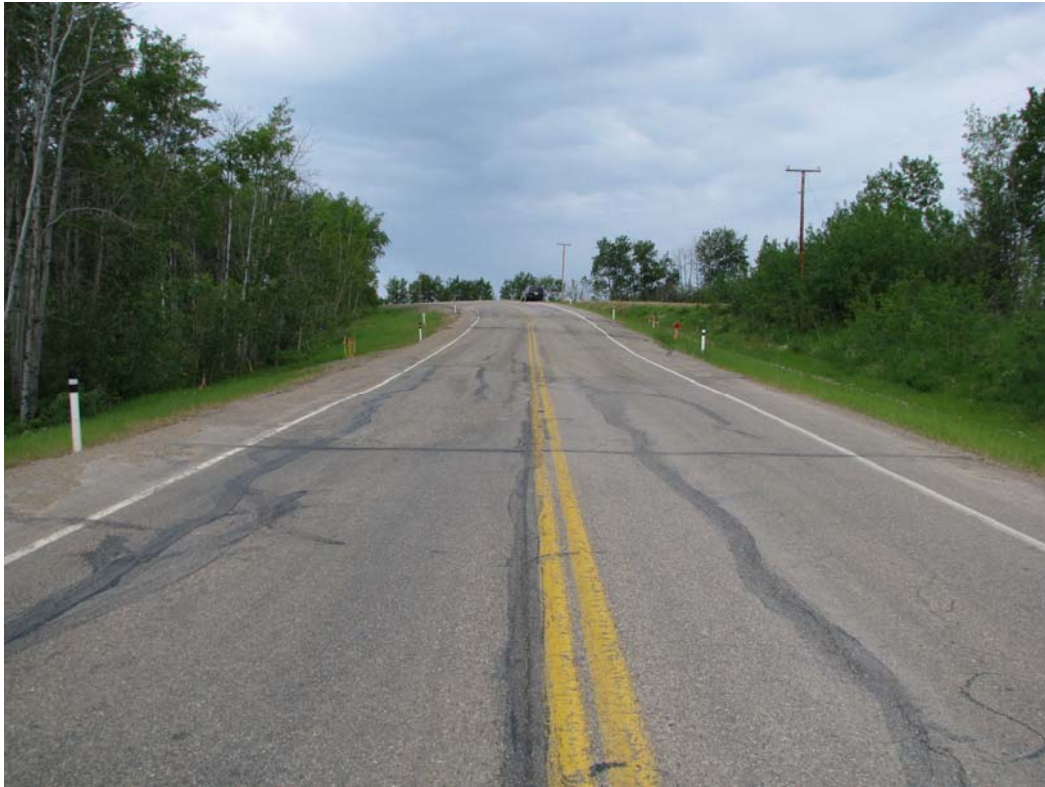
Photo 3 - View of Highway 690 showing the 2008 ACP patch, looking west.

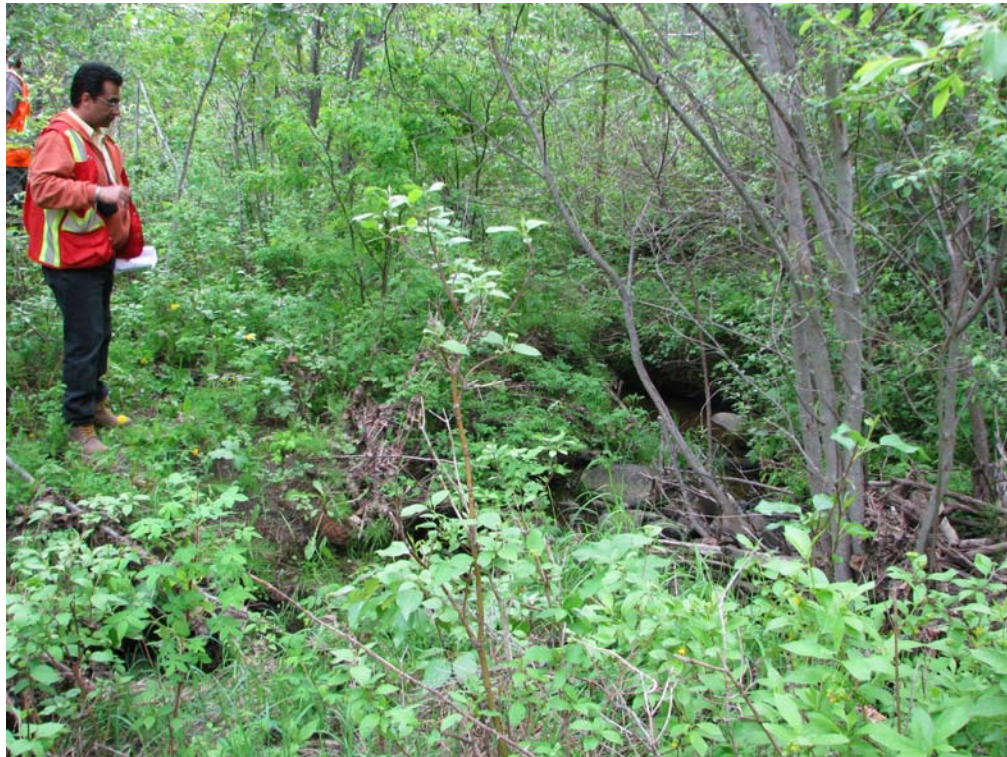
Photo 4 - View of creek looking east.

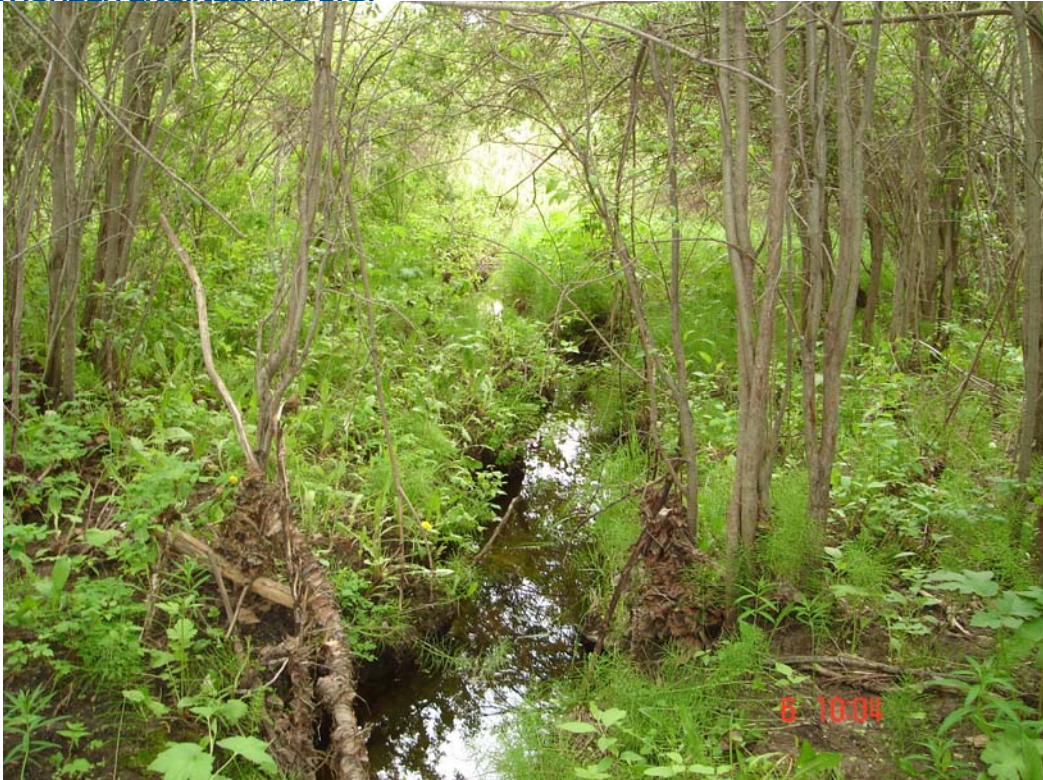
Photo 5 - View of creek looking west.

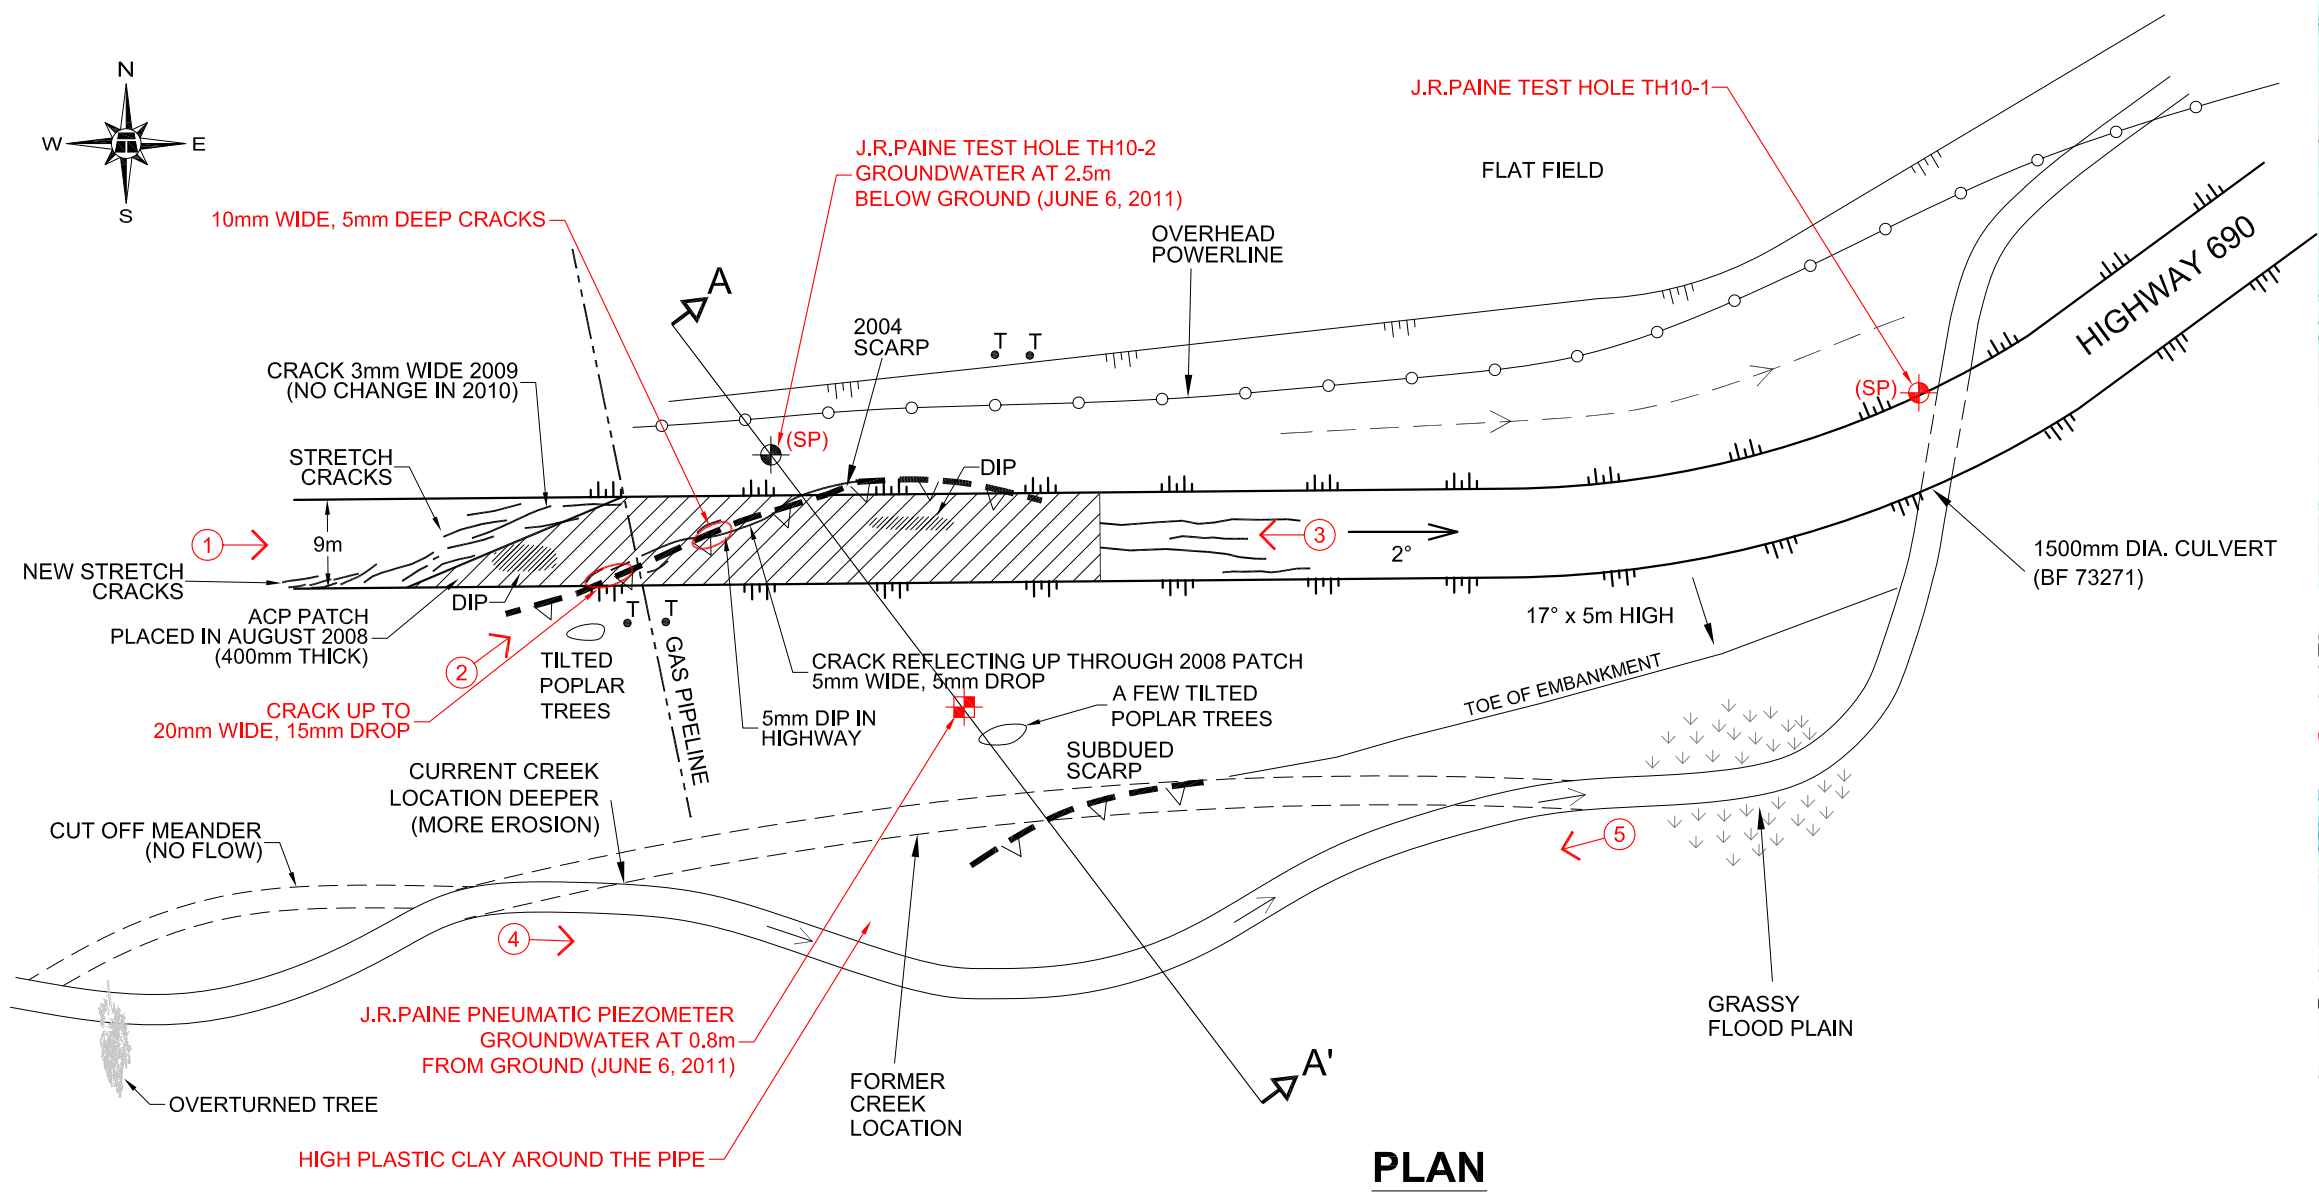
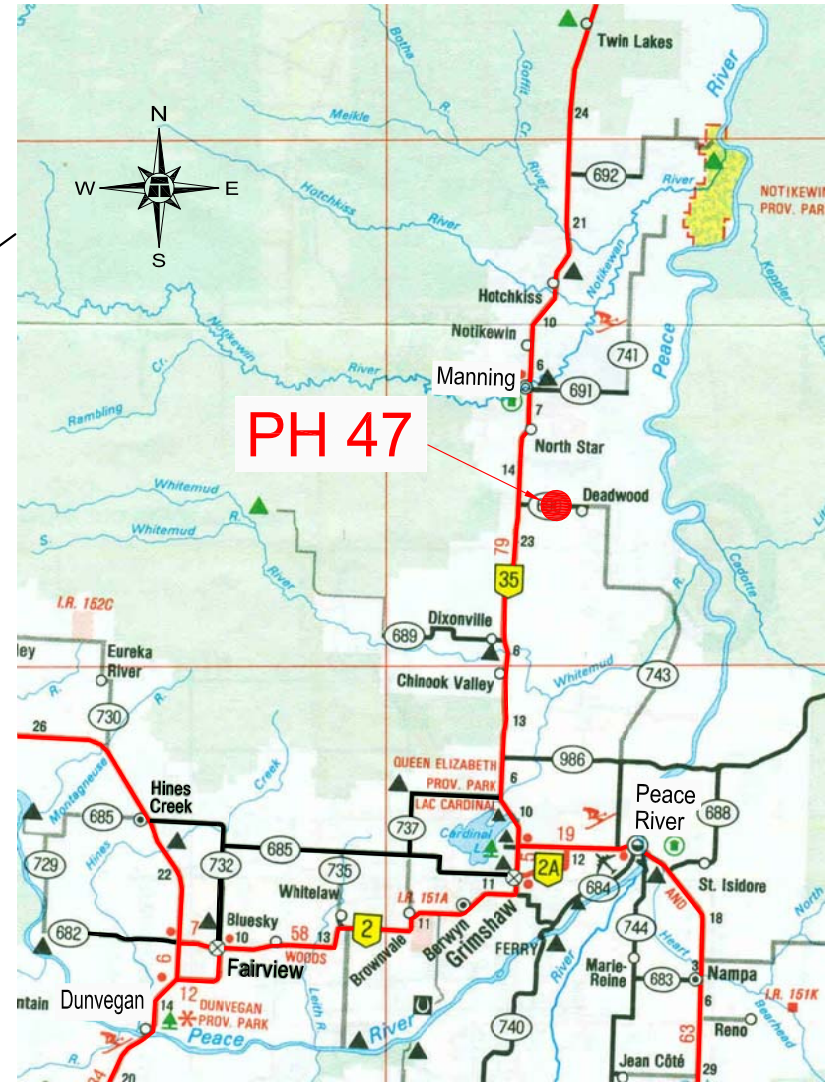
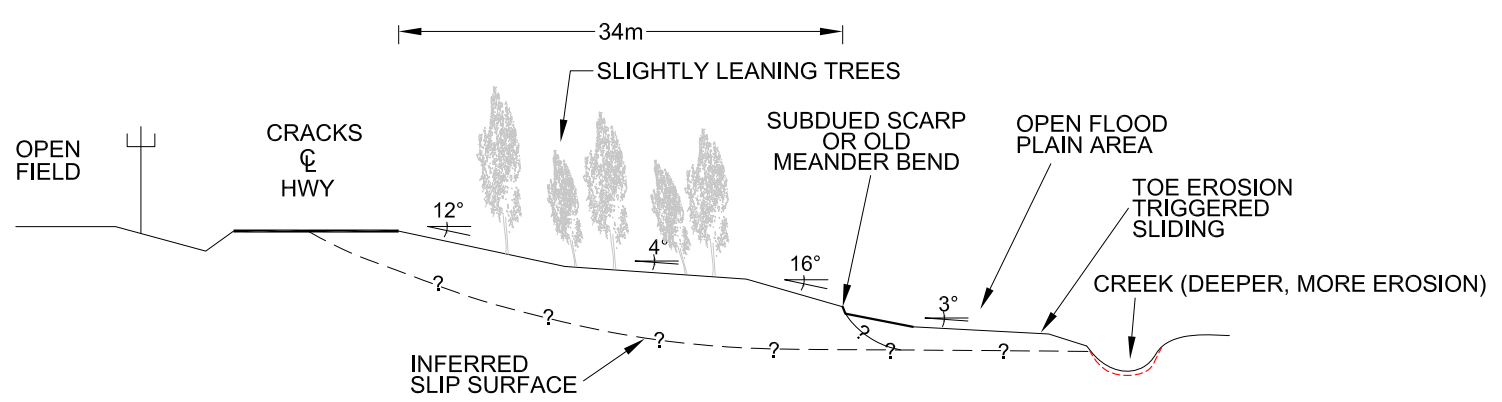
**FIGURE PH47-1
DEADWOOD SLIDE- PH47 - HWY 690:02
PEACE REGION (PEACE RIVER/HIGH LEVEL)
GEOHAZARD ASSESSMENTS**

- The slope failure appears to be the result of toe erosion caused by the creek located immediately south of the highway leading to over-steeping of the slope. It is expected that, if left untreated, slow creep movements will continue.
- Additional signs of movement were noticed during the 2011 site visit. The pavement cracks have opened up ranging between 10 mm and 20 mm wide and vertical drops of about 5 mm to 15 mm.
- Groundwater levels in the two standpipe piezometers were recorded at levels of about 0.8 m to 2.5 m below ground surface at the time of our visit on June 6, 2011.
- High plastic grey clay drill cuttings were noticed around the SI installations.

As recommended during 2010 assessment, geotechnical investigation was undertaken by others which involved drilling three test holes. Two slope inclinometers and three standpipe piezometers were also installed as part of the investigation. The approximate locations are shown on Figure PH47-1.

The first option would involve the installation of a 1500 mm diameter CSP culvert along the toe of the slide, which would prevent further creek erosion of the toe of the slope. In addition to the culvert installation, a toe berm would be constructed and the slide mass re-graded to a flatter uniform slope in order to re-establish slope stability. A DFO authorization would be required to carry out this option.

The second solution would be based on the use of a pile wall to stabilize the highway side slope.

The third option would include either partial or full excavation of the slide mass, construction of a deep shear key, and reconstruction of the highway sideslope. This option would also involve the lining of the creek bed with rip rap in order to prevent further toe erosion.
