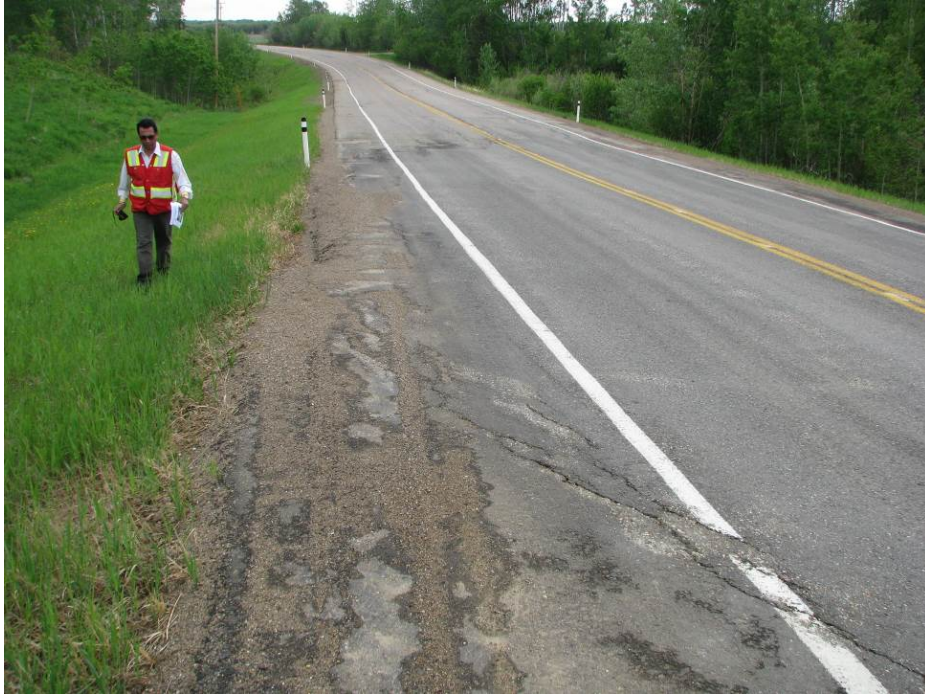
Photo 1 - View of Highway 690 showing the 2011 ACP patch, looking east.

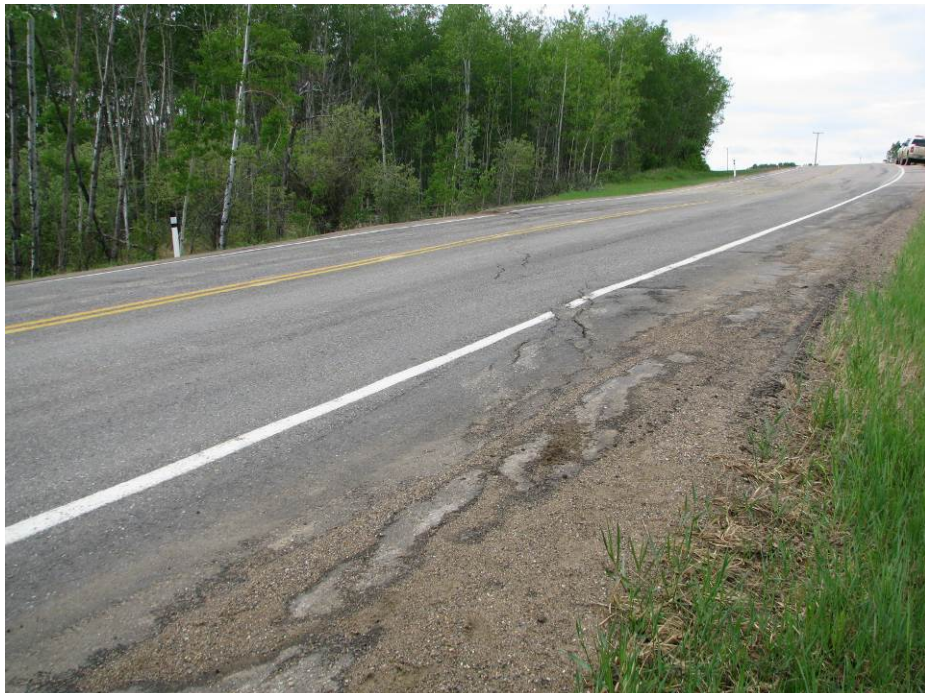
Photo 2 – View of the crack on the highway and asphalt thickness, looking southwest.

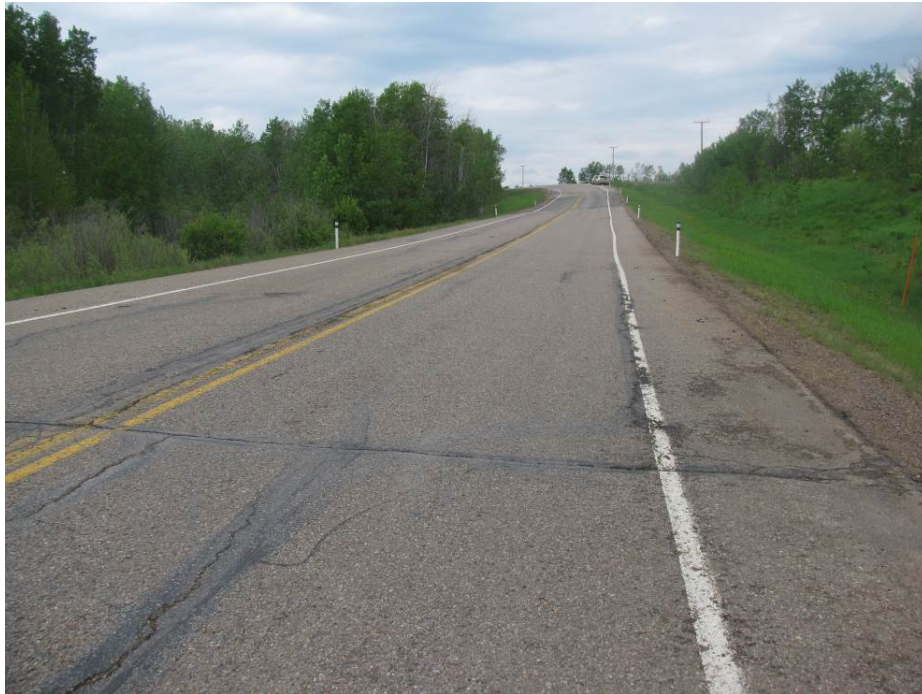
Photo 3 - View of Highway 690 showing the 2011 ACP patch, looking west.

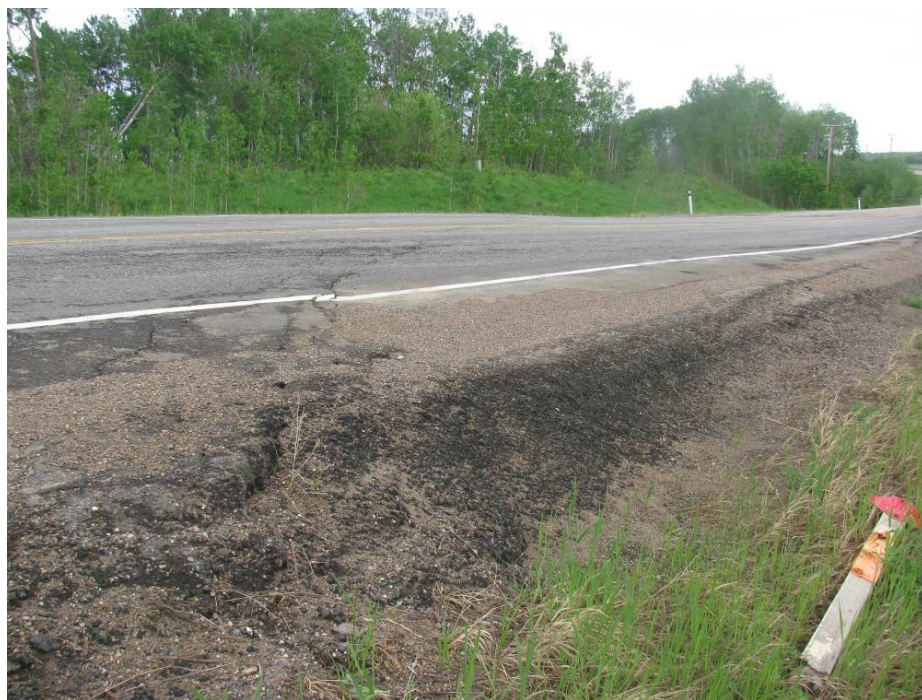
Photo 4 – View of asphalt thickness and crack
