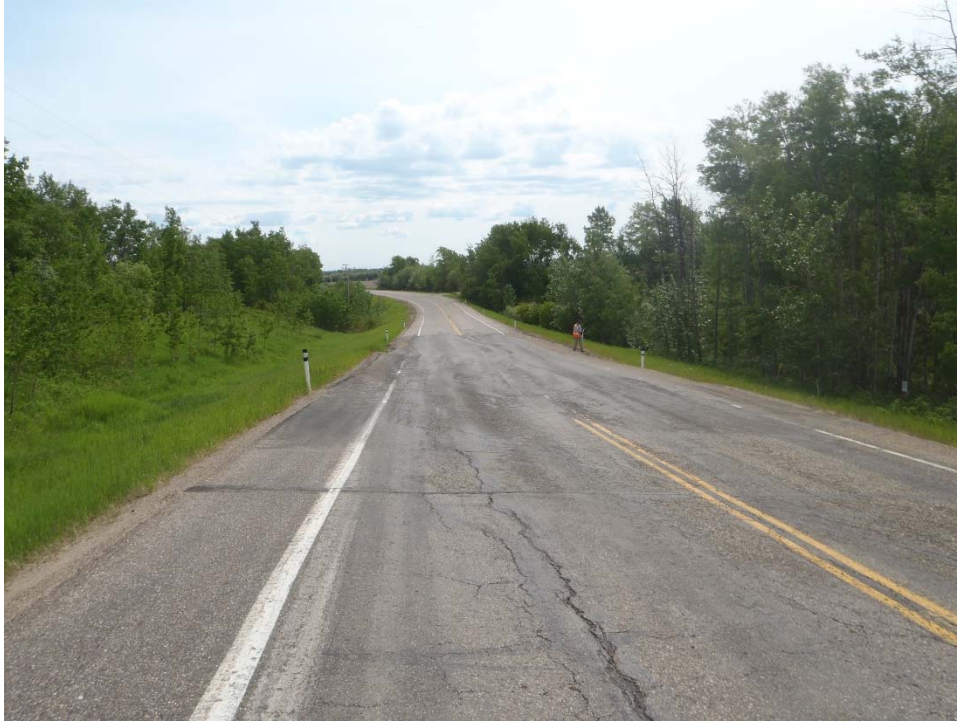
Photo 1 - View of Highway 690 showing the 2011 ACP patch, looking east.

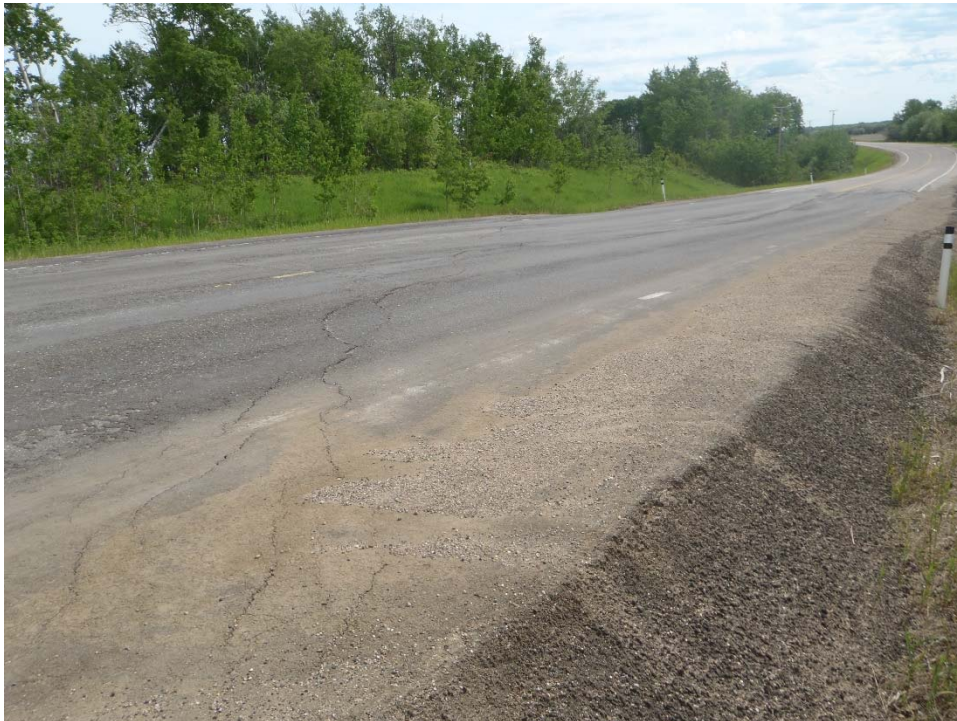
Photo 2 – View of the crack and asphalt thickness, looking northeast. The dip in the highway surface can be seen in the centre of the patch

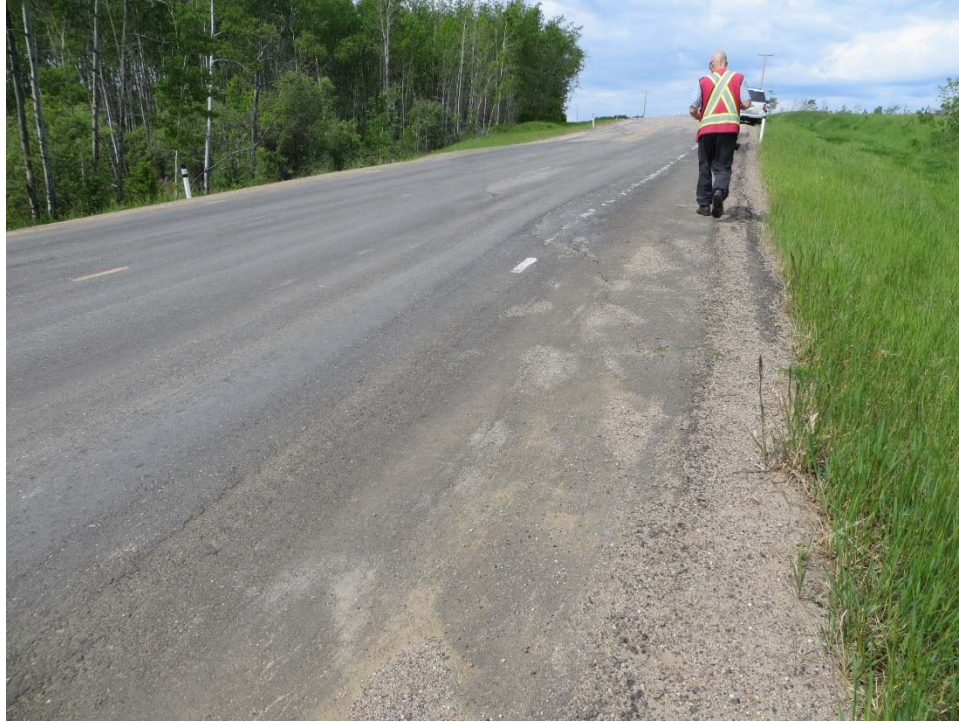
Photo 3 – Looking west at west portion of crack and recent patch.

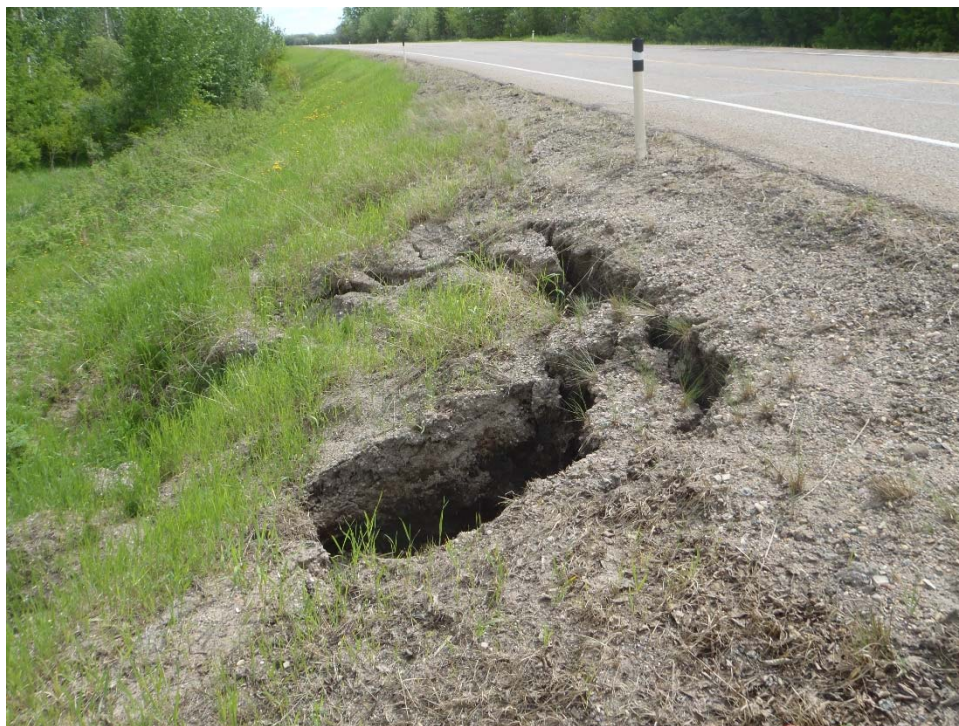
Photo 4 – Slumping at the culvert outlet on the north side of the highway.
