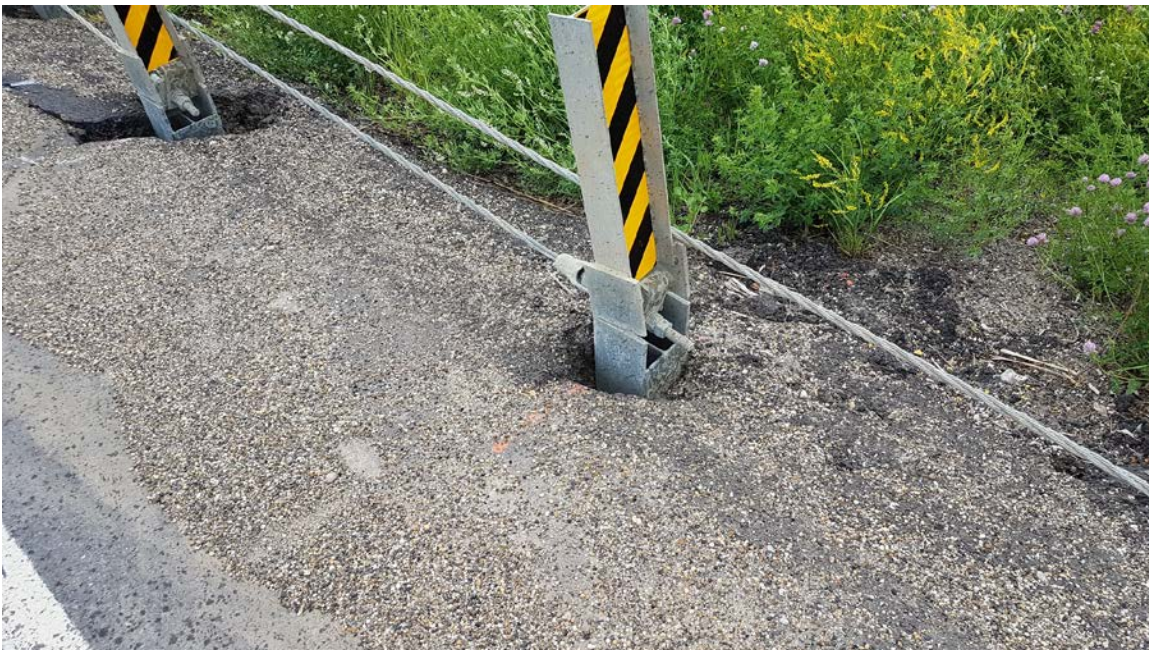
Photo 2 – Looking at voids around HTSCB on south side of highway at the west end.

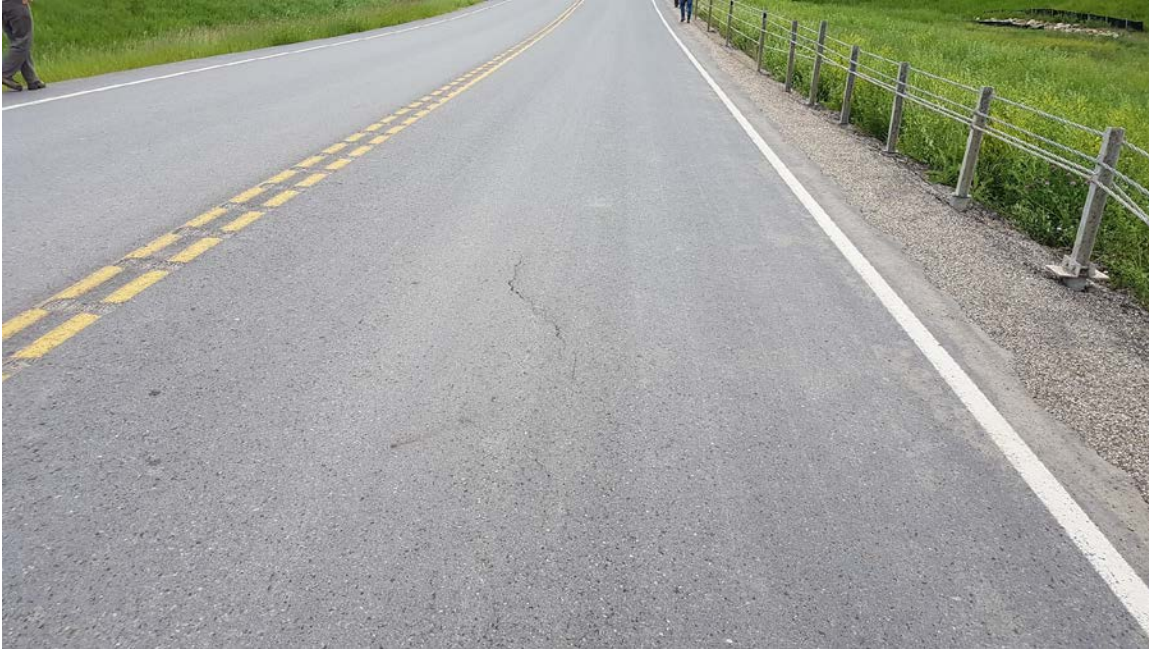
Photo 3 – Looking east at small crack at west end of slide area near the end of the HTSCB.

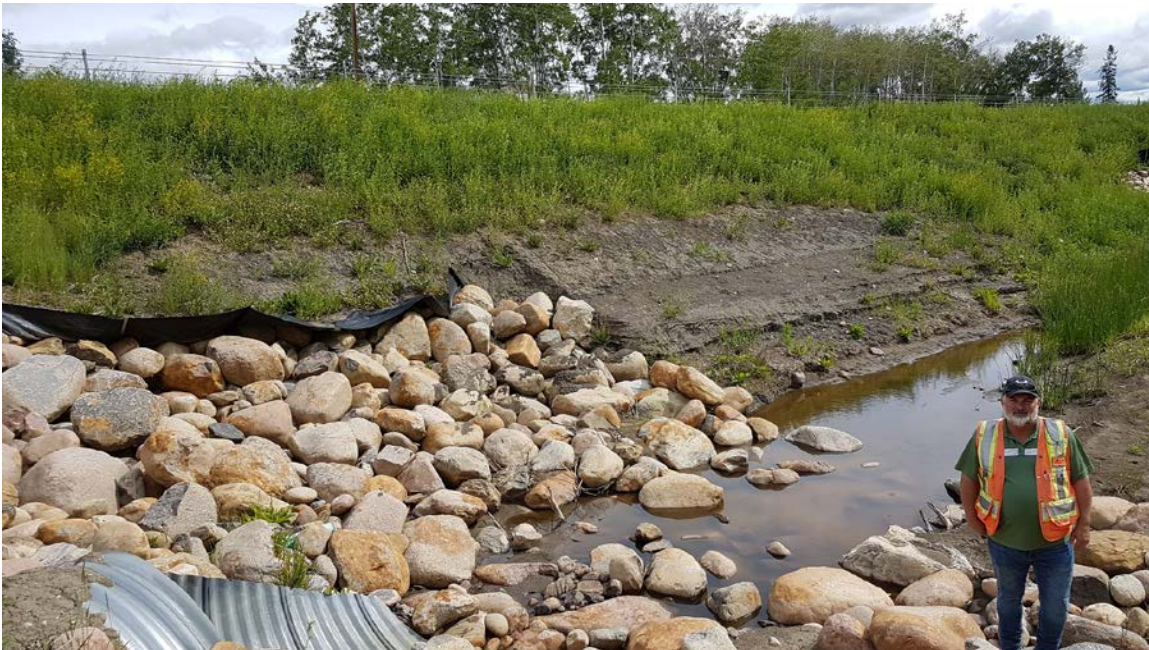
Photo 4 – Looking west at bare area at culvert outlet where possible tension cracks may be forming. Subdrain outlet is just on the far side of the culvert outlet.

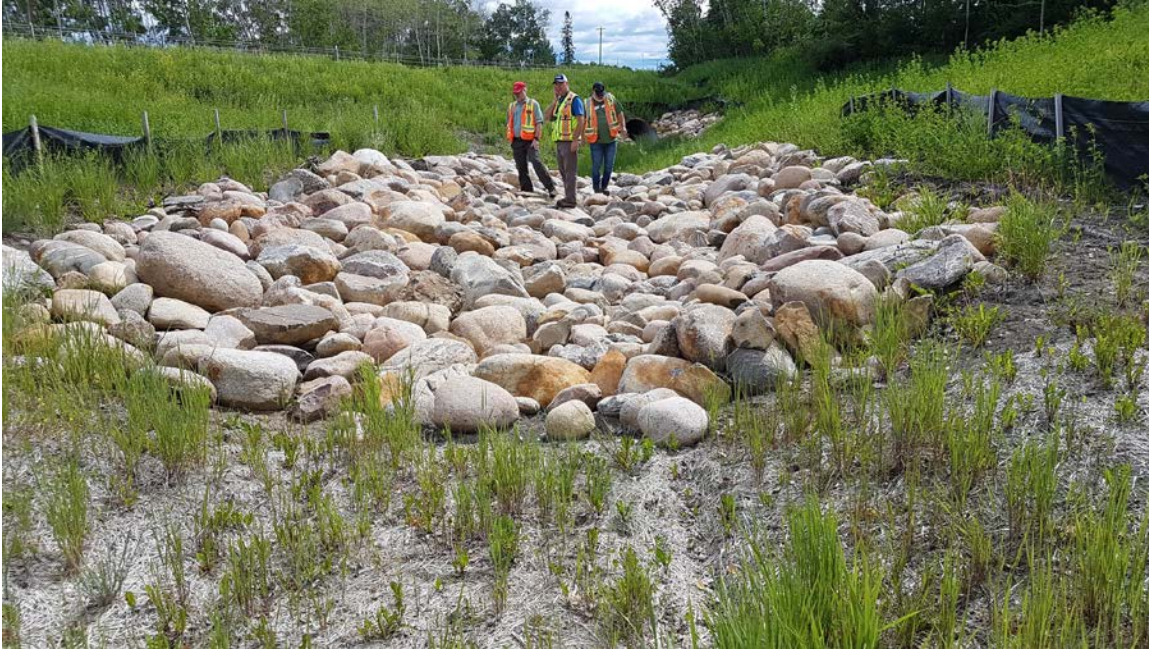
Photo 5 – Looking east from lined swale at bare spot between the swale and riprap apron.

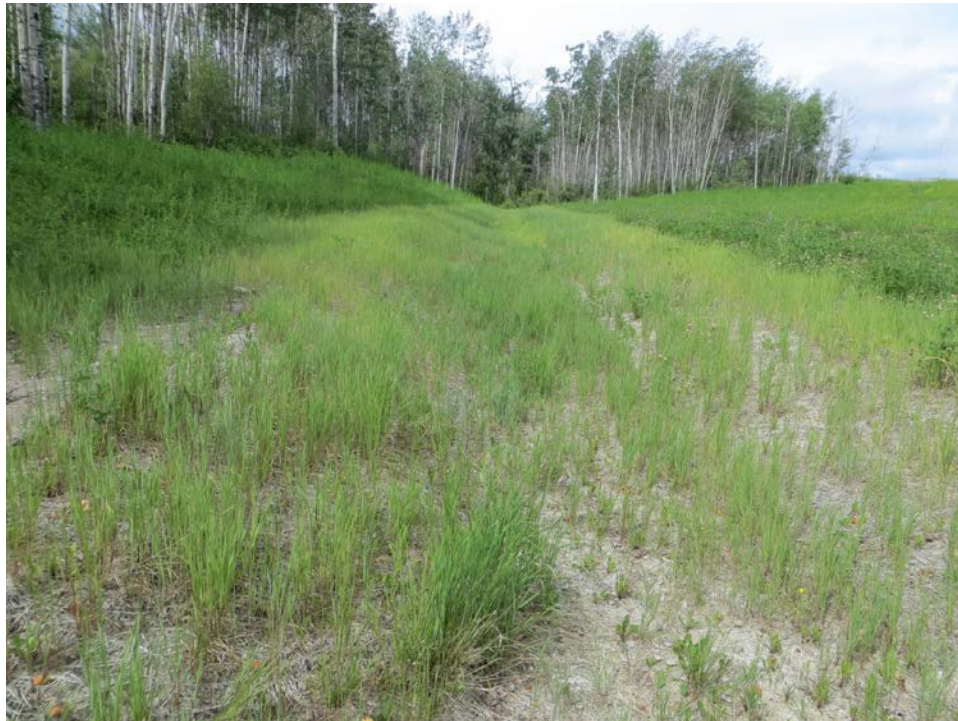
Photo 6 – Looking west along lined swale located at the south end of the toe berm.

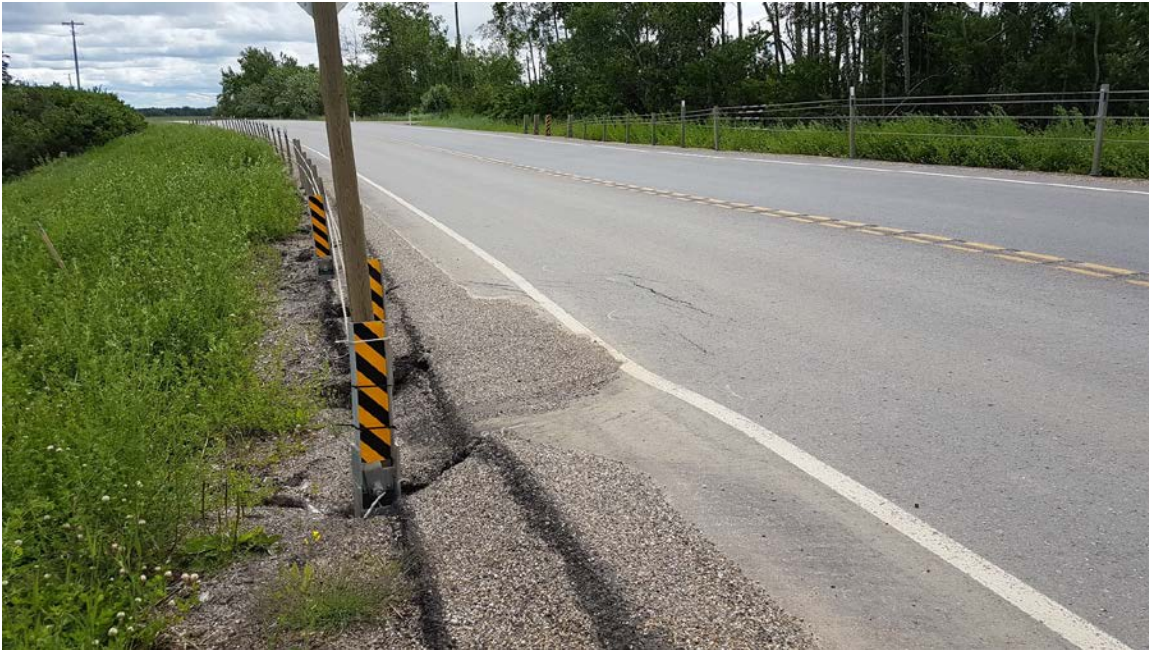
Photo 7 – Looking east at voids around HTSCB posts and settlement cracking of the pavement at west end of the north barrier located by the outlet of BF72371 culvert.

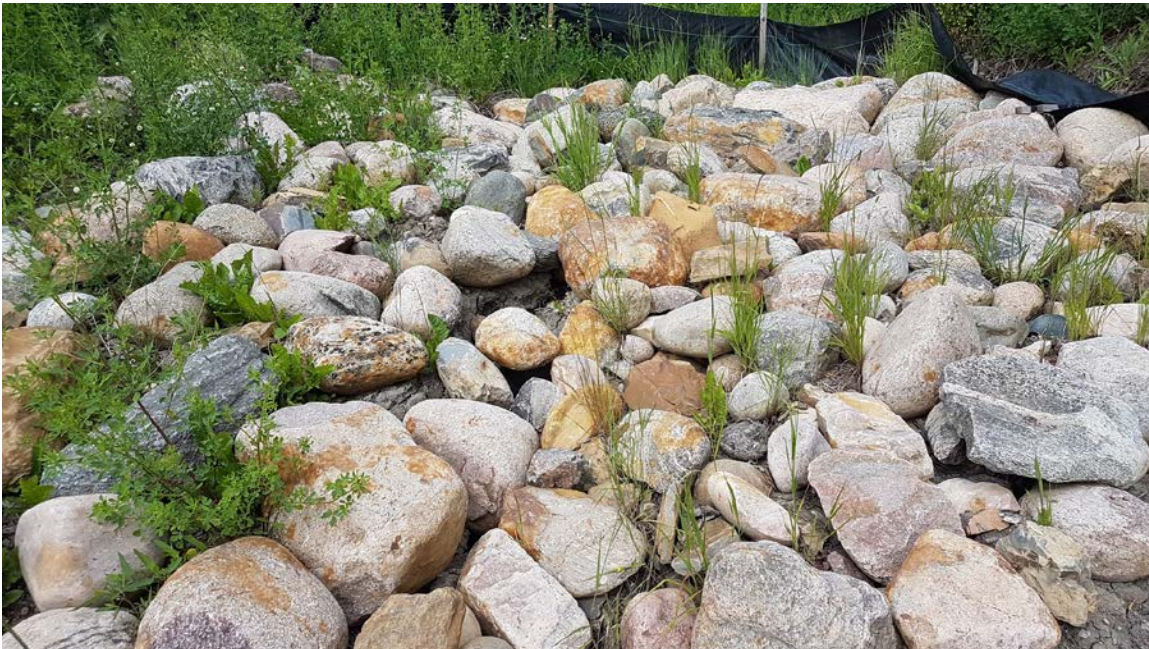
Photo 8 – Looking at riprap placed over bare ground (no nonwoven fabric below) at east end of north ditch the outlet of BF72371.
