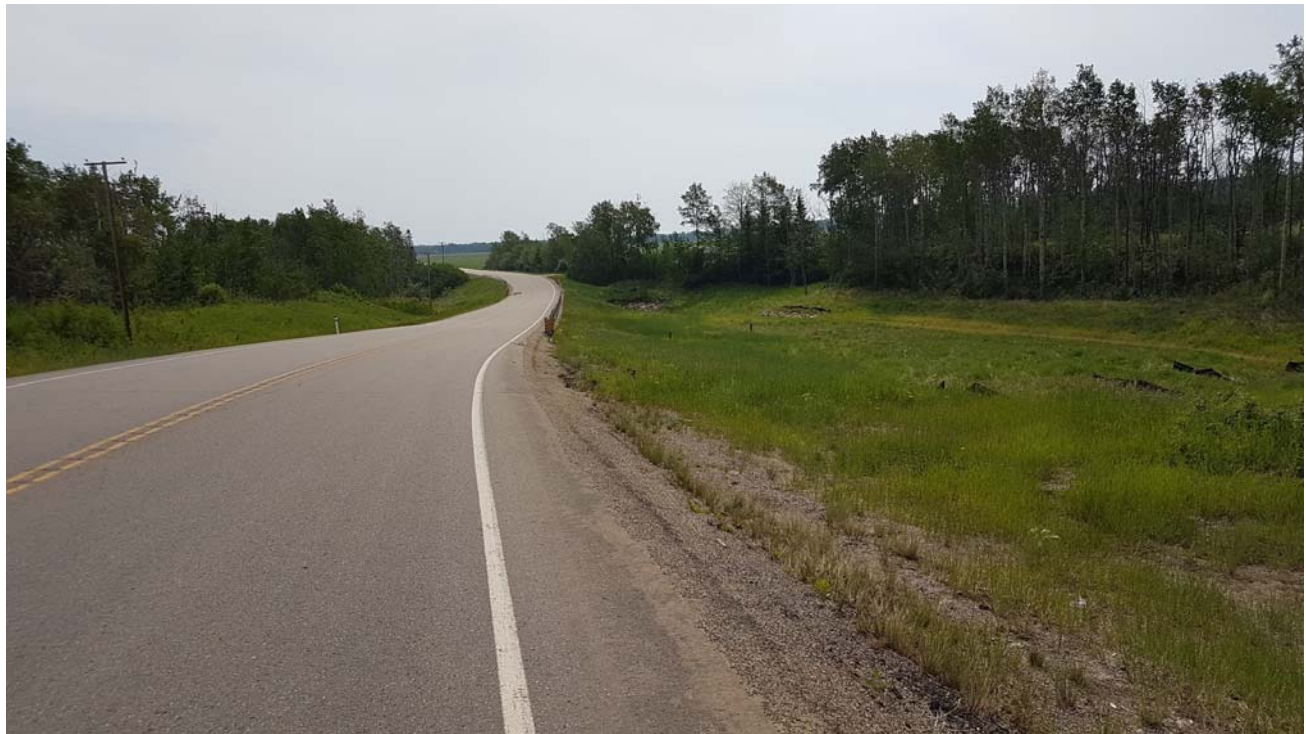
Photo 1 – Looking east over repaired highway and toe berm.

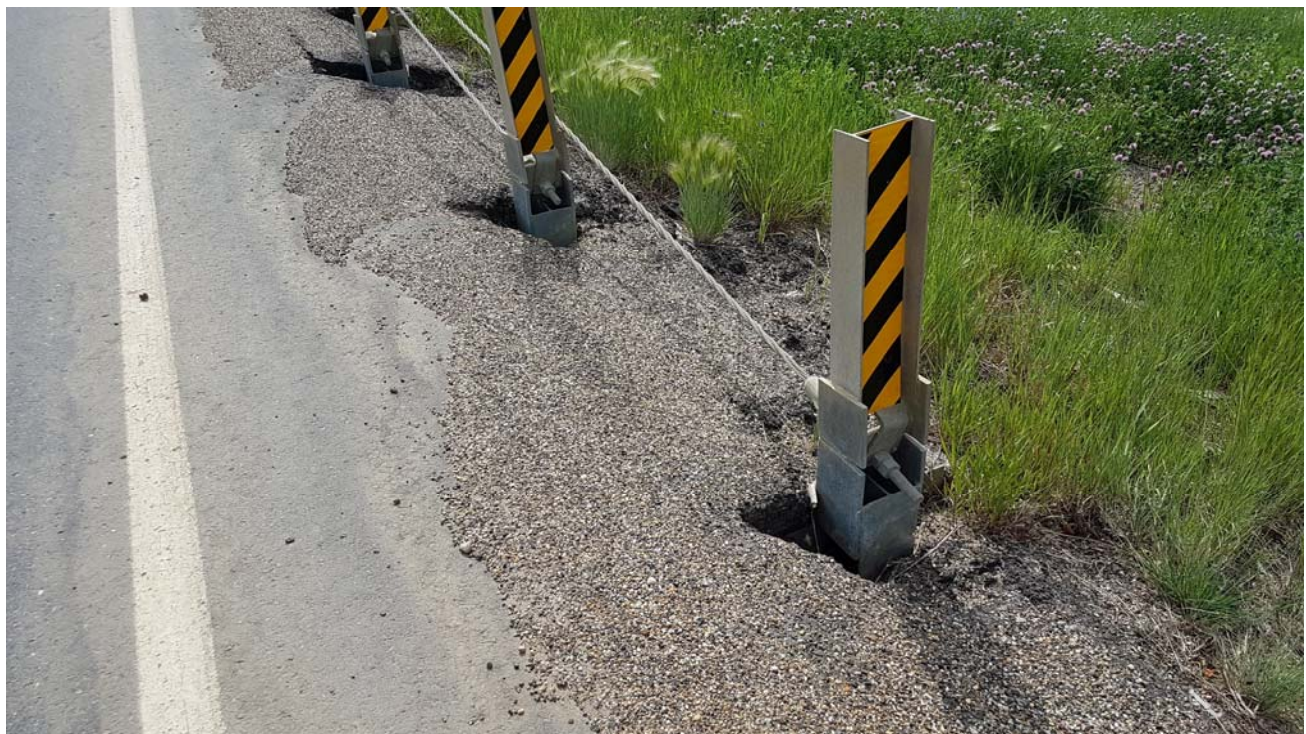
Photo 2 – Looking at voids around HTSCB on south side of highway at the west end.

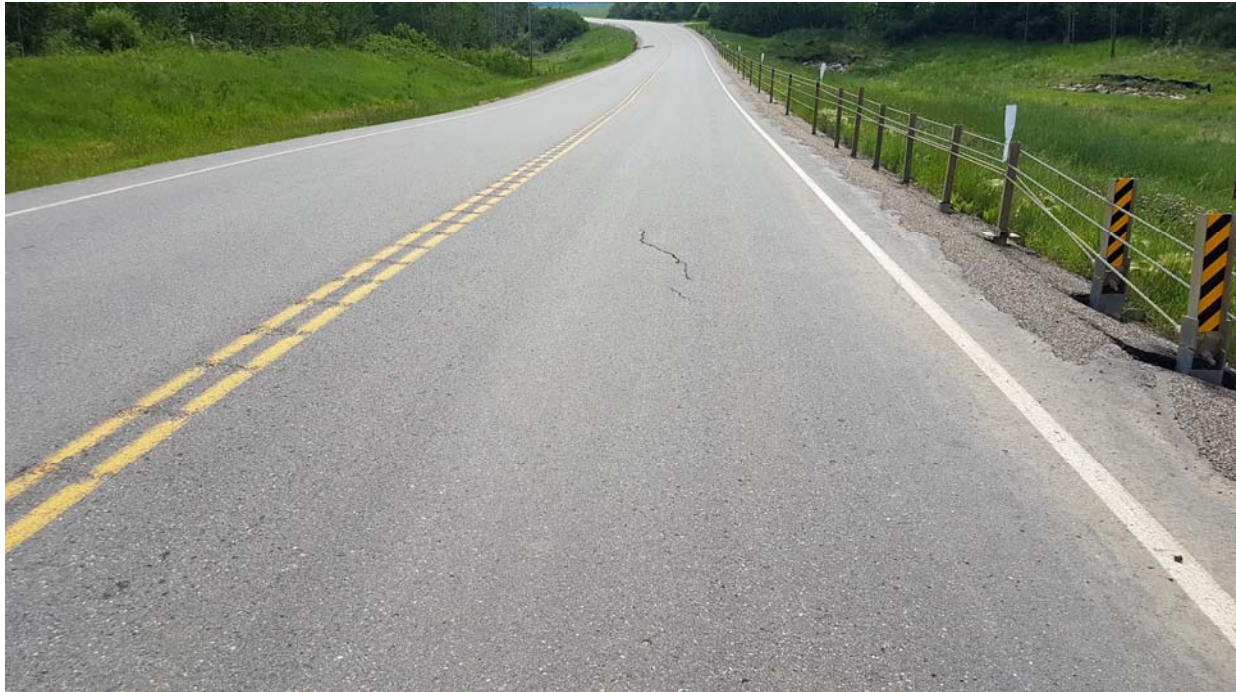
Photo 3 – Looking east at small crack at west end of slide area near the end of the HTSCB.

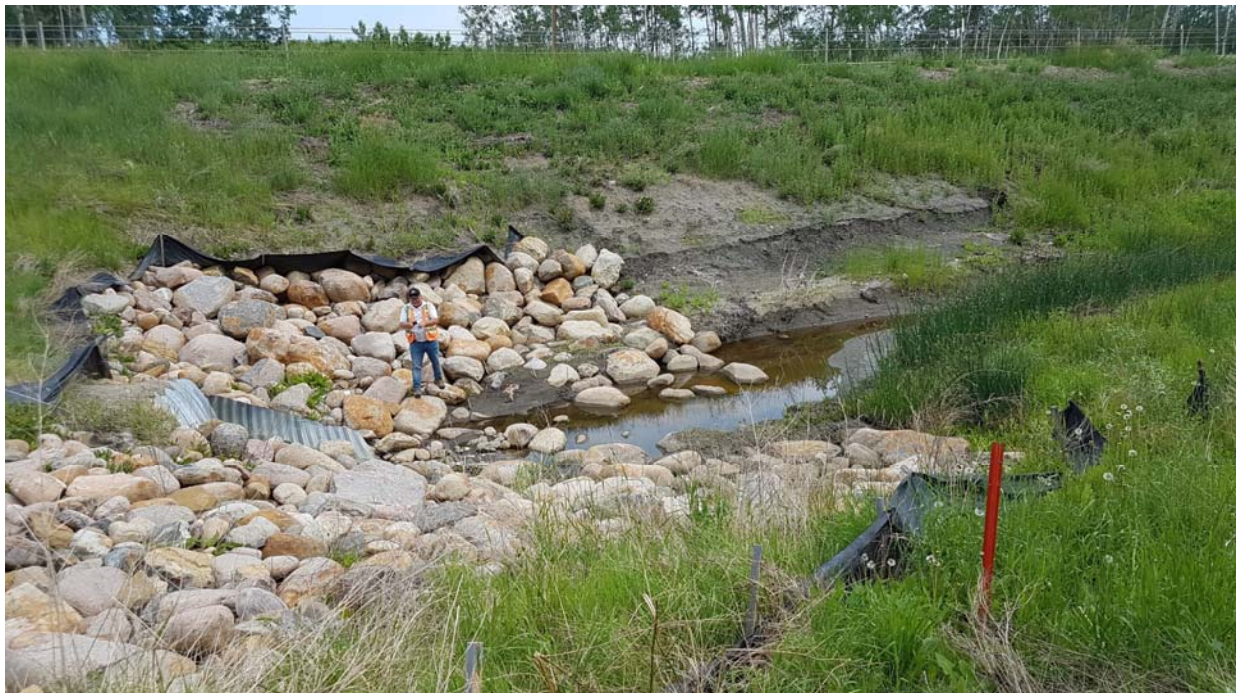
Photo 4 – Looking west at bare area at culvert outlet where possible tension cracks may be forming. Subdrain outlet is just on the far side of the culvert outlet. Note the eroded bare spot just beyond the riprap.

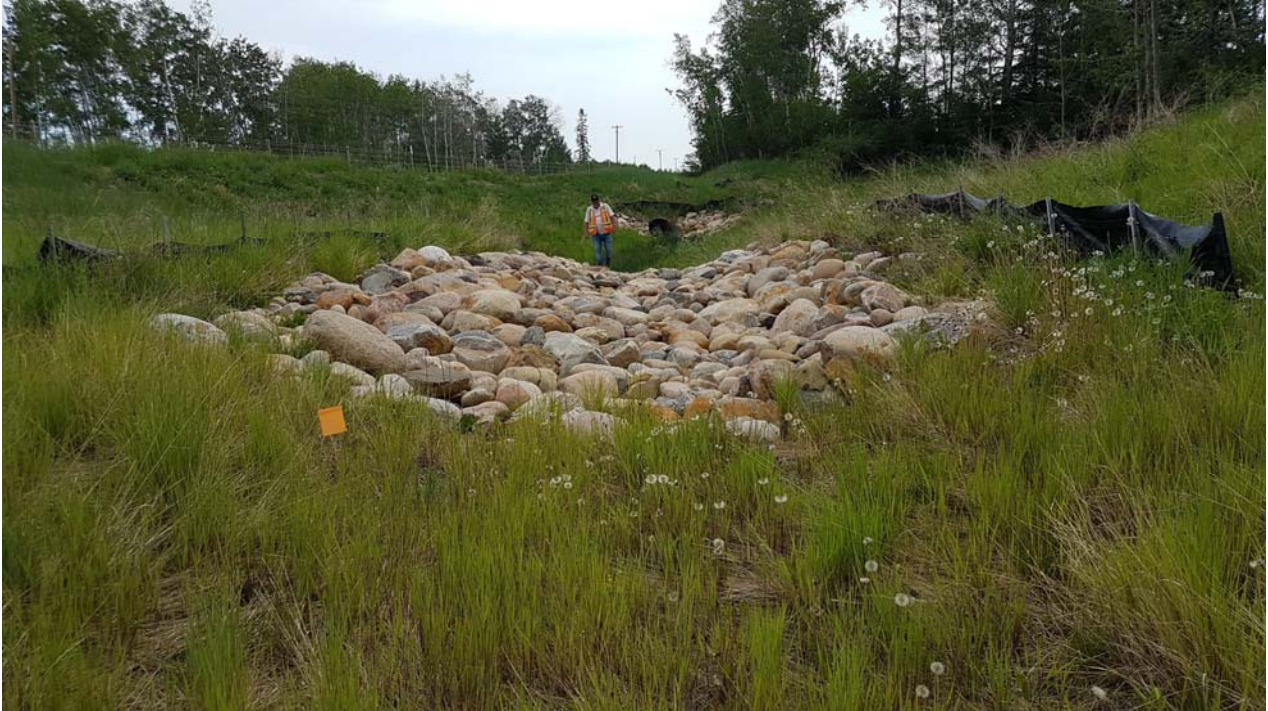
Photo 5 – Looking east from lined swale at bare spot between the swale and riprap apron where vegetation growth has been slowly improving.

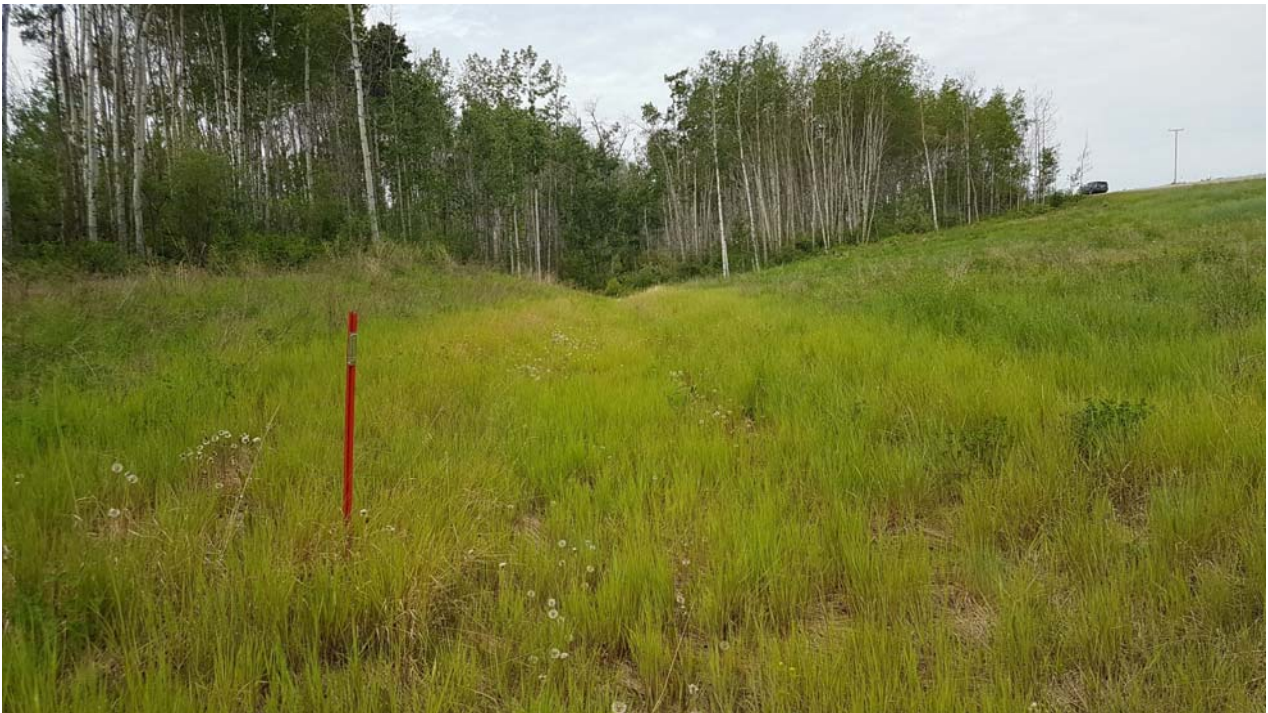
Photo 6 – Looking west along lined swale located at the south end of the toe berm.

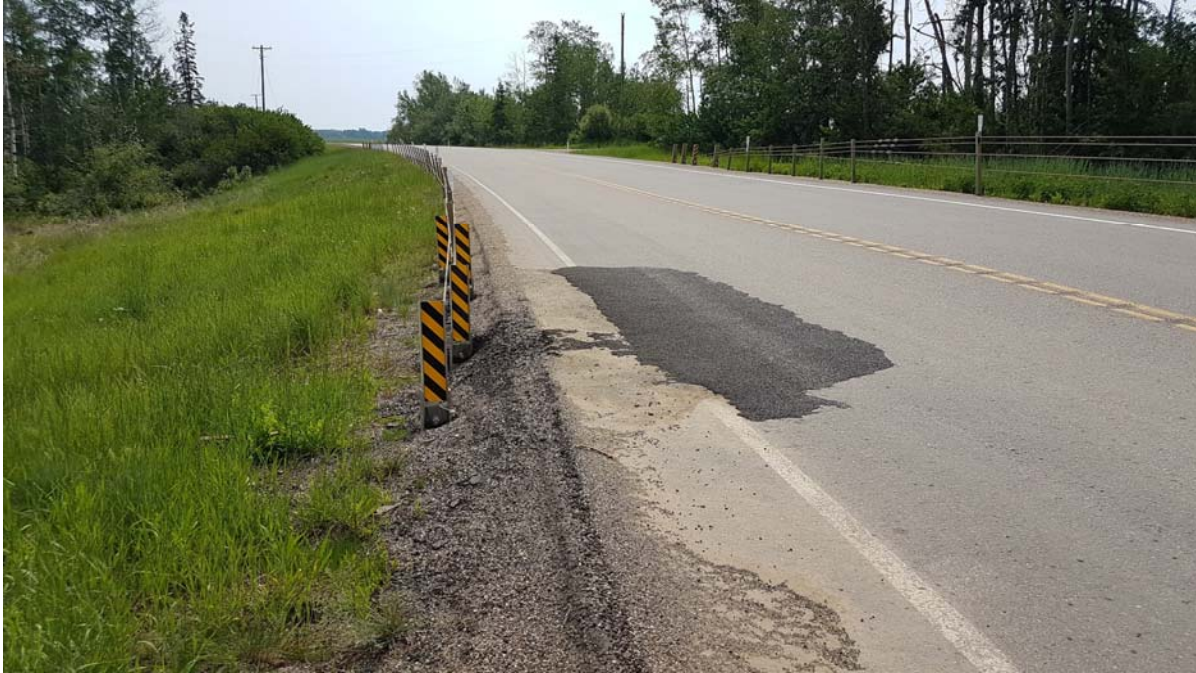
Photo 7 – Looking east at voids around HTSCB posts and settlement cracking of the pavement at west end of the north barrier located by the outlet of BF72371 culvert. Note that two patches have been required in this area.

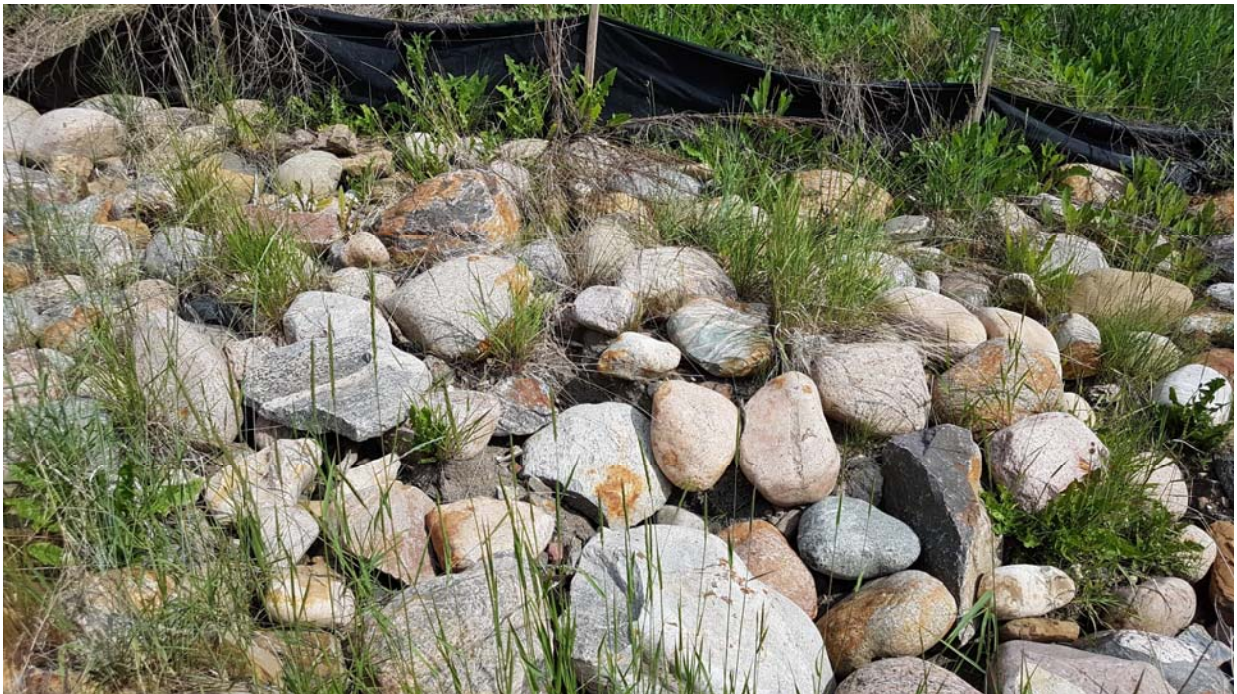
Photo 8 – Looking at riprap placed over bare ground (no non-woven fabric below) at east end of north ditch at the outlet of BF72371.
