GEOHAZARD ASSESSMENT PROGRAM

PEACE RIVER / HIGH LEVEL AREA

2011 CALLOUT INSPECTION

Site Number	Location	Name	Hwy	km
PH47	West of Deadwood, AB	Deadwood Slide	690:02	Approx. 2.2
Legal Description		UTM Co-ordinates		
SW1/4 28-89-23-W5M		11V N 6289120	E 462789

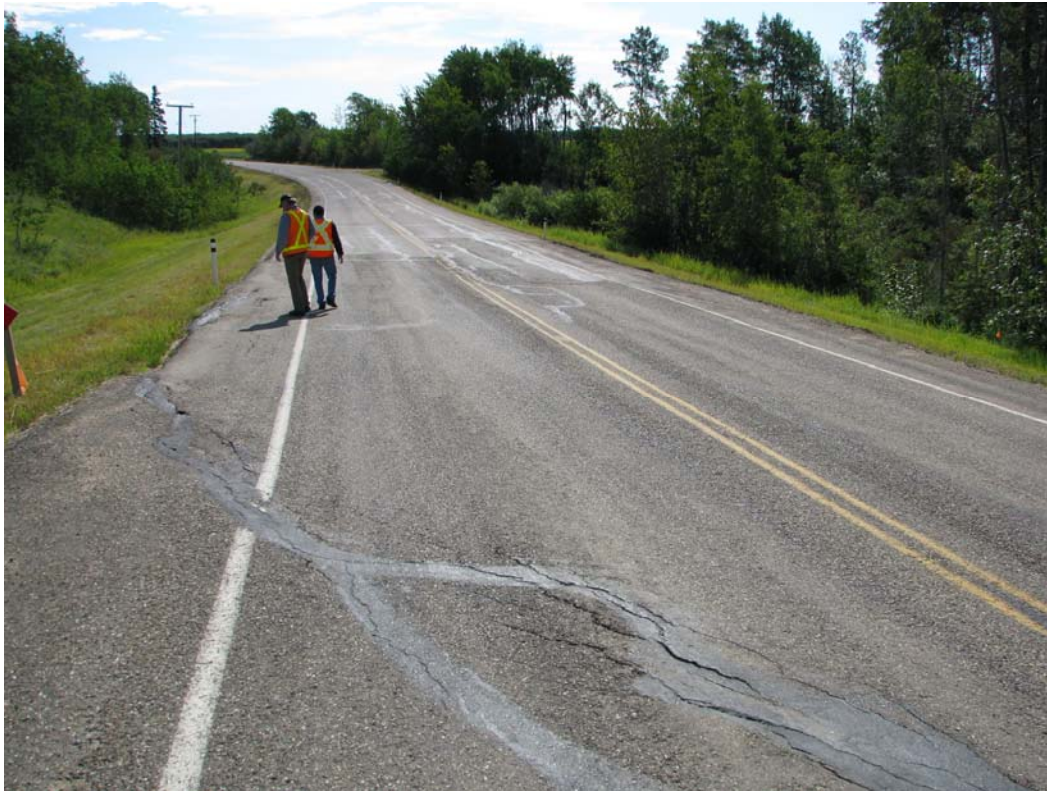
Photo 1 - View of Highway 690 showing the 2008 ACP patch, looking east.

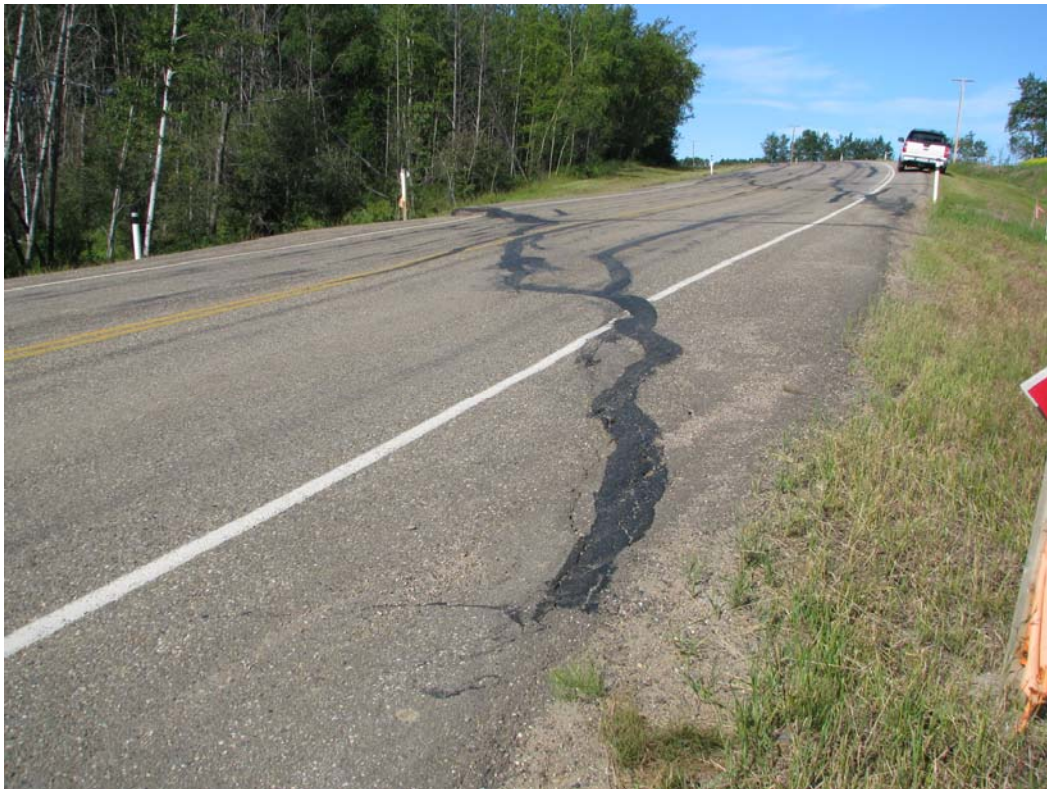
- The slope failure appears to be the result of toe erosion caused by the creek located immediately south of the highway leading to over-steeping of the slope. It is expected that, if left untreated, slow creep movements will continue. Heavy rainfall in July 2011 has triggered the additional movement and it is understood from Alberta Transportation that the slide movement rate increased on July 26, 2011, following a period of heavy rain.
- The pavement cracks have opened up to about 30 mm wide and vertical drops of about 100 mm.

Photo 2 – View of the crack on the highway and asphalt thickness, looking southwest.

In the short term, the cracks, and vertical drops in the pavement structure should be milled and patched to maintain a smooth even road surface for traffic safety.

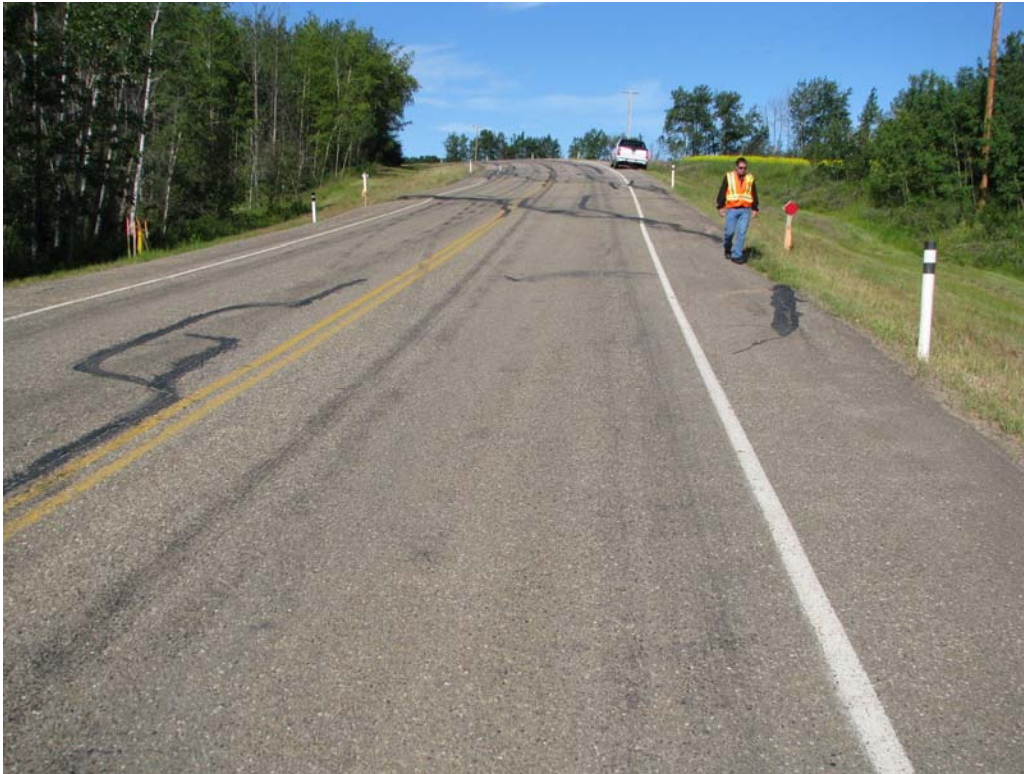
Photo 3 - View of Highway 690 showing the 2008 ACP patch, looking west.

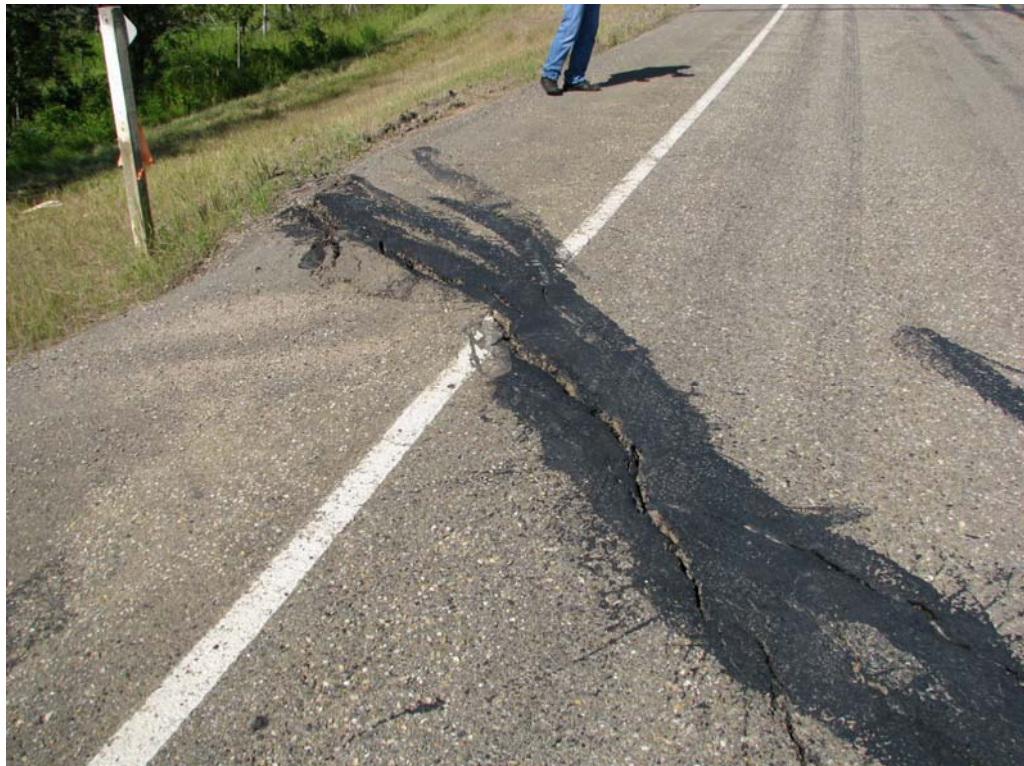
Photo 4 – View of asphalt crack and dip

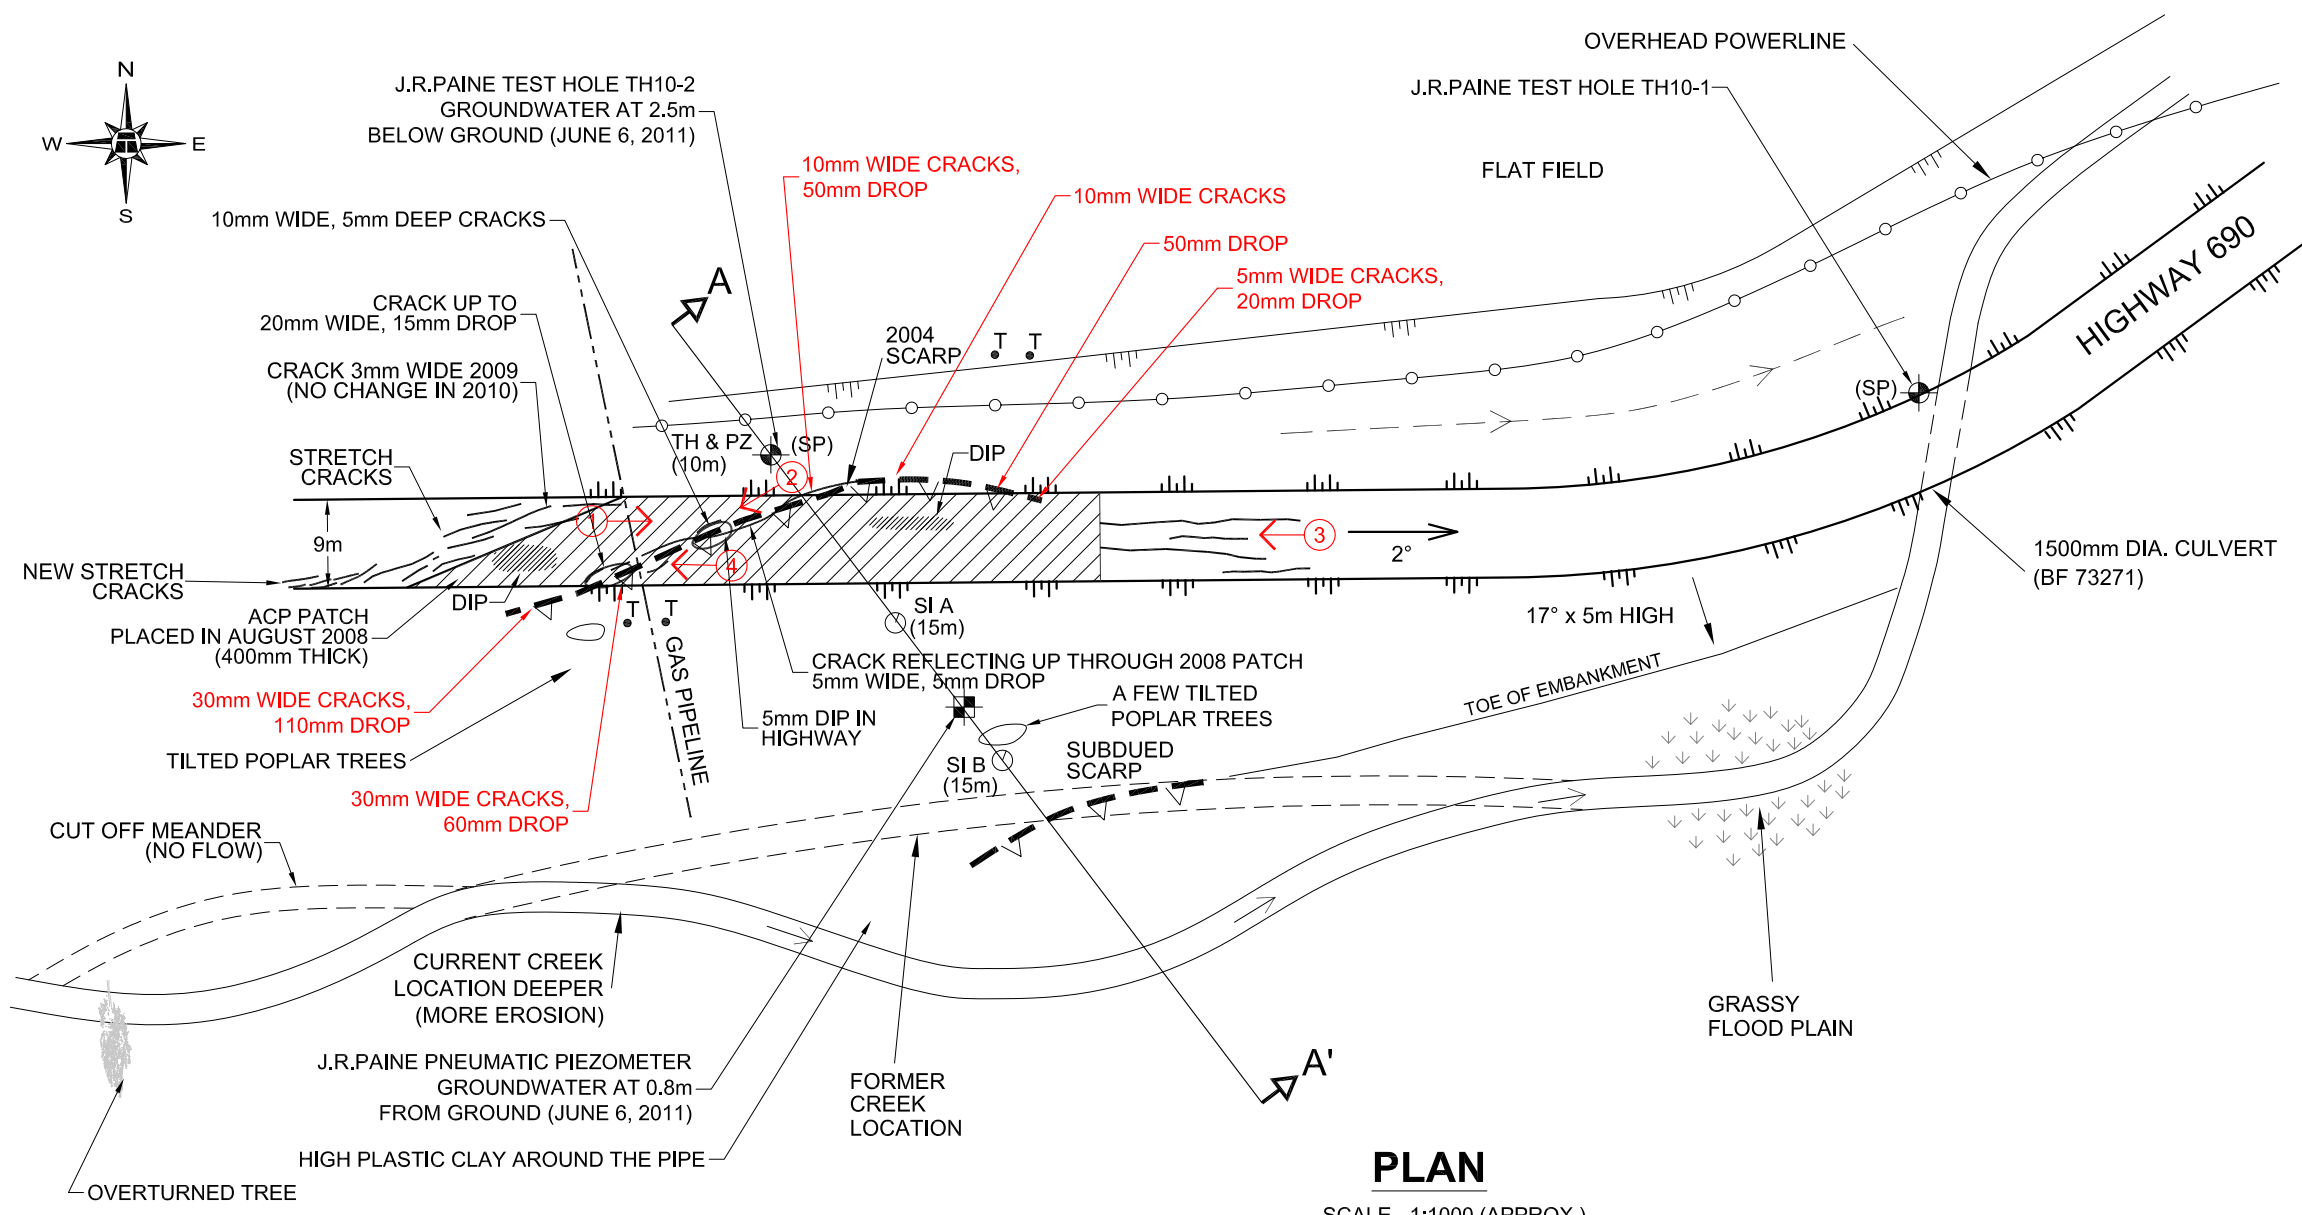
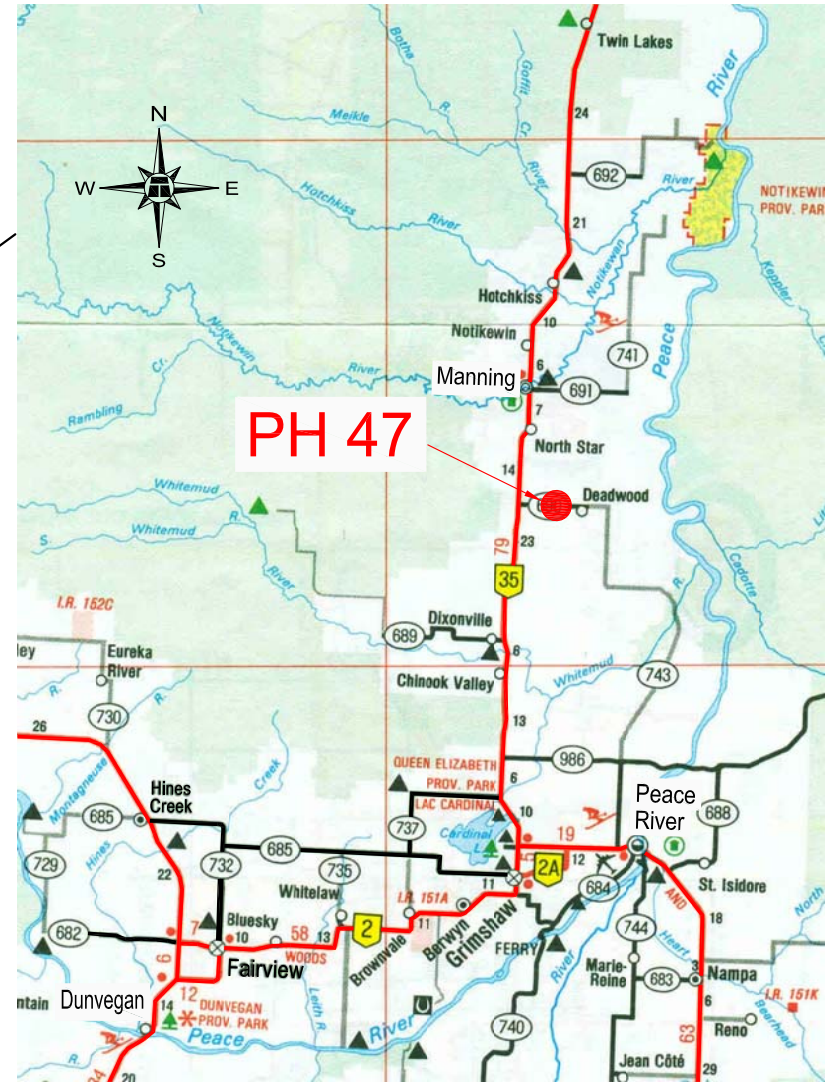
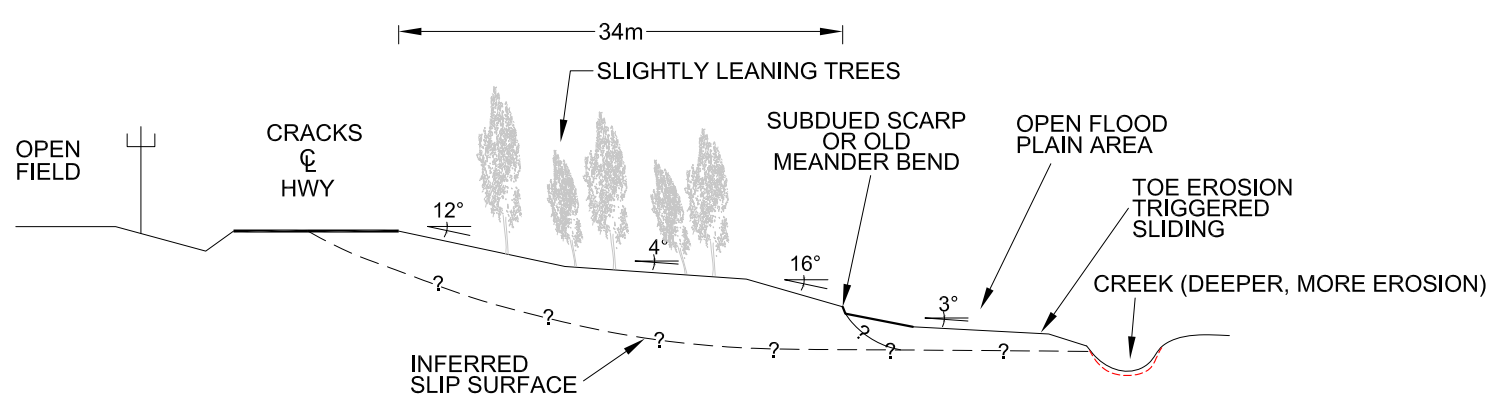
**FIGURE PH47-1 CALLOUT
DEADWOOD SLIDE- PH47 - HWY 690:02
PEACE REGION (PEACE RIVER/HIGH LEVEL)
GEOHAZARD ASSESSMENTS**
DATE : AUGUST 2, 2011
THURBER PROJECT # 15-16-264

- As recommended during our 2010 assessment, geotechnical investigation was undertaken by J.R. Paine which involved drilling five test holes. Two slope inclinometers, three standpipe piezometers and a pneumatic piezometer were also installed as part of the investigation. The test hole logs are attached with this report. The approximate locations of the test holes and SI's are shown on Figures 47-1 and PH47-2. A stratigraphic cross-section is provided on Figure 47-3.
- The soil conditions as shown in the test hole logs indicate presence of clay fill, overlying clay/clay till followed by clay shale.
- The slip surface of the slide is based in the shale.

Three options have been identified as possible long term solutions.

The first option would involve the installation of a 1500 mm diameter CSP culvert along the toe of the slide, which would prevent further creek erosion of the toe of the slope. In addition to the culvert installation, a toe berm would be constructed and the slide mass re-graded to a flatter uniform slope in order to re-establish slope stability. A DFO authorization would be required to carry out this option.

The second solution would be based on the use of a pile wall to stabilize the highway side slope. Drilled, reinforced concrete piles would likely be needed to stabilize the slide. As the slide appears to be greater than 5 m to 6 m deep, tie-back anchors might also be needed.

The third option would include either partial or full excavation of the slide mass, construction of a deep shear key, and reconstruction of the highway sideslope. This option would also involve the lining of the creek bed with rip rap in order to prevent further toe erosion.

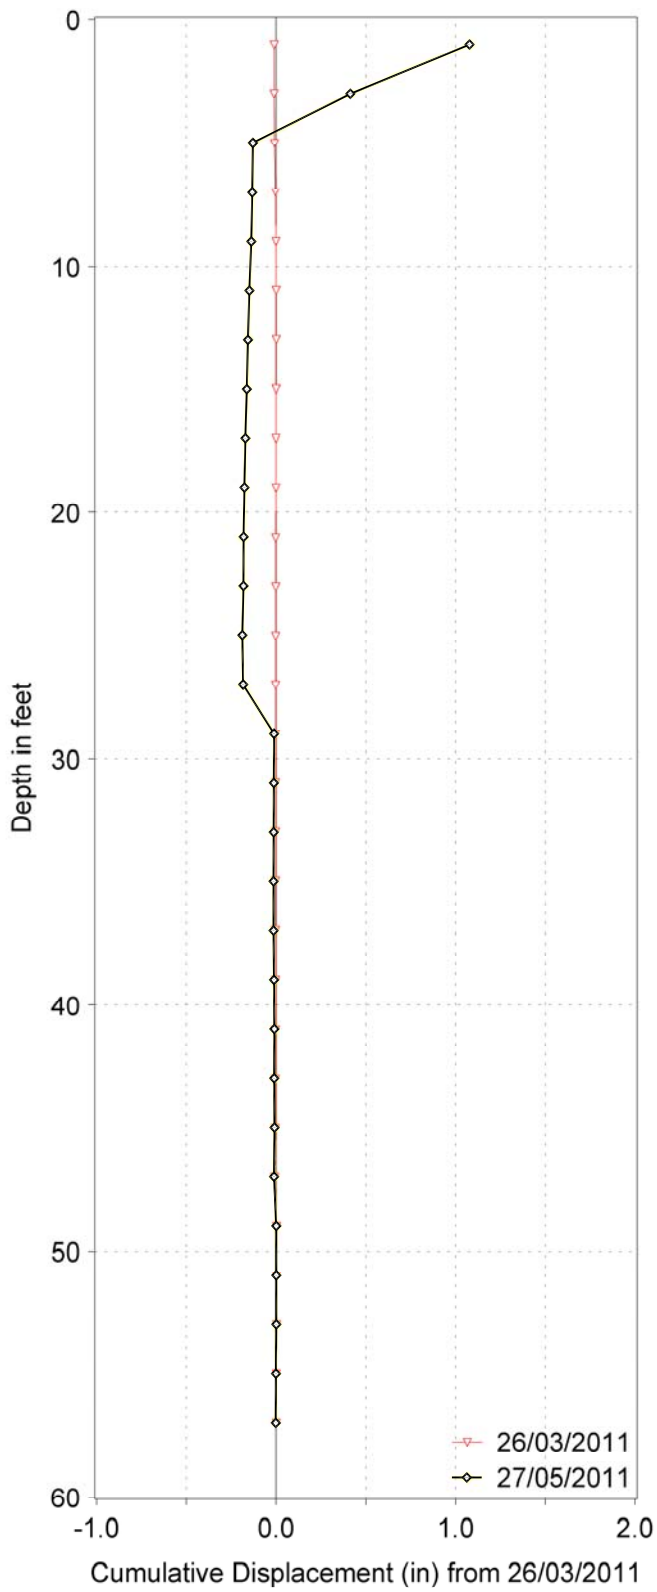
YES 10_1, A-Axis

Two slope inclinometers were installed by J.R. Paine. Slope movement of about 10 mm is recorded between March and May 2011 at depths of about 9 m and 7 m in SI-10-1 and SI-10-2 respectively. The SI plots provided by J.R. Paine are attached with this report.
