**ALBERTA TRANSPORTATION  
GEOHAZARD ASSESSMENT PROGRAM  
PEACE REGION – HIGH LEVEL  
2023 INSPECTION REPORT**

Site Number	Location	Name	Hwy	km
PH086	Manning, Alberta	Pinewood Estates	691:02	0.06
Legal Description		UTM Co-ordinates		
NE21-091-23-W5M		11U E 461,782	N	6,308,097

PH086-1: HWY 691:02 AND HWY 35:06  
2023 SITE INSPECTION PLAN

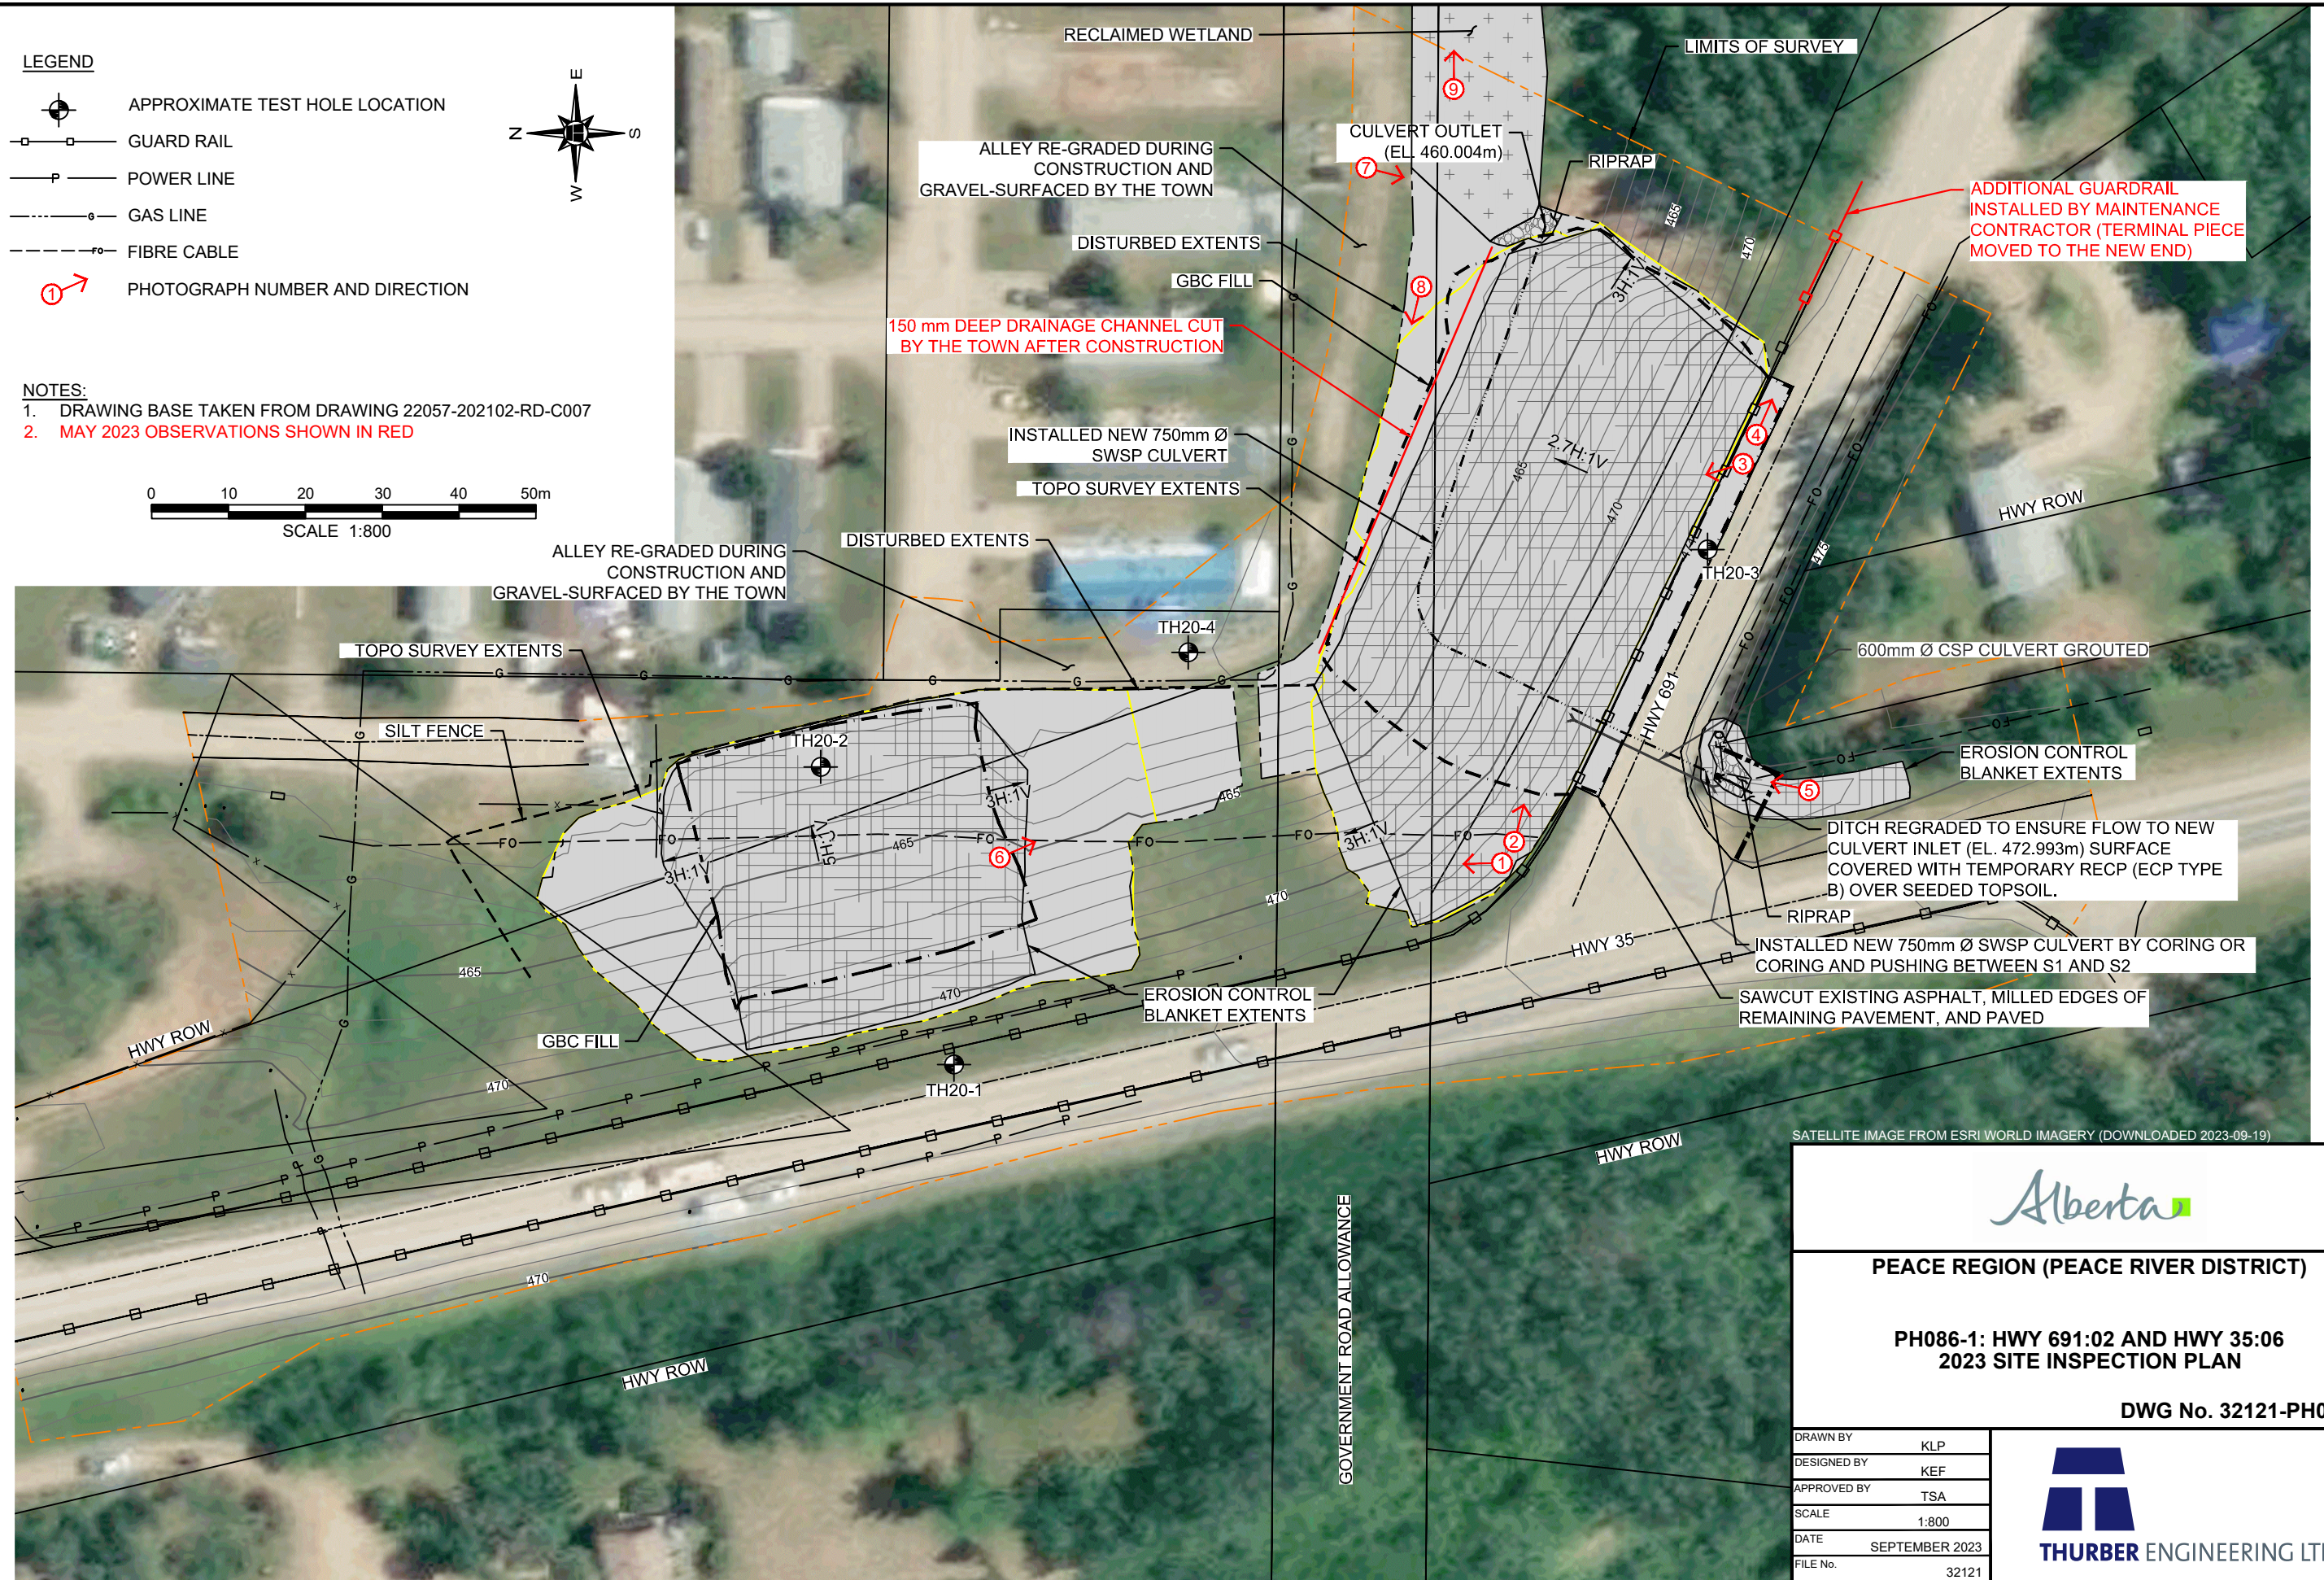
<b>Primary Site Issue:</b>	Landslide affecting the side slope of Hwy 691	
<b>Dimensions:</b>	50 m length of highway, 30 m wide, ~11 m high slope Tension cracks extend about 4 m further west The active slide is about 36 m wide parallel to the highway and 20 long in the downslope direction. Tension cracks extend an additional 15 m to the east. The slope is about 11 m high at the slide location. The bare backslope of the slide is inclined at 32 degrees and the side slopes outside the slide are inclined at 28 degrees to the horizontal.	
<b>Date of Remediation:</b>	2021 (CON0022057): Landslide repairs consisted of excavating the slumped material, installing a shear key at the toe, and rebuilding the slopes at a flatter inclination using compacted 2-25 gravel. A new SWSP culvert was installed under Hwy 691:02.	
<b>Maintenance:</b>	2021: Guardrail extended further east along Hwy 691:02	
<b>Observations:</b>	<b>Description</b>	<b>Worsened?</b>

<input checked="" type="checkbox"/> Pavement Distress	2019 tension cracks became scarp in 2020; New tension crack formed at west end. Removed and repaved during 2021 repair.	<input type="checkbox"/>
<input checked="" type="checkbox"/> Slope Movement	2019 slide mass continues to move and break up. It extended both east and west in 2020. Removed and replaced with compacted gravel during 2021 repair.	<input type="checkbox"/>
<input checked="" type="checkbox"/> Erosion	Exposed soil of slide mass eroding. Finished slopes topsoiled, seeded, and covered with erosion control blanket. New ditch constructed by Town at toe of slope is eroding slightly.	<input checked="" type="checkbox"/>
<input checked="" type="checkbox"/> Seepage		<input type="checkbox"/>
<input checked="" type="checkbox"/> Bridge/Culvert Distress	600 mm CSP culvert outlet hanging 1.3m in 2020 and riprap apron destroyed by slide movement. Piece of 600 mm concrete culvert on west flank of slope but origin and inlet unknown. Old culverts removed or grouted and new SWSP installed during 2021 repair.	<input type="checkbox"/>

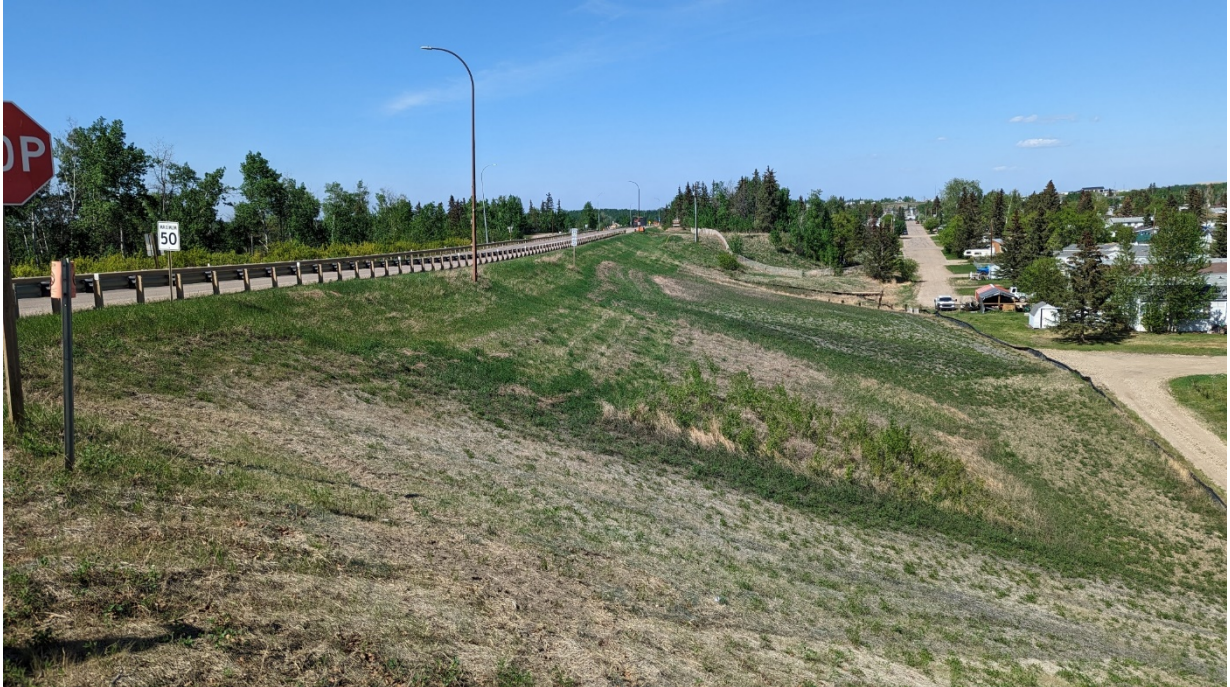
Photo 1 – Looking north toward the slide repaired on the east side of Hwy 35.

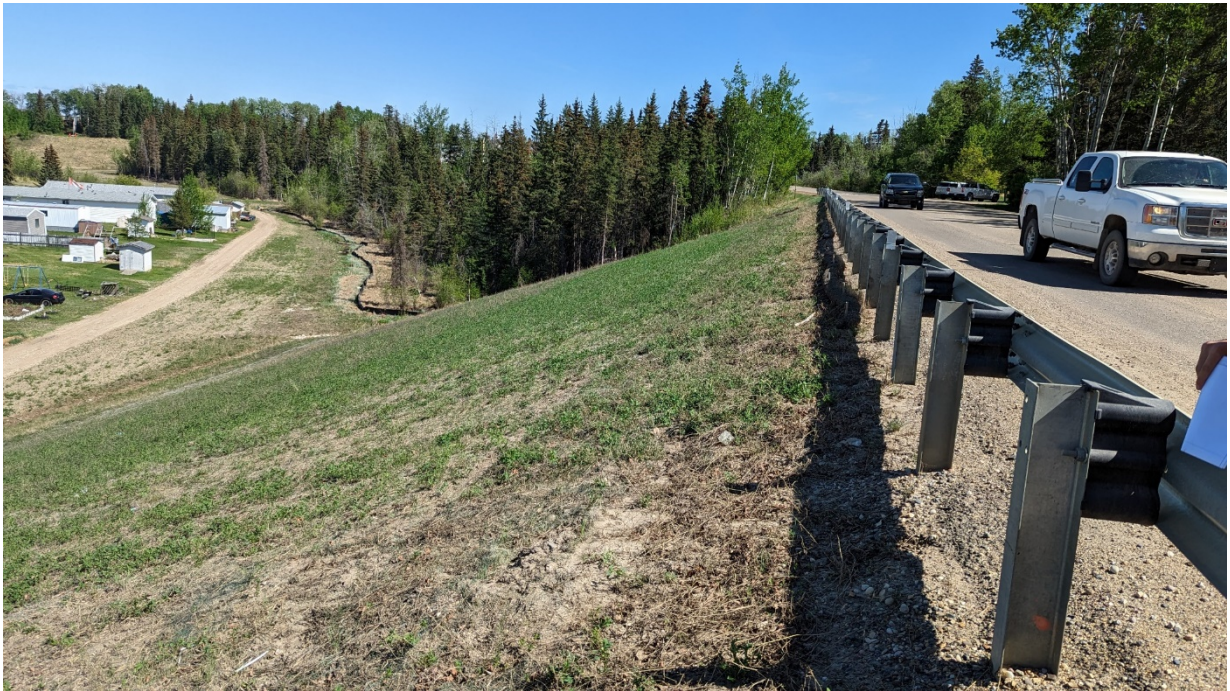
Photo 2 – Looking east along the top of the repaired Hwy 691 slide.

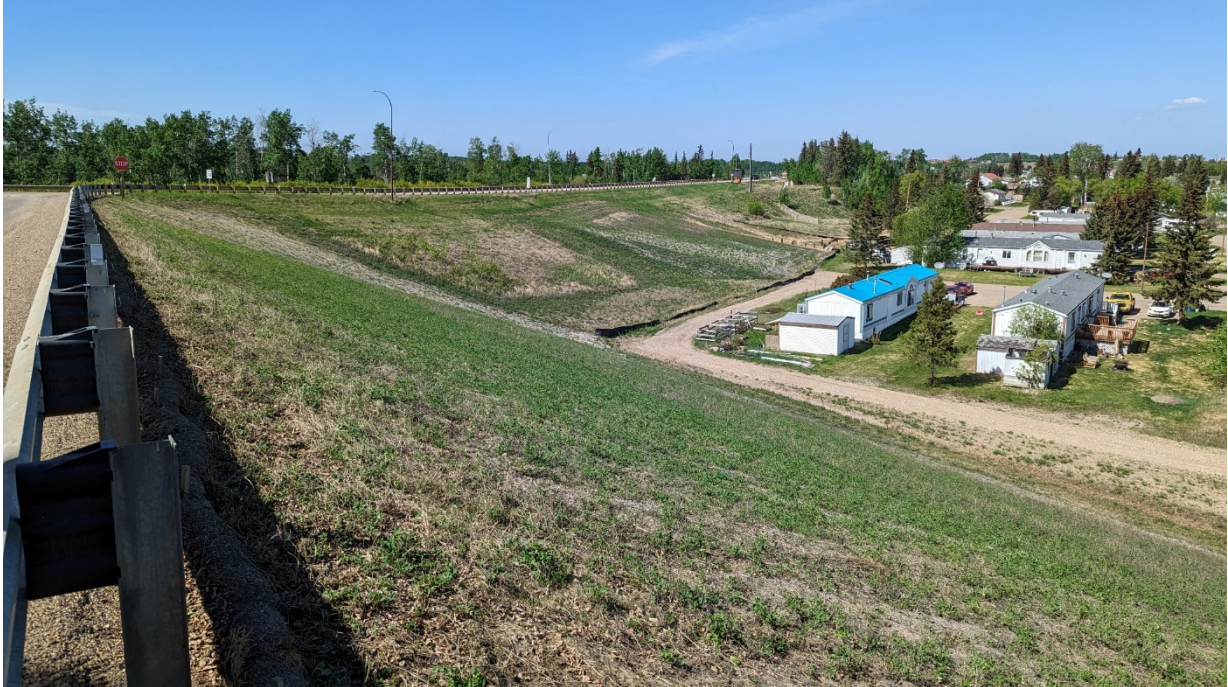
Photo 3 – Looking northwest toward Hwy 35 along the top of the repaired Hwy 691 slide.

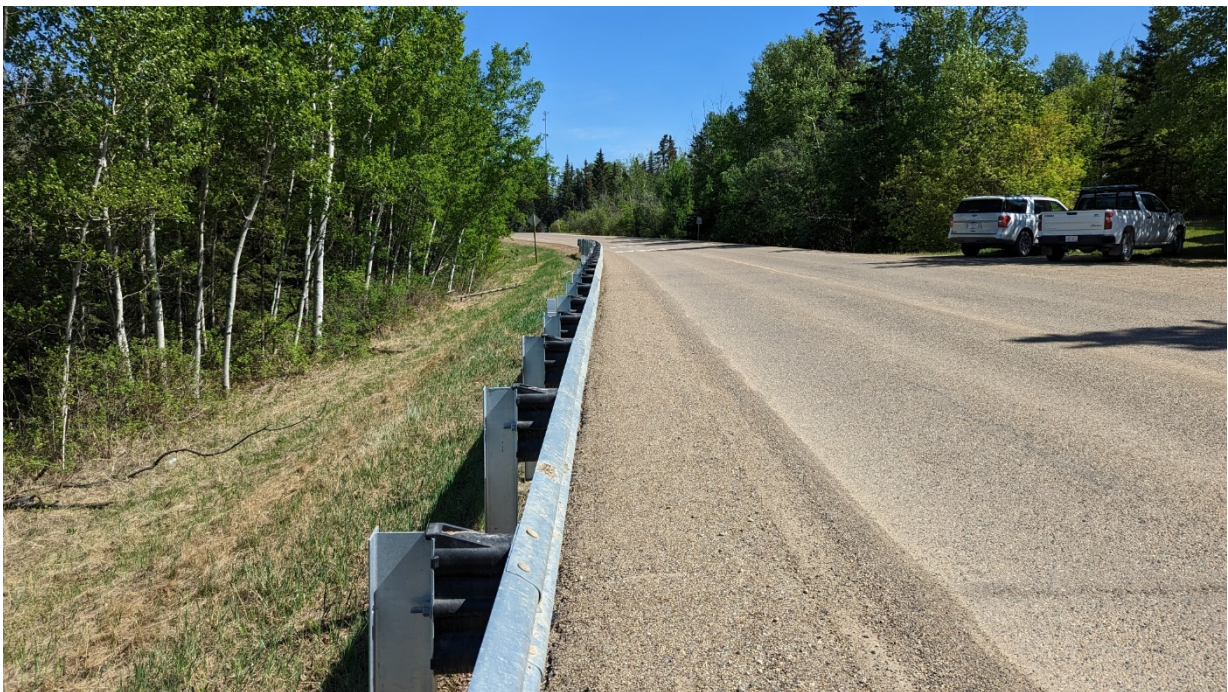
Photo 4 – Looking east along Hwy 691 at the east end of the site where the guardrail was extended by the Maintenance Contractor.

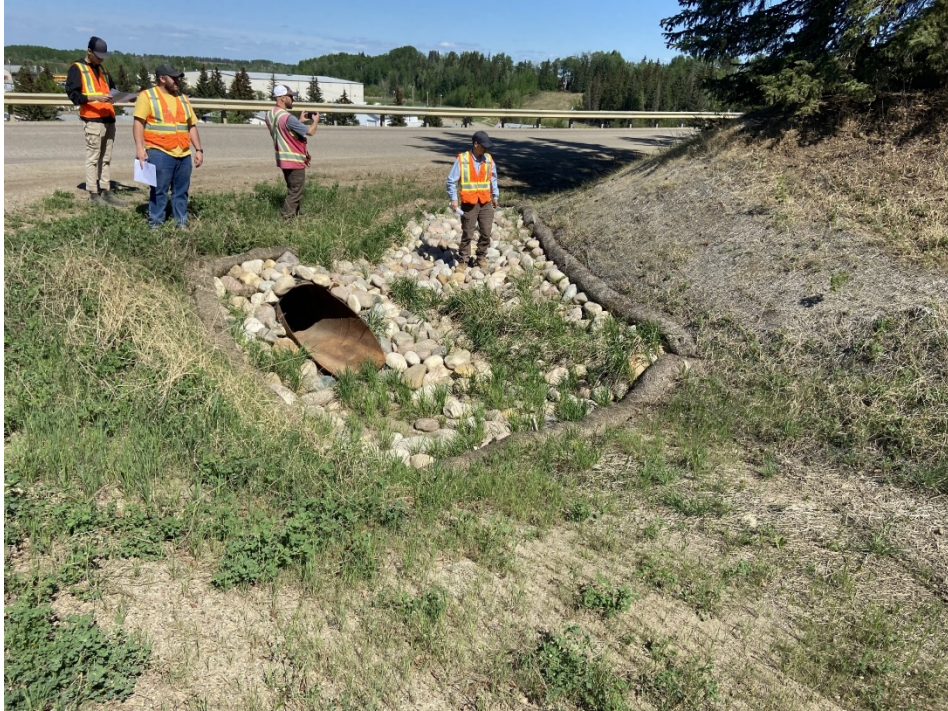
Photo 5 – New SWSP inlet in the east ditch of Hwy 35 on the south side of Hwy 691.

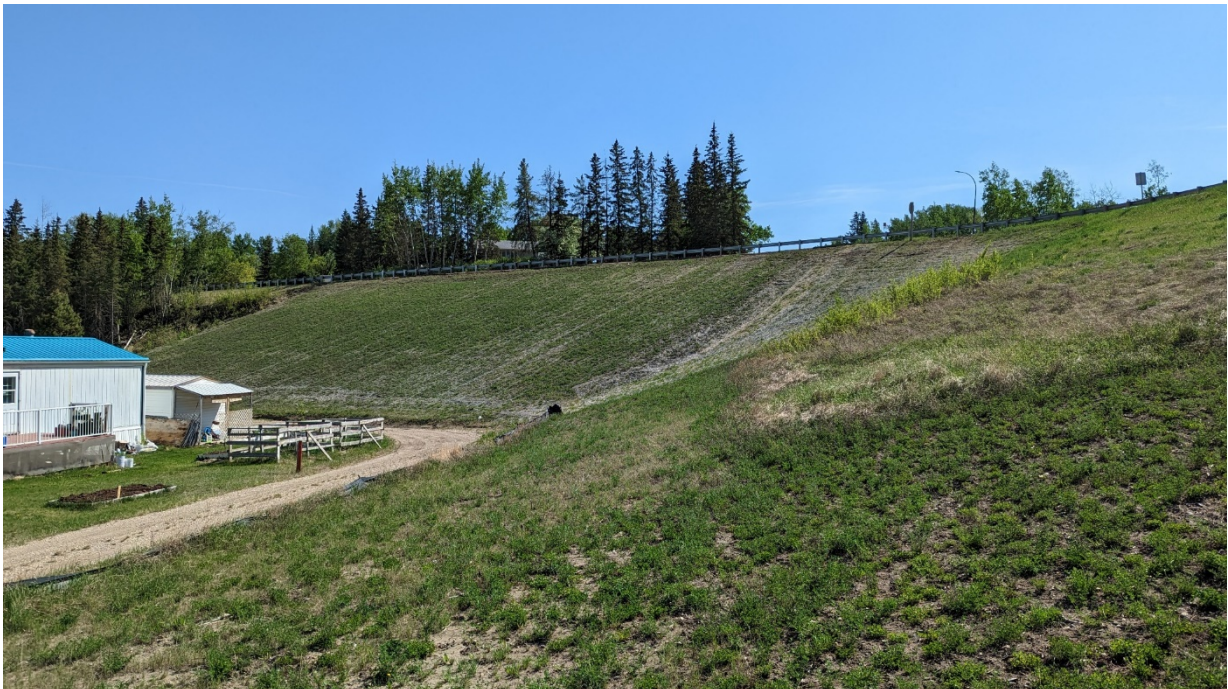
Photo 6 – Looking southeast at the repaired Hwy 691 slide.

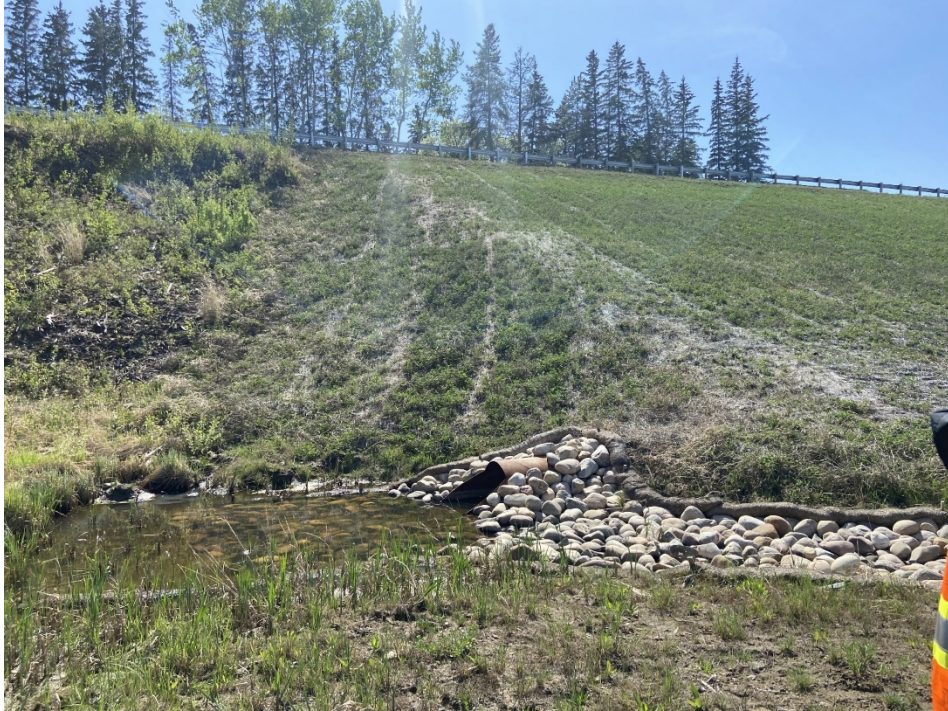
Photo 7 – Looking south at the outlet of the 750 mm SWSP with the wetland to the left.

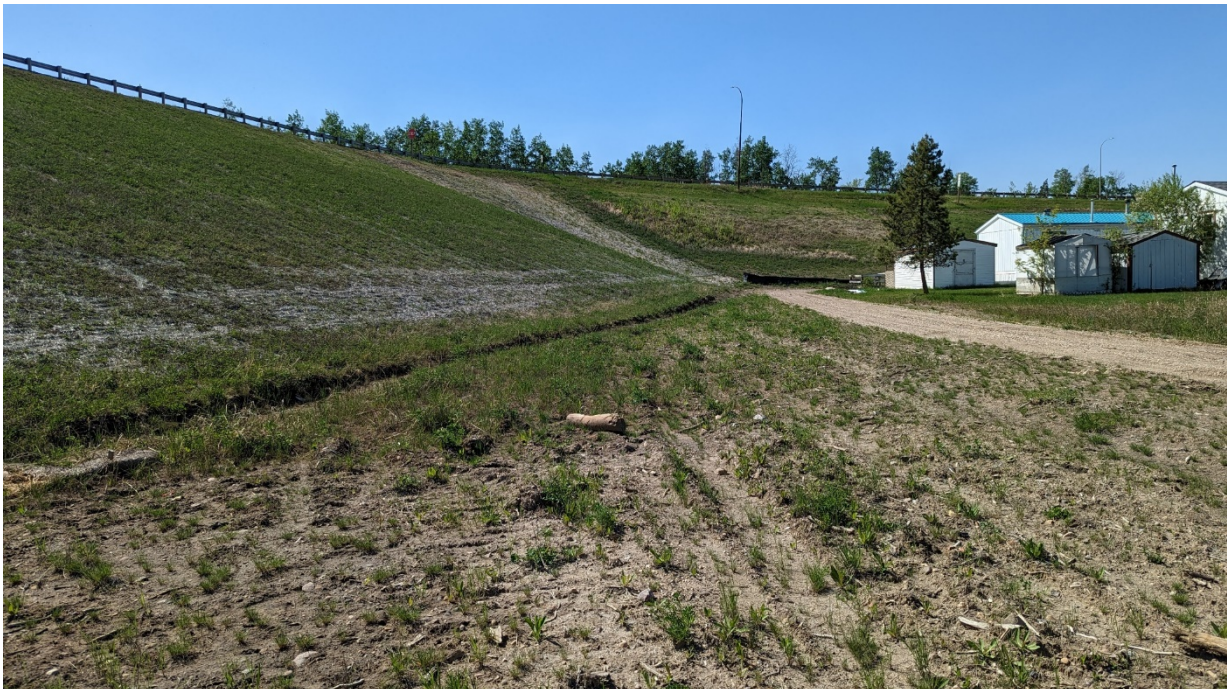
Photo 8 – Looking west along the toe of the Hwy 691 embankment where the Town cut a drainage channel which ties into the culvert outlet.

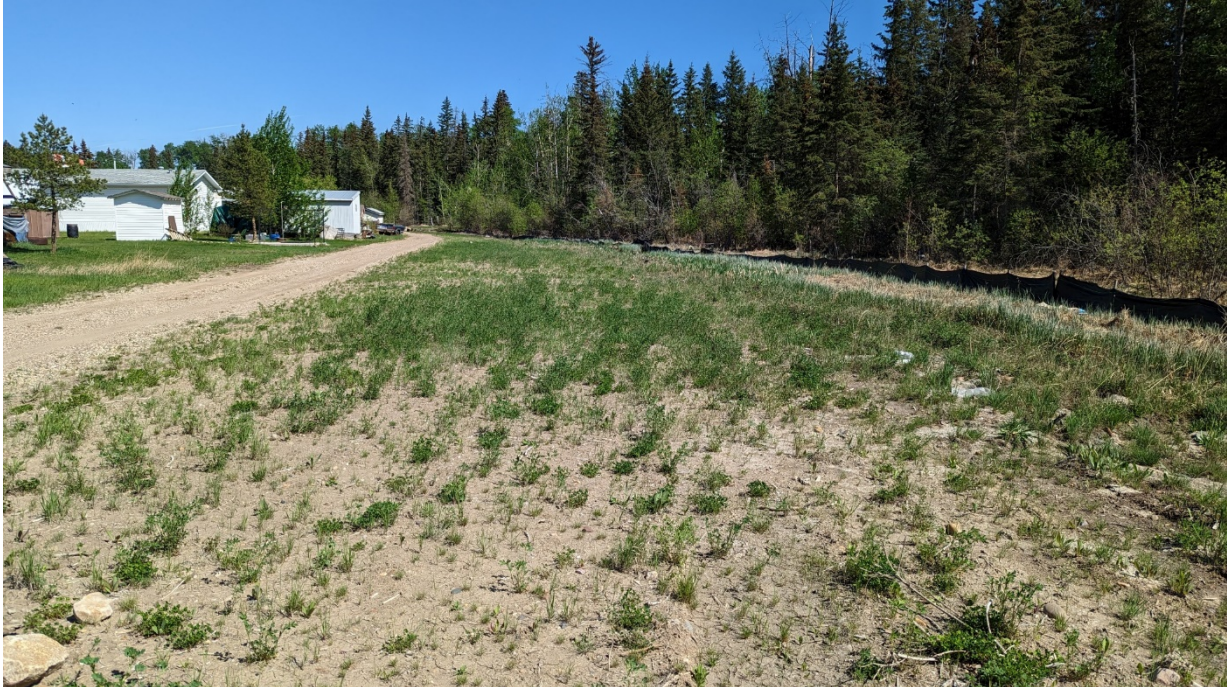
Photo 9 – Looking east along the reclaimed wetland and improved alley behind the Pinewood Estates.
