October 13, 2022

**GEOHAZARD RISK MANAGEMENT PROGRAM (CON0022164)
PEACE REGION (PEACE RIVER DISTRICT)**

**SECTION D CALL-OUT REPORT
EAST OF MANNING: HWY 691:02 km 4.14 to 4.18**

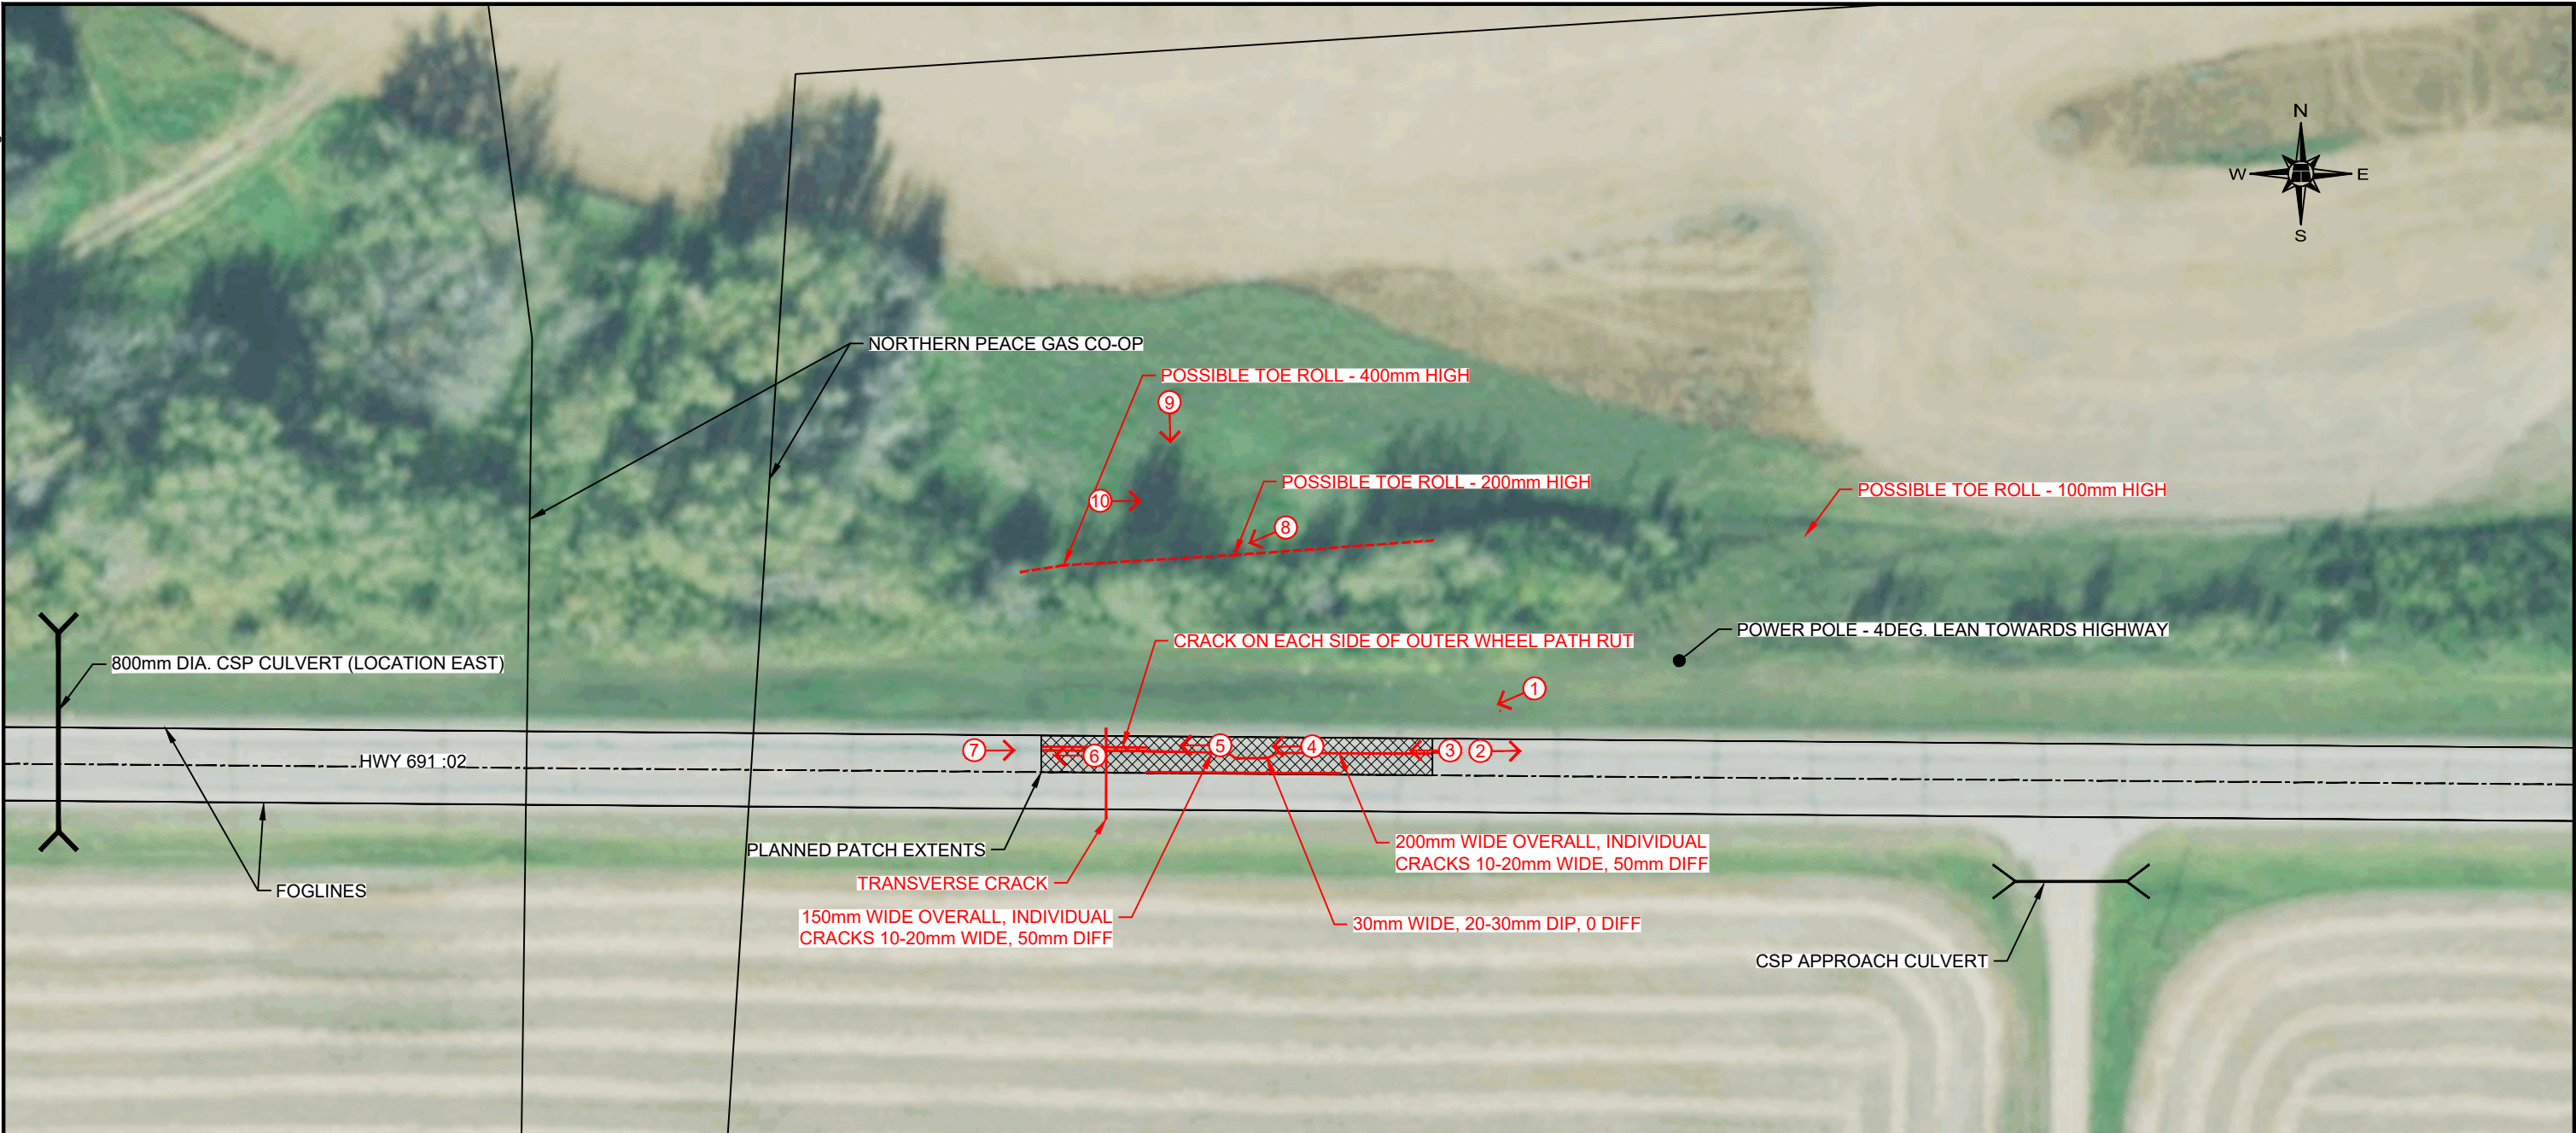
DWG No. 32121-HWY 691:02-CALLOUT-1

The highway embankment measures about 1.4 m in height on the south side with a sideslope of 3.7H:1V. The farmland beyond was relatively flat with no obvious drainage pattern. On the north side, the sideslope was about 2.5H:1V and the roadway surface was 8 m to 9 m above the lower-lying, flat farmland at the toe. There is a culvert under the south approach located about 80 m east of the site and an 800 mm dia. CSP centerline culvert about 120 m to the west of the site (km 4.017). A patch was planned for the summer of 2022, which was marked out by spray paint and stakes spanning a length of about 49 m of the west-bound lane (WBL).

At the time of the callout inspection, the main crack pattern was located within the area delineated by the planned patch. The main crack was in the outer wheel path of the WBL and extended about 24 m within the planned patch. The western portion of this crack pattern was about 150 mm in overall width with individual crack widths of up to 20 mm and a slight differential down to the north of about 50 mm. In the central portion, the crack deviated to the center of the lane and was about 30 mm without differential. The eastern portion was about 200 mm in overall width with individual crack widths of also about 20 mm and 50 mm differential. West of the main crack, and to the end of the planned patch, there were two roughly parallel cracks on either side of the slight outer wheel path rut that are likely related to the distress. To the east of the main crack, there was a single crack roughly in the center of the outer wheel path (OWP) that continued beyond the planned patch.

Observations at the toe of the slope noted a potential toe roll at the level of the adjacent field, although thick bush somewhat obscured the slope. This possible toe roll was between 200 mm and 400 mm high and spanned a distance of about 50 m and was in line with the main crack noted on the highway. There was another potential toe roll noted about 45 m east of the proposed patch but was only 100 mm in height and could be the result of previous farming disturbance. There was no obvious corresponding crack and differential in the highway surface at this location.

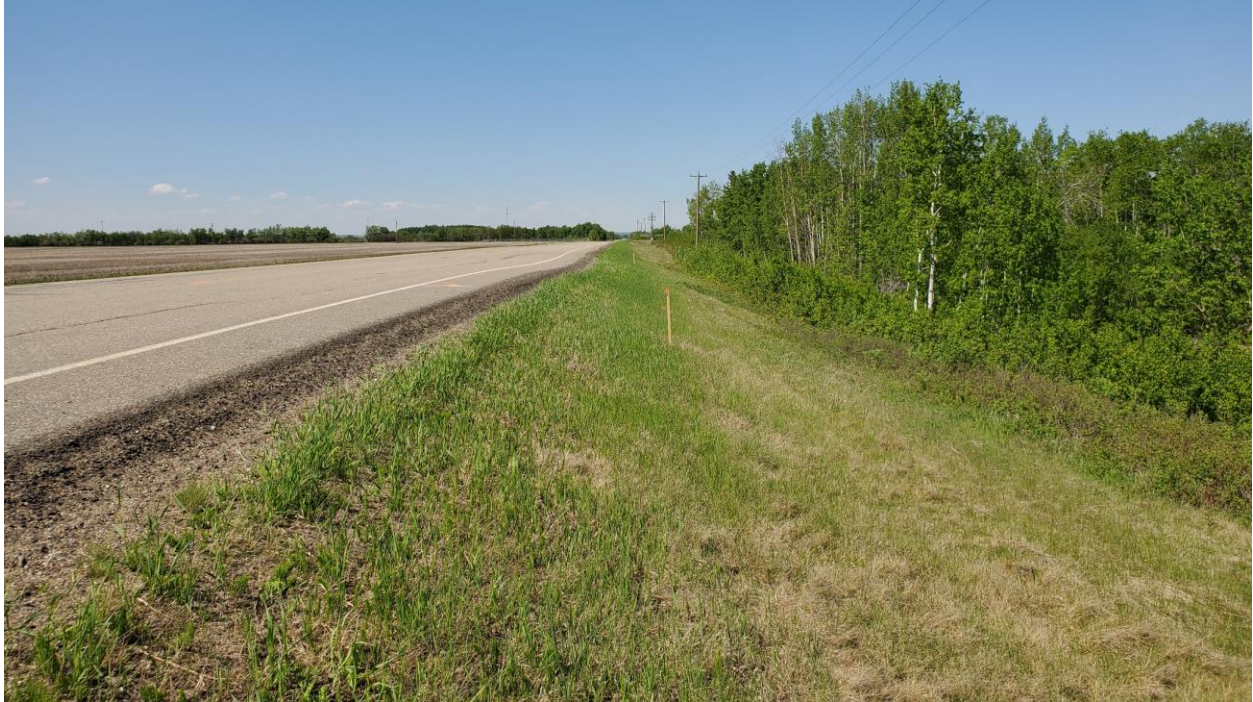
Photo 1 – Looking west over distressed area where dip is visible in the roadway surface and the stakes mark the planned patch.

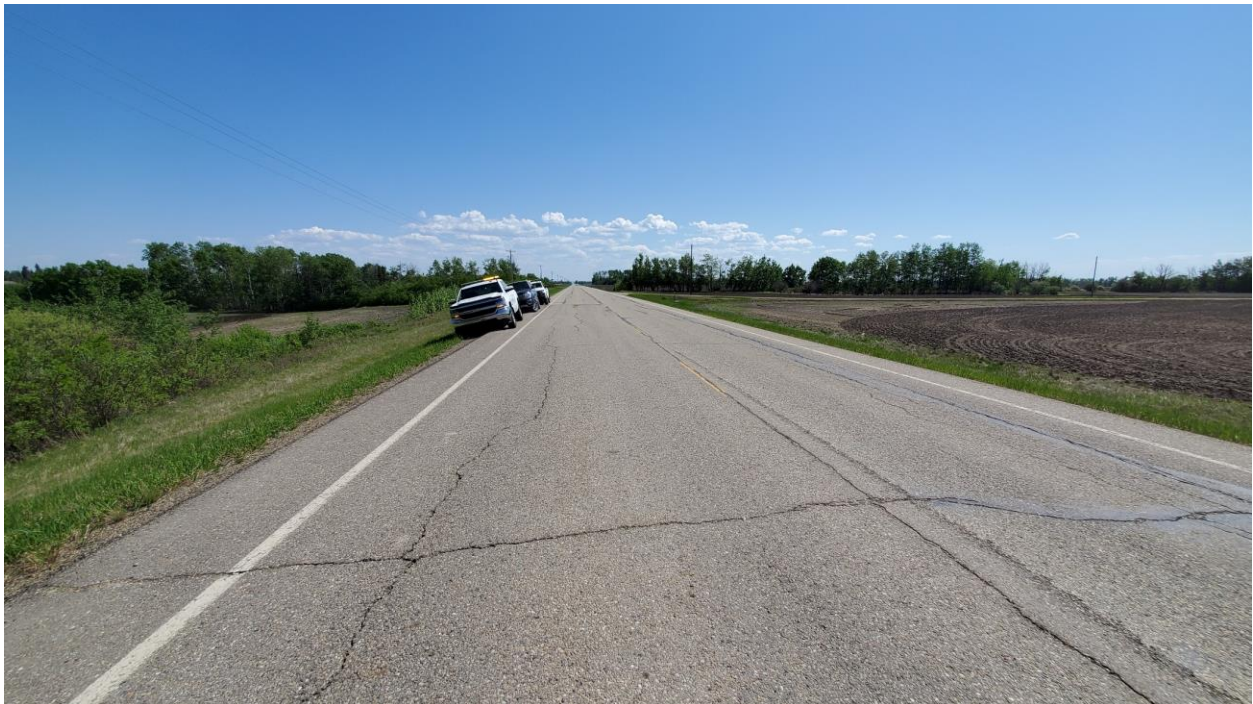
Photo 2 – Looking east beyond the area of distress.

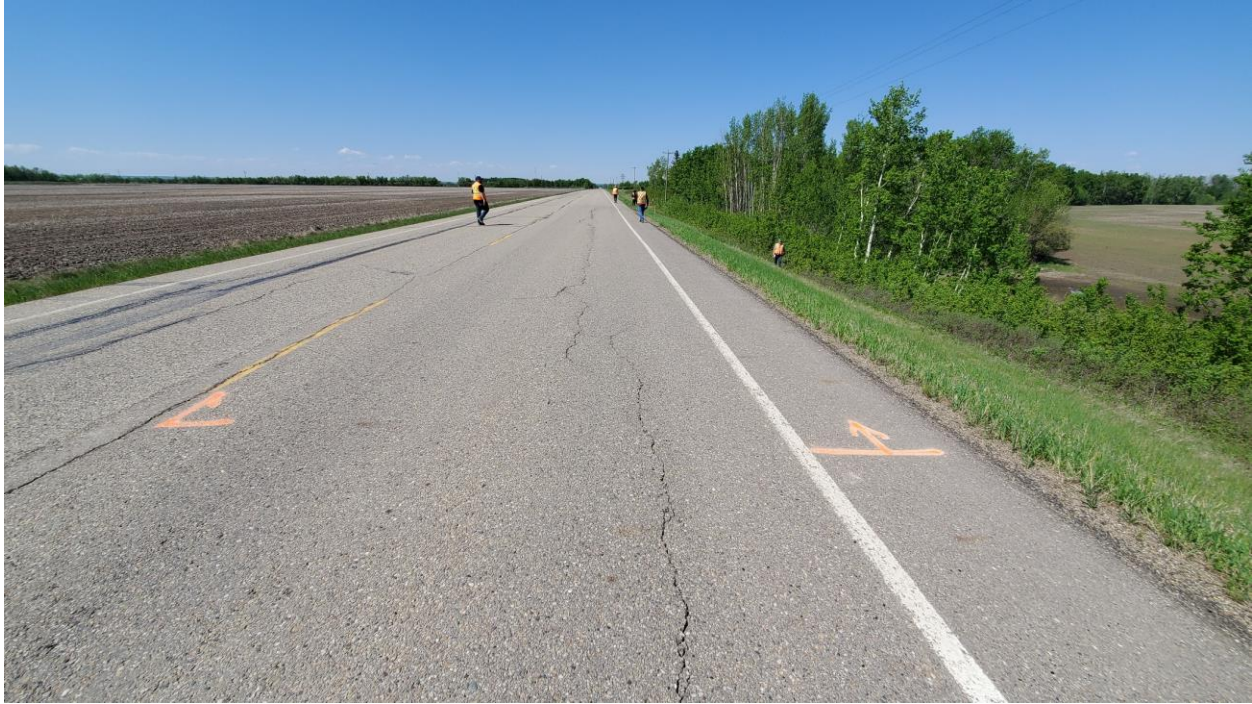
Photo 3 – Looking west at east of the proposed patch over the distressed area.

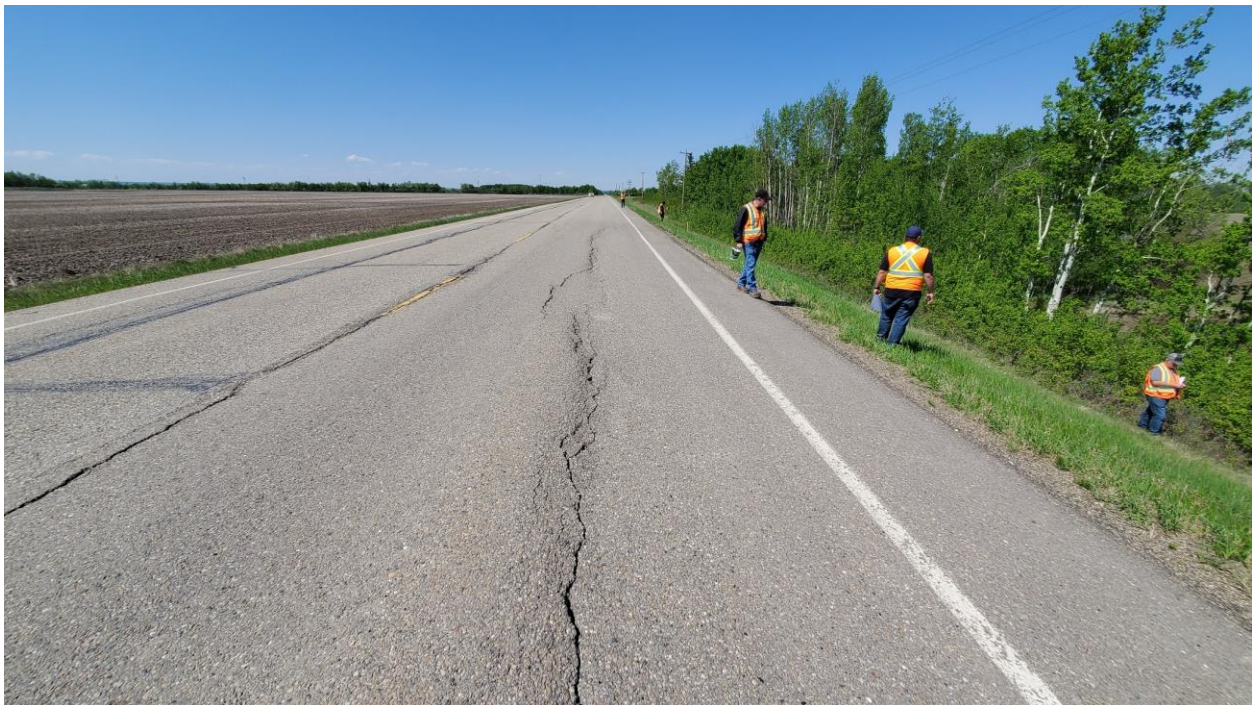
Photo 4 – Looking west at the central portion of the crack forming in the area of distress.

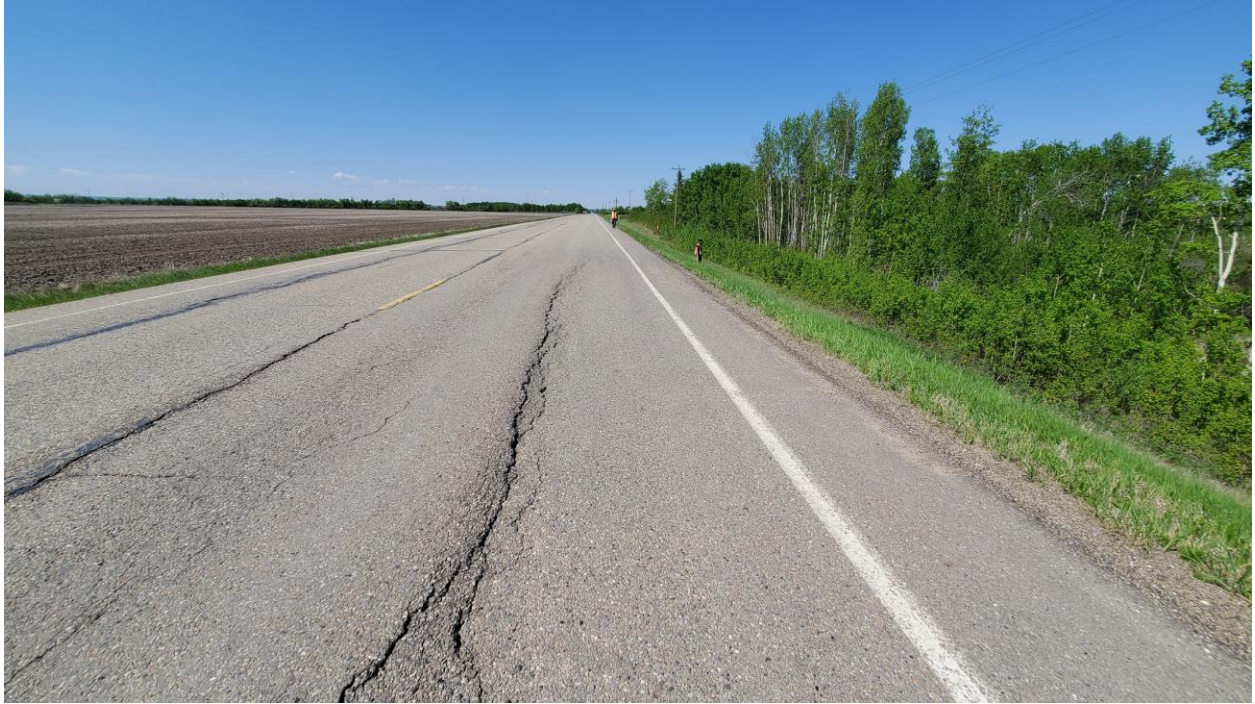
Photo 5 – Looking west at the main crack (taken west of Photo 4).

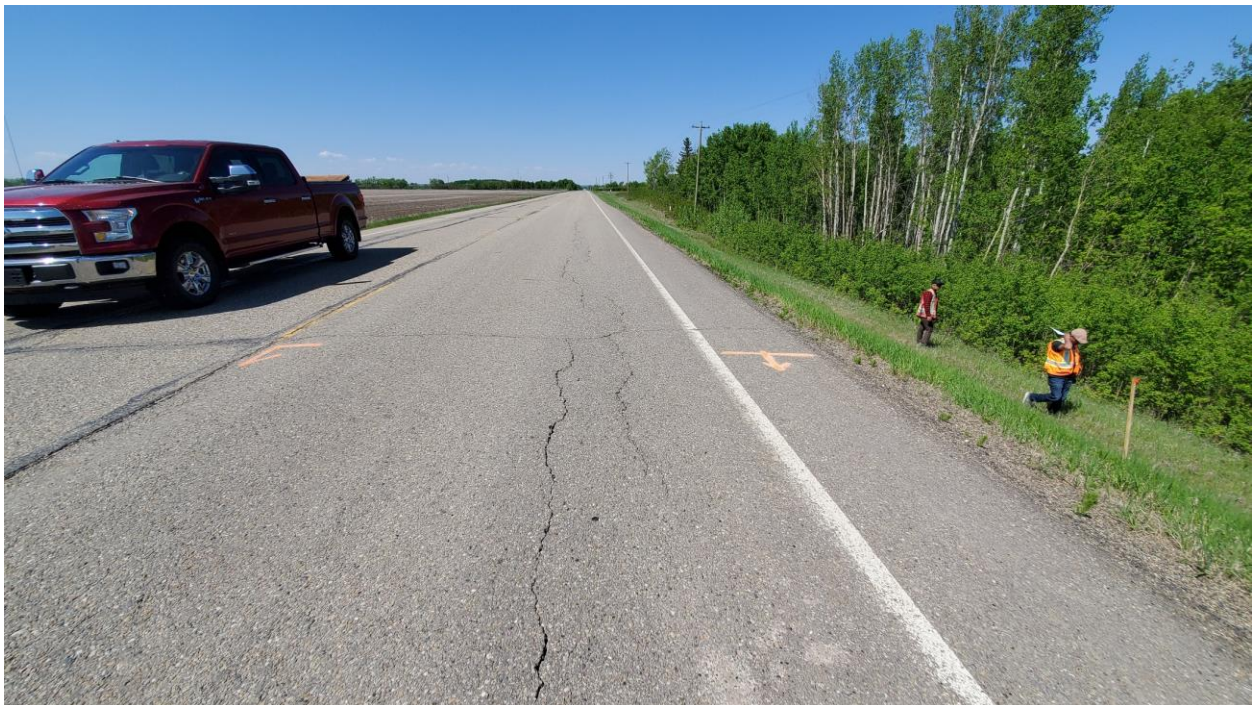
Photo 6 – Looking west at end of proposed patched and beyond the area of distress.

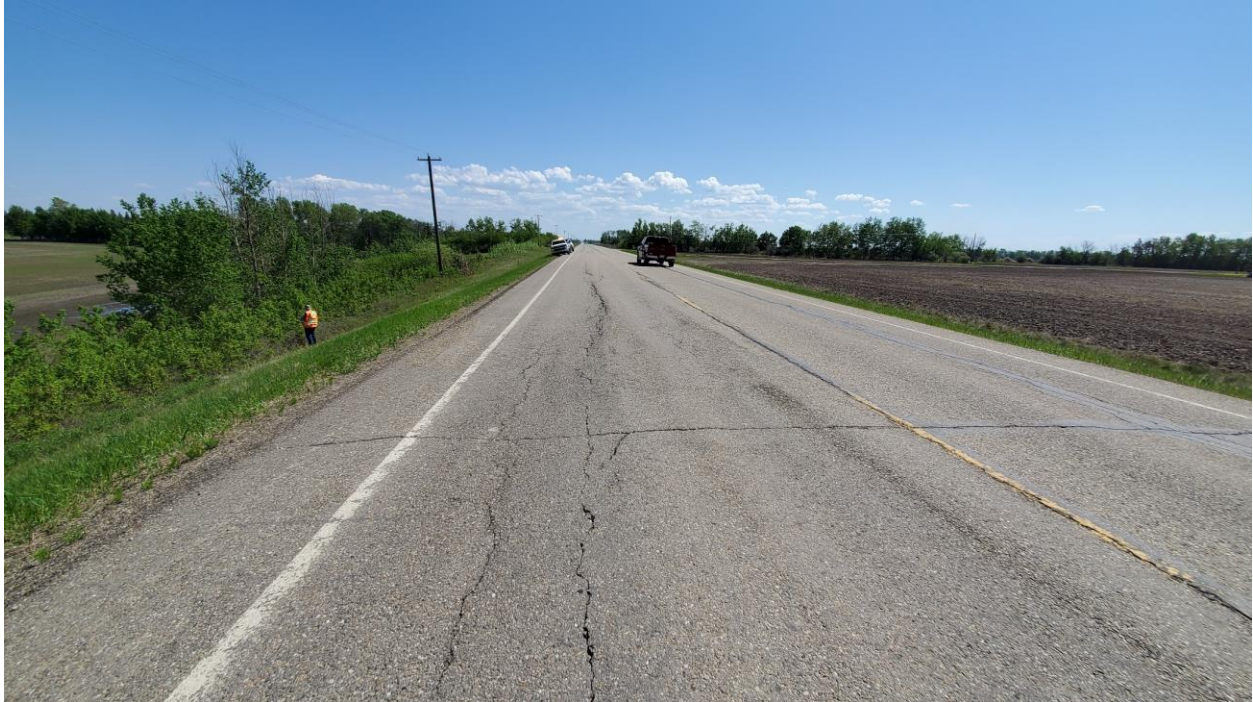
Photo 7 – Looking east from near the west end of the area of distress.

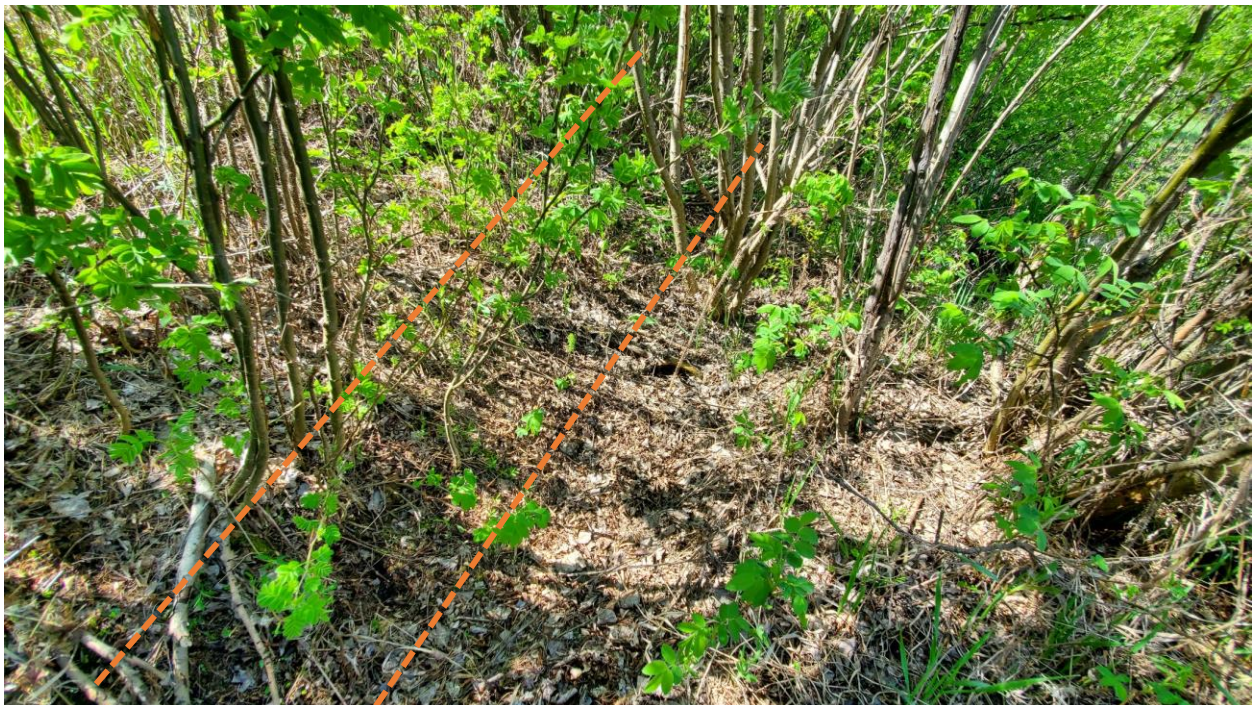
Photo 8 – Possible toe roll below the area of distress.

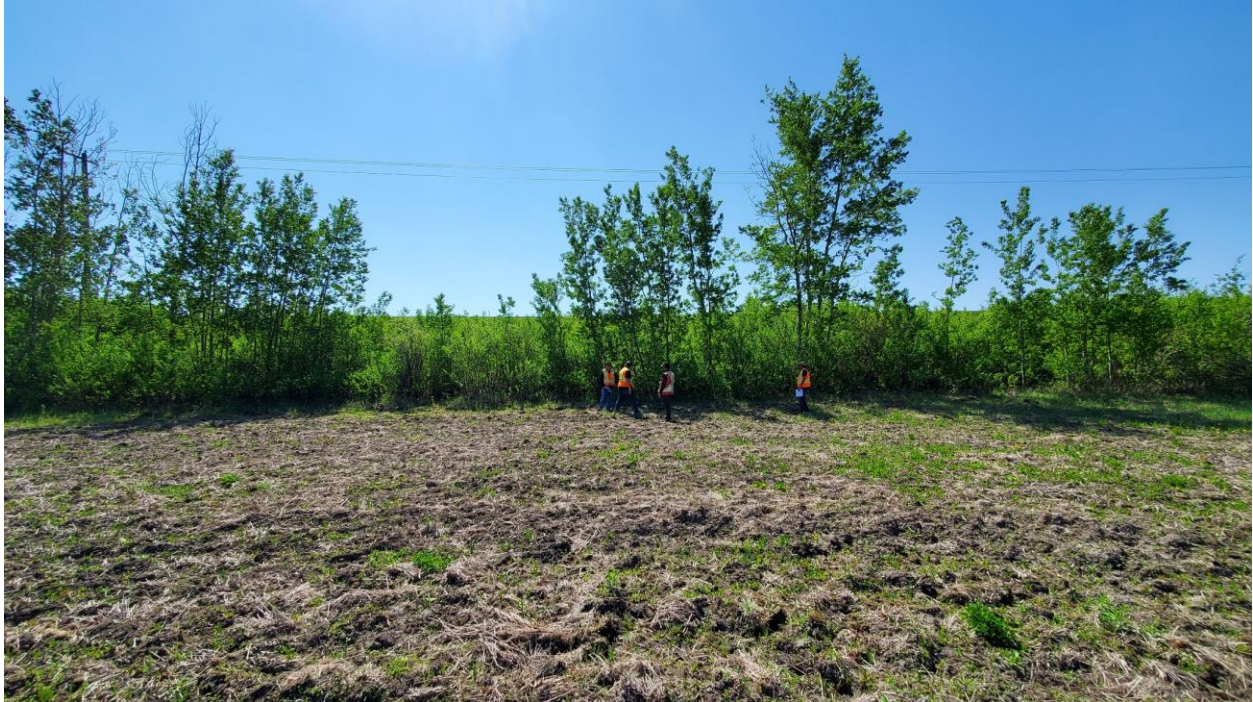
Photo 9 – Looking south at the meander bend scar slope with overhead powerline and the highway beyond.

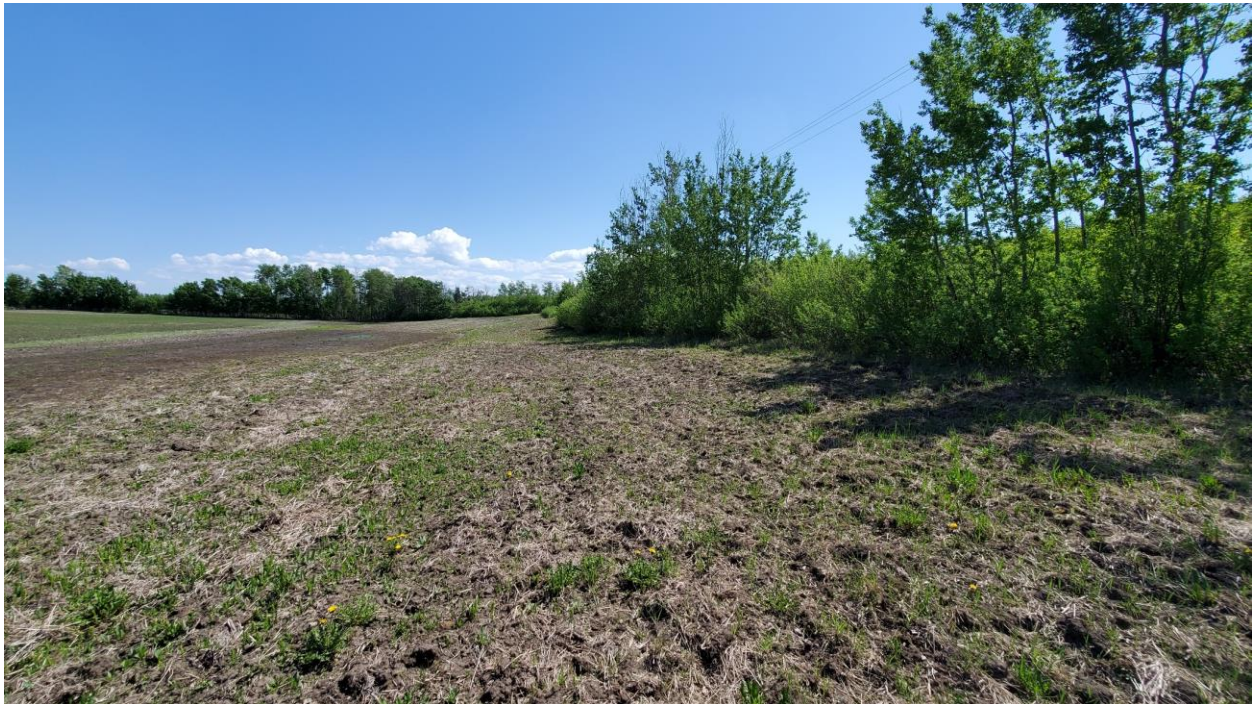
Photo 10 – Looking east along the toe of the slope.
