**ALBERTA TRANSPORTATION AND  
ECONOMIC CORRIDORS  
GEOHAZARD ASSESSMENT PROGRAM  
PEACE REGION – PEACE RIVER DISTRICT  
2024 INSPECTION**

Site Number	Location	Name	Hwy	km
PH091	East of Manning	Embankment Settlement East of Manning	691:02	4.2
Legal Description		UTM Co-ordinates		
SW-25-91-23-W5		11U N 6,308,105	E 465,862

**HWY 691:02 km 4.14-4.18  
PH091: 4 km EAST OF MANNING, ALBERTA  
2024 SITE INSPECTION PLAN**

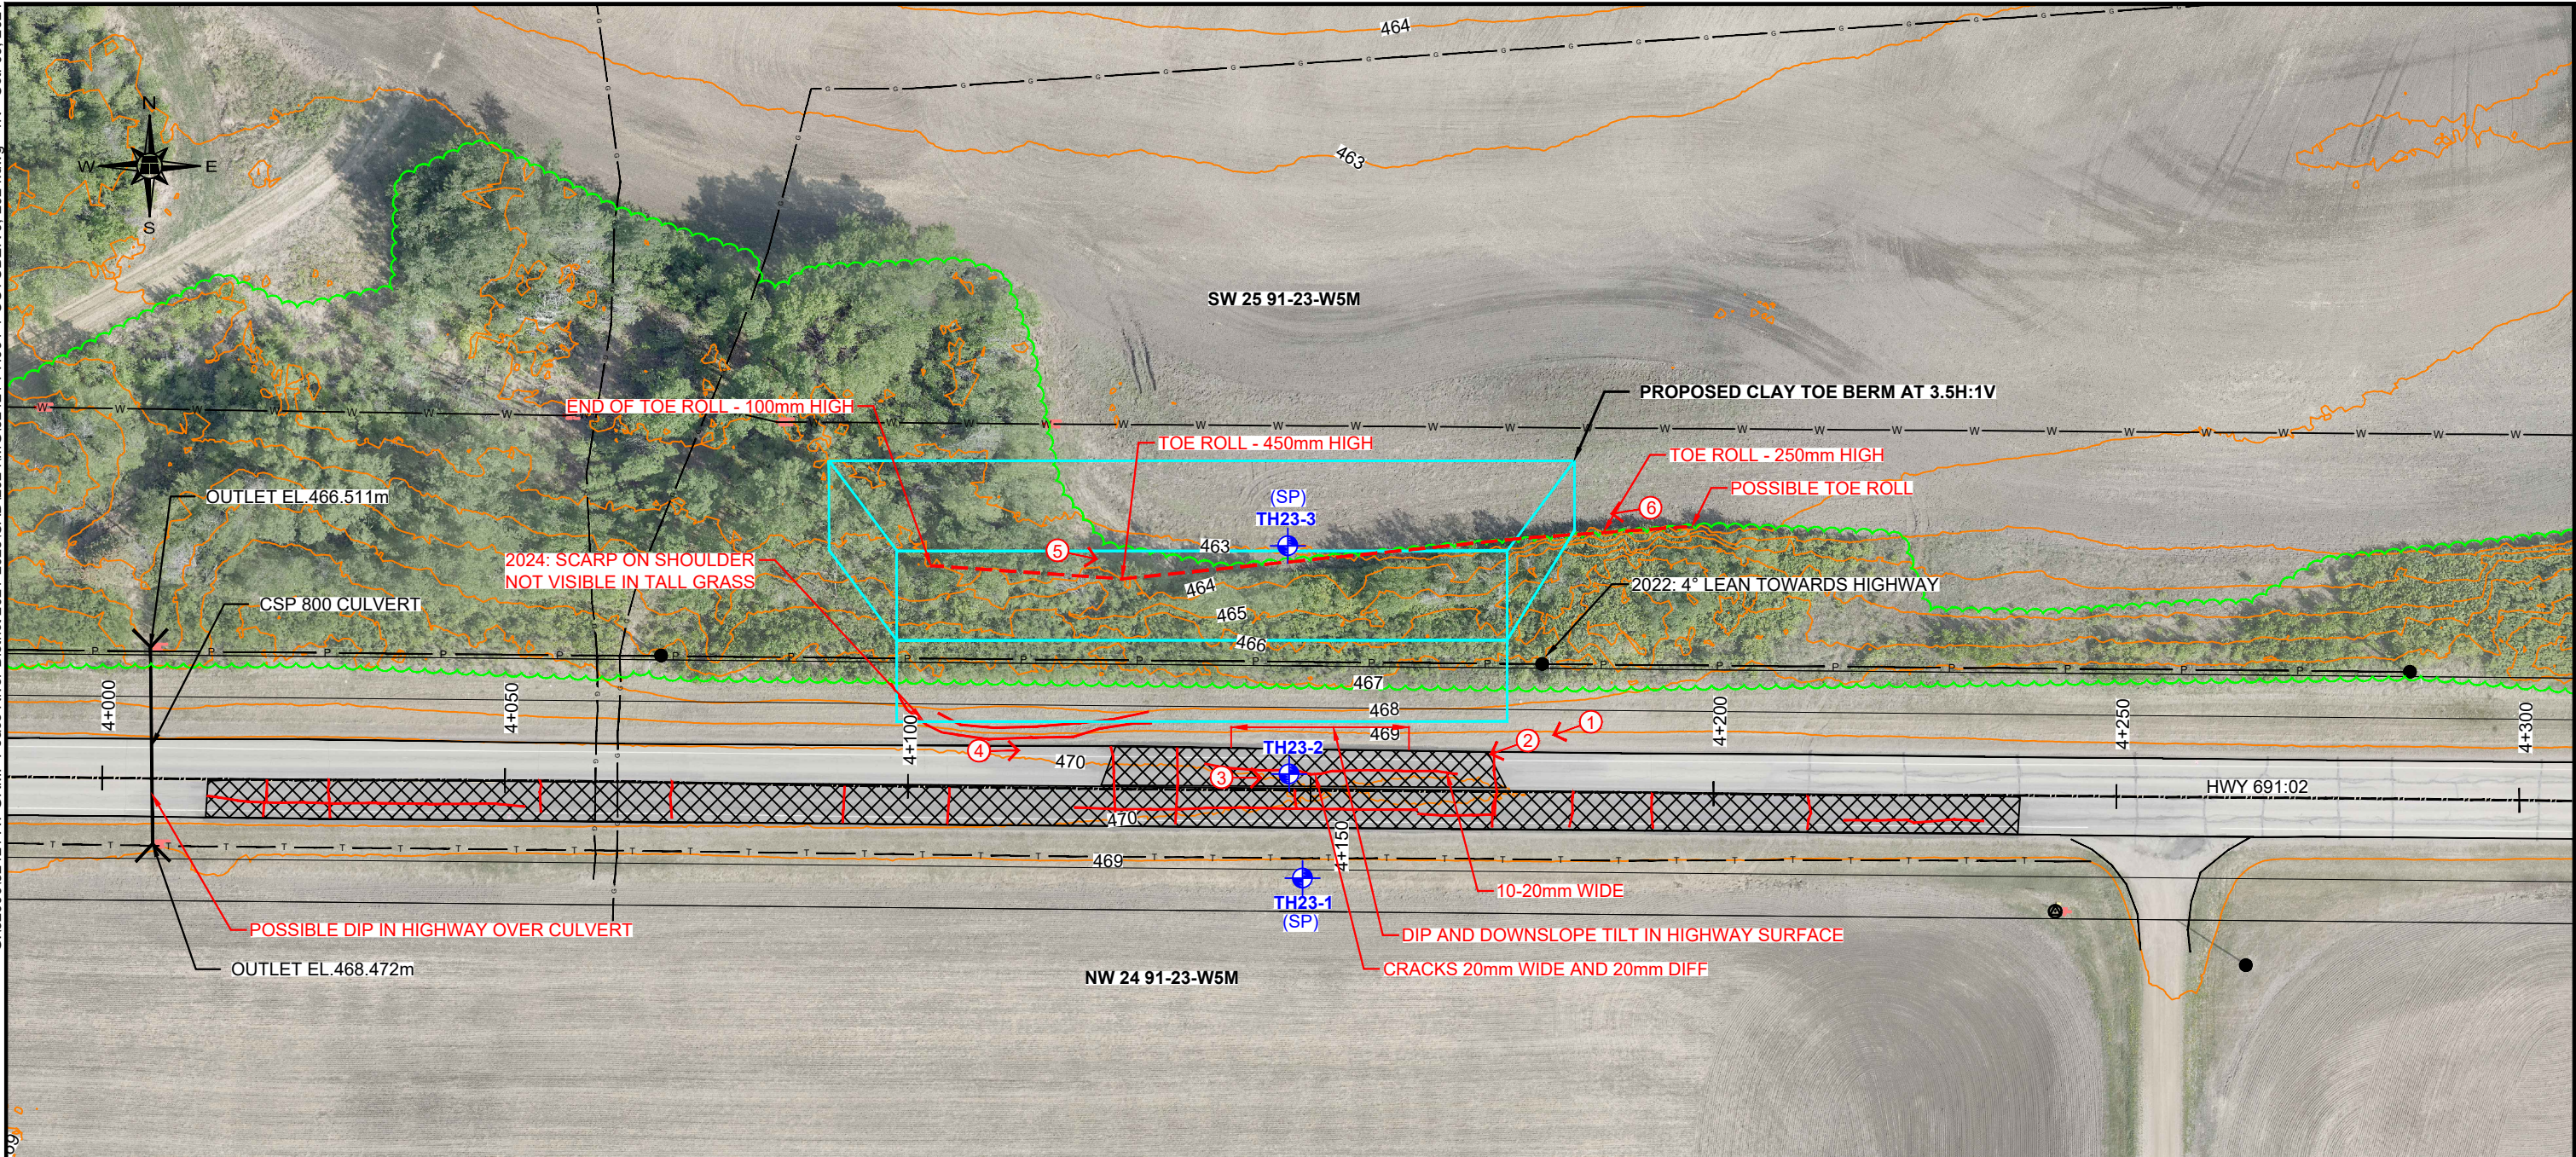
**DWG No. 32121-PH091-1**

<b>Primary Site Issue:</b>	Landslide affects the 7 m high north sideslope of the highway embankment, causing distortion and distress on the highway pavement.		
<b>Dimensions:</b>	The landslide is about 50 m wide (on highway) with an embankment fill height of 7 m on north sideslope. The depth of the landslide is estimated at 4 to 5 m BGS based on slope stability back analysis results.		
<b>Date of Remediation:</b>	None. Preliminary design report completed in November 29, 2023. Detailed design of a toe berm buttress is in progress to address the issues at this site.		
<b>Maintenance:</b>	2017: Highway Patching 2022: Highway Patching 2024: Highway Patching (July)		
<b>Observations:</b>	<b>Description</b>	<b>Worsened?</b>	
<input checked="" type="checkbox"/> Pavement Distress	The main crack pattern has resurfaced after the 2022 patch.	<input checked="" type="checkbox"/>	
<input checked="" type="checkbox"/> Slope Movement	The site was visited in 2023 and cracks and a slight bulge in the north sideslope west of the zone of distress on the pavement. A toe roll was confirmed in 2024 and had increased in height from 2023 observations.	<input checked="" type="checkbox"/>

We understand that this site will be remediated as part of the HWY 691:02 overlay contract tentatively scheduled for 2025. We recommend proceeding with the detailed design for this landslide repair. The preliminary design indicated construction of a toe berm that is 13.5 m wide and 4.5 m high at 3.5H:1V inclination would be required.

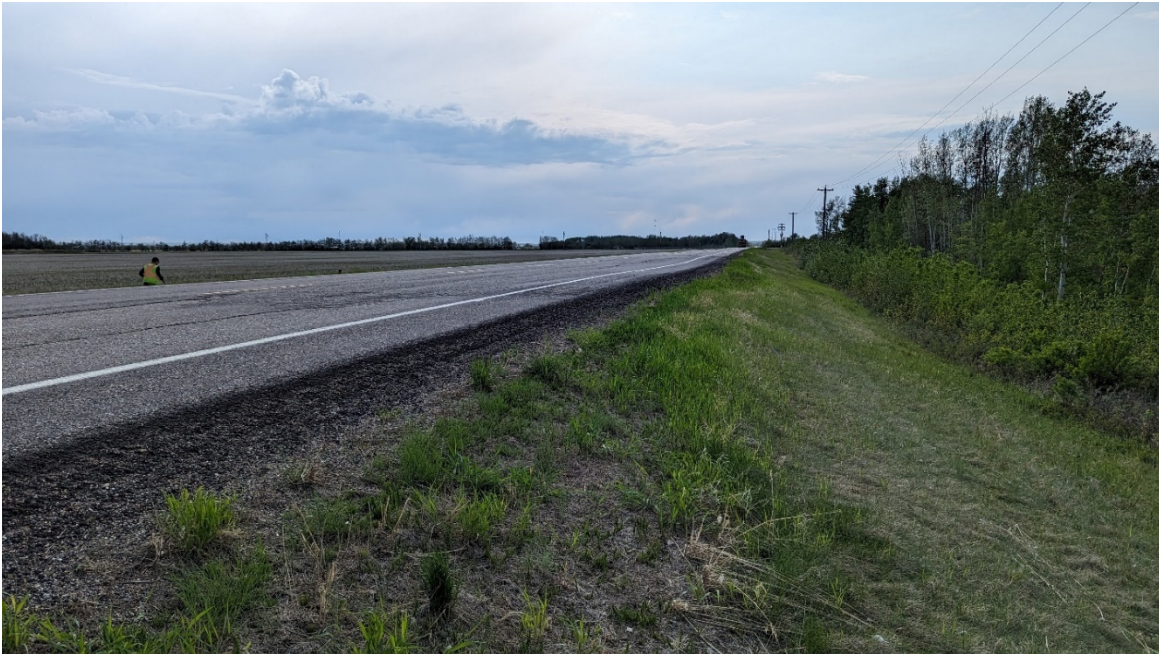
At the time of the callout inspection, the main crack pattern was located within a 50 m wide zone around km 4.15. The main crack was in the outer wheel path of the WBL and had an overall width that ranged from 150 mm to 200 mm, widths that ranged from 20 mm to 30 mm, and differential that ranged from 20 mm to 50 mm.

**Photo 1 – Looking west over distressed area where dip is visible in the roadway surface.**

Short-term road maintenance (patching and milling to provide a safe, smooth surface) should continue as required. Sealing of cracks on the road surface would assist in limiting the infiltration of water into the embankment.

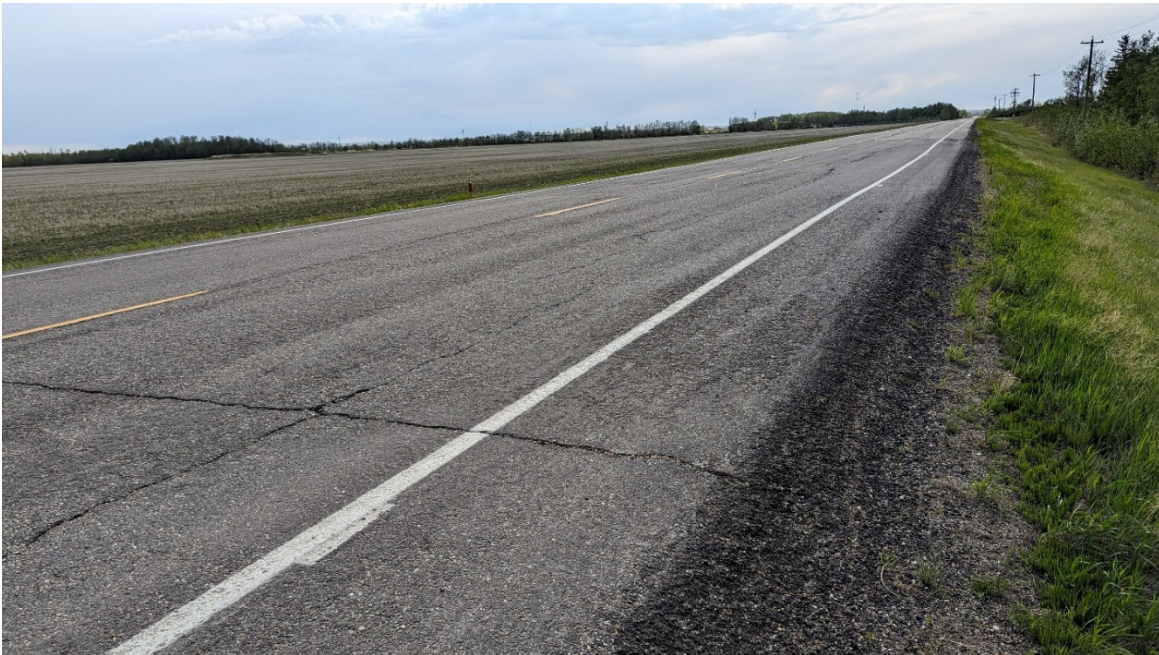
**Photo 2 – Looking west at distressed area.**

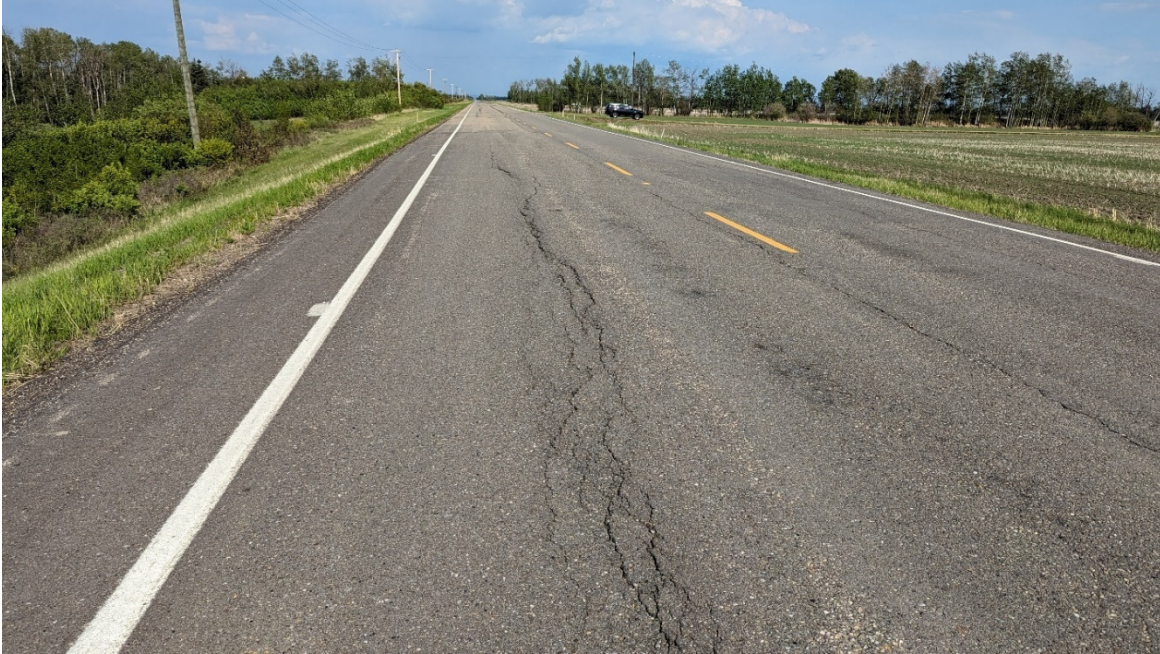
**Photo 3 – Looking east at the central portion of the crack forming in the area of distress.**

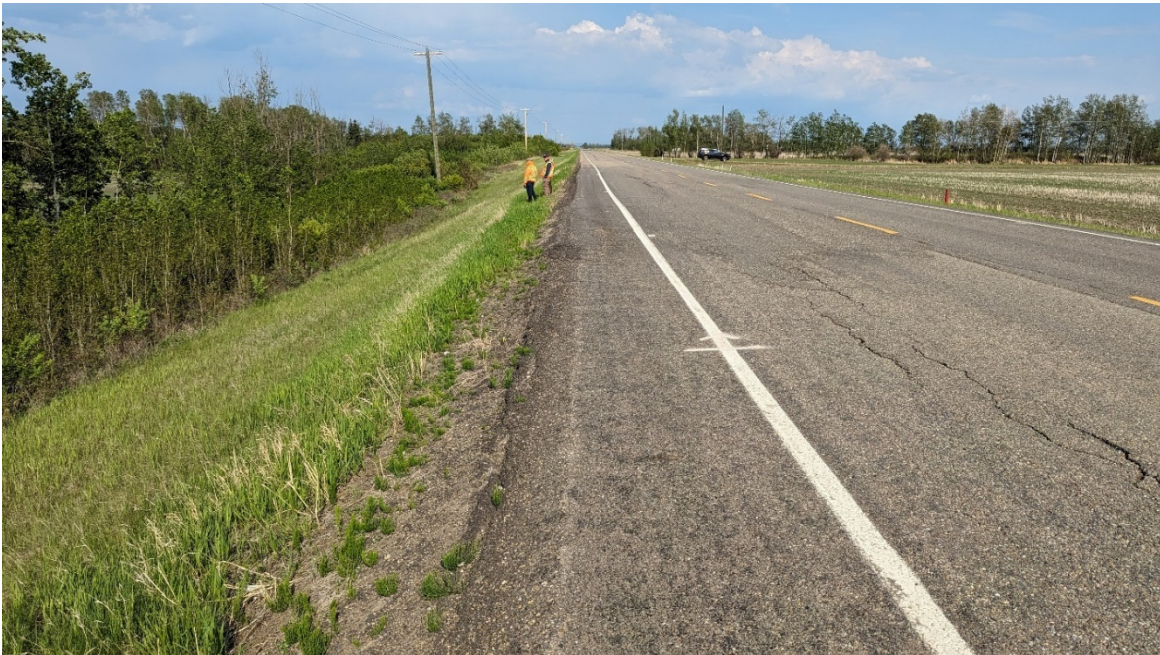
<b>Instrumentation: (Fall 2023)</b>	
Standpipe TH23-1 Standpipe TH23-3	Short term monitoring indicated that the groundwater table is about 1.2 m to 1.4 m below the existing ground surface.
<b>Assessment:</b>	
This site was patched 3 to 4 years ago (likely 2017 or earlier) when the distress appeared to be rutting in the outer wheel path of the west-bound lane (WBL). However, the “rutting” has increased in extents to the center of the lane indicating there might be a landslide occurring. The site was scheduled for additional patching in the summer of 2022 to maintain a safe traveling surface. The MCI requested a

**Photo 4 – Looking east from past the previously patched area.**

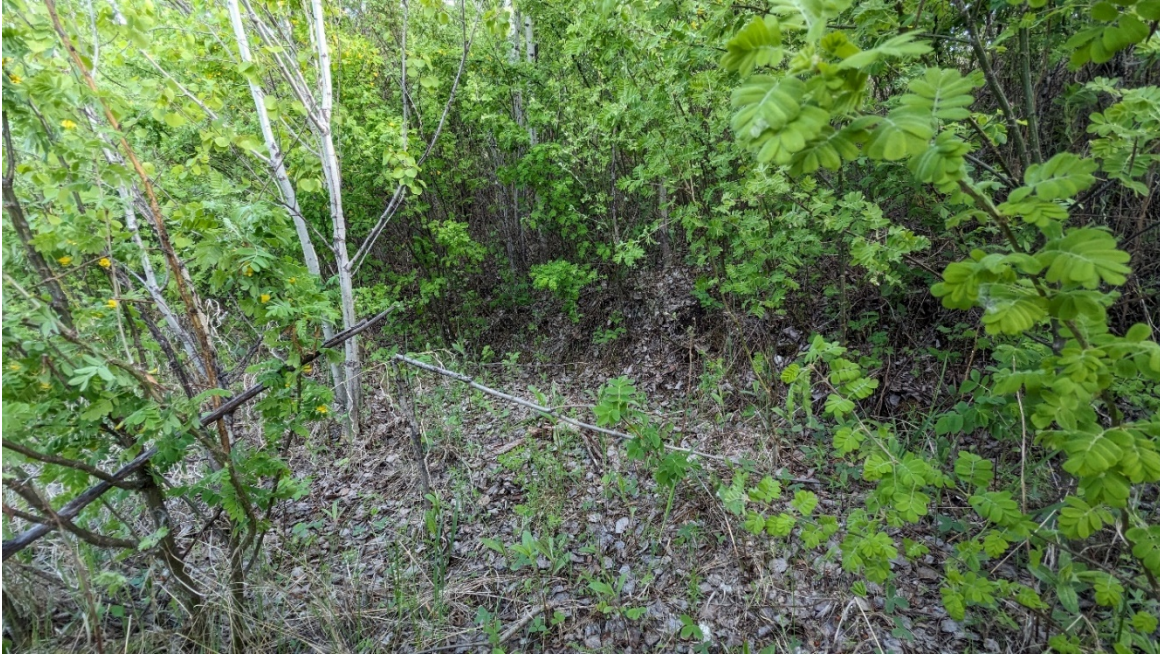
During the callout, observations at the toe of the slope noted a potential toe roll at the level of the adjacent field, although thick bush somewhat obscured the slope. This possible toe roll was between 200 mm and 400 mm high and spanned a distance of about 50 m and was in line with the main crack noted on the highway. During the 2024 inspection, the toe roll was confirmed and was 100m to 450 mm high.

**Photo 5 – Observed toe roll below the area of distress.**

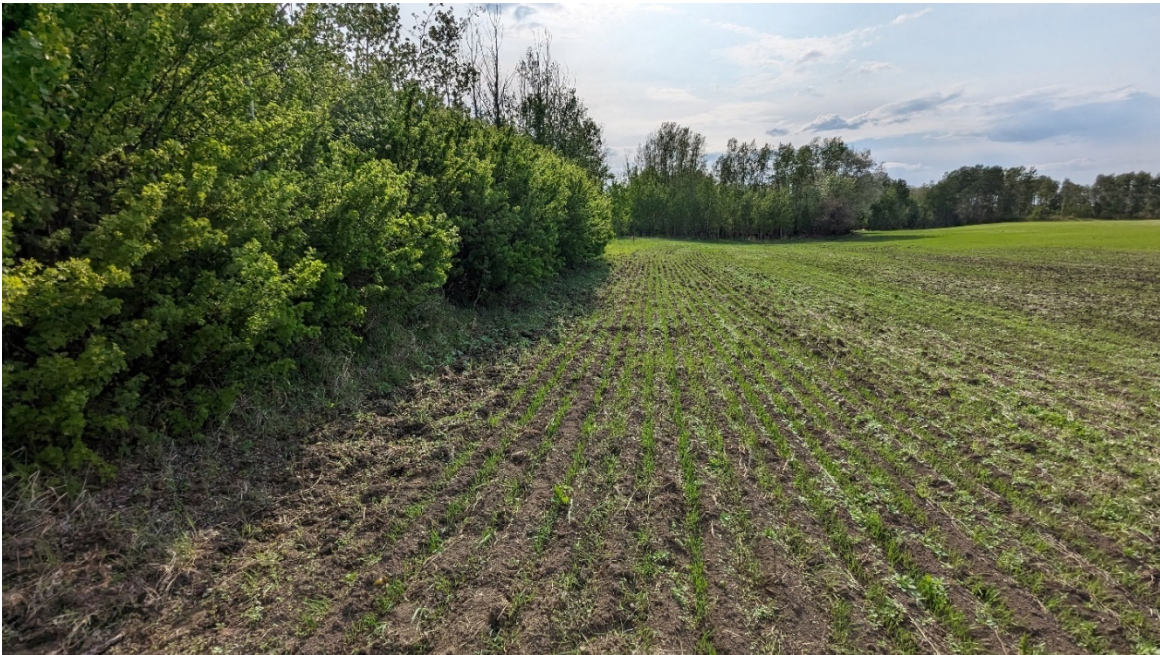
**Photo 6 – Looking west along the toe of the slope.**
