**ALBERTA TRANSPORTATION AND
ECONOMIC CORRIDORS
GEOHAZARD ASSESSMENT PROGRAM
PEACE REGION (PEACE RIVER DISTRICT)
2024 INSPECTION**

Site Number	Location	Name	Hwy	km
PH092-1	North of Manning	Gravina Creek	692:02	3.13-3.30
Legal Description		UTM Co-ordinates		
SW15-95-22-W5M		11 E 491,100	N	6,425,466

PH092: GRAVINA CREEK HWY 692:02 km 2.85 - km 3.30
2024 SITE INSPECTION PLAN

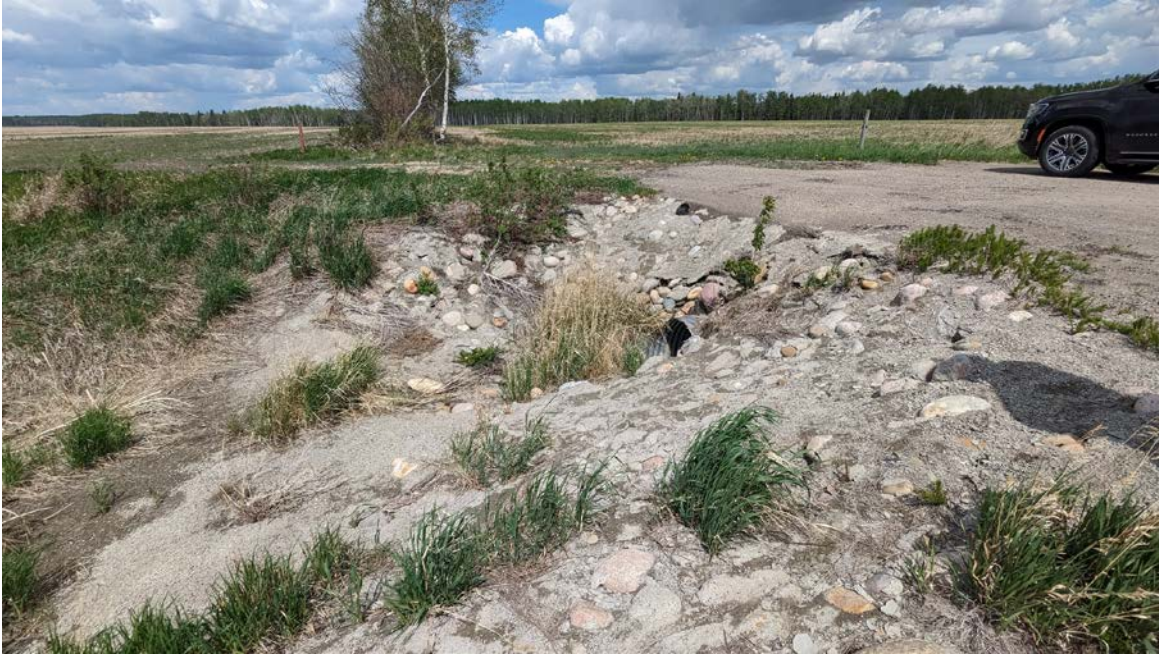
The flow in this ditch also resulted in the approach culvert at km 2.845 washing out in 2018. The approach was rebuilt, paved (to increase erosion resistance if overtopped again), and additional riprap placed. It was repaired again in the fall of 2021 when the culvert became plugged with displaced riprap. As part of this repair, the riprap at the culvert inlet was grouted in place. At the time of 2024 inspection, this approach and culvert appeared to be stable.

Photo 1 – Grouted riprap at inlet of culvert at km 2.845 approach.

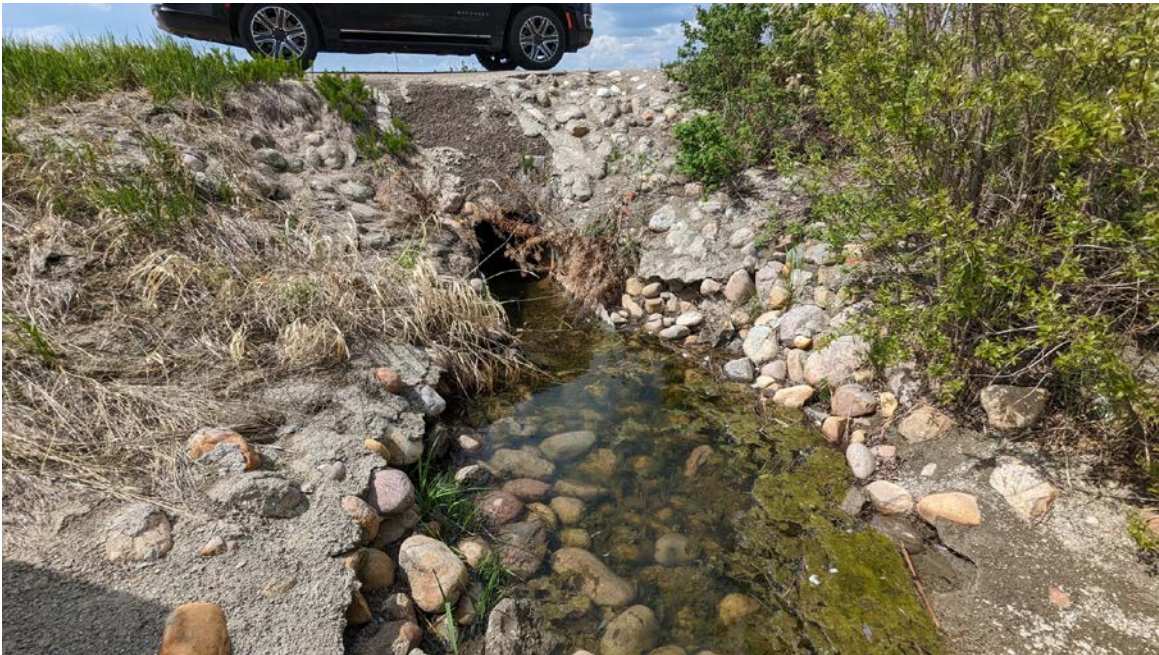
Photo 2 – Standing water at outlet of culvert at km 2.845 approach.

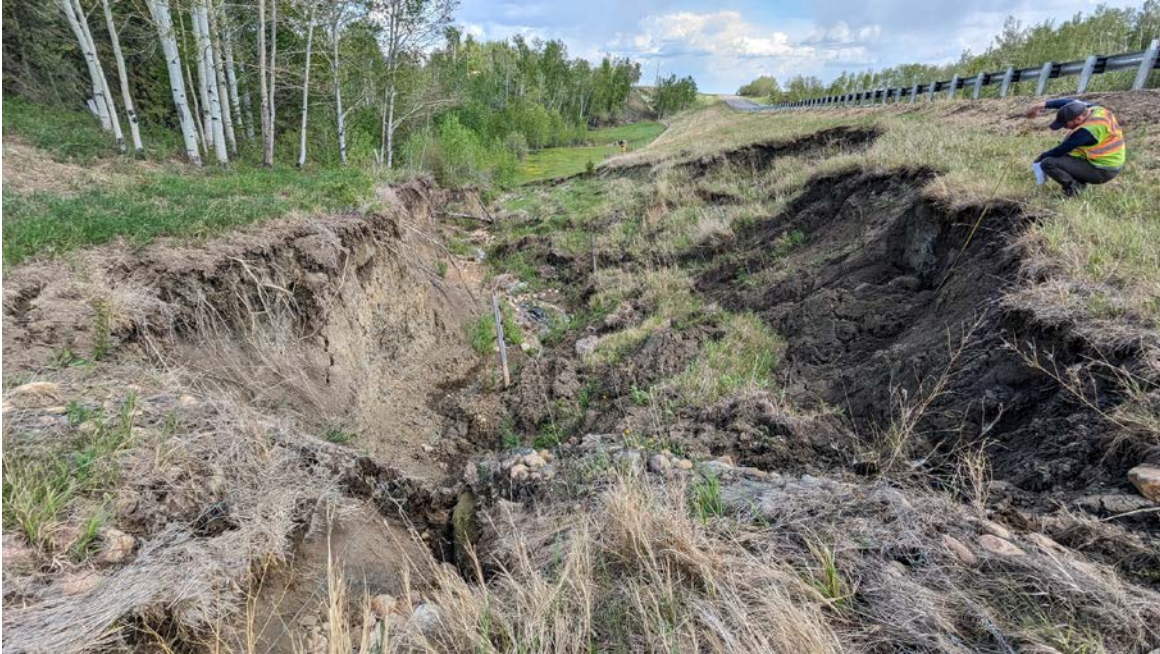
Photo 3 – Looking east at start of erosion gully in northwest corner of the highway embankment.

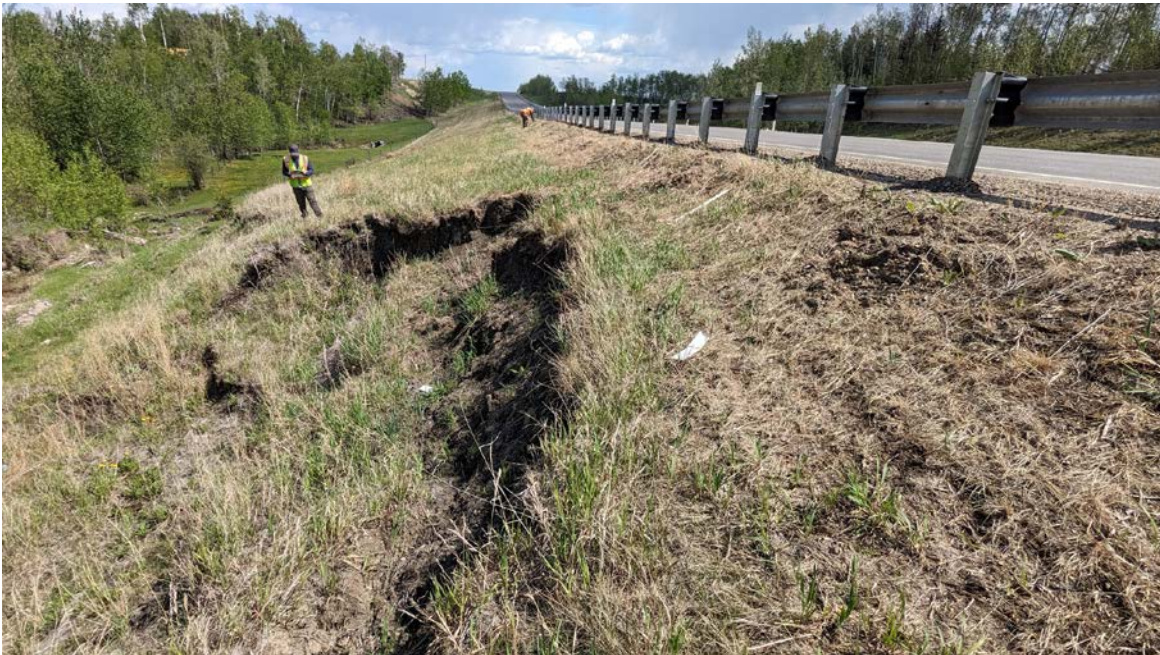
Primary Site Issue:	Deep, wide, and actively enlarging erosion gully adjacent to the highway embankment is destabilizing the embankment.	
Dimensions:	The erosion gully is about 70 m long, 20 m wide and up to 4 m deep.	
Date of Remediation:	None	
Maintenance:	2018: Approach and culvert at km 2.845 replaced and paved 2021: Riprap replaced and grouted at km 2.845 (see Photos 1 and 2)	
Observations:	Description	Worsened?
<input type="checkbox"/> Pavement Distress	Highway overlaid in Fall 2023 including new strong-post guardrail installation.	<input type="checkbox"/>
<input checked="" type="checkbox"/> Slope Movement	Downcut of gully has caused shallow slides within the embankment fill above the erosion. The slides have retrogressed towards the highway at about 0.6 m to 0.7 m per year until about 2021.	<input type="checkbox"/>
<input checked="" type="checkbox"/> Erosion	Aggressive downcutting at NW corner of embankment fill at BF74654 has undermined gabion mattress that lined the ditch and transition slope along the fill and valley slope. The steep slope is now unprotected against erosive flows.	<input checked="" type="checkbox"/>

Photo 4 – Looking east where erosion gully slumping is closest to the highway.

- Routine monitoring by MCI or Maintenance Contractor to confirm that the erosion and embankment deterioration has not undermined the guardrail or the highway. This will be particularly important during the spring snow melt.

- Detailed design is underway to reconstruct the ditch and install new erosion control measures.

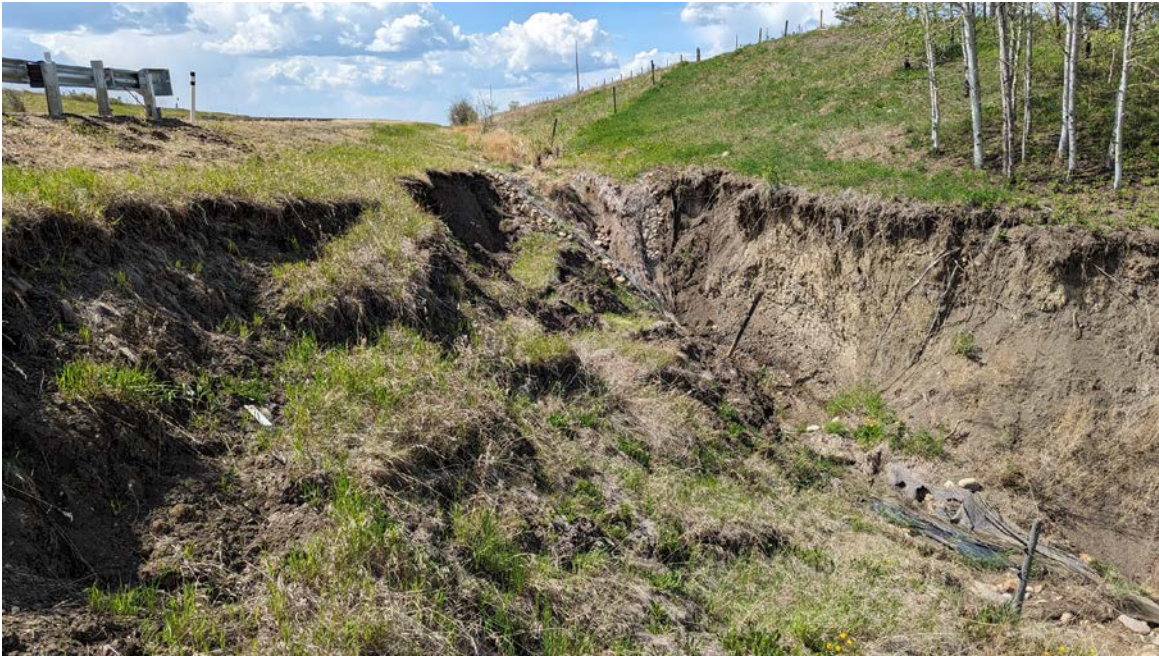
Photo 5 – Looking west at the nick point at the top of the erosion gully where the damaged gabion mattress and underlying nonwoven geotextile is exposed.

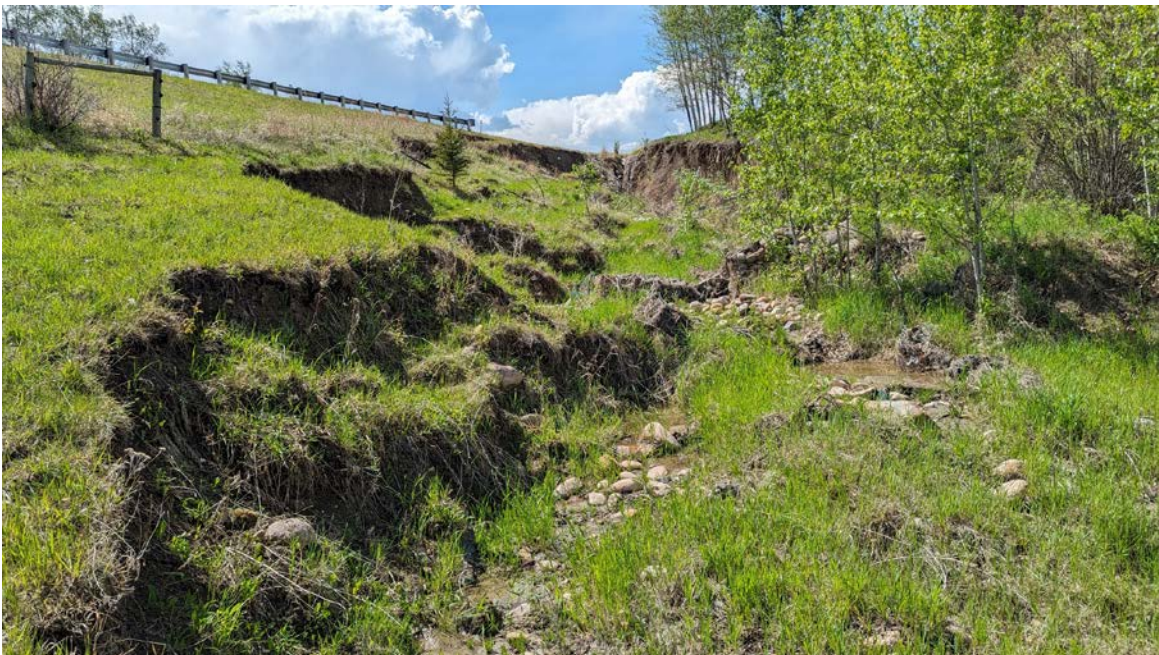
Photo 6 – Looking west near the bottom of the fill where remnants of a gabion basket check dam are visible on the right-hand side of the photo.

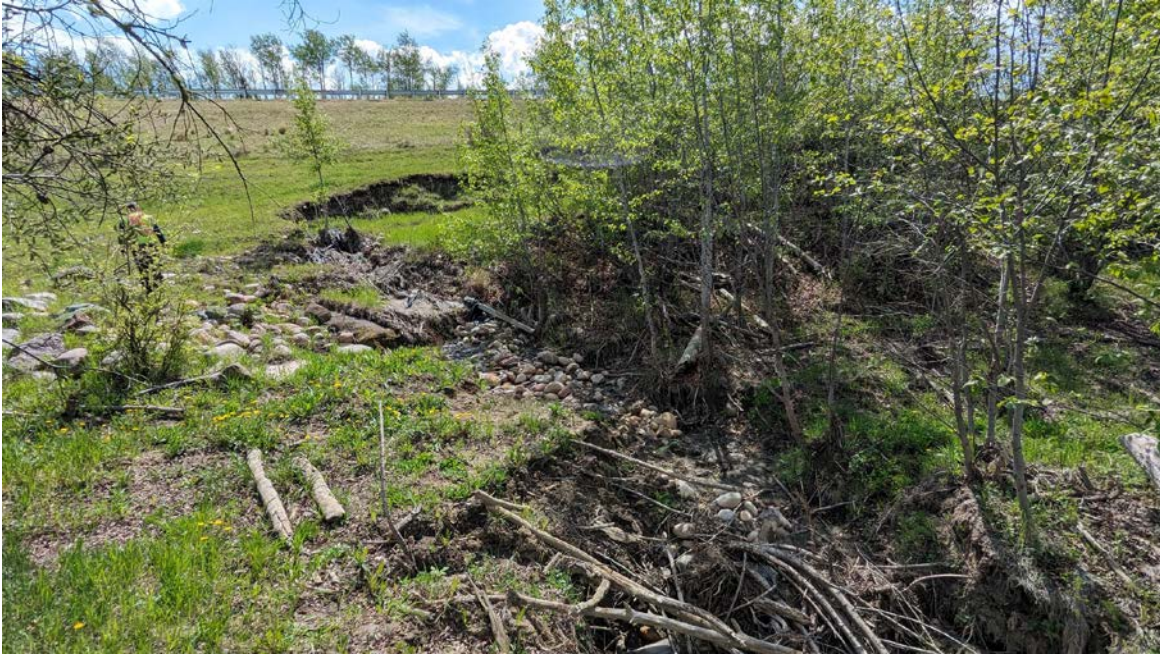
Photo 7 – Looking south where the erosion gully discharges into Gravina Creek.

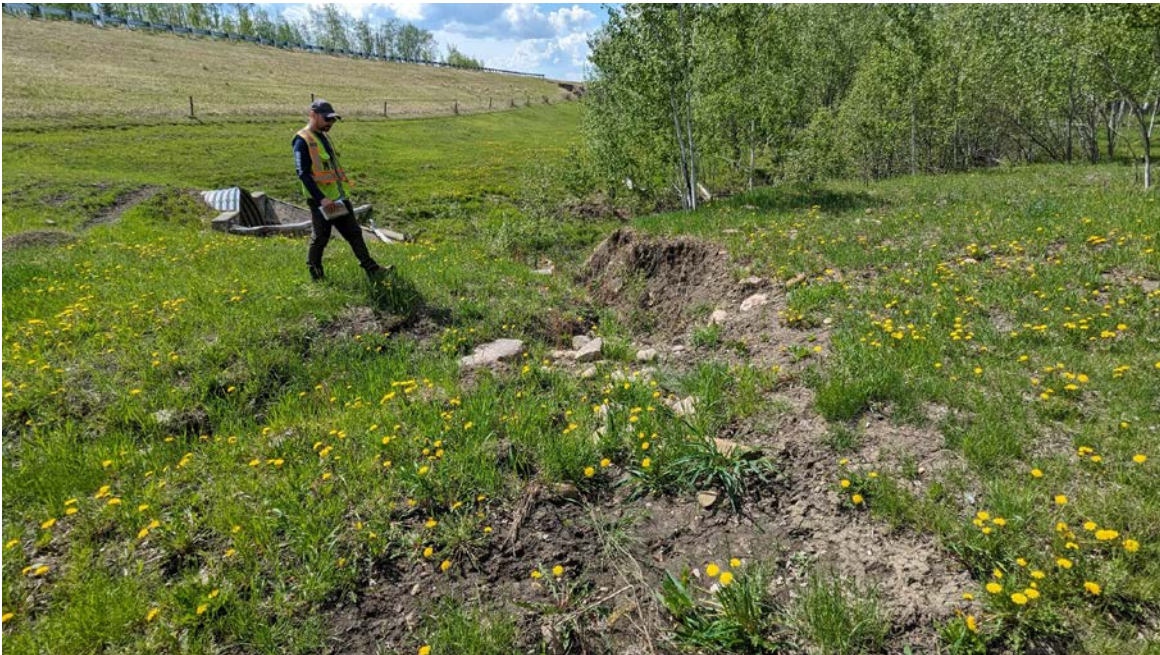
At the time of the call-out in 2022, Mr. Kurz, the Maintenance Contract Inspector (MCI) for the area, reported that the slumping of the highway embankment had not gotten worse since 2021. The conditions observed in 2024 also noted that there had not been significant retrogression of the erosion features to the west or south. The locations of the edges of the erosion gully were noted for future reference. Comparisons to the 2022 call-out were difficult as grading and guardrail replaced had occurred since then. An erosion gully was noted near the inlet of the Bridge File culvert which had not be observed in 2022.

Photo 8 – Looking west at the erosion gully forming near the BF culvert inlet.

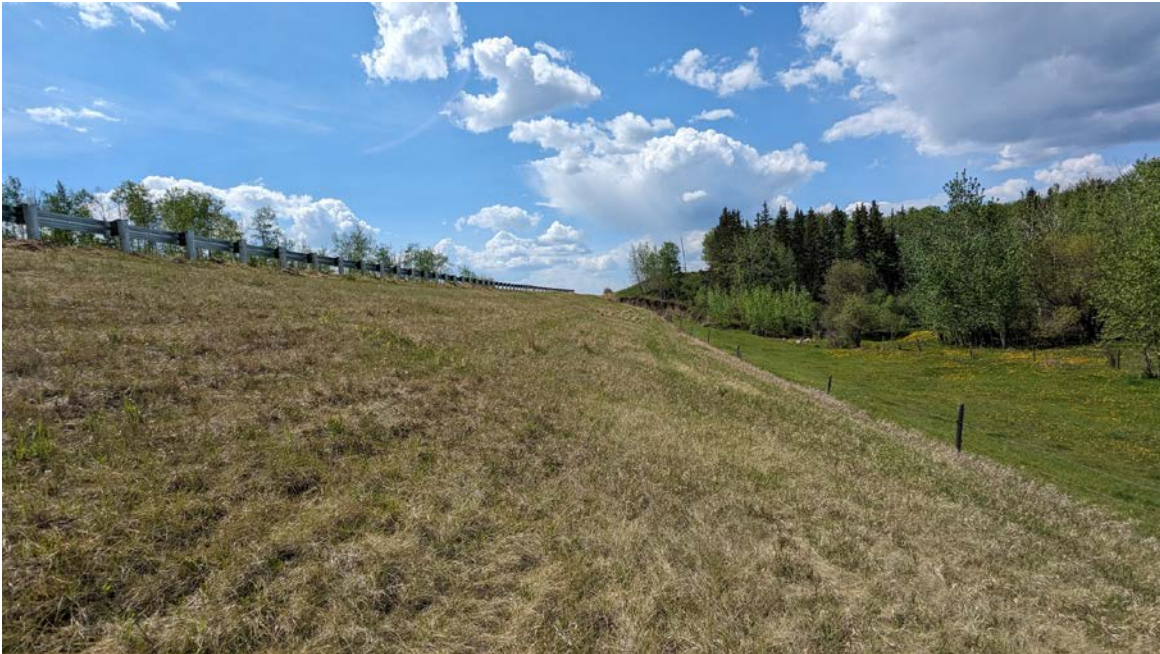
Photo 9 – Looking west along the north slope of the highway embankment fill which shows no evidence of slumping.

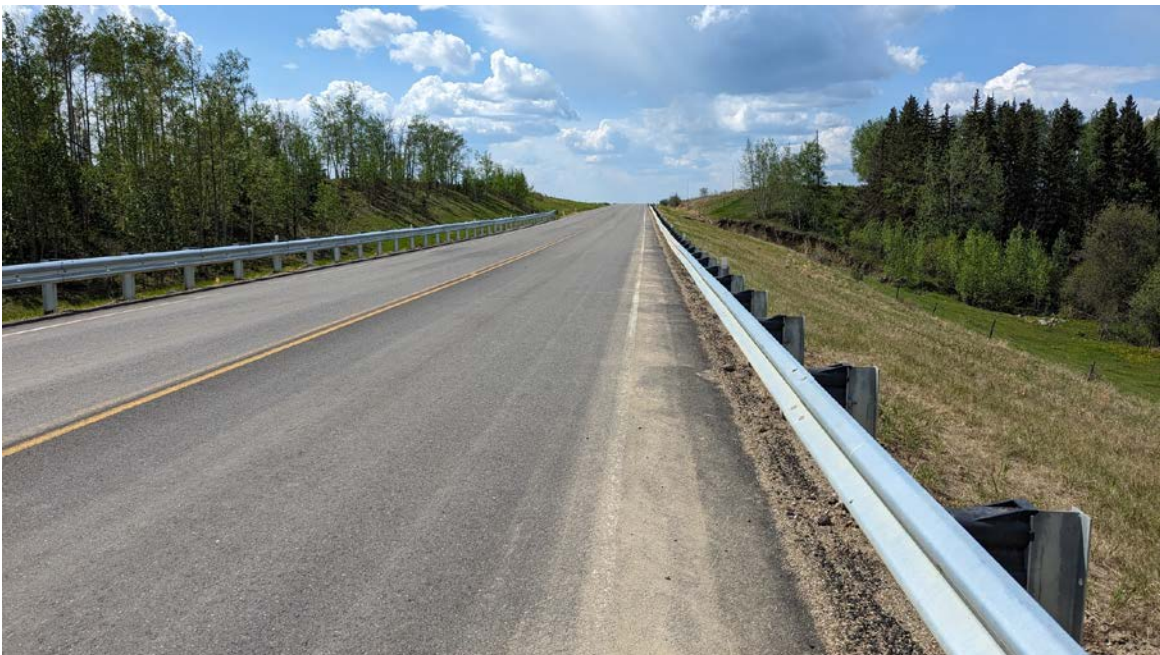
Photo 10 – Similarly, there was no evidence of slumping visible through the recent highway overlay.
