July 12, 2023

**ALBERTA TRANSPORTATION AND ECONOMIC CORRIDORS GRMP (CON0022164)
PEACE REGION (PEACE RIVER DISTRICT)
INSTRUMENTATION MONITORING RESULTS – SPRING 2023**

SITE PH006: HWY 697:02, TOMPKINS LANDING

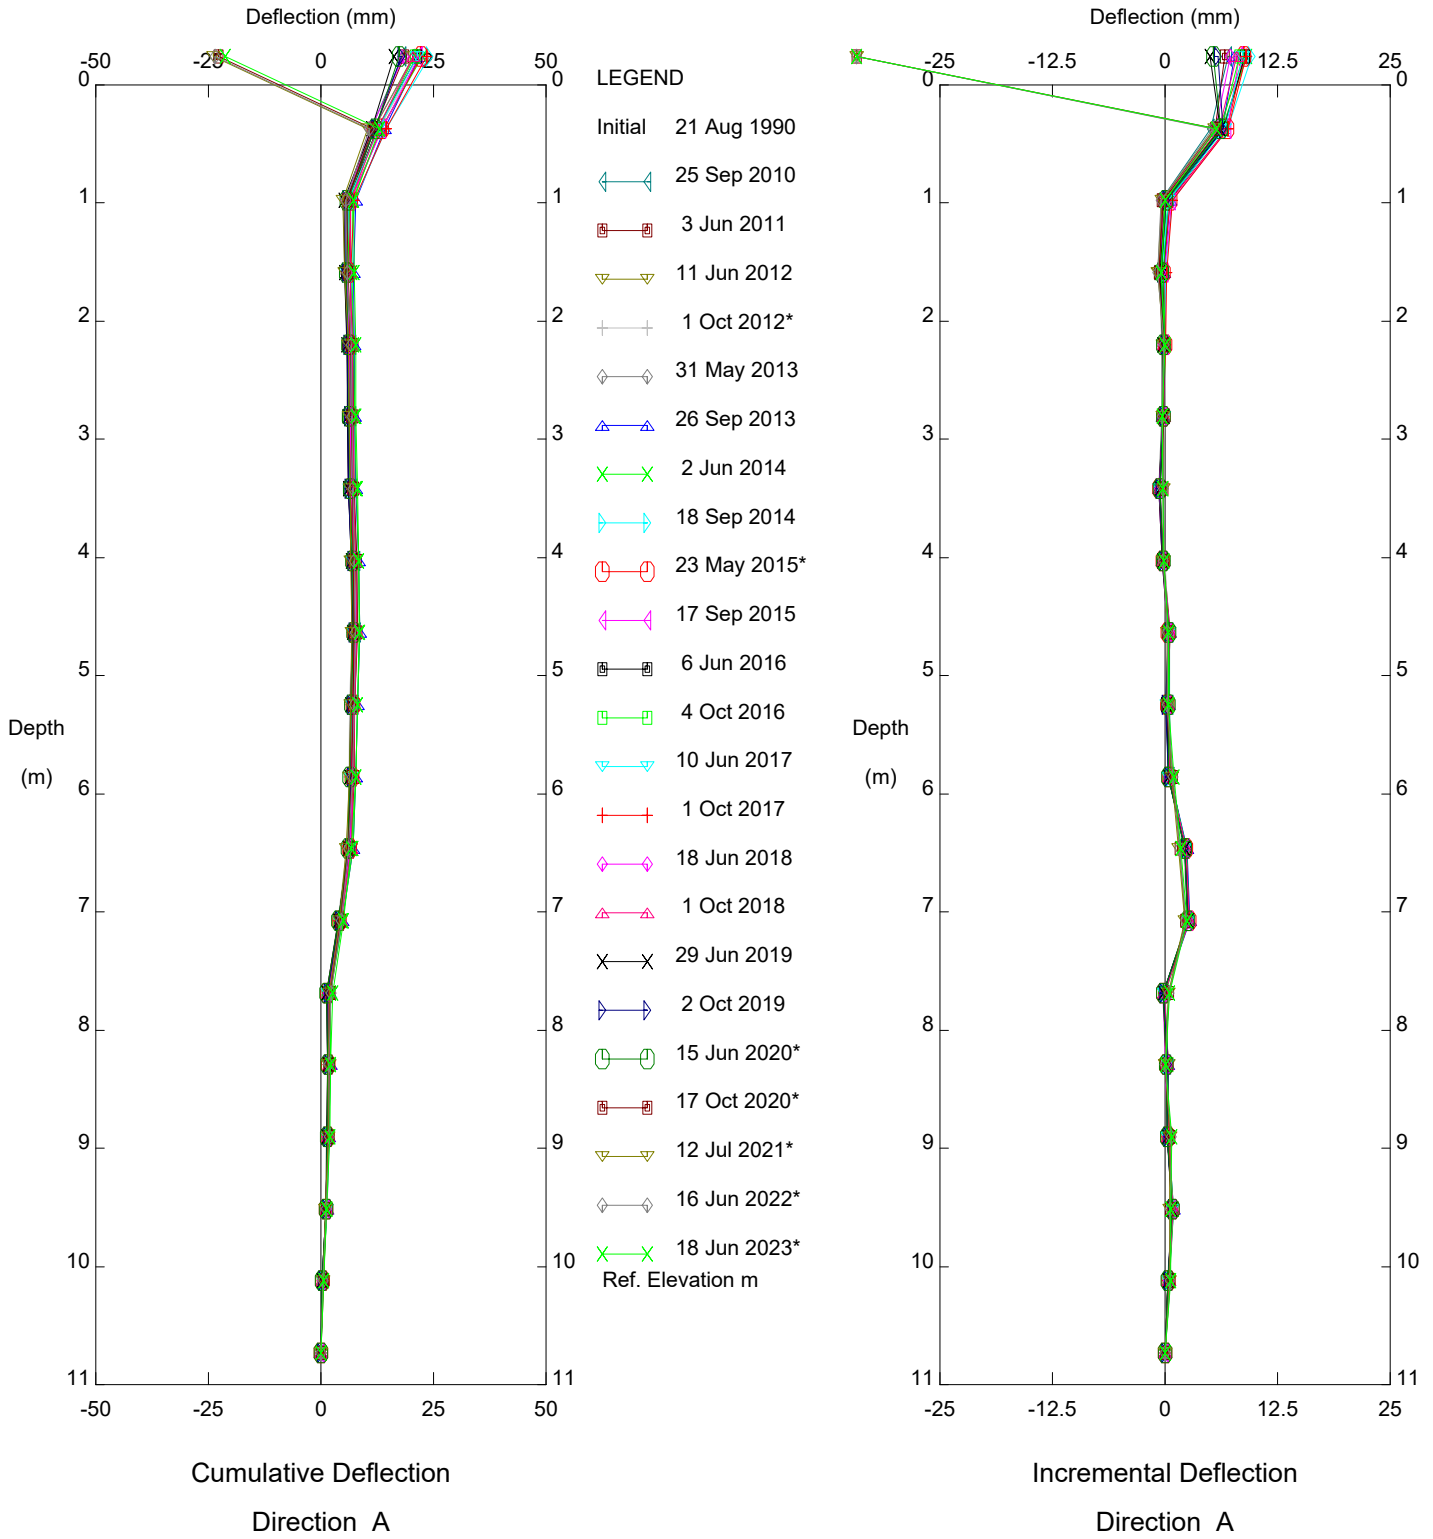
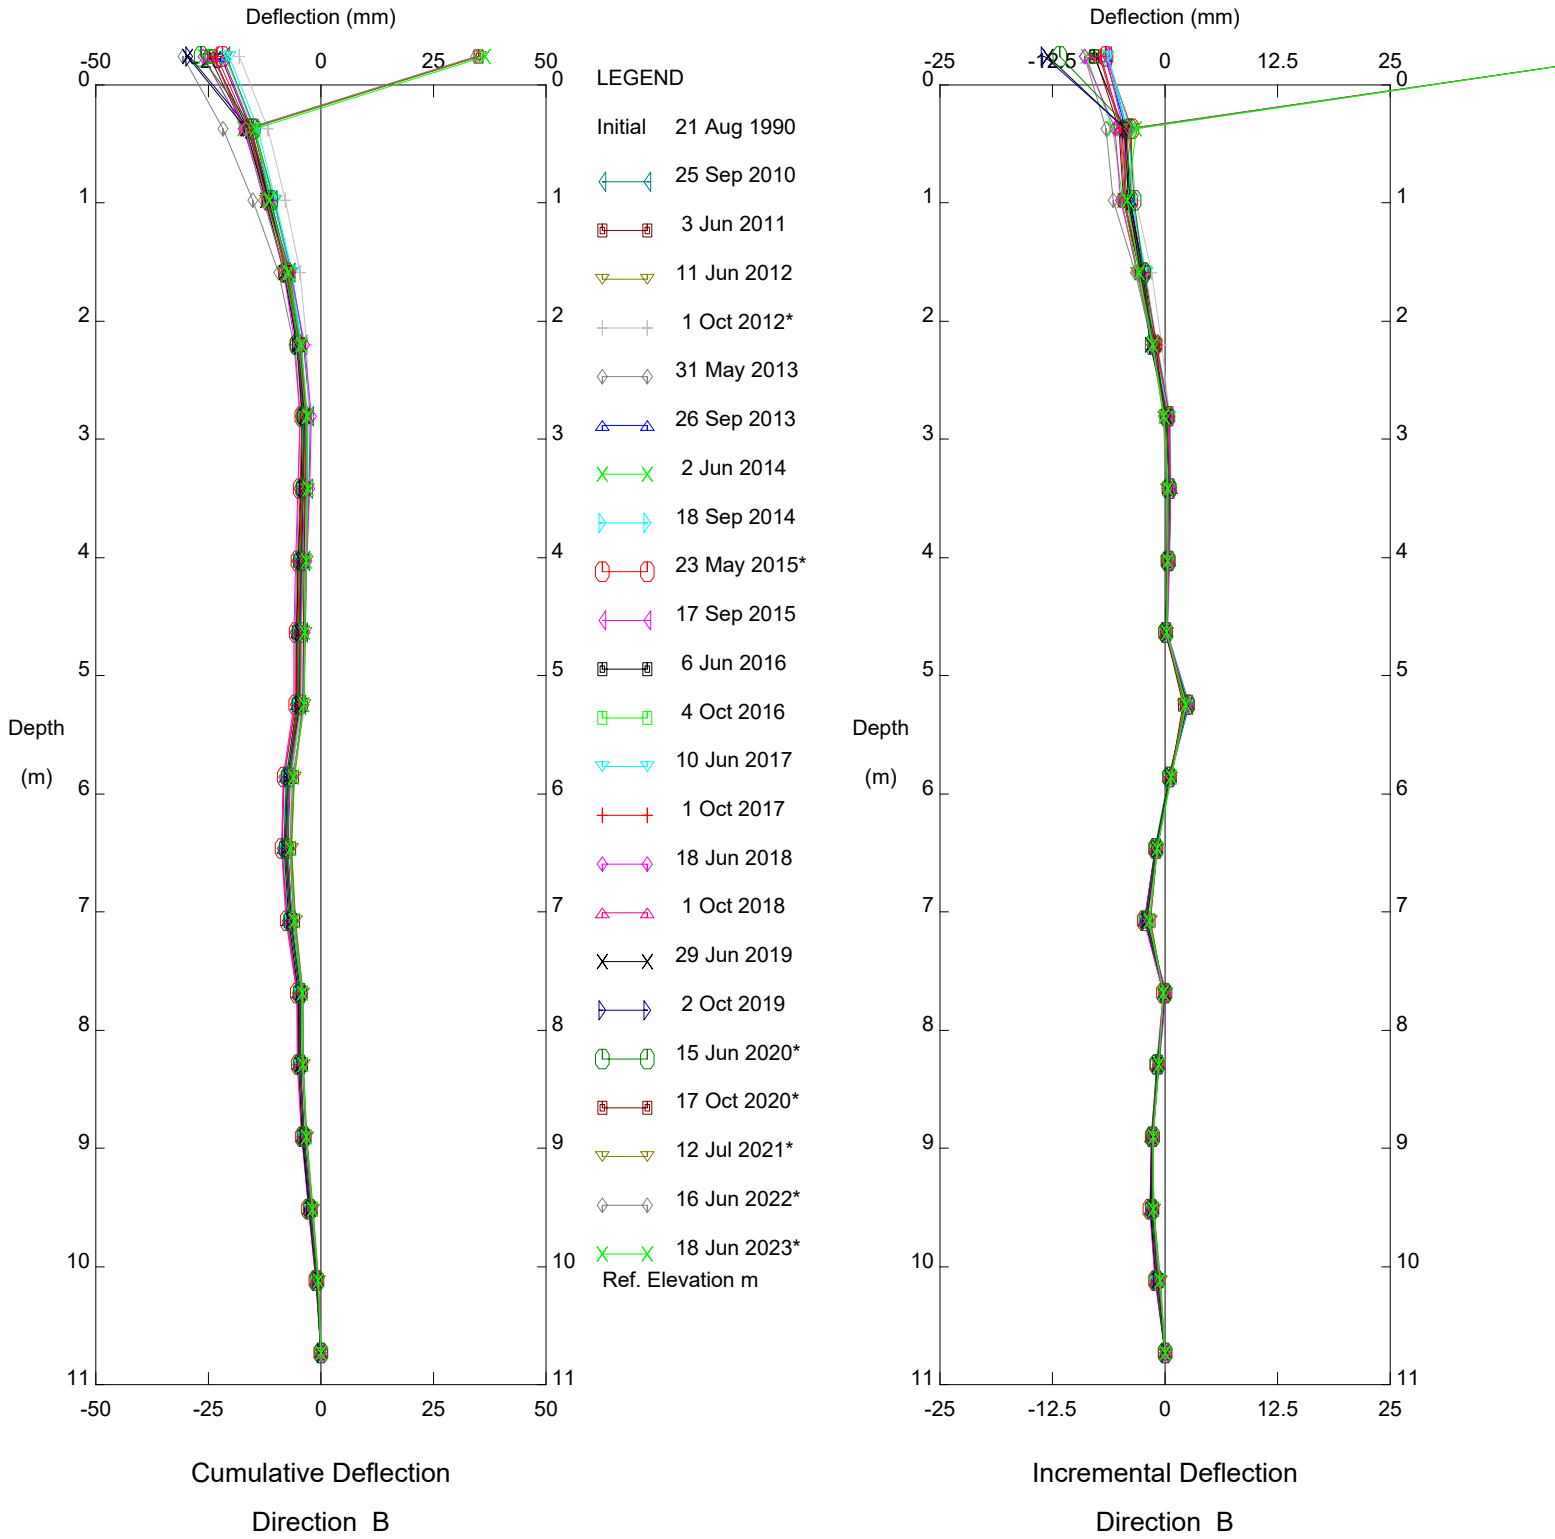
HWY 697:02 - STA. 17+360, Inclinometer SI-1

Three slope inclinometers (SI-1, SI-5 and SI-13) and one pneumatic piezometer (PN02-3) were read at the Hwy 697:02 Tompkins Landing site on June 18, 2023 by Mr. Niraj Regmi, G.I.T., and Mr. Omar Elshimi, both of Thurber Engineering Ltd. SI-1 has been damaged by a mower during the spring of 2020 readings, however it was still readable from the ground surface during the current reading cycle.

Slope inclinometer SI-1 continued to show no discernible movement. Both movement zones in SI-5 showed a rate of movement of 6.8 mm/yr over 0.1 m to 2.6 m depth, compared to the overall average rate (since initialization) of 3.1 mm/year. The lower zone at SI-5, over 2.6 m to 11.1 m depth, had a rate of movement of 18.1 mm/yr since the spring of 2022 readings. The overall rate (since installation in 1996) over this zone is 12.9 mm/year which includes the rapid movement occurred after the initialization of the SI. The trend since 2007 is 9.2 mm/yr; however, the rate of movement has accelerated starting in 2019 to 15.0 mm/yr. Slope inclinometer SI-13 showed a rate of movement of 36.0 mm/yr over 1.7 m to 14.5 m depth compared to the overall rate of 12.9 mm/year. From installation in 1998 to the spring of 2020, the overall movement rate was 10.4 mm/yr. Since the fall of 2020, the overall rate has accelerated to 30.6 mm/yr. This timing of accelerated movement is similar to the pattern observed in SI-5.

SI-1 should be repaired during the next reading cycle. PN02-5 is also damaged; however, this instrument would require mechanical excavation to splice on a new section of pneumatic line so it may not be economical to repair this instrument at this time.

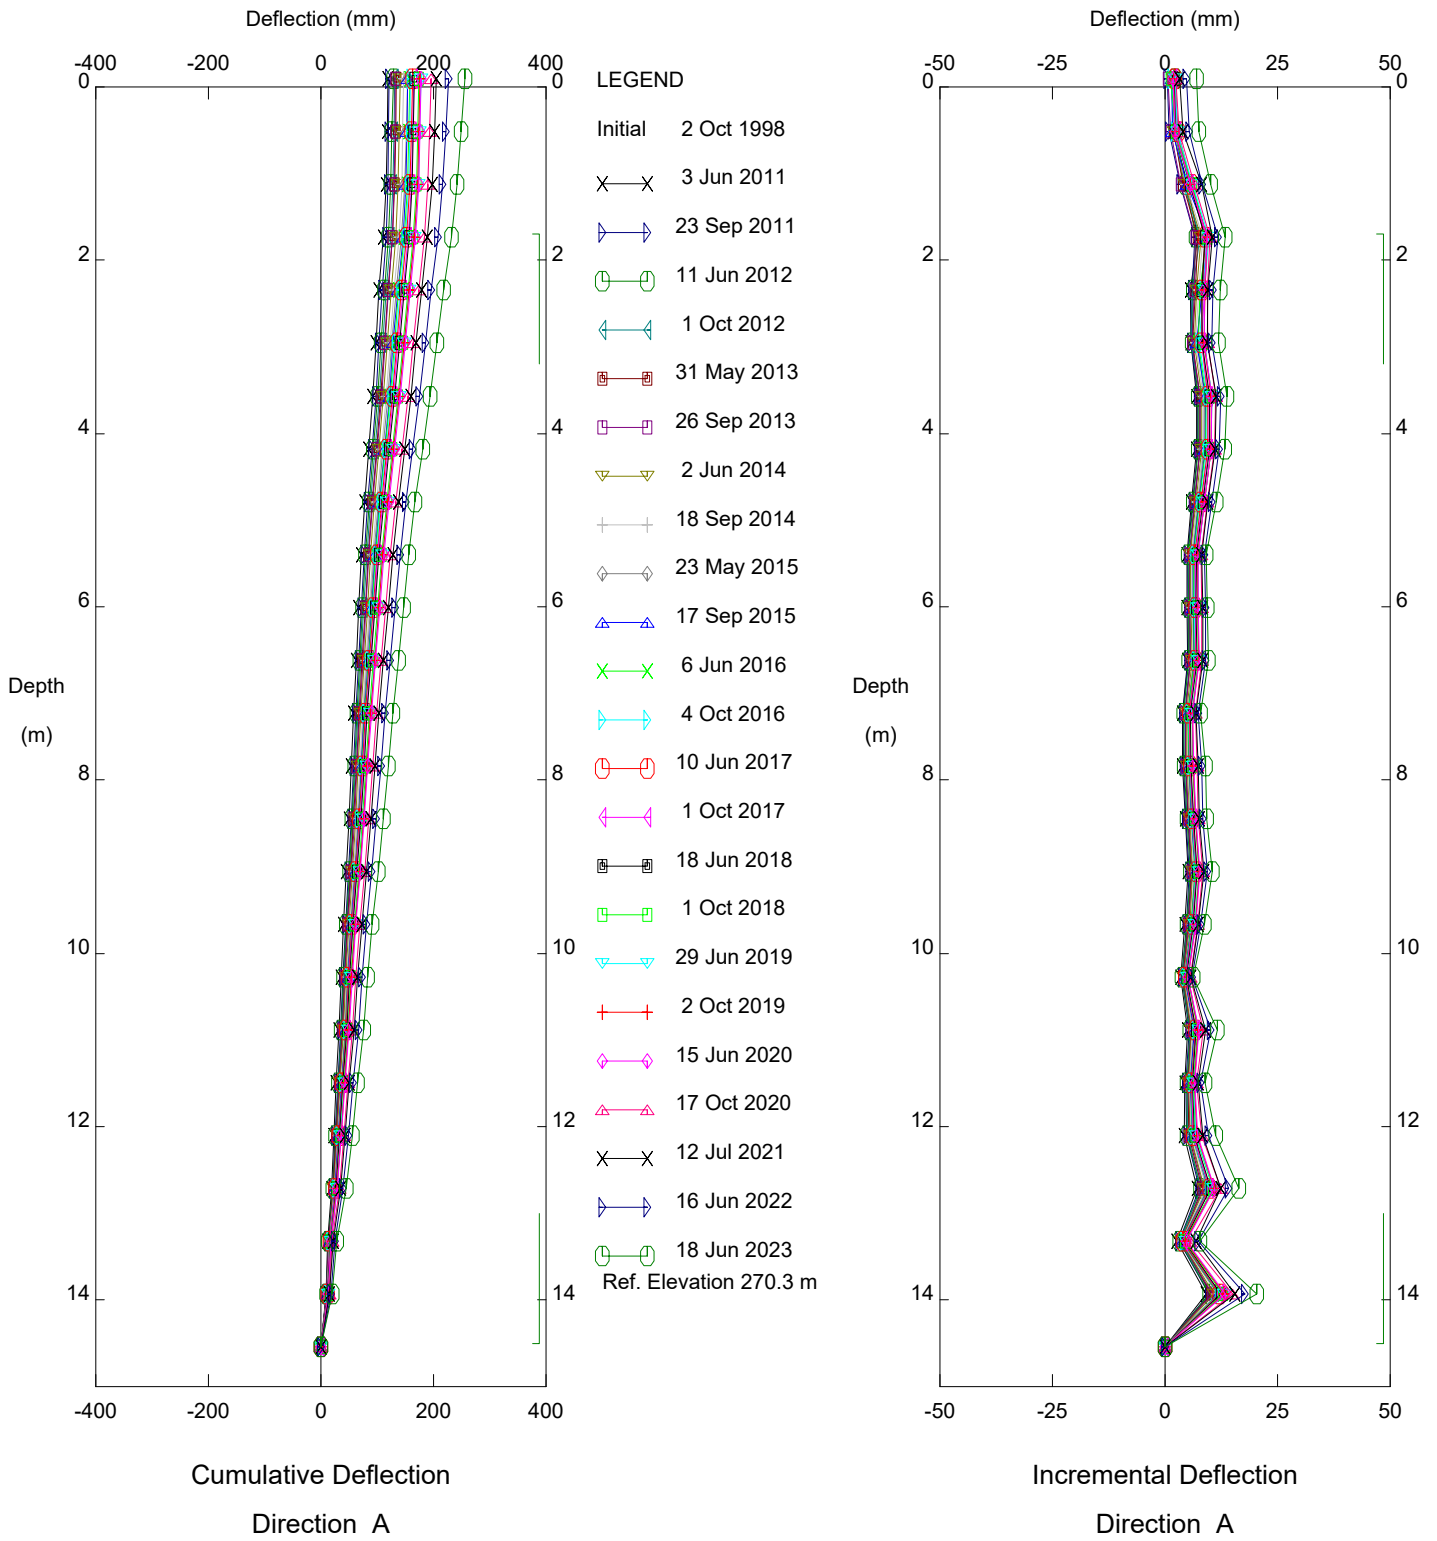
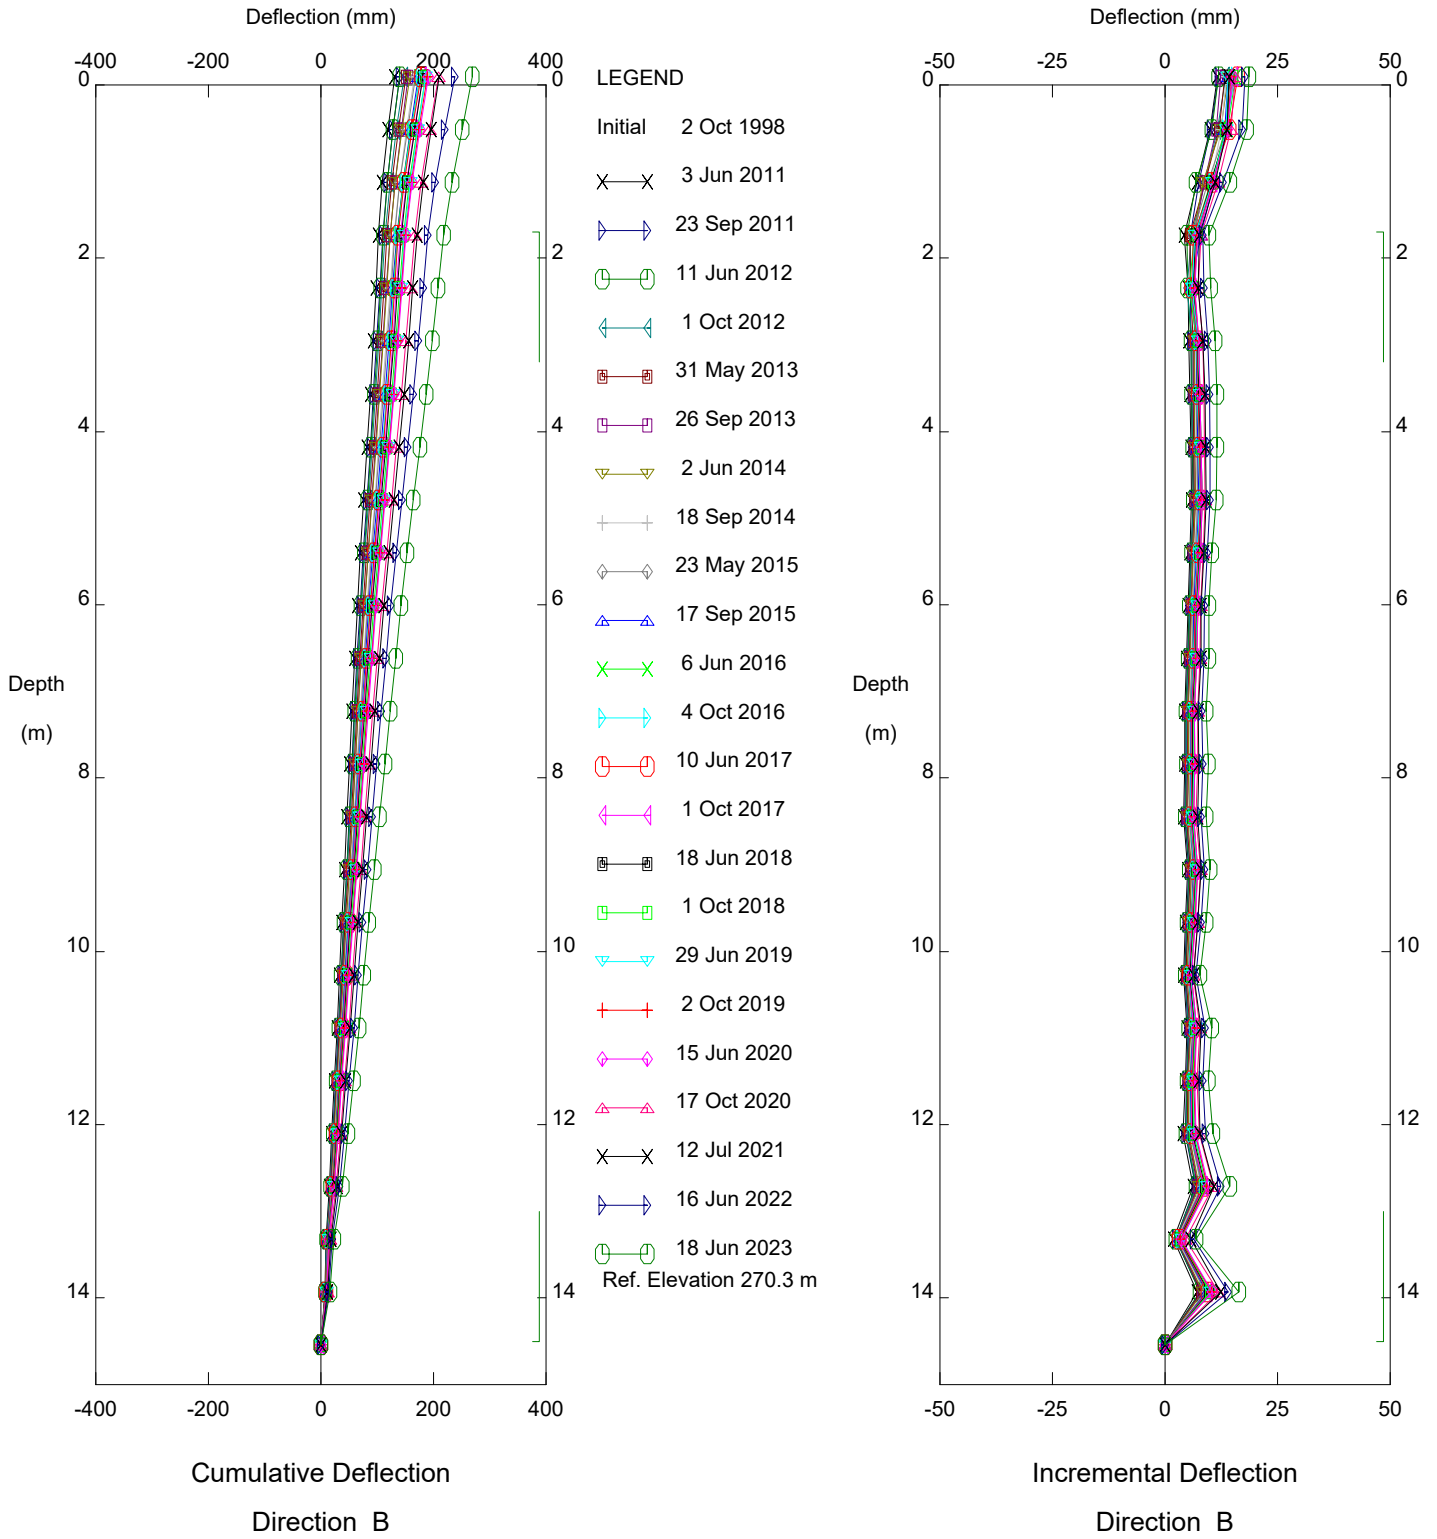
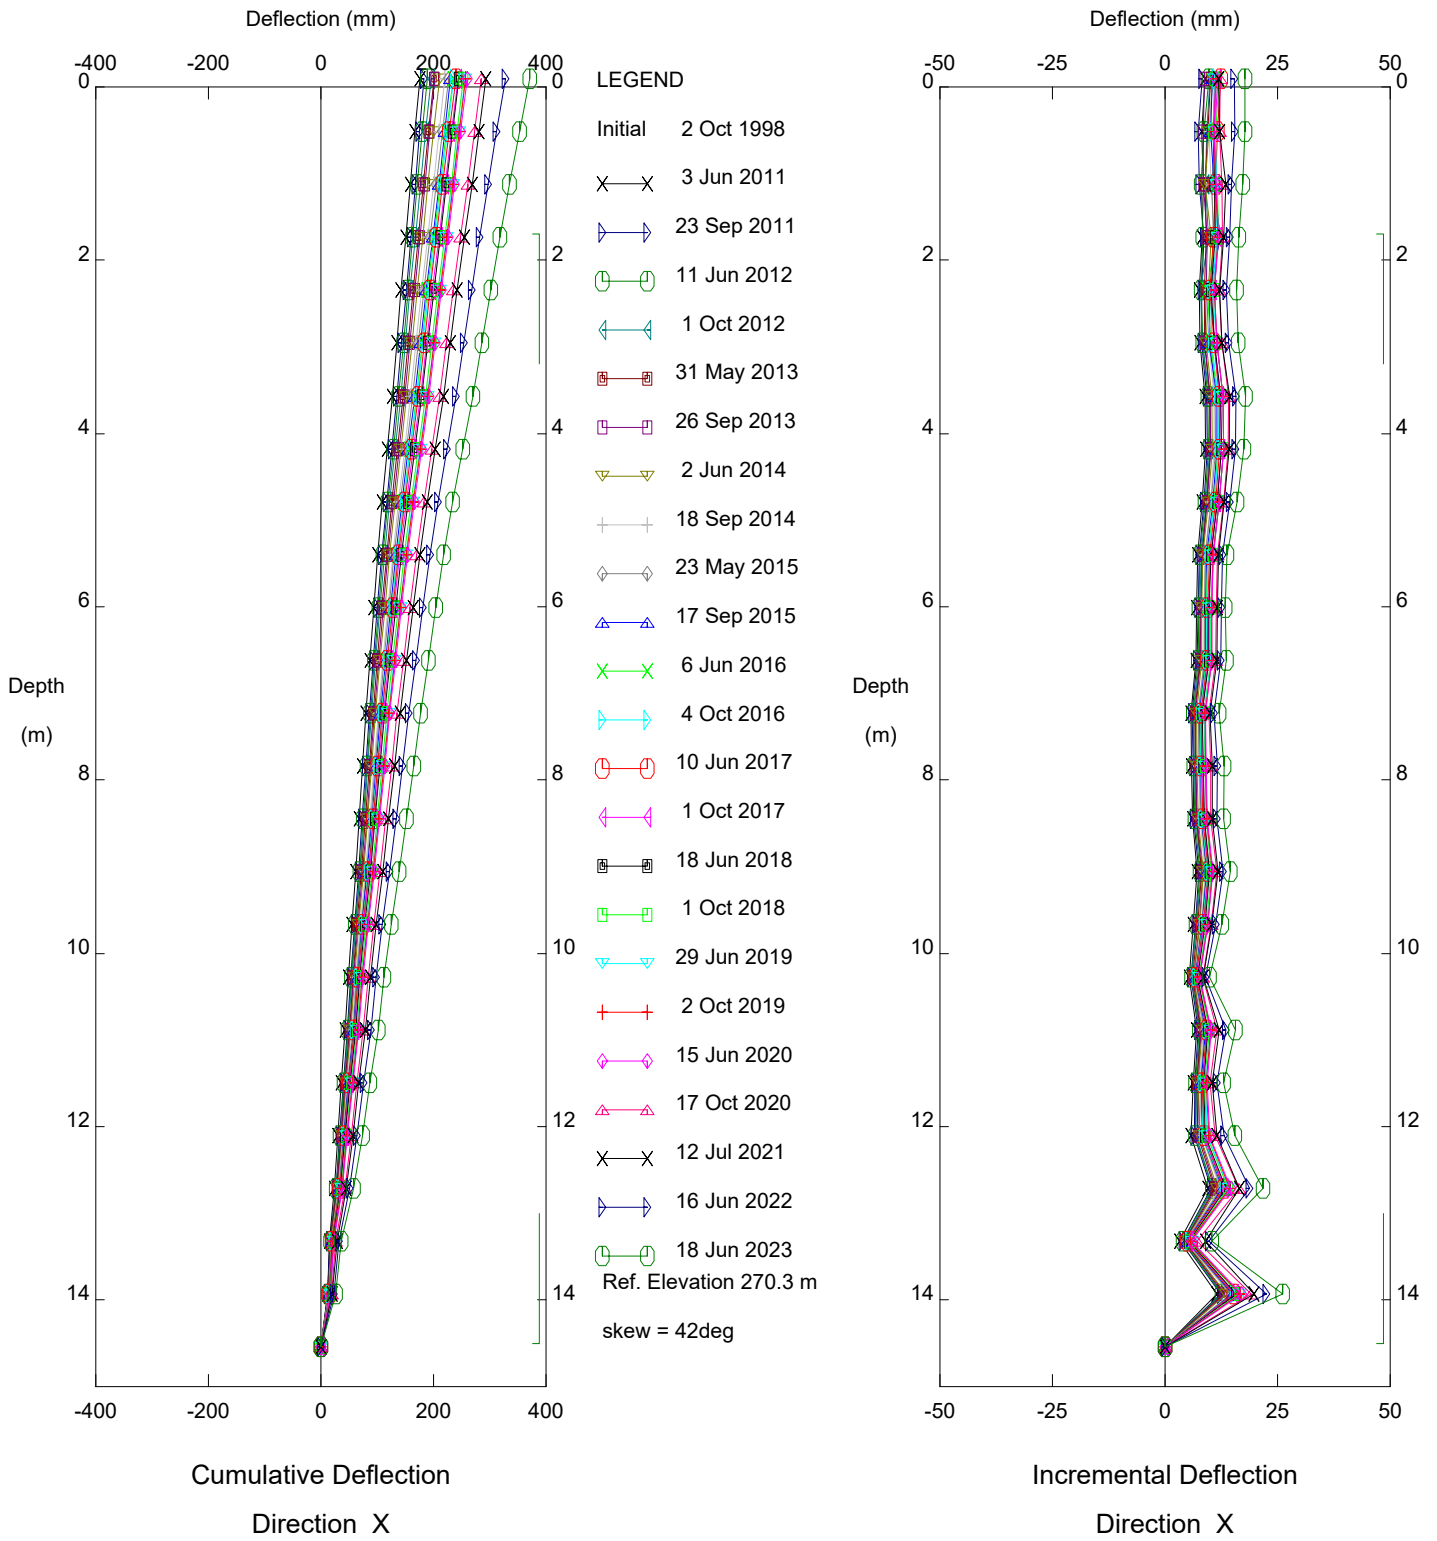
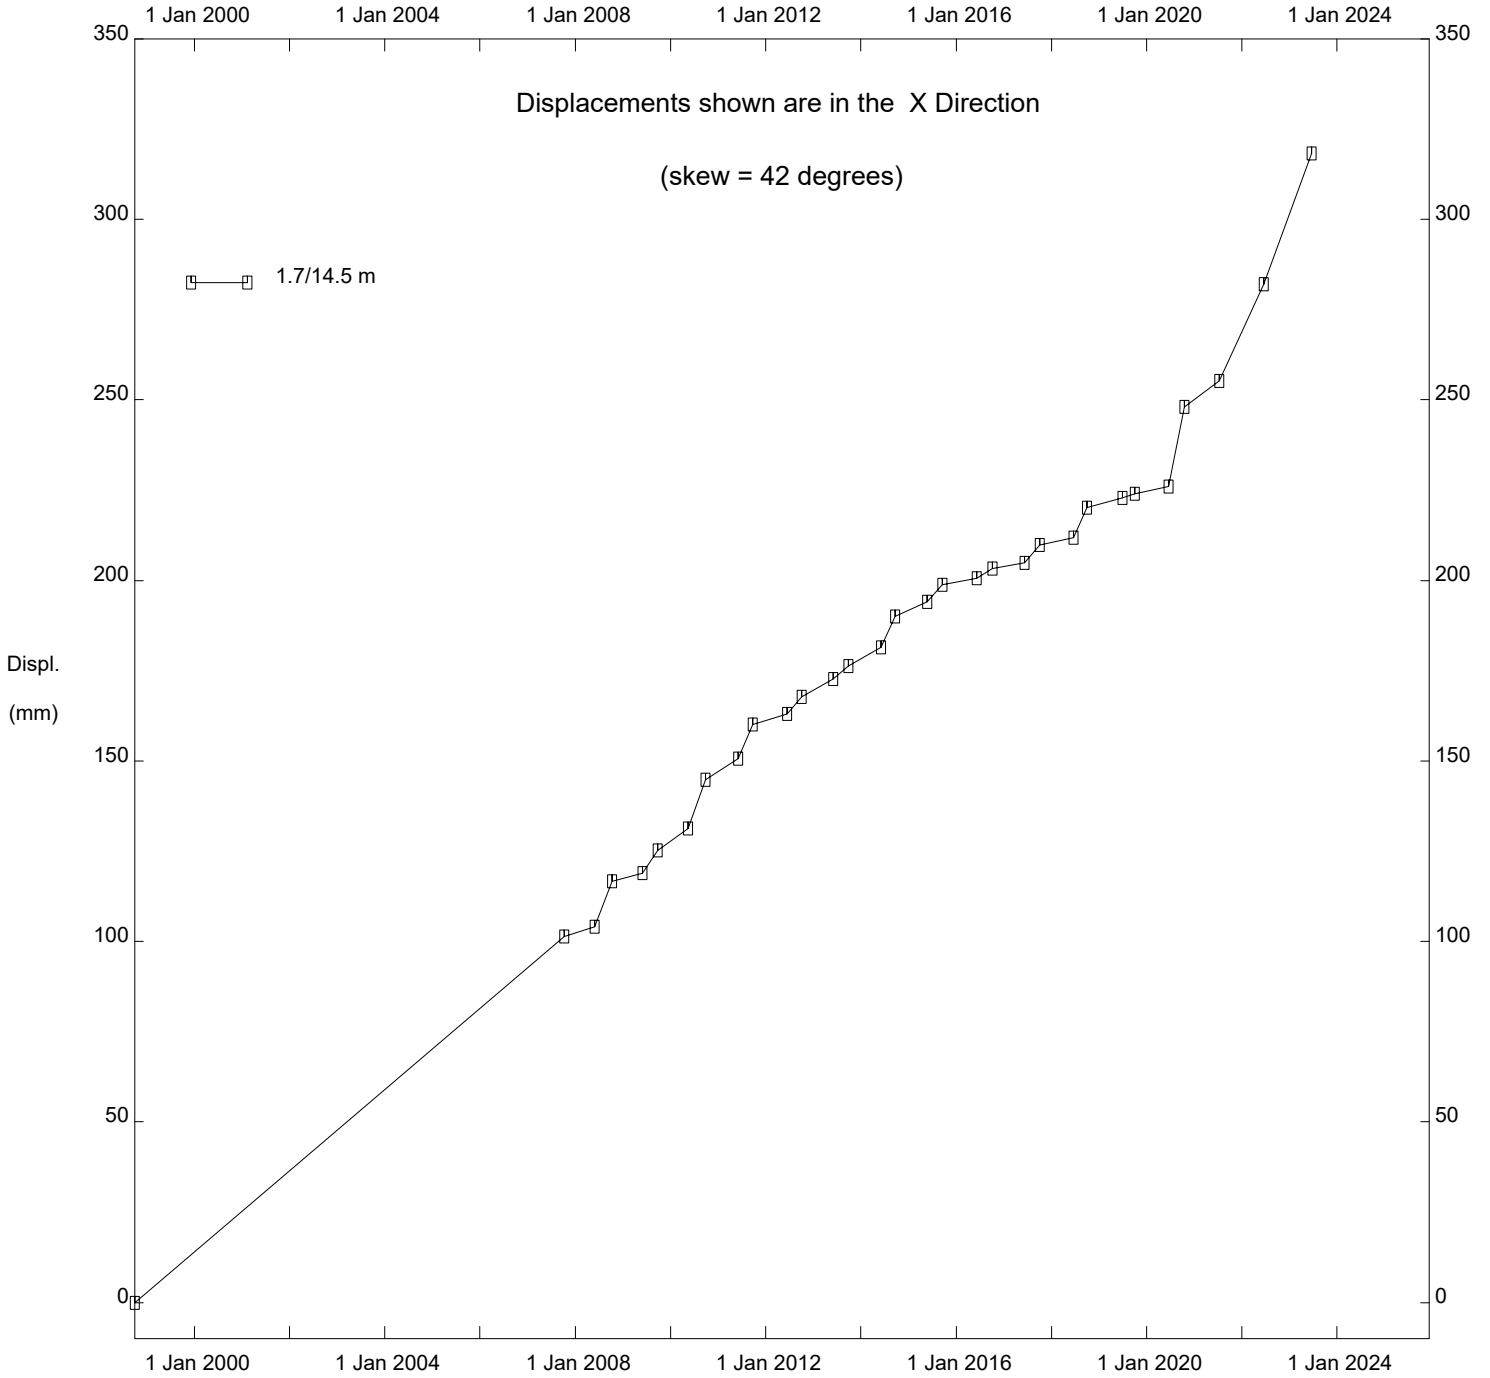
HWY 697:02 - STA. 17+360, Inclinometer SI-13

Based on previous instrument readings and site observations, it appears that the three operational SIs at this site are installed too shallow to fully intercept the main slip surface of the slide but are, nonetheless, moving and significantly within the overall slide blocks.

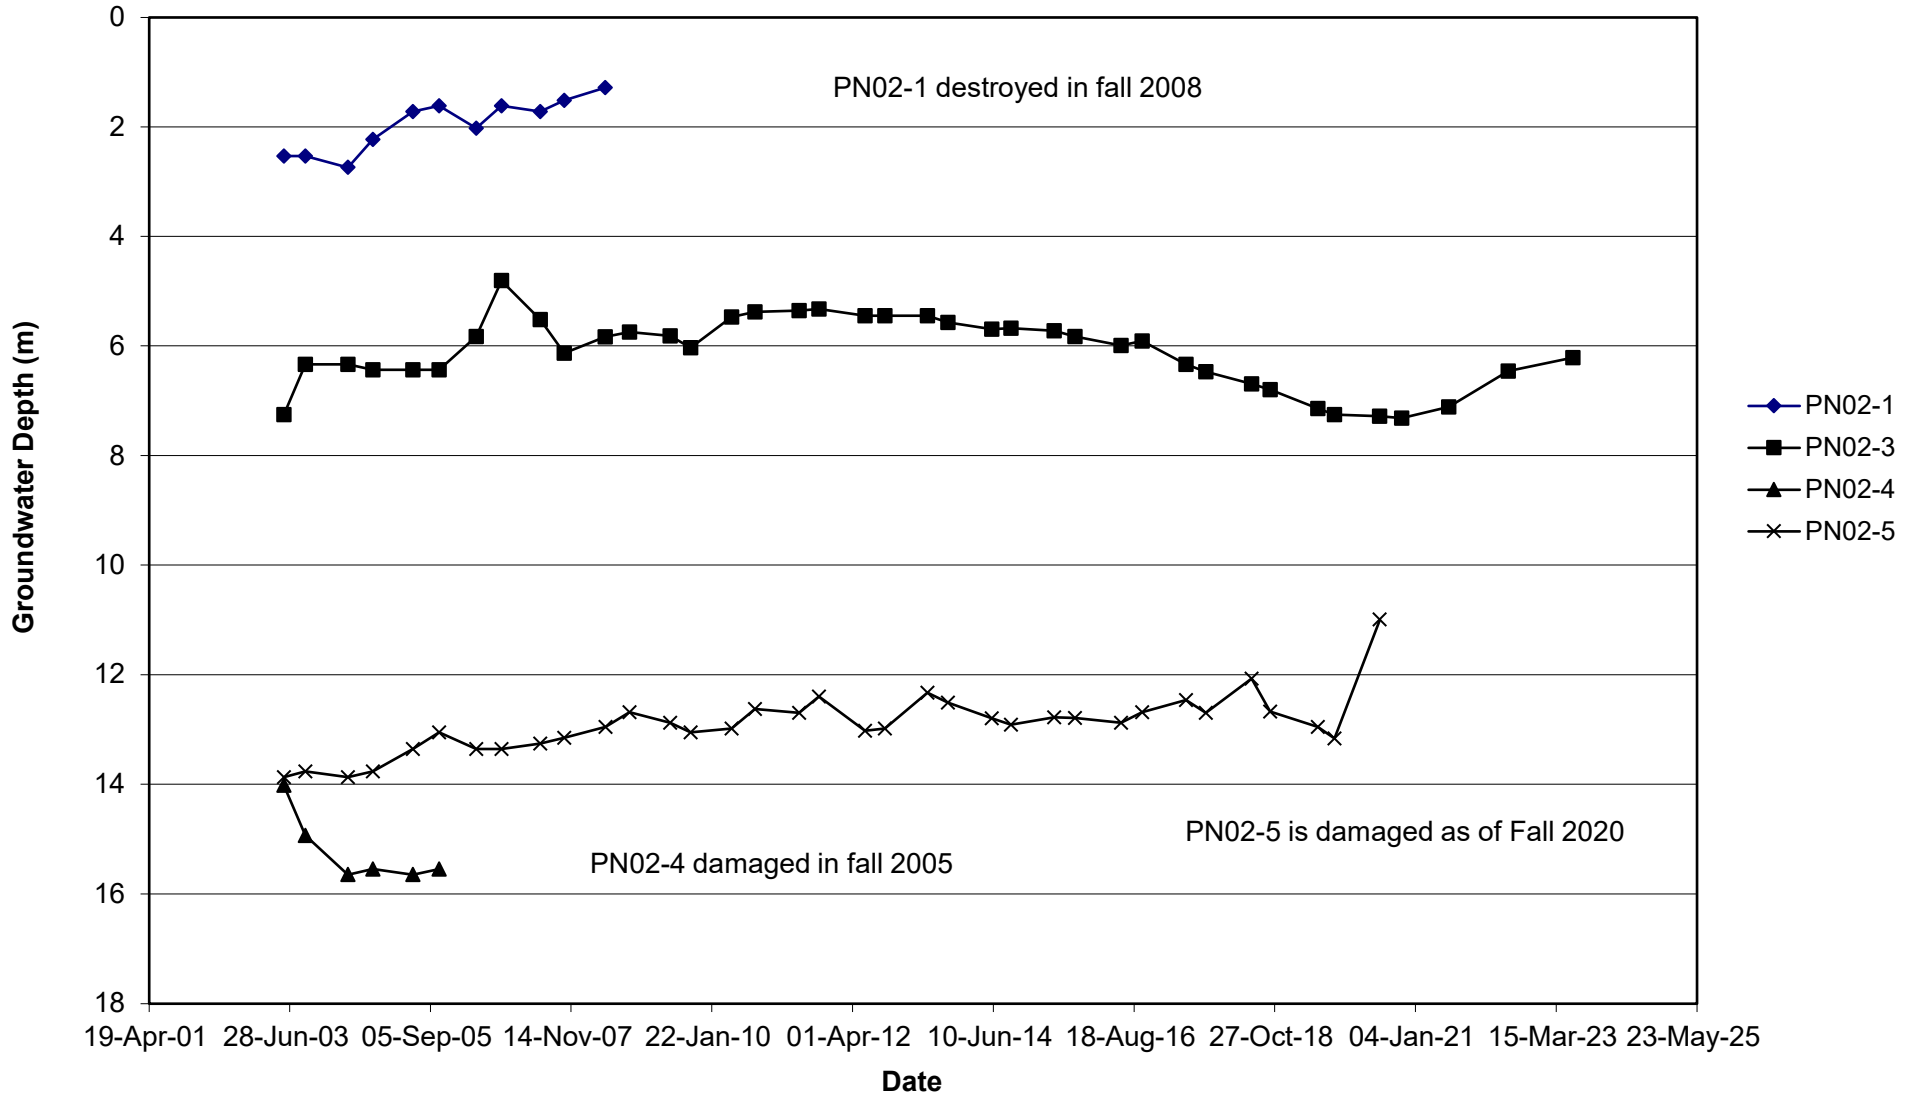
**FIGURE PH006-1
PIEZOMETER DATA FOR HWY 697:02 TOMPKINS LANDING**

The groundwater level increased in pneumatic piezometer PN02-3 by 0.25 m since the spring of 2022. PN02-3 has shown a trend of increasing groundwater levels since the fall of 2020 readings; however, the current readings are still within the historic range of the instrument. The inclinometers have been showing an accelerated movement over this same time period, which seems to be related to this increase in groundwater levels. Pneumatic piezometer readings are summarized in Table PH006-2 in this report and are plotted on in Figure PH006-1 in Appendix A.
