**ALBERTA TRANSPORTATION AND
ECONOMIC CORRIDORS
GEOHAZARD ASSESSMENT PROGRAM
PEACE REGION (PEACE RIVER DISTRICT)
2024 INSPECTION**

Site Number	Location	Name	Hwy	km
PH006-1	North of Paddle Prairie	Tompkins Landing	697:02	16.90-17.50
Legal Description		UTM Co-ordinates		
NW30-103-19-W5M / E25-103-20-W5M		11U E 491,100	N	6,425,466

PH006-1: HWY 697:02 - TOMPKINS LANDING SLIDE

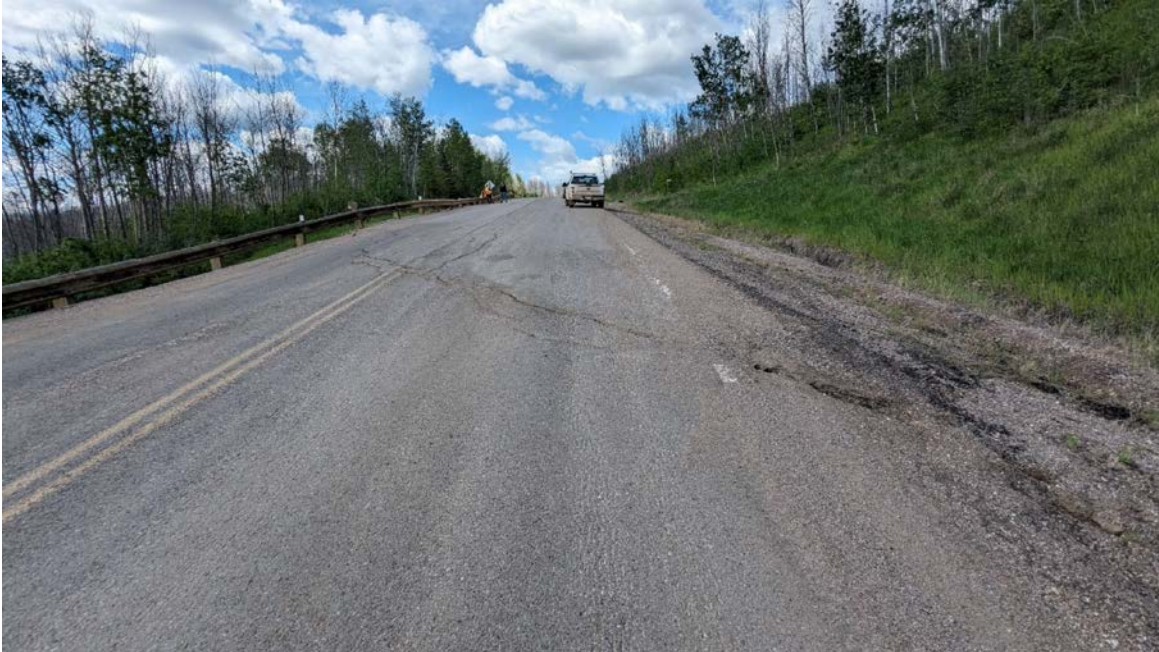
Photo 1 – Looking west at the main scarp crack near the top of the valley at Sta. 17+015.

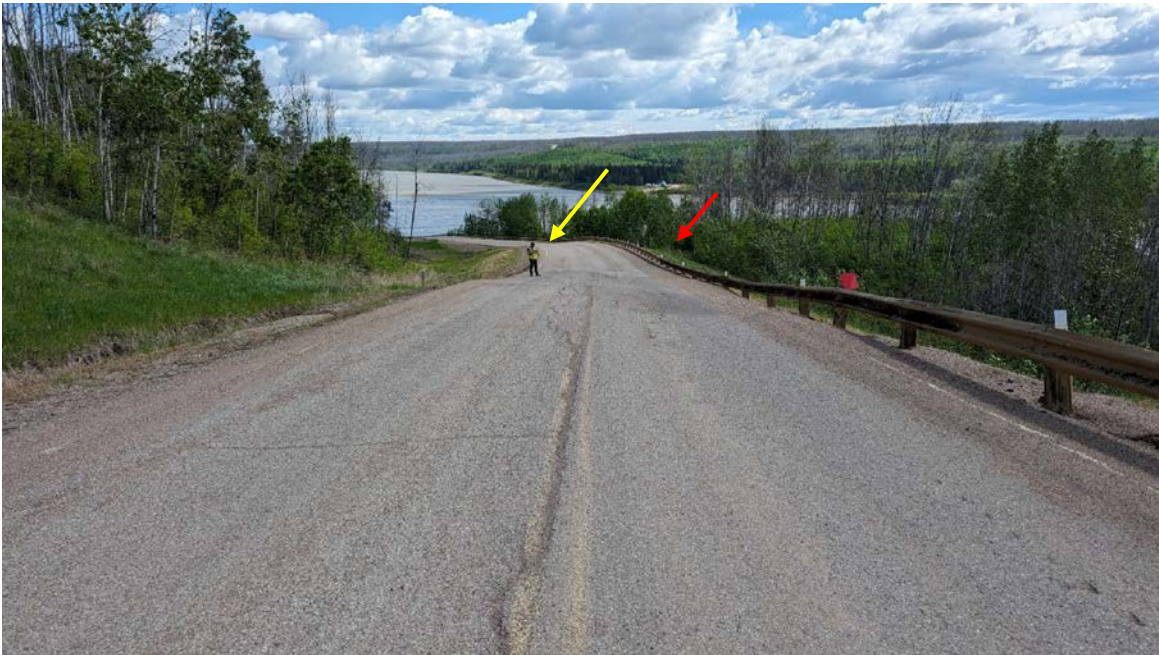
Photo 2 – Looking northeast at dips in the road (yellow arrow and red arrow).

- Routine crack sealing, milling, and patching should be undertaken, as necessary, to maintain a safe riding surface and reduce water infiltration.
- The section of the highway that spans the landslide blocks east and downhill of about Sta. 16+950 should be converted to gravel as that may be less expensive to maintain than asphalt. Once all the asphalt and GBC have been removed, the highway subgrade should be reprofiled at a lower elevation, the superelevation and crossfall fixed, and then rebuilt with surfacing gravel. This way, when further movements distort the highway, it can be regraded without having to mill or patch. It will require more frequent maintenance but should be less expensive in the long-term. Ditch repairs and linings should be carried out in combination with the highway regrading work.

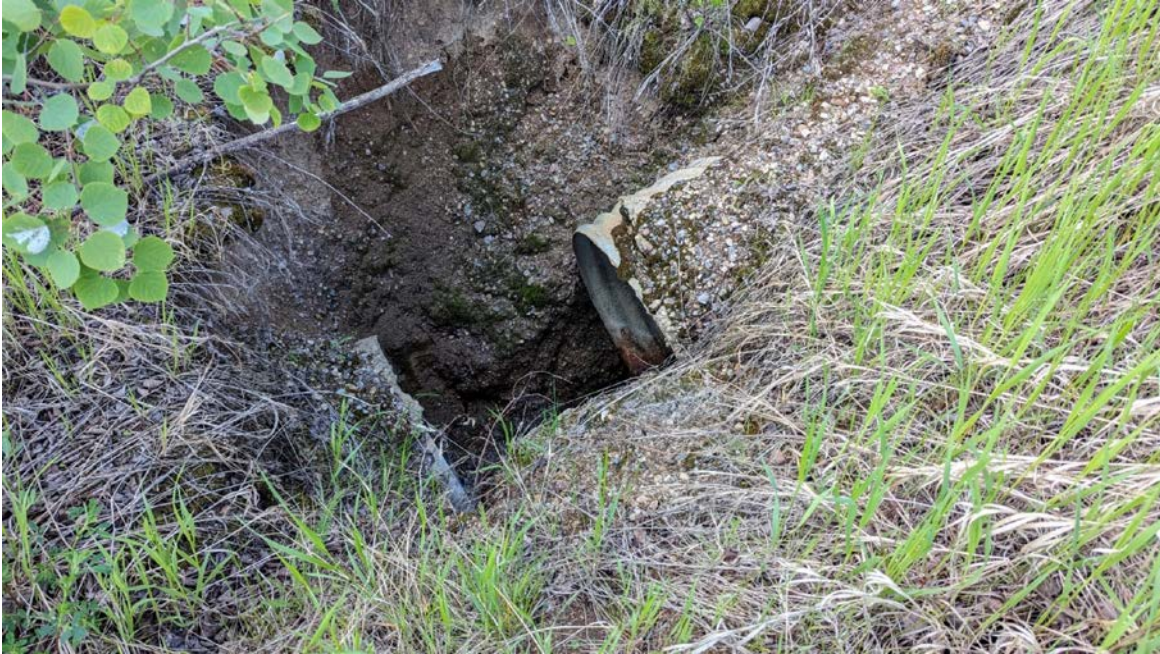
<input checked="" type="checkbox"/> Seepage	Seepage previously observed from the GBC between Sta. 17+300 and 17+400.	<input type="checkbox"/>
<input checked="" type="checkbox"/> Bridge/Culvert	800 mm CSP downpipe in southwest site is being pulled apart by slope movement. Adjacent 600 mm CSP centerline culvert inlet becoming obstructed, and invert badly corroded. Inlet of N 600 mm CSP culvert at 17+367 covered with dirt; inlet of S CSP badly corroded.	<input checked="" type="checkbox"/>
<input type="checkbox"/> Other		<input type="checkbox"/>

Photo 3 – Sinkhole at separated 800 mm CSP downpipe south of the highway.

Recommendations:	
<p>Short-Term:</p> <ul style="list-style-type: none"> ▪ The gap in the 800 mm culvert should be repaired to reduce the amount of runoff into the slide mass. The culvert could be excavated and replaced; alternatively, a collar could be used to span the gap with one end not fastened to allow for future movement. The sinkhole should be backfilled with compacted low- to medium-plastic clay. ▪ The pair of 600 mm culverts should be replaced and the outlet(s) properly armoured to dissipate the energy from the water flow. Alternatively, the flow should be conveyed to the river edge either in a riprap channel, half-culvert, or elephant trunk with consideration given to the potential for ice damage. Ideally, the flow would be kept in the upslope ditch and managed at the flatter ground at the ferry dock but it is understood that this can lead to soft ground, icing problems, and slippery conditions during ice bridge operations.

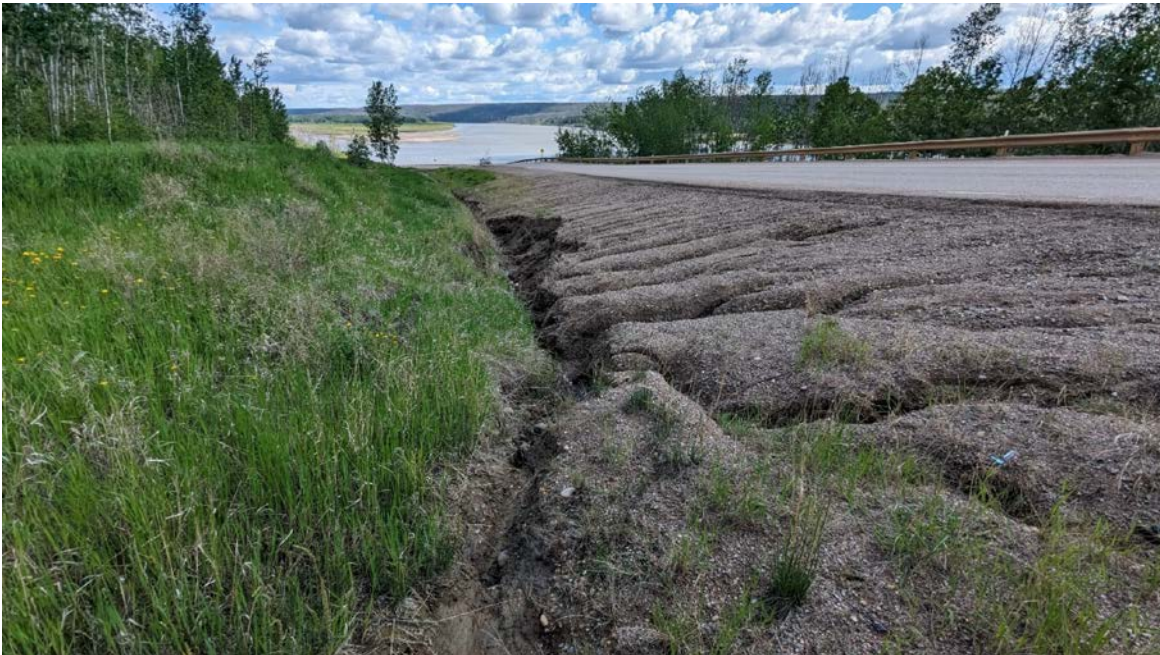
Photo 4 – Looking northeast at deep erosion gully in upslope ditch.

- The erosion gullies should be regraded and protected from future erosion with armour (like riprap) or TRM until vegetation can be re-established. Note that heavy sanding on this hill during winter will limit vegetation development within 2 m of the highway.

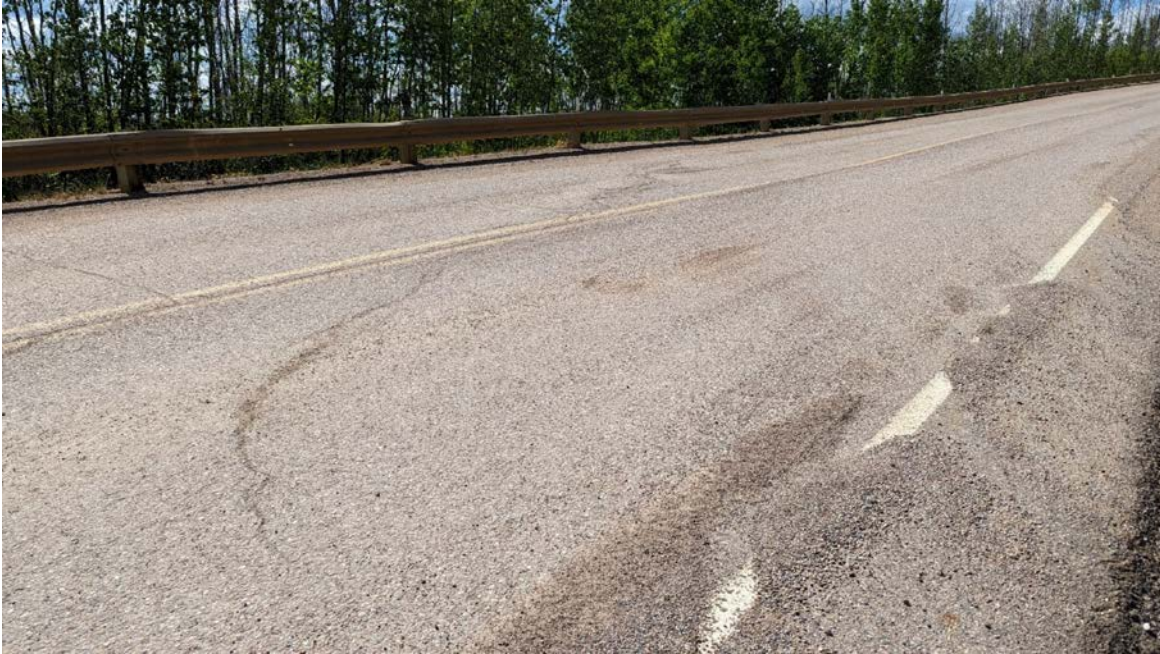
Photo 5 – Diagonal crack across the highway at Sta. 17+240.

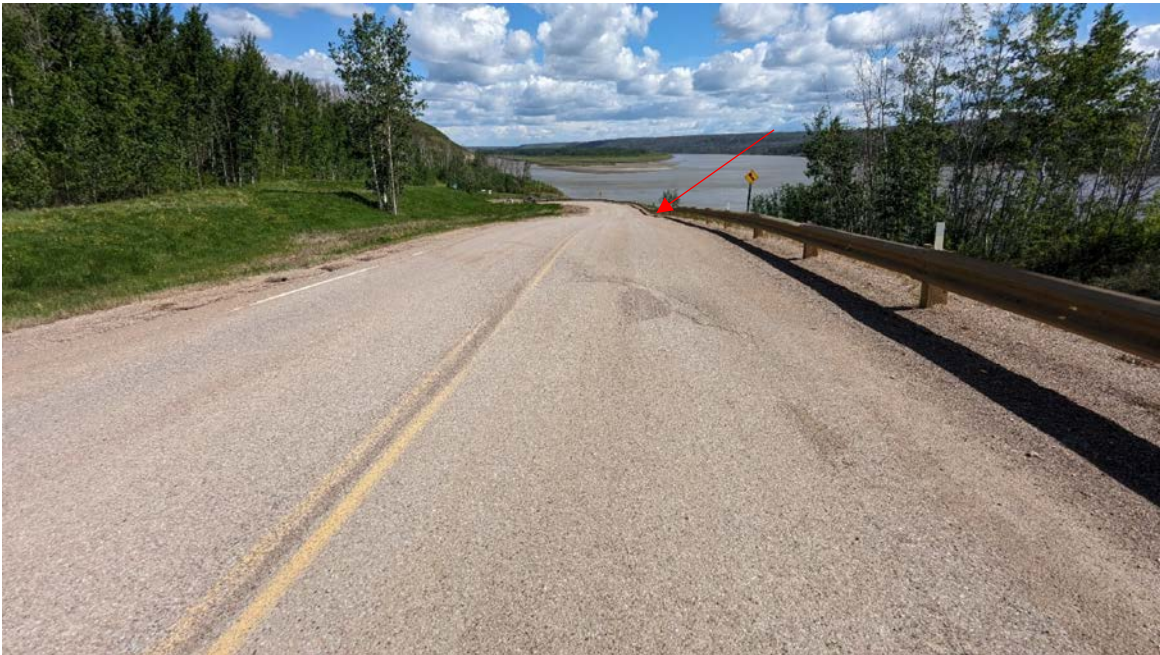
Photo 6 – Looking northeast across the diagonal crack from Photo 5 at another dip in the highway (red arrow).

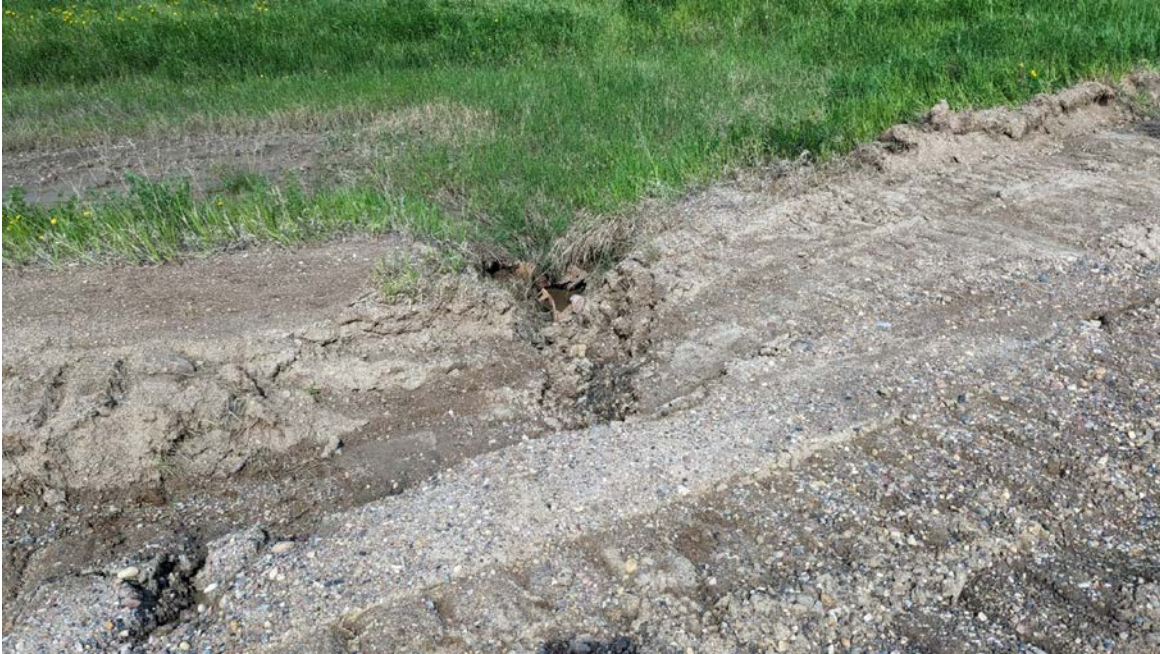
Photo 7 – Looking northwest at the partially visible inlet of only one of the twin culverts.

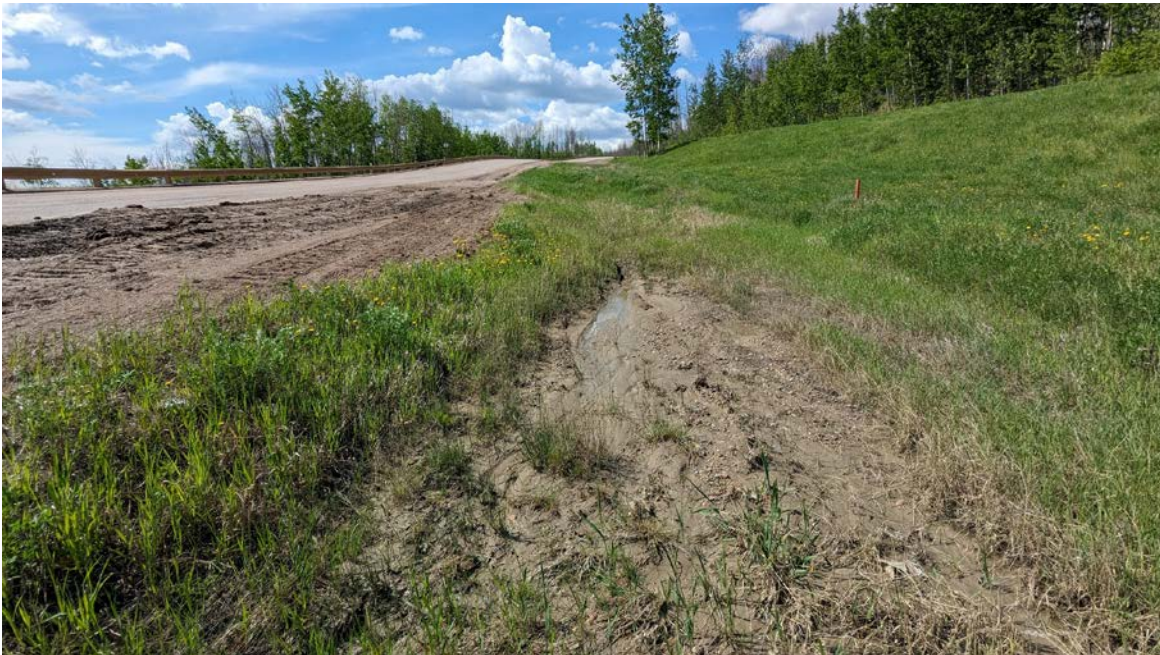
Photo 8 – Looking southwest at accumulating sediment at bottom of valley.

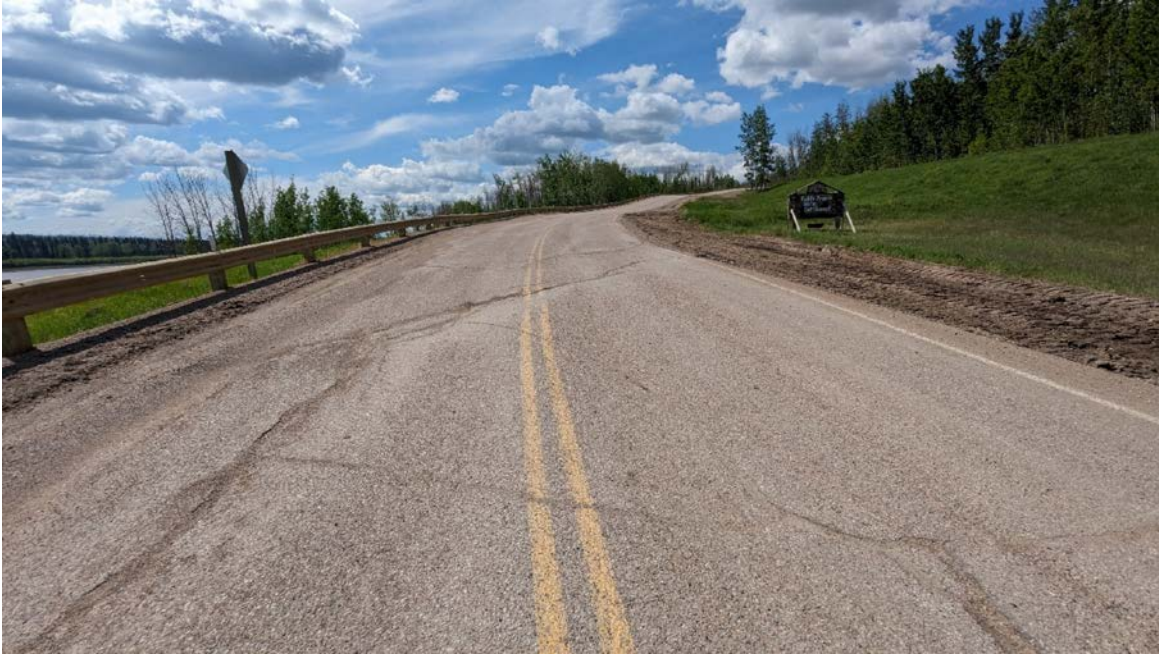
Photo 9 – Cracks on highway near bottom of valley.

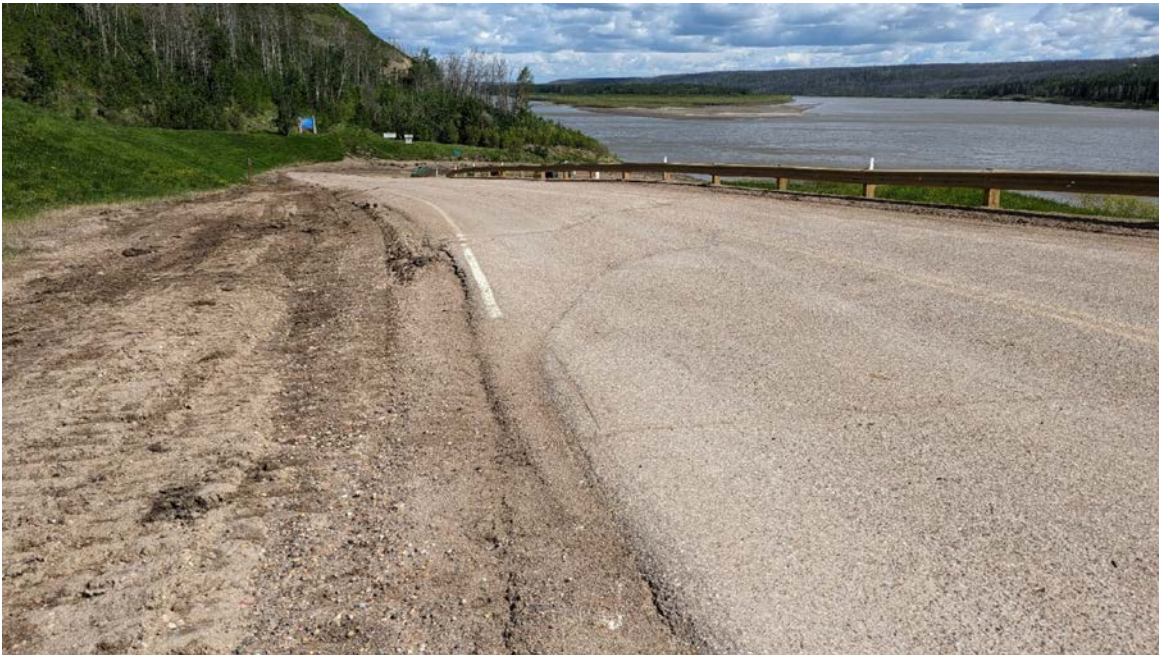
Photo 10 – Looking northeast at cracks on the highway and recent regrading on the upslope side.

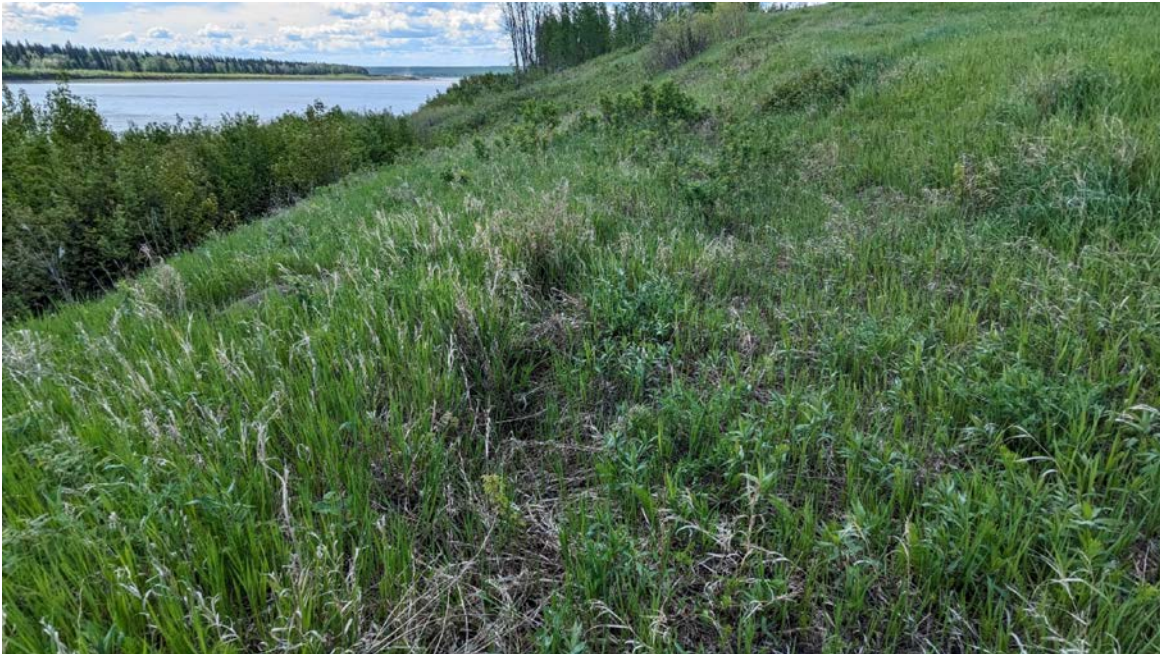
Photo 11 – Looking south at slope with ongoing movement in the northeast portion of the site. Much of this vegetation has regrown since it was destroyed by flooding in Spring 2018.

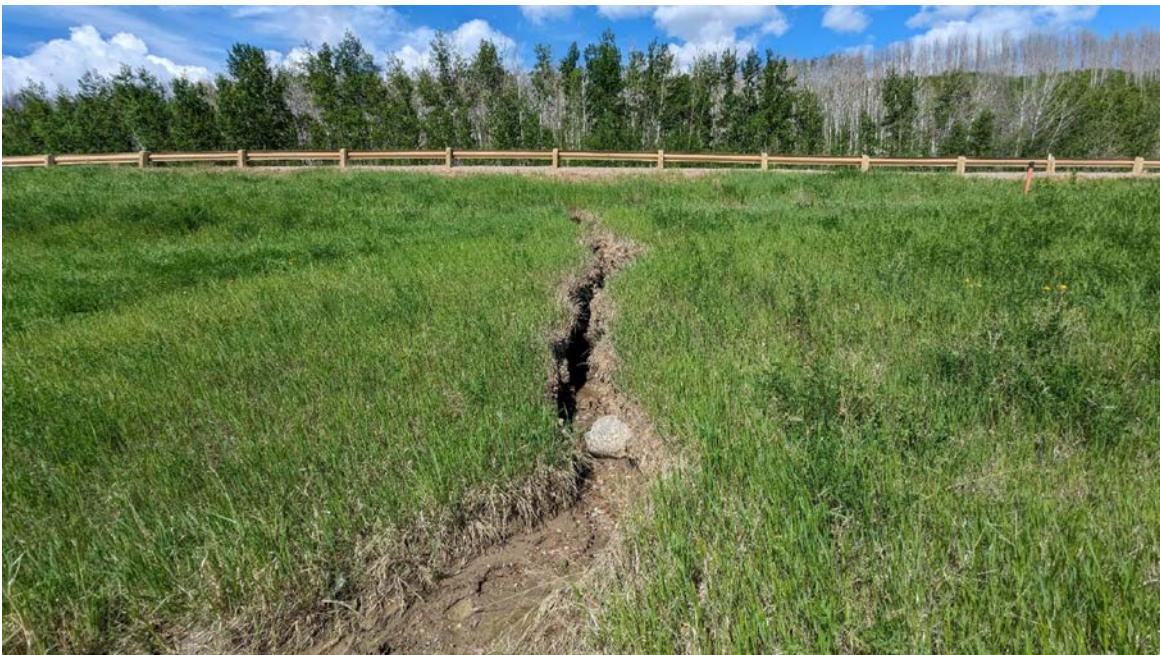
Photo 12 – Erosion gully forming on downslope side of highway at outlet of twin culverts.
