**ALBERTA TRANSPORTATION AND ECONOMIC CORRIDORS
GEOHAZARD ASSESSMENT
PEACE REGION (PEACE RIVER DISTRICT)
2024 CALLOUT INSPECTION**

Site Number	Location	Name	Hwy	km
PH006-1	North of Paddle Prairie	Tompkins Landing	697:02	16.97-17.62
Legal Description		UTM Co-ordinates		
NW30-103-19-W5M / E25-103-20-W5M		11U E 491,100	N	6,425,466

**PEACE REGION (PEACE RIVER/HIGH LEVEL)
PH006-1: HWY 697:02 - TOMPKINS LANDING SLIDE**

**SITE PLAN SHOWING SITE OBSERVATIONS ON
AUGUST 26, 2024**

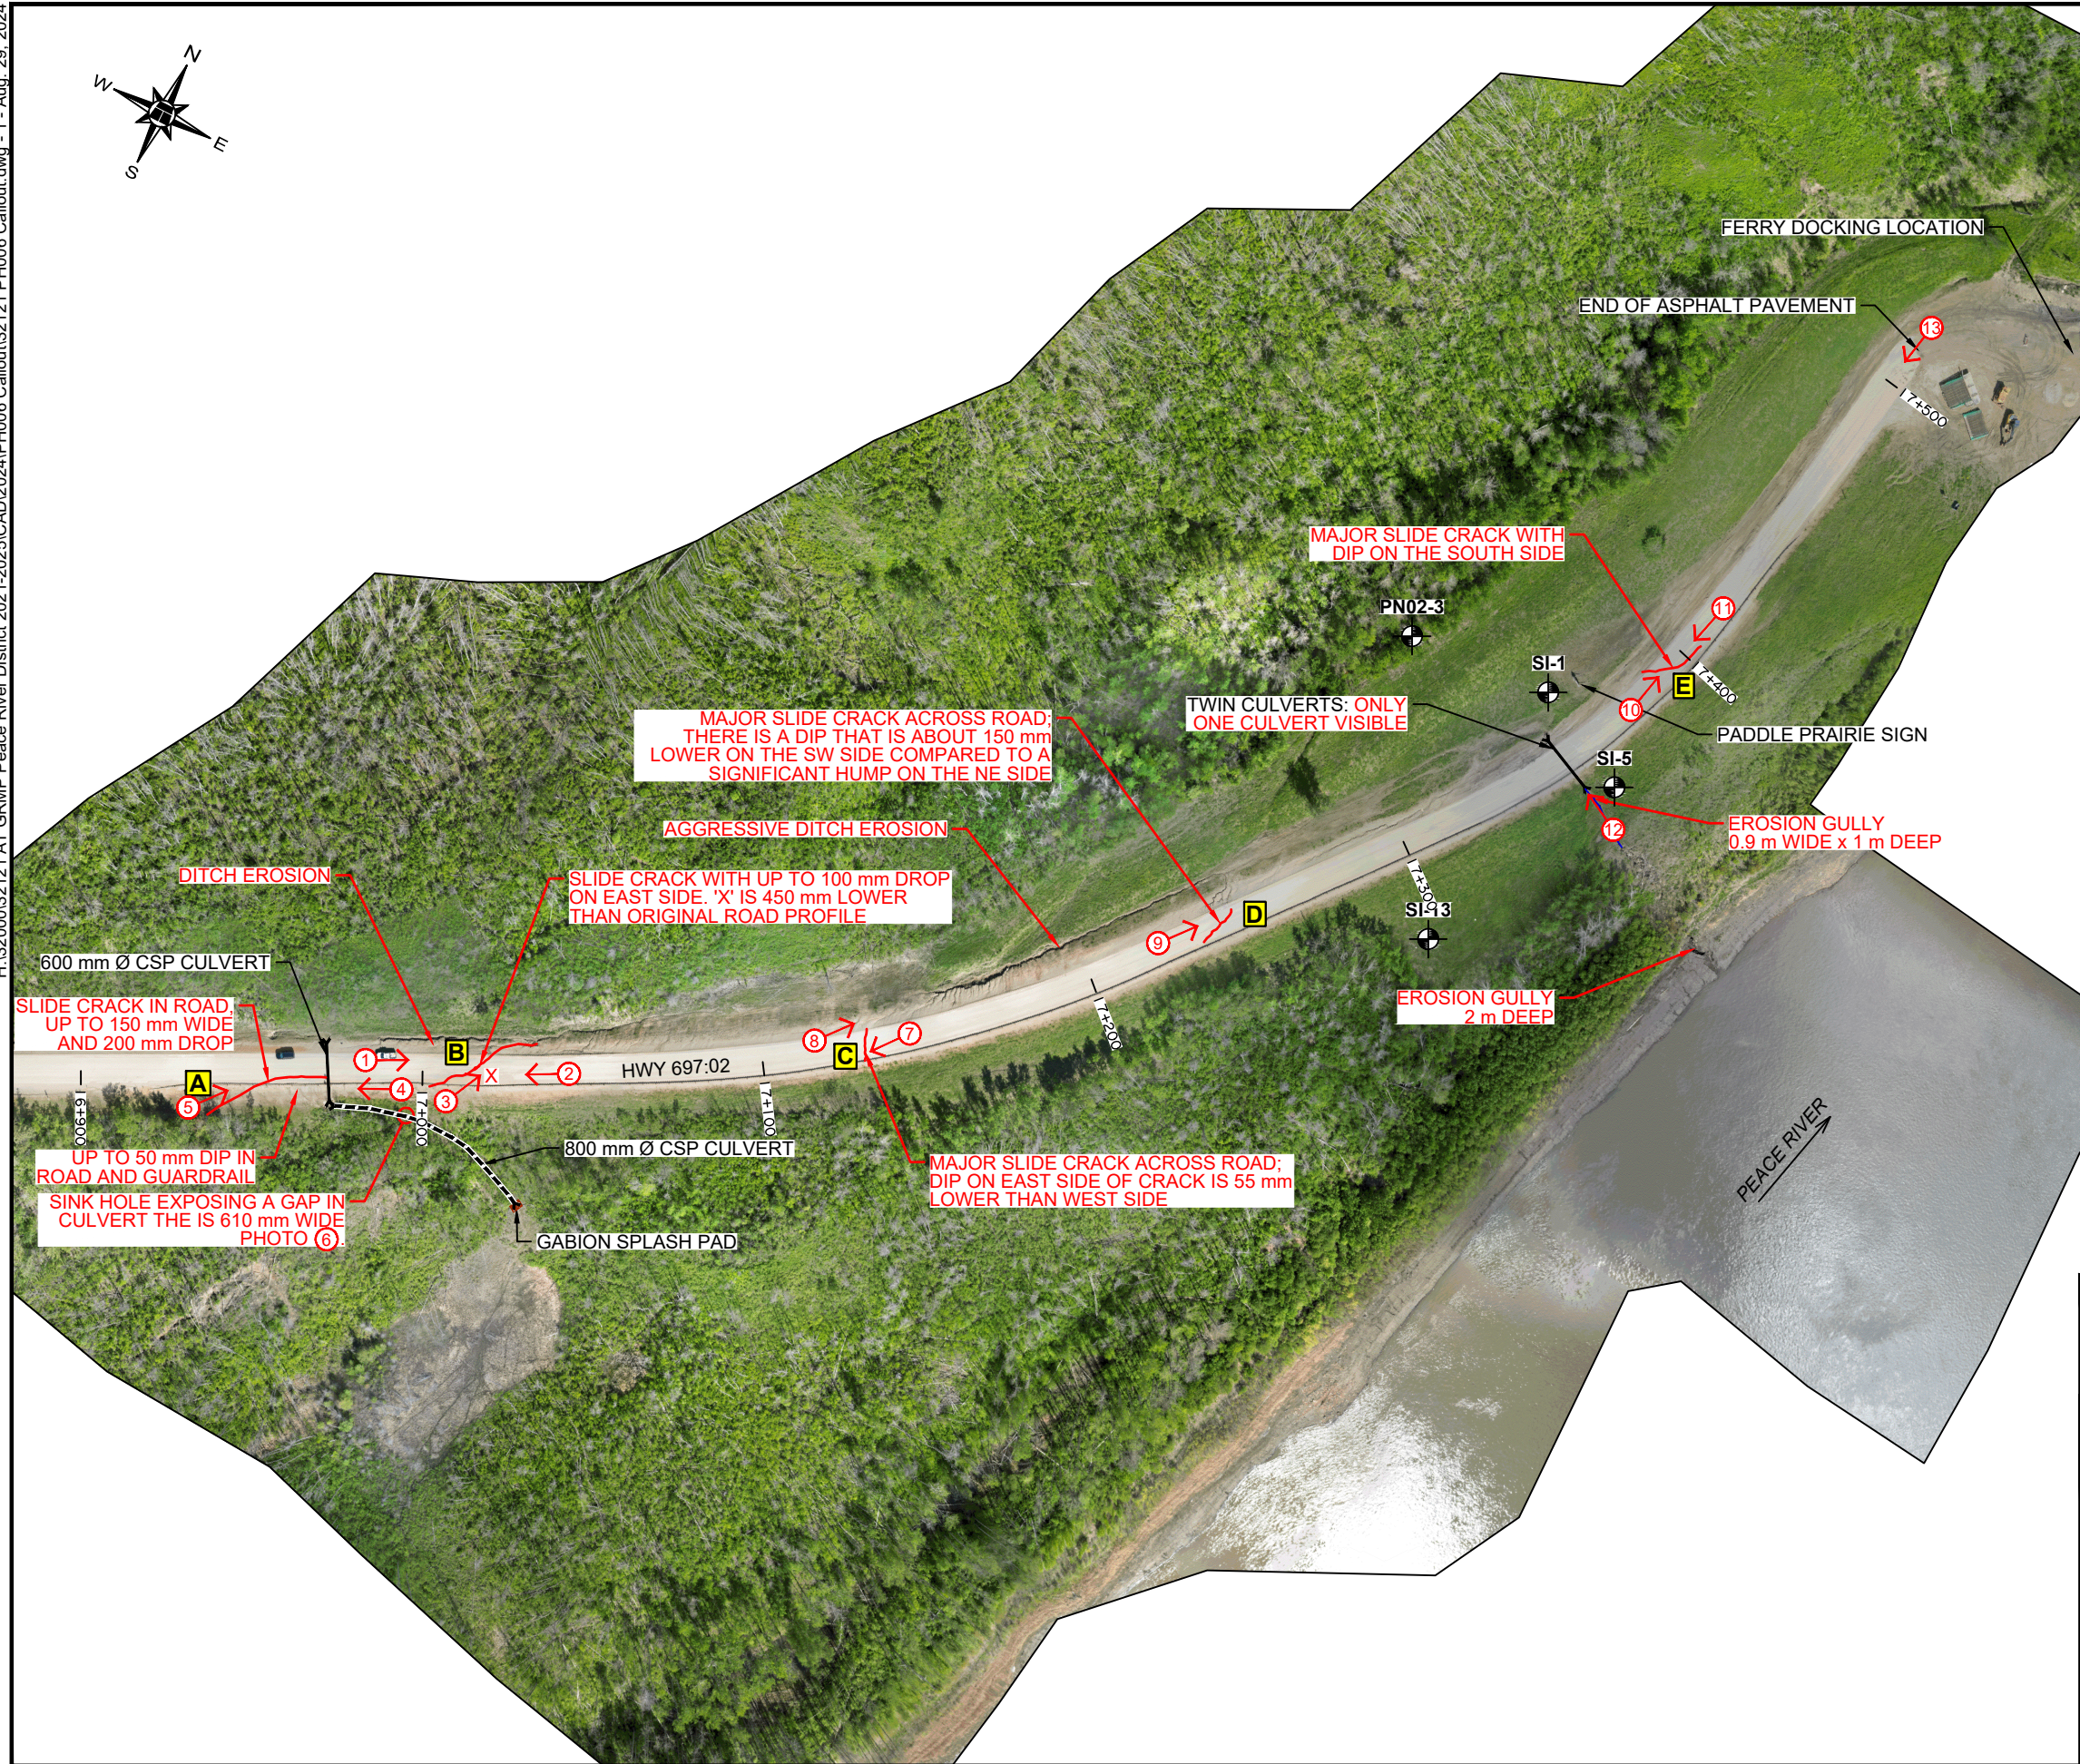
DWG No. 32121-PH006-1-1

1. AUGUST 26, 2024 OBSERVATIONS SHOWN IN RED.
2. 2024 ORTHOMOSAIC DERIVED FROM UAV IMAGERY FLOWN BY THURBER IN MAY 2024

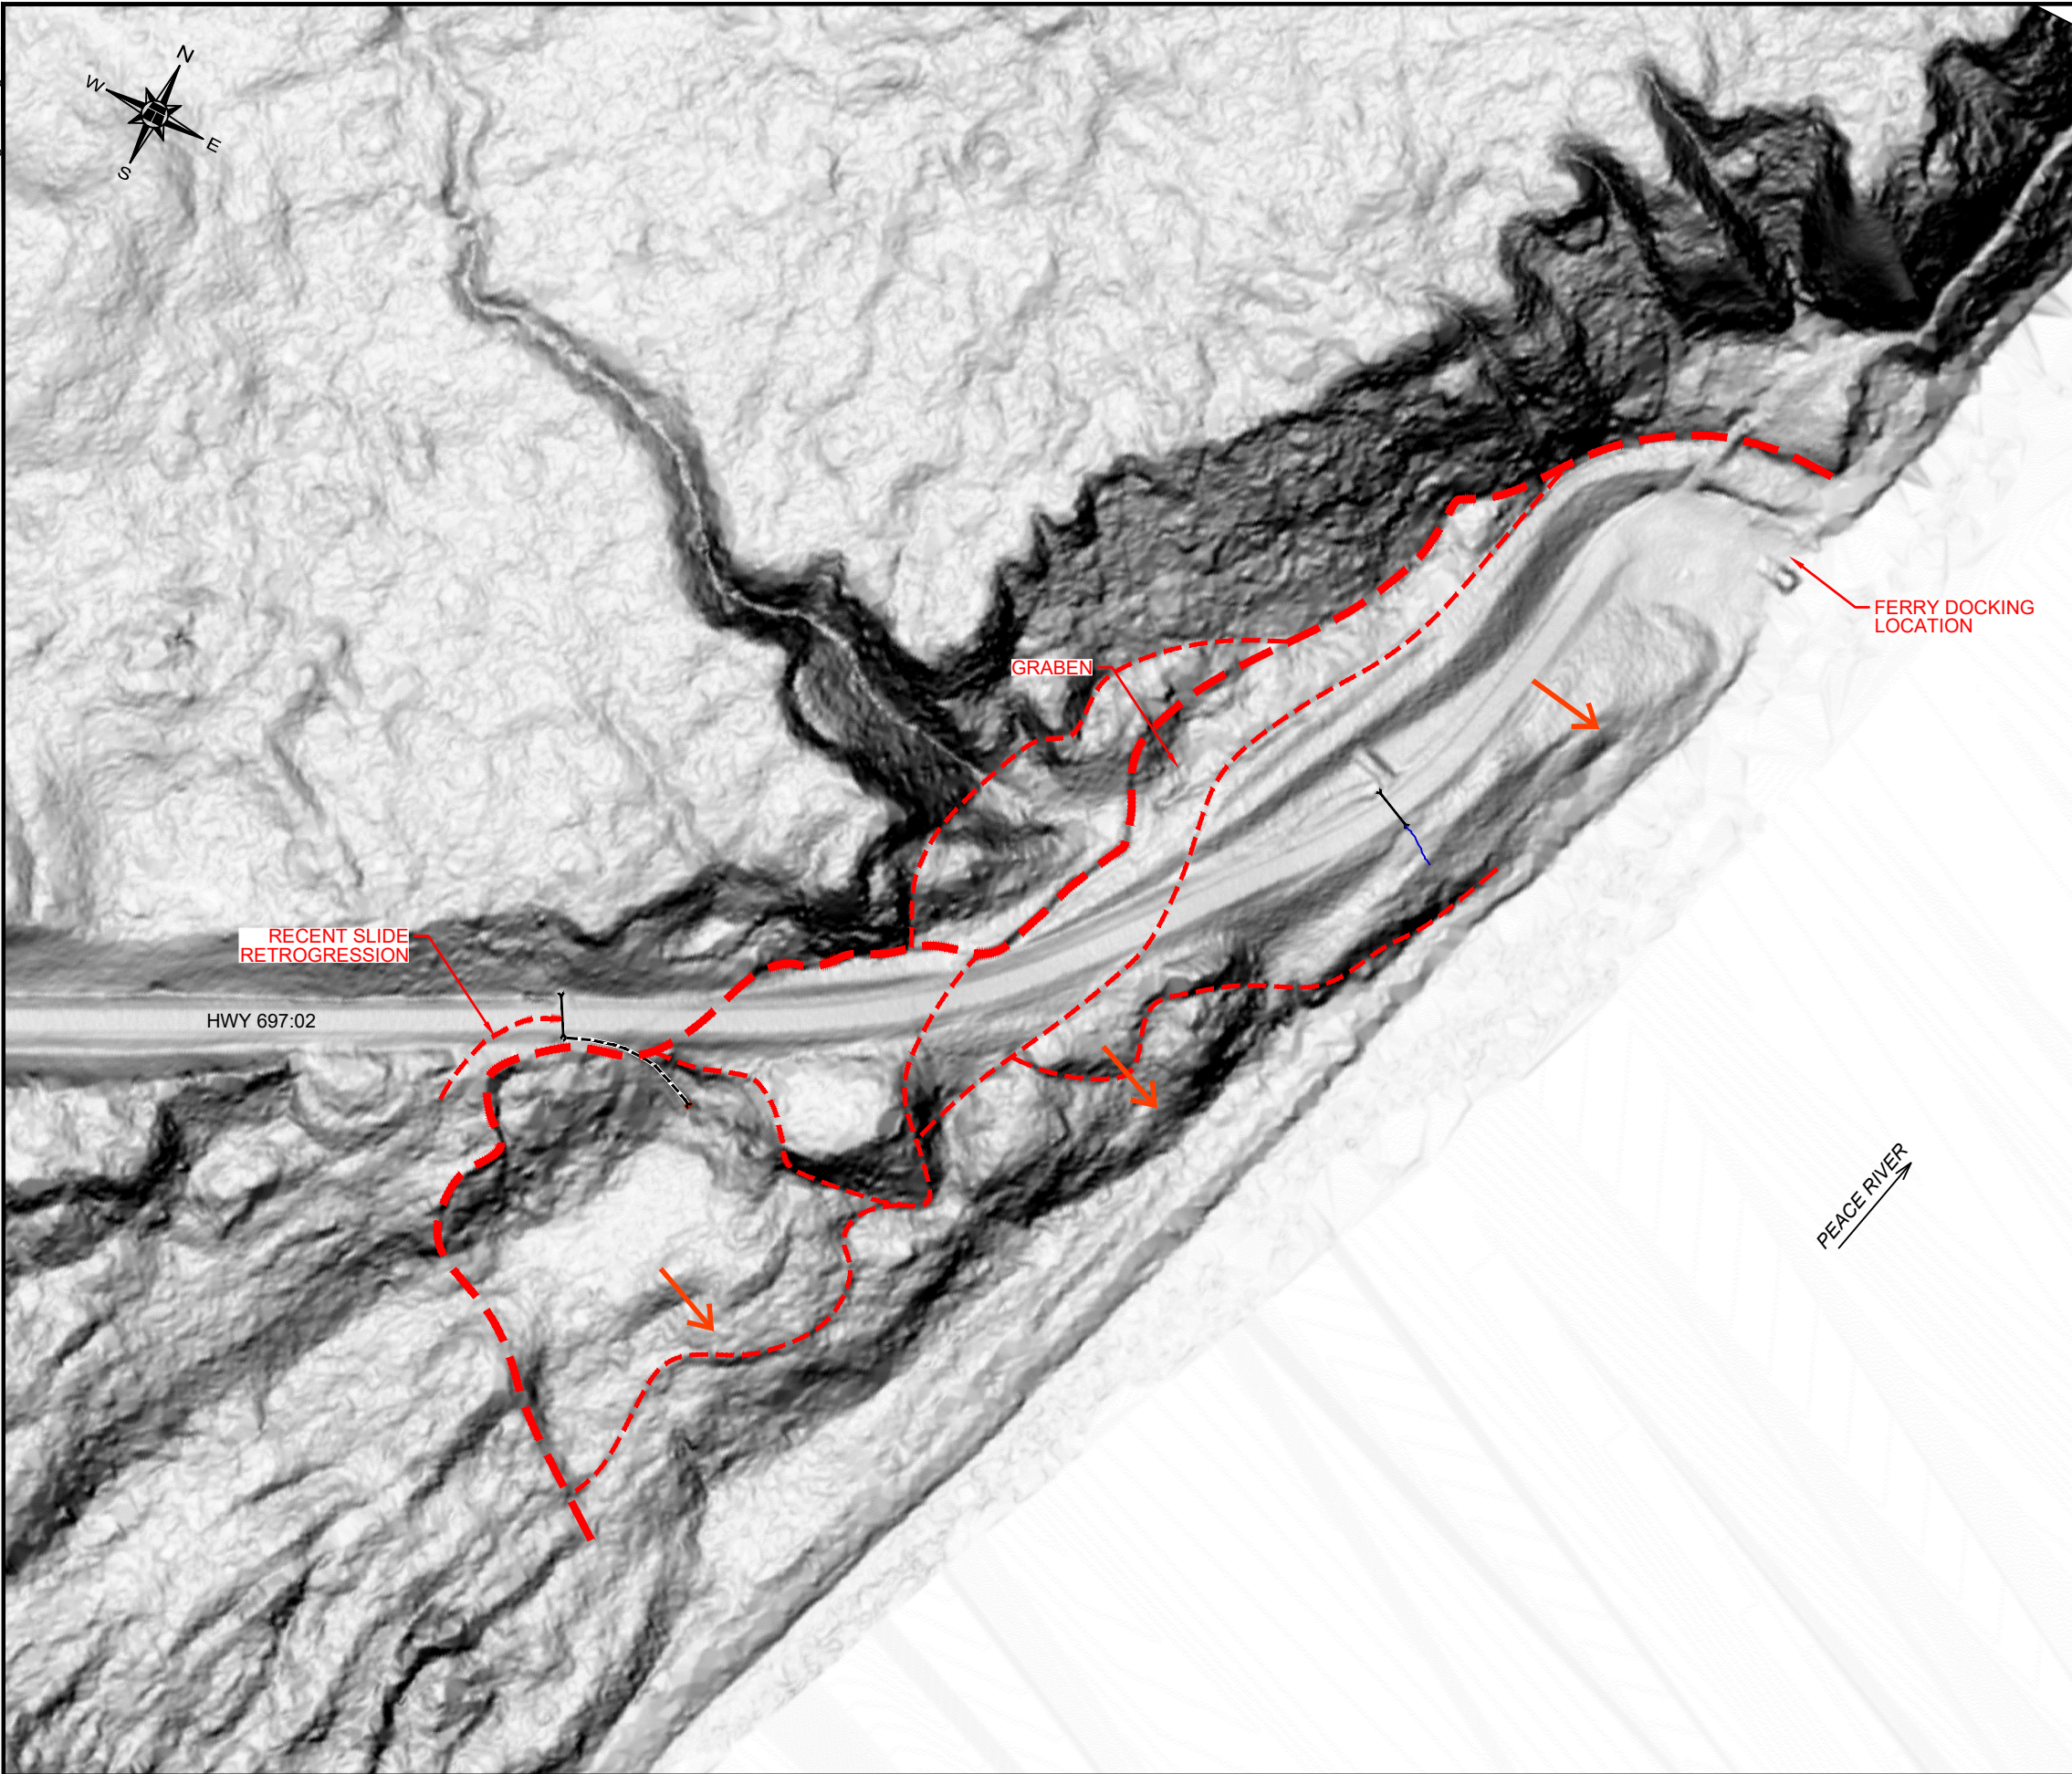
DWG No. 32121-PH006-1-2

The highway is situated on a deep-seated rotational slide. This large-scale movement is likely based in clay shale bedrock near the bottom of the river valley with the slide initially triggered, and kept moving, by river erosion at the toe of the slope. TEC personnel have indicated that the slide seems to accelerate when river levels are low. There may also be contribution from water-bearing sand and gravel layers providing water to the slip surface further reducing the shear strength of the soils. Through this site, the depth of the shear plane seems to be 20 m or deeper with intermediate scarps creating graben features. It is anticipated that this large-scale slide will continue to move with rates dependant on seasonal rainfall and the water level in the river. As the movement is deep-seated, remediating the slide will be difficult and may be limited to controlling localized issues. As shown on the drawings, there continues to be ongoing deterioration of the site. Erosion of the north ditch is an ongoing occurrence despite past regrading efforts using gravel fill. A sinkhole has formed over one of the culverts at Sta. 17+400. The slide movements are also creating increasing undulation of the pavement surface.

An interpretation of the major landslide blocks and movement directions is shown on Dwg. 32121-PH006-1-2.

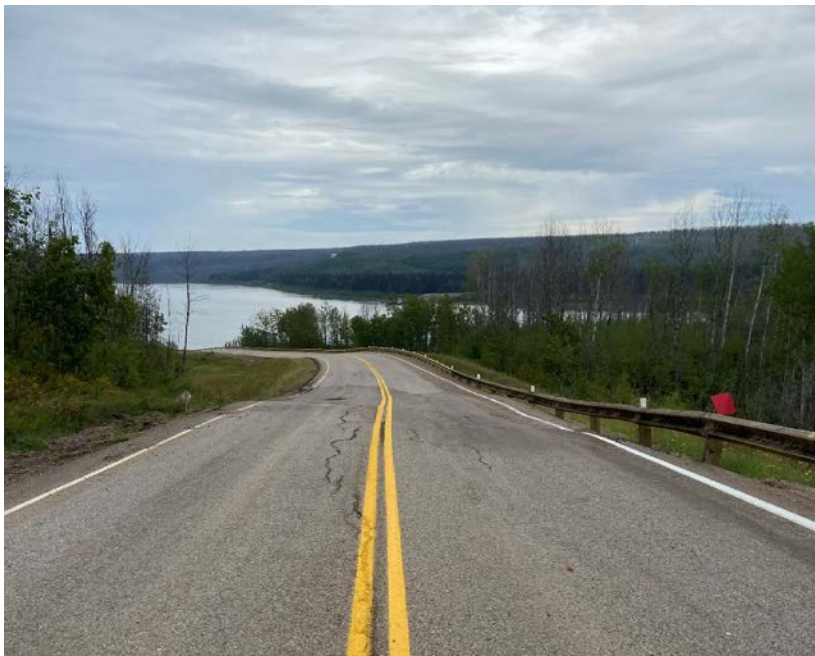
Slide movements have accelerated this month prompting the request for this call-out due to concerns by the MCI (Paul Catt) about the pronounced drop in the pavement downhill of Crack B. During the call-out visit, cracks and a depressed shoulder at Location A suggest that a landslide block is retrogressing into the shoulder of the highway at this location.

Photo 1. Looking NE at slide Crack B.

It is understood that the immediate concern to TEC is that the ferry is scheduled to open soon and there are safety concerns about opening the roadway to traffic due to the recent more-aggressive movements creating the sharp drop off across the road surface at Location B. The usual approach to deal with this, from a maintenance point of view, would be to add more asphalt on the downhill side of the crack to temporarily level out the road surface; however, the MCI has correctly raised concerns about adding additional load to the moving landslide block. To address the immediate need to open the road, it is recommended to cut down the highway starting with zero at a point of 15 m uphill of Crack B to a maximum depth of about 0.5 m right at the crack to remove the hump that has been created by the drop off on the downhill side. This will involve removing about 15 m of pavement on the uphill side and 5 m of pavement on the downhill side. The cut will likely expose the road subgrade so the subgrade will need to be subcut to allow room for new GBC and ACP to patch the cut section. TEC's records indicate that the pavement structure at this site consists of 100 mm of ACP over 300 mm of GBC in undisturbed/unaltered areas. Alternatively, this section could be left with just a gravel surface if TEC is willing to conduct frequent grading to repair ruts and washboards that could develop due to having a short stretch (20 m long parallel in direction of road centreline) of road turned to gravel. The subcut surface of the subgrade should be sloped toward the river to drain any water away from the road subgrade. Bump warning signs should be placed to warn traffic of the developing hazard at Location A. If this area subsides more rapidly consideration could be given to temporarily widening the north shoulder of the highway partly into the ditch and placing delineators around the affected area.

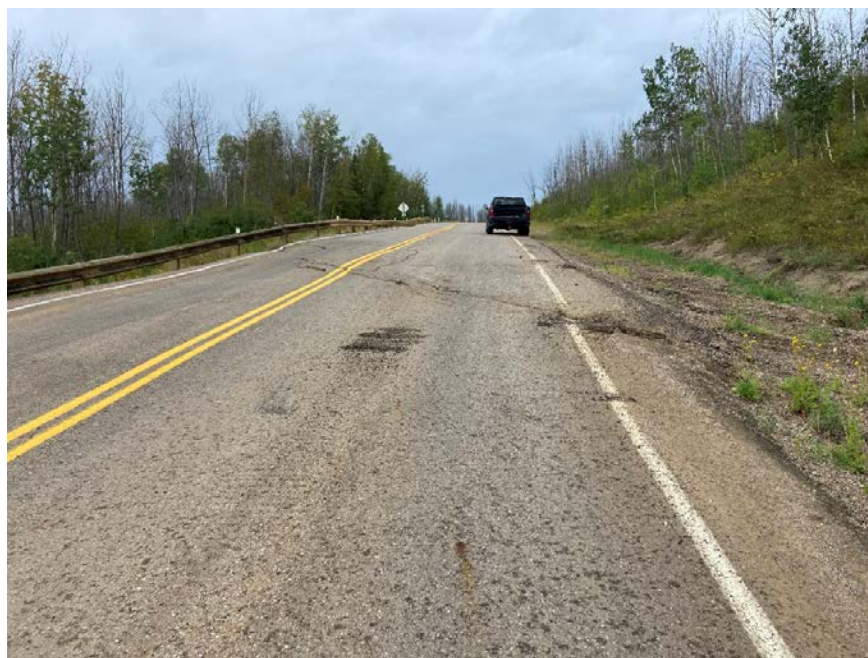
Photo 2. Looking SW at slide crack B.

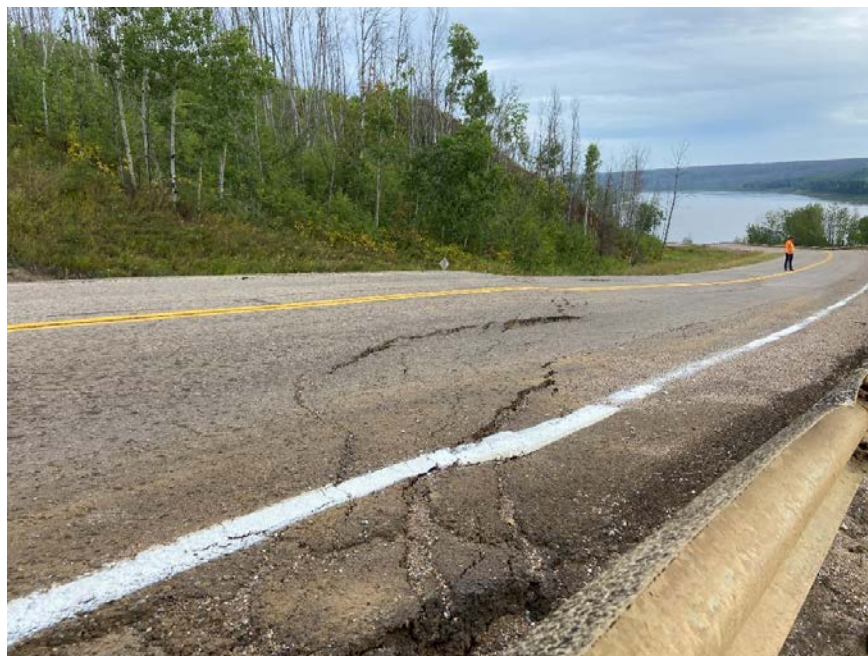
Photo 3. Looking north at Crack B.

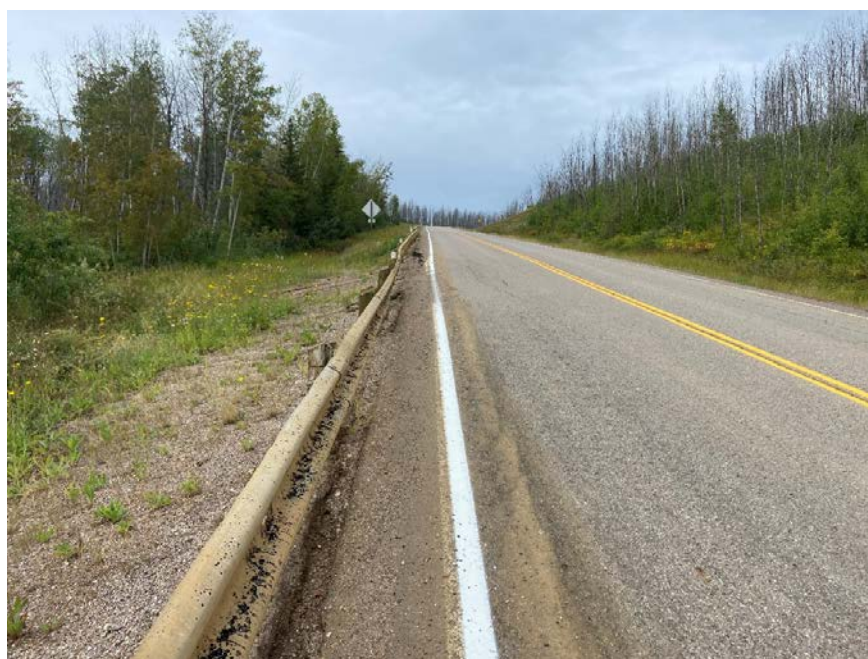
Photo 4. Looking SW at slide Crack A.

A pile wall (possibly driven steel) should be installed along the edge of the highway to support the roadway along retrogressing slide at Location A.

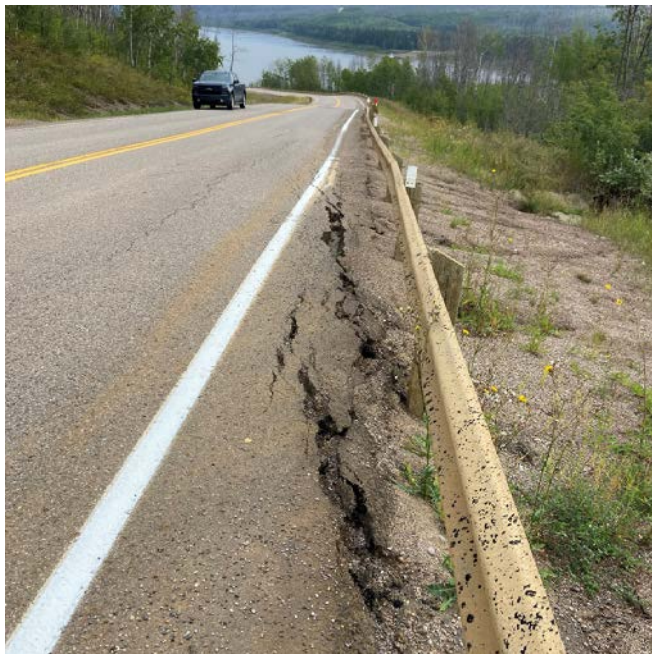
Photo 5. Looking NE at slide crack A.

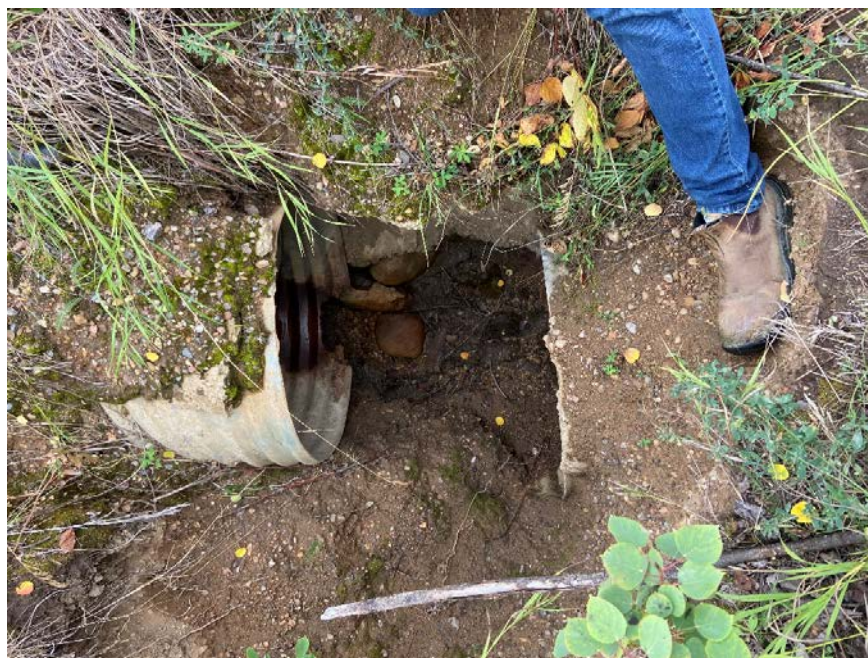
<input checked="" type="checkbox"/> Seepage	Seepage previously observed from the GBC between Sta. 17+300 and 17+400	<input type="checkbox"/>
<input checked="" type="checkbox"/> Bridge/Culvert Distress	800 mm CSP downpipe in southwest site is being pulled apart by slope movement. Adjacent 600 mm CSP centerline culvert inlet becoming obstructed and invert badly corroded. Inlet of N 600 mm CSP culvert at 17+400 covered with dirt; inlet and outlet of S CSP badly corroded.	<input checked="" type="checkbox"/>
<input type="checkbox"/> Other		<input type="checkbox"/>
Instrumentation (as of Spring 2024):		
Destroyed	SI02-2, -3, -4, and -5 sheared off between 2004 and 2009. PN02-4 was destroyed in 2005, PN02-1 in 2008 and PN02-05 in 2021. SI-1 was blocked or sheared at 3m below ground surface in 2024.	
Inclinometers	SI-5 showed a movement rate of 7.7 mm/yr over 0.1 m to 11.1 m depth since the spring of 2023 readings. This rate is consistent with a long term trendline of the movement rate

Photo 6. Separation in C.S.P. downpipe at slide crack

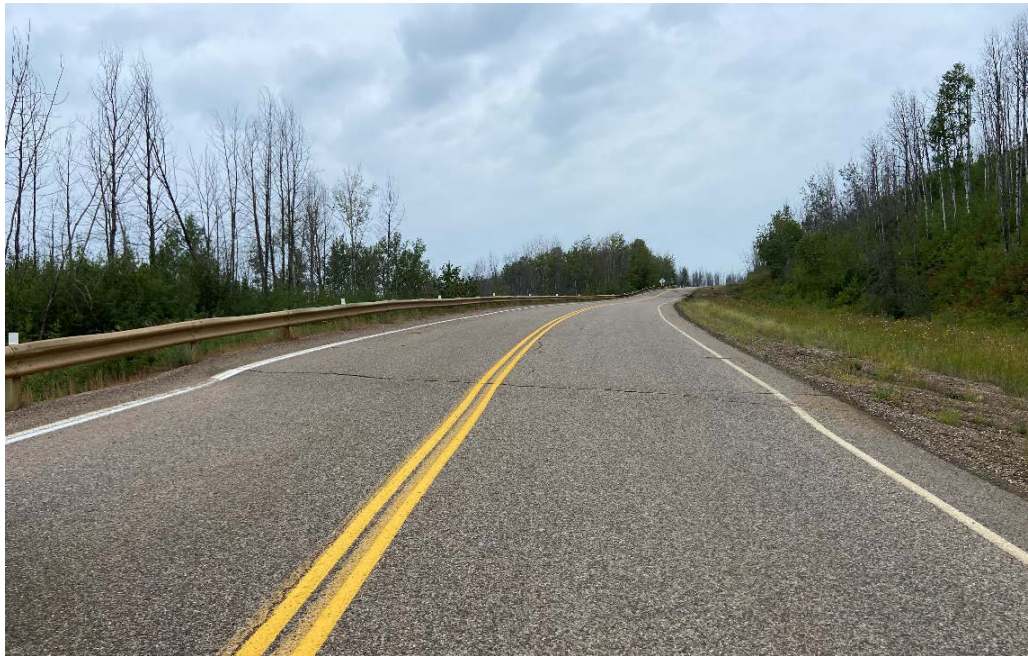
Photo 7. Looking SW at slide crack C.

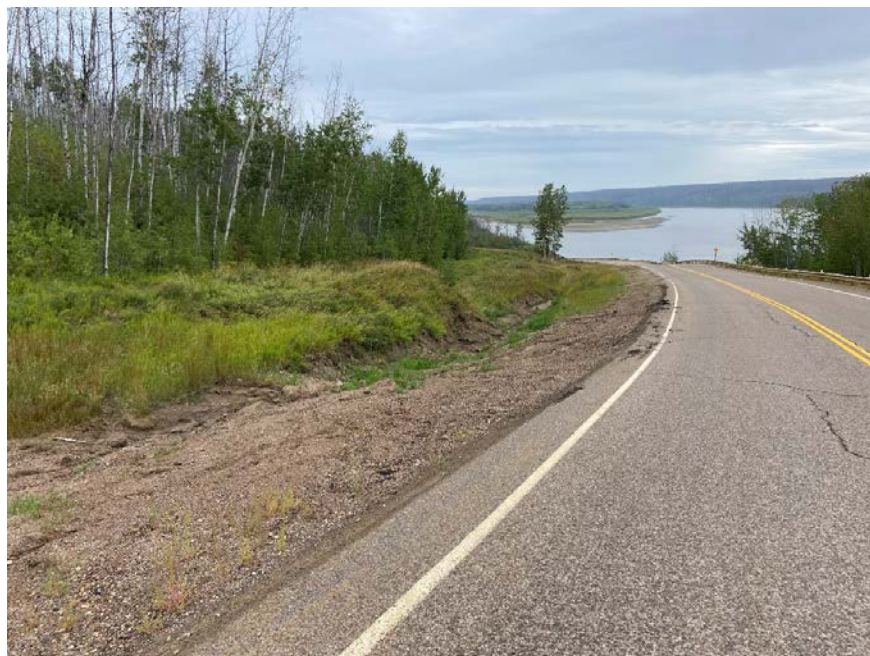
Photo 8. Looking NE at slide crack C with graben in background.

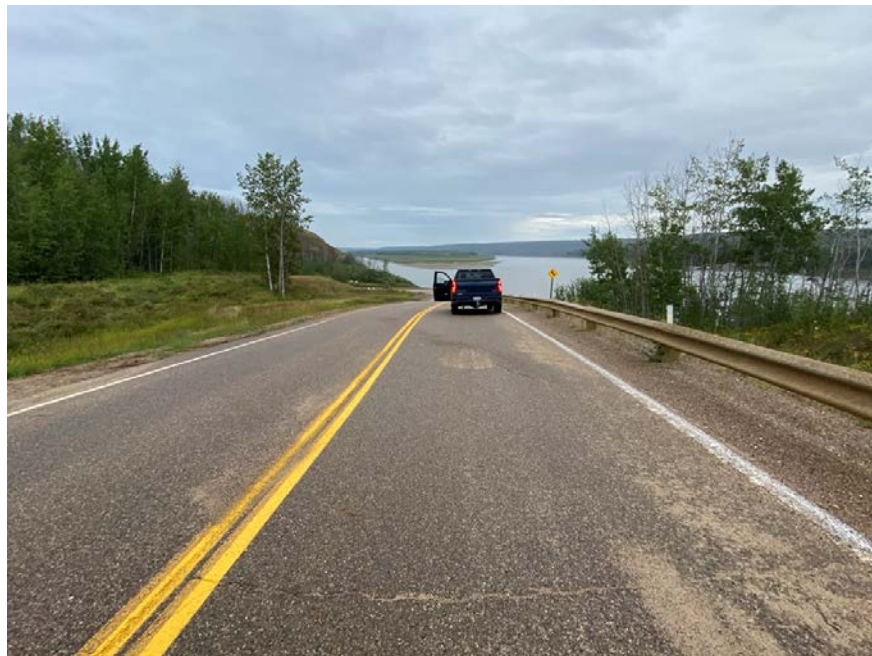
Photo 9. Looking NE at slide crack D.

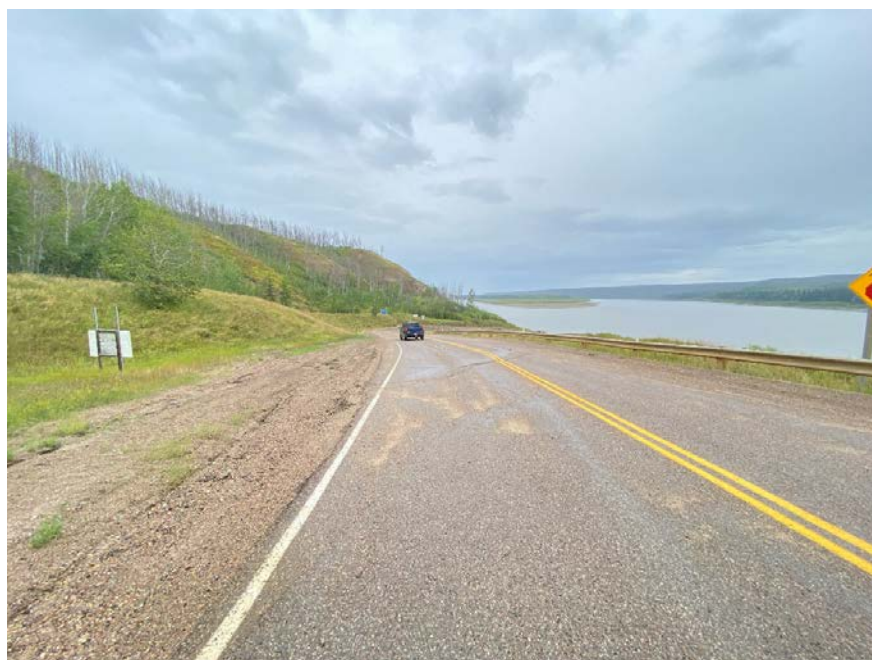
Photo 10. Looking north at slide crack E.

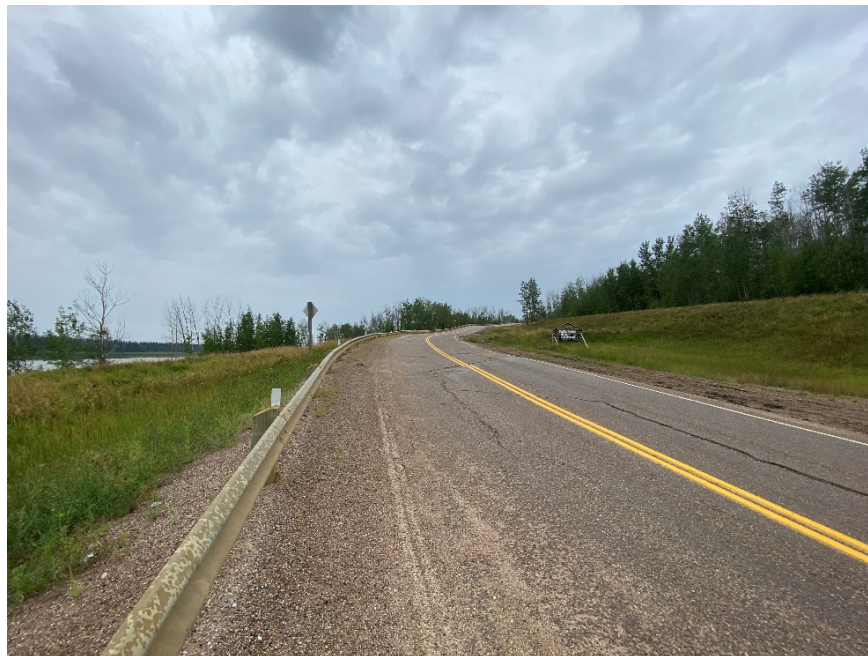
Photo 11. Looking south at slide crack E.

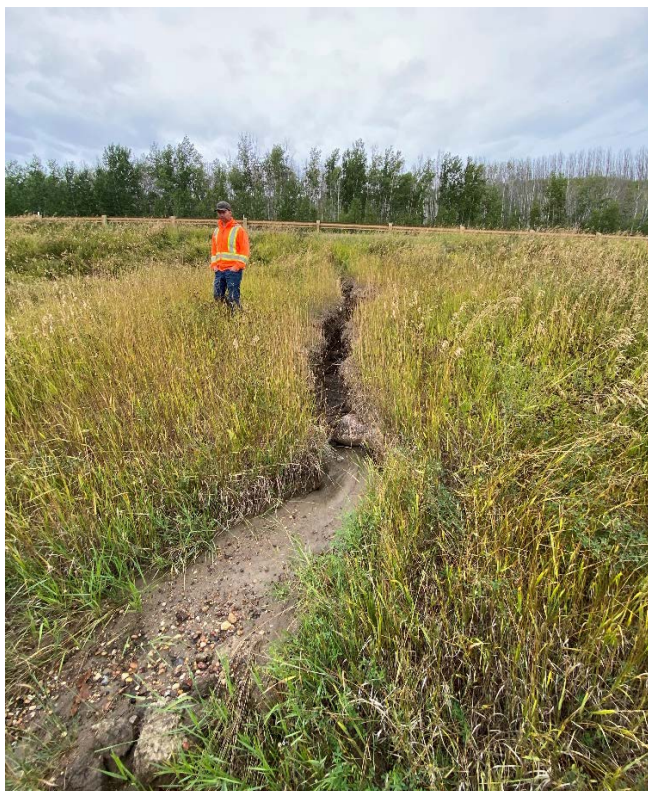
Photo 12. Erosion in sideslope downhill of culvert outlet.

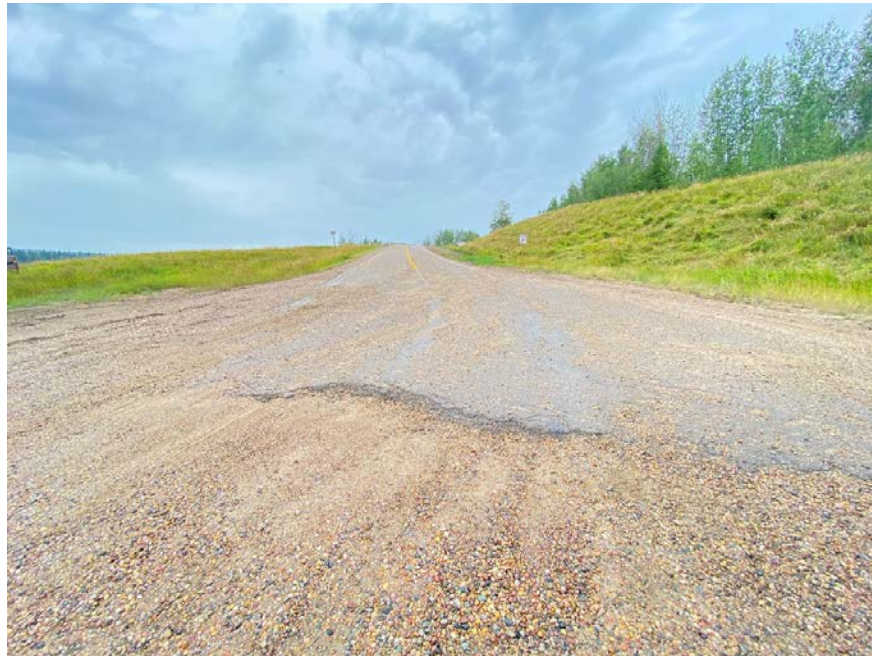
Photo 13. Looking south at end of pavement
