**ALBERTA TRANSPORTATION
GEOHAZARD ASSESSMENT
PEACE REGION (PEACE RIVER DISTRICT)
2023 INSPECTION**

THURBER ENGINEERING LTD.

Site Number	Location	Name	Hwy	km
PH011-2	North of Peace River	Whitemud River	743:02	43.2
PH011-3				42.8
Legal Description		UTM Co-ordinates		
PH011-2: SW01-88-21-W5		11U N 6,272,980	E	487,129
PH011-3: SW01-88-21-W5		11U N 6,272,586	E	487,326

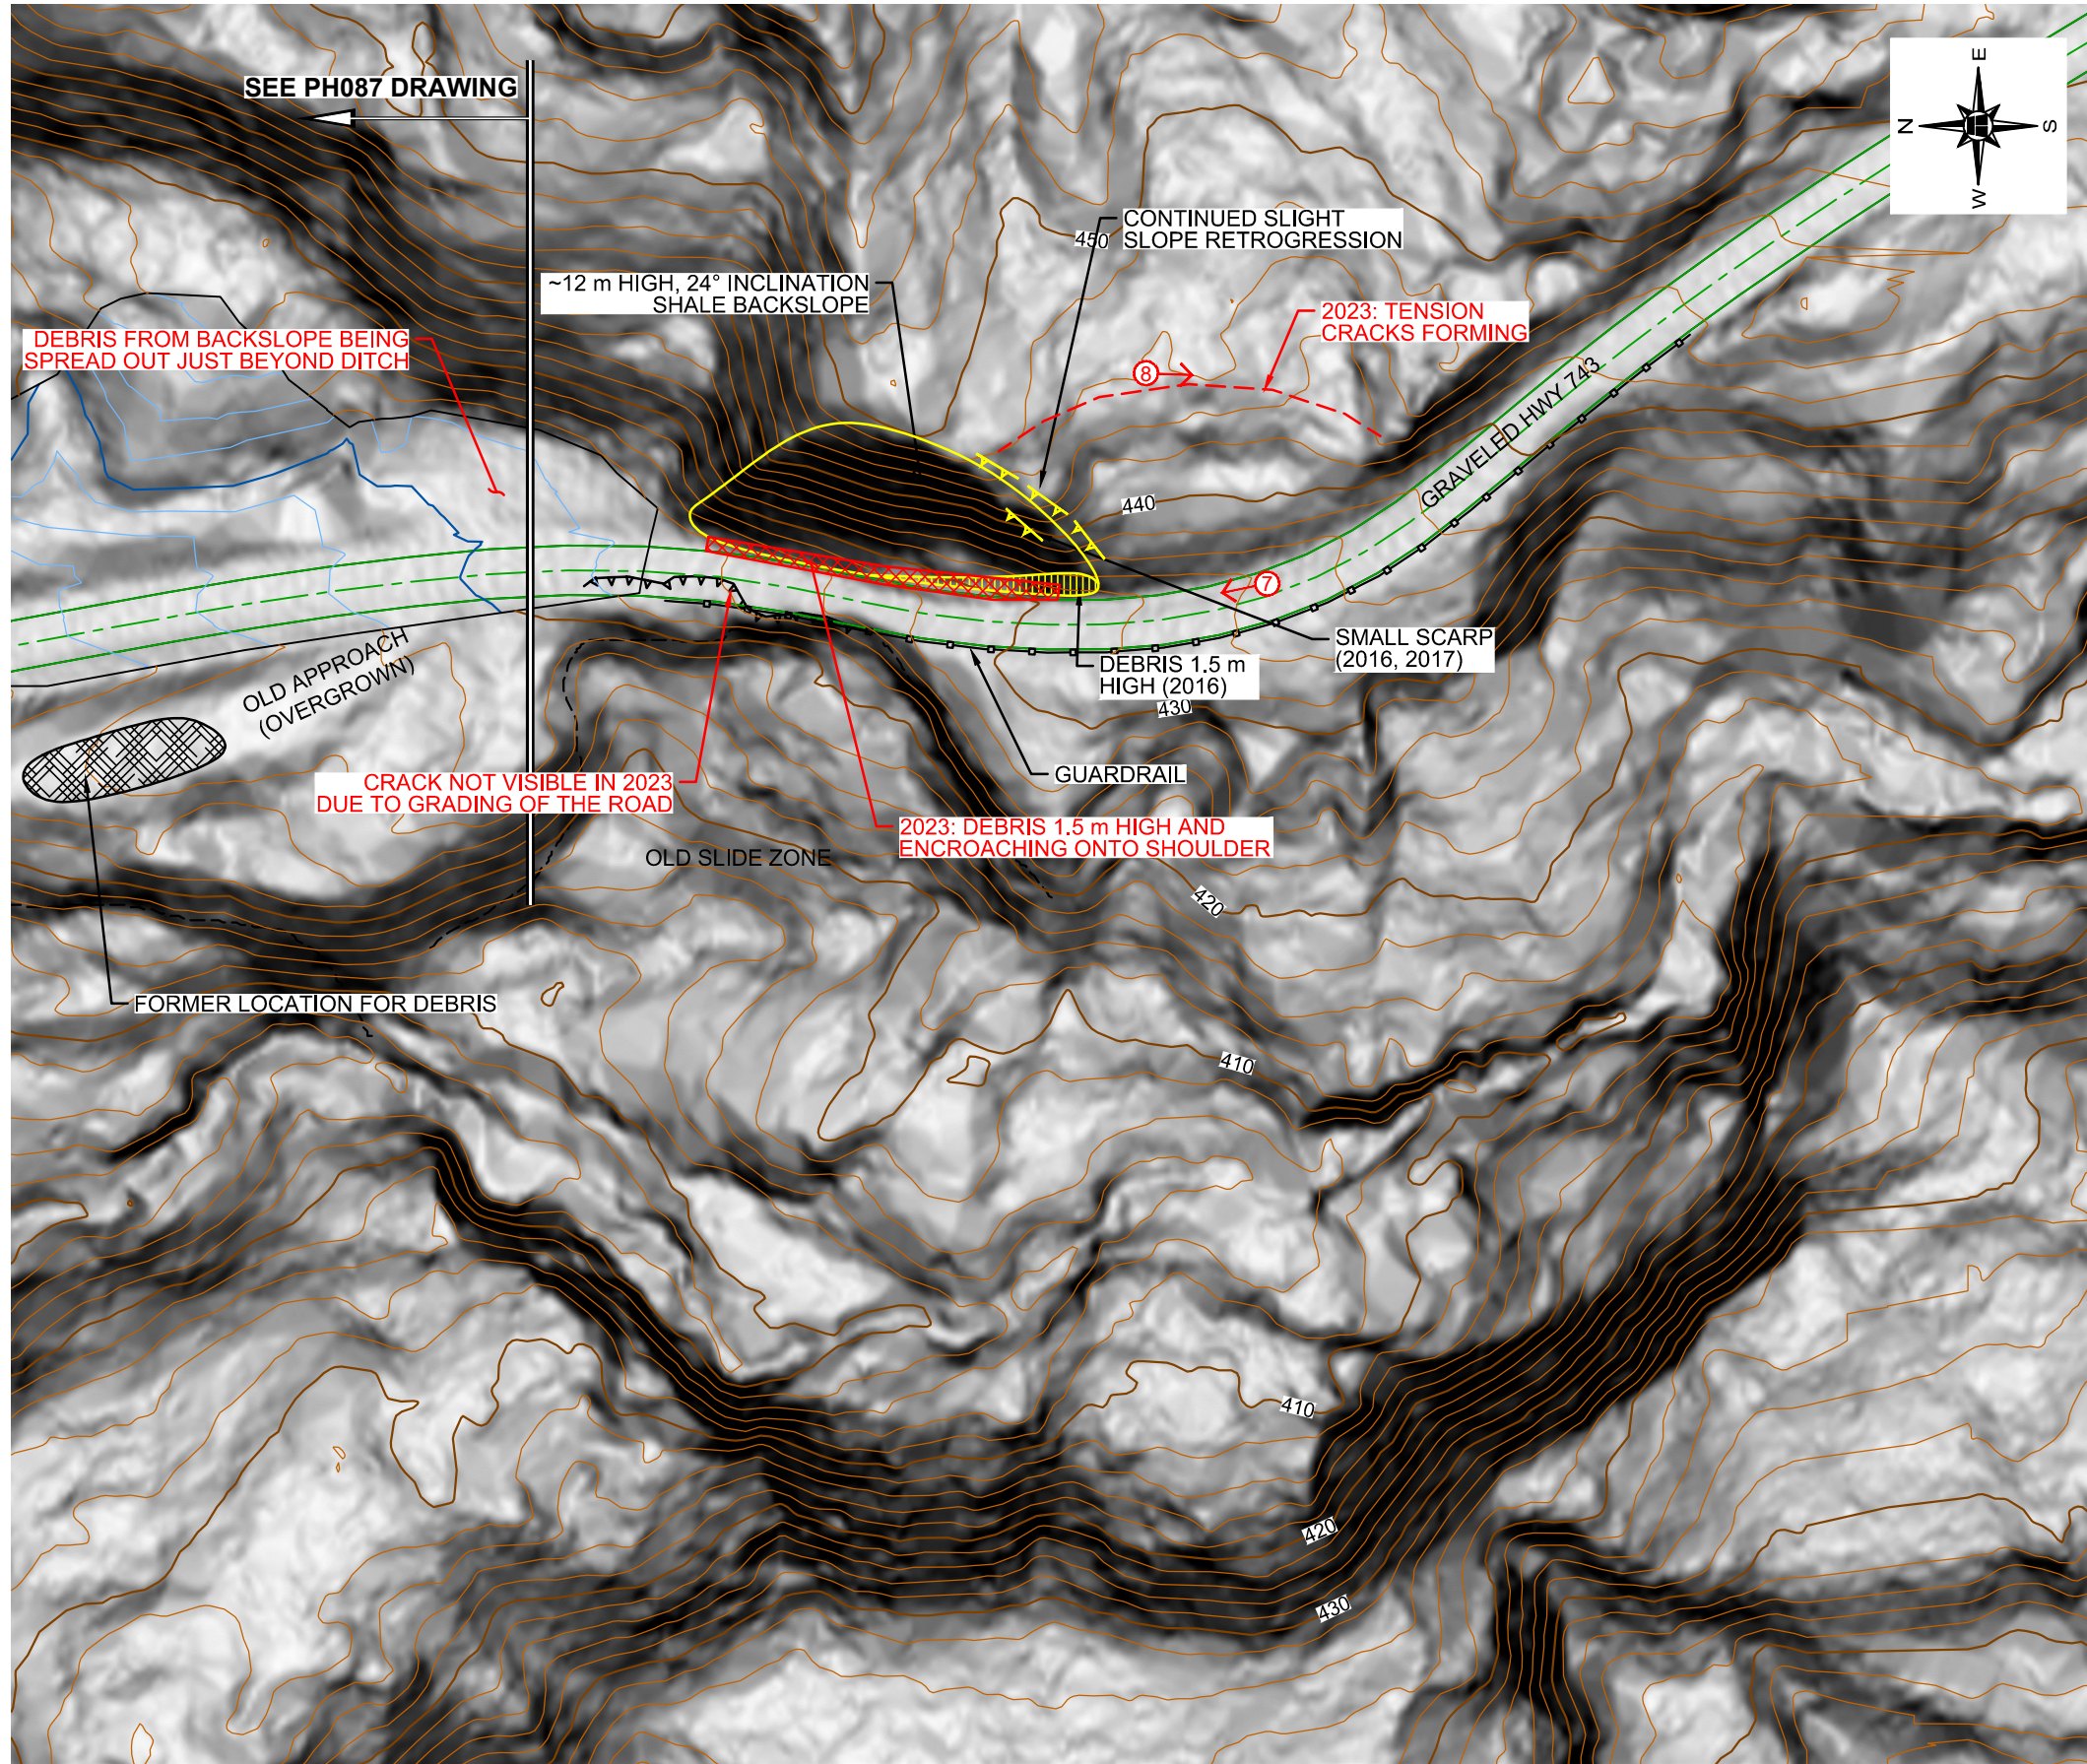
PH011-2: HWY 743:02
2023 SITE INSPECTION PLAN

PH011-2		
Primary Site Issue:	A steep backslope cut has been eroding and depositing material in the ditch and on the highway.	
Dimensions:	85 m wide measured along the shoulder, the slope is approximately 25 m high and inclined at 37°.	
Date of Remediation:	None	
Maintenance:	Ongoing grading to keep the ditch and roadway open	
Observations:	Description	Worsened?
<input checked="" type="checkbox"/> Pavement Distress	Material accumulating in the east ditch is encroaching onto the shoulder of the road	<input checked="" type="checkbox"/>
<input checked="" type="checkbox"/> Slope Movement	There are fresh scarps opening at the top of the slope.	<input checked="" type="checkbox"/>
<input checked="" type="checkbox"/> Erosion	Material has raveled downward due to erosion with a toe height of about 1.5m.	<input checked="" type="checkbox"/>
<input type="checkbox"/> Seepage		<input type="checkbox"/>
<input type="checkbox"/> Bridge/Culvert Distress		<input type="checkbox"/>

- At the PH011-1 (km 42.4) site, the exposed backslope should be textured (dozer walking up and down the slope), seeded, and covered with a temporary erosion control blanket. Consideration should be given to using a permanent control blanket in the ditch where flow will be concentrated.
- At the PH011-2 (km 43.2) site, the slumped material should be removed from the side of the road and hauled to the disposal area located just south of the valley. Consideration should be given to cutting back the slope to reduce the amount of material that could ravel onto the highway.

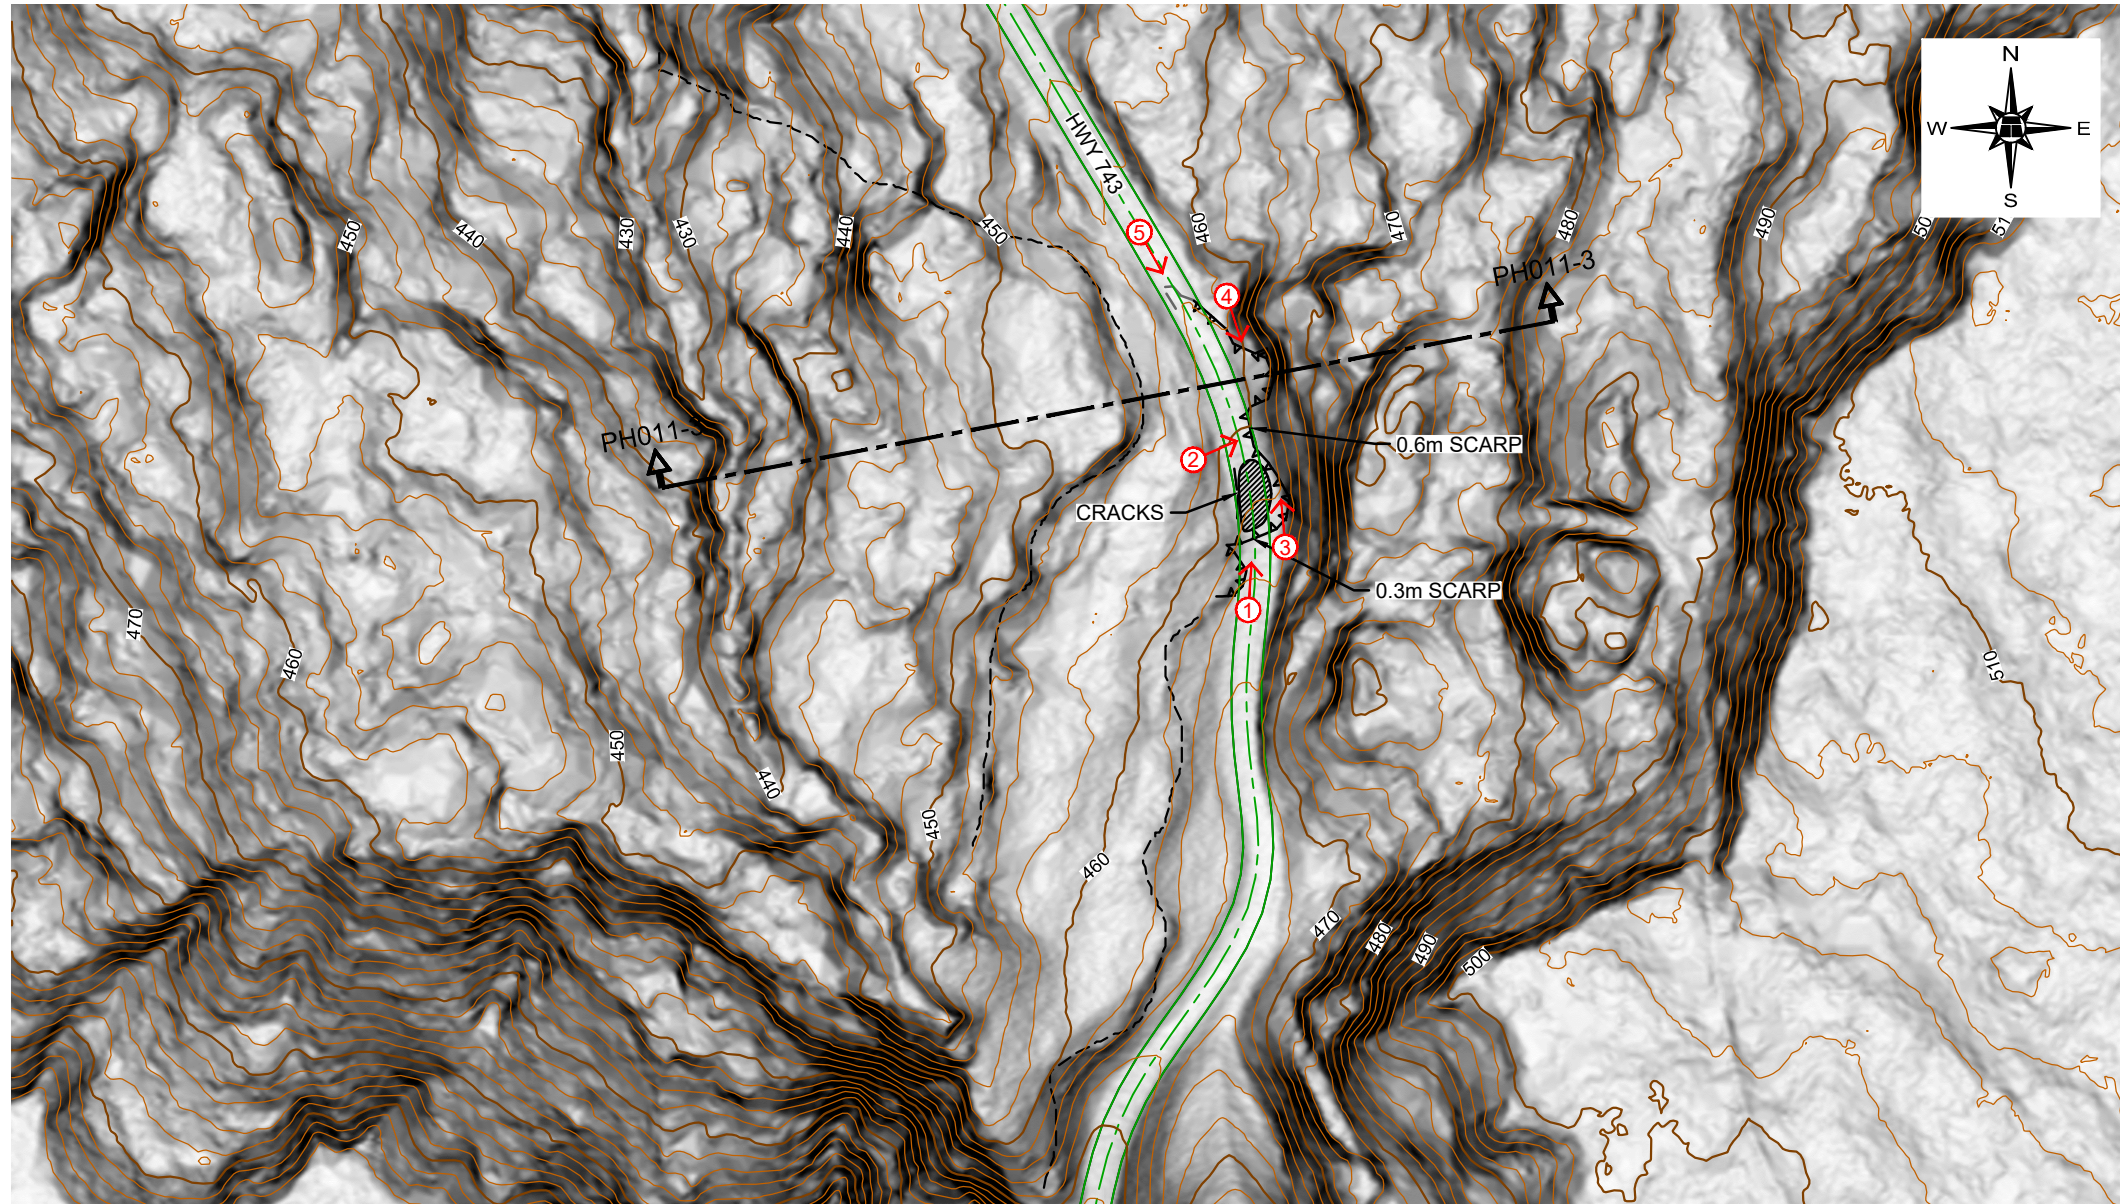
**PH011-3: HWY 743:02
2023 SITE INSPECTION PLAN**

<input type="checkbox"/> Other		<input type="checkbox"/>
PH011-3		
Primary Site Issue:	A landslide scarp has developed in the surface of a two laned gravelled road.	
Dimensions:	100 m wide along the shoulder, approx. 400 m wide at the creek and 170 m long from the highway to the creek.	
Date of Remediation:	2020: Backslope slump at original PH011-1 (km 42.4) site cut back later in the year when crews in the area constructing detours around other failures.	
Maintenance:	July 13, 2020: Highway closed due to landslide movements at other sites and reopened late in the year after detours had been constructed. 2021: Site regraded to remove unevenness from slide movements

Observations (PH011-3):	Description	Worsened?
<input checked="" type="checkbox"/> Pavement Distress	Cracks were crossing both lanes (graded out) and there is a dip in gravel road surface.	<input type="checkbox"/>
<input checked="" type="checkbox"/> Slope Movement	Cracks and dip across roadway indicate slope movement. LiDAR indicates historical landslide scarps on slope above and below roadway.	<input type="checkbox"/>
<input type="checkbox"/> Erosion		<input type="checkbox"/>
<input type="checkbox"/> Seepage		<input type="checkbox"/>
<input type="checkbox"/> Bridge/Culvert Distress		<input type="checkbox"/>
<input type="checkbox"/> Other		<input type="checkbox"/>
Instrumentation:		
None.

Recommendations:
<p>Short-Term (<3 months):</p> <ul style="list-style-type: none"> ▪ The cracks and slumping at PH011-3 can be managed with routine grading to provide a safe roadway surface. Nonetheless, frequent visits by the Maintenance Contractor are recommended to ensure that the roadway remains safe for the travelling public as there are several slides in this

valley that could reactivate and further damage the road, especially following heavy periods of precipitation and the coming spring thaw when groundwater levels could be higher. If possible, cutting an upslope ditch that could drain the site could be advantageous for controlling movement rates.

- A vertical realignment of the roadway through the slide could be carried out if the road condition worsens. The reprofiling could lower the road a few meters through the slide zone by taking out the hump in the road profile starting from south of the site. The slide area itself could be further unloaded by subexcavating some of the soil and replacing it with EPS light-weight fill. A subdrain could also be installed along the upslope side of the road to locally lower the groundwater and the shoulder of the road in the slide zone could be cut down to take a bit of the weight of the slide block.

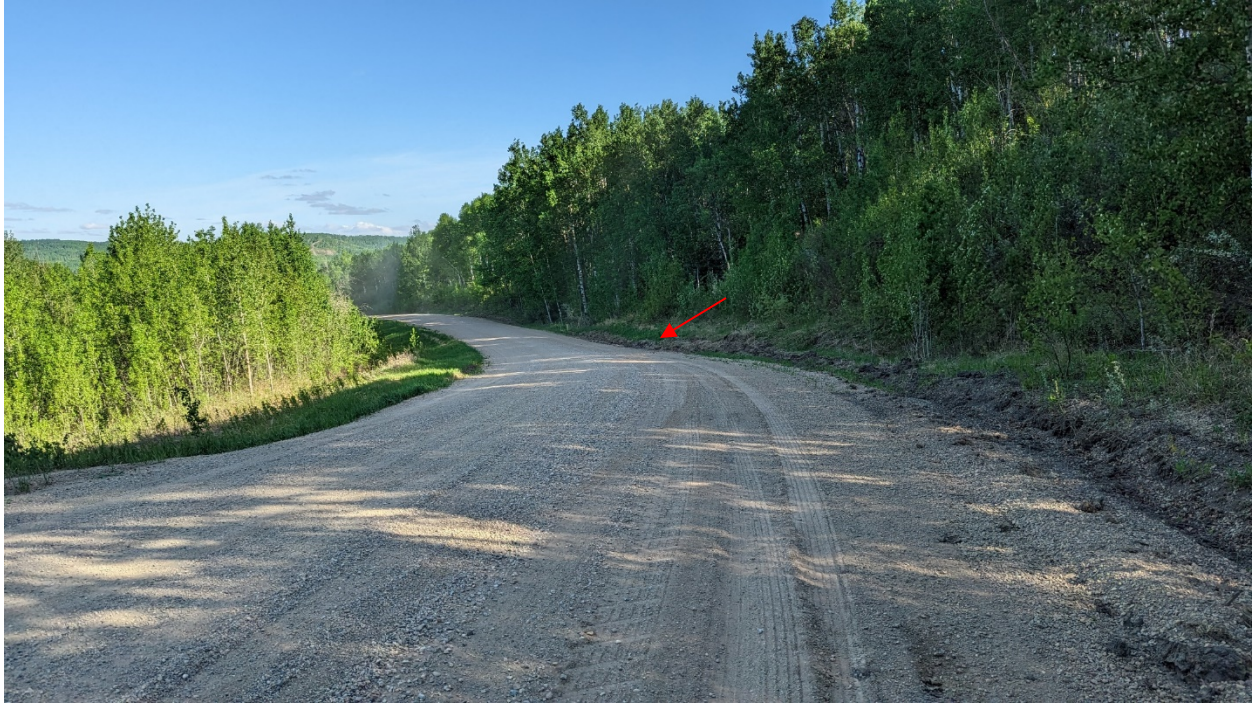
Photo 1 (PH011-3) – Looking north at landslide site identifiable by the dip in the highway surface.

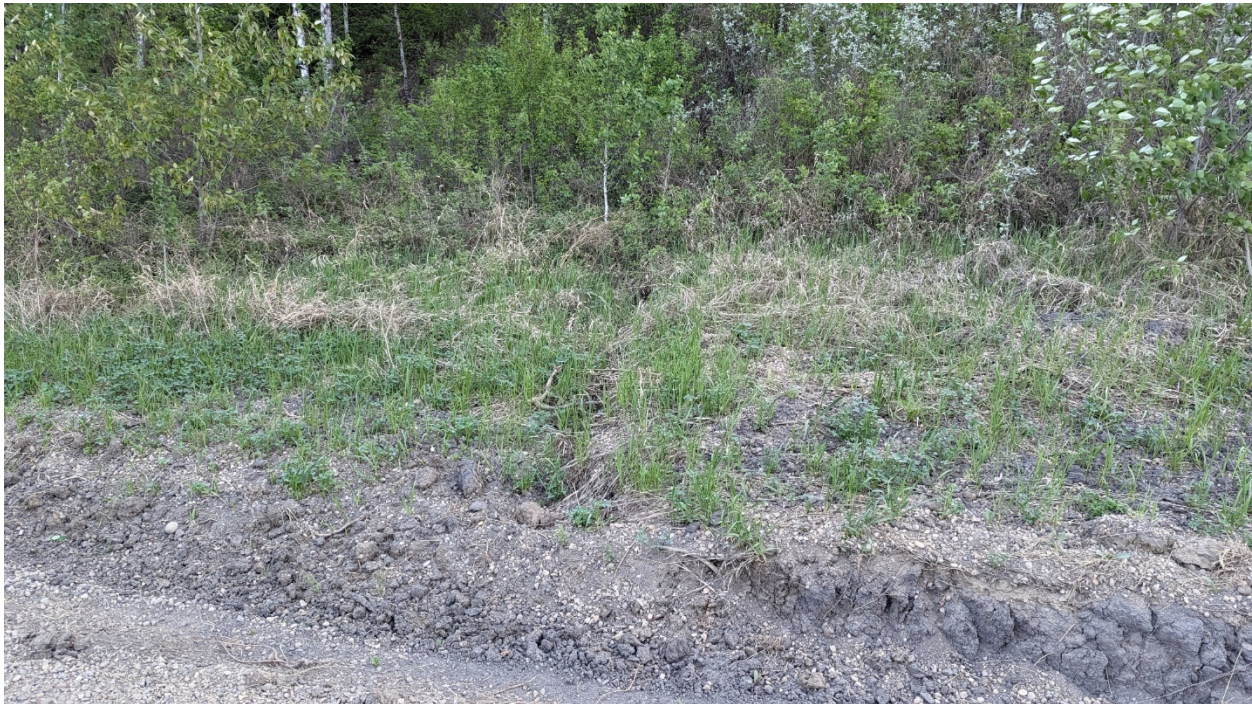
Photo 2 (PH011-3) – Scarp crack beyond the edge of the road.

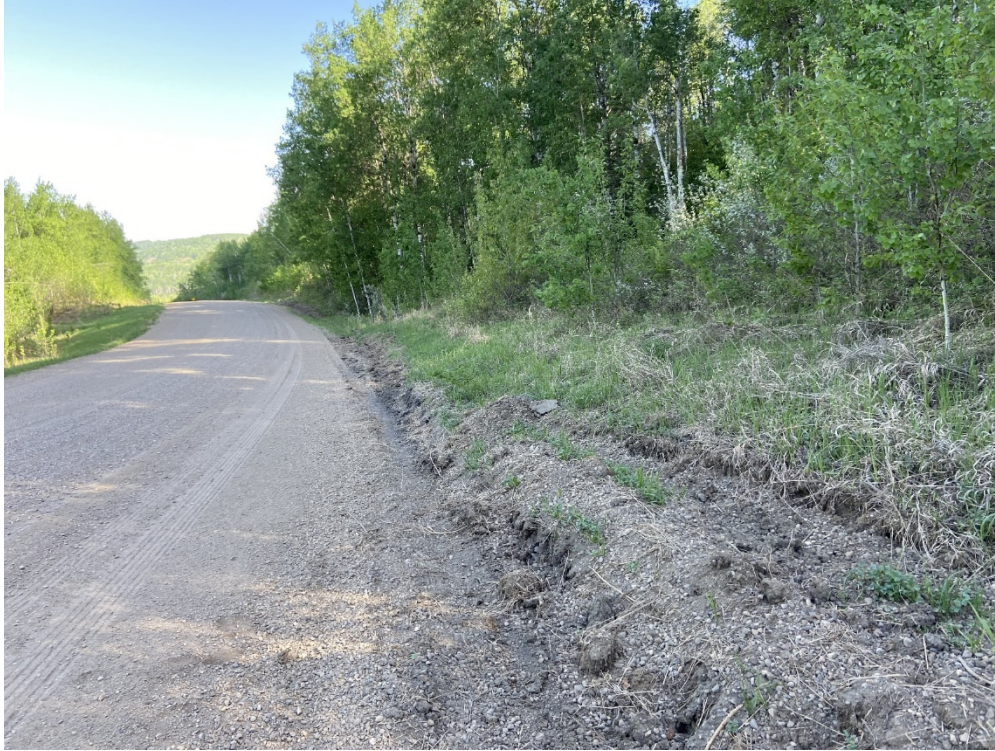
Photo 3 (PH011-3) – Looking north along backscarp crack (in the grass).

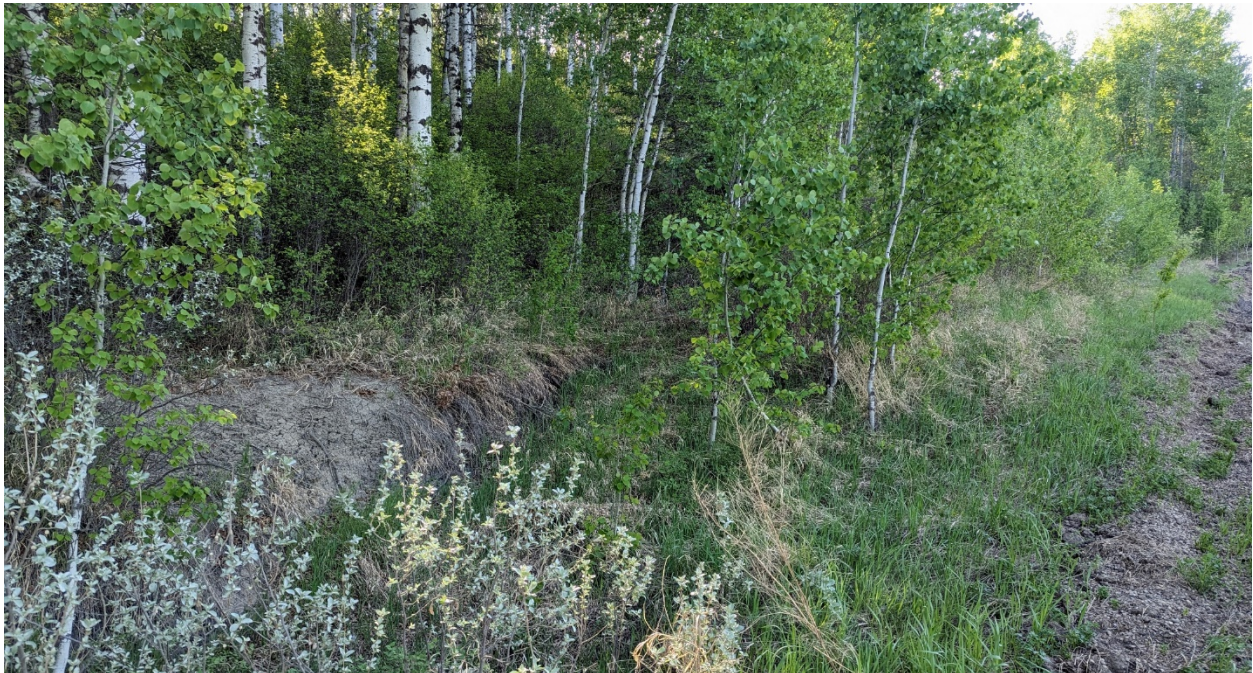
Photo 4 (PH011-3) – Looking south at where displacement has occurred along backscarp of slide at edge of highway.

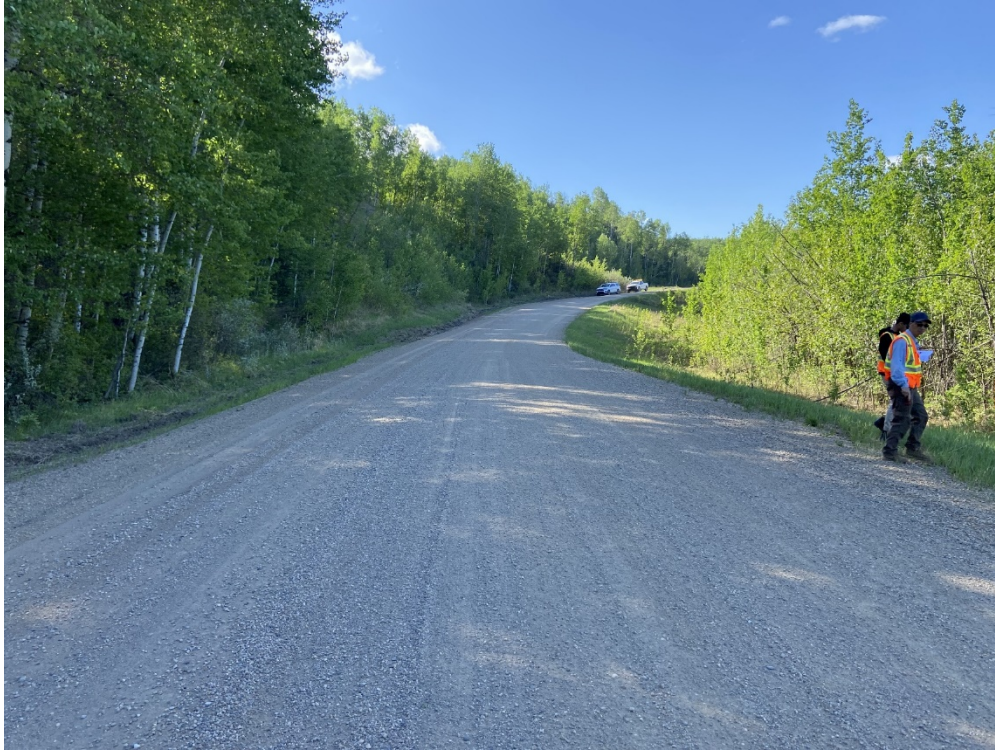
Photo 5 (PH011-3) – Looking south toward the landslide.

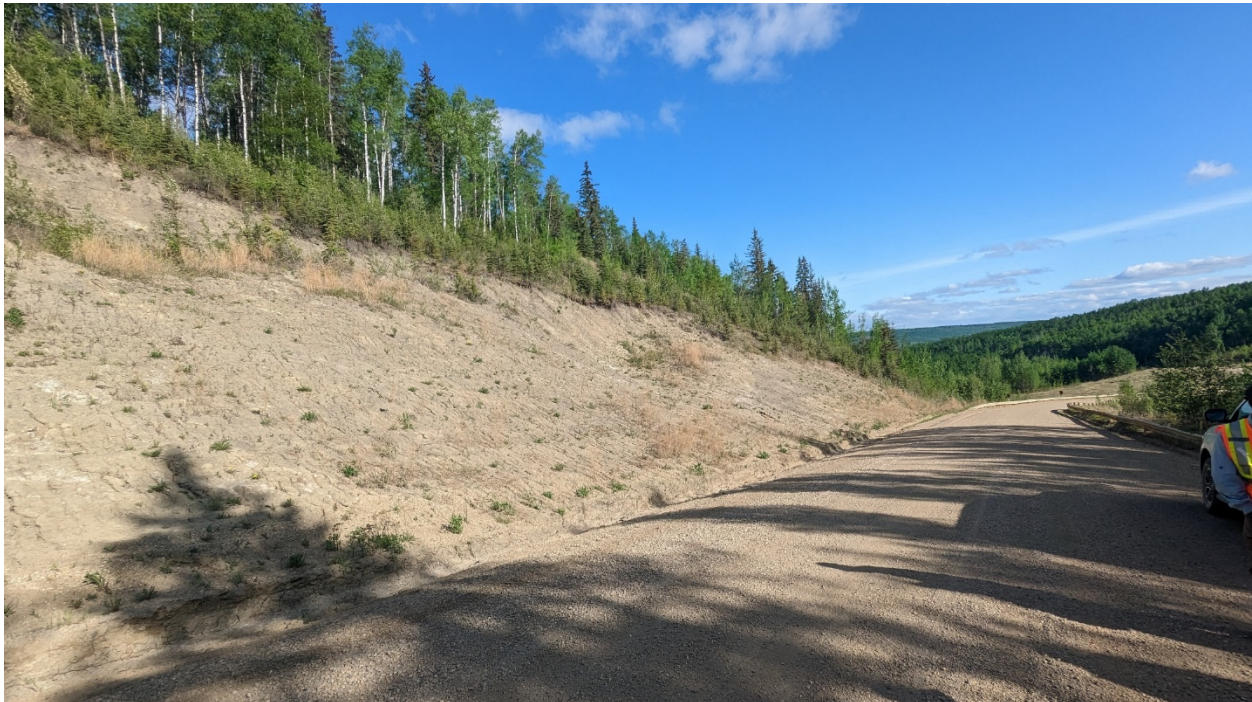
Photo 6 (PH011-1) – Looking at regraded backslope failure area at PH011-1 site (km 42.4).

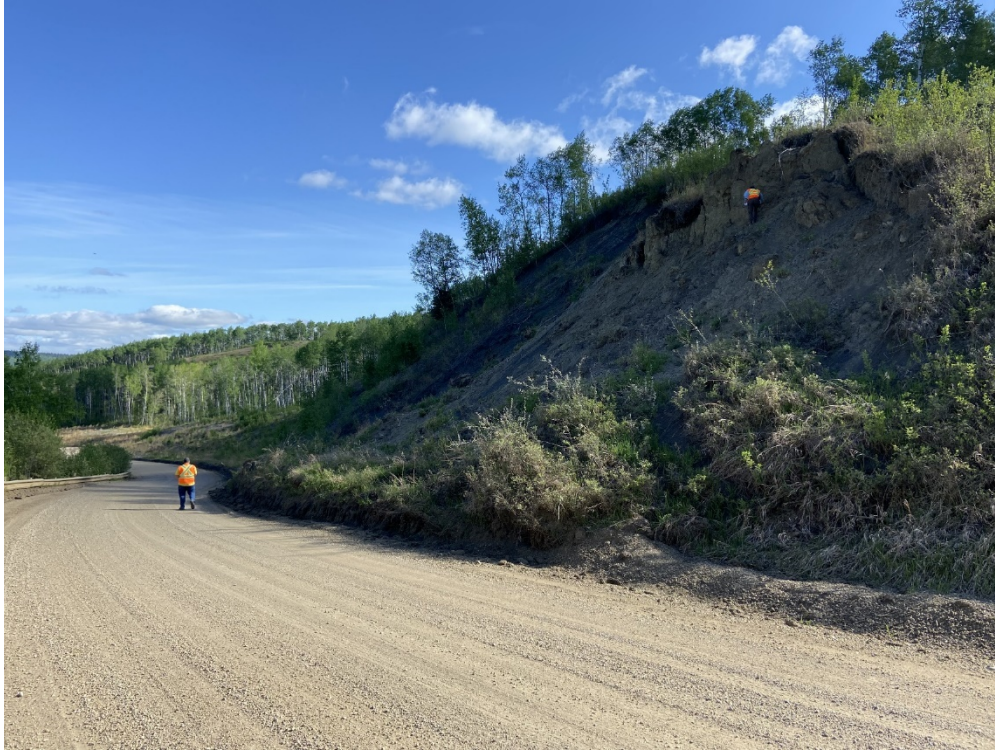
Photo 7 (PH011-2) – There has been a recent movement on this backslope resulting in material accumulating onto the east shoulder of the highway.

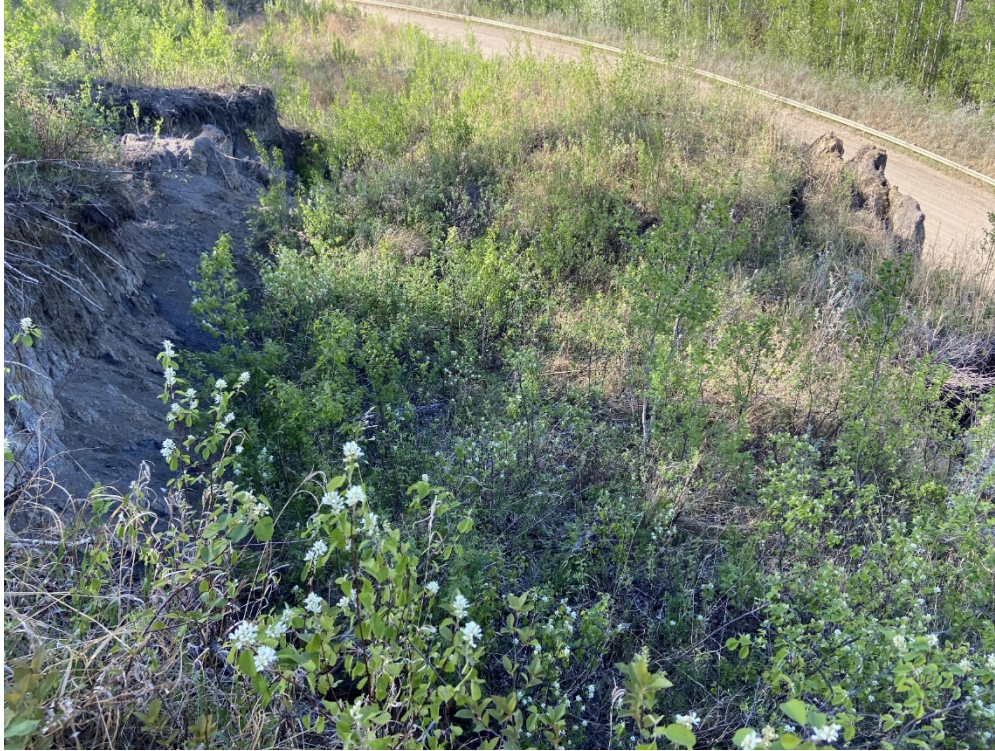
Photo 8 (PH011-2) – There is an evidence of recent scarp cracks opening behind the top of the slope.
