**ALBERTA TRANSPORTATION
GEOHAZARD ASSESSMENT
PEACE REGION (PEACE RIVER DISTRICT)
2023 INSPECTION**

Site Number	Location	Name	Hwy	km
PH038-1	North of Town of Peace River	Whitemud River (km 45.5)	743:02	45.3
Legal Description		UTM Co-ordinates		
S11-88-21-5		11V N 6,274,373	E 485,755

PH038-1: HWY 743:02 WHITEMUD RIVER, km 45.3
2023 SITE INSPECTION PLAN

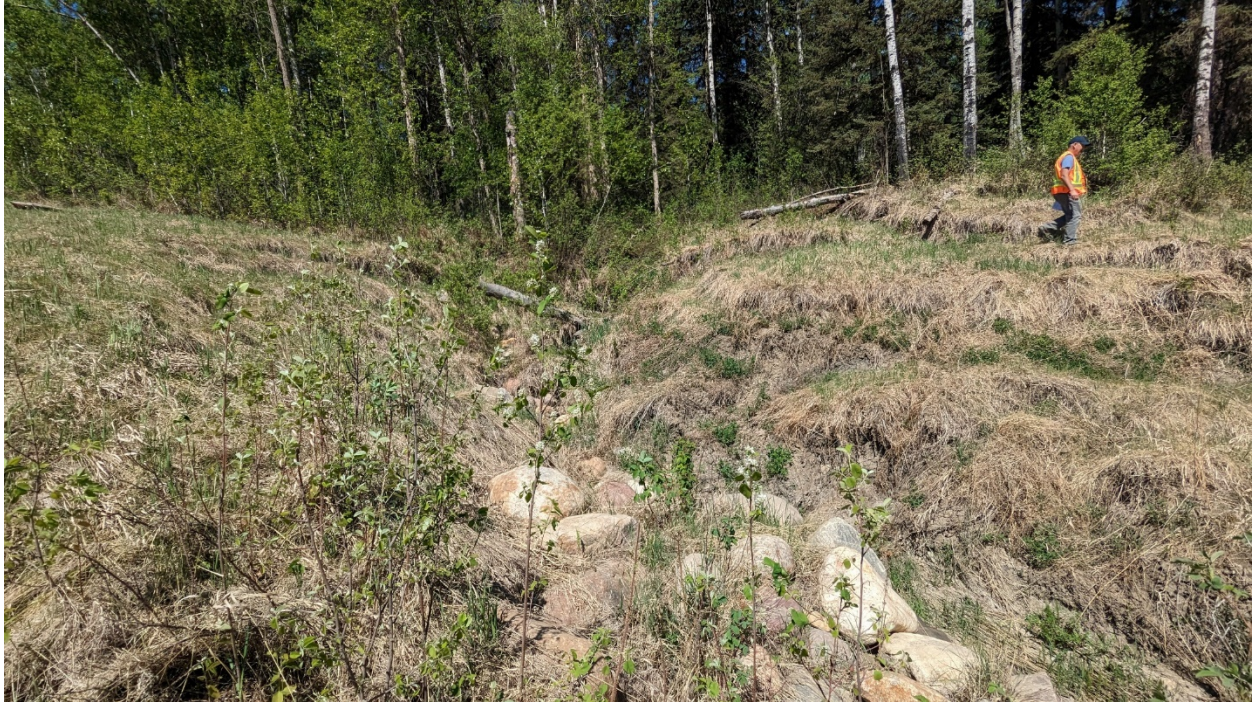
Photo 1 – Looking at the north end of drainage swale.

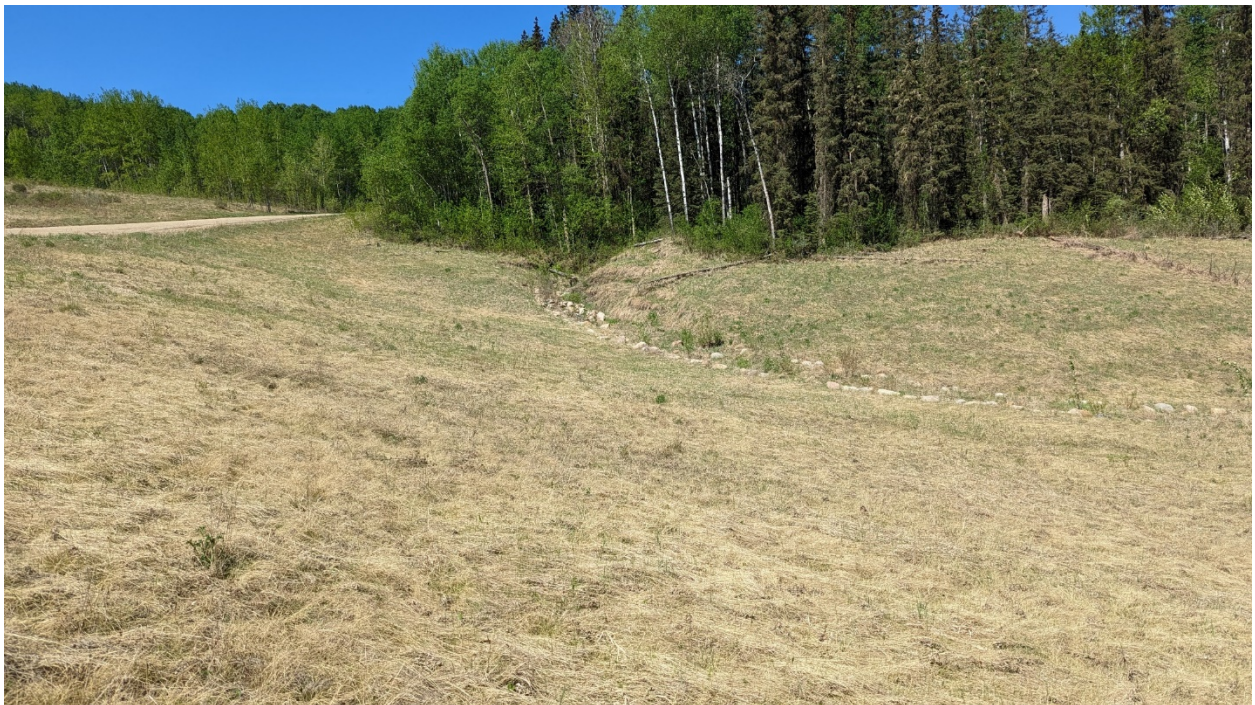
Photo 2 – Looking northeast at drainage swale.

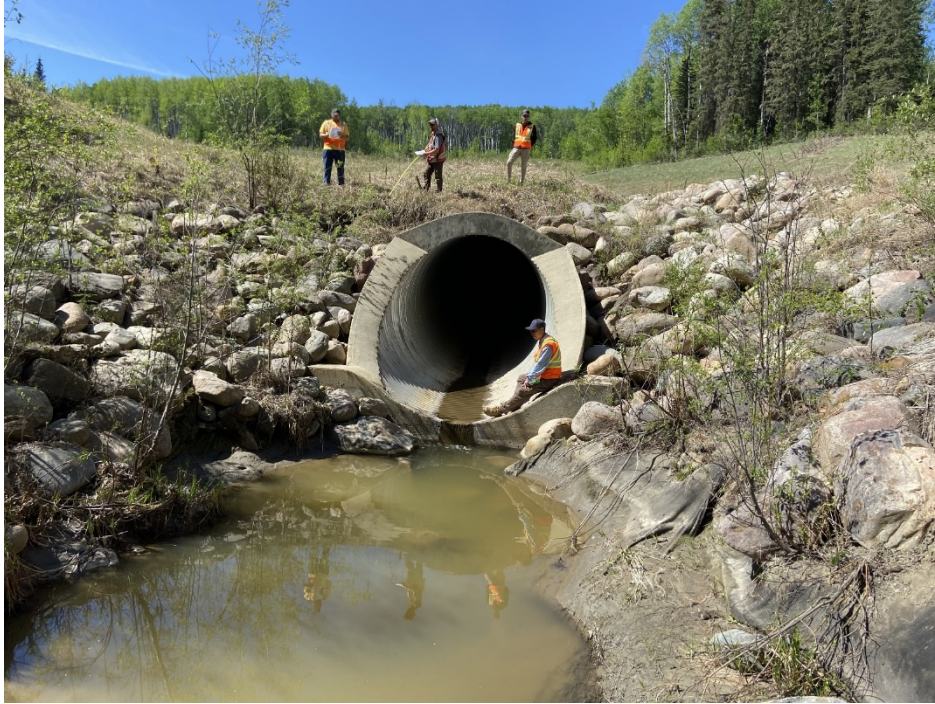
<input checked="" type="checkbox"/> Slope Movement	No noticeable signs of movement of embankment. Slumping occurring along east swale and near both the culvert inlet and outlet.	<input checked="" type="checkbox"/>	<input type="checkbox"/>
<input checked="" type="checkbox"/> Erosion	Erosion has occurred along the east swale causing slumping along the entire length. Voids forming below concrete headwalls at inlet and outlet.	<input type="checkbox"/>	<input checked="" type="checkbox"/>
<input checked="" type="checkbox"/> Seepage	Minor seepage was noted in the riprap apron at the culvert outlet. Seepage also noted along the highway west ditch which was become quite pronounced since 2020 and the grader operator related it flows year-round.	<input checked="" type="checkbox"/>	<input type="checkbox"/>
<input checked="" type="checkbox"/> Culvert Distress	The 2.43 m dia. culvert (BF77273-2) was installed in 2009 and is in good condition. There is a 900 mm dia. culvert at the north side of the site: the inlet is sunken well below ditch level and an erosion bowl has formed at the outlet.	<input type="checkbox"/>	<input checked="" type="checkbox"/>

Photo 3 – Looking northwest at culvert outlet.

- The voids forming below the concrete headwalls should be grouted if the other repairs are undertaken at the site.
- Similarly, if other repairs are being done, consideration should be given to adding additional riprap along the creek banks at the outlet to replace that lost to water erosion as well as at both headwalls.

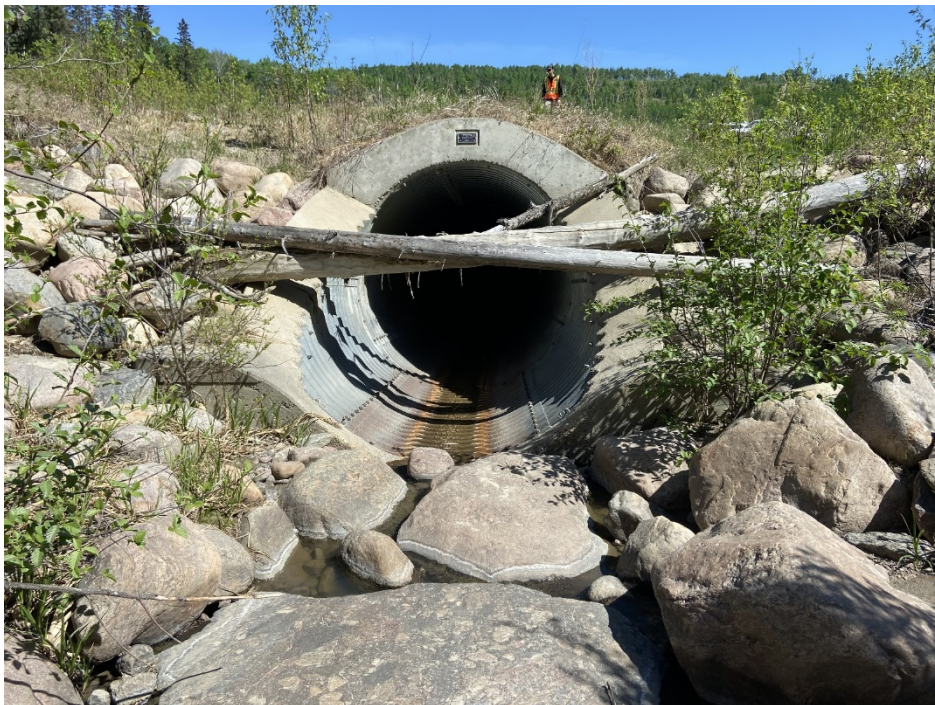
Photo 4 – Looking southeast at culvert inlet.

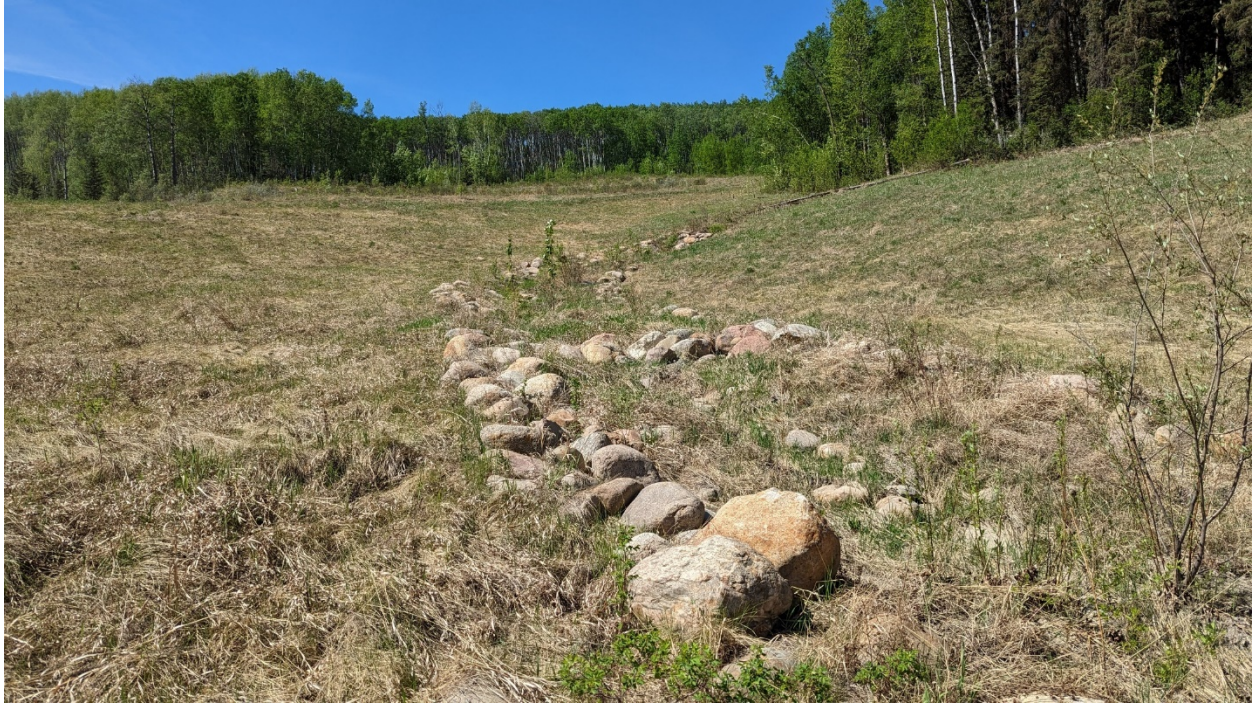
Photo 5 – Looking north at swale near the culvert outlet.

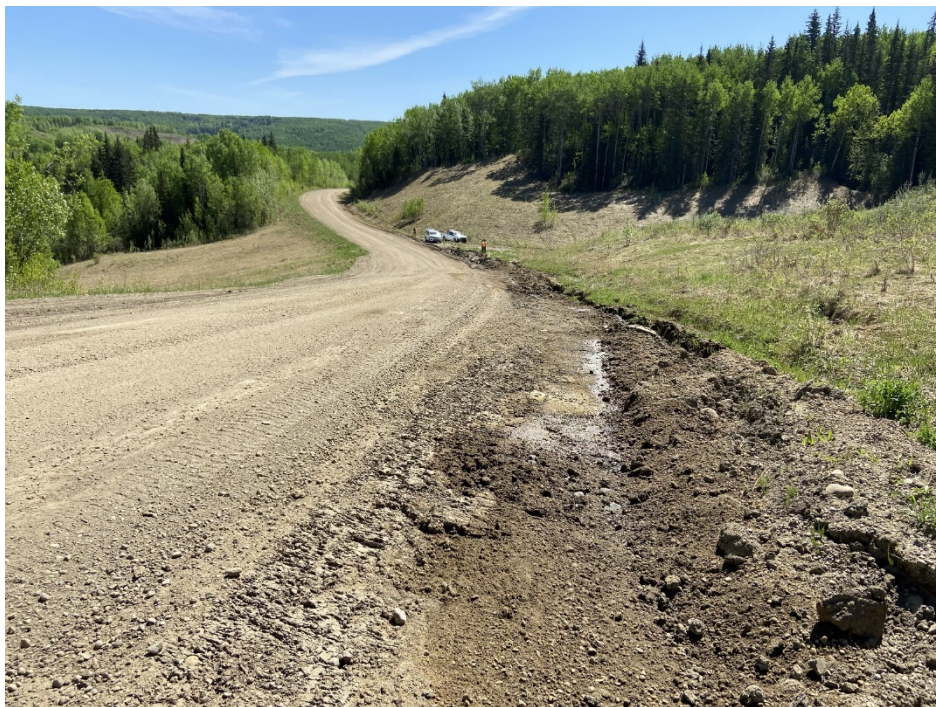
Photo 6 – Looking southwest at road and seepage along west ditch.

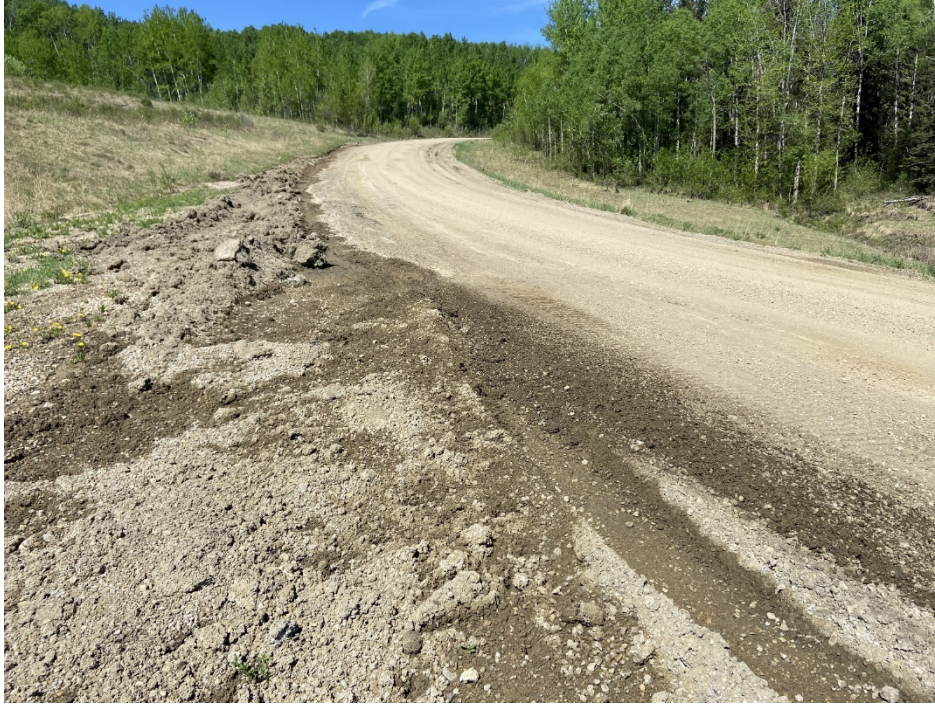
Photo 7 – Looking at seepage along west side of road near the north end of the site.

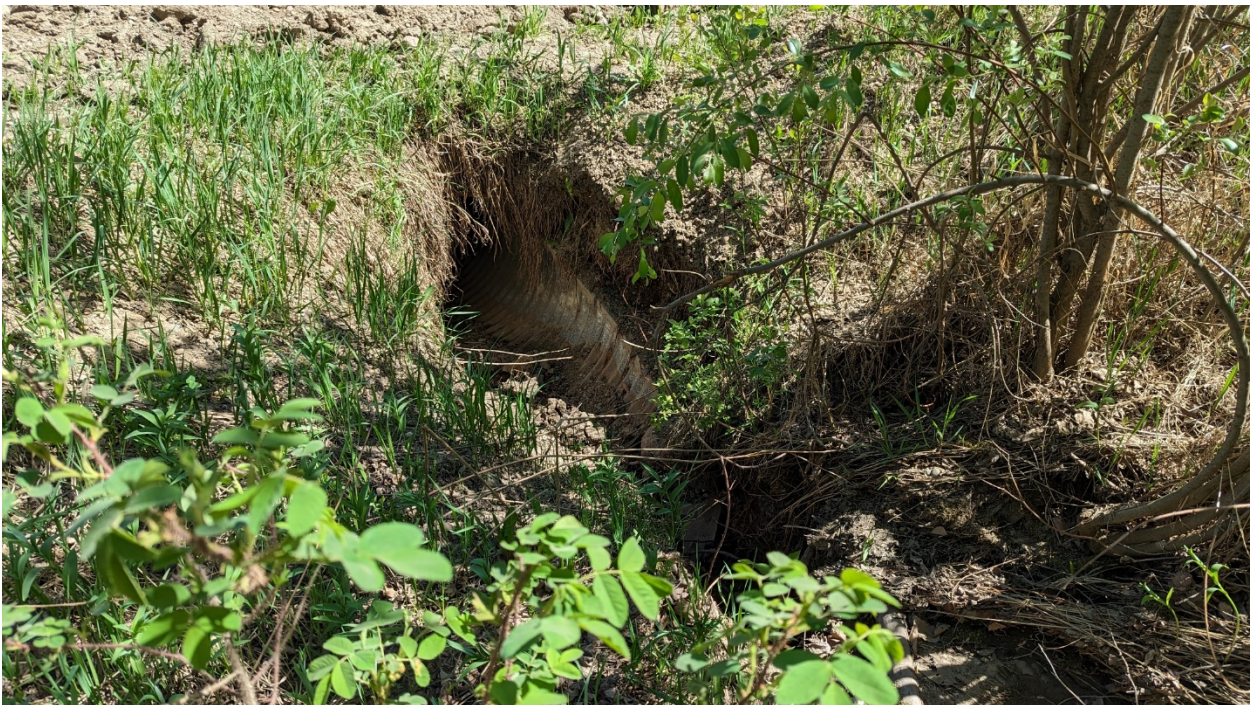
Photo 8 – 900 mm-dia. culvert outlet at the north end of the site.

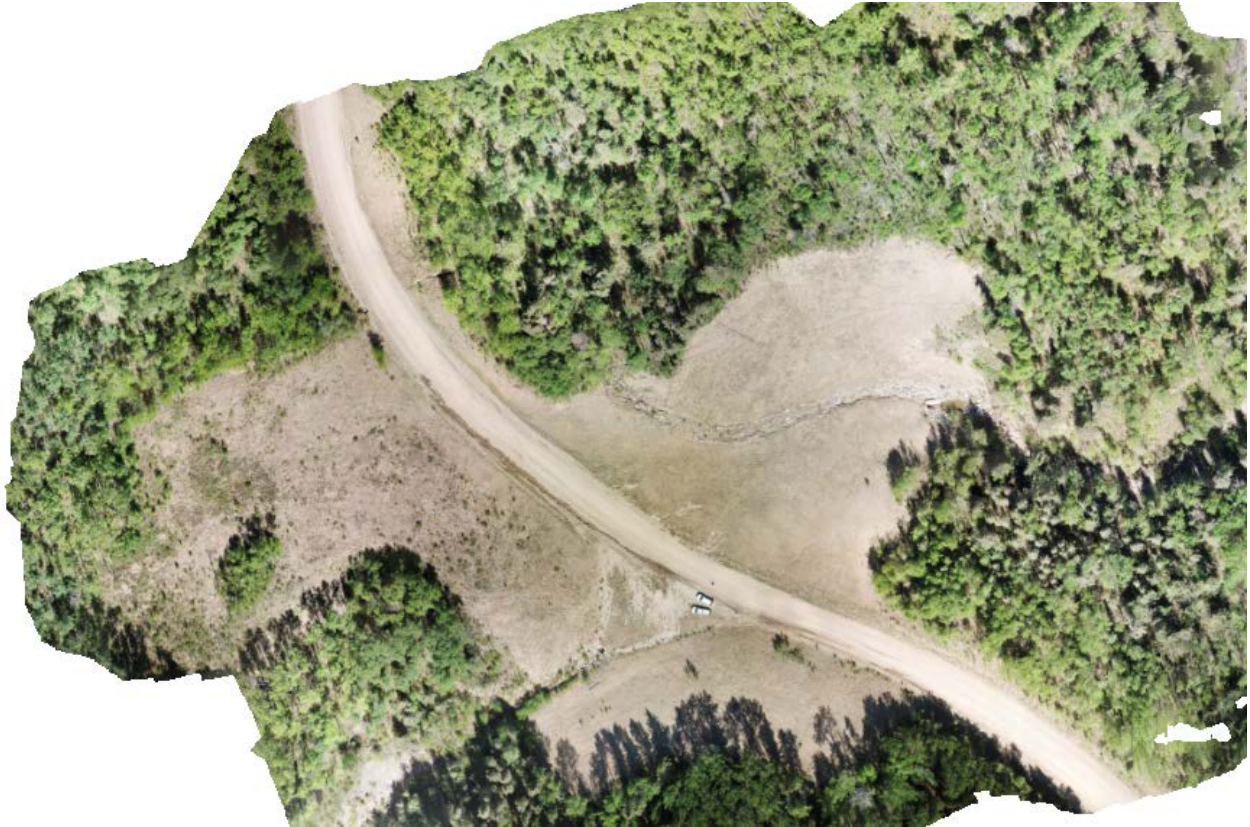
UAV 2023 Orthomosaic: Seepage can be seen along the left side of the highway; the eroding and slumping channel is to the right of the highway.

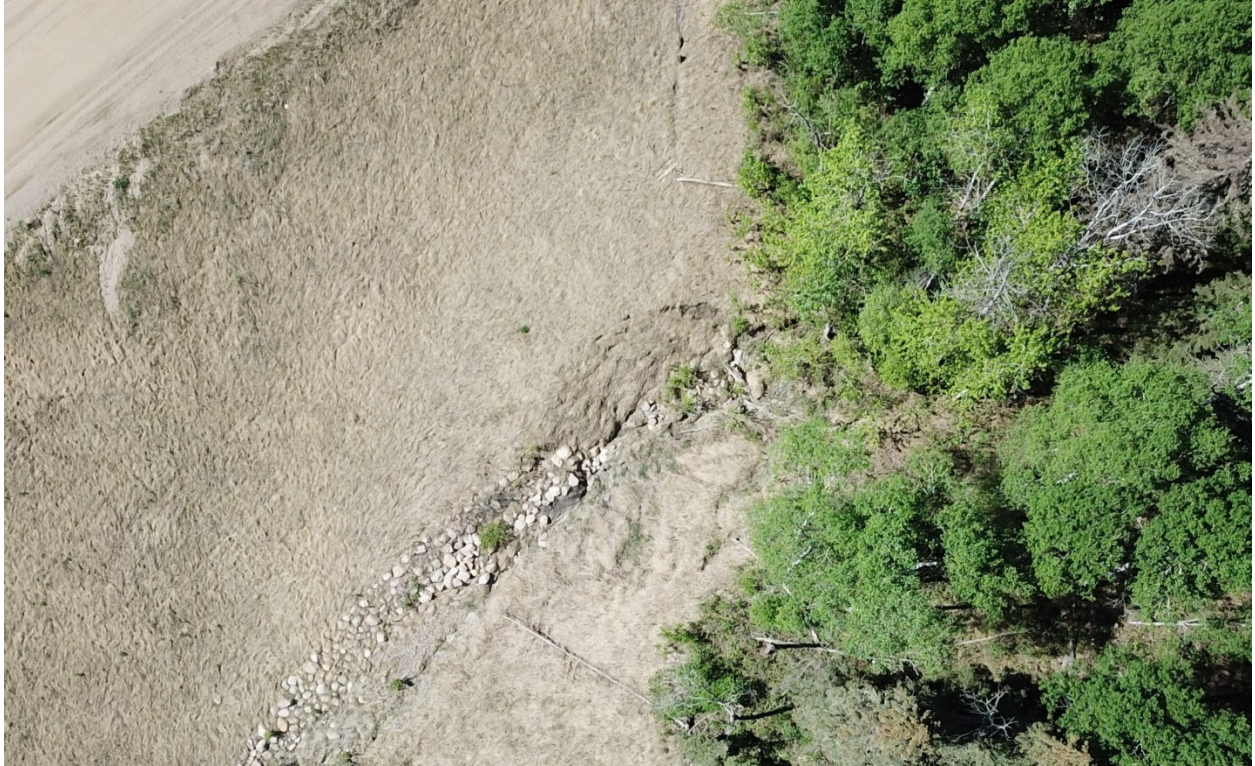
UAV 2023 UAV Image – Slumping at the north end of the of the riprap-lined channel on the east embankment.
