**ALBERTA TRANSPORTATION
GEOHAZARD ASSESSMENT
PEACE REGION (PEACE RIVER DISTRICT)
2023 INSPECTION**

Site Number	Location	Name	Hwy	km
PH075-1	North of Peace River	Whitemud River (km 44.4)	743:02	44.4
PH075-2		Whitemud River (km 44.8)		44.8
Legal Description		UTM Co-ordinates		
NE2-88-21-W5M		11U E 486,395 486,112	N	6,273,737 6273,982

Date	PF	CF	Total
Previous Inspection:	7-July-2021	PH075-1: 11 PH075-2: 9	4 6	44 54
Current Inspection:	16-May-2023	PH075-1: 13 PH075-2: 8	4 6	52 48
Road AADT:	163		Year:	2023
Inspected By:	Max Shannon, TEC Rocky Wang, TEC Pramaya Kannel, TEC		Don Proudfoot, Thurber Ken Froese, Thurber	
Report Attachments:	<input checked="" type="checkbox"/> Photographs	<input checked="" type="checkbox"/> Plans	<input type="checkbox"/> Maintenance Items

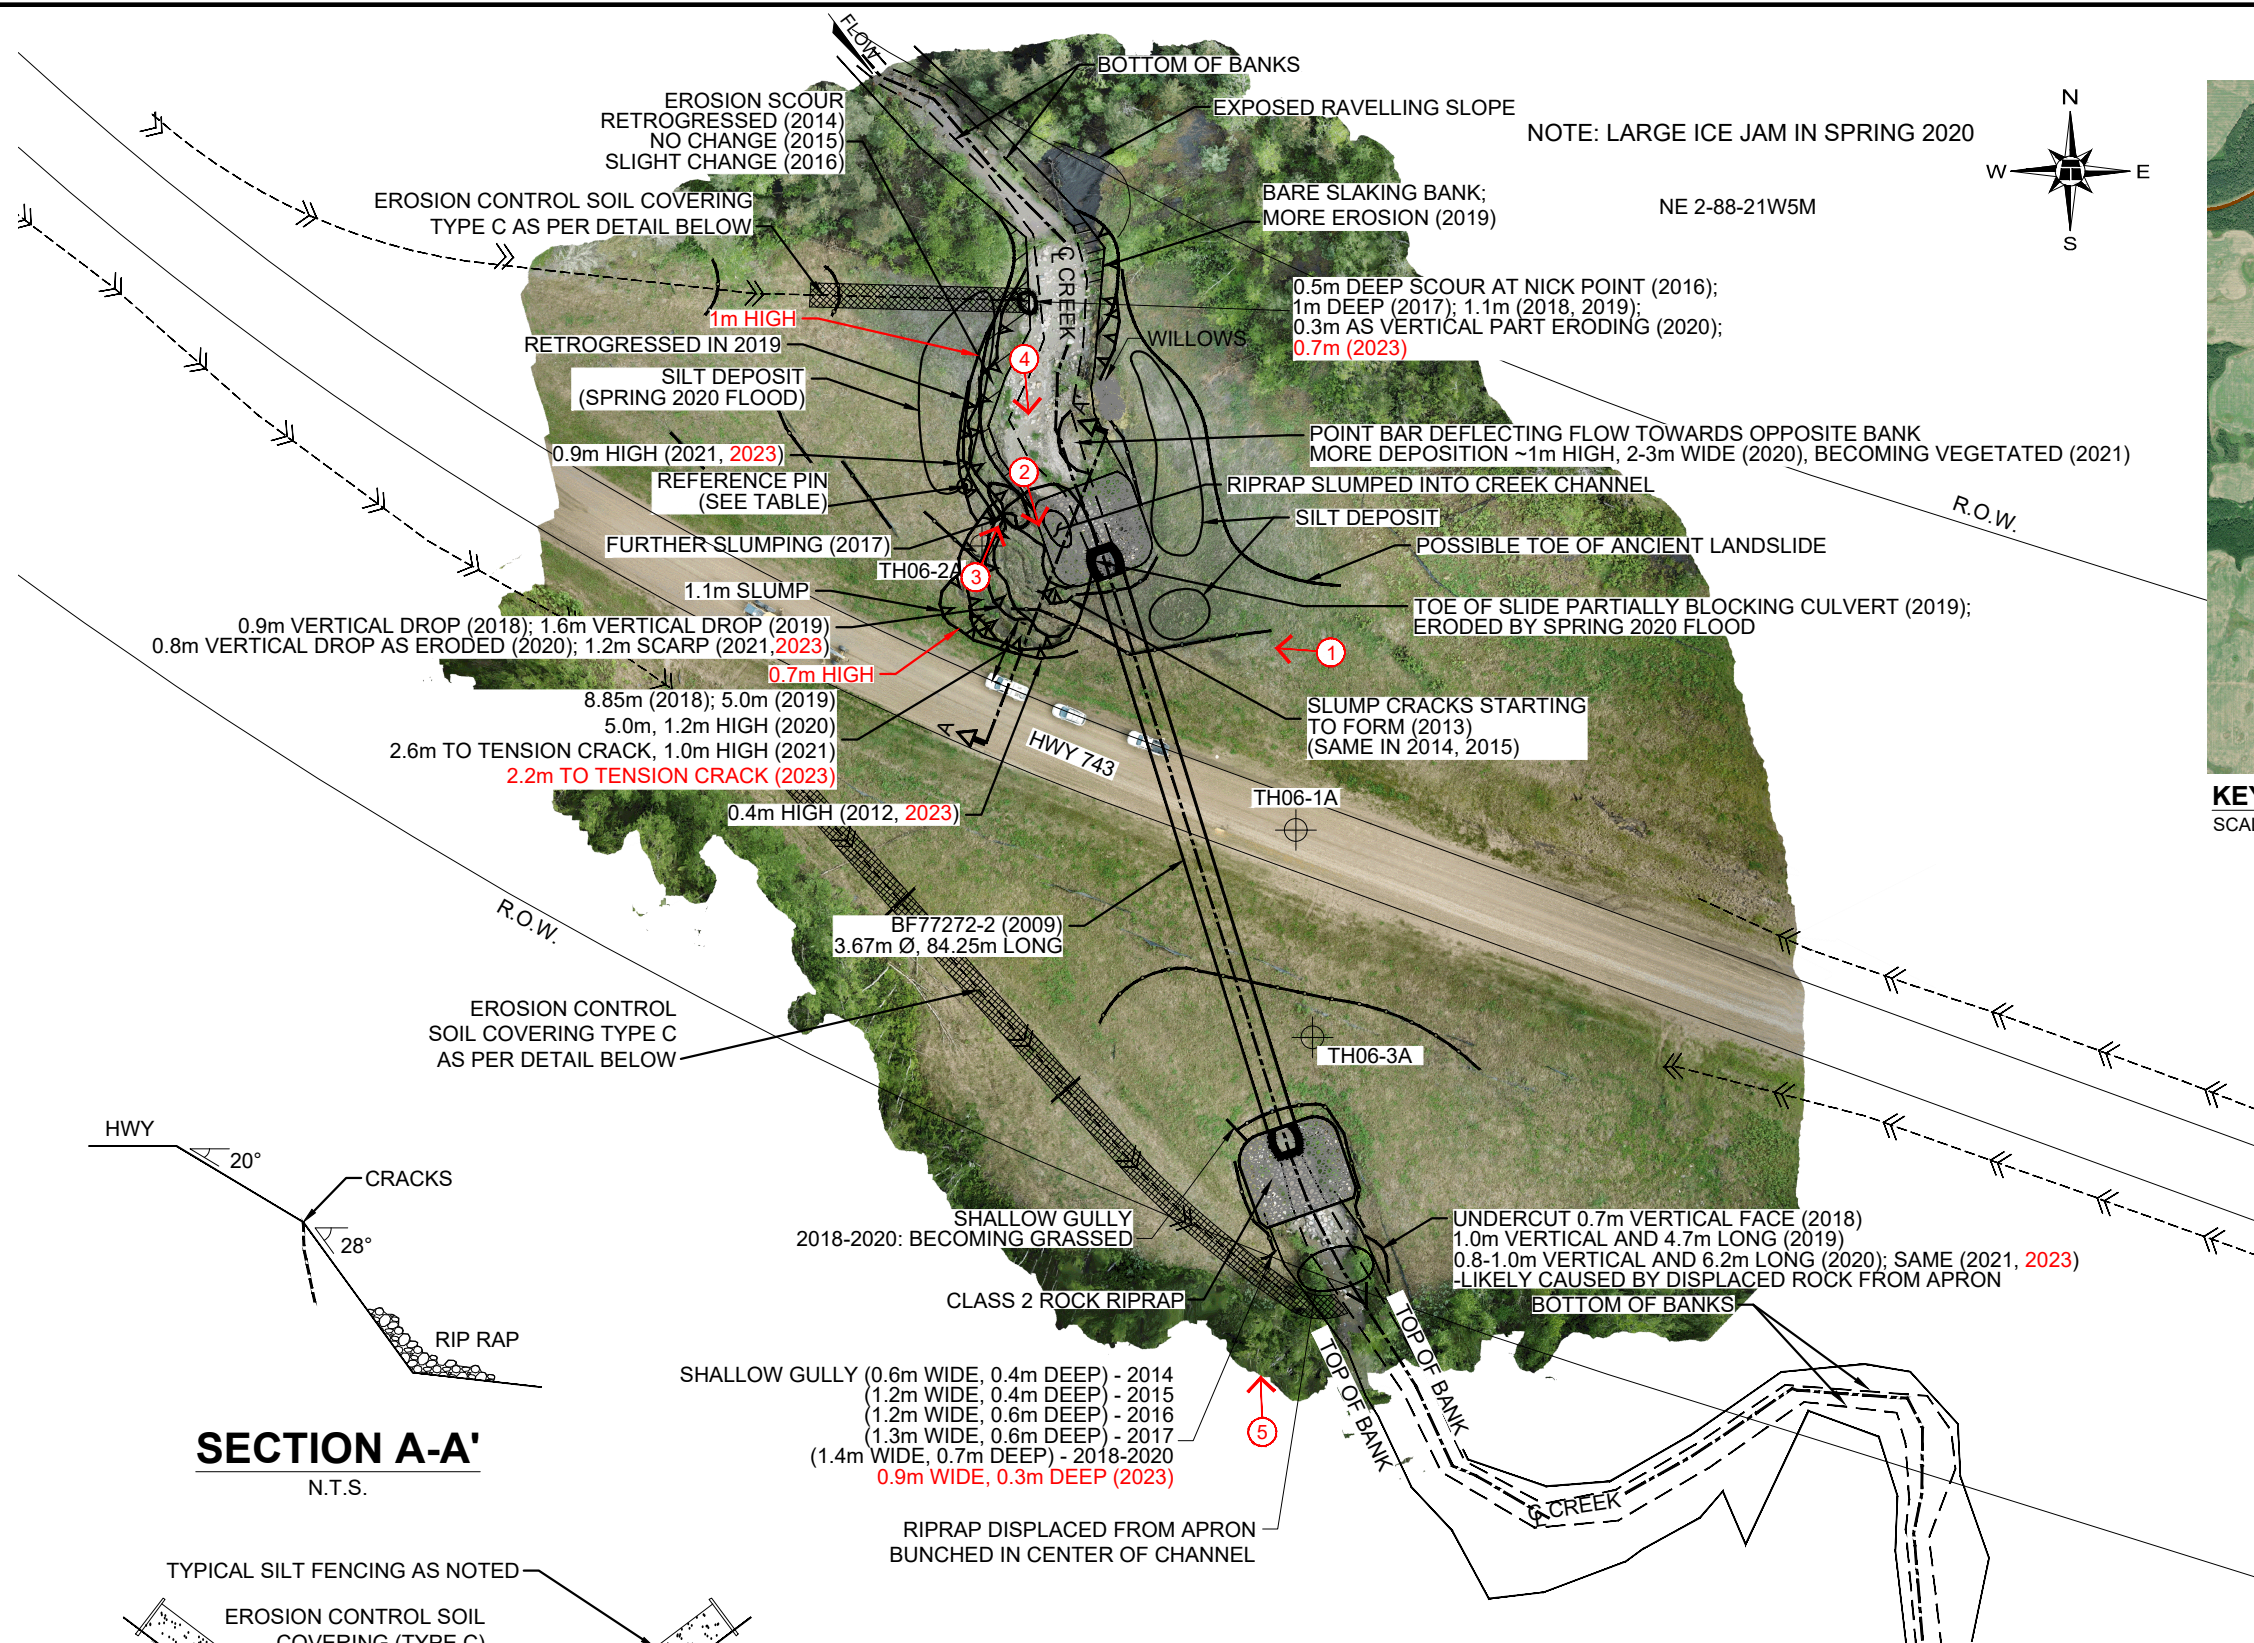
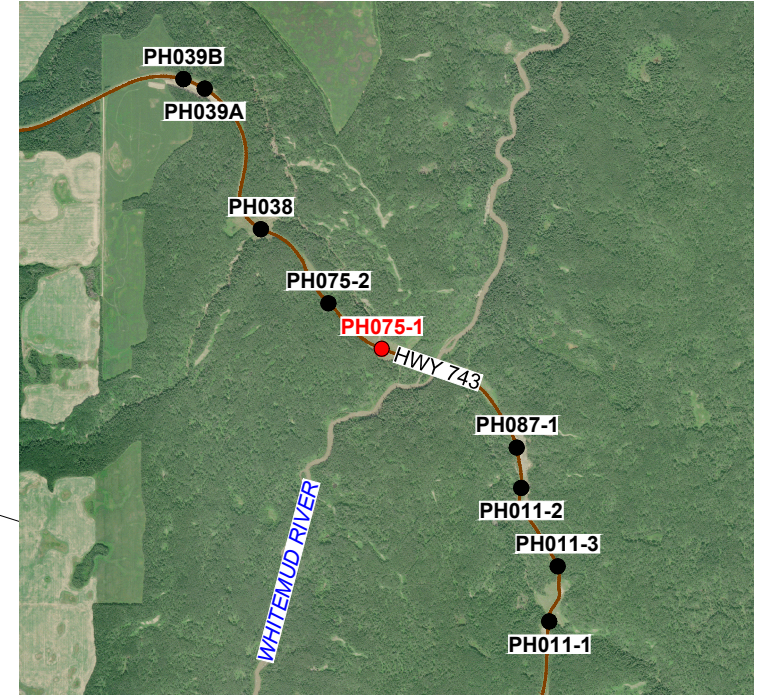
DWG No. 32121-PH075-1-1

Primary Site Issue:	PH075-1: Creek bank erosion and slumping of over-steepened slope above culvert inlet. PH075-2: Retrogressive landslide scarp through both lanes	
Dimensions:	PH075-1: 40 m of creek bank erosion PH075-2: 55 m wide along the shoulder, approx. 275 m wide at the creek and 160 m long from the highway to the creek.	
Date of Remediation:	2009: Culvert replaced and sideslopes rebuilt.	
Maintenance:	Highway closed on Jul 13, 2020, until detours opened in Fall 2020.	
PH075-1 Observations:	Description	Worsened?
<input type="checkbox"/> Pavement Distress	Highway is gravel-surfaced.	<input type="checkbox"/>
<input checked="" type="checkbox"/> Slope Movement	Slump above culvert regressed significantly in 2018 and continues to move. There is major bank slumping upstream of the culvert and minor bank slumping downstream of the outlet.	<input checked="" type="checkbox"/>
<input checked="" type="checkbox"/> Erosion	Slump on the west side of the creek at the inlet has continued to retrogress since 2015; erosion at end of north ditch channel relatively stable. Erosion occurring in east ditch sporadically over 200 m length between km 44.3 to 44.1 south of PH075-1.	<input type="checkbox"/>

<p>The creek bank at the culvert inlet began to regress significantly due to heavy runoff in Spring 2018. The spring of 2020 also had significant runoff and there was an ice jam at this site (reported by MCI). The scarps above the culvert have formed into numerous slump blocks and continue to retrogress and were 2.2 m (slope distance) from the edge of the gravel surfacing (was 2.6 m in 2021, 8.85 m in 2018, and 5 m in 2020). Slumping continues to worsen along the west bank of the creek moving further into the slope since first mapped in 2017. In 2018, the pin installed 2 m upslope of the tension crack was only 0.36 m from the resulting scarp and was shifted 3 m further upslope. The pin was 3.0 m from the scarp in 2019, had to be reset again in 2020, and was lost in 2021. The slumping of the riverbank is undermining the embankment and is causing instability which will impact the highway and has started to impact the culvert obstructing the inlet slightly.</p> <p>The embankment slope above the riprap was about 2H:1V which is steeper than usual for a slope constructed using clay in this area. This steeper slope will likely result in more rapid retrogression if the channel experiences similar water flows. The ongoing slumping on the west side at the culvert inlet has displaced much of the riprap apron which increases the vulnerability of the slope to future highwater events. Furthermore, the point bar forming on the east side of the channel also concentrates flow into the west bank. This point bar had increased in size noticeably in 2020 and started to vegetate in 2021 and became denser in 2023.</p> <p>Erosion was previously noted where the north ditch contacts the west bank north of the culvert inlet. The rate of downcutting has slowed with only an additional 0.1 m deeper and wider since 2017. A significant amount of sediment has accumulated at the culvert inlet in 2021 which may be from the progressive downcutting and toe erosion that triggered the slide movements at PH039 and elsewhere in the valley.</p> <p>The shallow gully that formed at the west side of the top of the outlet riprap has vegetated and did not appear to have increased in size since 2017. This gully has likely formed due to surface runoff short-cutting out of the ditch channel. It was also observed that the displaced riprap from the culvert outlet apron is mounded in the centre of the channel forcing flow around causing the increasing undercut on the east bank. The length of affected bank was slightly longer in 2020 but unchanged in 2021 and 2023.</p>

- Site 1: The steep embankment slope above the culvert inlet needs to be stabilized. As the slope is now failing, it should be rebuilt with geogrid-reinforced granular material. The stream channel should be realigned through the point bar to reduce erosion pressure of the highway embankment. A stability analyses should be undertaken to assess the potential effectiveness of these measures.
 - Alternatively, the extent of slope reconstruction would be reduced by lowering the roadway over the culvert to flatten the slopes.
- Site 1: The mound of riprap downstream of the outlet should be redistributed to create a flow path down the centre of the channel rather than the unprotected sides.

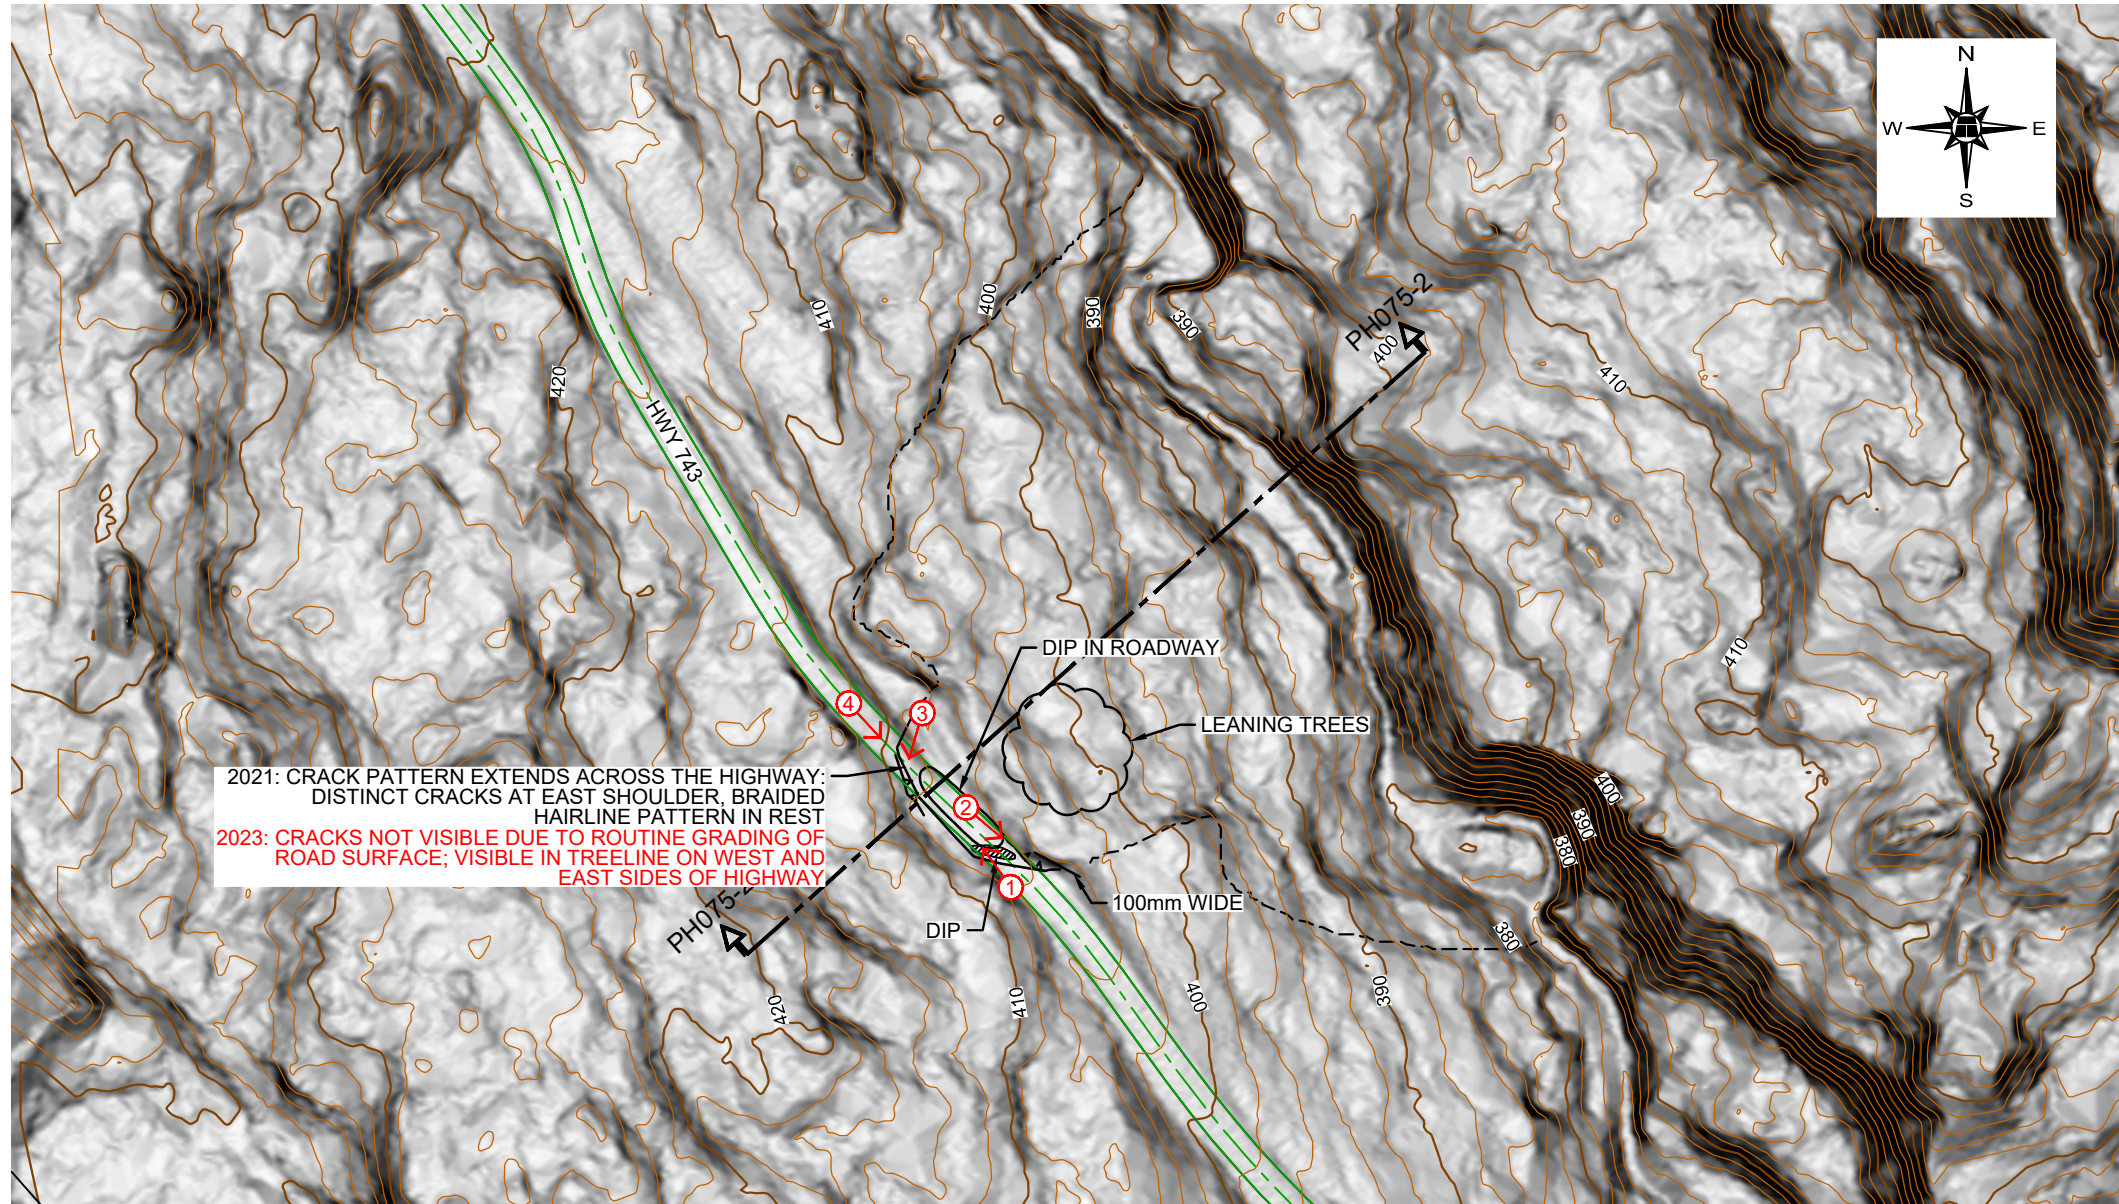
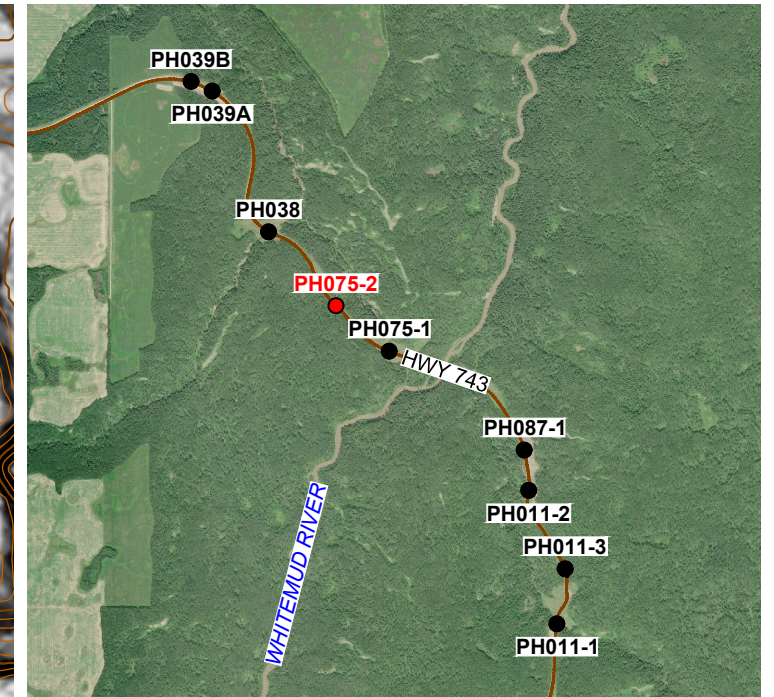
DWG No. 32121-PH075-2

PH075-2 (Drawing 32121-PH075-2)		
The slide at PH075-2 was first noticed during a callout inspection of other sites on Hwy 743 on August 4, 2020, shortly after movements closed the highway. The site is located on a sidehill

alignment ascending the valley slope of a tributary to the Whitemud River. LiDAR provided by TEC shows that the valley slope has been affected by historic landslide movements. Similar to the other sites along this highway that moved during the summer of 2020, it was likely that higher groundwater levels re-activated a large slide block which affected about 55 m of the road surface. The highway is located about 25 m vertically above the creek. The valley slope surface, as shown by the cross-section on Dwg. No.13351-PH075-2, is hummocky, indicating the presence of several retrogressive slide blocks between the creek and the road. The dip encompasses the entire roadway surface at this location and trees at the toe of the embankment are being to tilt. Ongoing grading has obscured the cracks in the highway although the main scarp is still visible on both sides of the highway.

- Site 1: A localized realignment to the southwest by about one lane width which allow for slope flattening to the northeast.
- Site 2: A localized realignment to the west of the roadway around the slide could be carried out if the slide accelerates and the road condition becomes unsafe.
- Site 2: A driven steel pile wall might also be considered to provide temporary support to the road but might become distorted over time if the larger slide blocks move again.

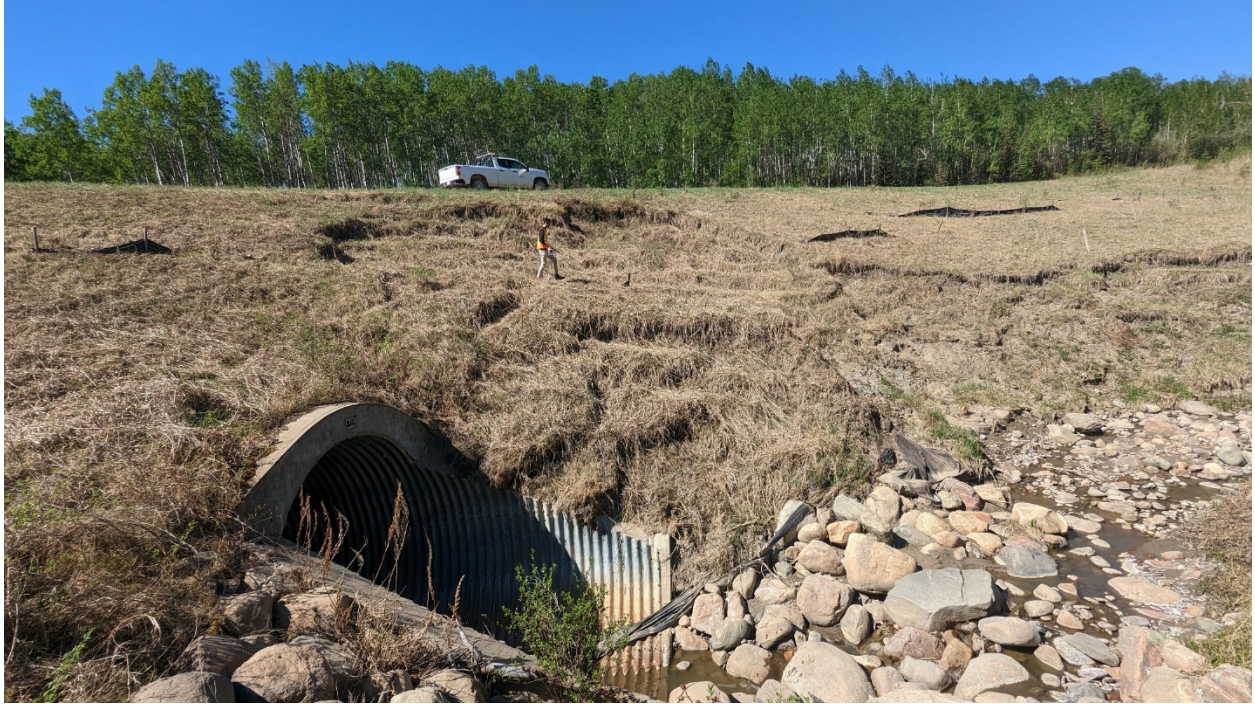
Site 1, Photo 1 – Looking west at north sideslope.

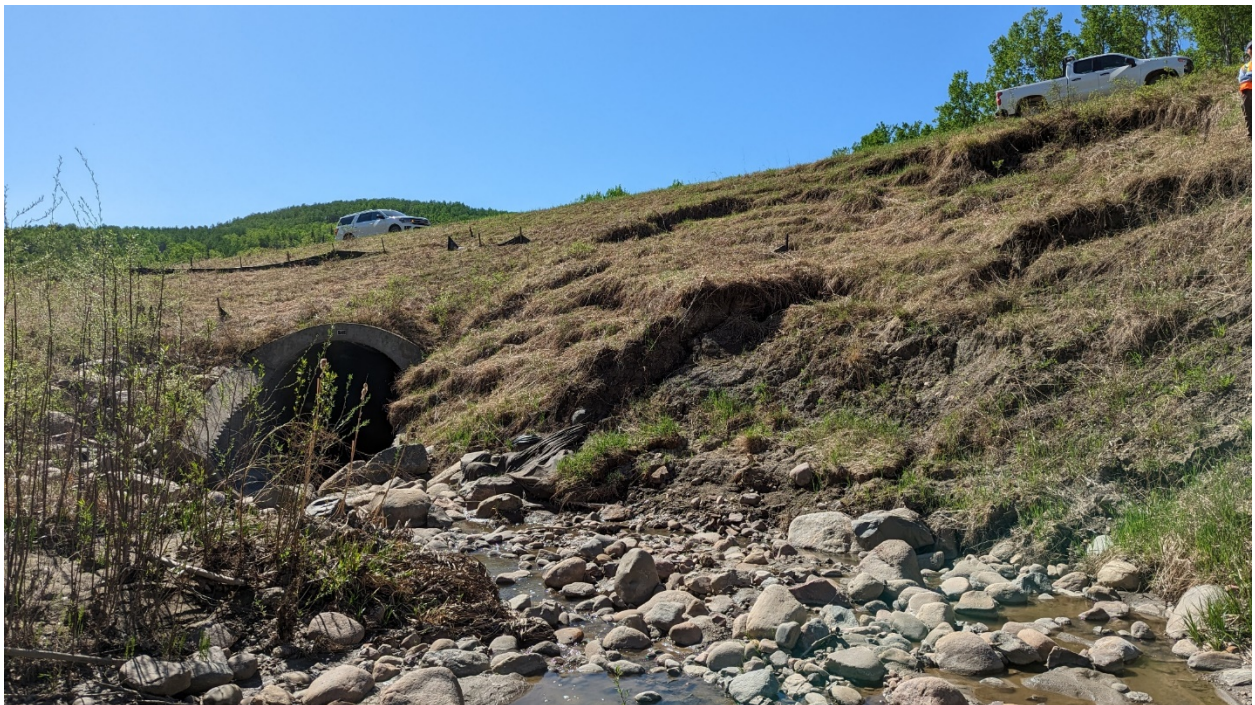
Site 1, Photo 2 – Looking southeast at creek bank slumping upstream of the culvert inlet.

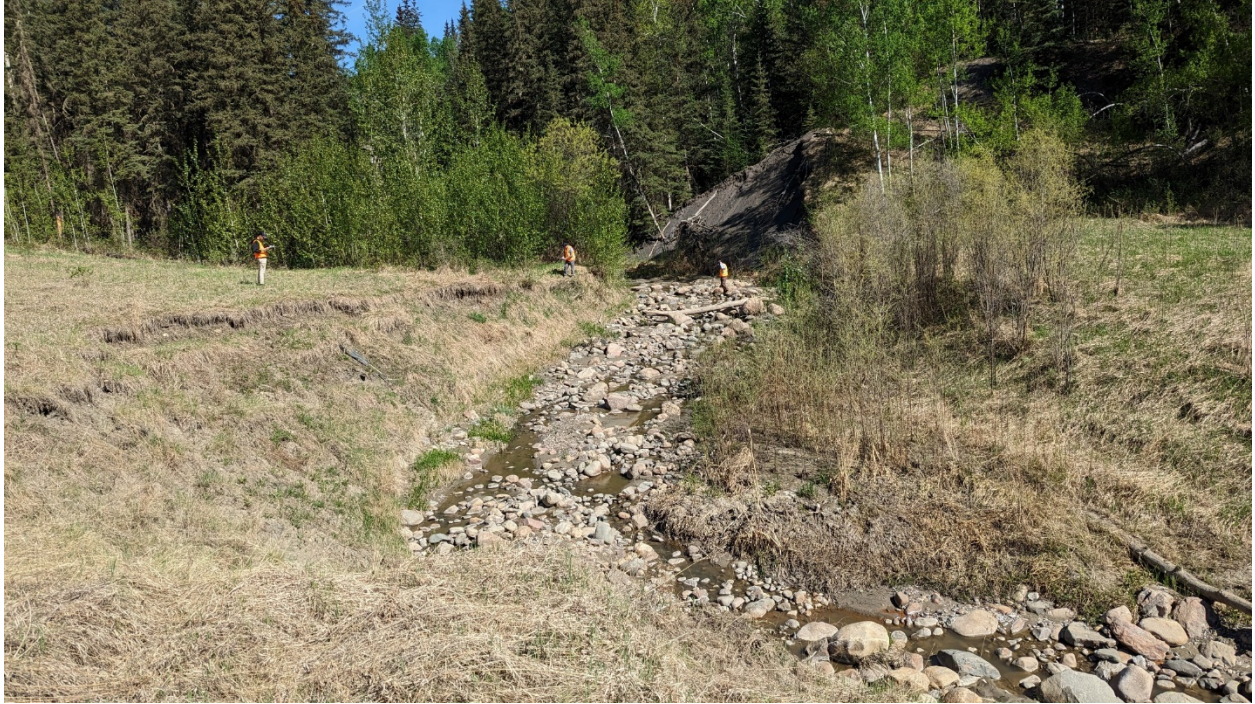
Site 1, Photo 3 – Looking north at creek bank slumping upstream of the culvert inlet.

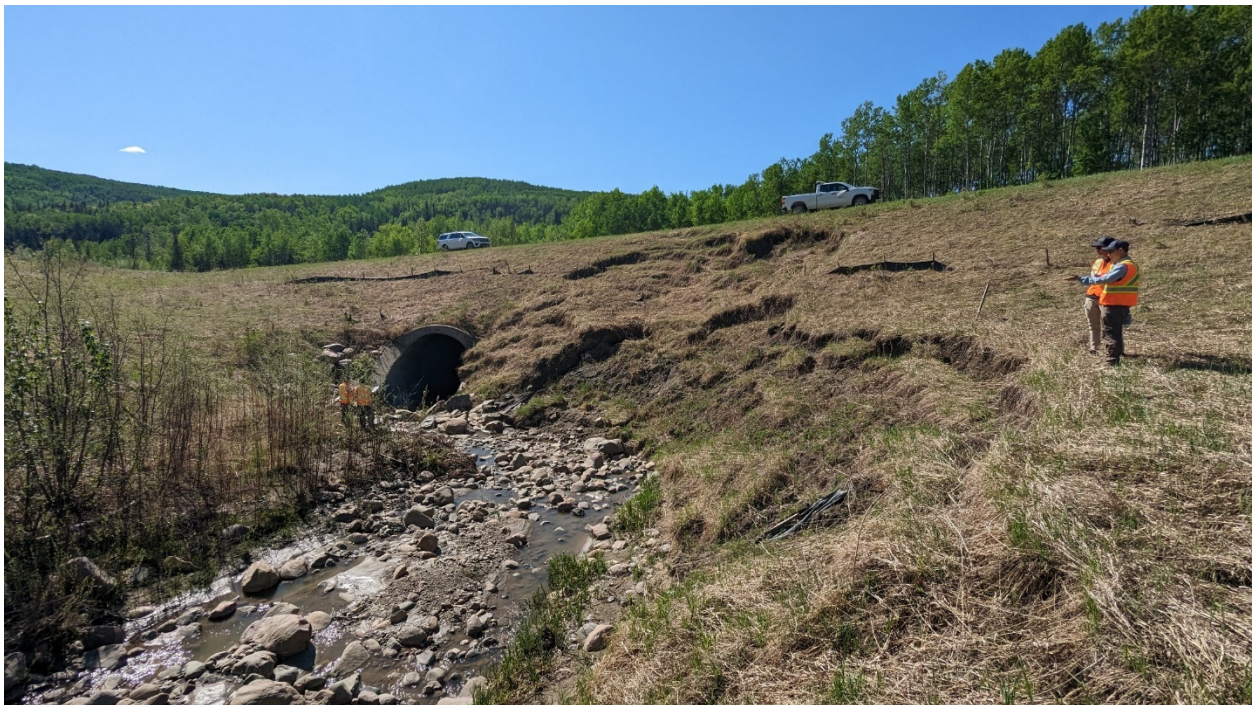
Site 1, Photo 4 – Looking south at culvert inlet.

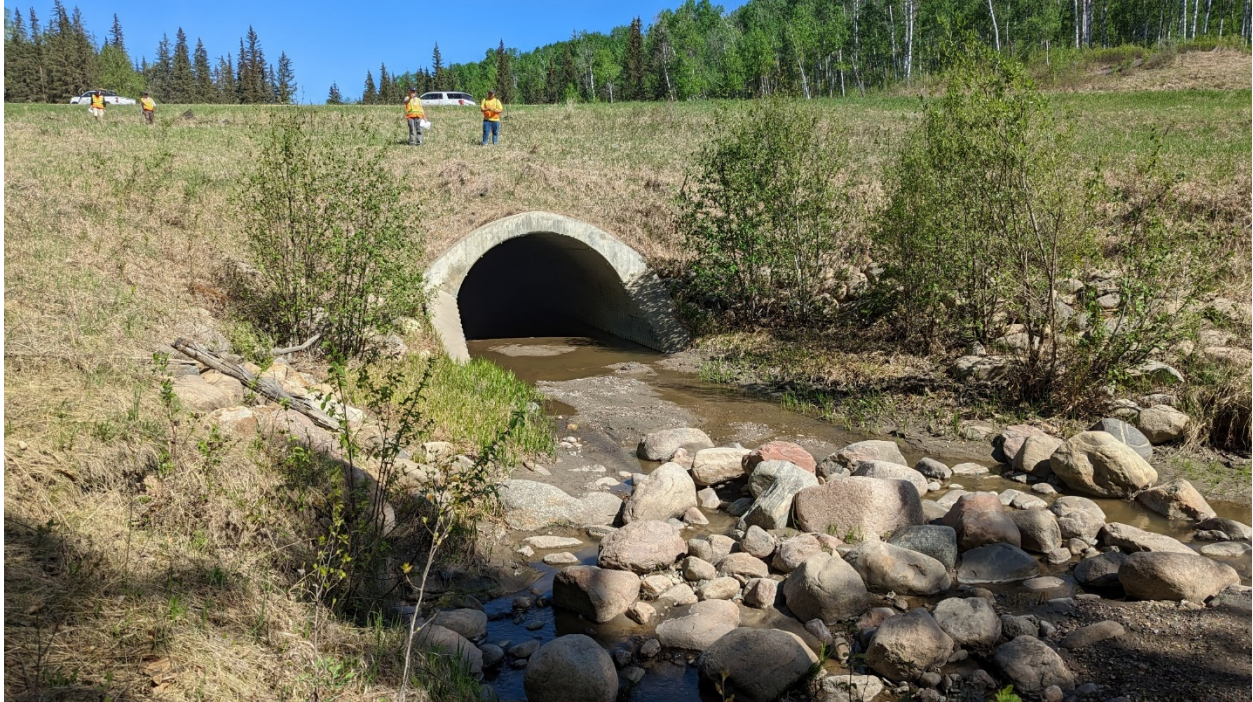
<input type="checkbox"/> Seepage		<input type="checkbox"/>
<input checked="" type="checkbox"/> Bridge/Culvert Distress	No signs of distress in the culvert itself; however, slide movements are obstructing flow at the inlet and sediment is accumulating at the outlet.	<input checked="" type="checkbox"/>
<input type="checkbox"/> Other		<input type="checkbox"/>

Site 1, Photo 5 – Looking north at culvert outlet. There is significant sediment accumulation.

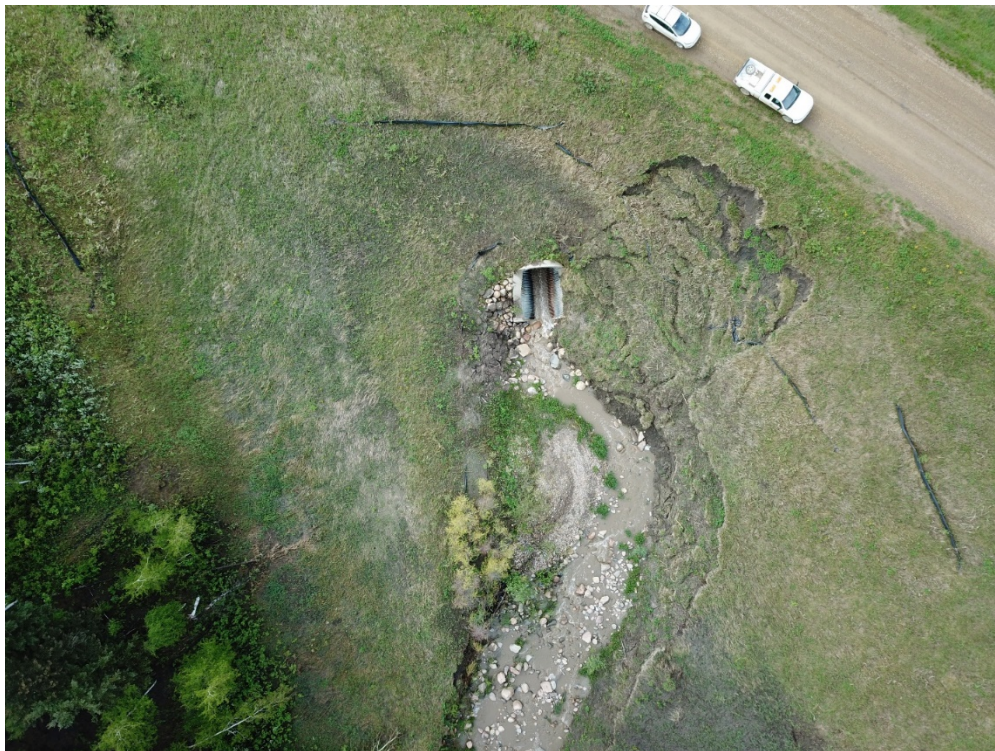
2020 UAV Image of slumping around Site 1 culvert inlet.

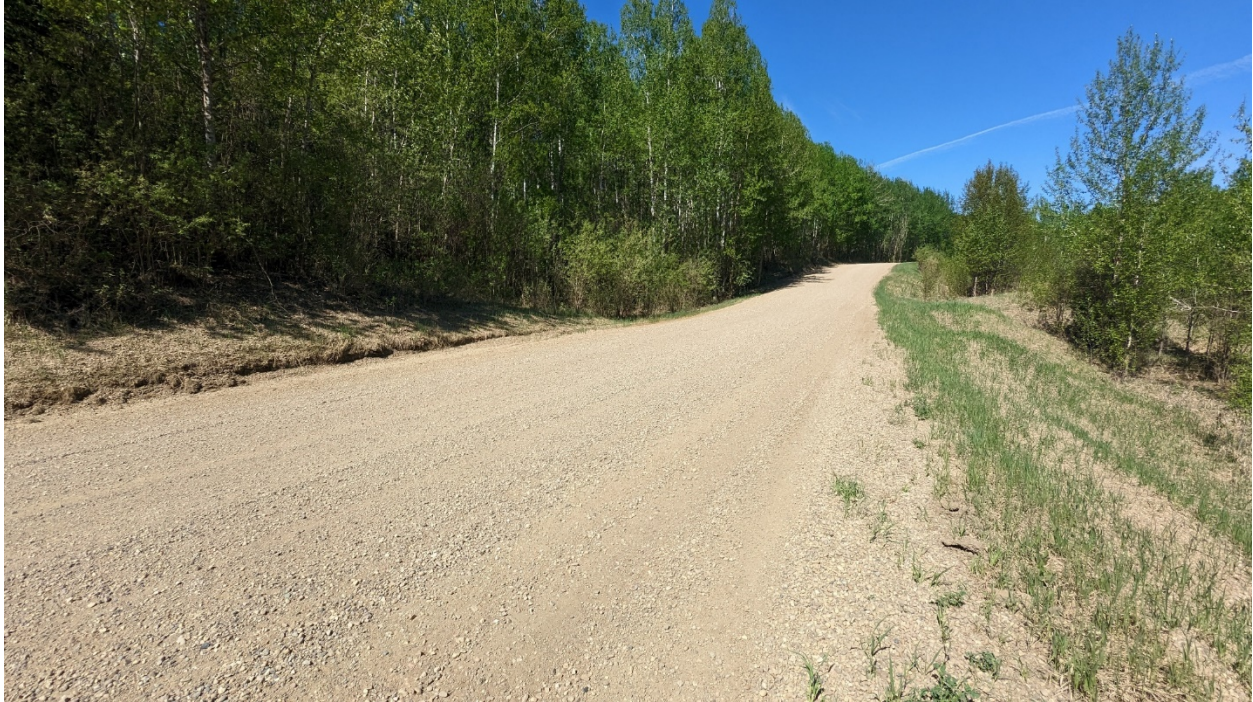
Site 2, Photo 1 – Looking northeast along highway where scarp cracks had previously been visible (since graded over).

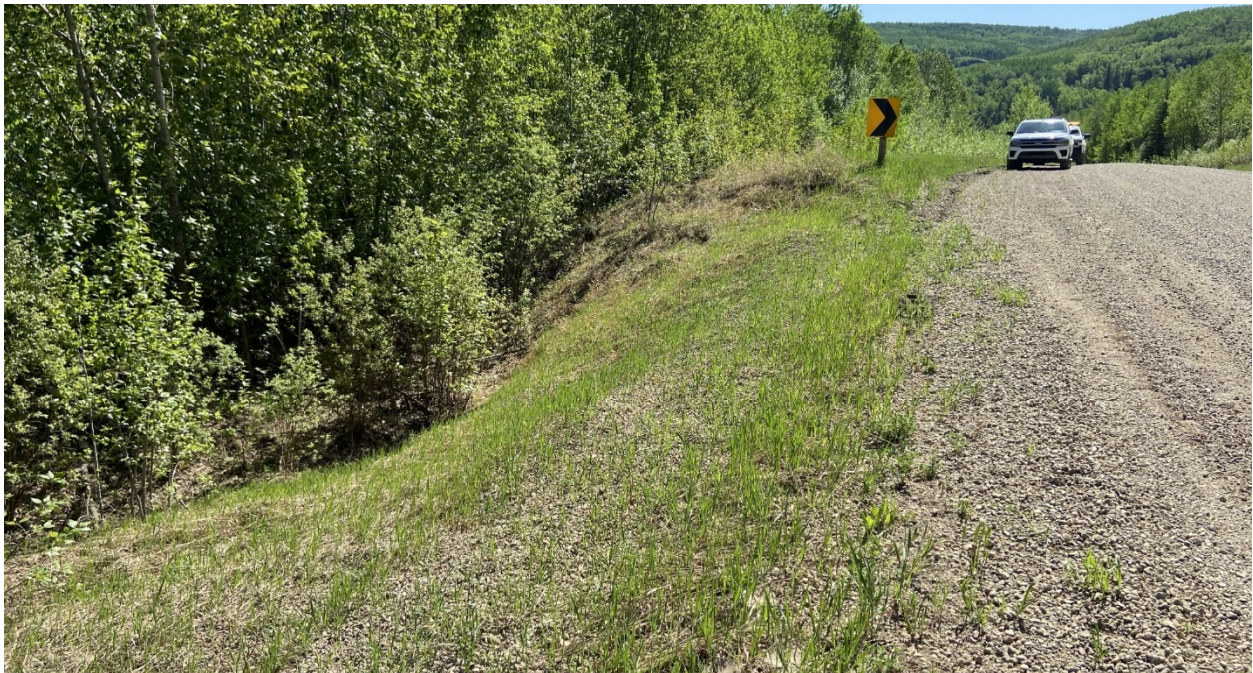
Site 2, Photo 2 – Looking southeast where scarp crack is visible on the east side of the highway.

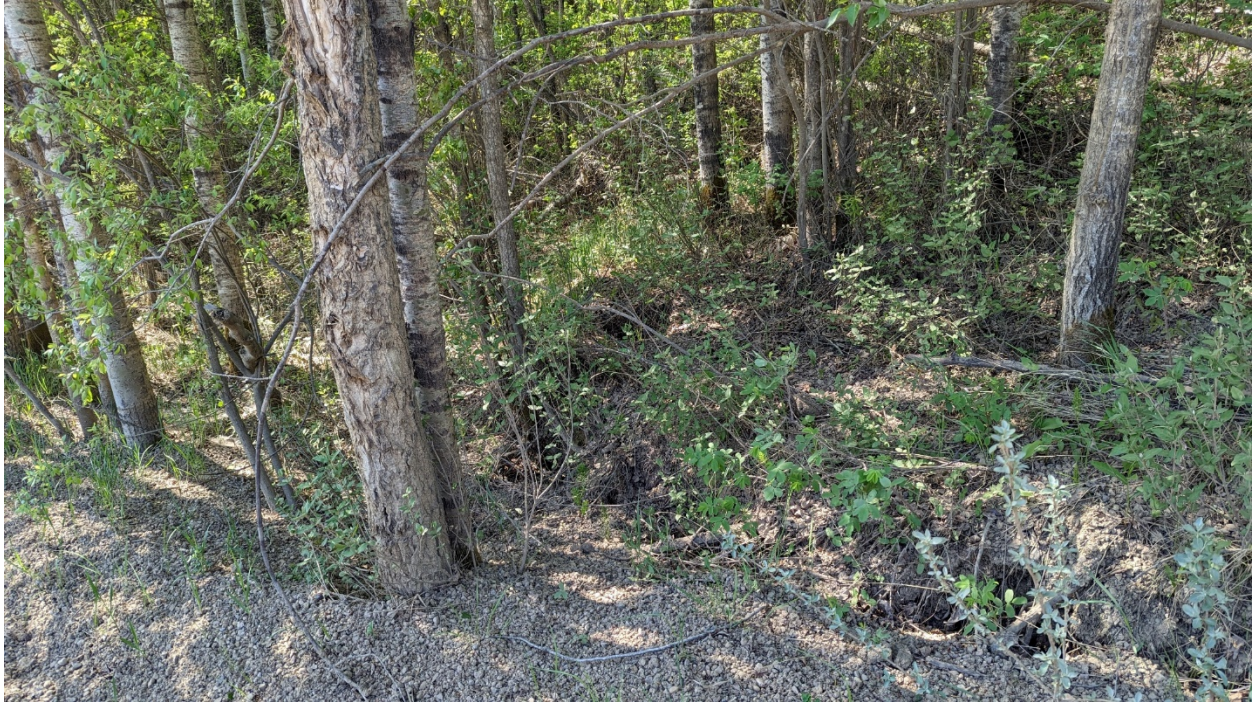
Site 2, Photo 3 – Looking south where scarp continues on the west side of the highway.

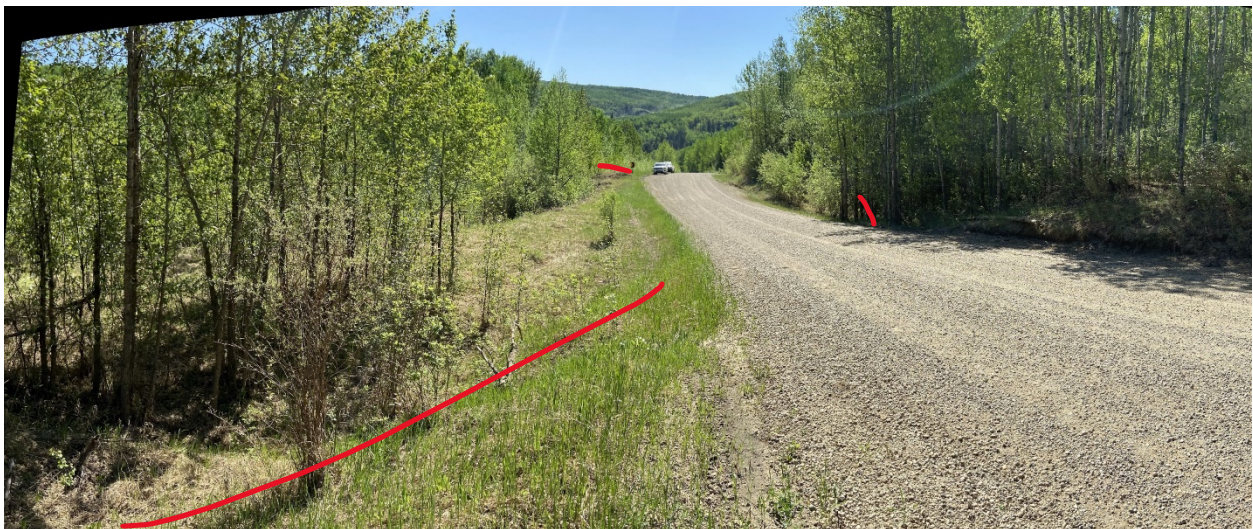
Site 2, Photo 4 (composite) – Looking southeast from north end of the site at the sag in the highway where it crosses the slide mass. The clearly visible scarps are shown with red lines.
