**ALBERTA TRANSPORTATION
GEOHAZARD ASSESSMENT
PEACE REGION (PEACE RIVER DISTRICT)
2023 INSPECTION**

| Site Number | Location | Name | Hwy | km |

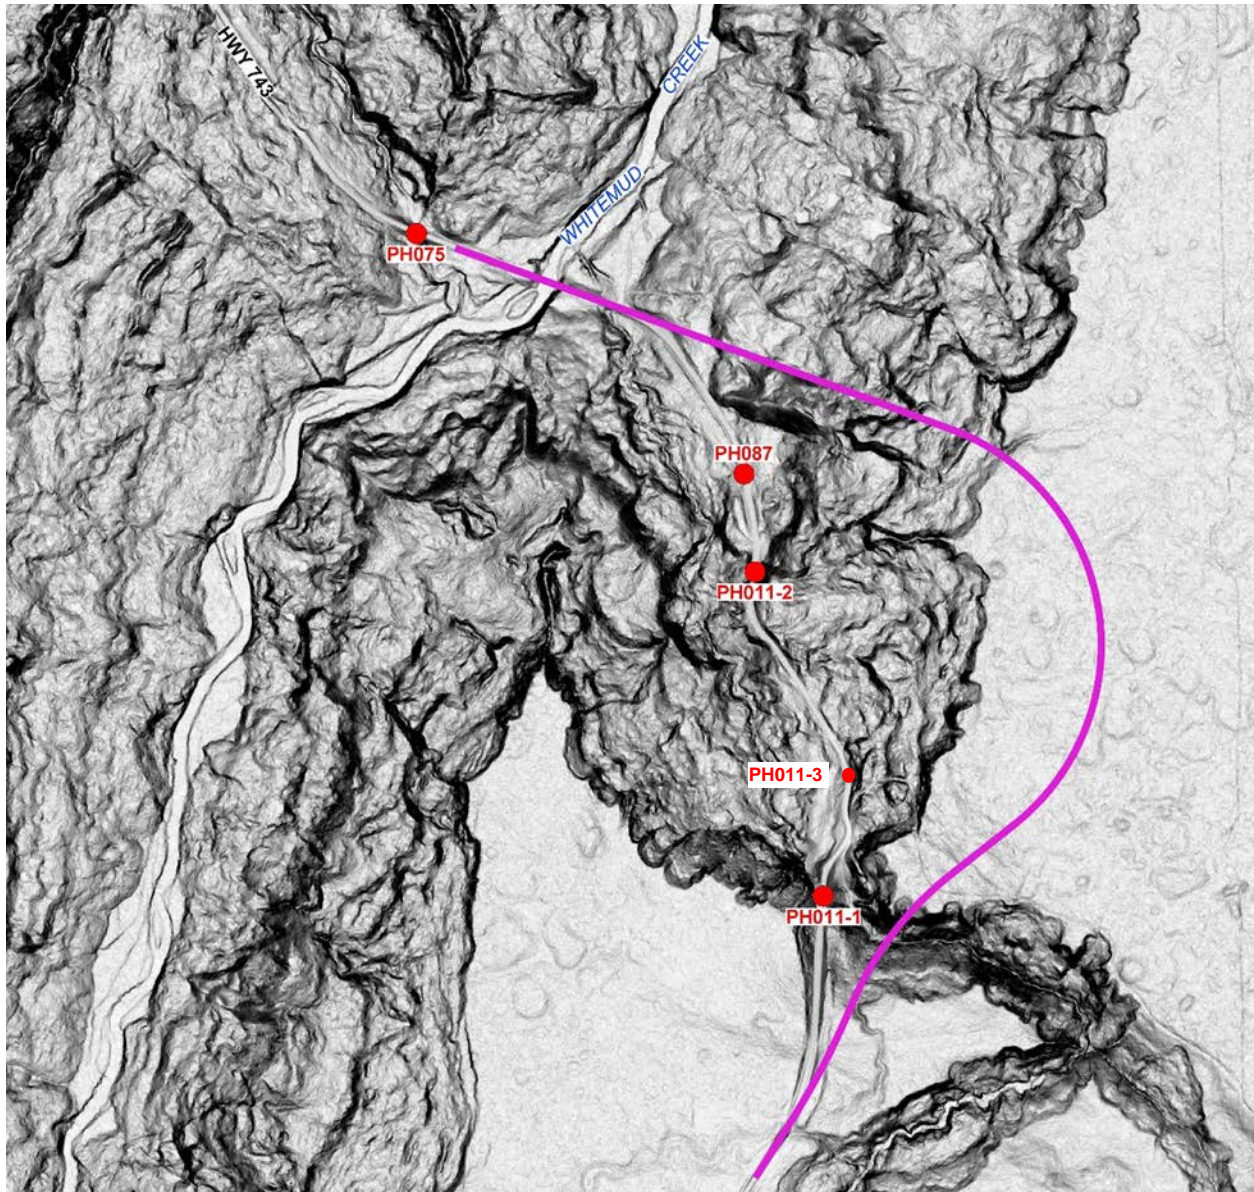
Figure 1: Proposed long term realignment for Hwy 743:02 south of the Whitemud Creek

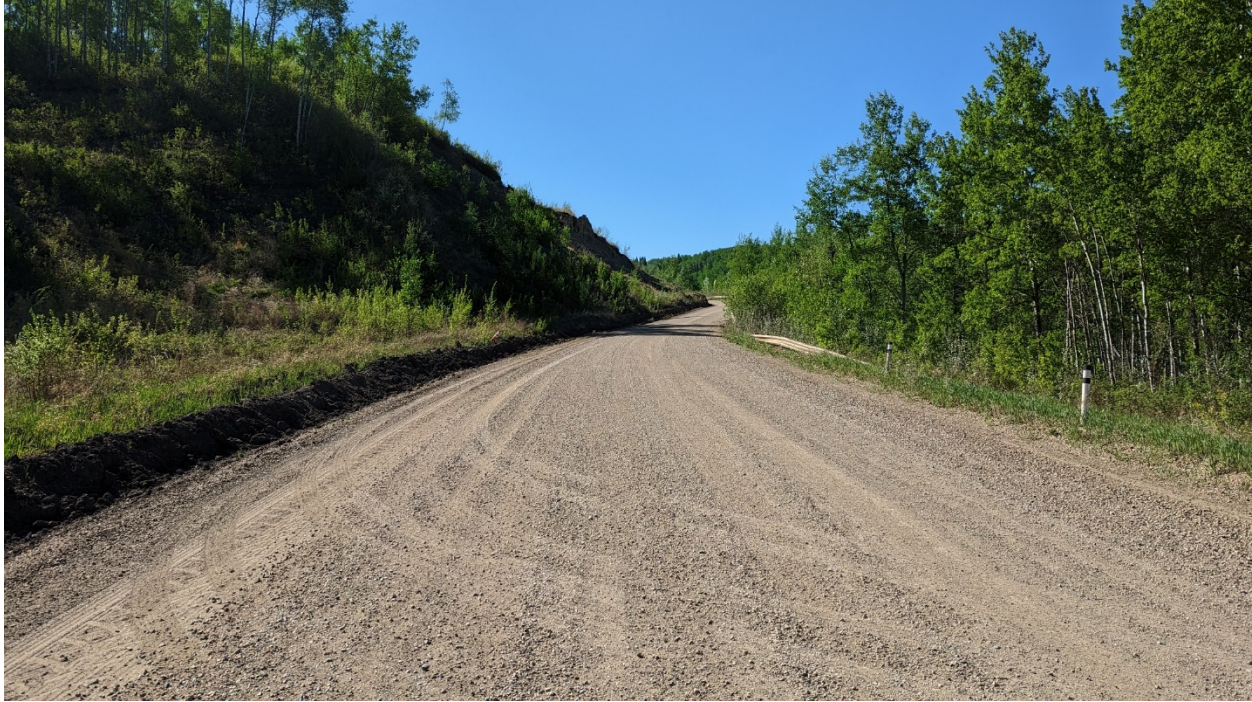
Photo 7 – Looking south towards the south landslide lobe and high shale backslope (PH011-2) on left. The cracks are at the guardrail but had been graded out at the time of the photo.

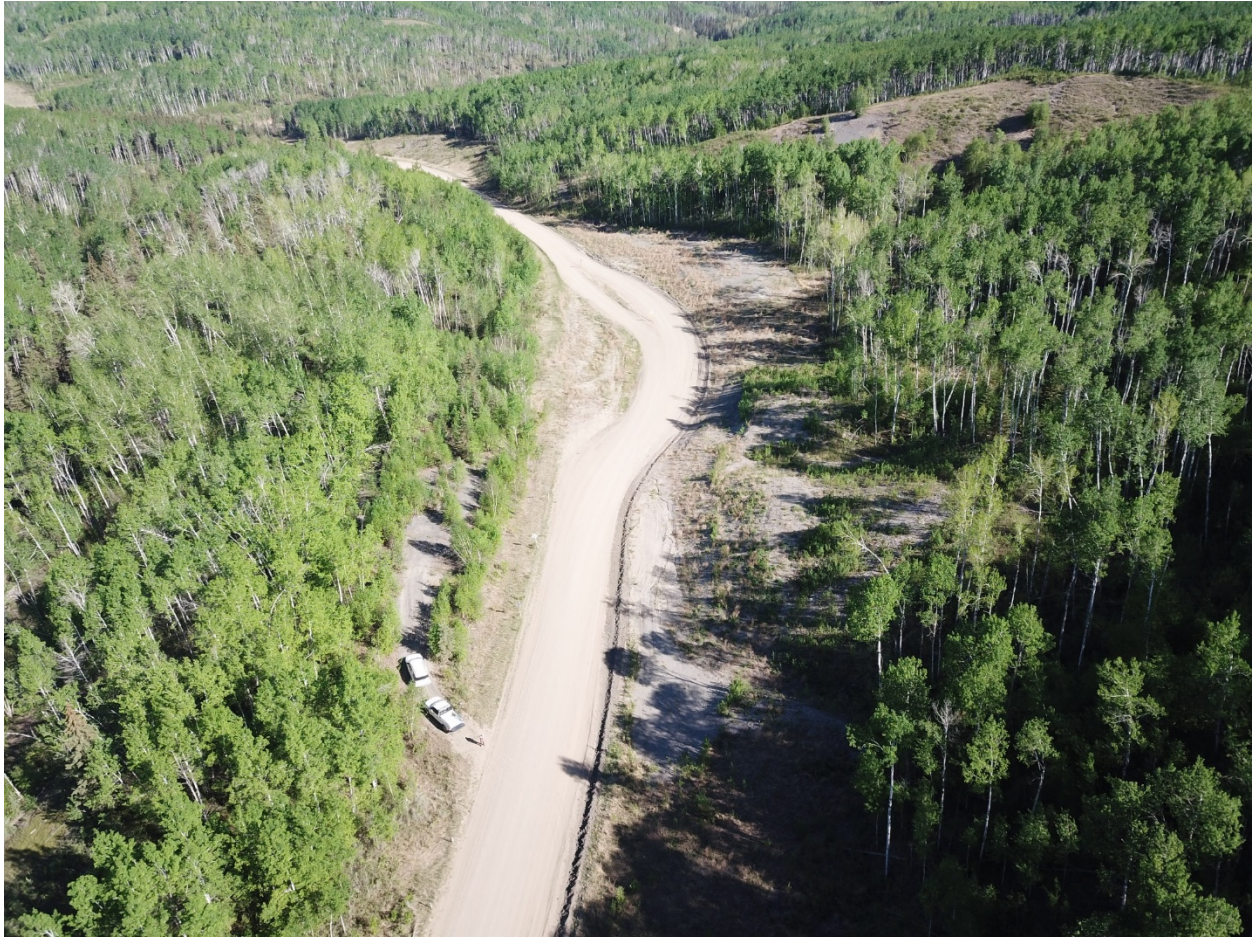
UAV Photo 2023 – Looking north toward the site: trucks are parked on the approach that was previously used for slumped soil from the PH011-2 backslope site. The bare area on the right side of the highway is where PH011-2 material has been spread recently. The detour around the slide is visible further north.
