**ALBERTA TRANSPORTATION AND
ECONOMIC CORRIDORS
GEOHAZARD ASSESSMENT PROGRAM
PEACE REGION - SWAN HILLS
2024 INSPECTION**

Site Number	Location	Name	Hwy	km
SH010-1	Little Smoky River	Little Smoky River Valley, South Hill – Site #1	744:02	14.4-14.7
Legal Description		UTM Co-ordinates		
NE-13-76-23-W5		11U E 473,759	N	6,160,016

Date	PF	CF	Total
Previous Inspection:	6-Jun-2023	11	3	33
Current Inspection:	4-Jun-2024	11	3	33
Road AADT:	270		Year:	2023
Inspected By:	Rishi Adhikari, TEC Robert Senior, TEC		Ken Froese, Thurber Roger Skirrow, Thurber	
Report Attachments:	<input checked="" type="checkbox"/> Photographs		<input checked="" type="checkbox"/> Plans	<input type="checkbox"/> Maintenance Items

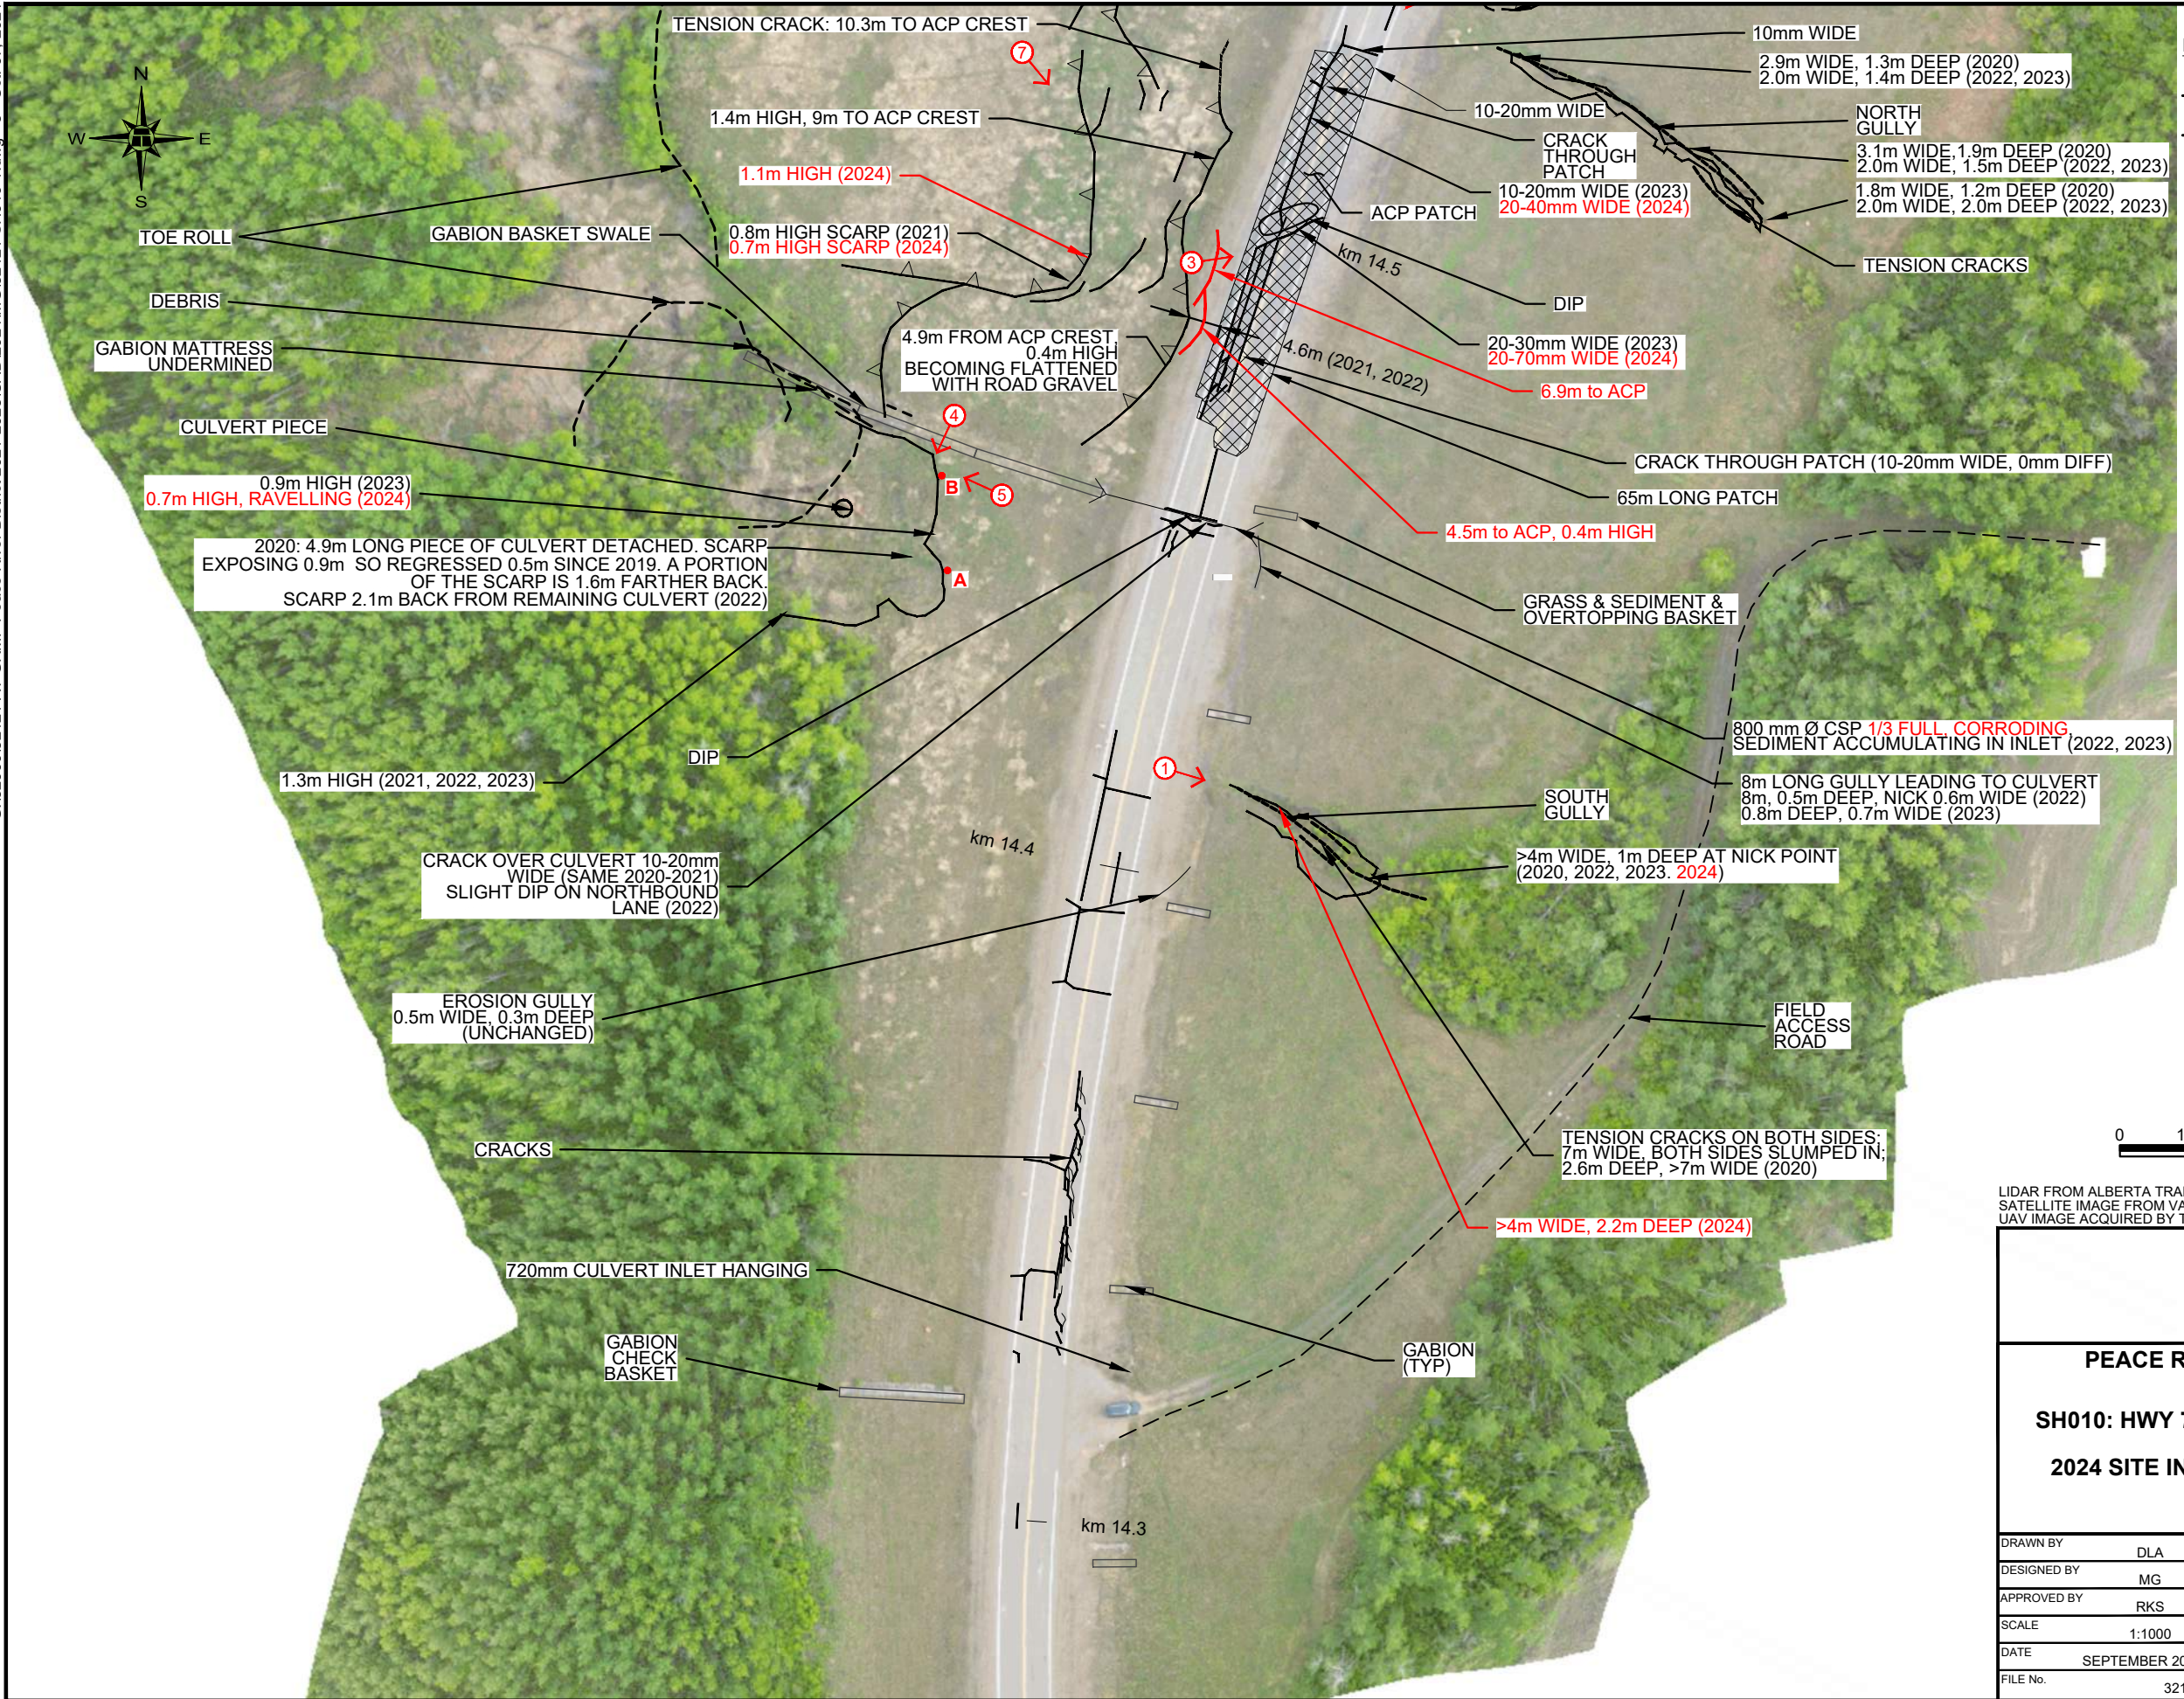
DWG No. 32121-SH010-1-3

MARKER	DISTANCE FROM SCARP		VERTICAL HEIGHT OF SCARP	
	2023	2024	2023	2024
A	2.0m	1.9m	0.8m	0.9m
B	1.8m	-	0.3m	-

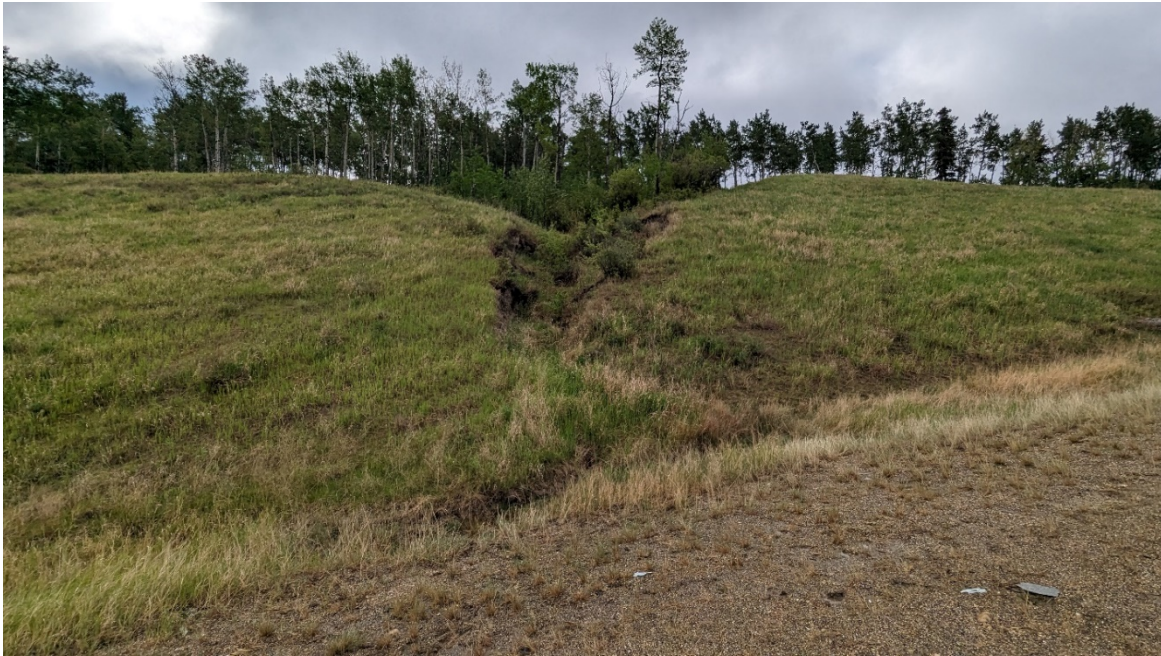
The two gullies in the backslope did not appear to have widened. The south gully was observed to be deeper during the 2024 inspection. Continued movement has caused ravelling and slumping of the slopes. These gullies will continue to worsen until repaired. Sediment from these gullies is accumulating in the ditch and culvert inlet and overtopping the gabion check baskets reducing their effectiveness.

Photo 1 – Looking east at south gully.

The backslope erosion gullies should be repaired, and properly sized swales should be constructed to carry water down the slope to the highway east ditch.

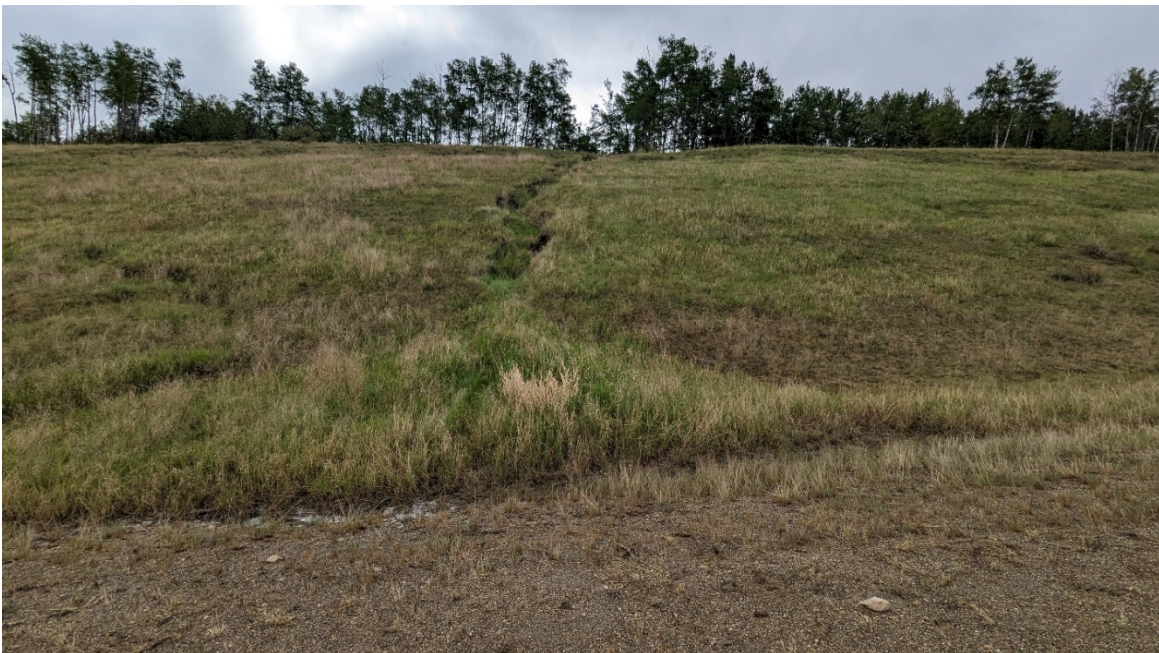
Photo 2 – Looking east at north gully; note slump to left of gully on lower part of slope.

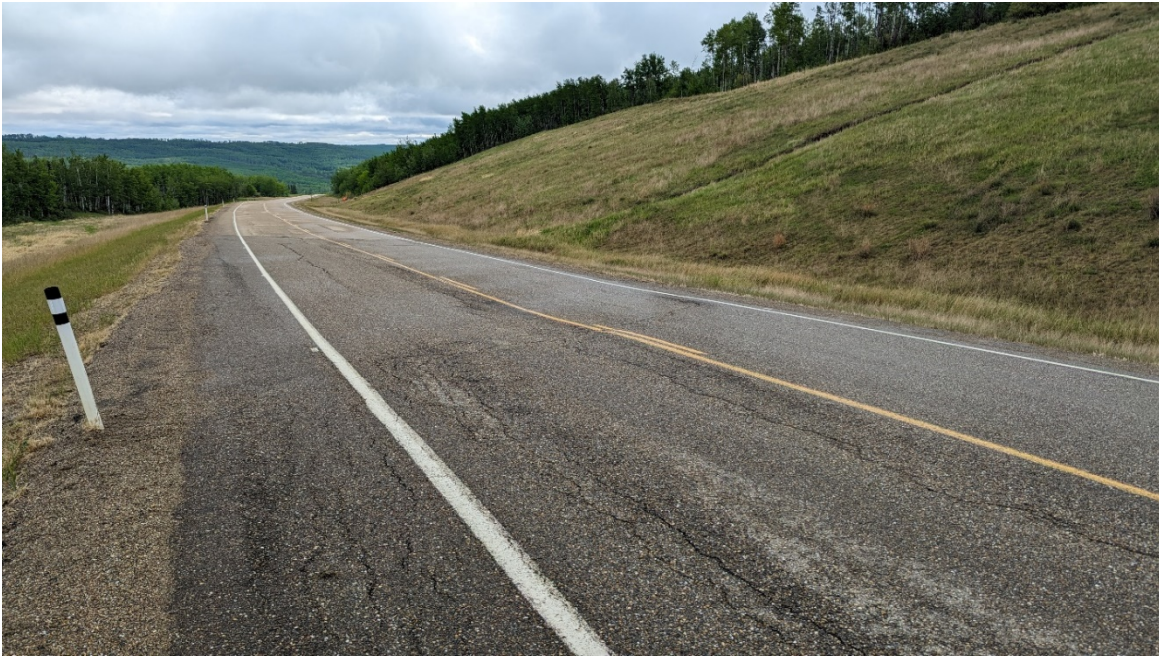
Photo 3 – Looking northeast at crack pattern reflecting through patch on highway above scarps shown in Photo 7.

The local MCI should continue to monitor the highway surface for movements and seal open cracks to limit surface water infiltration into the landslide mass.

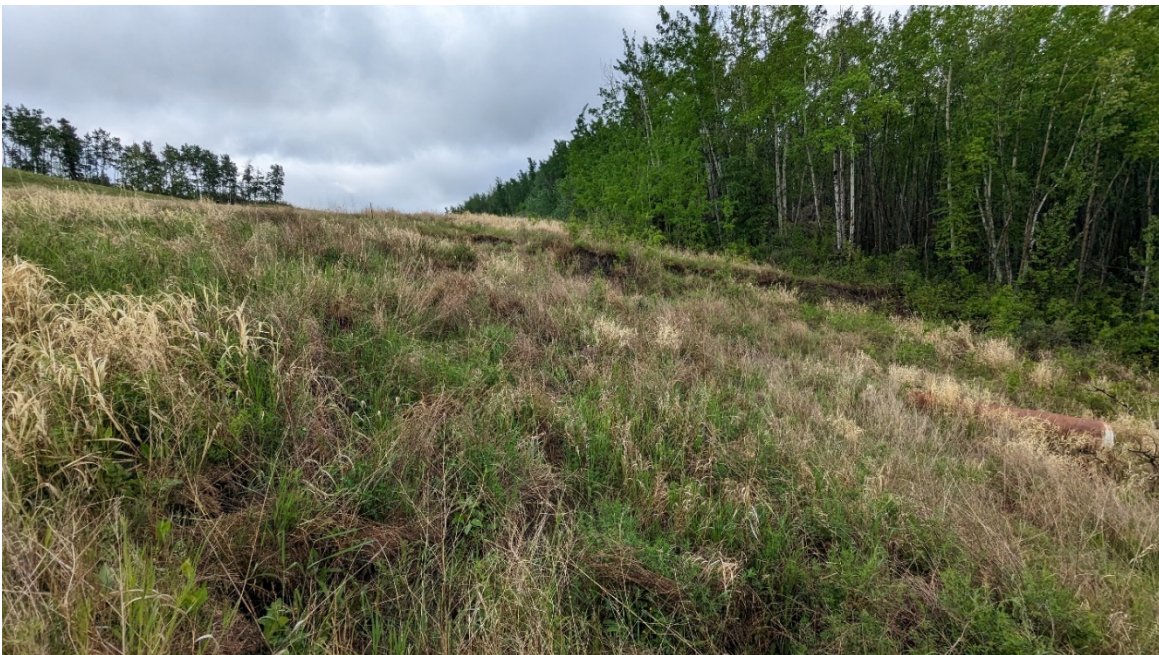
Photo 4 – Looking south at slide at km 14.45 located adjacent to south gabion basket swale. The culvert may be from the previous highway alignment.

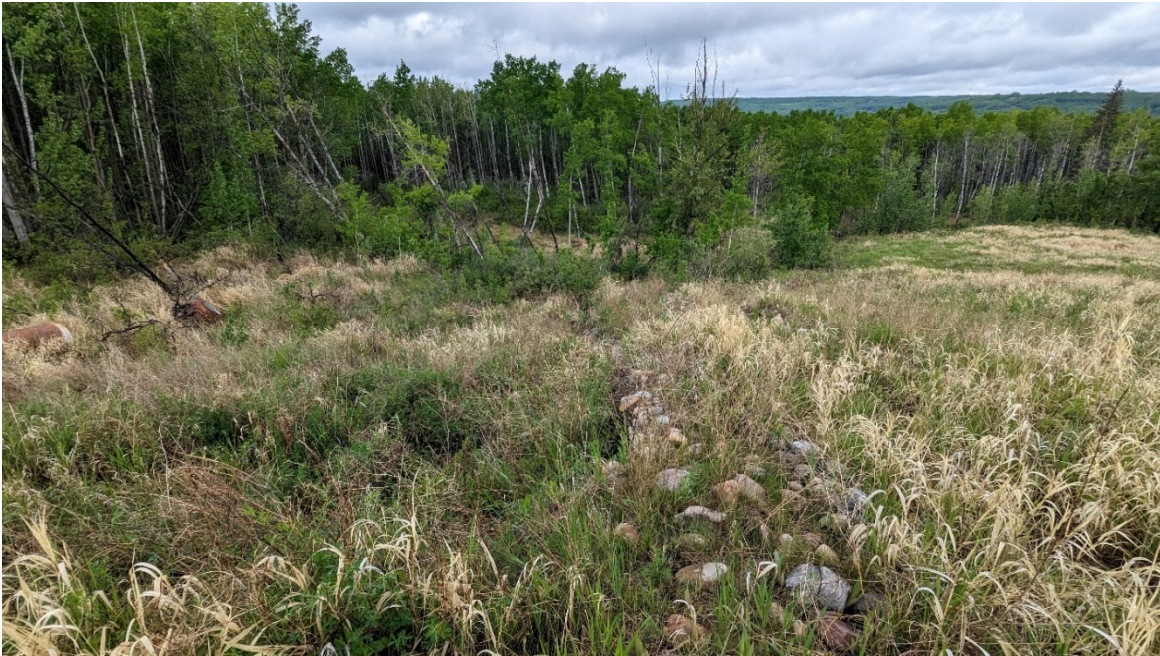
Photo 5 – Looking west where slide at km 14.45 cuts into the gabion basket swale. There has been a lot of vegetative growth in this area.

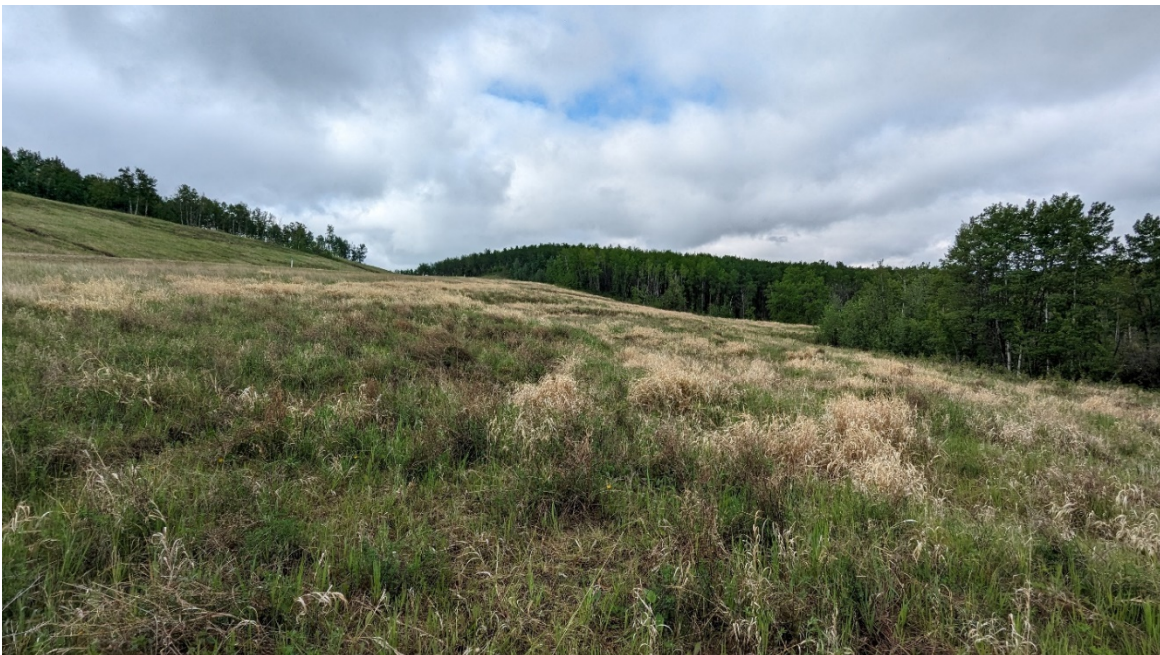
Photo 6 – Looking south at scarps downslope of highway at about km 14.6.

The large slide mass between km 14.48 and km 14.62 is active. Determining the feasibility of various mitigation options for this site requires additional investigation and study. It is recommended that a geotechnical investigation be undertaken to better understand the extent of the slide and the stratigraphy. It is recommended that two deep inclinometers be installed within this slide mass (to determine the depth and rate of movement) and a third placed upslope of the km 14.45 slump (to monitor regression toward the highway).

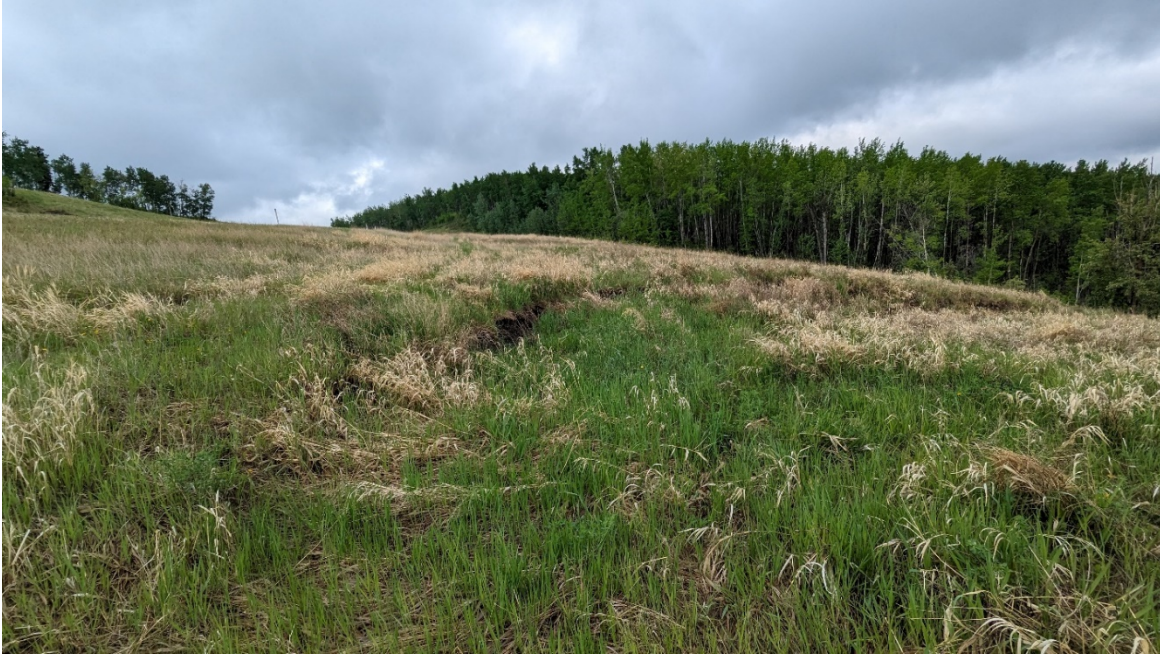
Photo 7 – Looking southeast at scarps downslope of the highway at about km 14.5.
