December 8, 2006

File: 15-85-38

**PEACE REGION (SWAN HILLS AREA) GEOHAZARD ASSESSMENT  
HWY 744:02 LITTLE SMOKY RIVER SOUTH OF BRIDGE (SH 10, SITE #1C)  
2006 ANNUAL INSPECTION REPORT**

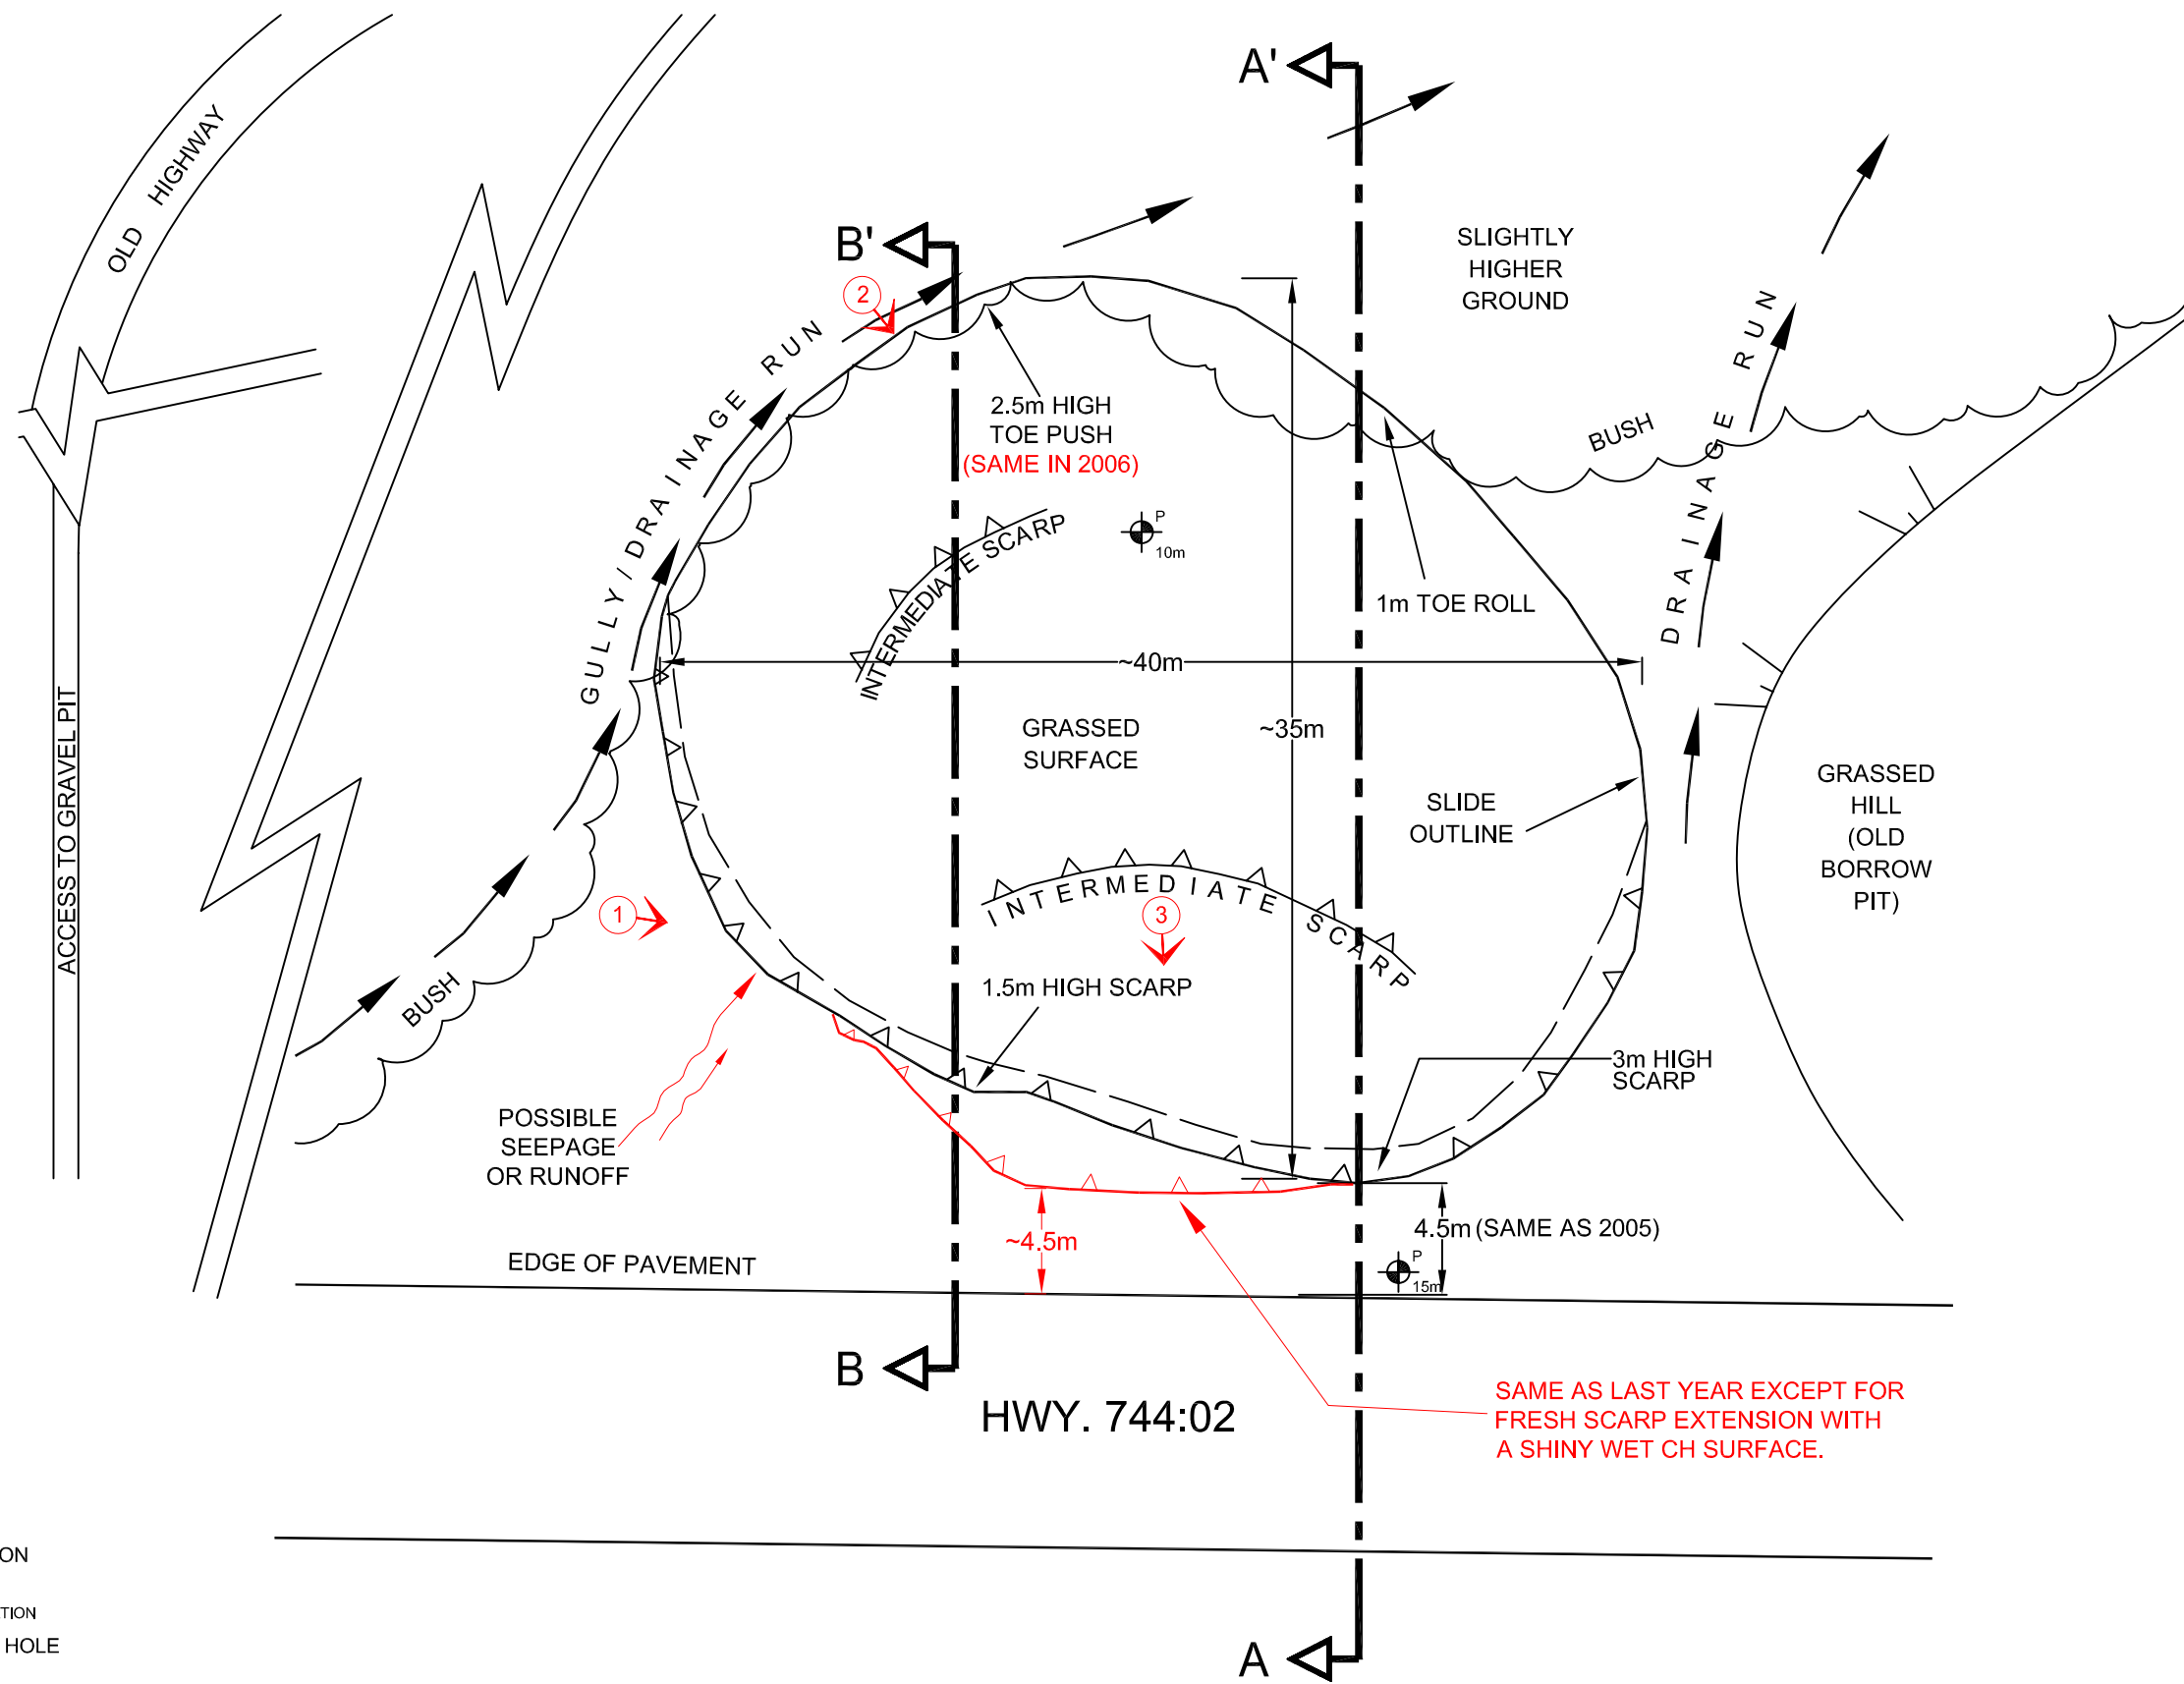
**FIGURE SH10-1C-1 - SITE PLAN  
SLIDE ON HWY 744:02, SH10-SITE 1C  
PEACE RIVER (SWAN HILLS) REGION**

During this year's visit, the backscarp had retrogressed back towards the highway further south and was about 4.5 m away from the edge of the pavement. The surface of the backscarp had a shiny appearance as in Photo 3 and was indicative of the presence of high plastic clays in the slump mass. Slight signs of surface runoff or seepage were observed on the highway embankment southeast of the slide.

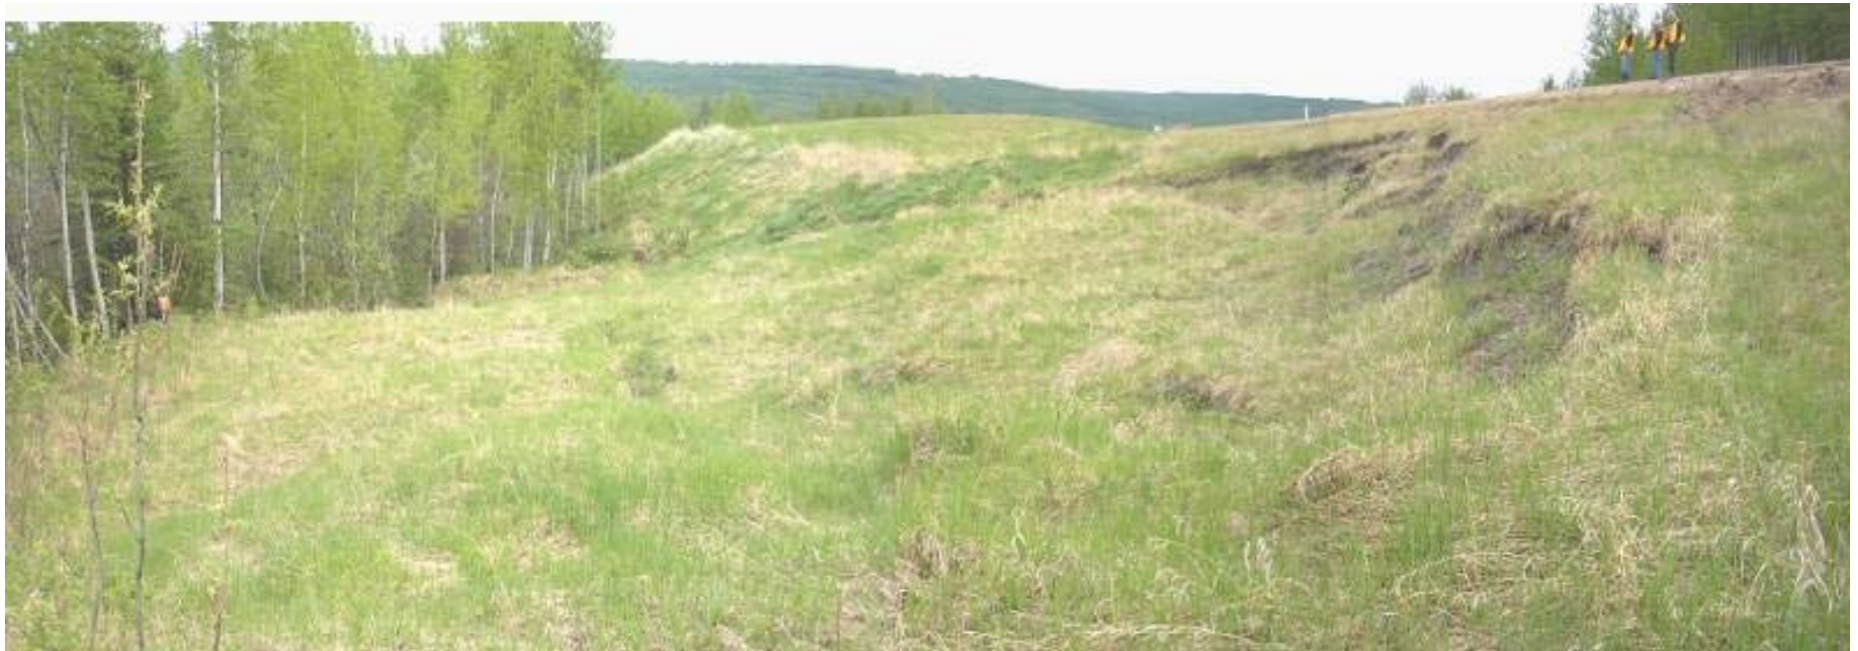
Photo 1 - Looking north from south edge of slide, May 24, 2006.

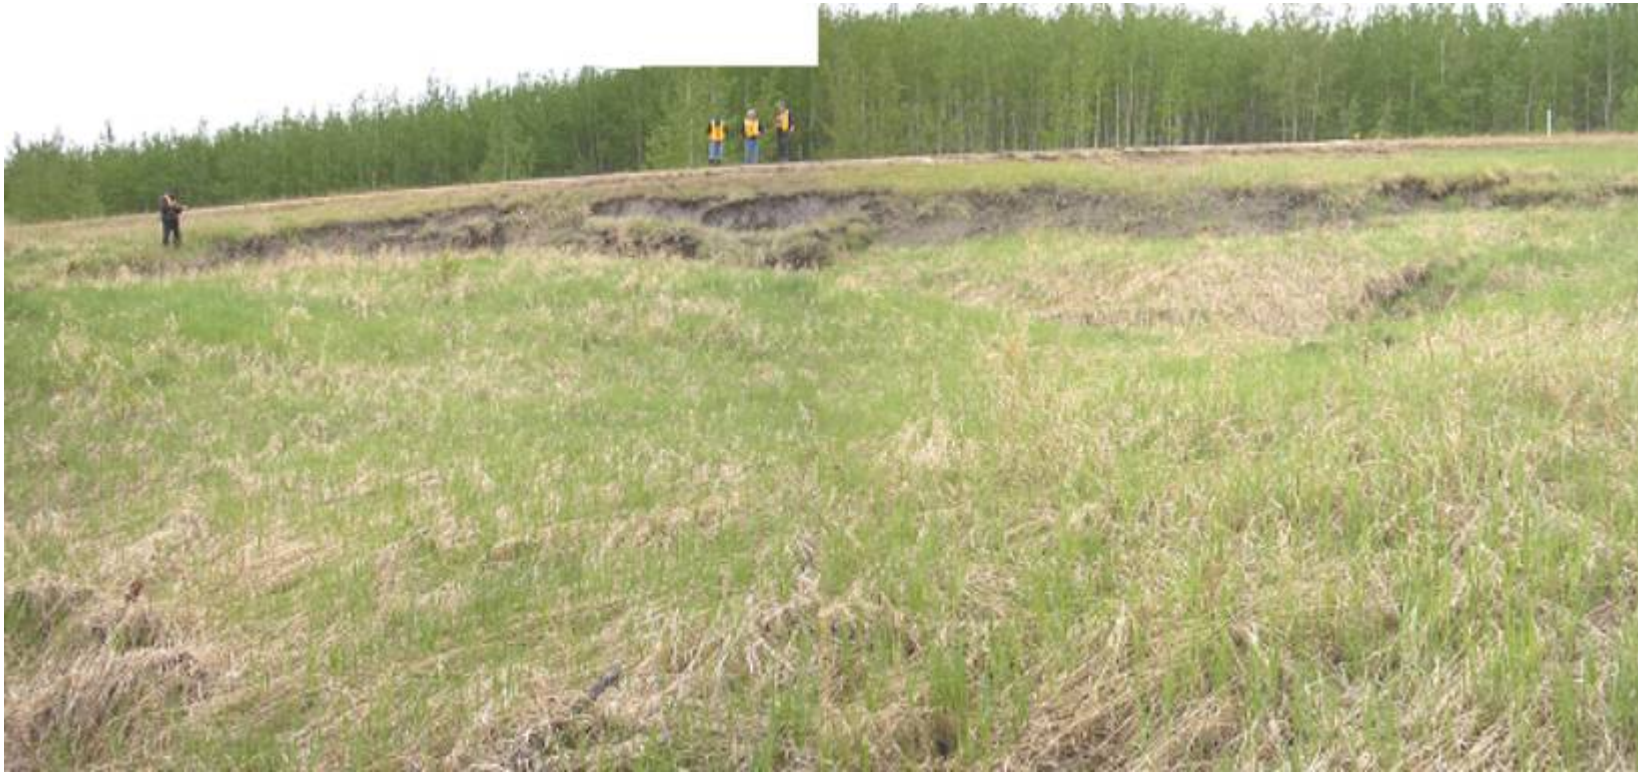
Photo 2 - Looking east from the grassed hill west of slide, May 24, 2006.

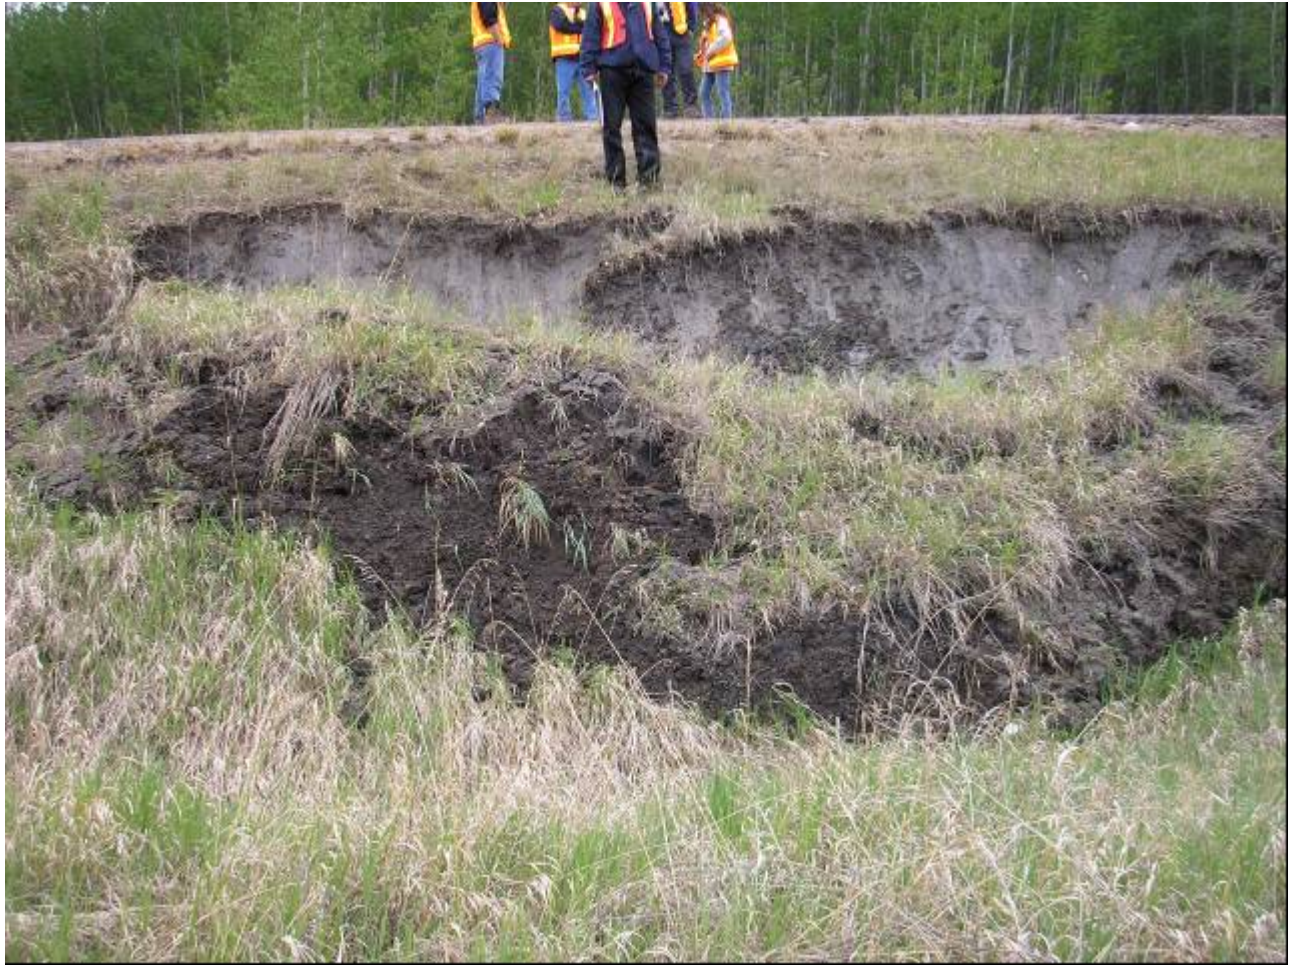
Photo 3 - Looking east (upslope) along slide from middle of slump, slickensides can be noticed, May 24, 2006.
