January 17, 2008

File: 15-85-73

**PEACE REGION (SWAN HILLS AREA) GEOHAZARD ASSESSMENT
HWY 744:02 LITTLE SMOKY RIVER SOUTH OF BRIDGE (SH 10, SITE #1C)
2007 ANNUAL INSPECTION REPORT**

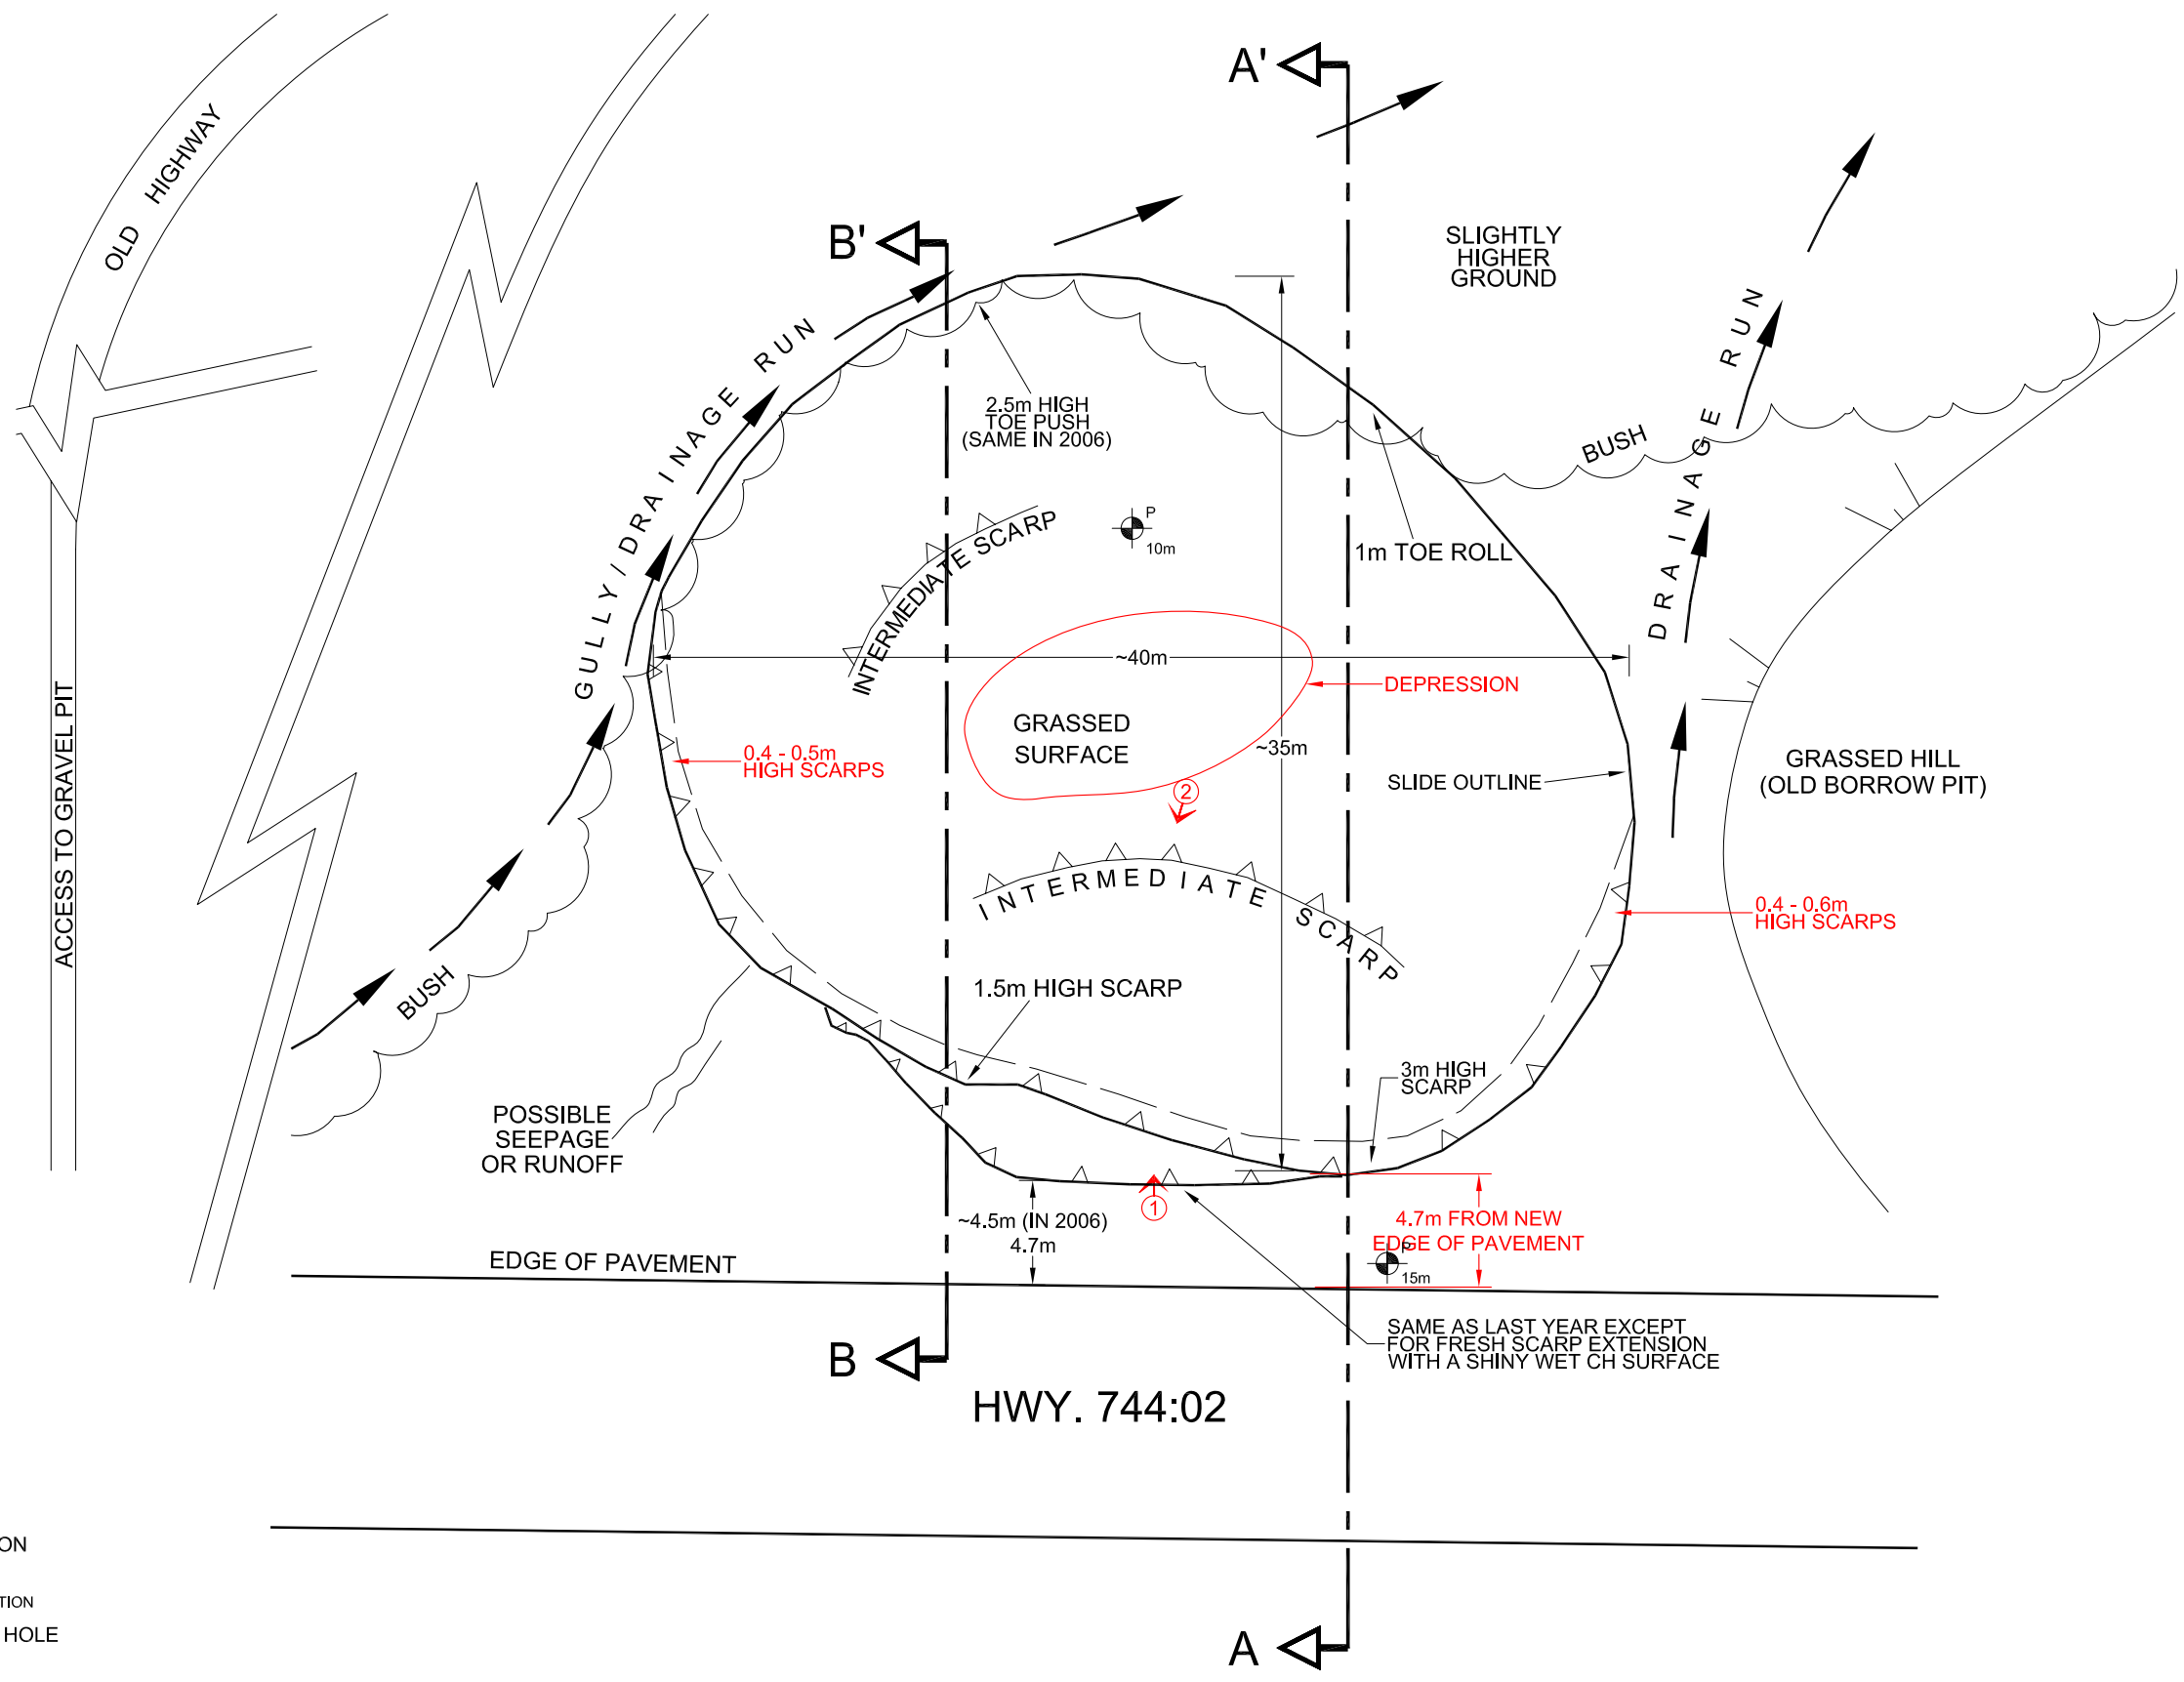
**FIGURE SH10-1C-1 - SITE PLAN
SLIDE ON HWY 744:02, SH10-SITE 1C
PEACE RIVER (SWAN HILLS) REGION**

The highway along this site was paved with an ACP overlay last year. During this year's visit, the backscarp was at the same location as last year which is about 4.7 m away from the new edge of the pavement. The height of the backscarp along the flanks of the slide varied from 0.4 m to 0.6 m. No signs of further movement or retrogression were observed. The slumped mass and the slickensides observed last year in 2006 had slight surface erosion and grass growing over it. The center of the slump mass had a more distinct depression in it. No seepage was however observed on the highway embankment southeast of the slide, as observed last year.

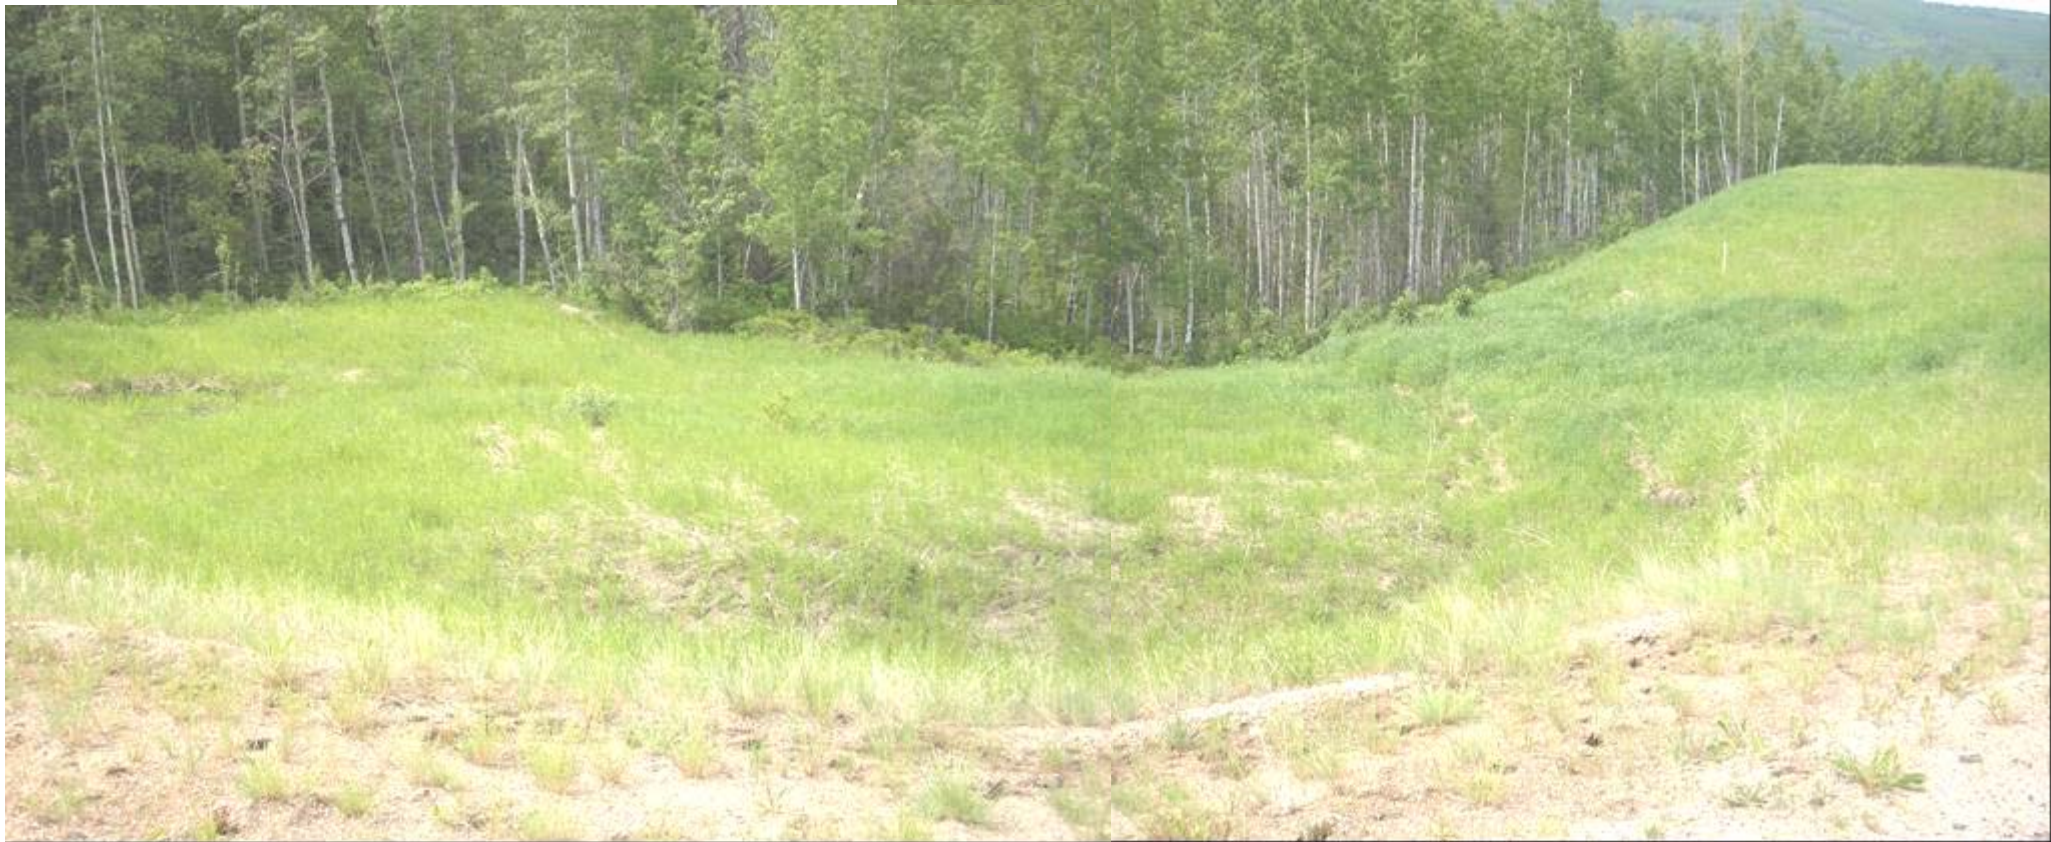
Photo 1 - Looking northwest from south edge of slide, June 14, 2007.

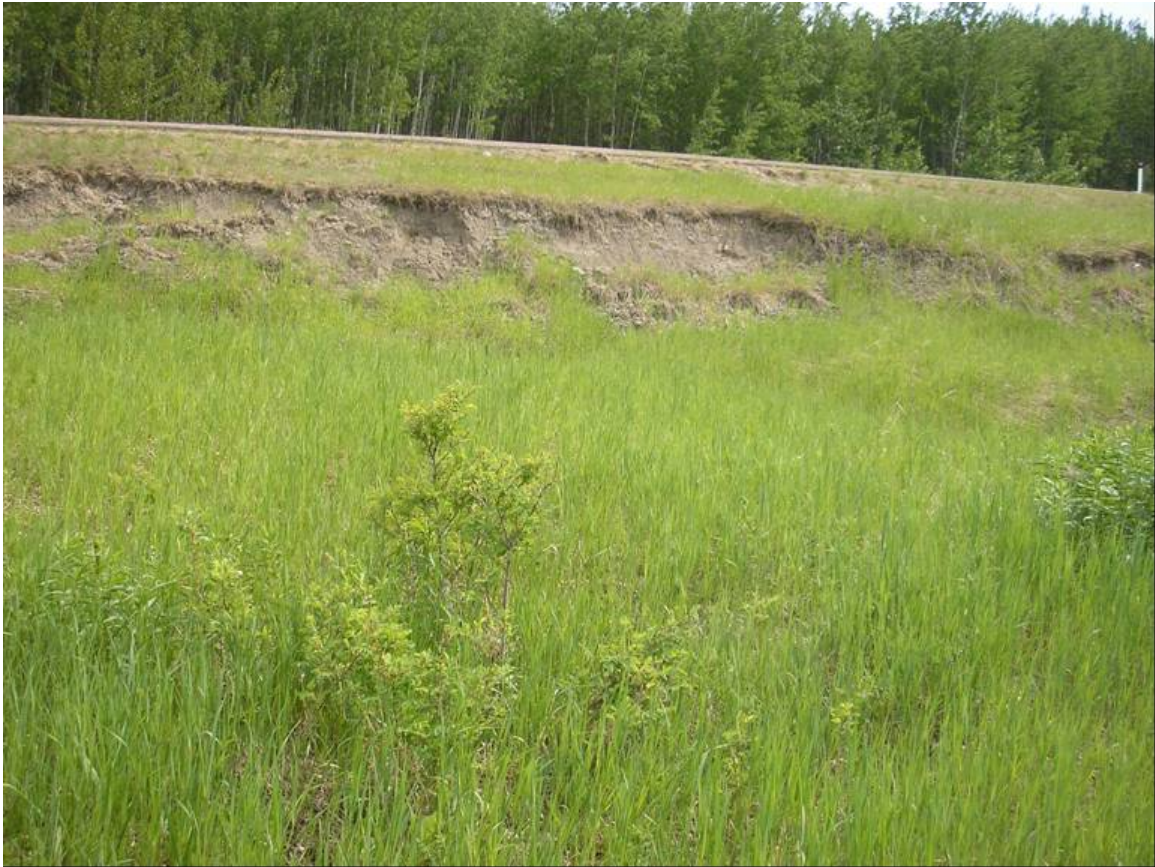
Photo 2 - Looking southeast (upslope) along slide from middle of slump.
