**ALBERTA TRANSPORTATION AND
ECONOMIC CORRIDORS
GEOHAZARD ASSESSMENT PROGRAM
PEACE REGION – SWAN HILLS
2024 INSPECTION**

Site Number	Location	Name	Hwy	km
SH011-3 SH011-4	Little Smoky River	Little Smoky River Valley, North Hill – Sites #3 and #4	744:02	18.26-18.52 18.62-18.90
Legal Description		UTM Co-ordinates		
Site 3: SE20-76-22-W5M		11U E 476,536	N	6,161,182
Site 4: SE20-76-22-W5M		11U E 476,872	N	6,161,121

SH011-3: HWY 744:02 LITTLE SMOKY RIVER VALLEY
2024 SITE INSPECTION PLAN

**SH011-4: HWY 744:02 LITTLE SMOKY RIVER VALLEY
2024 SITE INSPECTION PLAN**

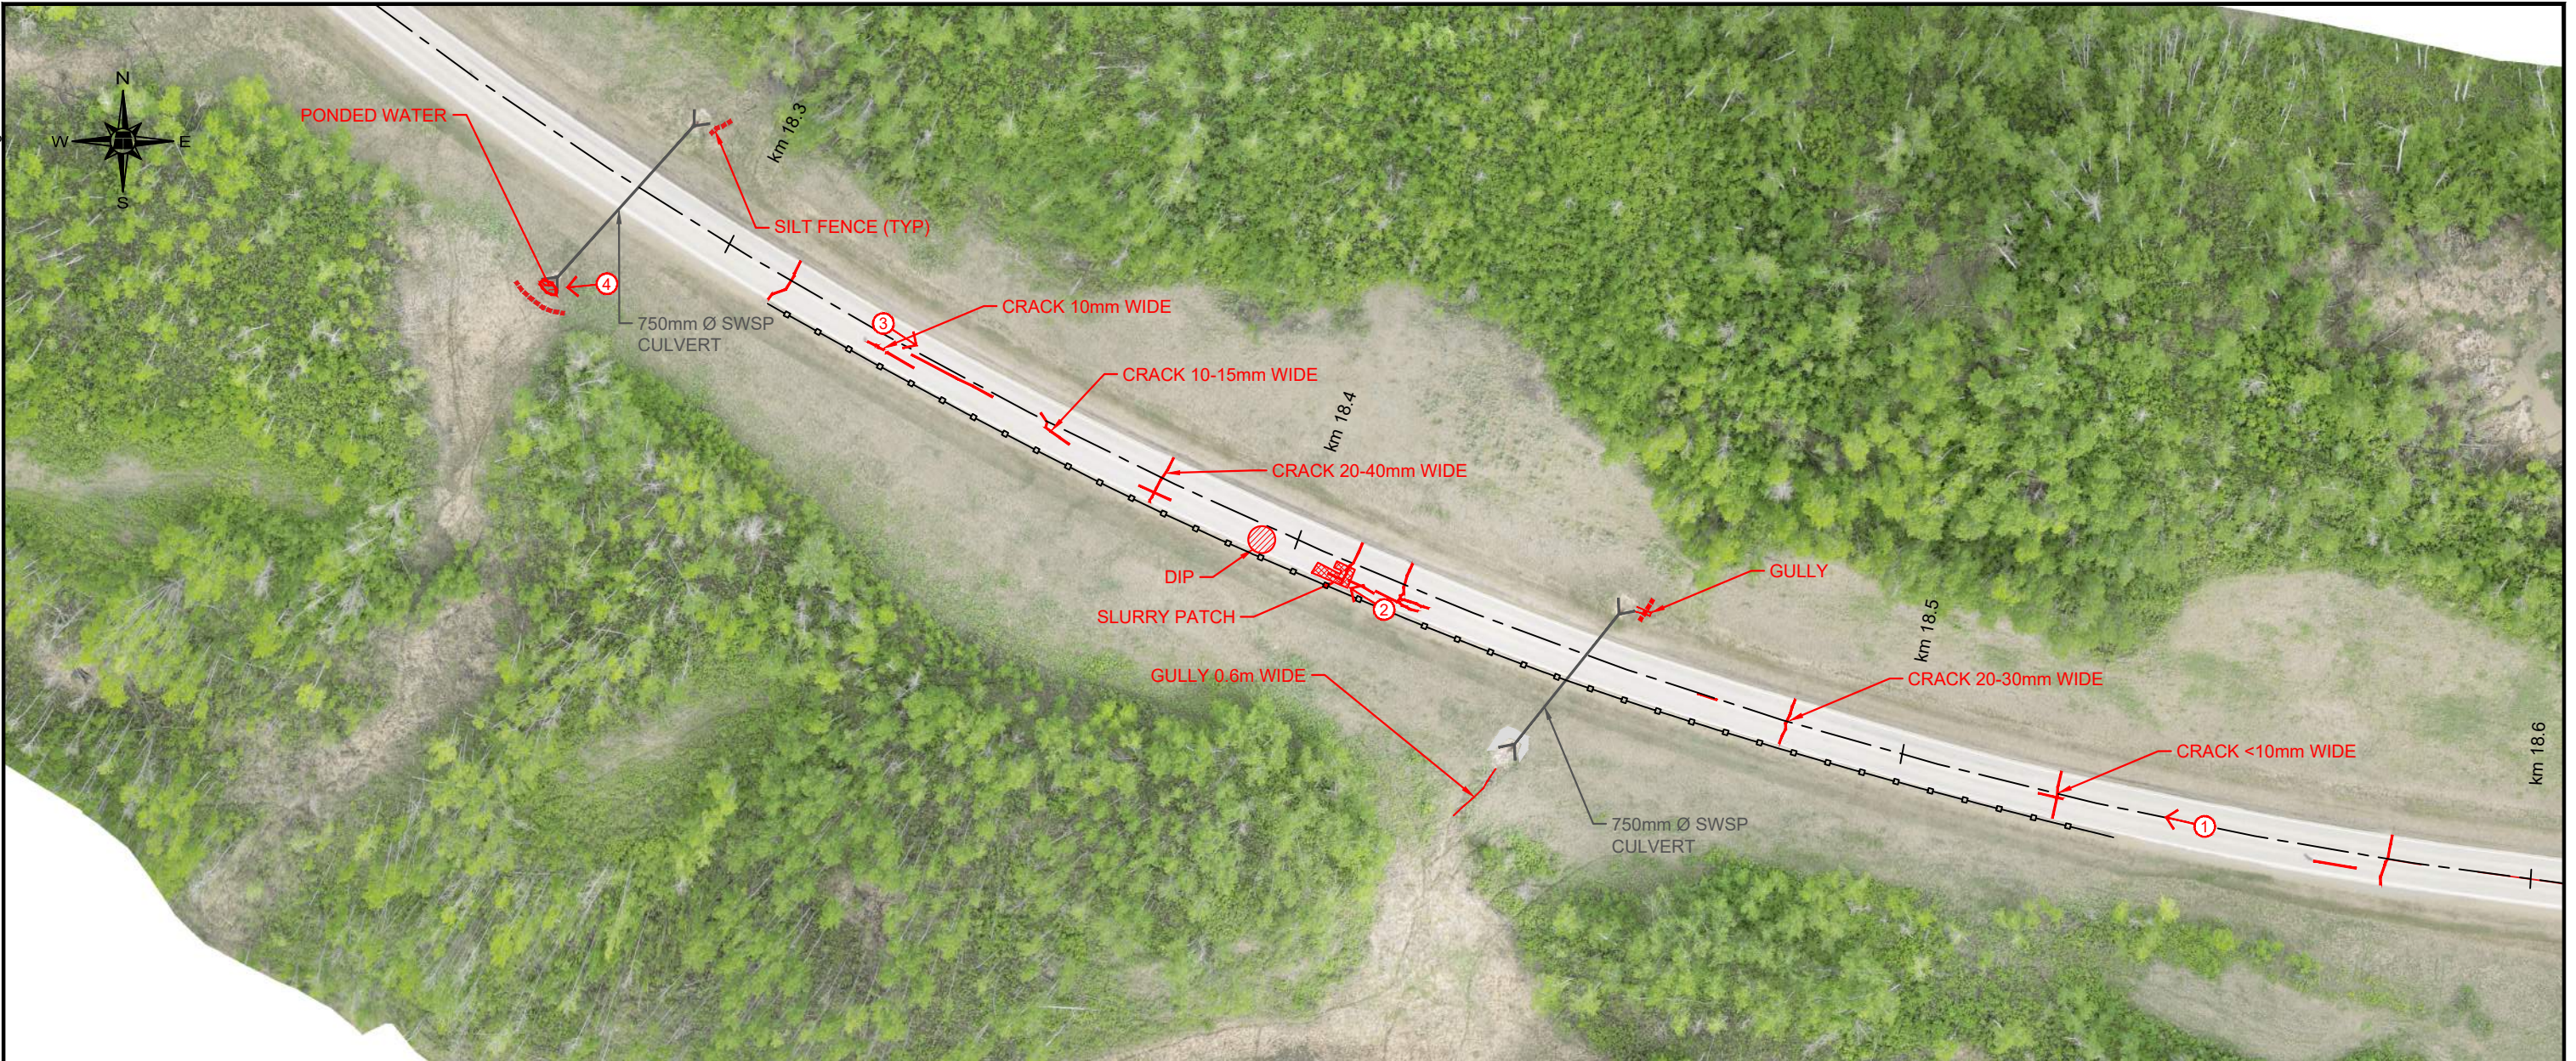
Observations (Site 3):	Description	Worsened?
<input checked="" type="checkbox"/> Pavement Distress	Site was last inspected in 2019 and the highway was overlaid in 2021. Some of the previous longitudinal and transverse cracks have reflected through. Cracks were observed on the patch along the EBL.	<input checked="" type="checkbox"/>
<input checked="" type="checkbox"/> Slope Movement	Site is located on an active deep-seated landslide moving toward the Little Smoky River.	<input type="checkbox"/>
<input type="checkbox"/> Erosion		<input type="checkbox"/>
<input type="checkbox"/> Seepage		<input type="checkbox"/>
<input checked="" type="checkbox"/> Bridge/Culvert	SWSP culverts were likely installed during the 2021 overlay and replaced older CSP culverts. Culvert at km 18.28: Pounded water observed at outlet. Culvert at km 18.44: Erosion gullies observed at inlet and outlet.	<input type="checkbox"/>

Recommendations:		
<p>Short-Term:</p> <ul style="list-style-type: none"> ▪ Road maintenance should continue as necessary to maintain a safe roadway surface and may consist of milling, patching, and crack sealing of the ACP. ▪ Ditches (Site #4) and culvert outlets (Site #3) should be regraded to allow ponded water to drain. <p>Long-Term:</p> <p>It is understood that, currently, the only remediation option under consideration is realignment of the north hill section of Highway 744. A study is currently being undertaken for this purpose. Consideration is also being given to a shorter realignment which will occur farther up the slope and will likely not include Sites #3 and #4.</p> <p>Ongoing Investigation:</p> <ul style="list-style-type: none"> ▪ It is recommended that the bi-annual geohazard inspection continue as scheduled for Site #4 and include Site #3 due to the recent changes observed during the 2024 inspection. ▪ Test holes and instrumentation could be considered in the future in advance of any planned re-alignments or major slide repairs.

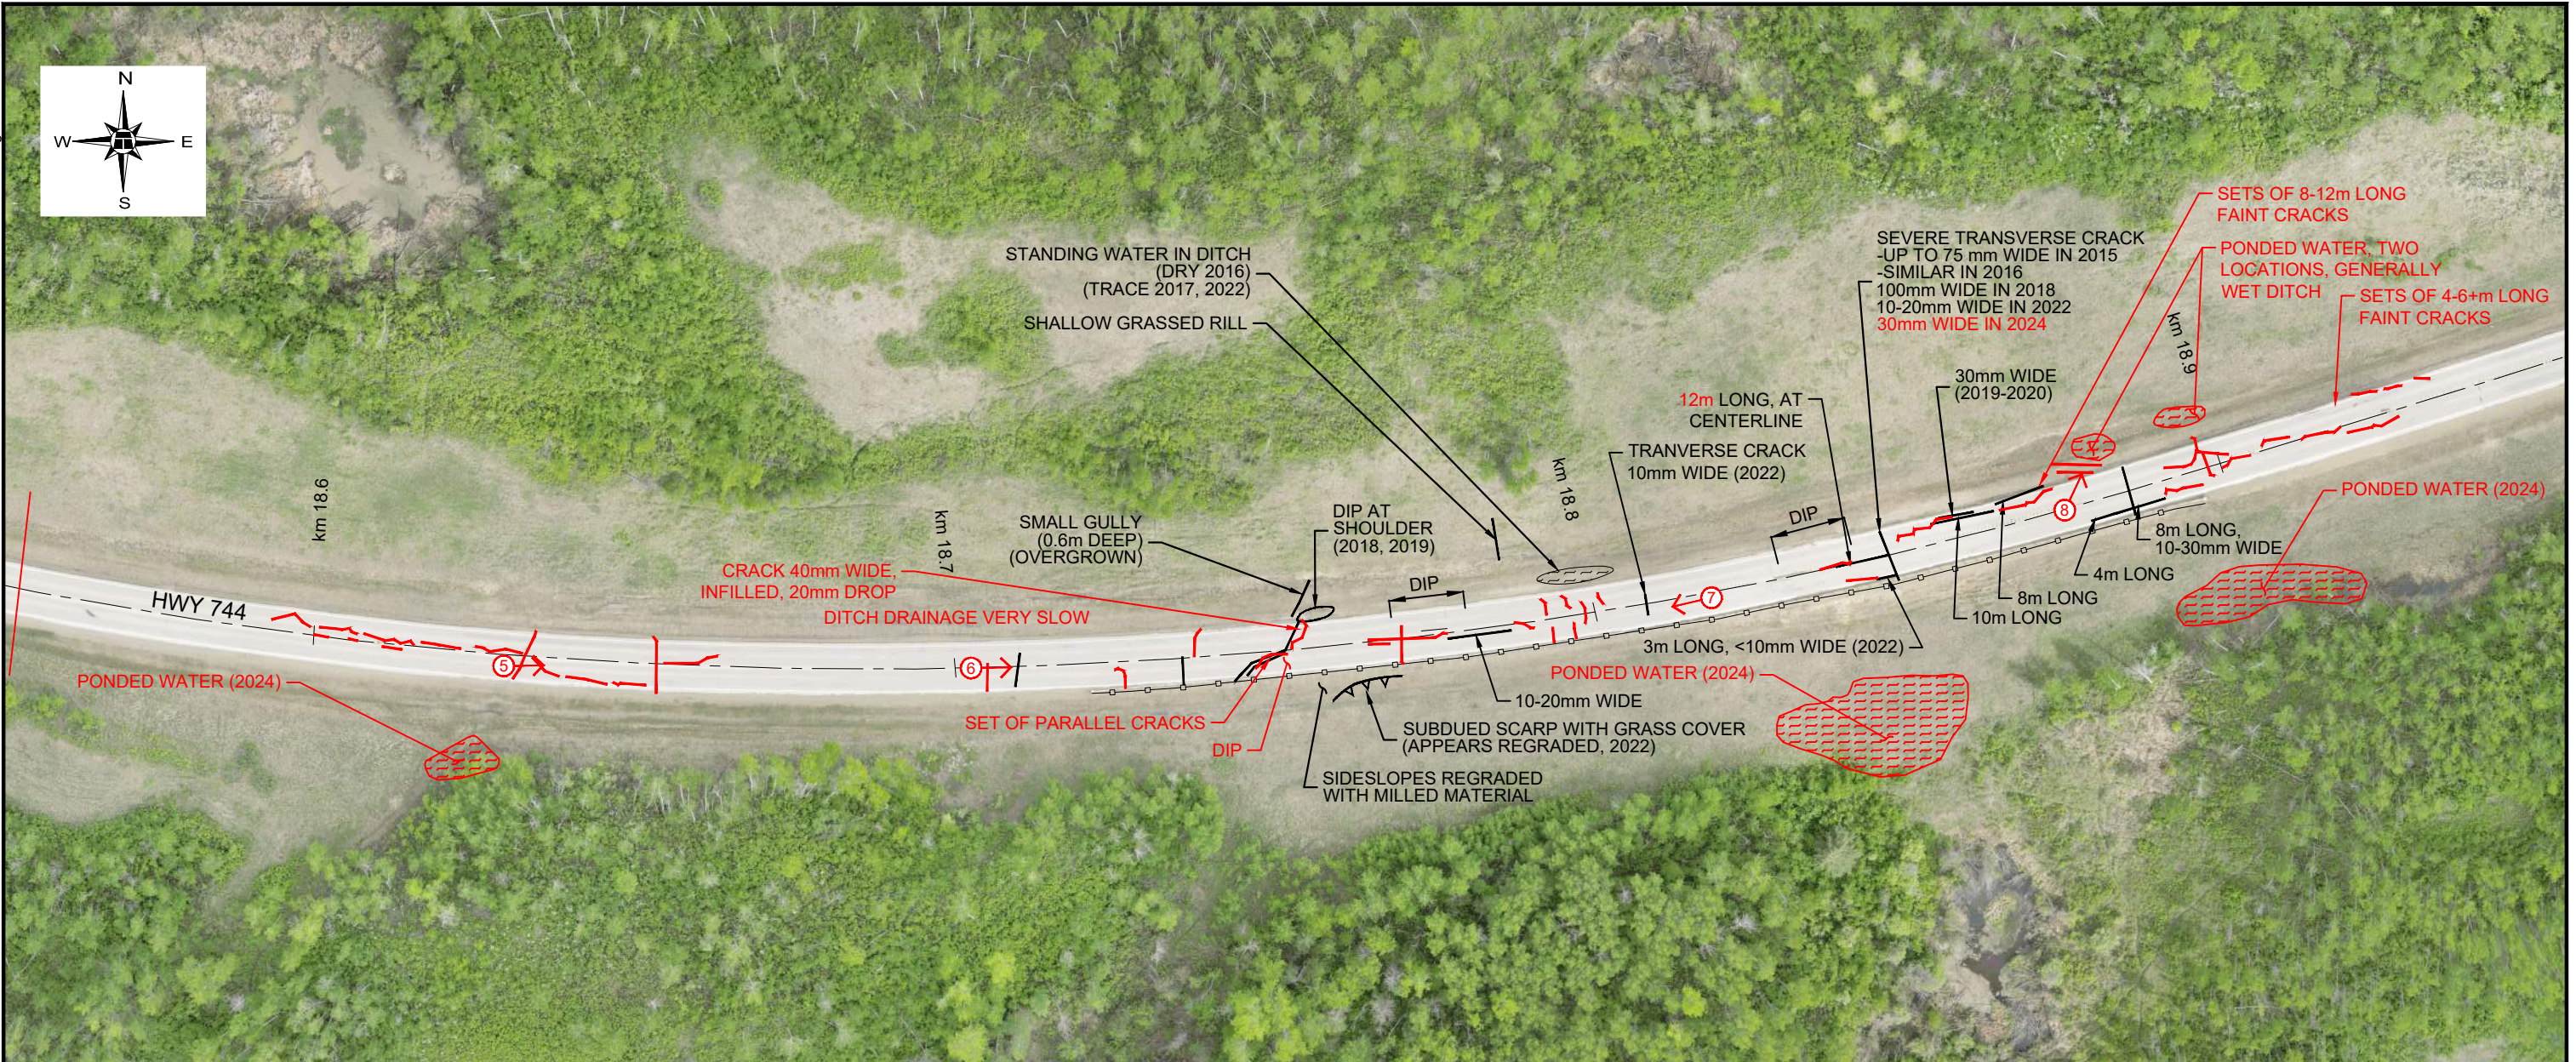
<input type="checkbox"/> Other		<input type="checkbox"/>
Observations (Site 4):	Description	Worsened?
<input checked="" type="checkbox"/> Pavement Distress	Some of the previous longitudinal and transverse cracks have reflected through and there are minor pavement undulations due to movement.	<input checked="" type="checkbox"/>
<input checked="" type="checkbox"/> Slope Movement	Site is located on an active deep-seated landslide moving toward the Little Smoky River.	<input checked="" type="checkbox"/>
<input type="checkbox"/> Erosion		<input type="checkbox"/>
<input checked="" type="checkbox"/> Seepage	Ponded water observed at several locations along north ditch and south of the highway. Ditch drainage appears to be very slow.	<input checked="" type="checkbox"/>
<input type="checkbox"/> Bridge/Culvert	No culverts within site boundaries	<input type="checkbox"/>
<input type="checkbox"/> Other		<input type="checkbox"/>

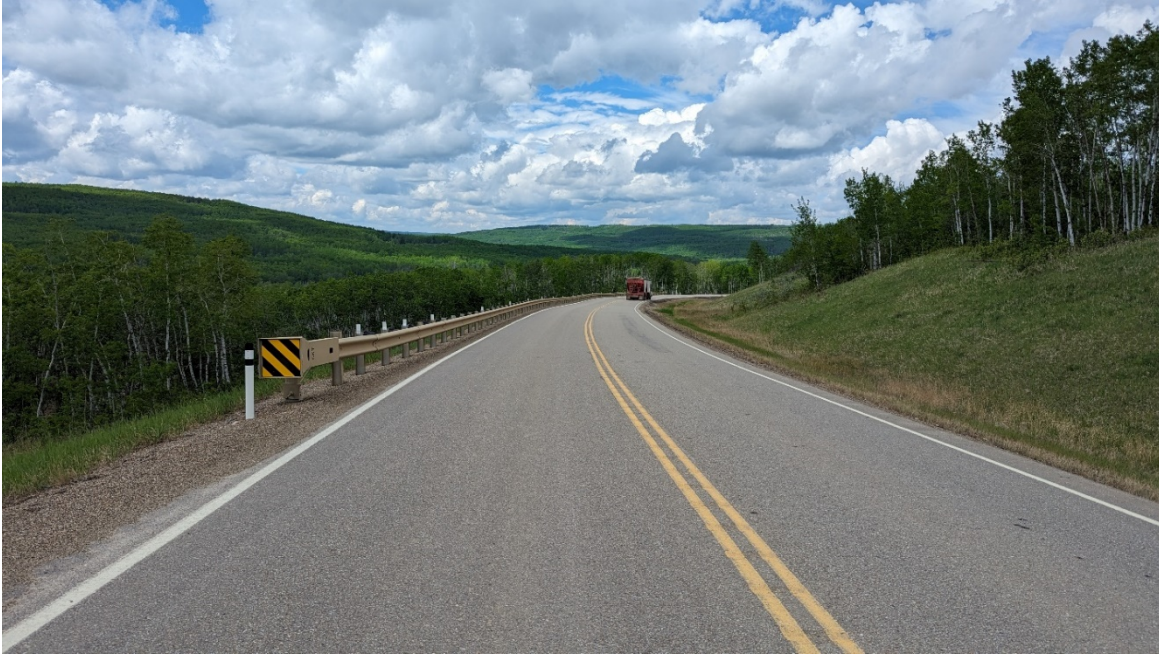
Photo 1, Site 4 – Looking northwest from the east end of site.

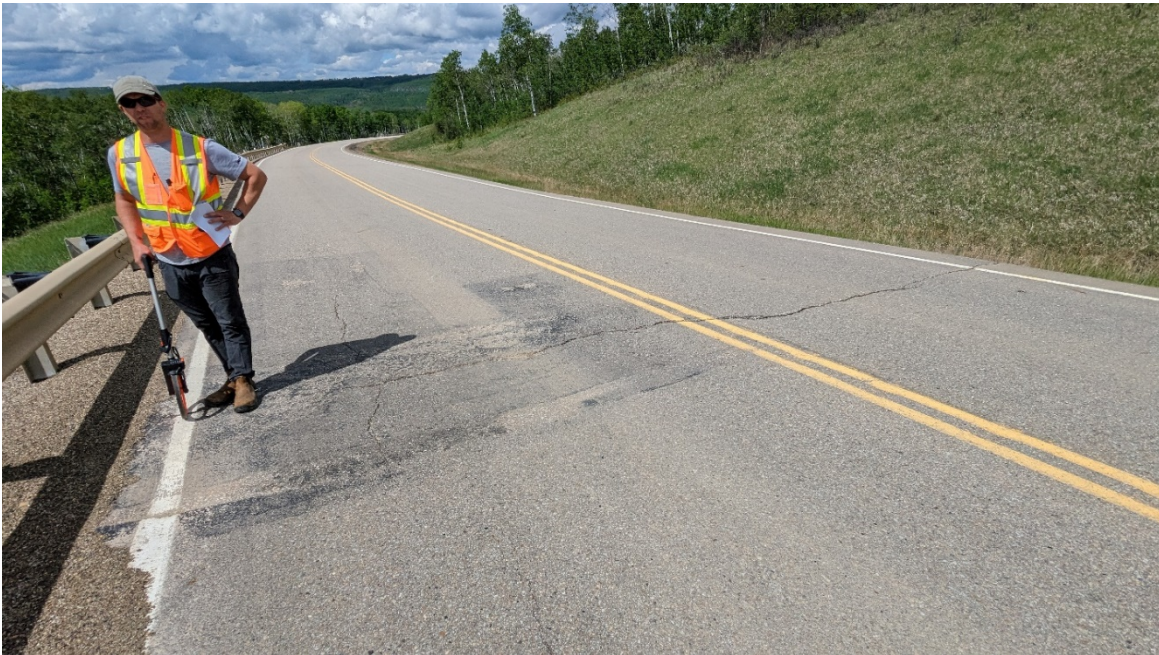
Photo 2, Site 4 – Looking northwest at cracking on patch along EBL.

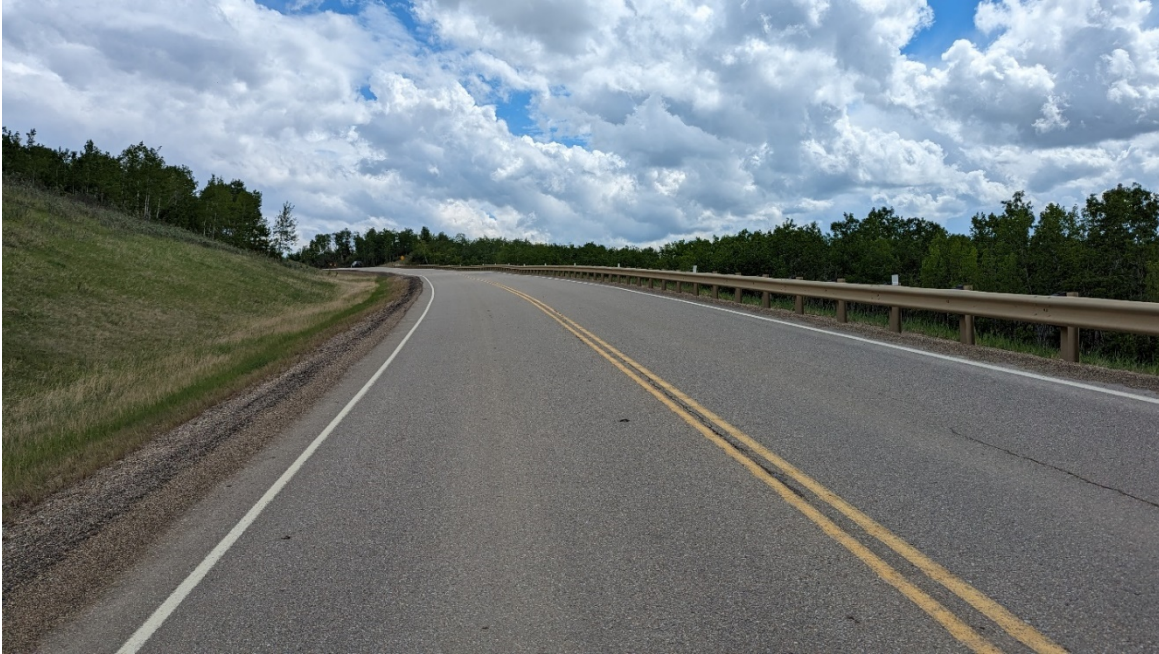
Photo 3, Site 4 – Looking southeast at cracking in highway surface at ~km 18.33.

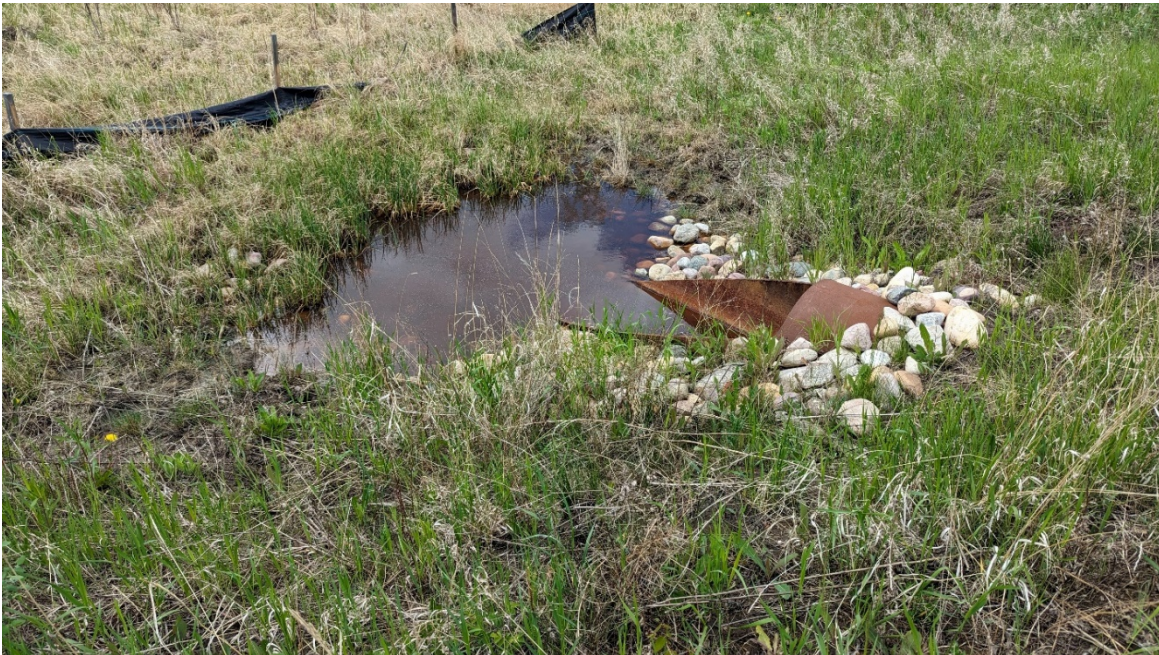
Photo 4, Site 3 –Ponded water observed at culvert outlet at km 18.28

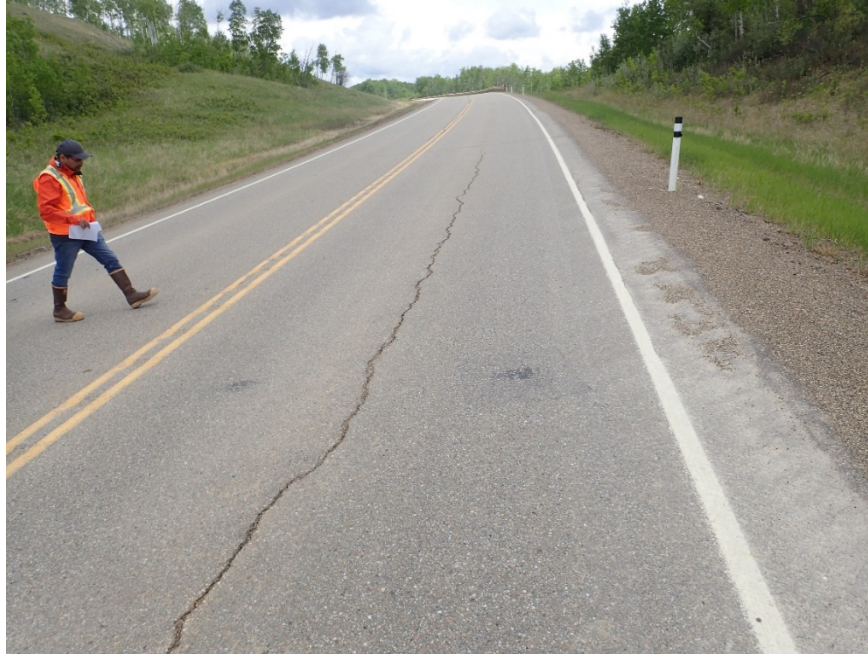
Photo 5, Site 4 – Looking east from the west end of site.

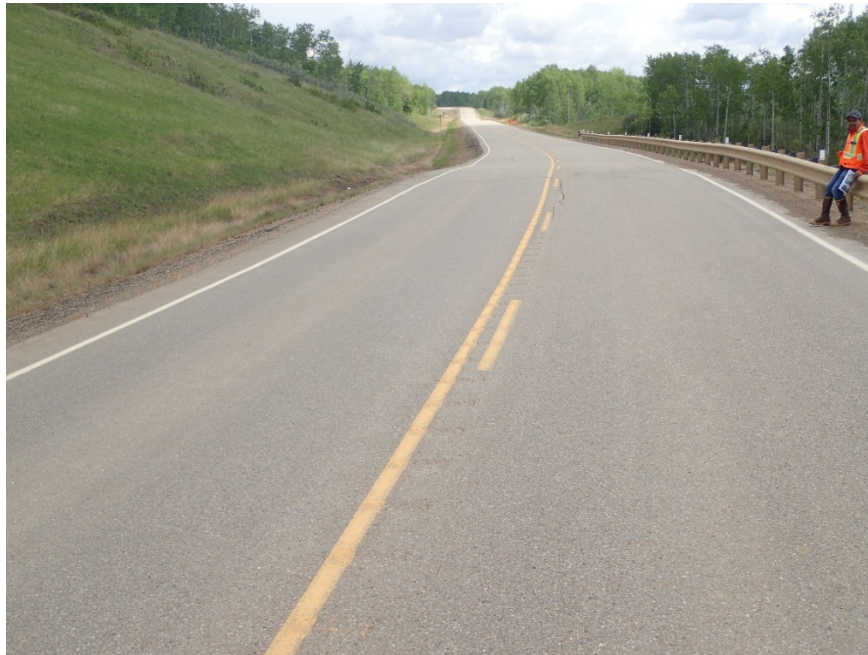
Photo 6, Site 4 – Looking east at ~km 18.73 where dip was observed.

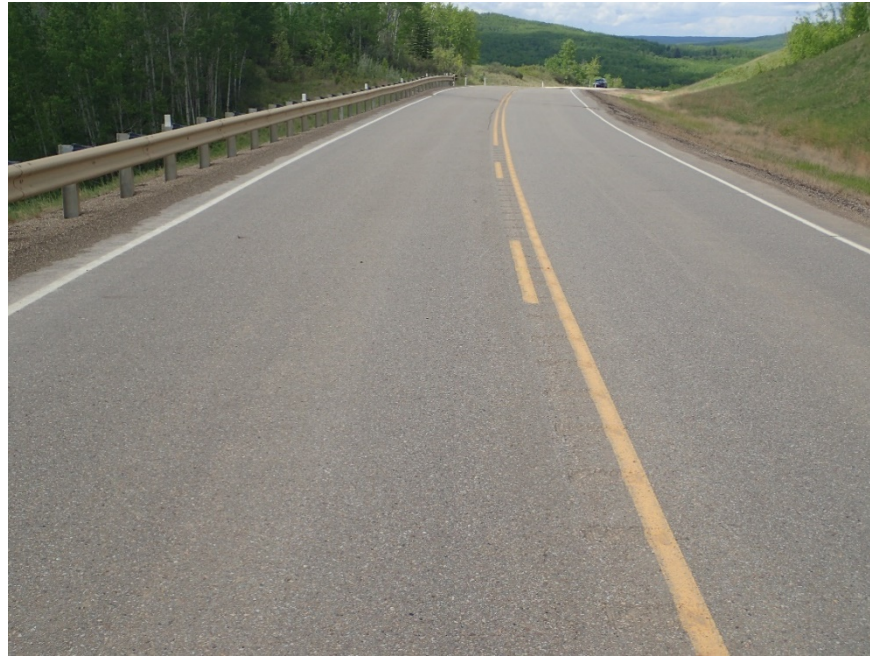
Photo 7, Site 4 – Looking west at ~km 18.82.

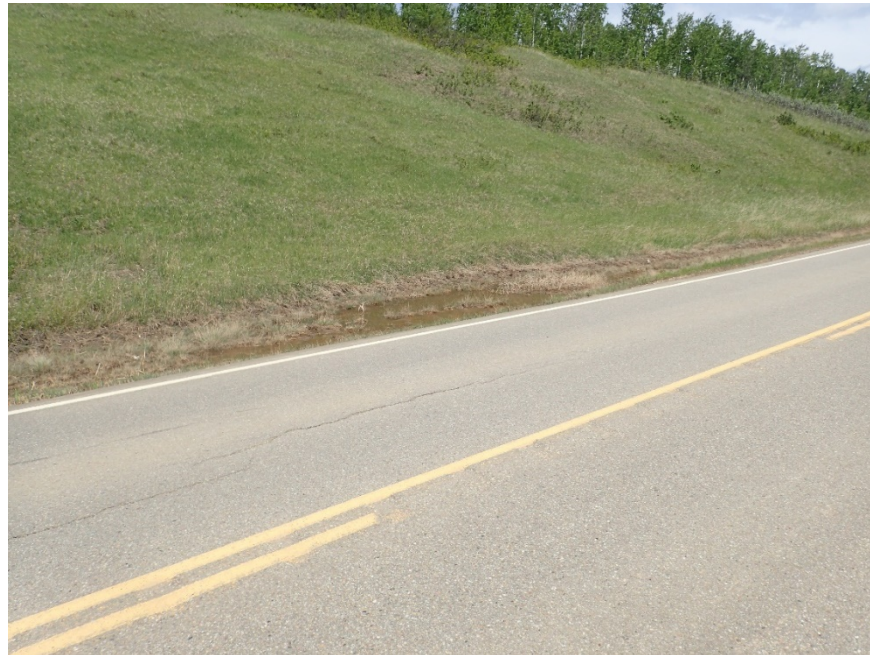
Photo 8, Site 4 – Looking northeast at ponded water in north ditch.
